ASBESTOS SURVEY REPORT FOR TOWN END ACADEMY, TOWN END FARM, SUNDERLAND, SR5 4NX

**Town End Academy, Town End Farm, Sunderland**

**Date: 28 March 2025**

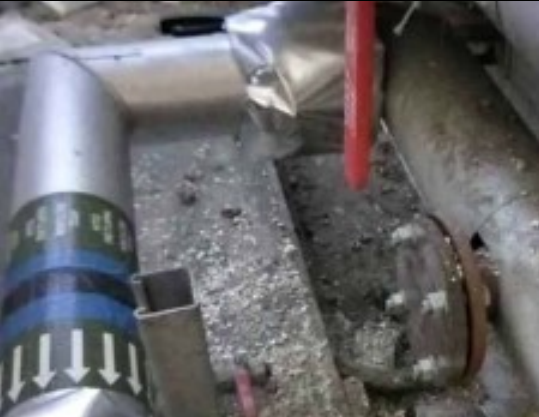
22	AW006019	Pipework Gaskets	Boiler Room G/083	No Risk

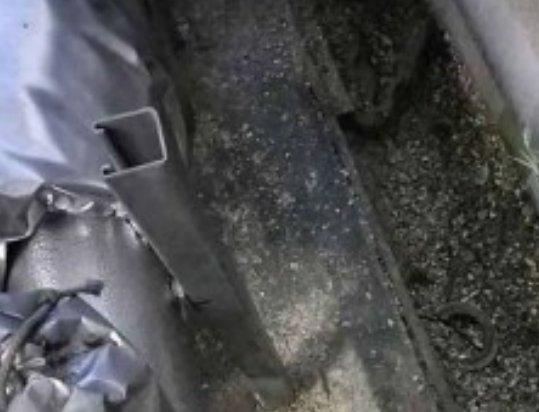
23	AW006020	Floor Debris	Boiler Room G/083	No Risk

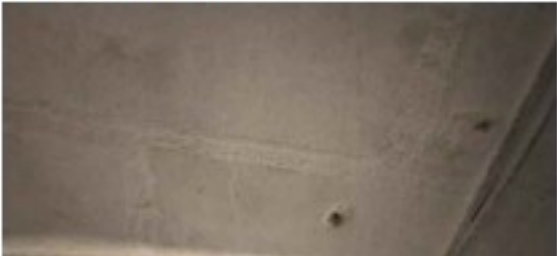
24	AW006021	Wall Debris	Boiler Room G/083	Low Risk – 6 monthly
<b>Photo 1: Wide Angle</b>			<b>Photo 2: Clos</b>

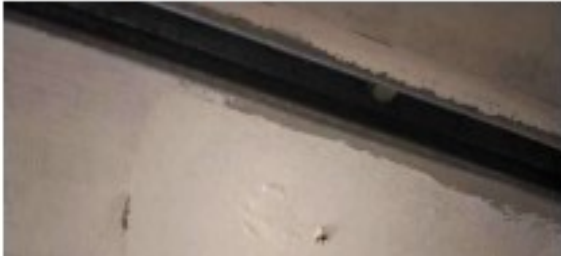
25	AW006022	Ceiling Debris	Boiler Room G/083	Low Risk – 6 monthly
<b>Photo 1: Wide Angle</b>			<b>Photo 2: Clos</b>

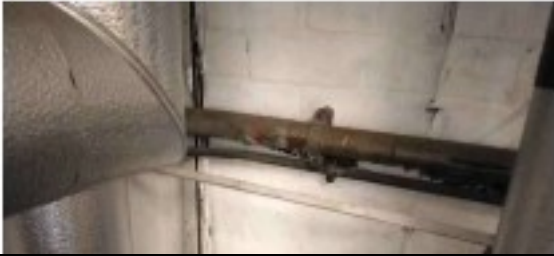
26	AW006023	Debris to electrical conduits	Boiler Room G/083	Low Risk – 6 monthly
<b>Photo 1: Wide Angle</b>			<b>Photo 2: Clos</b>

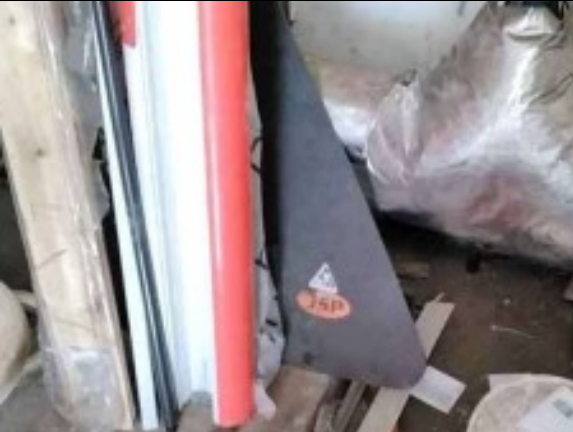
27	AW006024	Floor Debris	Boiler Room G/083	No Risk

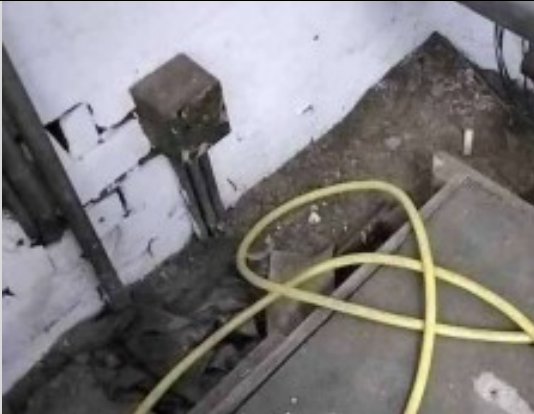
28	AW006025	Floor Debris	Boiler Room G/083	No Risk

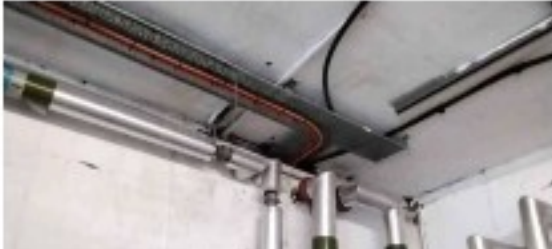
29	AW006026	Pipework Gaskets	Boiler Room G/083	Very Low Risk – 12 monthly
<b>Photo 1: Wide Angle</b>			<b>Photo 2: Close</b>

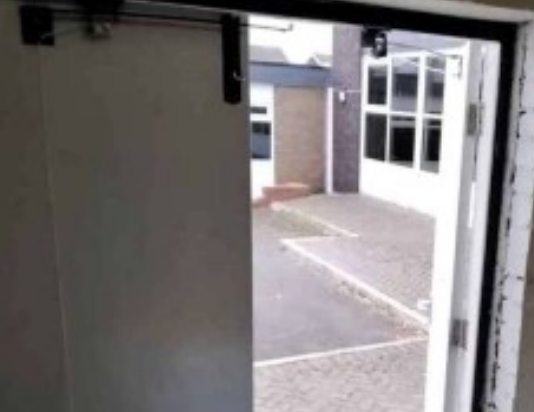
30	AW006027	Wall cavity damp proof course	Boiler Room G/083	No Risk

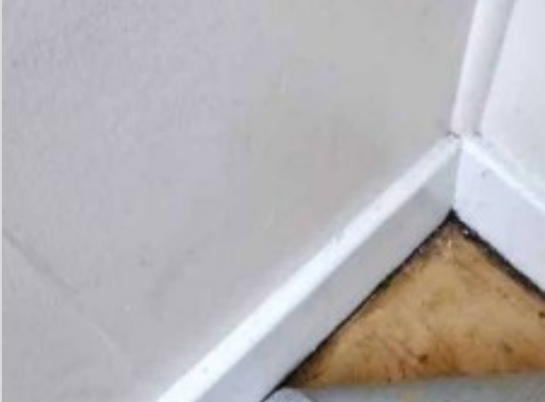
34	As AW006014	Floor covering	Lobby 1/002	No Risk

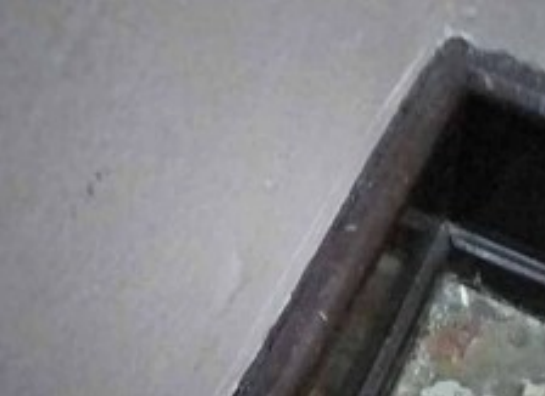
36	AW006018	Floor screed	Classroom 1/005	No Risk

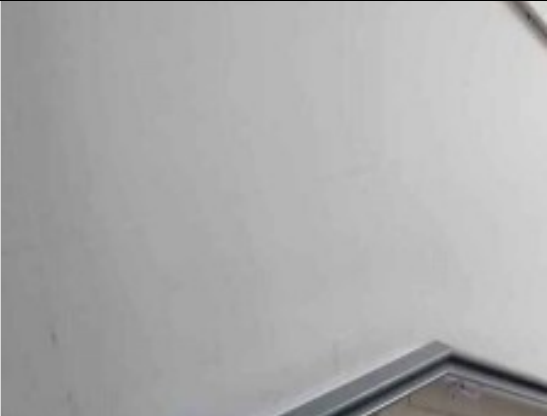
40	As AW006013	Wall tile	Stairwell 1/008	No Risk

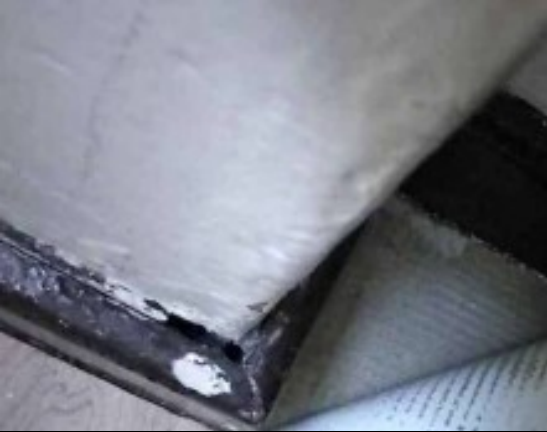
41	As AW006018	Floor screed	Classroom 1/009	No Risk

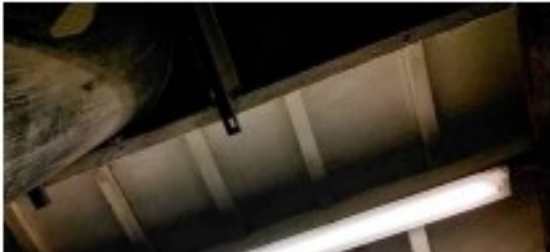
42	AW005977	Ceiling	Tank Room R/001	Very Low Risk – 12 monthly
<b>Photo 1: Wide Angle</b>			<b>Photo 2: Close</b>

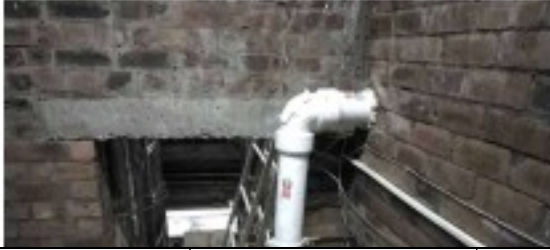
43	AW005978	Flue Pipe	Tank Room R/001	Very Low Risk – 12 monthly
<b>Photo 1: Wide Angle</b>			<b>Photo 2: Close</b>

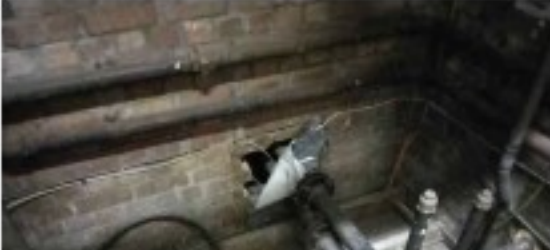
44	AW005979	Pipework Gasket	Tank Room R/001	Very Low Risk – 12 monthly
<b>Photo 1: Wide Angle</b>			<b>Photo 2: Close</b>

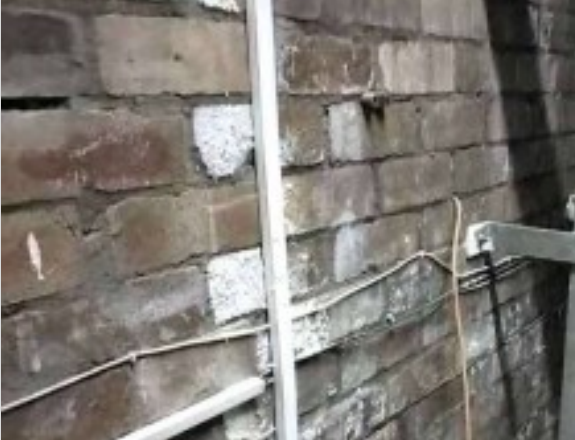
45	AW005980	Damp proof course	Tank Room R/001	No Risk
