ASBESTOS SURVEY REPORT FOR BEXHILL ACADEMY, TOWN END FARM, SUNDERLAND, SR5 4PJ

Bexhill Academy, Town End Farm, SR5 4PJ

Date: 30 July 2025

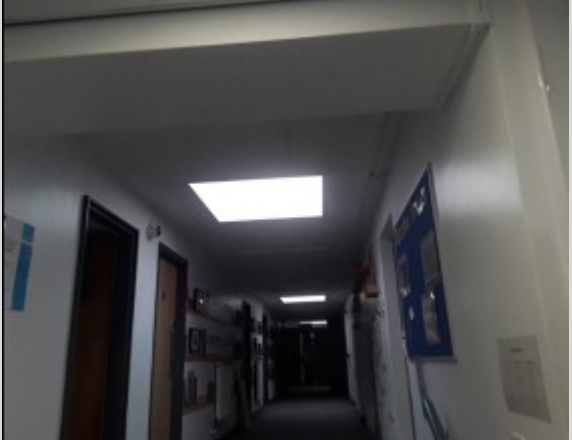
1	NZ001636	Ceiling tile – solid within ceiling void and corridor	Reception/Entrance Hall including corridor G/002	No Risk

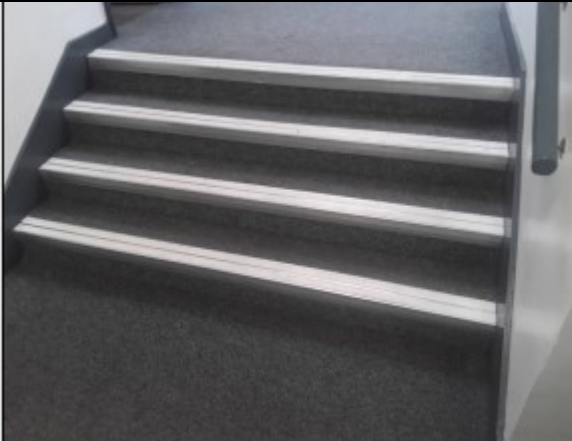
2	NZ001637	Floor nosing to stairs	Reception/Entrance Hall including corridor G/002	No Risk

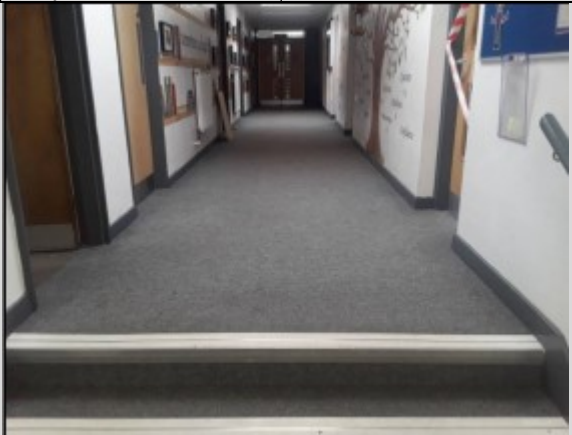
3	NZ001638	Floor tile with adhesive under carpet	Reception/Entrance Hall including corridor G/002	No Risk

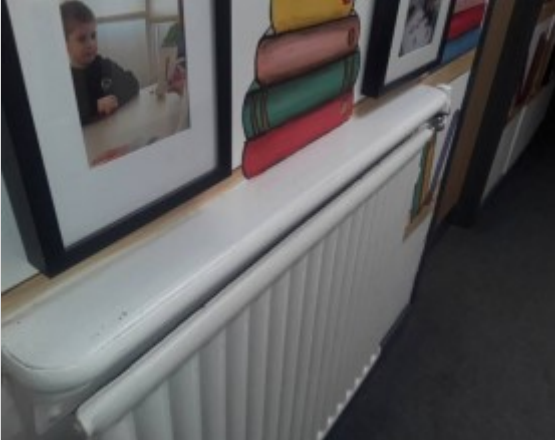
4	As NZ001654	Shelving putty to shelving above radiator	Reception/Entrance Hall including corridor G/002	No Risk

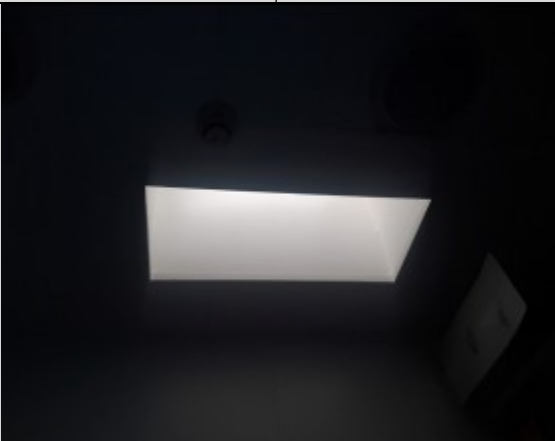
5	As NZ001636	Ceiling tile – solid	Corridor to Kitchen G/005	No Risk

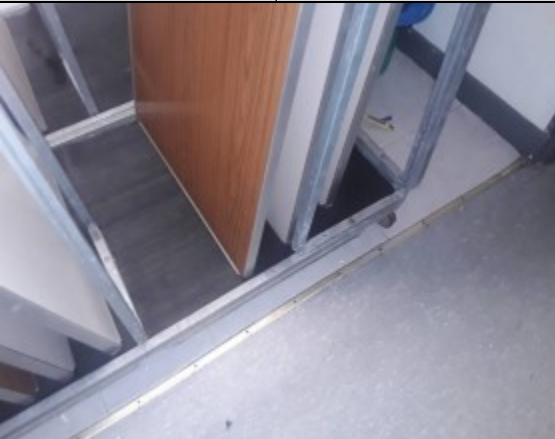
6	NZ001639	Floor tile with adhesive	Corridor to Kitchen G/005	No Risk

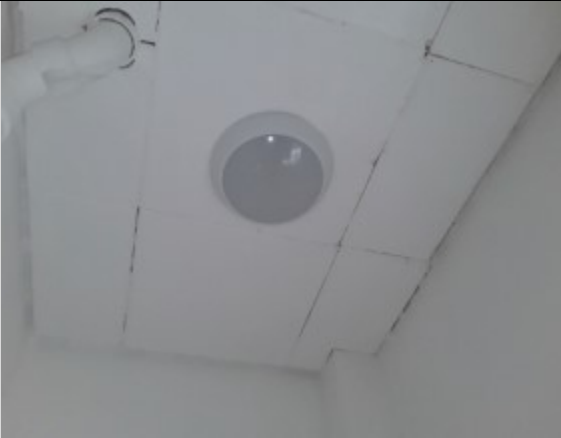
</div>				
14	As NZ001636	Ceiling tile – solid	Toilets Staff G/008	No Risk

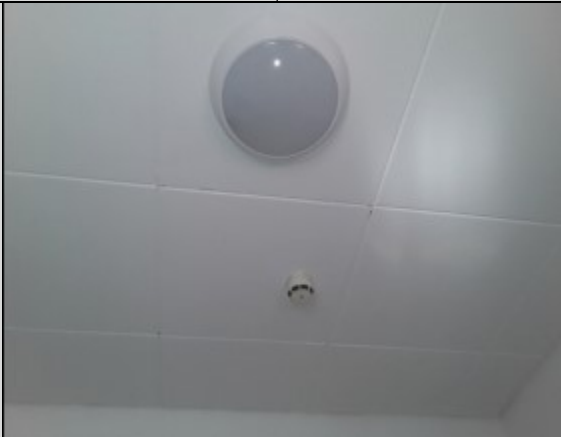
15	NZ001644	Ceiling tile - solid	Staff Room Kitchen G/009	No Risk

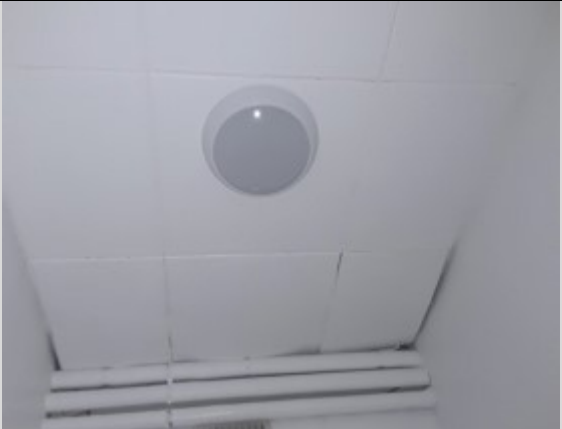
16	As NZ001644	Ceiling tile - solid	Store Room Dry Kitchen G/010	No Risk

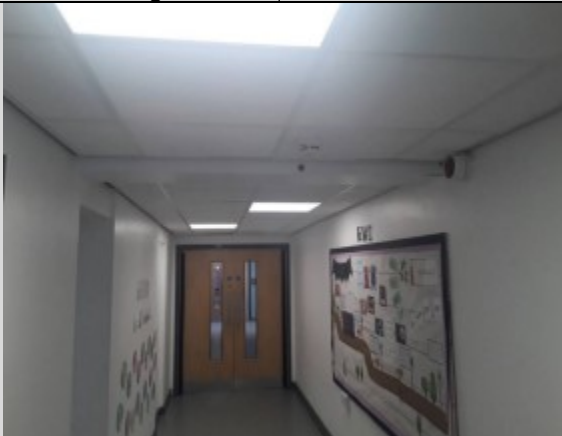
22	As NZ001644	Ceiling tile – solid within ceiling void	Corridor G/016	No Risk

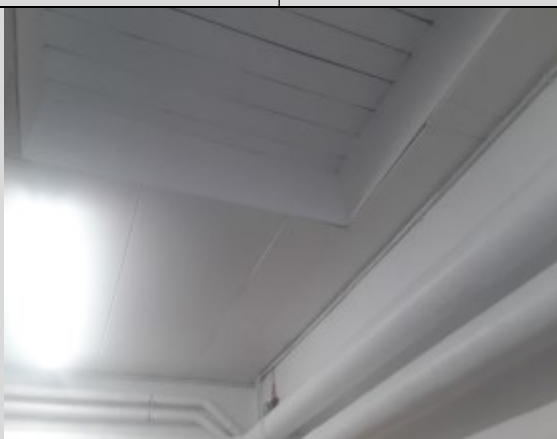
33	As NZ001644	Ceiling tile – solid	Corridor G/064	No Risk

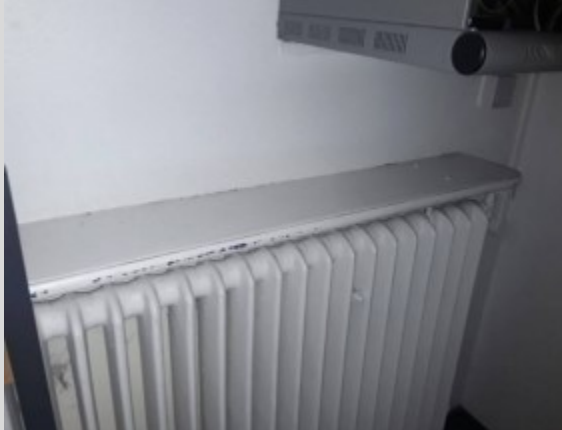
47	As NZ001654	Shelving putty to shelving above radiator	Hub/Network room under staircase G/076	No Risk

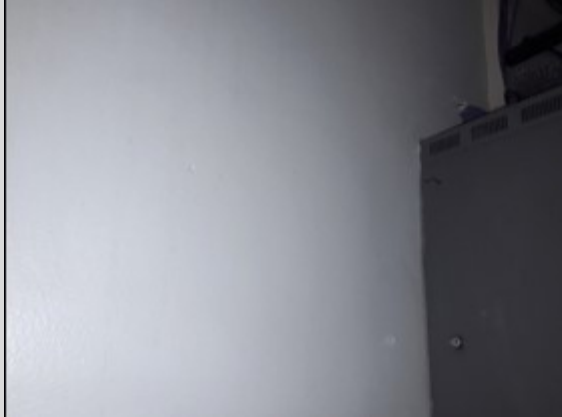
48	As NZ001655	Wall coating to stairwell	Hub/Network room under staircase G/076	No Risk

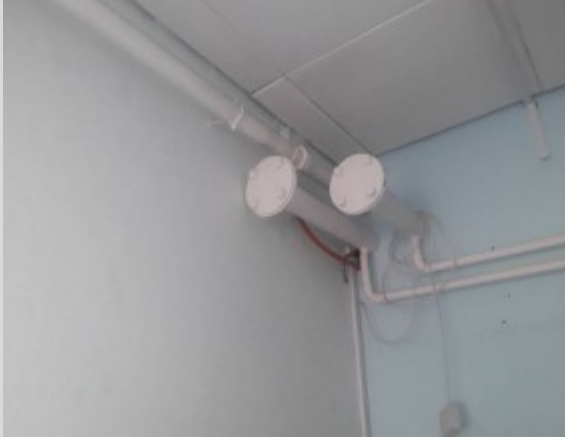
49	NZ001656	Pipework Gaskets	Office G/077	No Risk

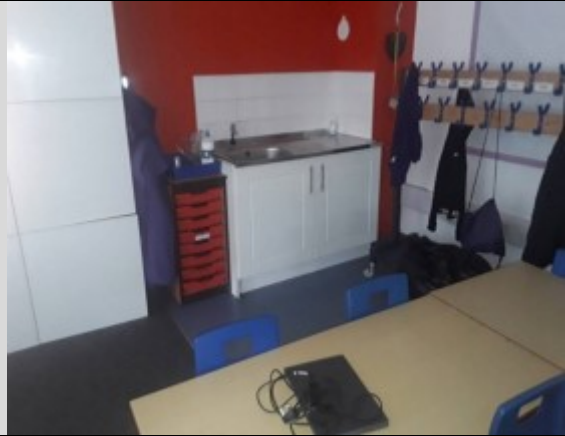
50	As NZ001653	Under sink mat	Classroom G/078	No Risk

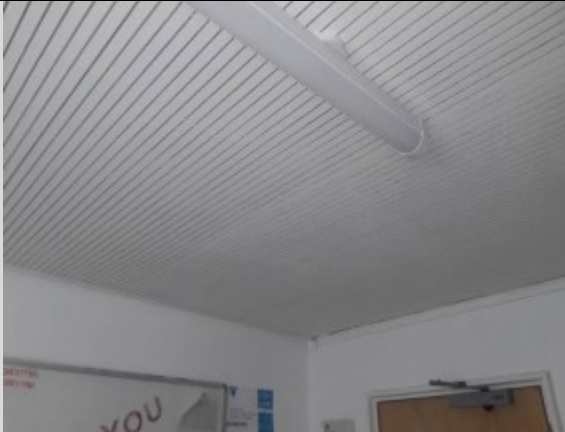
51	NZ001657	Ceiling tile – solid	Office Headteachers G/080	No Risk

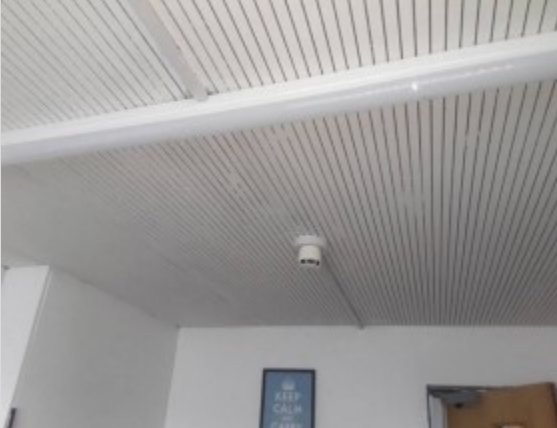
54	As NZ001657	Ceiling tile – solid	Room Conference G/083	No Risk

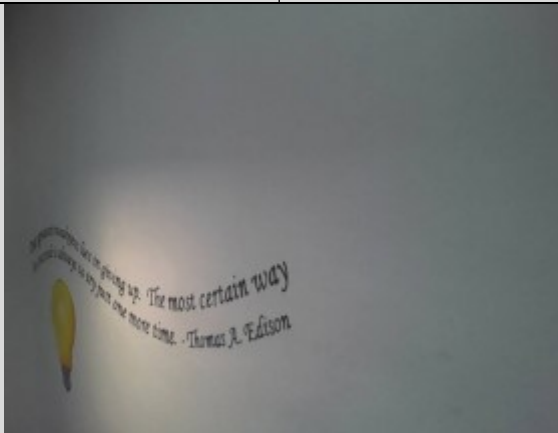
59	As NZ001655	Wall coating	Landing 1/002	No Risk

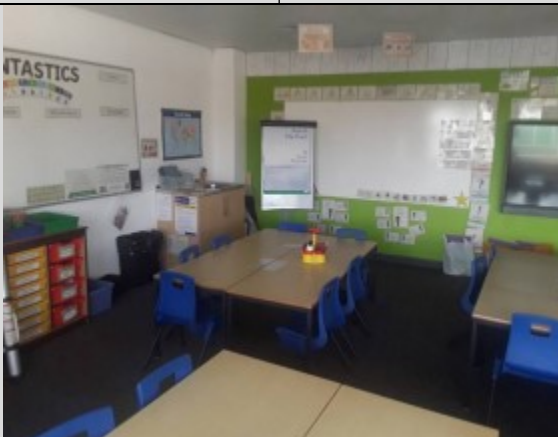
60	As NZ001653	Under sink mat	Classroom 1/004	No Risk

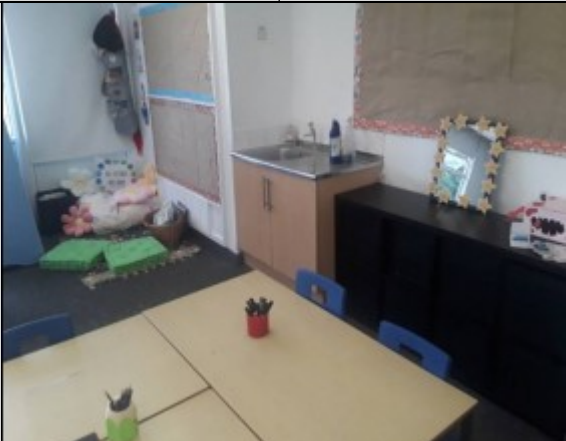
63	As NZ001653	Under sink mat	Classroom 1/009	No Risk

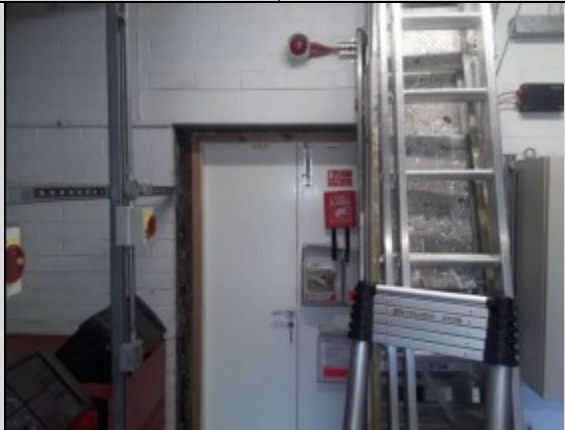
72	As NZ001648	Damp proof course to door and window frame	Boiler Room E/005	No Risk

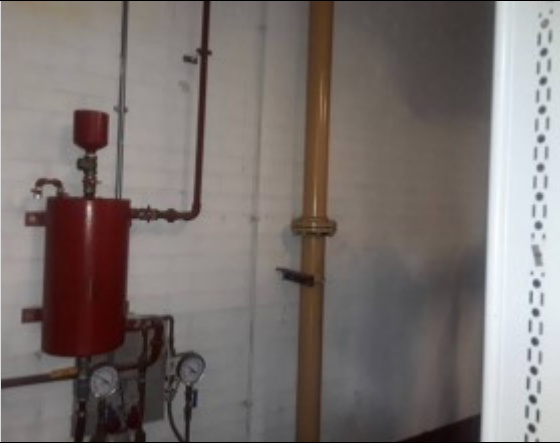
79	NZ001670	Pipework gaskets to gas pipework	Boiler Room E/005	No Risk

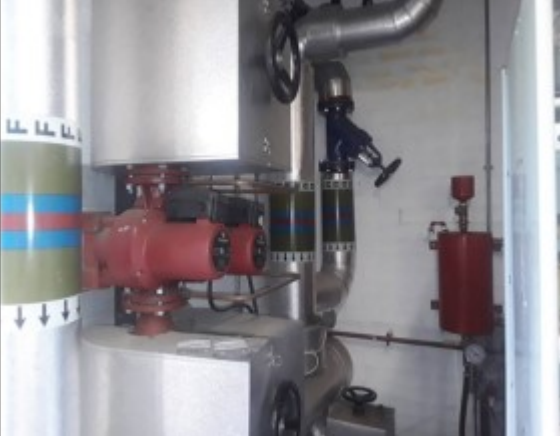
80	NZ001671	Pipework gaskets to pipework	Boiler Room E/005	No Risk

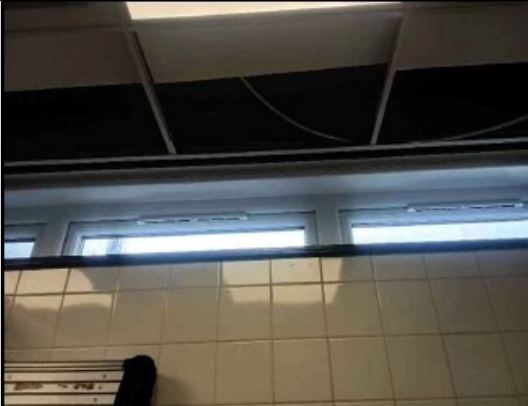
81	TL001059	Ceiling void residue to walls	Toilets Female G/039	No Risk
