ASBESTOS SURVEY REPORT FOR BEXHILL ACADEMY, TOWN END FARM,  
SUNDERLAND, SR5 4PJ

**Bexhill Academy, Town End Farm, SR5 4PJ**

**Date: 12 February 2025**

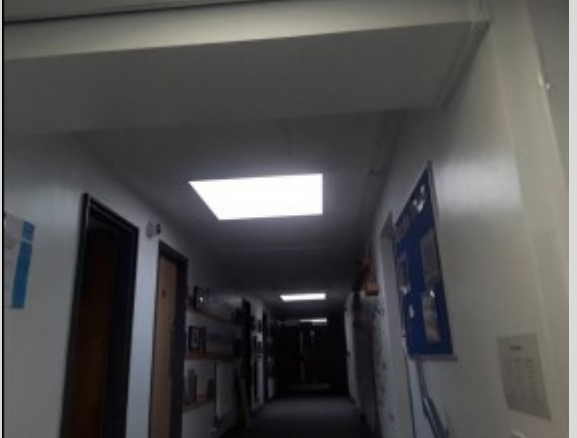
1	NZ001636	Ceiling tile – solid within ceiling void and corridor	Reception/Entrance Hall including corridor G/002	No Risk

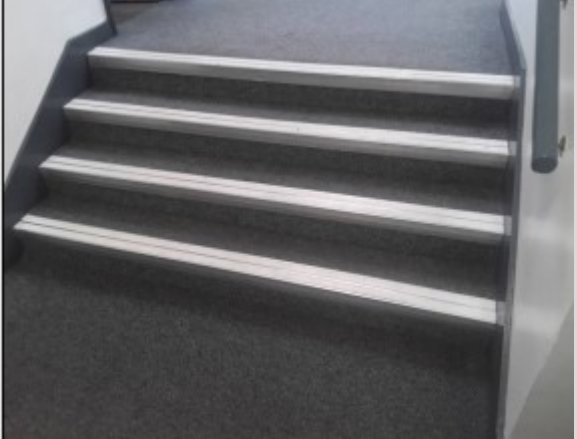
2	NZ001637	Floor nosing to stairs	Reception/Entrance Hall including corridor G/002	No Risk

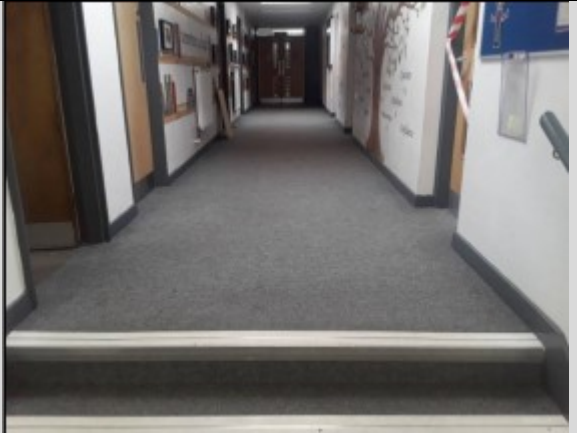
3	NZ001638	Floor tile with adhesive under carpet	Reception/Entrance Hall including corridor G/002	No Risk

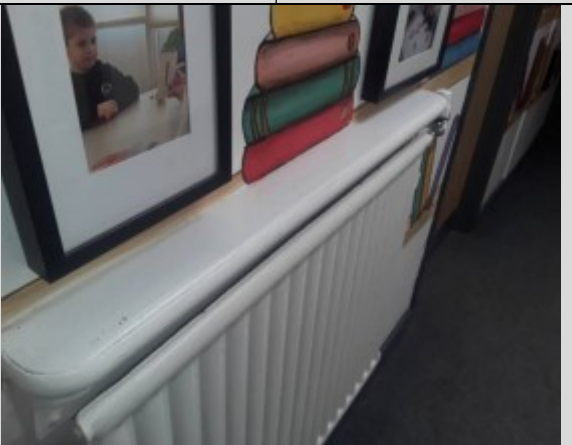
4	As NZ001654	Shelving putty to shelving above radiator	Reception/Entrance Hall including corridor G/002	No Risk

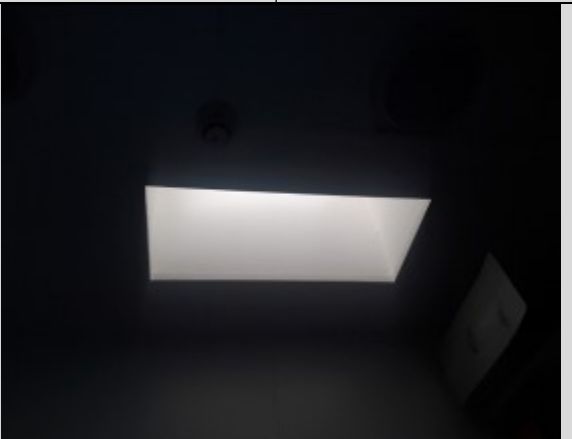
5	As NZ001636	Ceiling tile – solid	Corridor to Kitchen G/005	No Risk

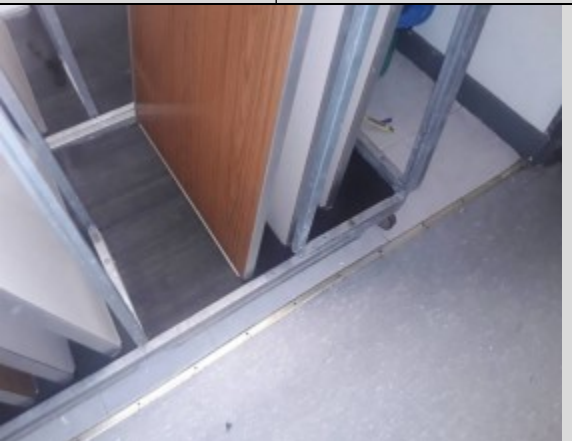
6	NZ001639	Floor tile with adhesive	Corridor to Kitchen G/005	No Risk

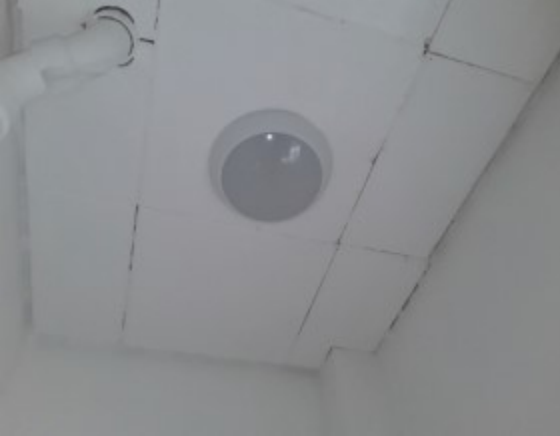
14	As NZ001636	Ceiling tile – solid	Toilets Staff G/008	No Risk

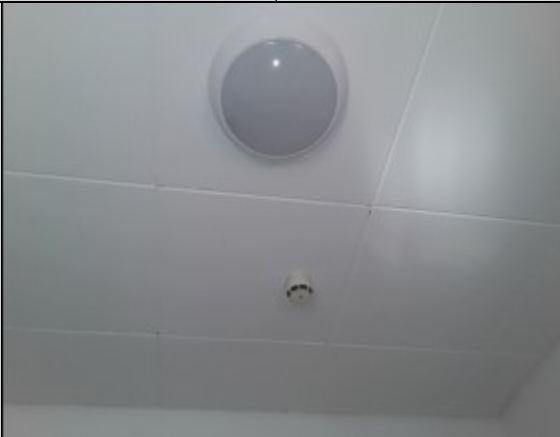
15	NZ001644	Ceiling tile - solid	Staff Room Kitchen G/009	No Risk

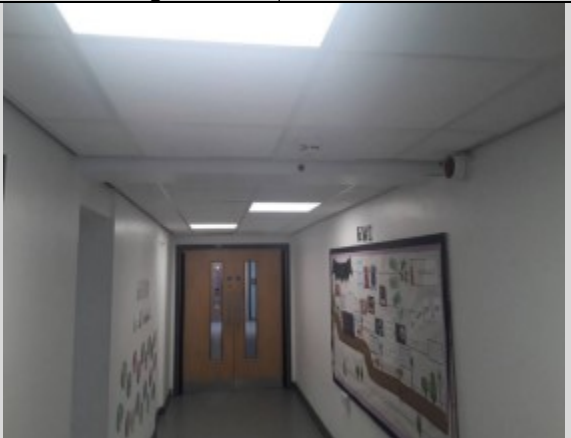
22	As NZ001644	Ceiling tile – solid within ceiling void	Corridor G/016	No Risk

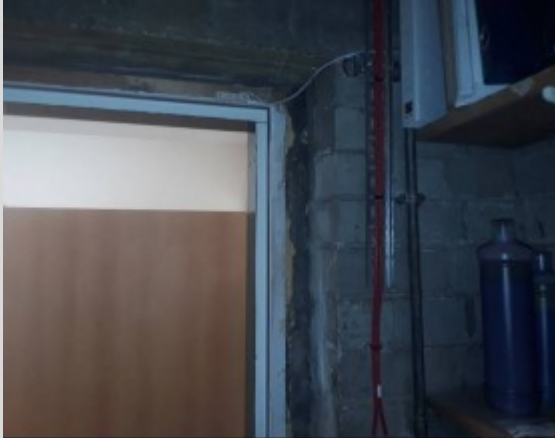
31	NZ001648	Damp proof course to door frame	Store room adjacent boiler room within male toilet G/060	No Risk

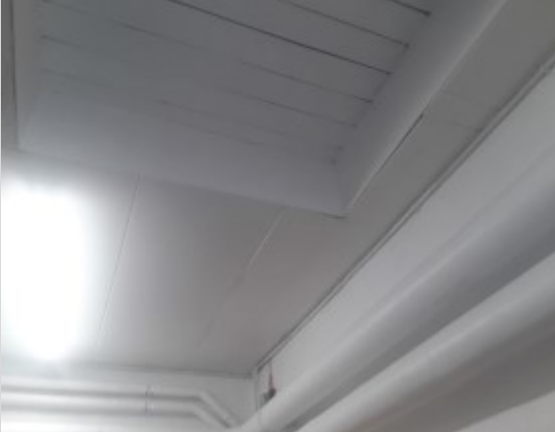
33	As NZ001644	Ceiling tile – solid	Corridor G/064	No Risk

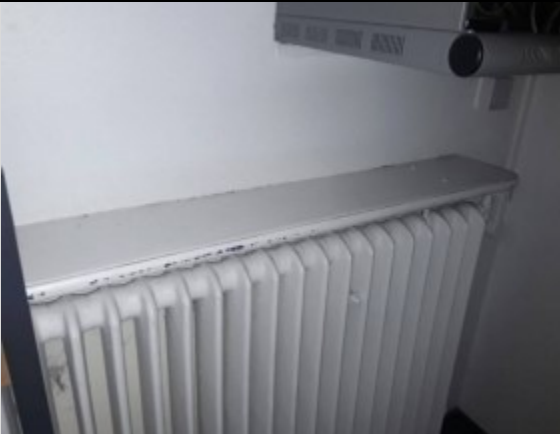
47	As NZ001654	Shelving putty to shelving above radiator	Hub/Network room under staircase G/076	No Risk

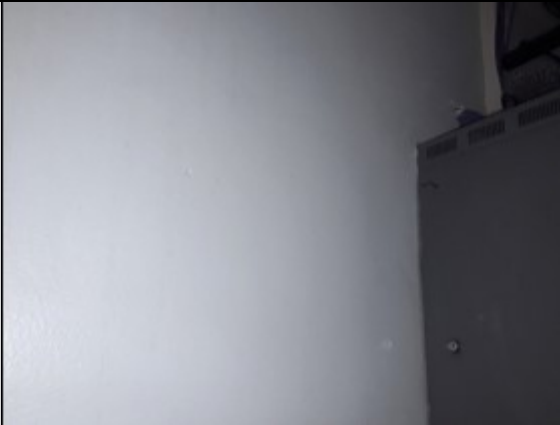
48	As NZ001655	Wall coating to stairwell	Hub/Network room under staircase G/076	No Risk

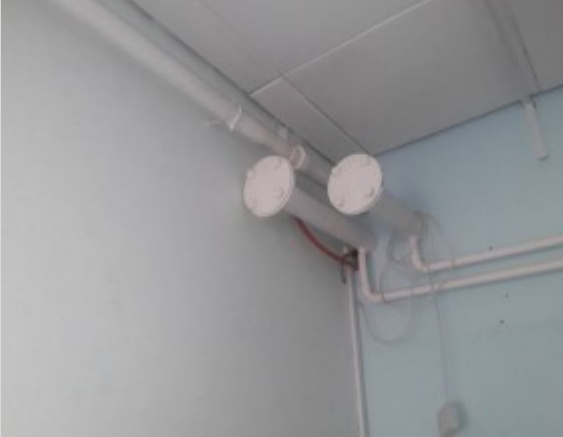
49	NZ001656	Pipework Gaskets	Office G/077	No Risk

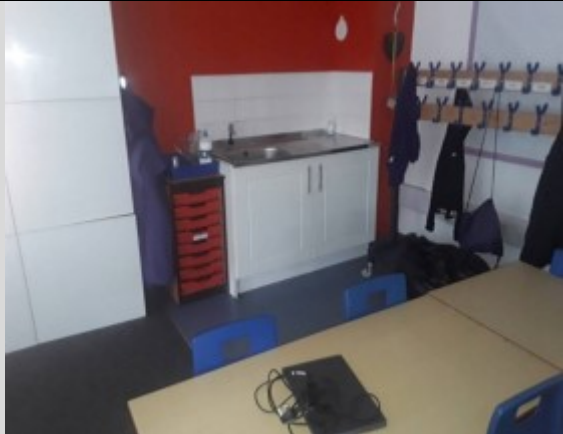
50	As NZ001653	Under sink mat	Classroom G/078	No Risk

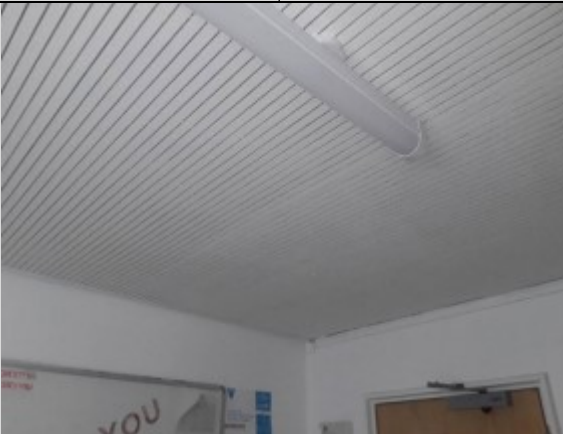
51	NZ001657	Ceiling tile – solid	Office Headteachers G/080	No Risk

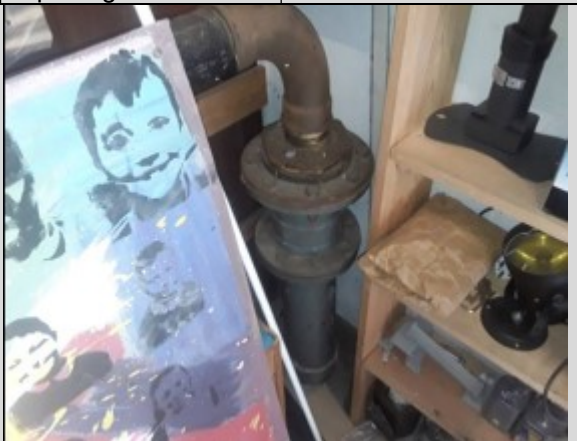
55	NZ001658	Pipework Gasket Gas inlet pipework top flange	Room Gas inlet G/084	No Risk

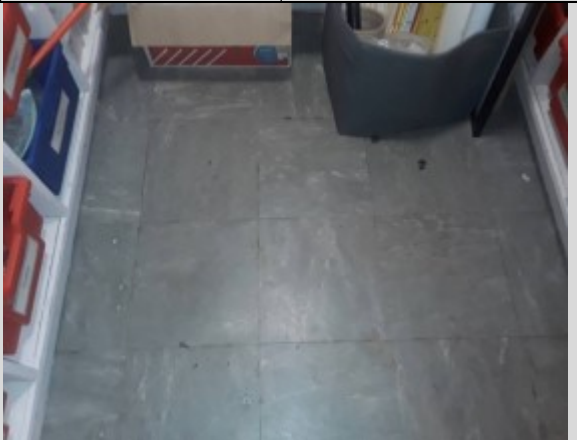
56	NZ001659	Floor tile with adhesive	Cupboard store G/093	No Risk

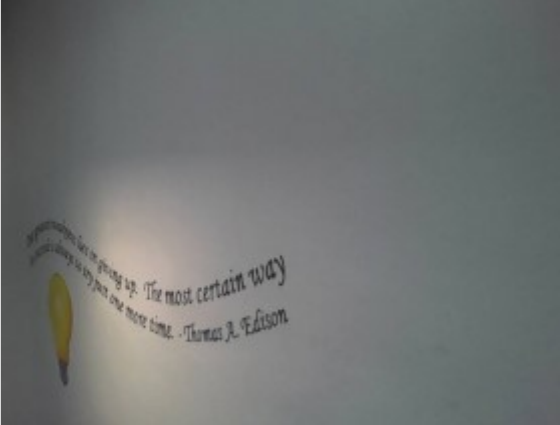
59	As NZ001655	Wall coating	Landing 1/002	No Risk

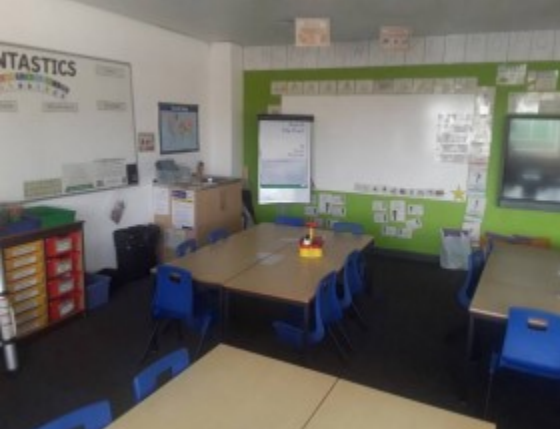
60	As NZ001653	Under sink mat	Classroom 1/004	No Risk

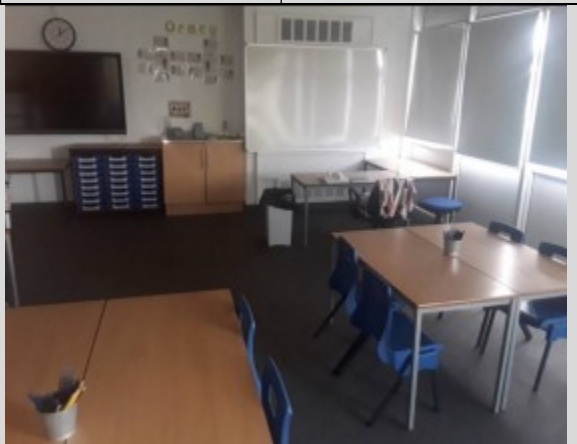
62	As NZ001653	Under sink mat	Classroom 1/007	No Risk
