ASBESTOS SURVEY REPORT FOR BEXHILL ACADEMY, TOWN END FARM,  
SUNDERLAND, SR5 4PJ

**Bexhill Academy, Town End Farm, SR5 4PJ**

**Date: 16 May 2025**

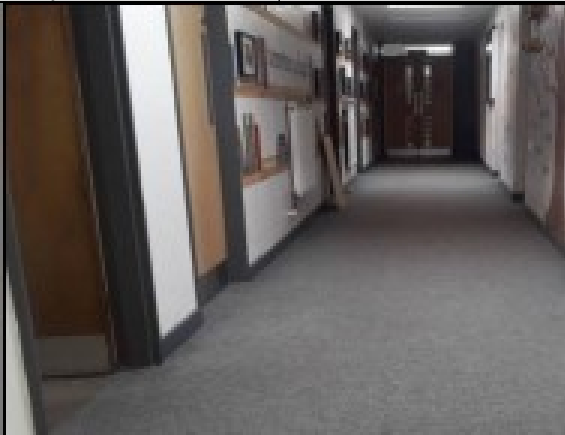
| 3 | NZ001638 | Floor tile with adhesive under carpet | Reception/Entrance Hall including corridor G/002 | No Risk |

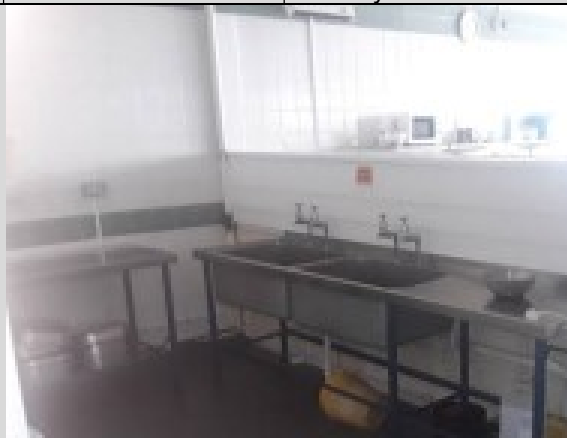
| 11 | NZ001641 | Under sink mat paint | Kitchen including servery G/007 | No Risk | | | | | | | | | | |

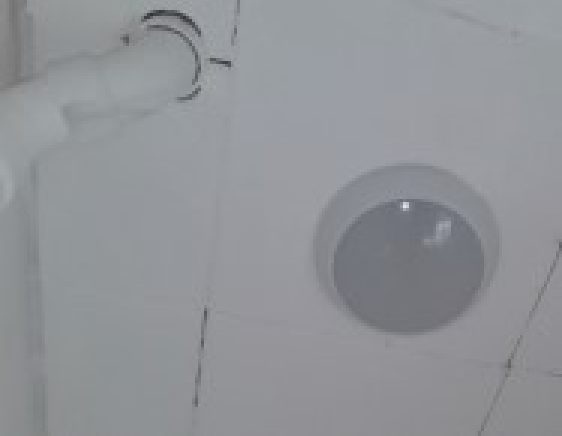
| 14 | As<br>NZ001636 | Ceiling tile – solid | Toilets Staff G/008 | No Risk |

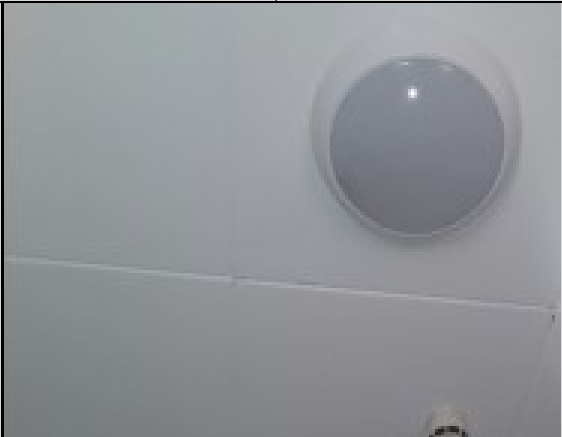
| 15 | NZ001644 | Ceiling tile - solid | Staff Room Kitchen G/009 | No Risk |

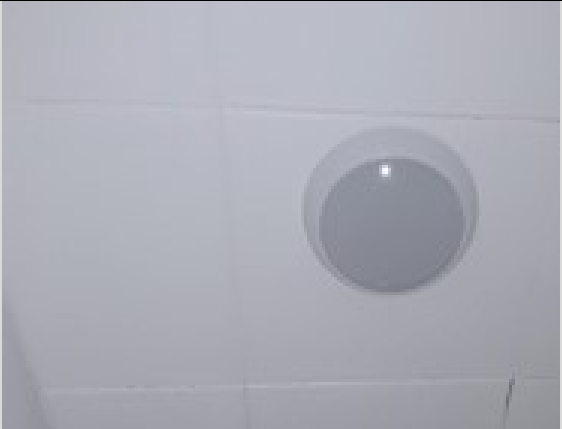
| 16 | As<br>NZ001644 | Ceiling tile - solid | Store Room Dry<br>Kitchen G/010 | No Risk |

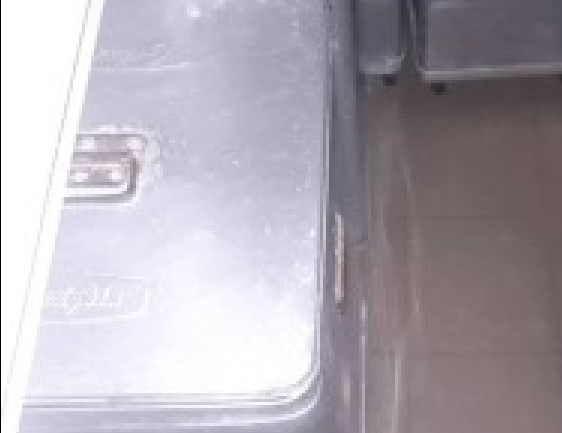
| 17 | NZ001645 | Floor tile with<br>adhesive light brown | Store Room Dry<br>Kitchen G/010 | No Risk |

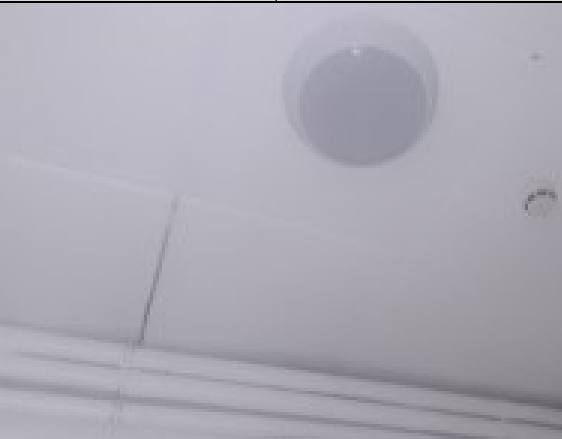
| 18 | As<br>NZ001644 | Ceiling tile - solid | Store Room Veg<br>Kitchen G/011 | No Risk |

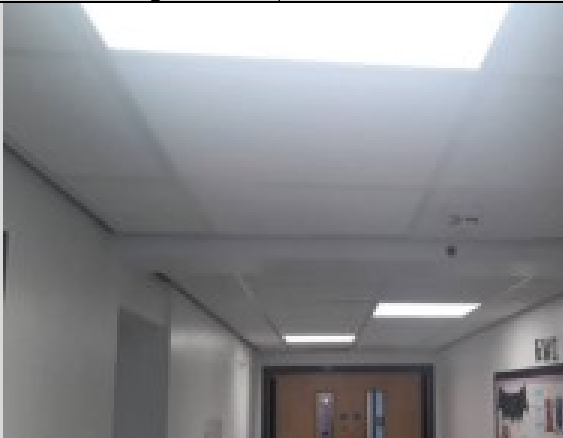
| 22 | As<br>NZ001644 | Ceiling tile – solid<br>within ceiling void | Corridor G/016 | No Risk | | | | |

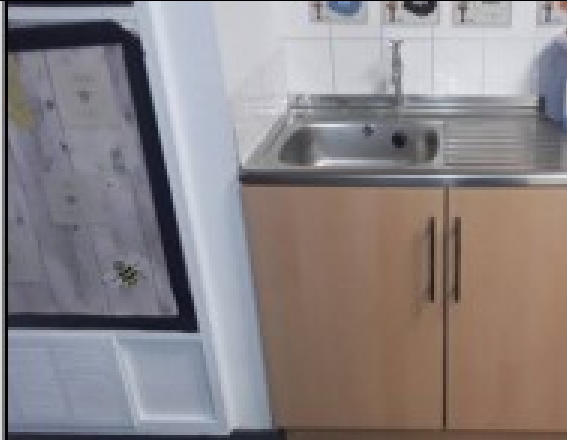
| 38 | NZ001653 | Under sink mat | Classroom G/069 | No Risk | | | | | | | | |

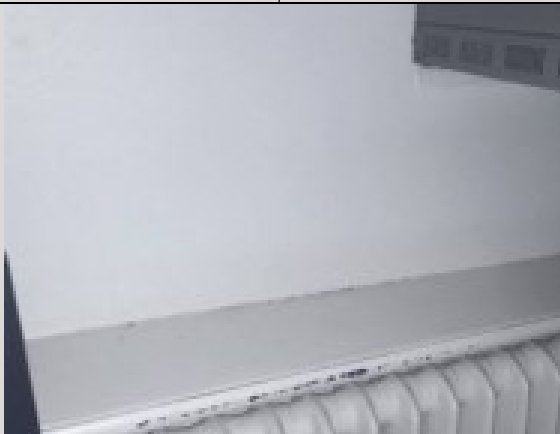
| | | | | | | | | |
|--|---|--|---|---|---|---|---|---|
| 46 | As<br>NZ001651 | Floor tile with<br>adhesive under<br>modern flooring | Hub/Network room<br>under staircase G/076 | Very Low Risk | | | | |
| <table><tr><td><b>Photo 1: Wide Angle</b></td><td><b>Photo 2: Close</b></td></tr><tr><td> </td><td> </td></tr></table> | | | | | <b>Photo 1: Wide Angle</b> | <b>Photo 2: Close</b> | | |
| <b>Photo 1: Wide Angle</b> | <b>Photo 2: Close</b> | | | | | | | |
| | | | | | | | | |
| 47 | As<br>NZ001654 | Shelving putty to<br>shelving above<br>radiator | Hub/Network room<br>under staircase G/076 | No Risk | | | | |
|

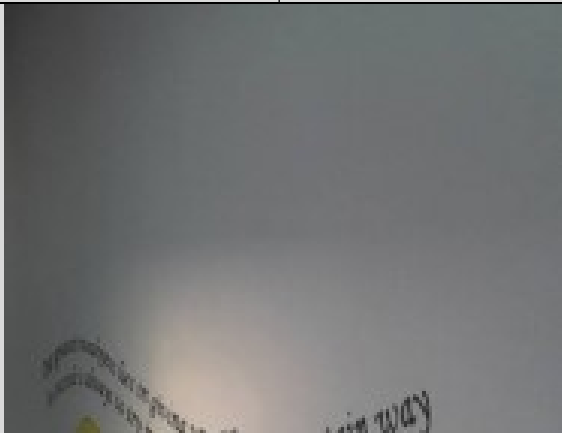
| | | | | | | | | | | | | | | |
|--|---|--|---|---|---|--|--|---|--|---|--|--|---|--|
| 58 | As<br>NZ001650 | Debris from flue<br>install to upper and<br>lower tank | Tank Room 1/001 | Low Risk | | | | | | | | | | |
| <table><tr><td colspan="3">Photo 1: Wide Angle</td><td colspan="2">Photo 2: Close</td></tr><tr><td colspan="3"> </td><td colspan="2"> </td></tr></table> | | | | | Photo 1: Wide Angle | | | Photo 2: Close | | | | | | |
| Photo 1: Wide Angle | | | Photo 2: Close | | | | | | | | | | | |
| | | | | | | | | | | | | | | |
| 59 | As<br>NZ001655 | Wall coating | Landing 1/002 | No Risk | | | | | | | | | | |
|

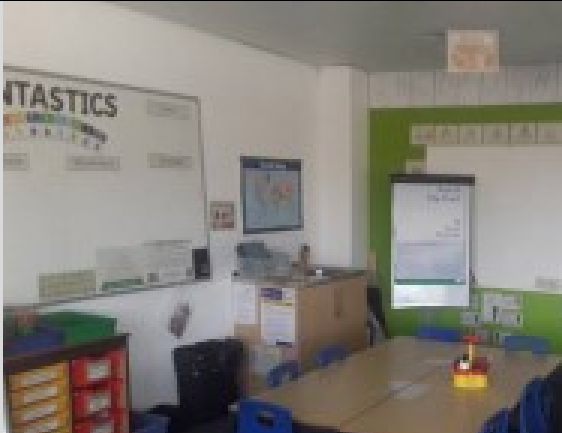
| | | | | | | | | | | | | | |
| 60 | As<br>NZ001653 | Under sink mat | Classroom 1/004 | No Risk | | | | | | | | | | |
|

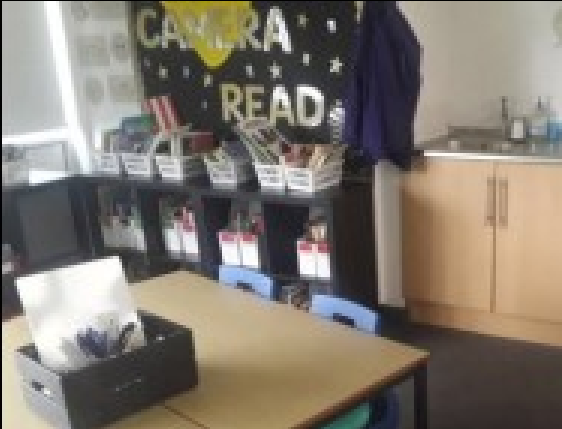
| 61 | As<br>NZ001653 | Under sink mat | Classroom 1/006 | No Risk |

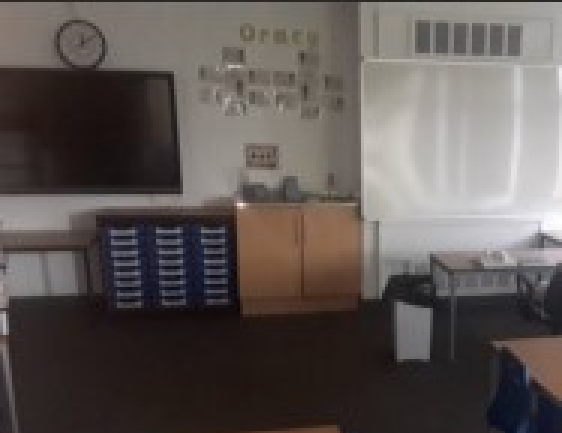
| 62 | As<br>NZ001653 | Under sink mat | Classroom 1/007 | No Risk |

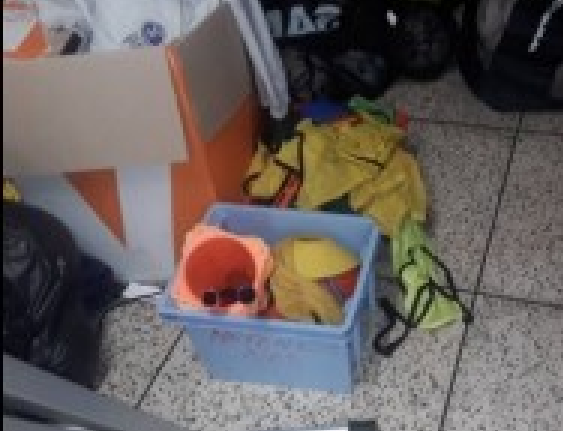
| 70 | NZ001662 | Floor tile jointing | Store Room E/002 | No Risk |

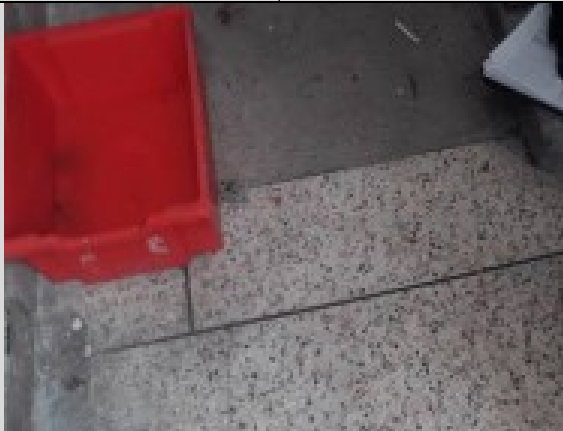
| 71 | As<br>NZ001662 | Floor tile jointing | Boiler Room Small<br>E/004 | No Risk |

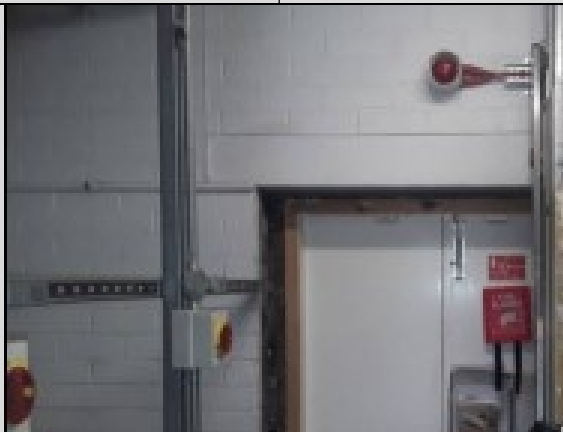
| 72 | As<br>NZ001648 | Damp proof course<br>to door and window<br>frame | Boiler Room E/005 | No Risk |
