ASBESTOS SURVEY REPORT FOR HALTWHISTLE PRIMARY ACADEMY,  
PARK AVENUE, HALTWHISTLE, NORTHUMBERLAND, NE49 9BA

## Asbestos Register for

**Haltwhistle Primary Academy, Park Avenue, Haltwhistle,  
Northumberland, NE49 9BA**

**Date: 25 June 2025**

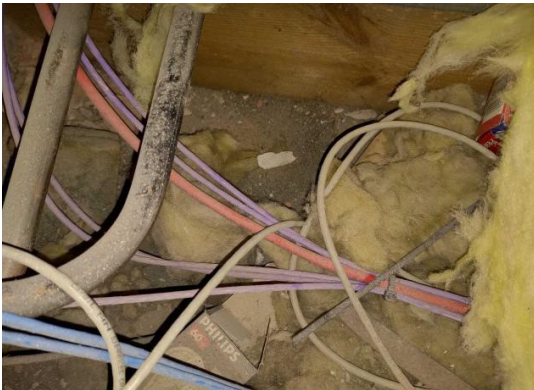
### **Item 1 Ref: 21-39567-1**

- (Item 1) Ref: 21-39567-1 – Debris to floor adjacent doorway (Area 3/Loft Space 3) – Removed May 2022
- (Item 2) Ref: Presumed – Pipes (Gaskets) (Area 4/Loft Space 4) – Low Risk

The debris to floor adjacent doorway (Area 3/Loft Space 3) contains asbestos.

*Removed May 2022*

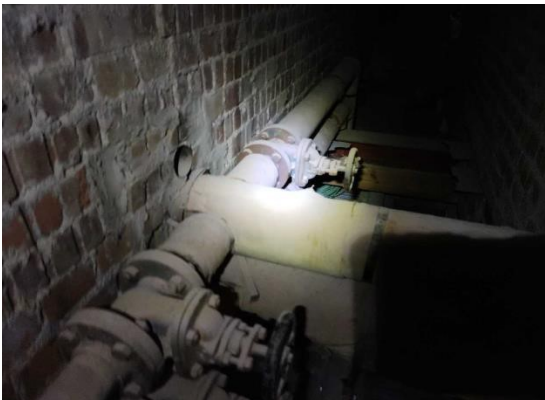
### **Item 2 Ref: Presumed**

The pipes (Gaskets) (Area 4/Loft Space 4) are presumed to contain asbestos.

Any change in its appearance should be recorded and passed to Property Services.

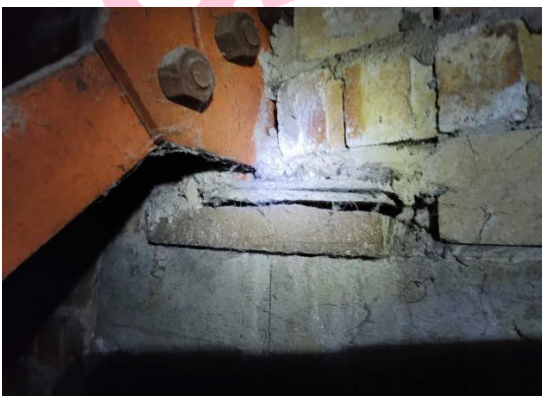
### **Item 3 Ref: 21-39567-2**

- (Item 3) Ref: 21-39567-2 – Packers below steel joists within brick wall (Encapsulated May 2022) (Area 7/Loft Space 7) – Very Low Risk
- (Item 4) Ref: 21-39567-4 – Floor screed (Area 8/Classroom) – No Risk

The packers below steel joists within brick wall (Area 7/Loft Space 7) contain asbestos.

Any change in its appearance should be recorded and passed to Property Services.

*Encapsulated May 2022 – continue to monitor*

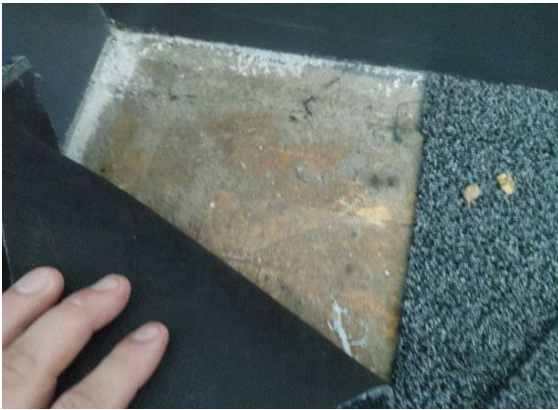
### **Item 4 Ref: 21-39567-4**

The floor screed (Area 8/Classroom) does not contain asbestos.

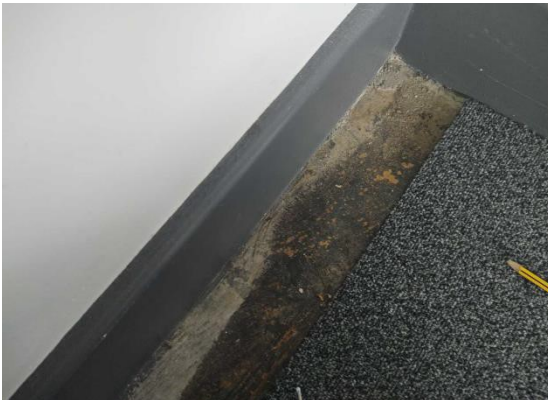
### **Item 5 Ref: 21-39567-4**

The floor screed (Area 9/Classroom 2) does not contain asbestos.

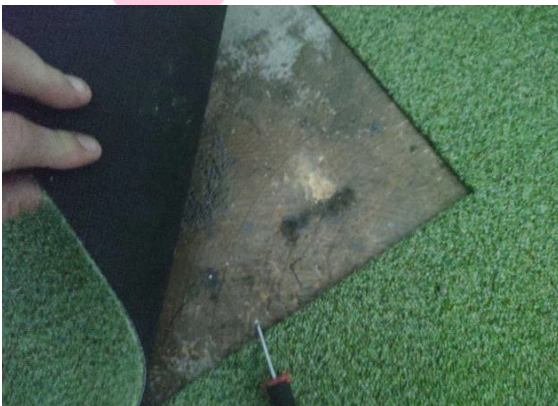
### **Item 6 Ref: 21-39567-4**

The floor screed (Area 15/Library and Cupboard) does not contain asbestos.

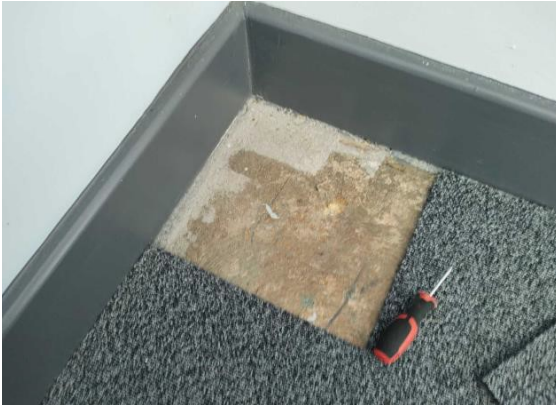
### **Item 7 Ref: 21-39567-5**

The floor screed (Area 16/Classroom 3 and Cupboard) does not contain asbestos.

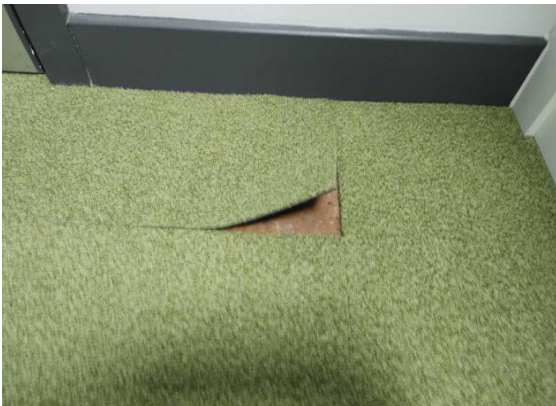
### **Item 8 Ref: 21-39567-5**

The floor screed (Area 16/Classroom 3 and Cupboard) does not contain asbestos.

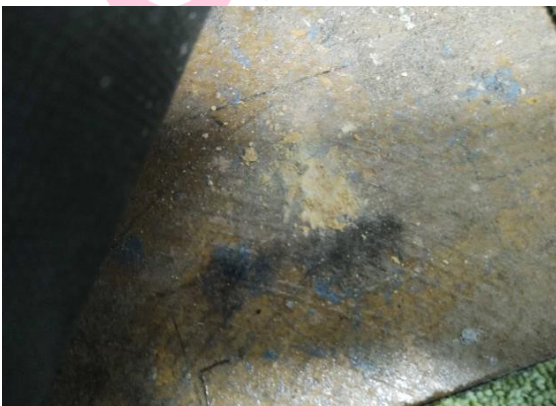
### **Item 9 Ref: 21-39567-5**

The floor screed (Area 17/Classroom 4 and Cupboard) does not contain asbestos.

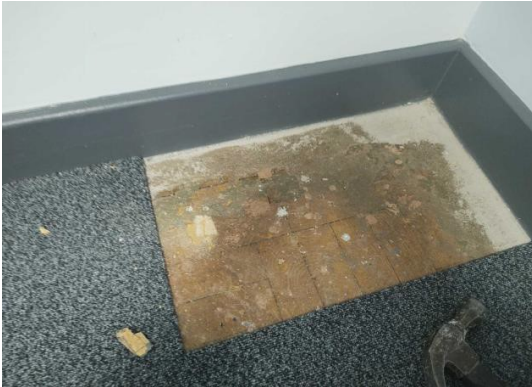
**Item 10 Ref: 21-39567-6**

The floor screed (Area 32/Classroom 7 and Cupboard) does not contain asbestos.

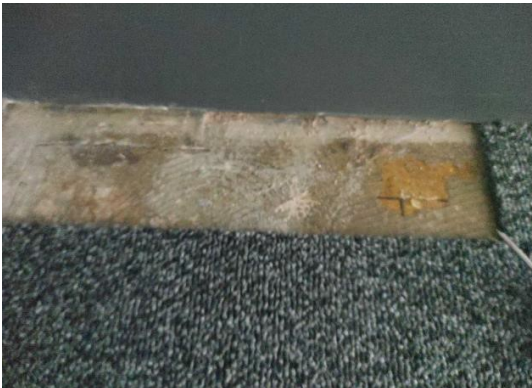
**Item 11 Ref: 21-39567-6**

The floor screed (Area 33/Classroom 8 and Cupboard) does not contain asbestos.

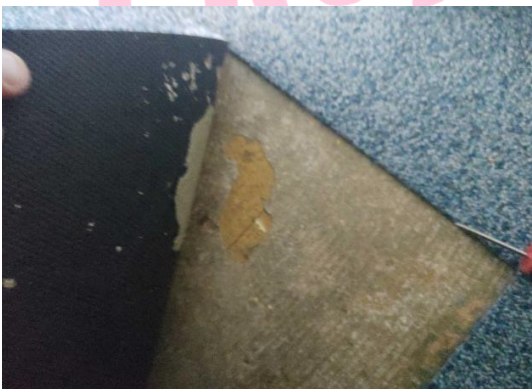
**Item 12 Ref: 21-39567-6**

The floor screed (Area 34/Library 2 and Cupboard) does not contain asbestos.

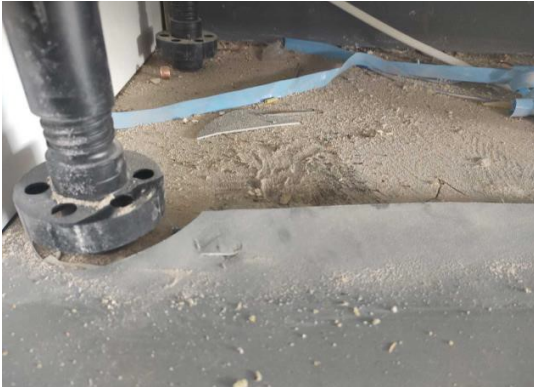
### **Item 13 Ref: 21-39567-7**

The floor adhesive (Area 41/Classroom 9) contains asbestos.

Any change in its appearance should be recorded and passed to Property Services.

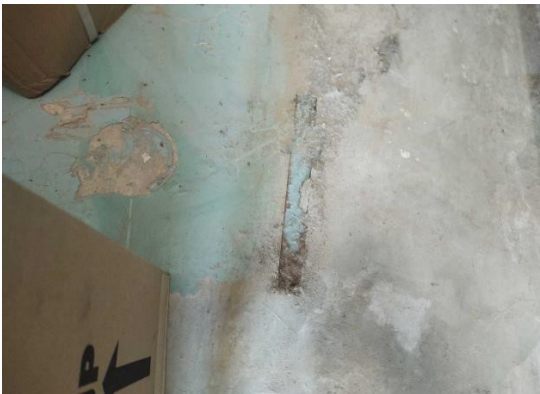
### **Item 14 Ref: 21-39567-8**

The blue floor screed (Area 60/Cupboard understairs 2) does not contain asbestos.

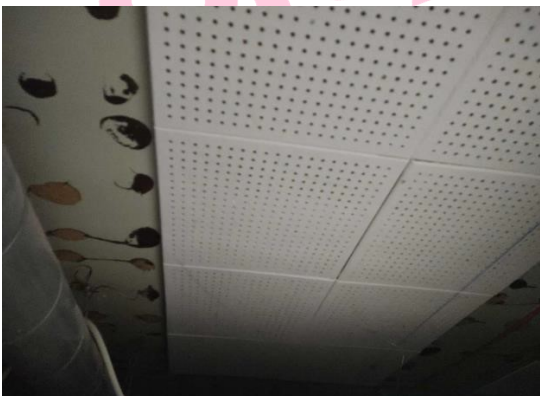
### **Item 15 Ref: 21-39567-9**

The ceiling (Area 62/Pastoral Office) does not contain asbestos.

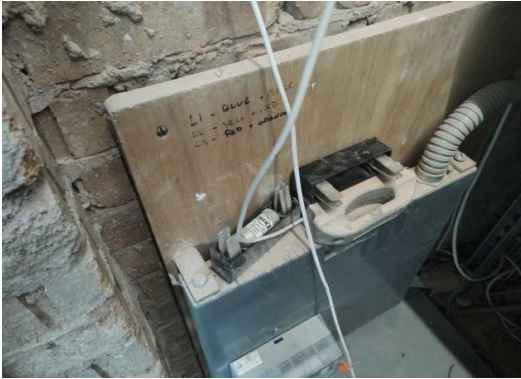
### **Item 16 Ref: 21-39567-10**

The electrical equipment, redundant cartridge fuses (Area 64/Electric meter cupboard) does not contain asbestos.

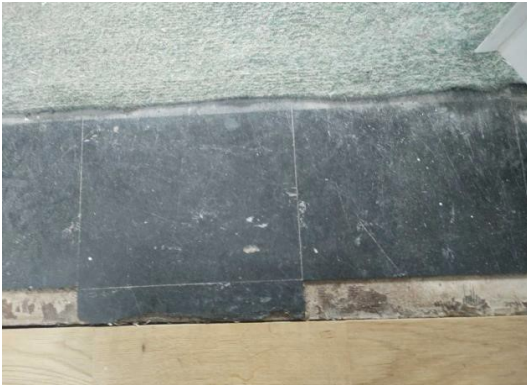
### **Item 17 Ref: 21-39567-11**

The floor tiles and adhesive (Area 82/Medical Room) contain asbestos.

Any change in its appearance should be recorded and passed to Property Services.

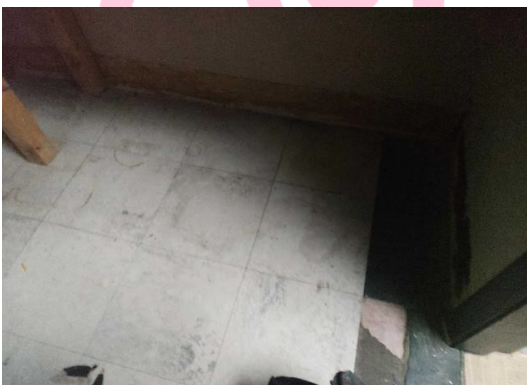
### **Item 18 Ref: 21-39567-12**

The floor tiles and adhesive (Area 84/Store) contain asbestos.

Any change in its appearance should be recorded and passed to Property Services.

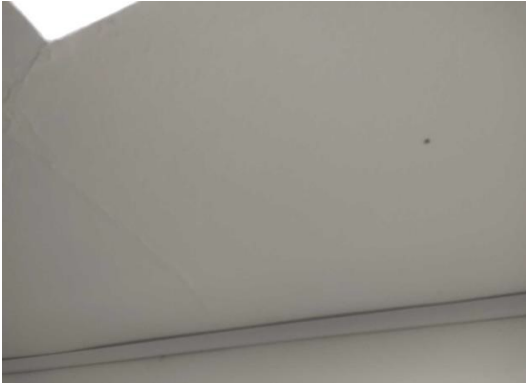
### **Item 19 Ref: 21-39567-13**

The textured coated ceiling (Area 87/Kitchen) contains asbestos.

Any change in its appearance should be recorded and passed to Property Services.

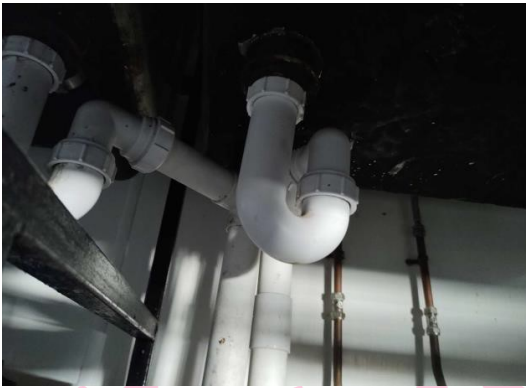
### **Item 20 Ref: 21-39567-14**

The sink pad (Area 87/Kitchen) does not contain asbestos.

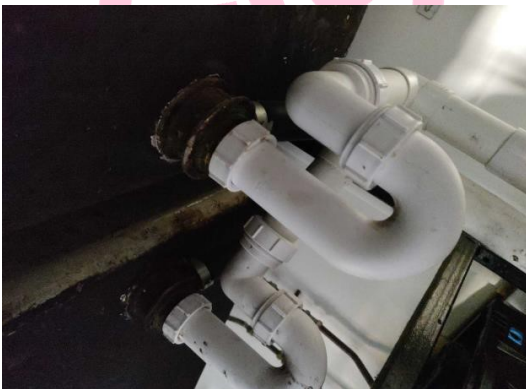
### **Item 21 Ref: 21-39567-15**

- (Item 21) Ref: 21-39567- 15 – Gaskets to underside of Portland sinks (Area 87/Kitchen) – Medium Risk
- (Item 22) Ref: 21-39567- 16 – Composite gasket to gas main flange (Area 90/Kitchen Store) – Low Risk

The gaskets to underside of Portland sinks (Area 87/Kitchen) contain asbestos.

Any change in its appearance should be recorded and passed to Property Services.

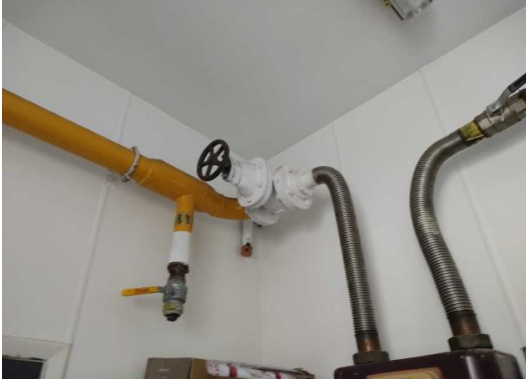
### **Item 22 Ref: 21-39567-16**

The composite gasket to gas main flange (Area 90/Kitchen Store) contains asbestos.

Any change in its appearance should be recorded and passed to Property Services.

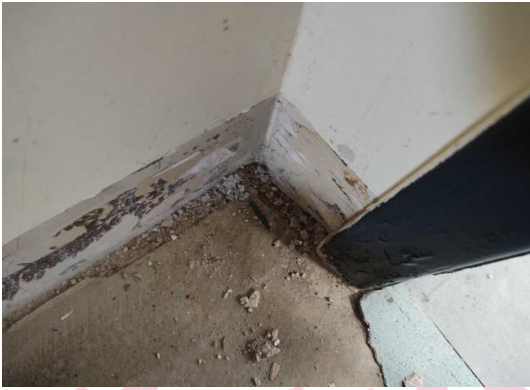
### **Item 23 Ref: 21-39567-17**

The floor tiles and adhesive (Area 96/Drying Store) does not contain asbestos.

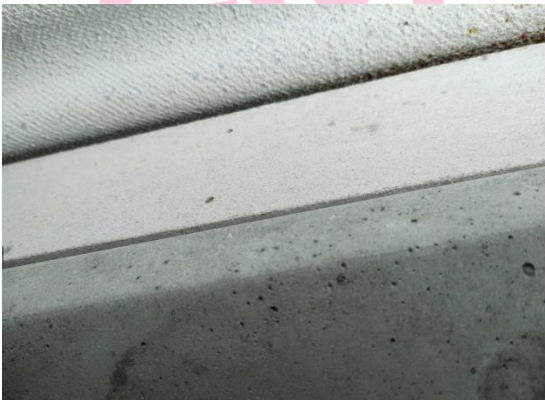
### **Item 24 Ref: 21-39567-18**

The infill panels to top of wall (Area 104/Garage 1) do not contain asbestos.

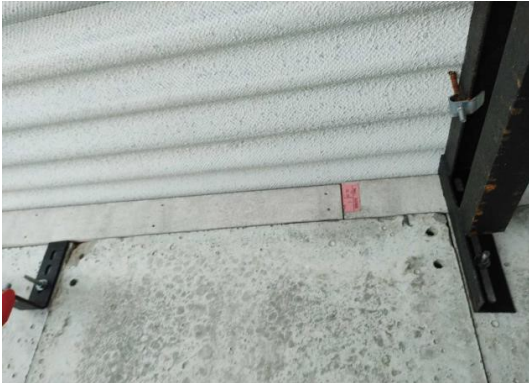
**Item 25 Ref: 21-39567-18**

The infill panels to top of wall (Area 105/Garage 2) do not contain asbestos.

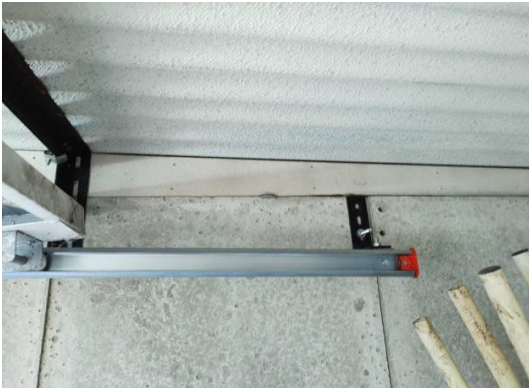
**Item 26 Ref: 21-39567-18**

The infill panels to top of wall (Area 106/Garage 3) do not contain asbestos.

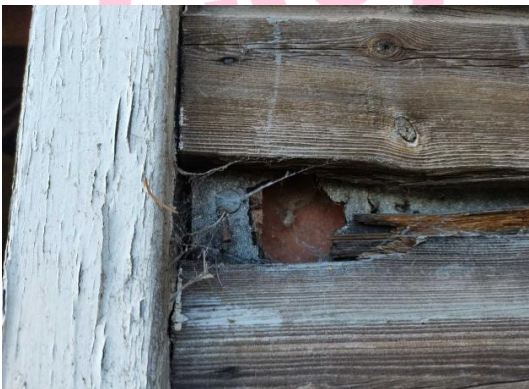
**Item 27 Ref: 21-39567-19**

The damp proof sheeting behind wood cladding to walls (Area 107/External Store) does not contain asbestos.

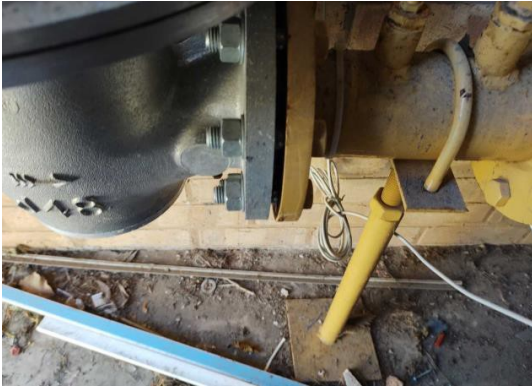
### **Item 28 Ref: 21-39567-20**

The gasket to gas main flanges (Area 108/Gas inlet cupboard) does not contain asbestos.

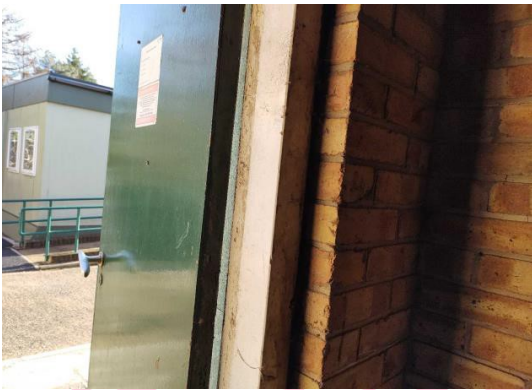
### **Item 29 Ref: 21-39567-27**

The door frame sealant (Area 108/Gas inlet cupboard) contains asbestos.

Any change in its appearance should be recorded and passed to Property Services.

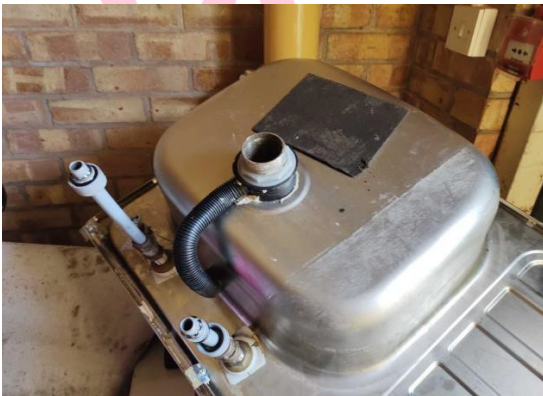
### **Item 30 Ref: 21-39567-28**

The sink pad to redundant sink (Area 108/Gas inlet cupboard) does not contain asbestos.

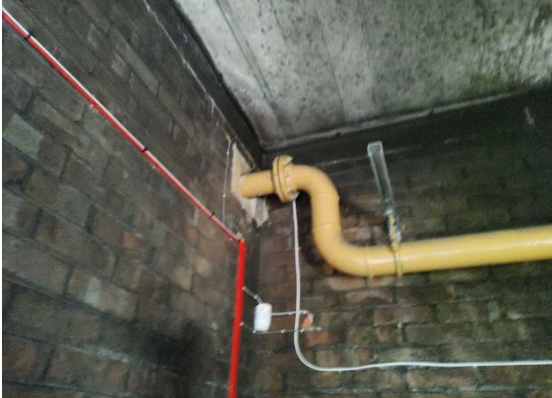
**Item 31 Ref: 21-39567-20**

The gasket to gas main pipe (Area 109/Vehicle store) does not contain asbestos.

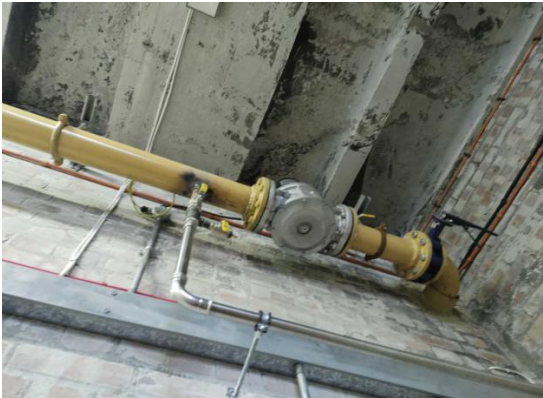
**Item 32 Ref: 21-39567-20**

The gasket to gas main pipe (Area 110/Boiler Room) does not contain asbestos.

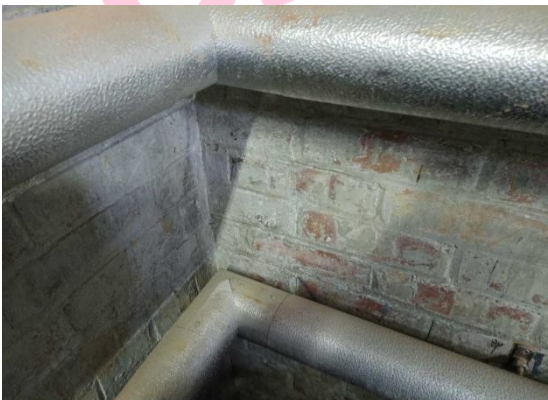
**Item 33 Ref: 21-39567-21**

The residue to wall 2 (Area 110/Boiler Room) does not contain asbestos.

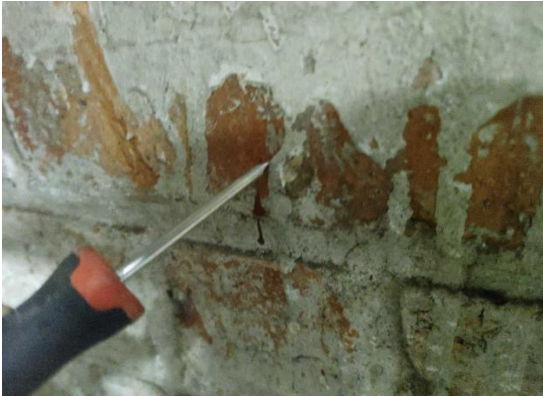
### **Item 34 Ref: 21-39567-22**

- (Item 34) Ref: 21-39567-22 – Residue to chimney breast wall (Encapsulated May 2022) (Area 110/Boiler Room) – Medium Risk
- (Item 35) Ref: 21-39567-23 – Residue to wall on wall 2 adjacent plasterboard wall panel (Encapsulated May 2022) (Area 110/Boiler Room) – Medium Risk

The residue to chimney breast wall (Area 110/Boiler Room) contains asbestos.

Any change in its appearance should be recorded and passed to Property Services.

*Encapsulated May 2022 – continue to monitor*

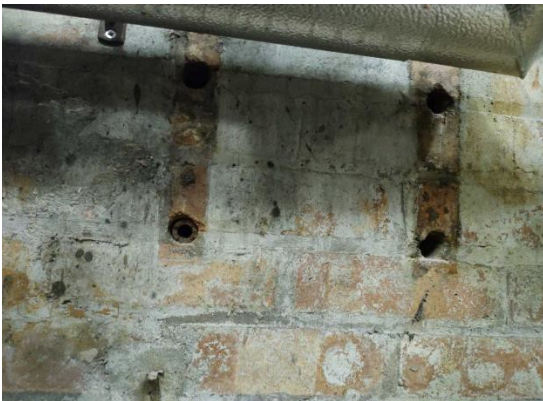
### **Item 35 Ref: 21-39567-23**

The residue to wall on wall 2 adjacent plasterboard wall panel (Area 110/Boiler Room) contains asbestos.

Any change in its appearance should be recorded and passed to Property Services.

*Encapsulated May 2022 – continue to monitor*

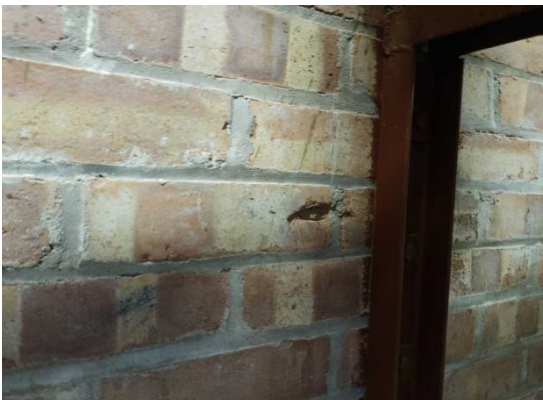
### **Item 36 Ref: 21-39567-24**

The residue to wall 3 (Area 110/Boiler Room) does not contain asbestos.

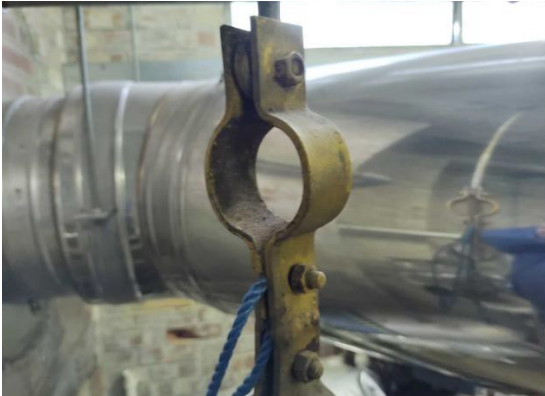
### **Item 37 Ref: 21-39567-25**

The residue to yellow hanging pipe hanger (Area 110/Boiler Room) contains asbestos.

Item 37	Residue to	Medium Risk	3 monthly	Removed

*Removed May 2022*

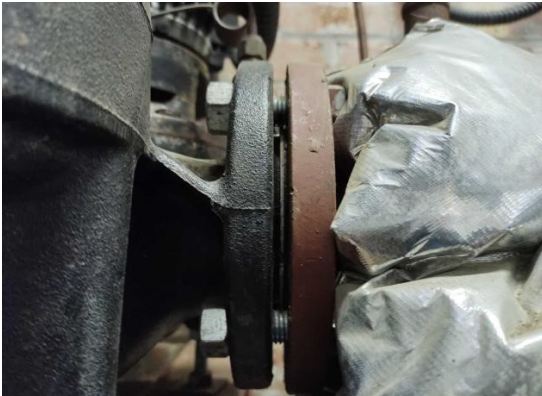
### **Item 38 Ref: 21-39567-26**

The gasket to flanges (Area 110/Boiler Room) do not contain asbestos.

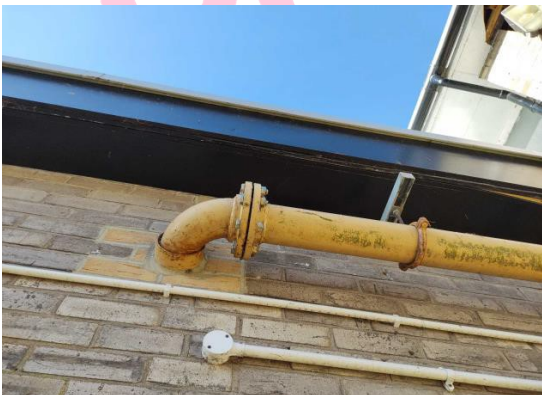
### **Item 39 Ref: 21-39567-20**

The gasket to flange of gas mains pipe (Area 129/ External) does not contain asbestos.

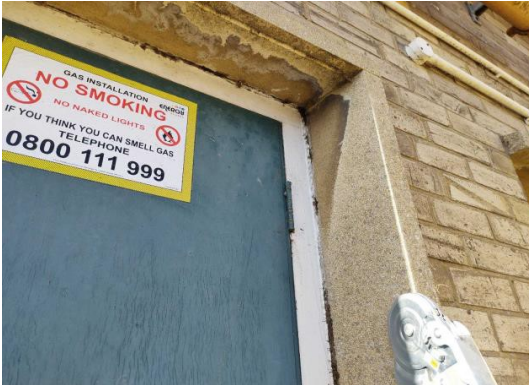
### **Item 40 Ref: 21-39567-27**

The mastic to outside door of gas inlet cupboard (Area 129/External) contains asbestos.

Any change in its appearance should be recorded and passed to Property Services.

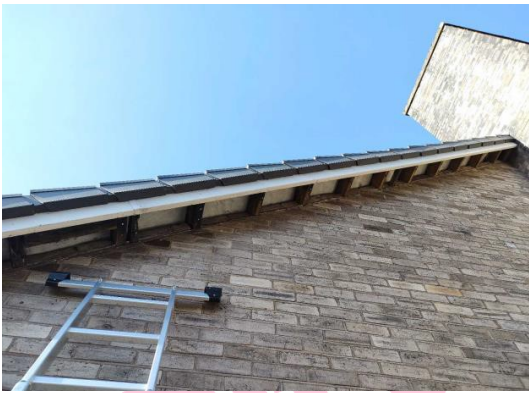
### **Item 41 Ref: 21-39567-29**

The residue to nails to former gable end soffits of Children's centre (Area 129/External) does not contain asbestos.

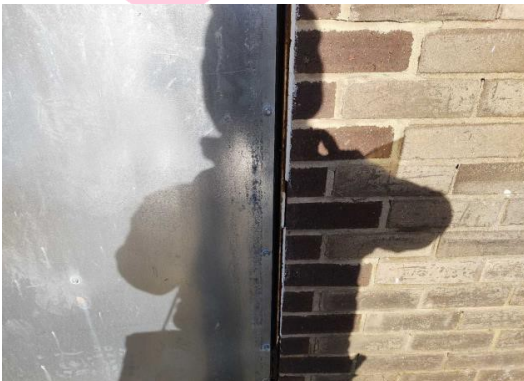
### **Item 42 Ref: 21-39567-30**

The mastic to quad bike store doors (Area 129/External) does not contain asbestos.

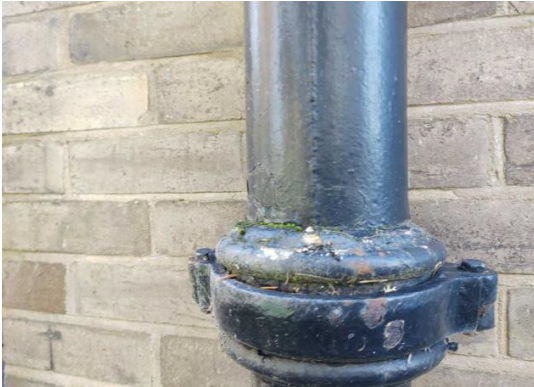
**Item 43 Ref: 21-39567-31**

The capping to soil pipe flanges (Area 129/ External) does not contain asbestos.

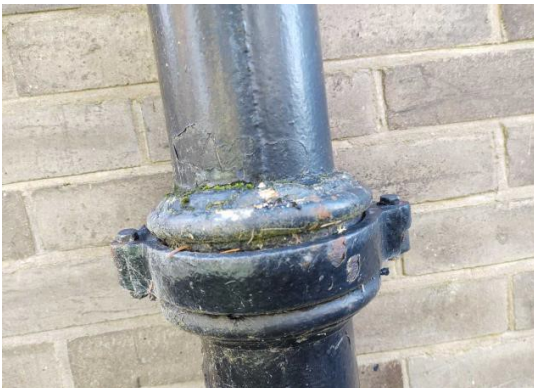
**Item 44 Ref: 21-39567-31**

The capping to soil pipe flanges (Area 129/ External) does not contain asbestos.

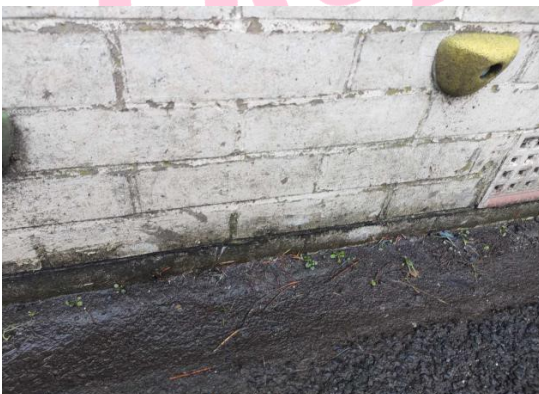
**Item 45 Ref: 21-39567-33**

The damp proof course to walls (Area 129/External) does not contain asbestos.

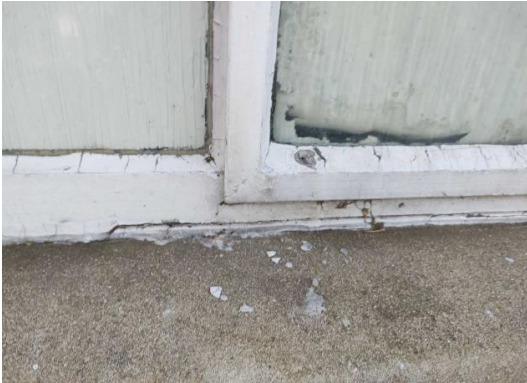
### **Item 46 Ref: 21-39567-34**

The glazing putty to metal windows (Area 129/External) does not contain asbestos.

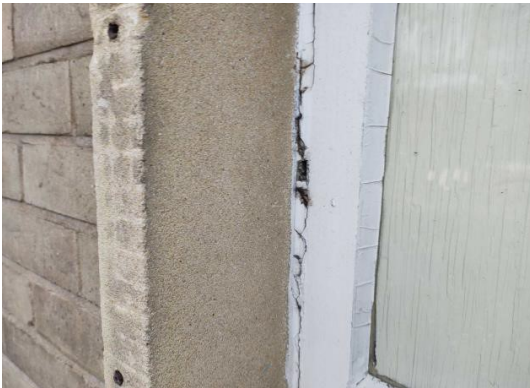
### **Item 47 Ref: 21-39567-35**

The window frame sealant (Area 129/External) contains asbestos.

Any change in its appearance should be recorded and passed to Property Services.

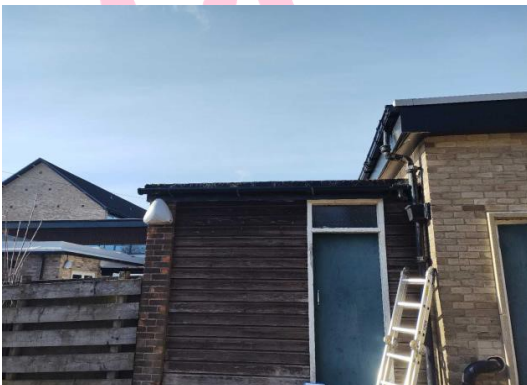
### **Item 48 Ref: 21-39567-32**

The roof felt (bitumen) (Area 107/External Store) does not contain asbestos.
