ASBESTOS SURVEY REPORT FOR HASTINGS HILL ACADEMY, THORNEY CLOSE, SUNDERLAND, SR3 4LY.

Asbestos Register for Hastings Hill Academy

Date: 14th November 2024

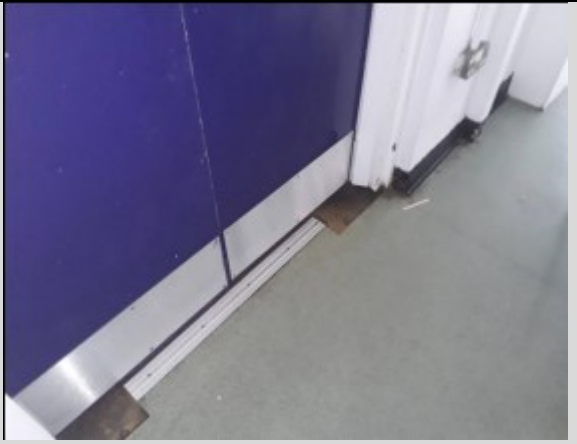
7	NZ001682	Wall skirting adhesive from removed skirting under modern skirting	Dining Room G/003	No Risk

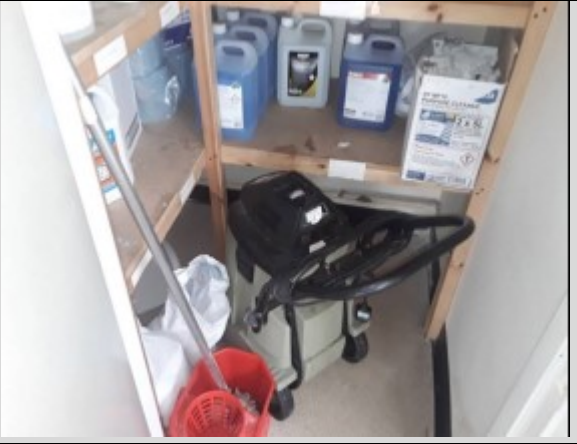
8	NZ001683	Pipework insulation wrap to pipework	Kitchen Cleaners Cupboard G/004	No Risk

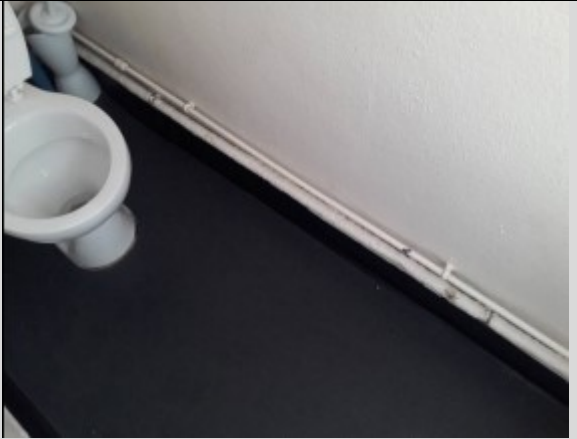
9	As NZ001683	Pipework insulation wrap to pipework	Kitchen Toilets G/005	No Risk

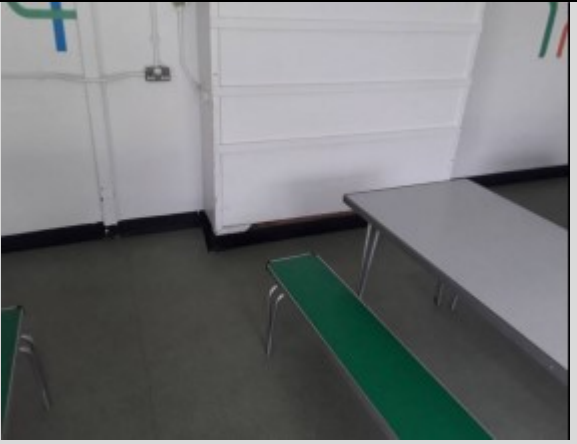
16	As NZ001682	Wall skirting adhesive from removed skirting under modern skirting	Dining Room 2 G/014	No Risk

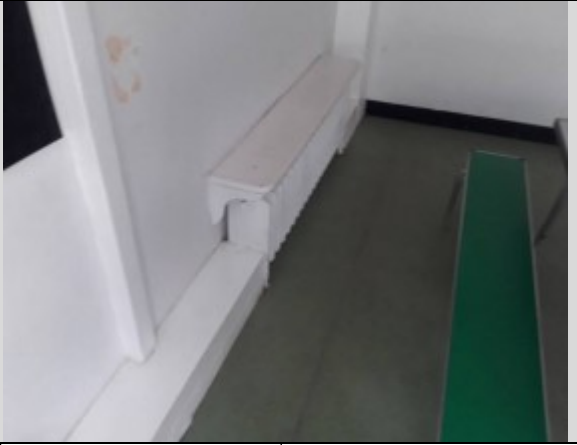
17	As NZ001678	Shelving rear panel above radiator behind shelving	Dining Room 2 G/014	No Risk

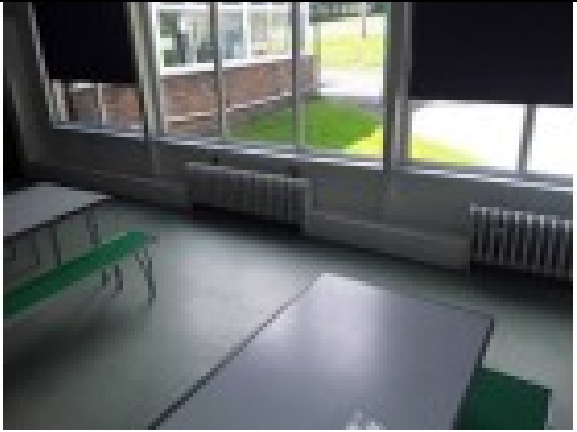
18	NZ001686	Wall skirting remnants to rear of radiators under modern skirting	Dining Room 2 G/014	Very Low Risk – 12 monthly

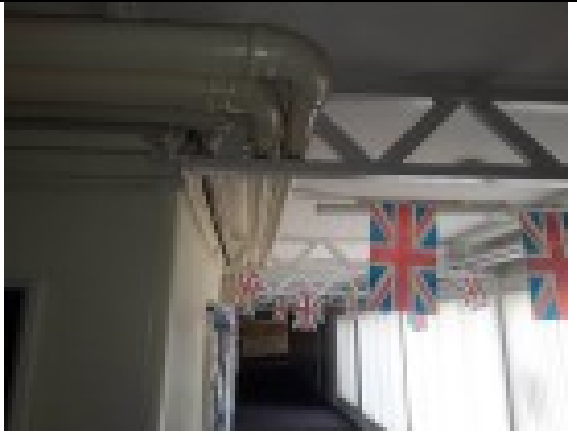
22	NZ001688	Pipework insulation remnants to pipework and metal ceiling supports	Corridor G/019	Low Risk – 6 monthly

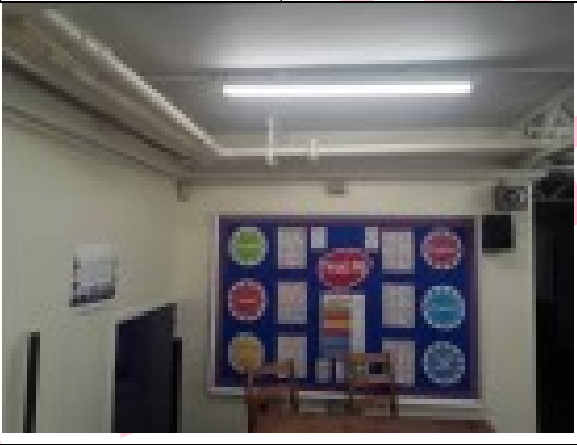
23	NZ001689	Pipework Gasket	Corridor G/019	Very Low Risk – 12 monthly

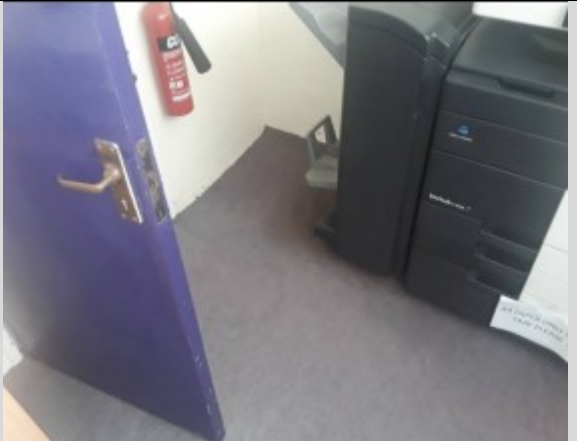
24	As NZ001682	Wall skirting adhesive from removed skirting	Store Room Music G/020	No Risk

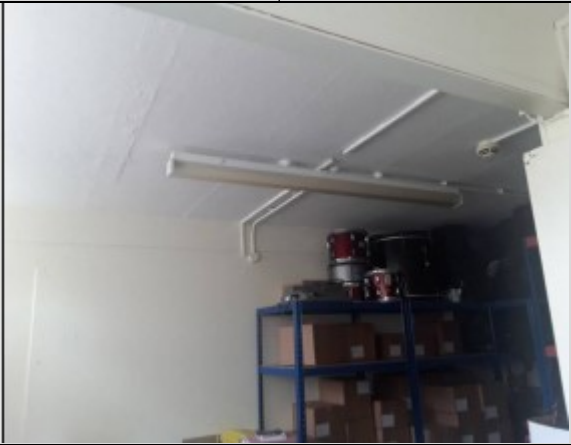
25	NZ001690	Ceiling Coating	Store Room Music G/020	No Risk

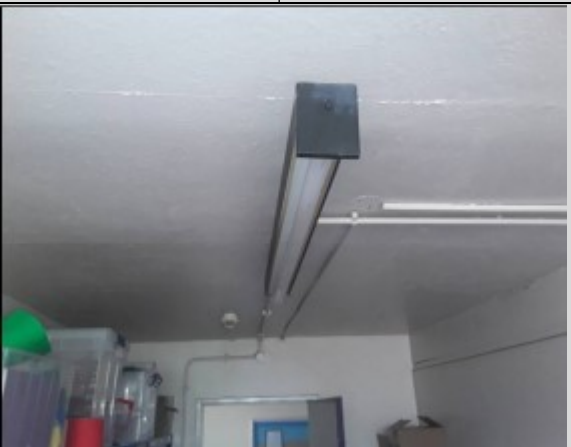
26	As NZ001690	Ceiling Coating	Store Room Art G/021	No Risk

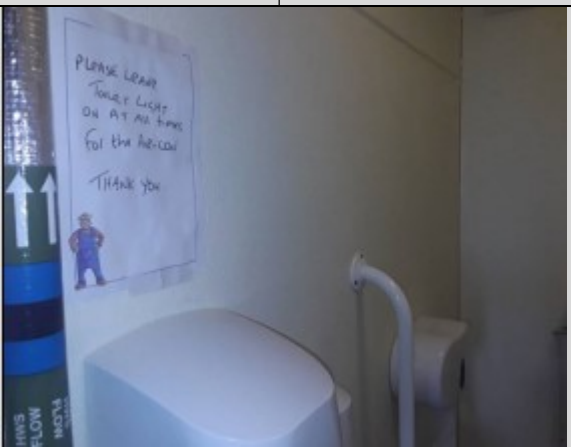
27	As NZ001684	Wall coating	Toilets G/023	No Risk

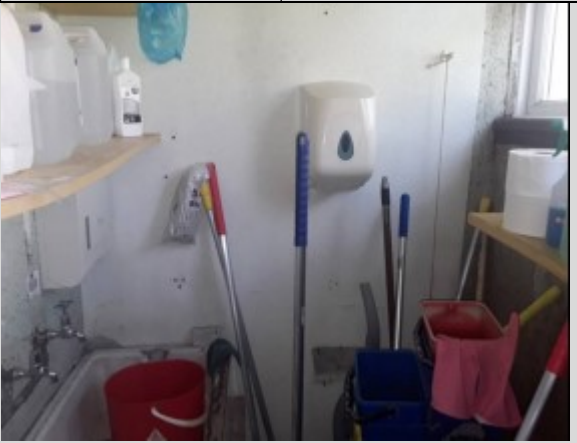
31	As NZ001684	Wall coating	Cupboard Cleaners G/029	No Risk

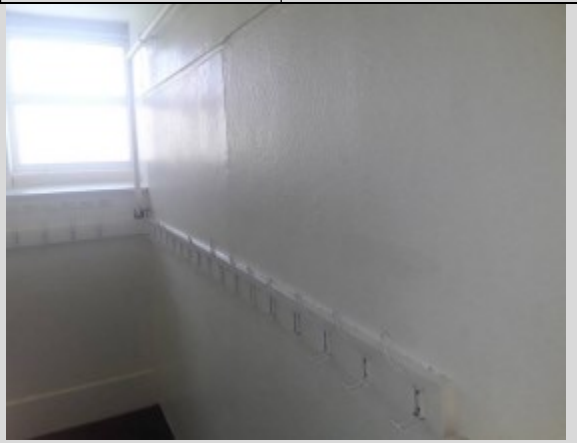
32	As NZ001684	Wall coating	Cloakroom G/032	No Risk

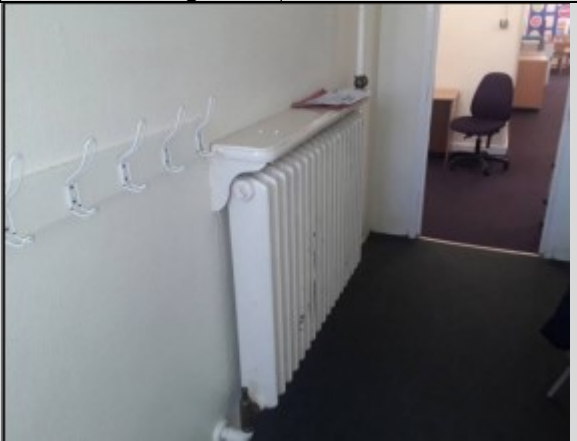
33	As NZ001678	Shelving rear panel above radiator behind shelving	Cloakroom G/032	No Risk

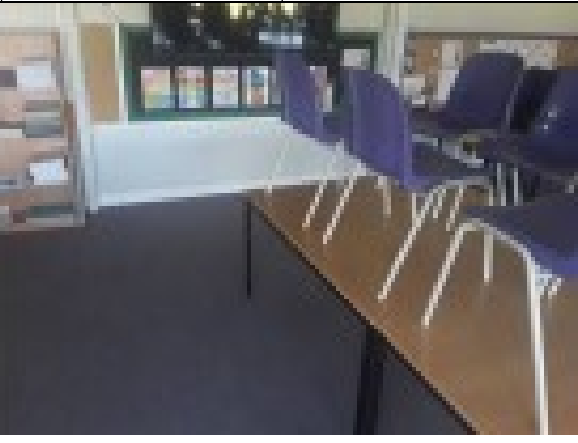
40	As NZ001693	Wall skirting	Classroom G/035	Very Low Risk – 12 monthly

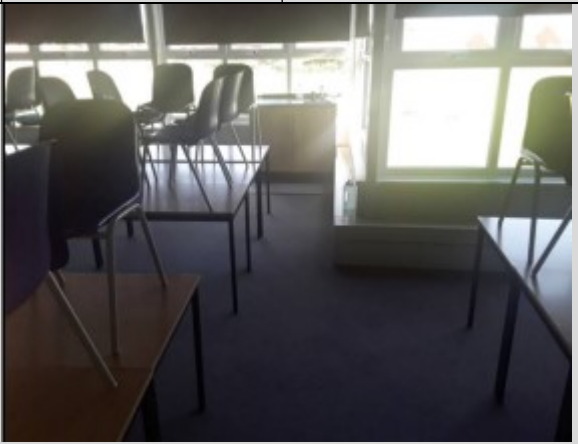
41	As NZ001694	Under sink mat	Classroom G/035	No Risk

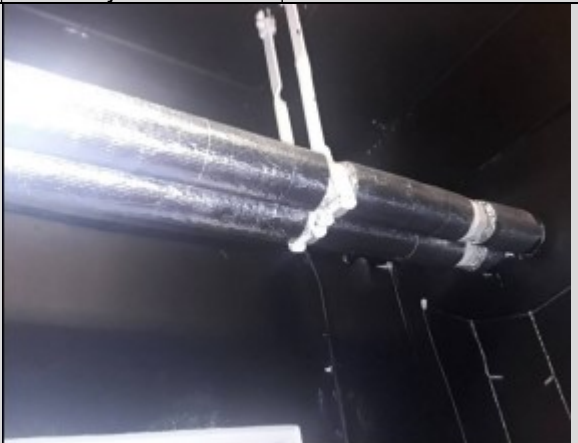
42	NZ001695	Pipework insulation remnants to pipework under modern insulation samples taken from several joints	Store Room G/036	No Risk

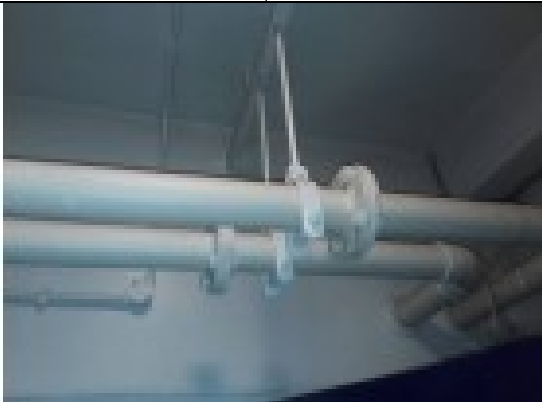
64	As NZ001689	Pipework Gasket	Store Room G/047	Very Low Risk – 12 monthly

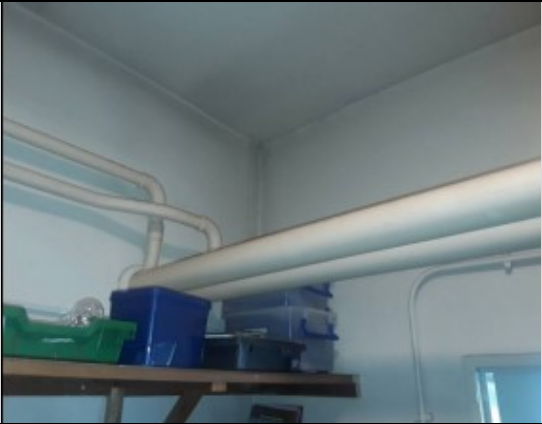
65	NZ001705	Pipework insulation remnants to pipework under modern insulation samples taken from several joints	Store Room G/047	No Risk

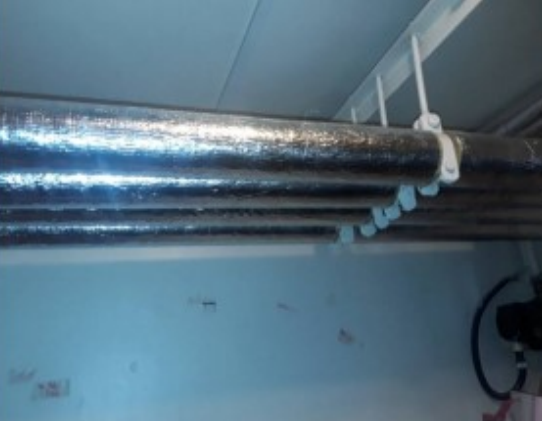
66	As NZ001705	Pipework insulation remnants to pipework under modern insulation samples taken from several joints	Hub/Network Room G/049	No Risk

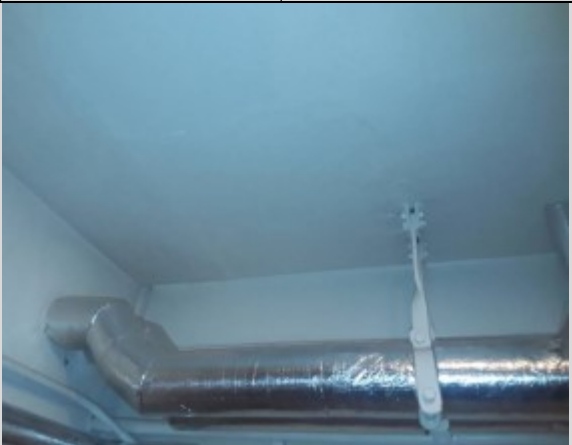
67	As NZ001690	Ceiling Coating	Hub/Network Room G/049	No Risk

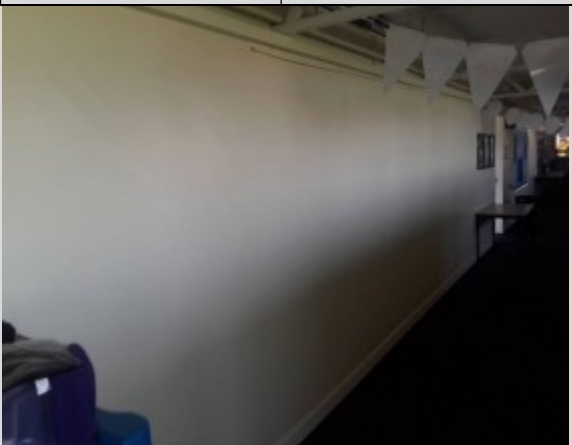
68	NZ001706	Wall Coating	Corridor including cloakrooms G/050	No Risk

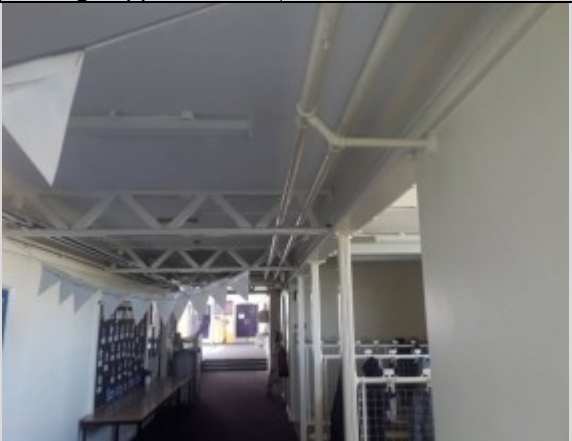
69	NZ001707	Pipework insulation remnants to pipework and metal ceiling supports	Corridor including cloakrooms G/050	No Risk

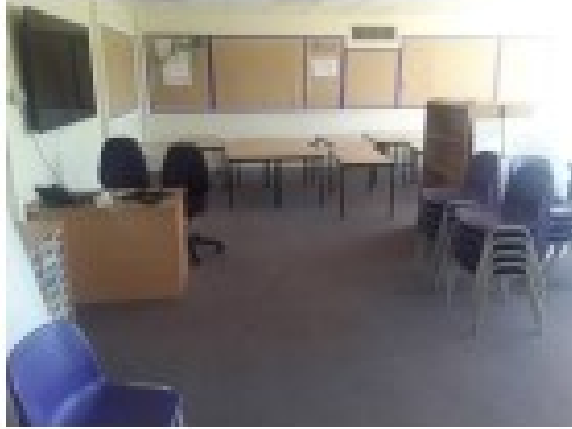
73	As NZ001699	Wall skirting	Classroom G/056	Very Low Risk – 12 monthly

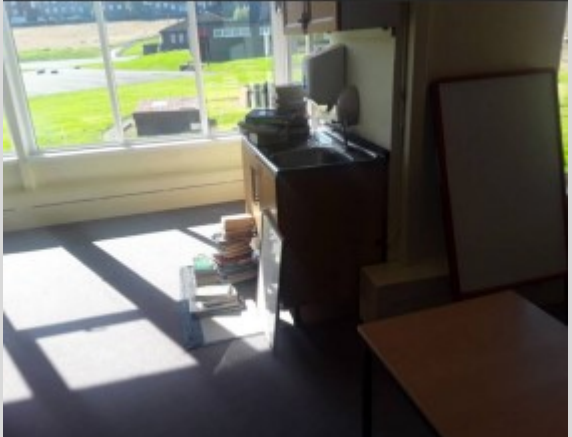
74	As NZ001700	Under sink mat	Classroom G/056	No Risk

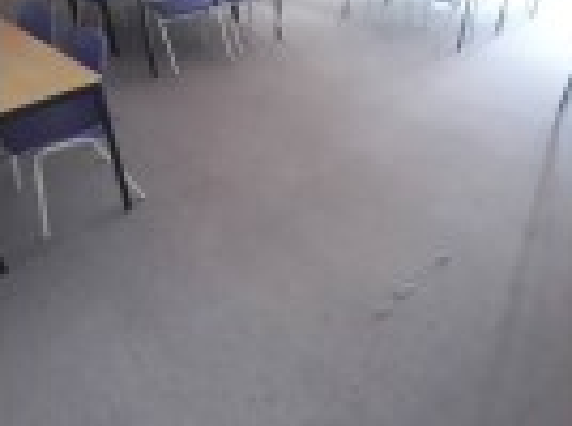
75	As NZ001698	Floor adhesive under carpet	Classroom G/057	Very Low Risk - 12 monthly

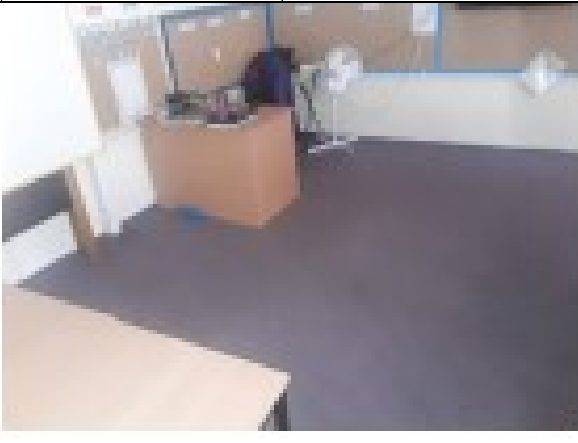
76	As NZ001699	Wall skirting	Classroom G/057	Very Low Risk – 12 monthly

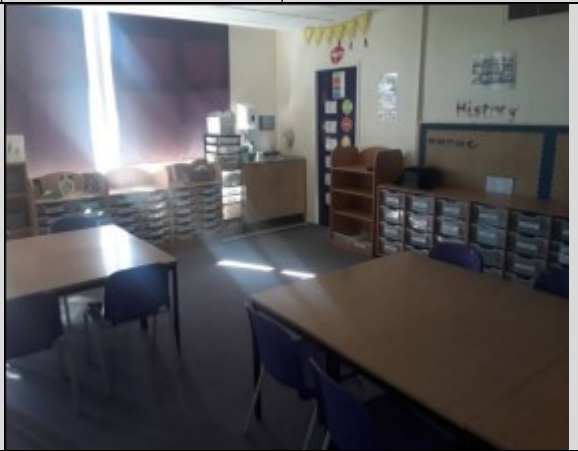
77	As NZ001700	Under sink mat	Classroom G/057	No Risk

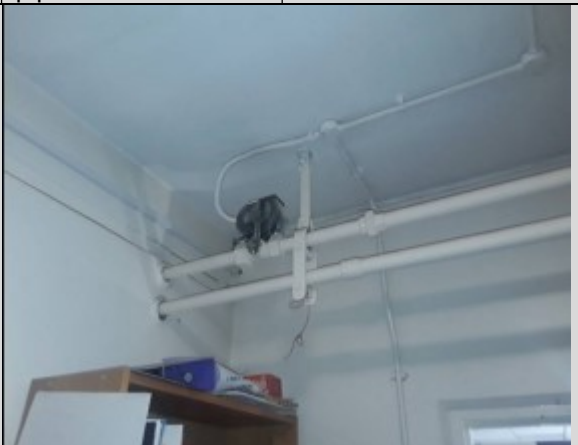
78	As NZ001707	Pipework insulation remnants to pipework	Store Cupboard G/058	No Risk

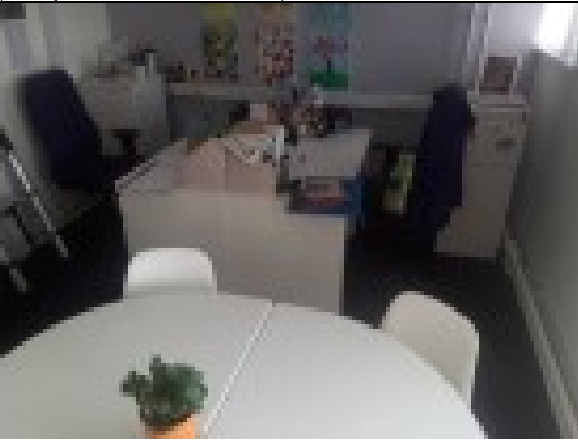
85	As NZ001698	Floor adhesive under carpet	Headteachers Office G/064	Very Low Risk – 12 monthly

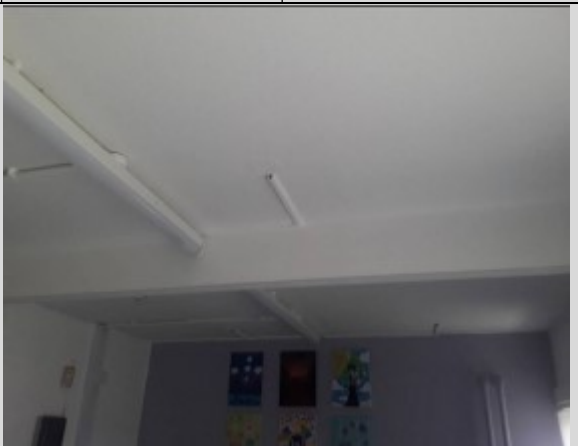
86	NZ001710	Ceiling Coating	Headteachers Office G/064	No Risk

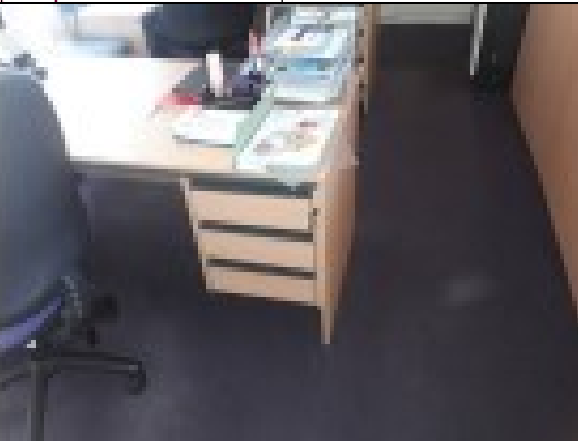
87	As NZ001698	Floor adhesive under carpet	Office main reception G/065	Very Low Risk -m 12 monthly

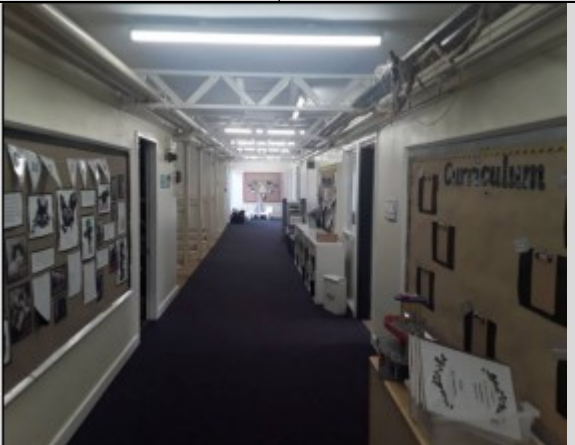
100	As NZ001714	Wall coating	Corridor including cloakrooms G/078	No Risk

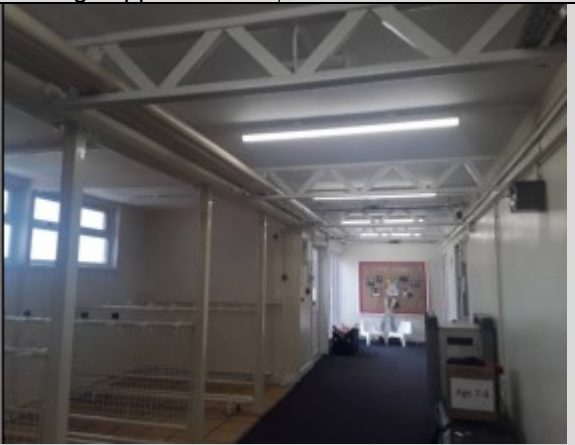
101	NZ001715	Pipework insulation remnants to pipework and metal ceiling supports	Corridor including cloakrooms G/078	No Risk

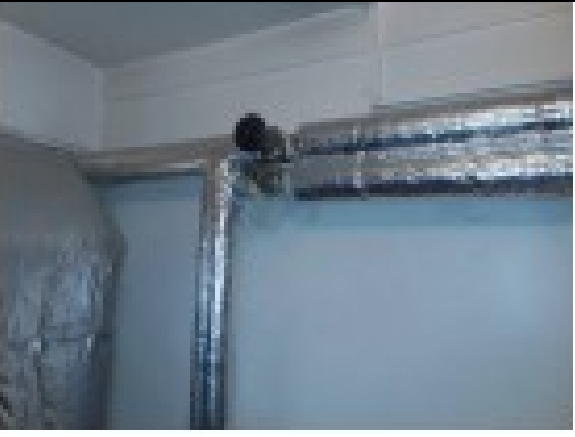
102	NZ001716	Pipework insulation remnants to pipework under modern insulation	Store room between cloakrooms G/079	Low Risk – 6 monthly

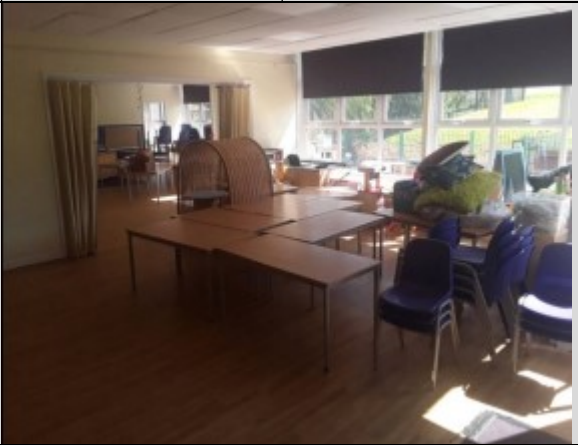
115	As NZ001722	Under sink mat	Classroom G/091	No Risk

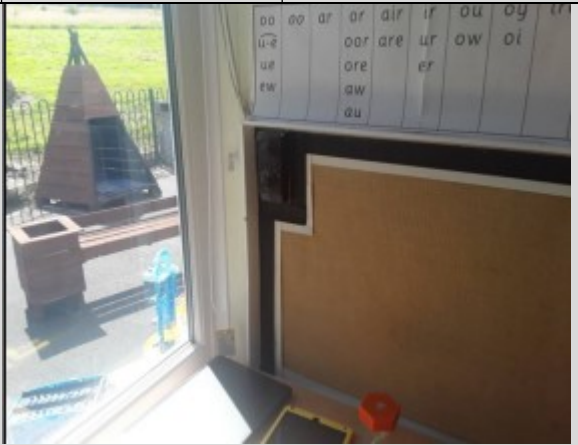
116	As NZ001687	Electrical Services Heater Switch	Classroom G/091	No Risk

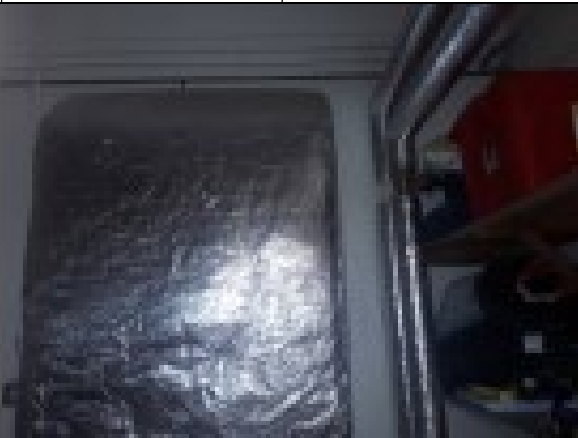
117	As NZ001703	Pipework insulation remnants to pipework under modern insulation	Store Room G/092	Low Risk – 6 monthly

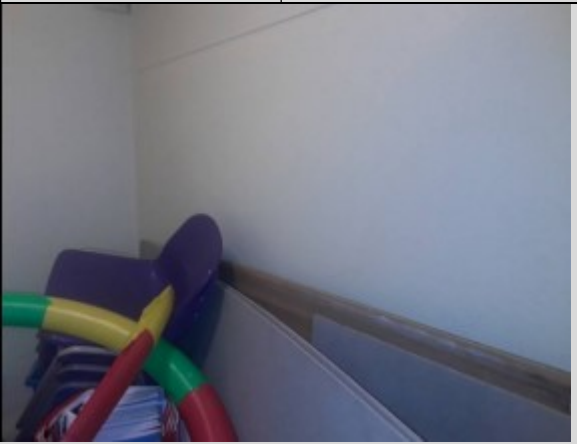
131	As NZ001684	Wall Coating	Toilets Easy Access G/107	No Risk

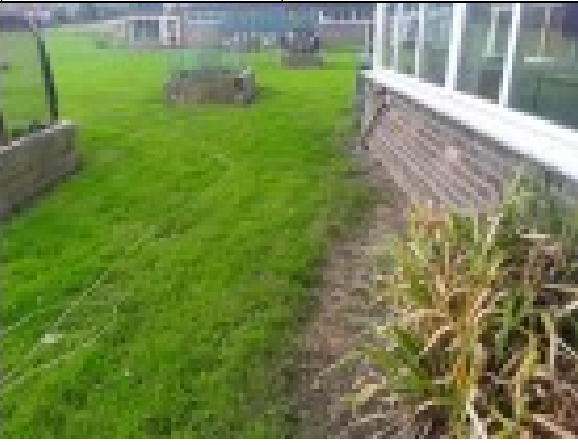
142	NZ001730	Debris/residue imbedded in ground around classroom area	External E/001	Very Low Risk – 12 monthly

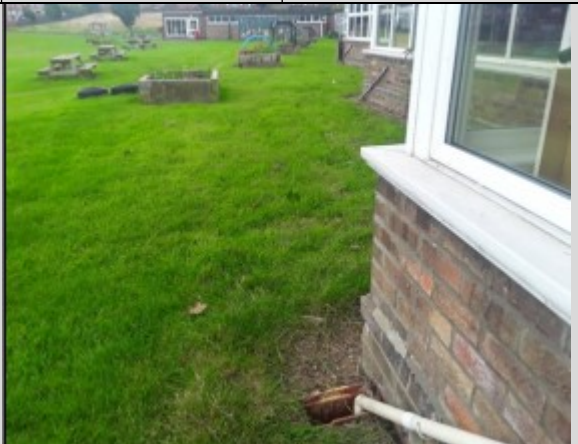
143	NZ001731	Debris/Residue embedded in ground presumed to be from removed windows	External E/001	No Risk

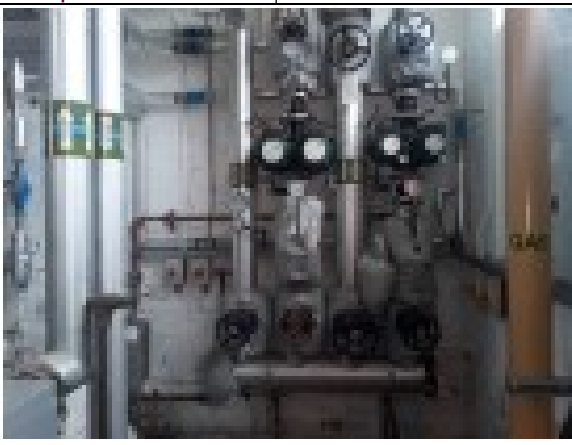
145	Presumed	Pipework Gasket too deeply recessed to sample	Boiler Room 1 E/002	Very Low Risk – 12 monthly

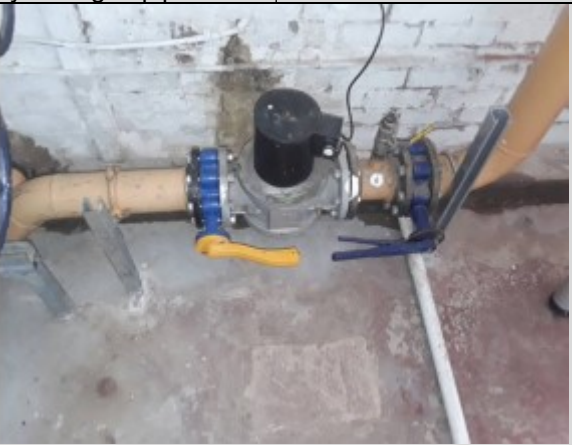
146	NZ001732	Pipework gasket to yellow gas pipework	Boiler Room 1 E/002	No Risk

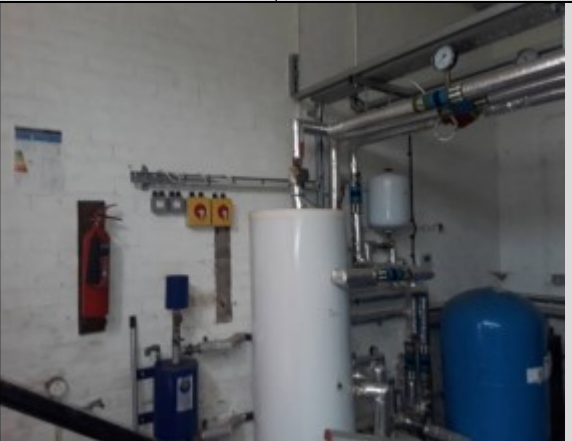
147	NZ001733	Debris/Residue to left hand wall	Boiler Room 1 E/002	No Risk

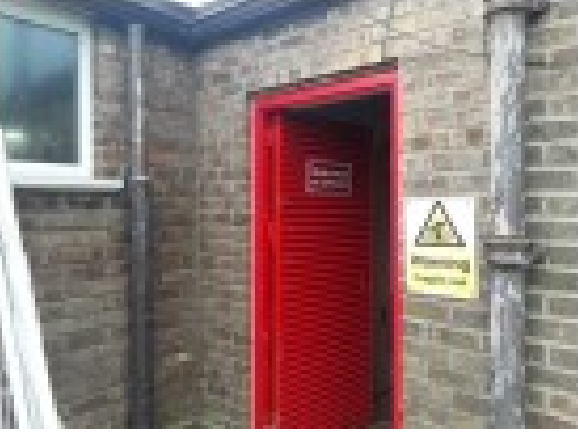
160	As NZ001738	Damp proof course around door frame	Boiler Room 2 E/003	Very Low Risk – 12 monthly

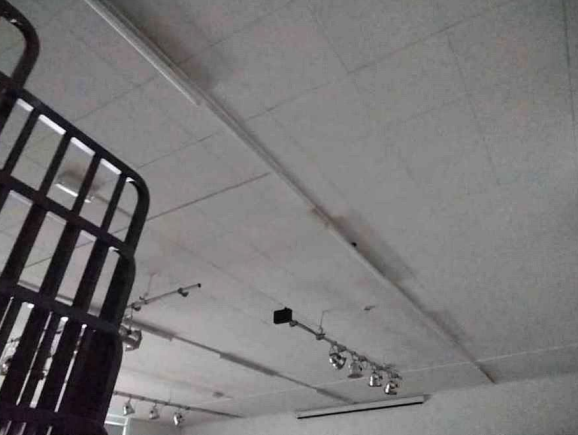
161	DC005125	Ceiling Tile - Suspended, Solid	Main Hall Room G/016	No Risk

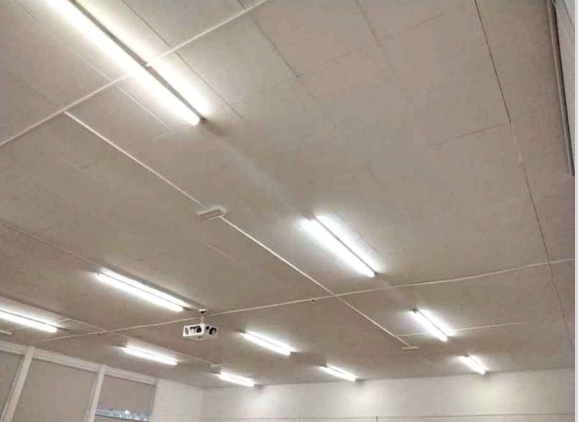
162	As DC005125	Ceiling Tile - Suspended, Solid presumed same due to height restrictions	Main Hall Room G/076	No Risk
