### **ASBESTOS SURVEY REPORT FOR PLAINS FARM ACADEMY, SUNDERLAND**

## **Asbestos Register for PLAINS FARM ACADEMY**

**Date: 27 January 2022**

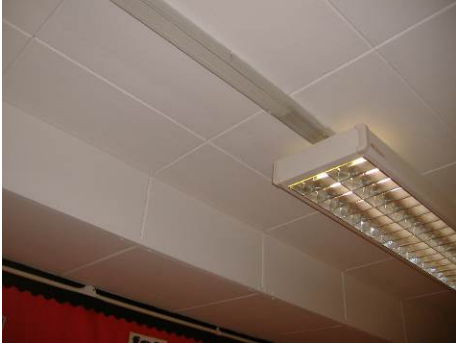
### **Item 1 Ref: AW0425/08**

The ceiling tiles to the ITC room (Rm 0/01) contain asbestos.

Any change in its appearance should be recorded, and passed to Property Services.

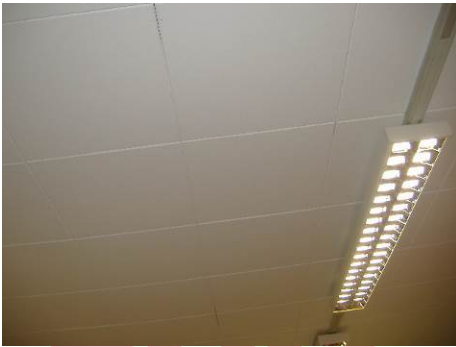
### **Item 2 - Ref: AW0426/08**

The ceiling tiles to the year 6 classroom (Rm 0/02) contain asbestos.

Any change in its appearance should be recorded, and passed to Property Services.

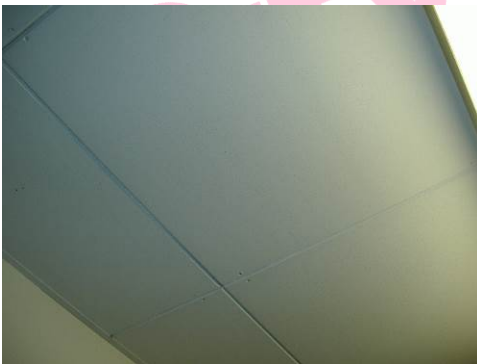
### **Item 3 - Ref: Presumed**

The ceiling tiles to the store room (Rm 0/03) are presumed to contain asbestos.

Any change in its appearance should be recorded, and passed to Property Services.

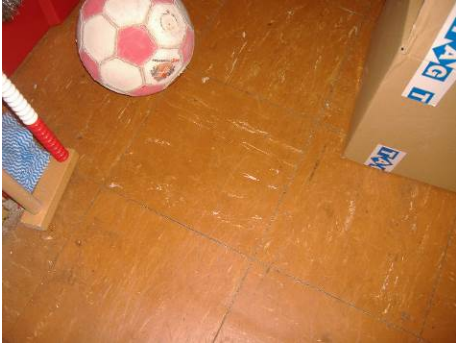
### **Item 4 Ref: AW0427/08**

The orange floor tiles to the store room (Rm 0/03) do not contain asbestos.

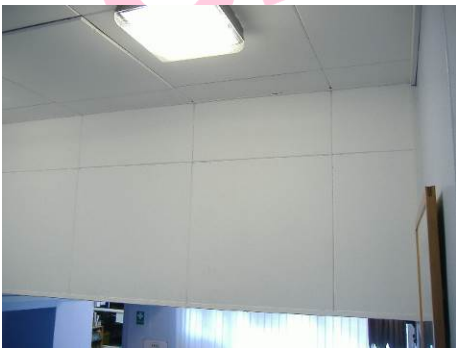
### **Item 25 - Ref: Presumed**

The ceiling tiles in the lobby (Rm 0/24) are presumed to contain asbestos.

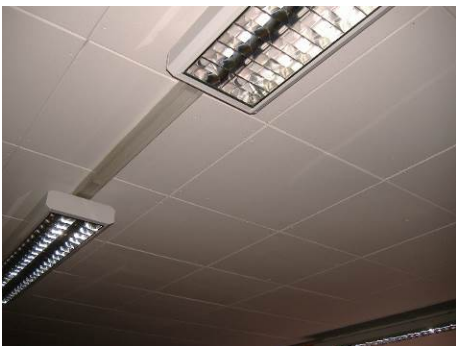
### **Item 31 - Ref: Presumed**

The ceiling tiles to the classroom (Rm 0/30) are presumed to contain asbestos.

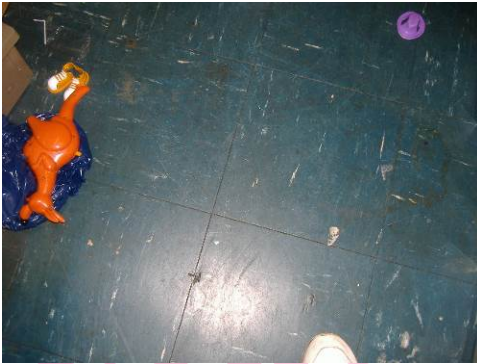
### **Item 33 Ref: AW0429/08**

The blue floor tiles to the store room (Rm 0/31) do not contain asbestos.

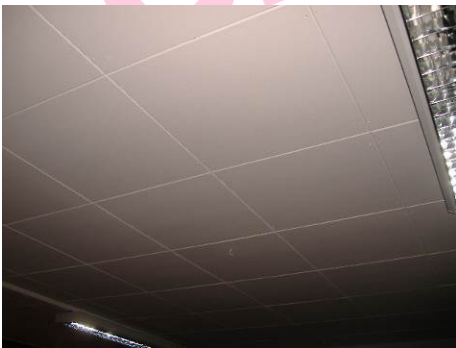
### **Item 37 - Ref: Presumed**

The ceiling tiles to the classroom (Rm 0/34) are presumed to contain asbestos.

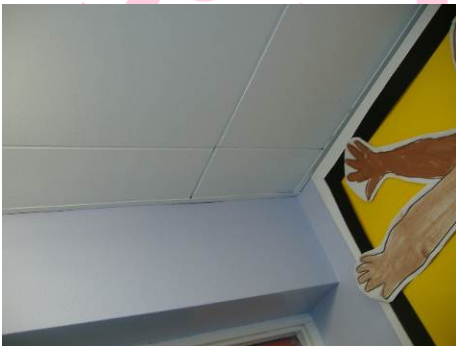
### **Item 40 - Ref: Presumed**

The ceiling tiles to the lobby (Rm 0/37) were presumed to contain asbestos.

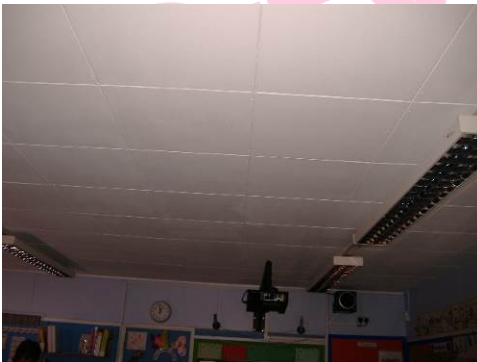
### **Item 44 - Ref: Presumed**

The ceiling tiles to the classroom (Rm 0/40) were presumed to contain asbestos.

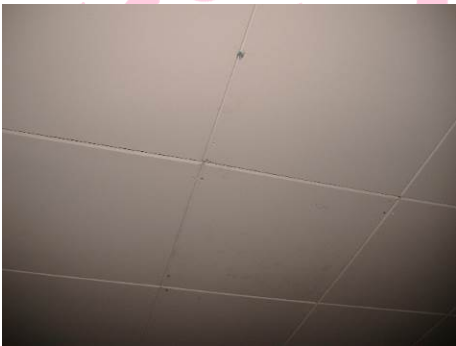
### **Item 47 - Ref: Presumed**

The ceiling tiles to the classroom (Rm 0/43) were presumed to contain asbestos.

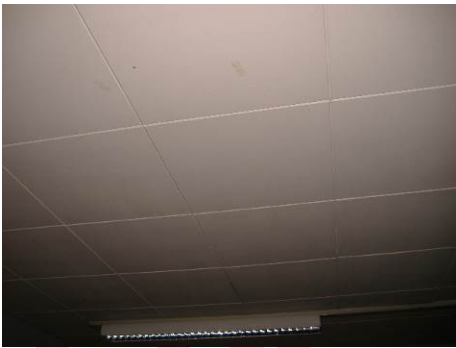
### **Item 49 - Ref: Presumed**

The ceiling tiles to the store room (Rm 0/46) are presumed to contain asbestos.

*These were removed in August 2015.*

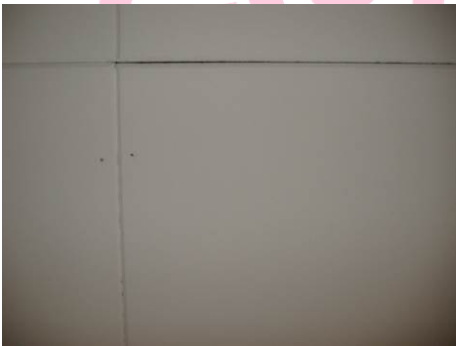
### **Item 50 - Ref: Presumed**

The ceiling tiles to the library/music (Rm 0/45) were presumed to contain asbestos.

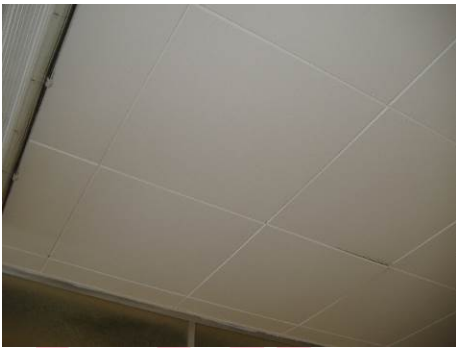
### **Item 55 - Ref: 247623-1**

The ceiling tiles to the kitchen (Rm 0/66) contain asbestos.

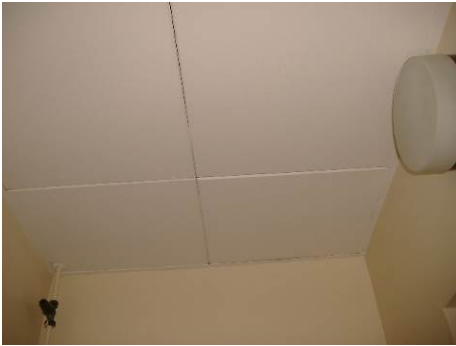
### **Item 57 - Ref: Presumed**

The ceiling tiles to the staff toilets (Rm 0/68) are presumed to contain asbestos.

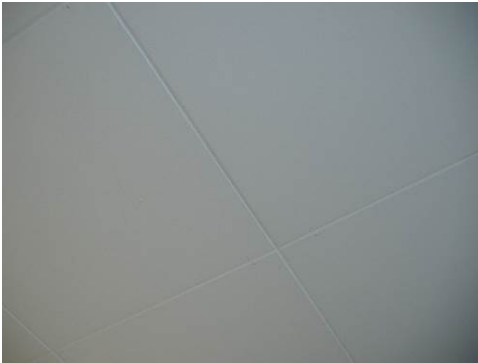
### **Item 60 - Ref: Presumed**

The ceiling tiles to the store room (Rm 0/71) are presumed to contain asbestos.

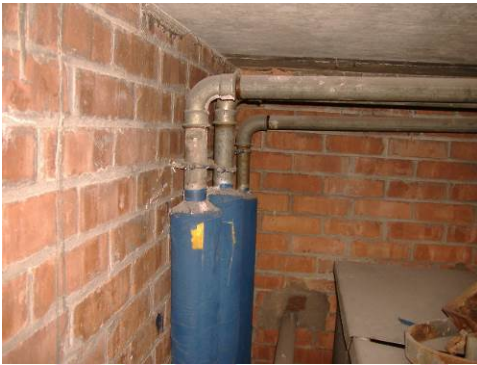
### **Item 64 - Ref: AW0445/08**

The pipework insulation to the tank room (Rm M274) does not contain asbestos.

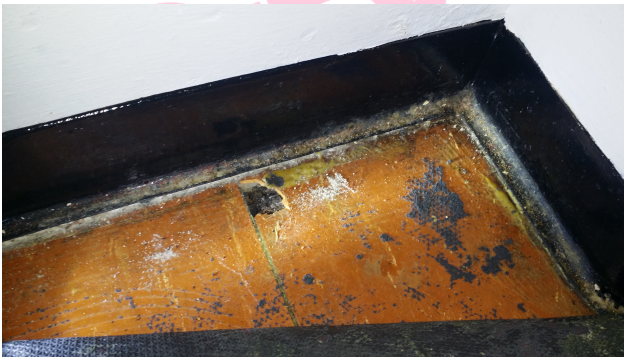
### **Item 68 - Ref: 266362-4**

The floor tiles with bitumen adhesive in 001/ICT suite do not contain asbestos.

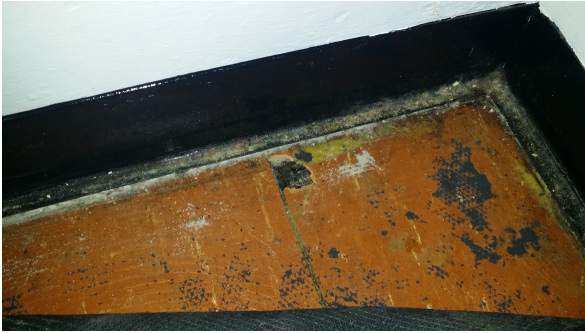
### **Item 69 - Ref: 266362-2**

The floor screed beneath tiles in 001/ICT suite does not contain asbestos.

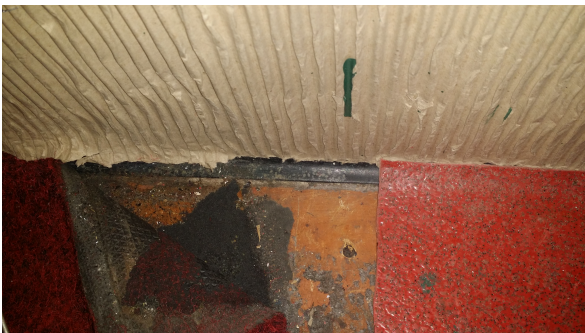
### **Item 70- Ref: As 266362-4**

The floor tiles with bitumen adhesive in 002/Year 6 classroom do not contain asbestos.

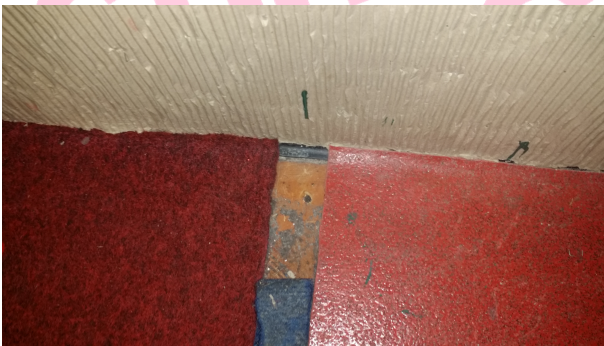
### **Item 71-Ref: As 266362-2**

The floor screed beneath tiles in 002/Year 6 classroom does not contain asbestos.

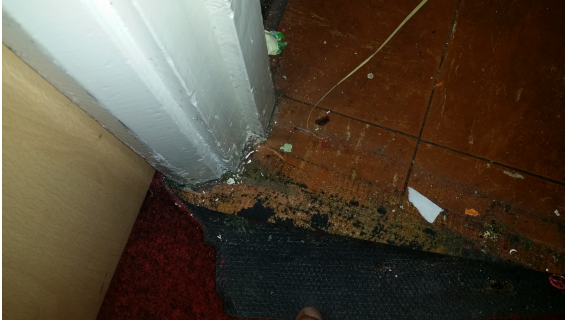
### **Item 72-Ref: As 266362-4**

The floor tiles with bitumen adhesive in 005/Year 5 classroom do not contain asbestos.

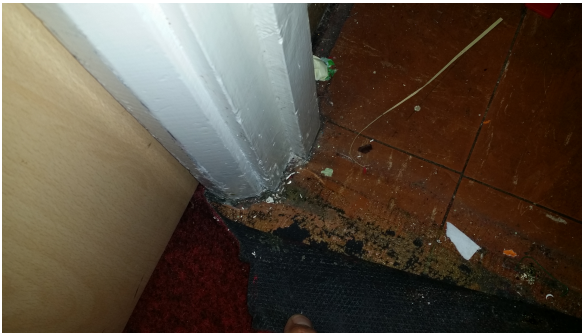
### **Item 73-Ref: As 266362-2**

The floor screed beneath tiles in 005/Year 5 classroom does not contain asbestos.

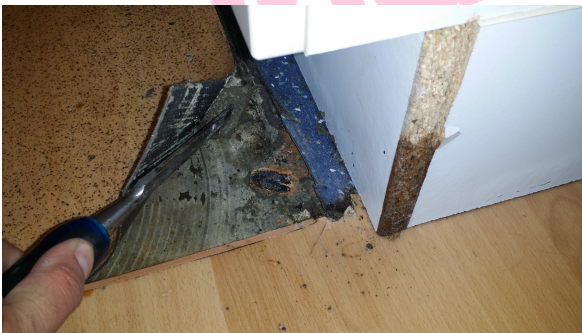
### **Item 74-Ref: 266362-5**

The floor tiles with bitumen adhesive in 006/Staffroom do not contain asbestos.

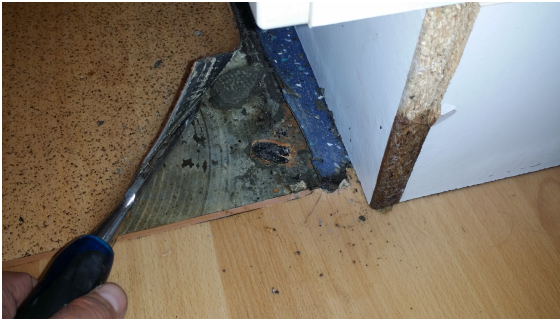
### **Item 75-Ref: 266362-6**

The floor screed beneath tiles in 006/Staffroom does not contain asbestos.

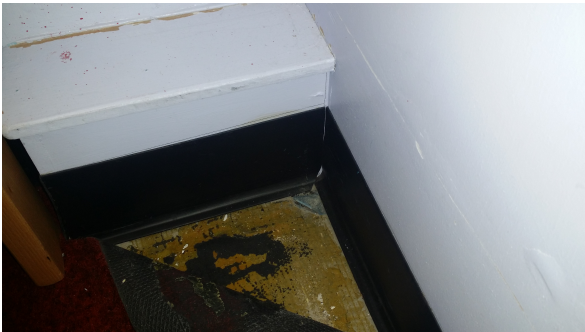
### **Item 76-Ref: As 266362-3**

The floor tiles with bitumen adhesive in 018/Office do not contain asbestos.

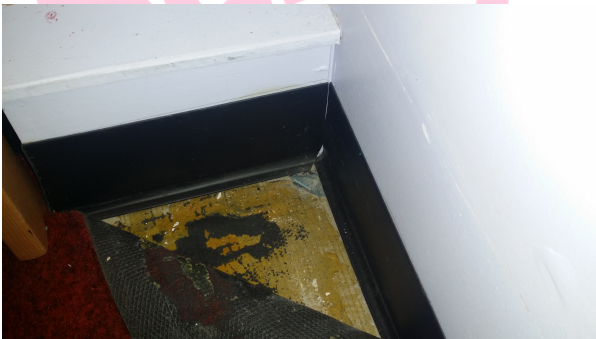
### **Item 77-Ref: As 266362-2**

The floor screed beneath tiles in 018/Office does not contain asbestos.

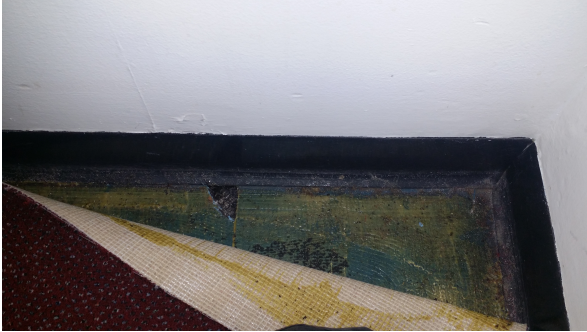
### **Item 78-Ref: 266362-3**

The floor tiles with bitumen adhesive in 020/Head teacher room do not contain asbestos.

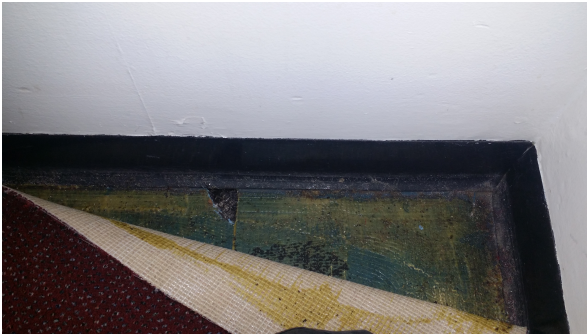
### **Item 79-Ref: As 266362-2**

The floor screed beneath tiles in 020/Head teacher room does not contain asbestos.

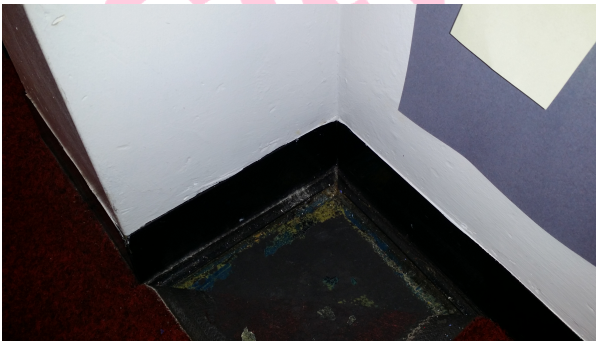
### **Item 80-Ref: As 266362-7**

The floor tiles with bitumen adhesive in 029/Year 3 classroom do not contain asbestos.

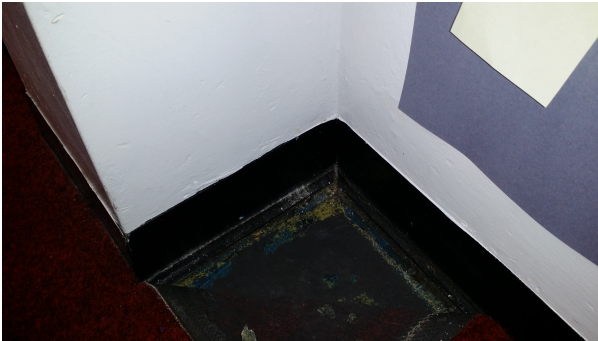
### **Item 81-Ref: As 266362-8**

The floor screed beneath tiles in 029/Year 3 classroom does not contain asbestos.

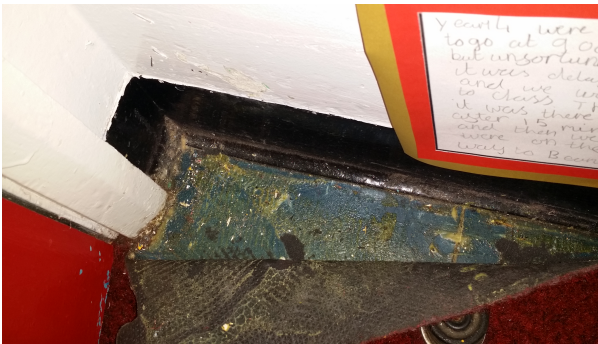
### **Item 82-Ref: As 266362-7**

The floor tiles with bitumen adhesive 030/Year 4 classroom do not contain asbestos.

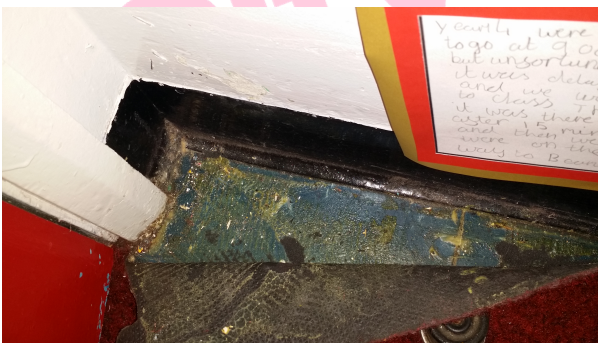
### **Item 83-Ref: As 266362-8**

The floor screed beneath tiles in 030/Year 4 classroom does not contain asbestos.

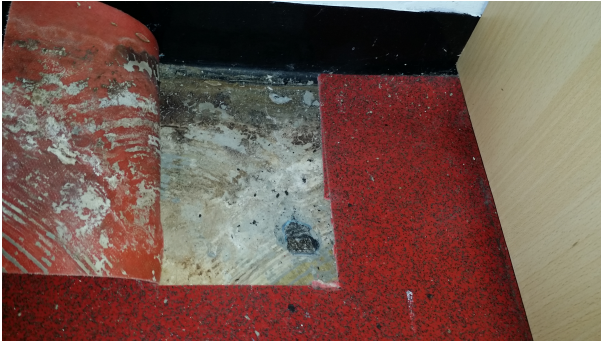
### **Item 84-Ref: 266362-7**

The floor tiles with bitumen adhesive 034/Group teaching room do not contain asbestos.

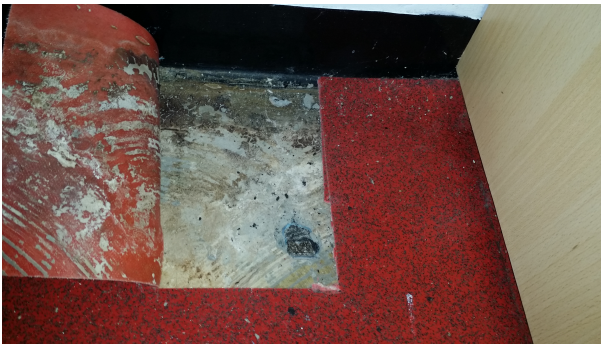
### **Item 85-Ref: 266362-8**

The floor screed beneath tiles in 034/Group teaching room does not contain asbestos.

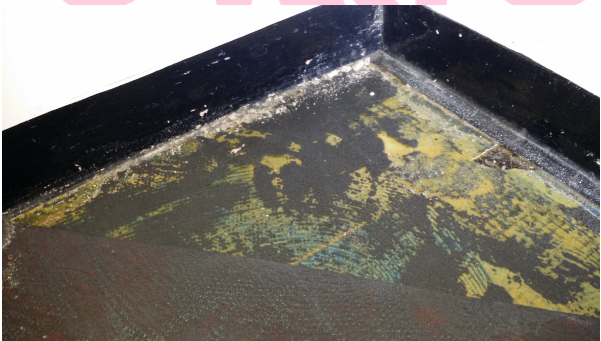
### **Item 86-Ref: 266362-9**

The floor tiles with bitumen adhesive in 036/Breakfast club do not contain asbestos.

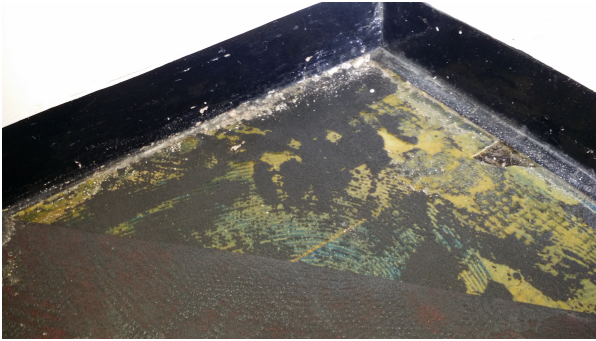
#### **Item 87-Ref: 266362-10**

The floor screed beneath tiles in 036/Breakfast club does not contain asbestos.

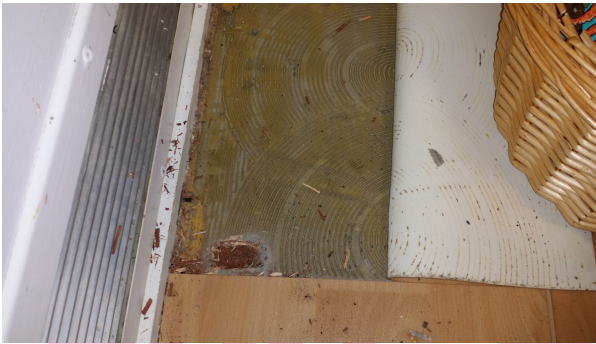
#### **Item 88-Ref: 266362-11**

The floor screed beneath tiles in 055/Reception does not contain asbestos.

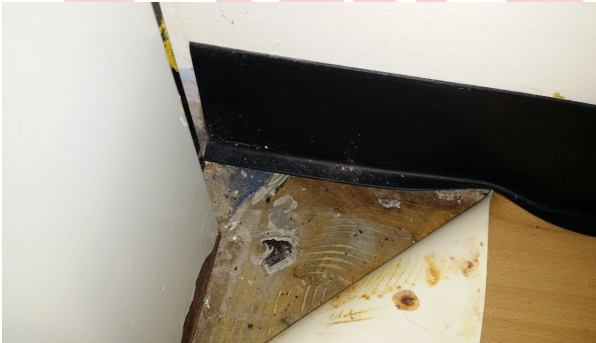
#### **Item 89-Ref: 266362-12**

The floor tiles with bitumen adhesive in 062/Nursery do not contain asbestos.

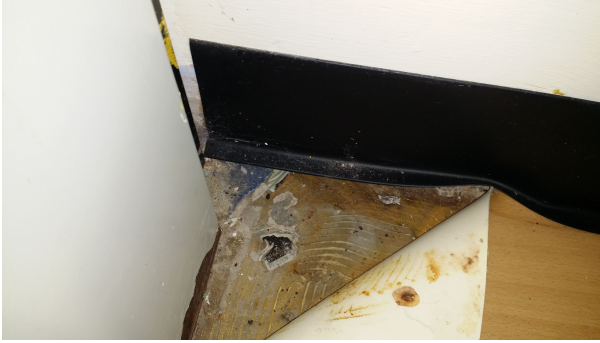
### **Item 90-Ref: 266362-13**

The floor screed beneath tiles in 062/Nursery does not contain asbestos.

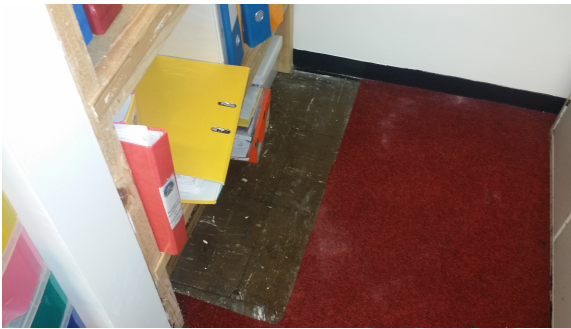
### **Item 91-Ref: 266362-1**

The floor tiles with bitumen adhesive in 075/Main office do not contain asbestos.

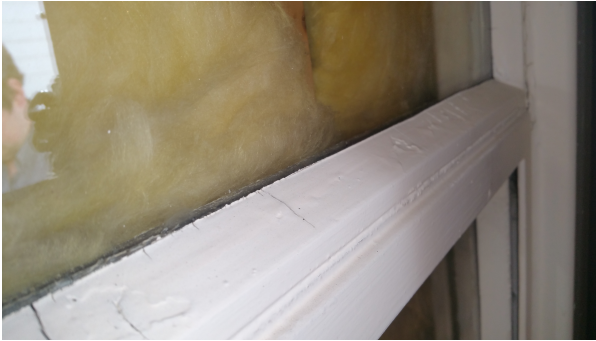
### **Item 93-Ref: As 270749-2**

The Sealant tot windows to rear of plastic fascias in externals Roof A area do not contain asbestos.

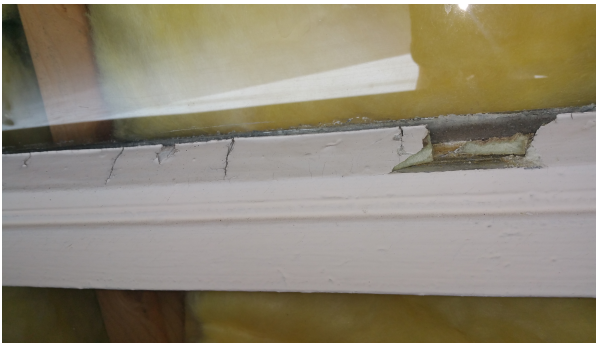
### **Item 94-Ref: 270749-2**

The Sealant to windows to rear of plastic fascias in externals Roof B area do not contain asbestos.

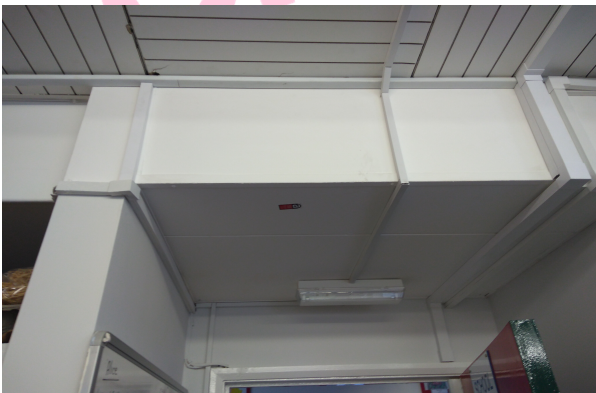
### **Item 95-Ref: 293720-1**

The Ceiling/boxing above entrance doors (& cupboards) in the main office contain asbestos.

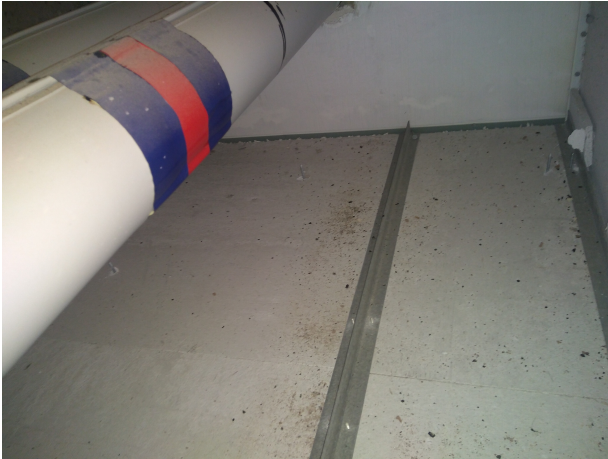
### **Item 96-Ref: As 293720-1**

The back side of ceiling/boxing above entrance doors (& cupboards) in the main office (void above) contain asbestos.

This item was removed November 2018.

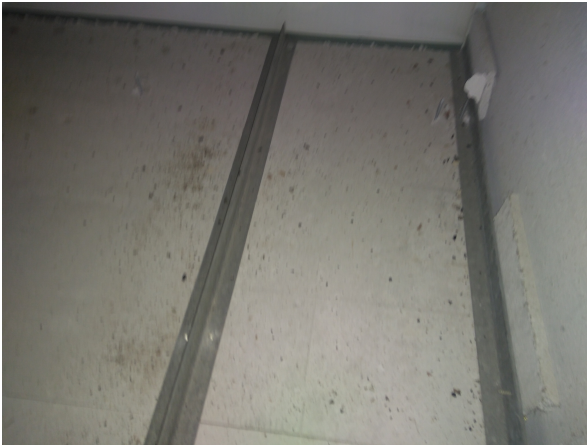
### **Item 97-Ref: 293720-2**

The board debris within boxing in the main office (void above) contains asbestos.

This item was removed November 2018.

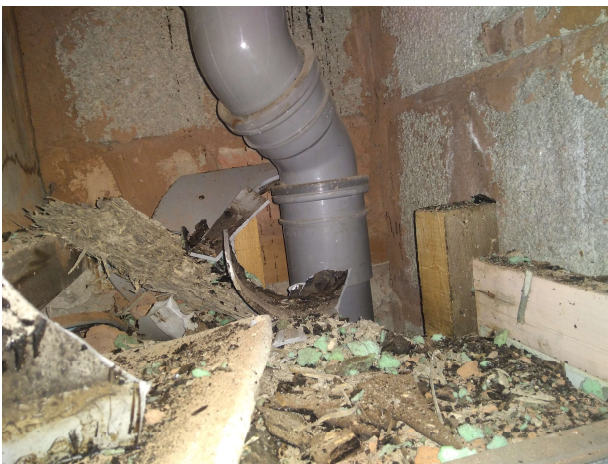
### **Item 98-Ref: 293720-3**

The bitumen roof covering debris in the main office (void above) contains asbestos.

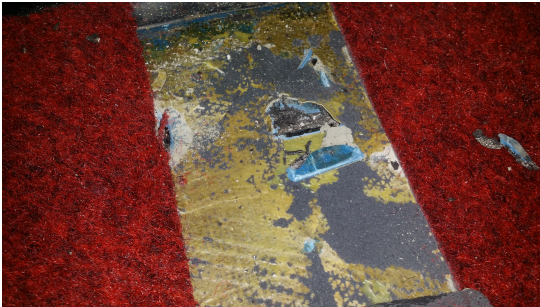
### **Item 100 Ref: 173107-3**

The floor covering below carpet in Rm 019/deputy heads office does not contain asbestos.

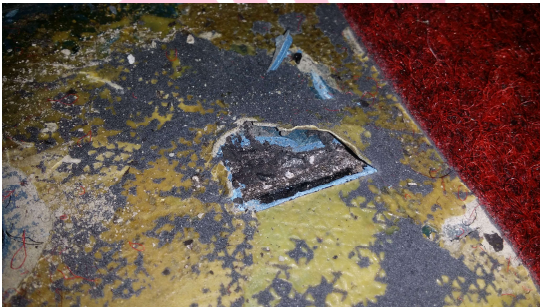
### **Item 101 Ref: As 173107-2**

The covering below two layers of floor covering in Rm 019/Deputy heads office does not contain asbestos.

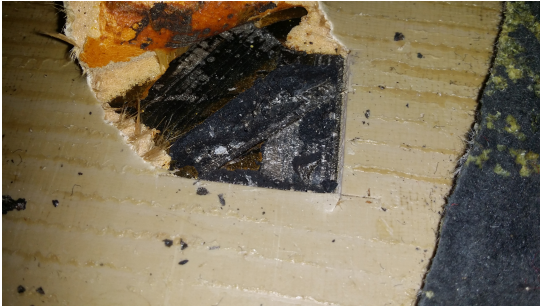
### **Item 102 Ref: 173107-1**

The covering below two layers of floor covering in Rm 021/Corridor does not contain asbestos.

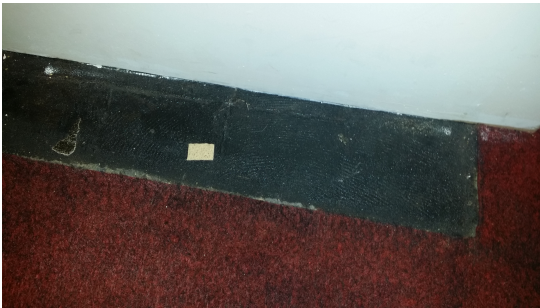
### **Item 103 Ref: 173107-2**

The adhesive below carpet in Rm 024/lobby & Corridor does not contain asbestos.

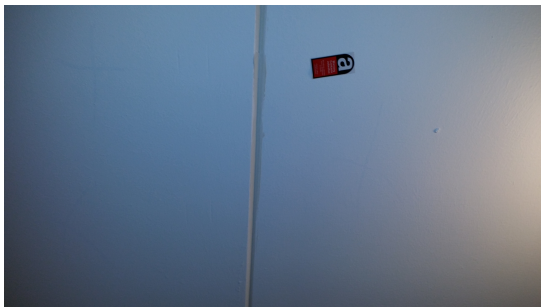
### **Item 107 Ref: As 247623-1**

The ceiling in Rm 003/Kitchen Toilet contains asbestos.

Any change in its appearance should be recorded and passed to Property Services.

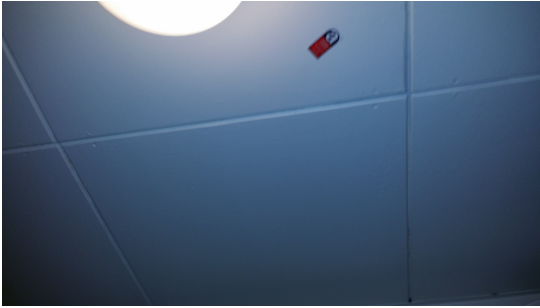
### **Item 108 Ref: As 247623-1**

The ceiling in Rm 004/Kitchen Store contains asbestos.

Any change in its appearance should be recorded and passed to Property Services.

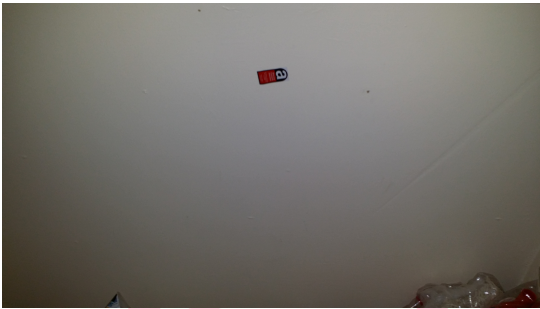
### **Item 109 Ref: Presumed**

The panels above wooden ceiling in Rm 005/Kitchen Store are presumed to contain asbestos.

Any change in its appearance should be recorded and passed to Property Services.

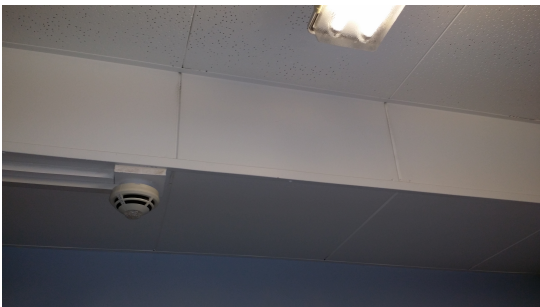
### **Item 110 Ref: As 247623-1**

The ceiling in Rm 006/Kitchen Office contains asbestos.

Any change in its appearance should be recorded and passed to Property Services.

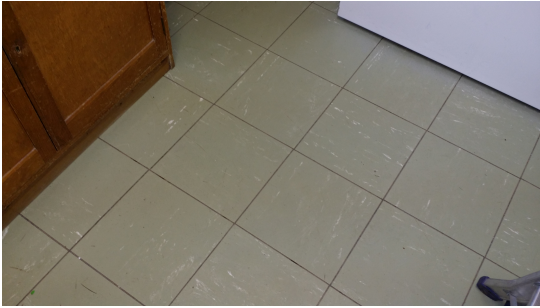
### **Item 111 Ref: 247623-2**

The floor covering in Rm 006/Kitchen Office does not contain asbestos.

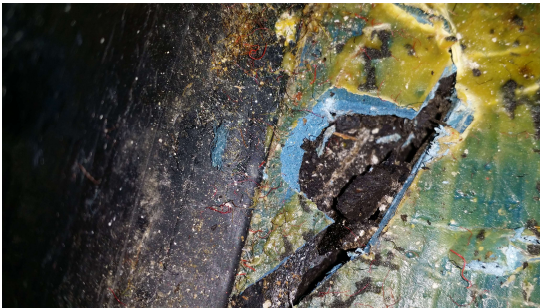
### **Item 112 Ref: 247623-4**

The screed to floor in Rm 007/Head teachers Office does not contain asbestos.

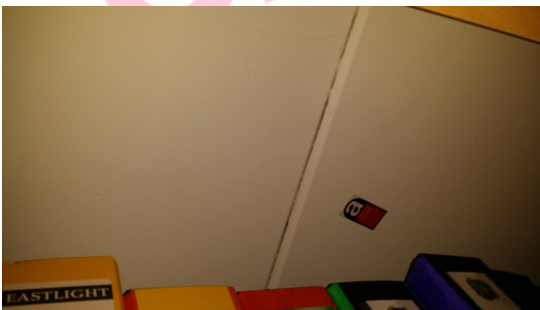
### **Item 113 Ref: 247623-3**

The ceiling in Rm 007/ Headteachers office cupboard contains asbestos.

Any change in its appearance should be recorded and passed to Property Services.

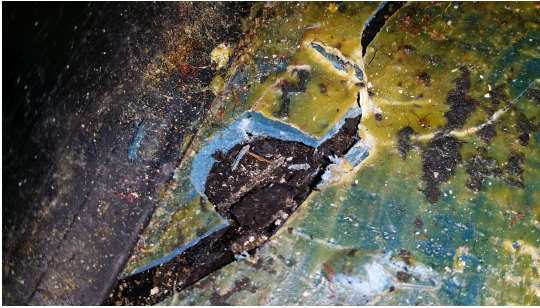
### **Item 114 Ref: As 247623-4**

The screed to floor in Rm 007/Headteachers office cupboard does not contain asbestos.

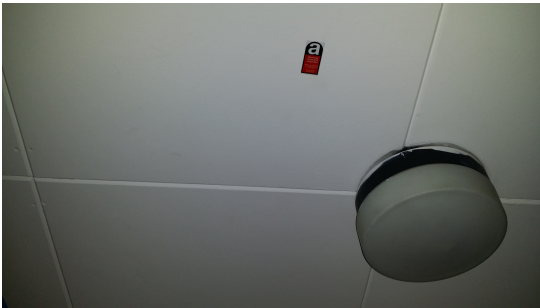
### **Item 115 Ref: As 247623-3**

The ceiling in Rm 008/reception contains asbestos.

Any change in its appearance should be recorded and passed to Property Services.

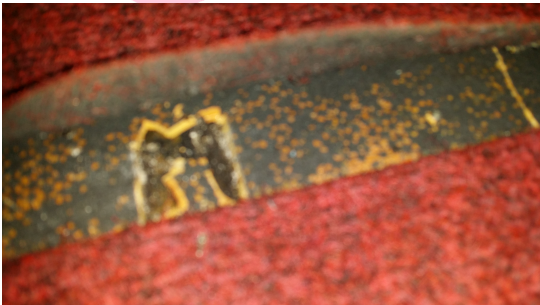
### **Item 116 Ref: 247623-6**

The subfloor in Rm 009/IT Suite does not contain asbestos.

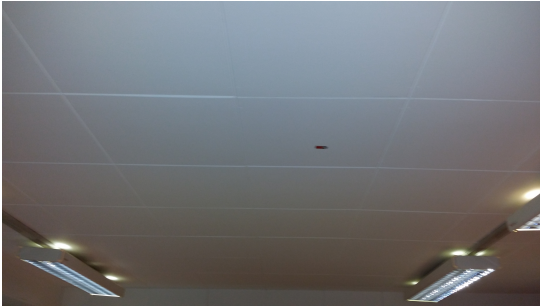
### **Item 117 Ref: As 247623-3**

The ceiling in Rm 009/IT Suite contains asbestos.

Any change in its appearance should be recorded and passed to Property Services.

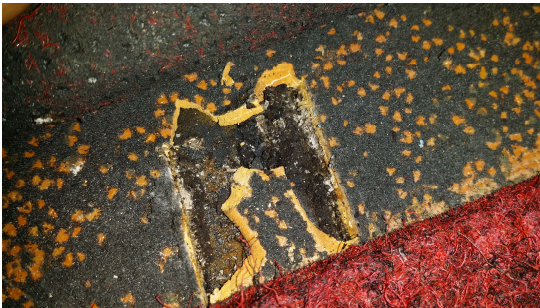
### **Item 118 Ref: As 247623-4**

The screed to floor in Rm 009/IT Suite does not contain asbestos.

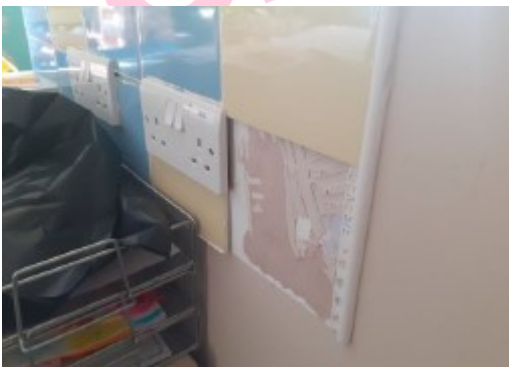
### **Item 119 Ref: 20-27587-1**

The walls rear of ceramic tiles adhesive in Kitchen within reception area do not contain asbestos.

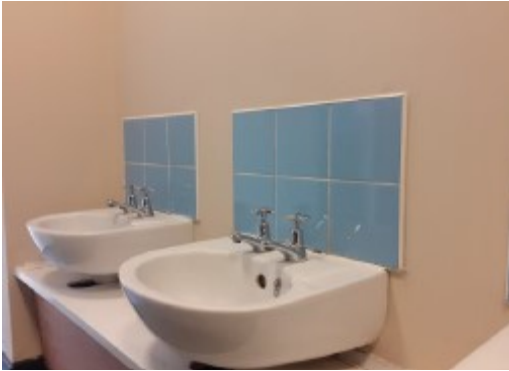
### **Item 120 Ref: As 20-27587-1**

The walls rear of ceramic tiles adhesive in Reception WC Area do not contain asbestos.

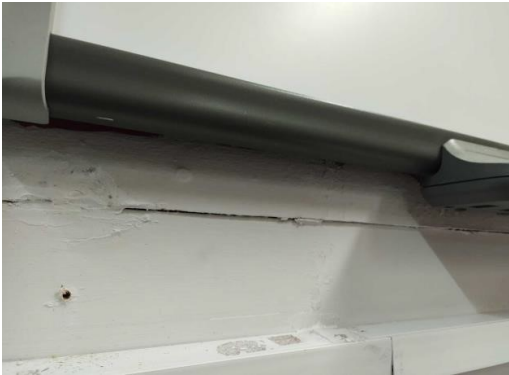
### **Item 121 Ref: 22-42201-1**

The walls behind whiteboard (Area 1/Year 6 Classroom) do not contain asbestos.

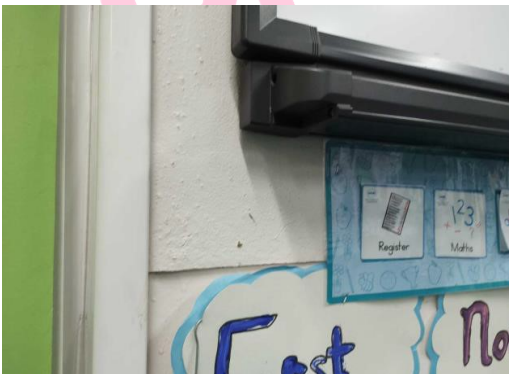
### **Item 122 Ref: 22-42201-1**

The walls behind whiteboard (Area 5/Year 2 Classroom) do not contain asbestos.
