ASBESTOS SURVEY REPORT FOR BURNSIDE ACADEMY, BURNSIDE ESTATE,
HOUGHTON LE SPRING

Asbestos Register for

**BURNSIDE ACADEMY, BURNSIDE ESTATE, HOUGHTON LE
SPRING**

Burnside Academy - Last updated 13/02/2025 – Version 2

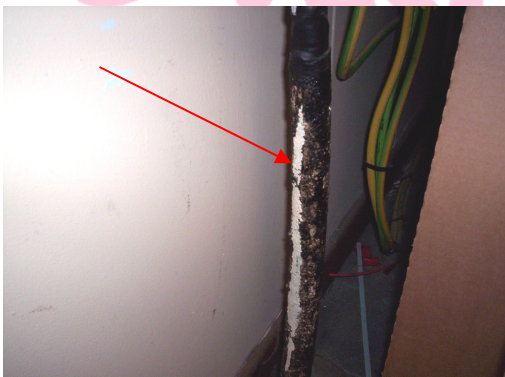
Item 5 - Ref: Presumed

The main cable sheath was inaccessible as it was live during the survey therefore it has to be presumed that there could be asbestos within.

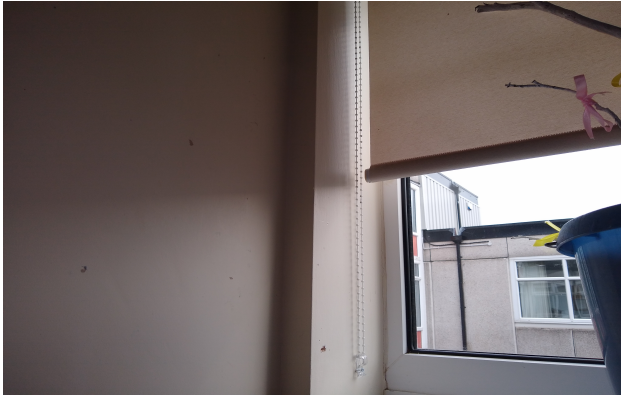
Item 51 – Ref: As 366050-3

The cladding to the beams in the classroom (Room 028) localised to wall does not contain asbestos.

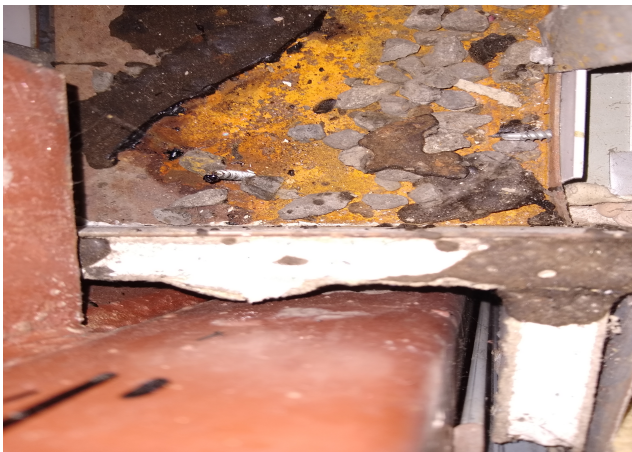
Item 52 – Ref: As 366050-3

The cladding to the beams in the classroom (Room 029) void above suspended ceiling does not contain asbestos.

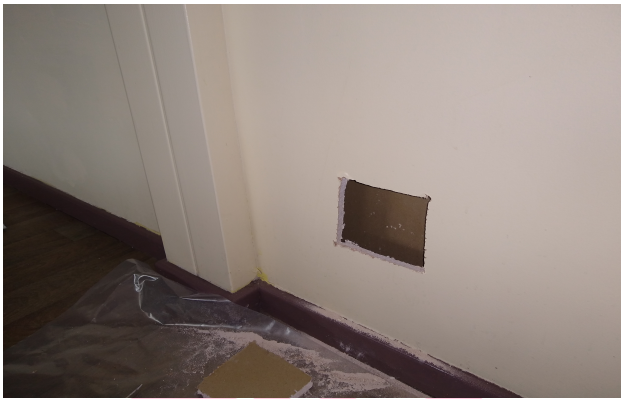
Item 55 – Ref: As 366050-2

The cladding to the columns in the corridor (Room 021) localised to wall does not contain asbestos.

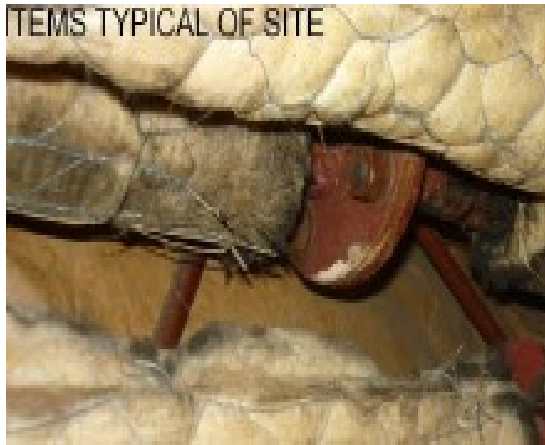
Item 120 – Ref: Presumed

The pipework flange gasket in the ceiling void in the staff room (Rm 008) is presumed to contain asbestos.

Further investigation is required before works should be carried out in this area.

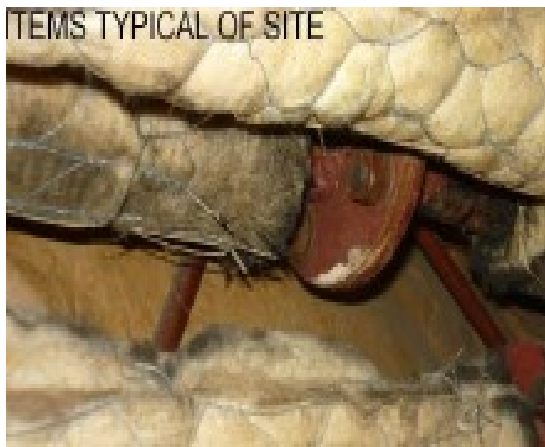
Item 121 – Ref: Presumed

The pipework flange gasket in the ceiling void in the office (Rm 011) is presumed to contain asbestos.

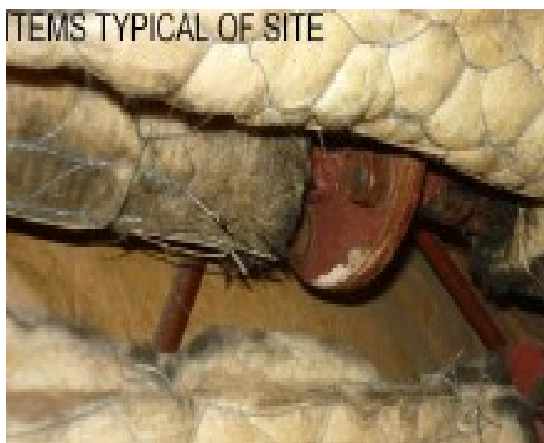
Item 125 – Ref: Presumed

The gasket in the ceiling void in the corridor/cloakroom (Rm 041) is presumed to contain asbestos.

Further investigation is required before works should be carried out in this area.

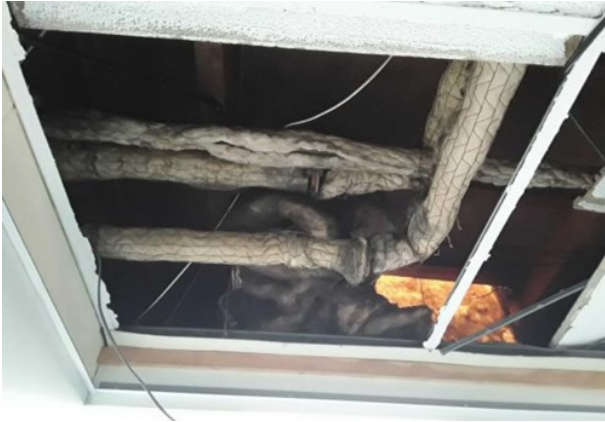
Item 129 – Ref: 22-50659-3

The string wrap to mmmf lagged pipes in the fire exit hallway (Area 5) does not contain asbestos.

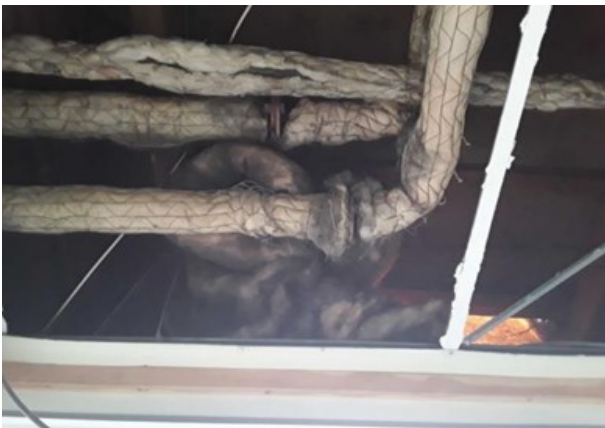
Item 130 – Ref: Presumed

The pipe flanges (gaskets) in the fire exit hallway (Area 5) is presumed to contain asbestos.

Any change in appearance should be reported to Property Services.

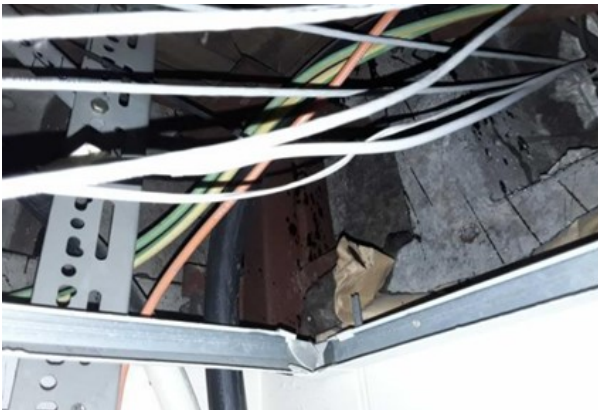
Item 131 – Ref: Presumed

The lining inside clasp columns in the electric meter cupboard (Area 6) is presumed to contain asbestos.

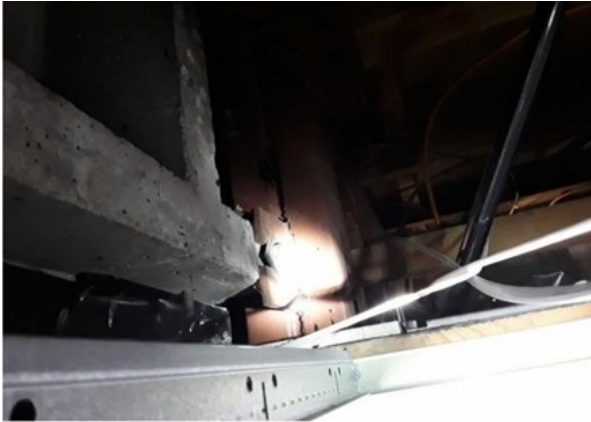
Item 133 – Ref: Presumed

The lining inside clasp columns in the staff room (Area 7) is presumed to contain asbestos.

Any change in appearance should be reported to Property Services.

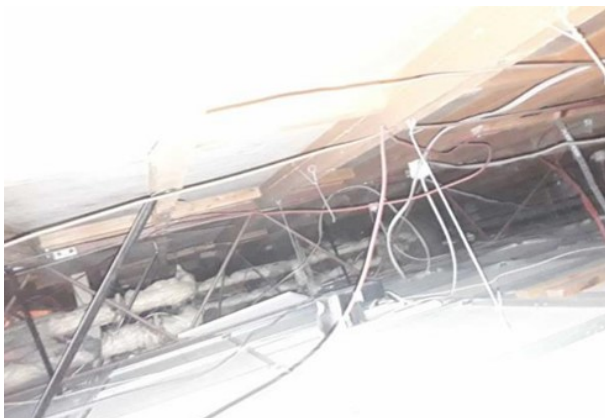
Item 134 – Ref: 22-50659-3

The string wrap to mmmf lagged pipes in the staff room (Area 7) does not contain asbestos.

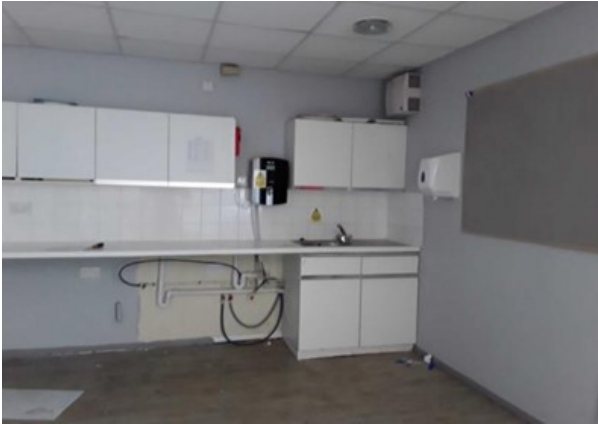
Item 135 – Ref: 22-50659-6

The ceramic tile adhesive to the walls in the staff room (Area 7) does not contain asbestos.

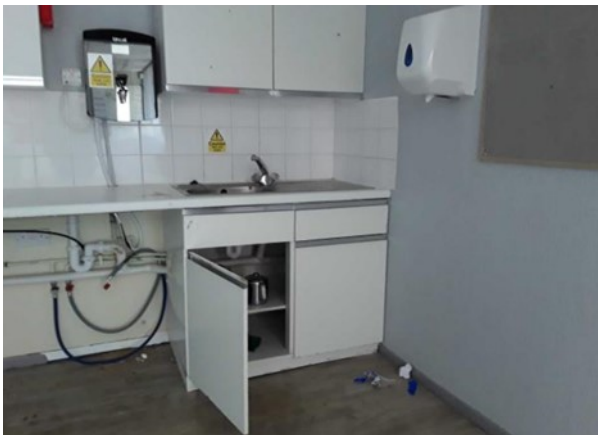
Item 136 – Ref: 22-50659-7

The sink pad in the staff room (Area 7) does not contain asbestos.

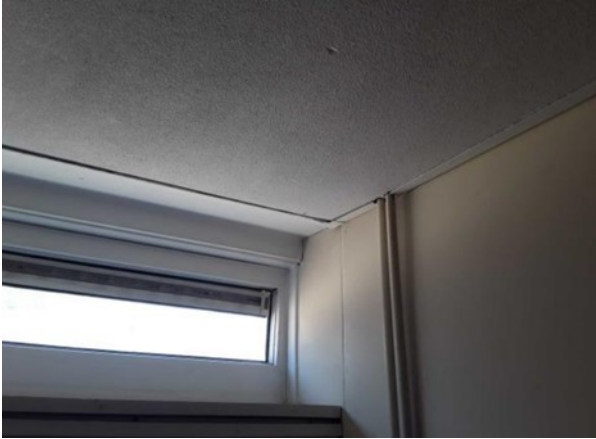
Item 138 – Ref: Presumed

The lining inside clasp columns in gents toilets (Area 8) is presumed to contain asbestos.

Any change in appearance should be reported to Property Services.

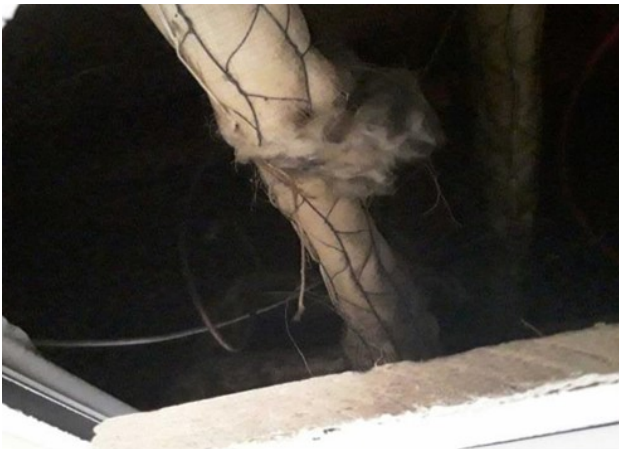
Item 139 – Ref: Presumed

The string wrap to mmmf lagged pipes in the gents toilet (Area 8) does not contain asbestos.

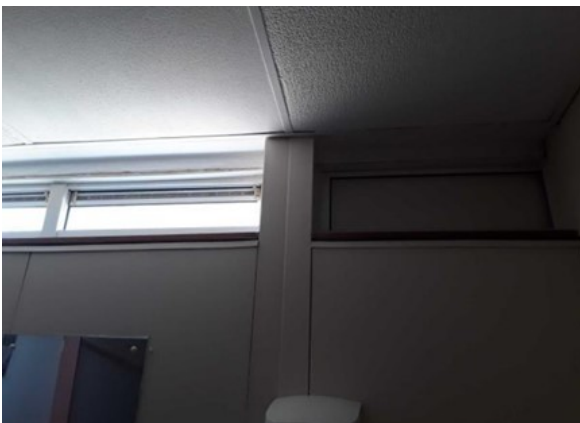
Item 140 – Ref: Presumed

The lining inside clasp columns in ladies toilet (Area 9) is presumed to contain asbestos.

Any change in appearance should be reported to Property Services.

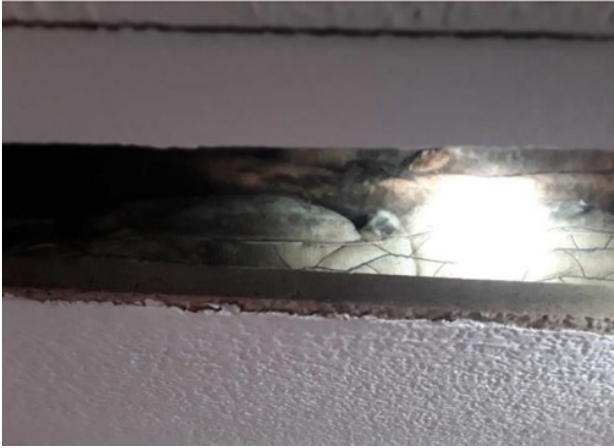
Item 141 – Ref: 22-50659-3

The string wrap to mmmf lagged pipes in the ladies toilet (Area 9) does not contain asbestos.

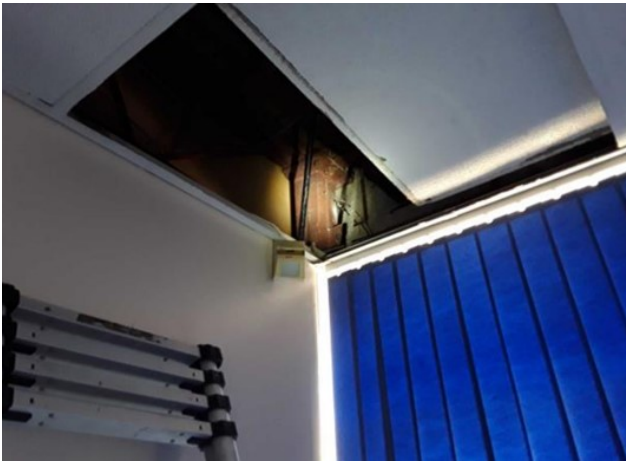
Item 142 – Ref: Presumed

The lining inside clasp columns in the meeting room (Area 10) is presumed to contain asbestos.

Any change in appearance should be reported to Property Services.

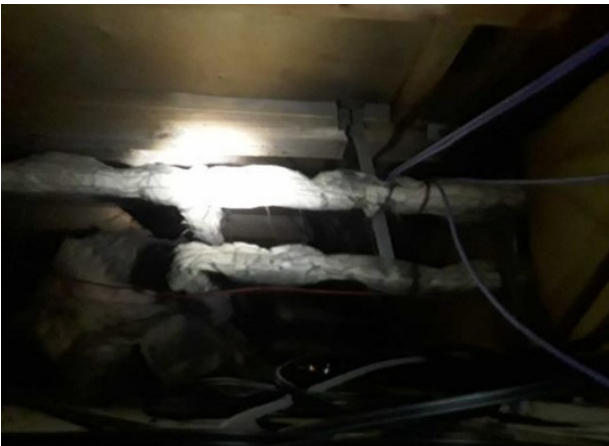
Item 143 – Ref: 22-50659-3

The string wrap to mmmf lagged pipes in the meeting room (Area 10) does not contain asbestos.

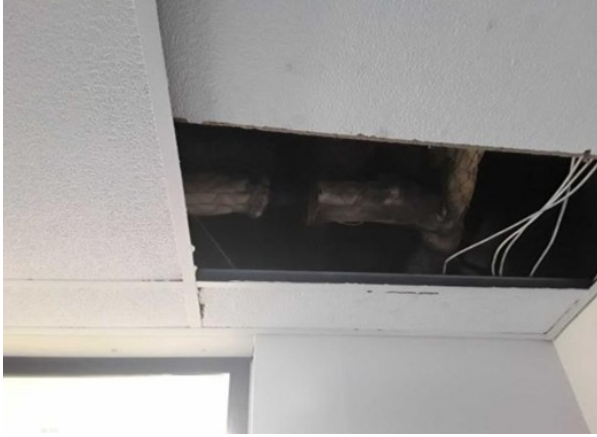
Item 144 – Ref: Presumed

The pipe flanges (gaskets) in the meeting room (Area 10) is presumed to contain asbestos.

Any change in appearance should be reported to Property Services.

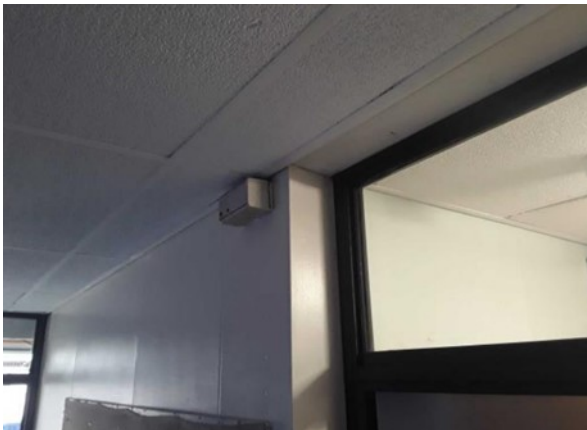
Item 145 – Ref: Presumed

The lining inside clasp columns in the store cupboard (Area 11) is presumed to contain asbestos.

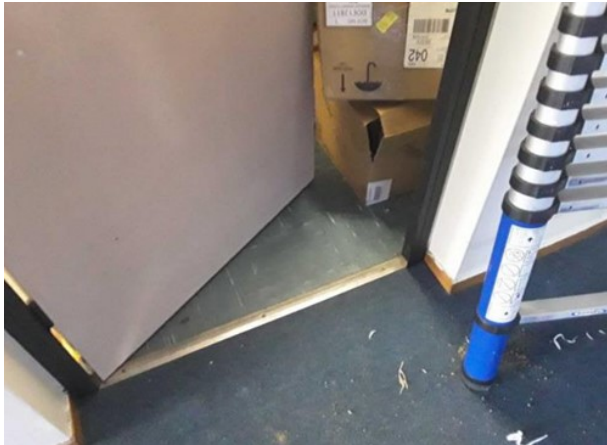
Item 147 – Ref: 22-50659-9

The floor tiles and adhesive in the store cupboard (Area 11) does contain asbestos.

Any change in appearance should be reported to Property Services.

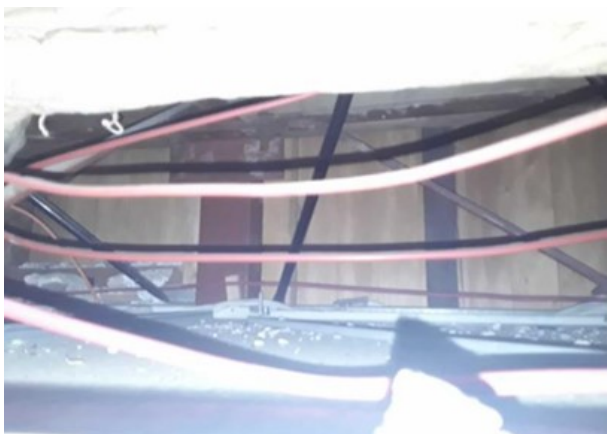
Item 148 – Ref: Presumed

The lining inside clasp columns in the store cupboard (Area 11) is presumed to contain asbestos.

Any change in appearance should be reported to Property Services.

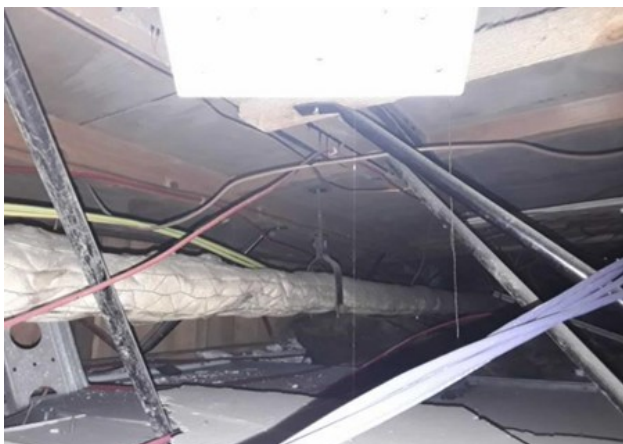
Item 149 – Ref: 22-50659-3

The string wrap to mmf lagged pipes in the store cupboard (Area 12) does not contain asbestos.

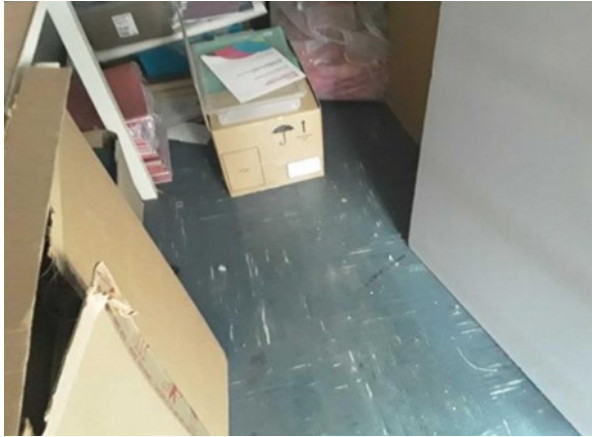
Item 150 – Ref: 22-50659-9

The floor tiles and adhesive in the store cupboard (Area 12) does contain asbestos.

Any change in appearance should be reported to Property Services.

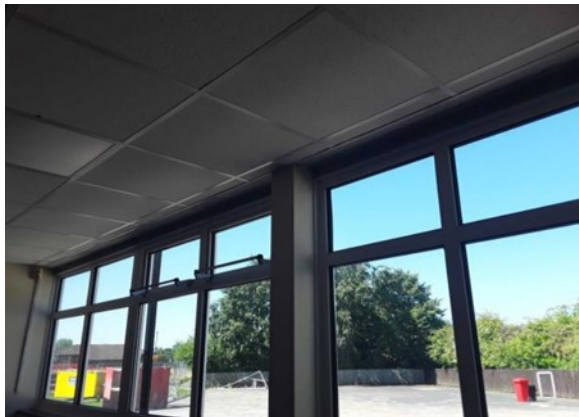
Item 151 – Ref: Presumed

The lining inside clasp columns in the corridor (Area 13) is presumed to contain asbestos.

Any change in appearance should be reported to Property Services.

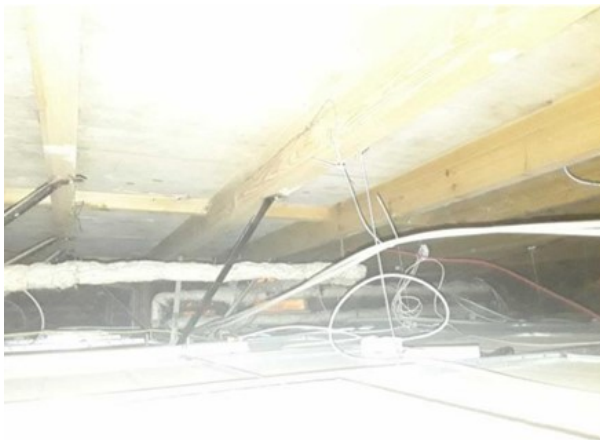
Item 152 – Ref: 22-50659-3

The string wrap to mmmf lagged pipes in the corridor (Area 13) does not contain asbestos.

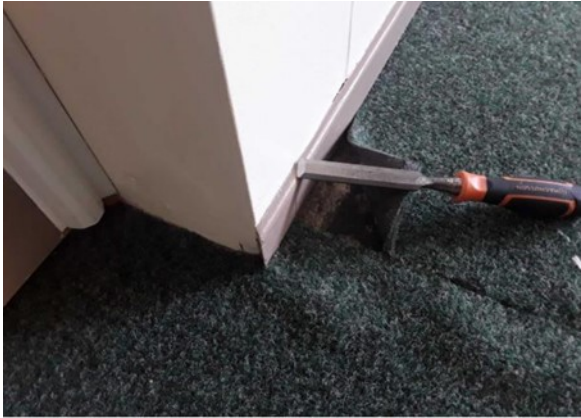
Item 153 – Ref: 22-50659-10

The residual adhesive beneath the screed in the head teachers office (Area 14) does contain asbestos.

Any change in appearance should be reported to Property Services.

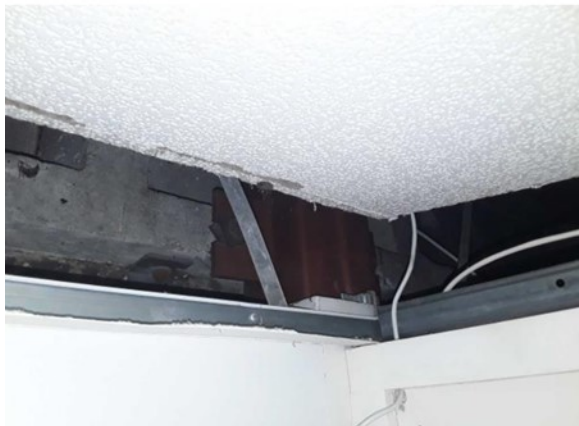
Item 154 – Ref: Presumed

The lining inside clasp columns in the headteachers office (Area 14) is presumed to contain asbestos.

Any change in appearance should be reported to Property Services.

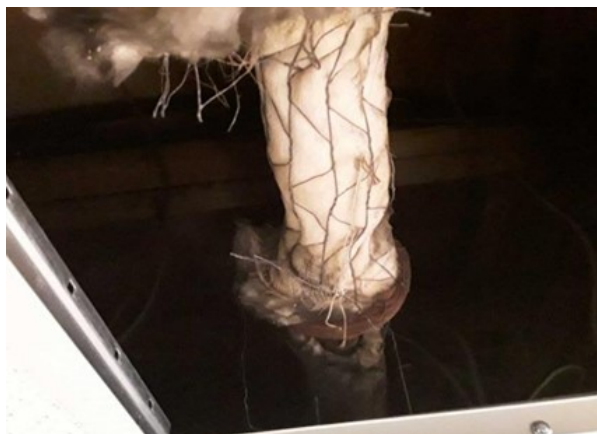
Item 158 – Ref: 22-50659-3

The string wrap on lagged pipes in the corridor (Area 13) does not contain asbestos.

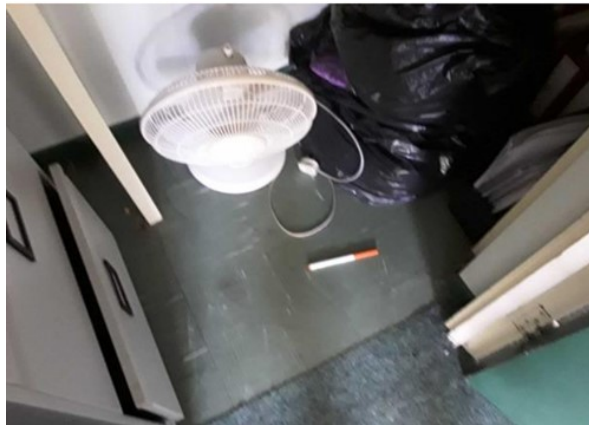
Item 160 – Ref: 22-50659-9

The floor tiles and adhesive in the headteachers store (Area 15) does contain asbestos.

(Screeded over Oct 22 – But residual still in place)

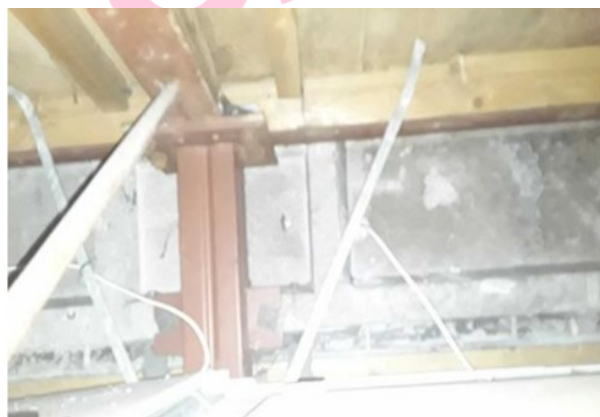
Item 161 – Ref: Presumed

The lining inside clasp columns in the deputy headteachers office and cupboard (Area 16) is presumed to contain asbestos.

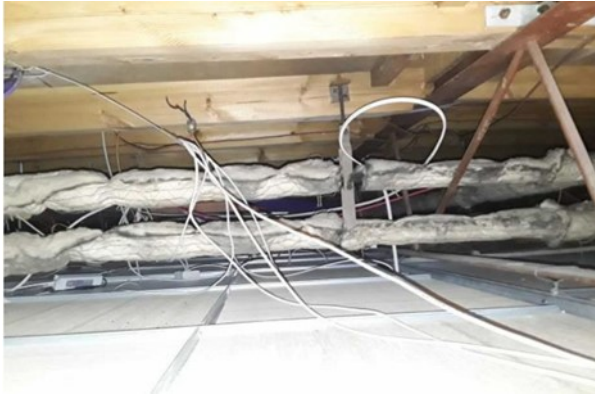
Item 162 – Ref: 22-50659-3

The string wrap to mmmf lagged pipes in the deputy headteachers office and cupboard (Area 16) does not contain asbestos.

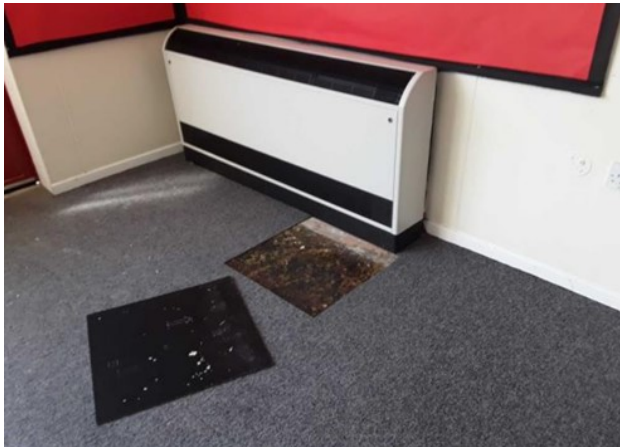
Item 163 – Ref: 22-50659-11

The floor residue to the ICT room and cupboards (Area 17) does to contain asbestos.

Any change in appearance should be reported to Property Services.

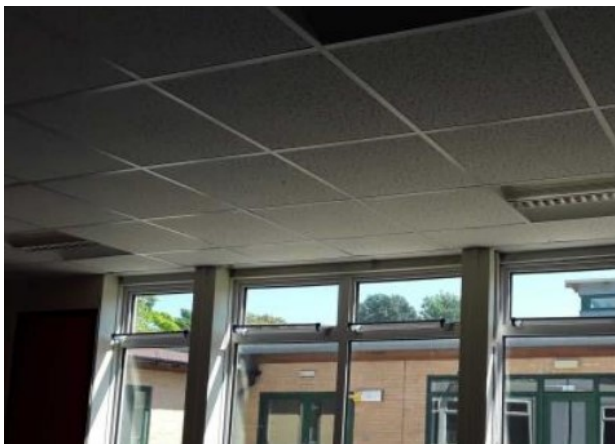
Item 164 – Ref: Presumed

The lining inside clasp columns in the ICT room and cupboards (Area 17) is presumed to contain asbestos.

Any change in appearance should be reported to Property Services.

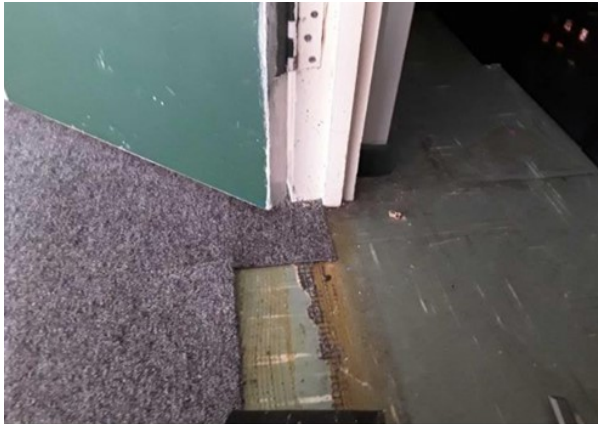
Item 165 – Ref: 22-50659-9

The floor tiles and adhesive in the ICT room and cupboards (Area 17) does contain asbestos.

Any change in appearance should be reported to Property Services.

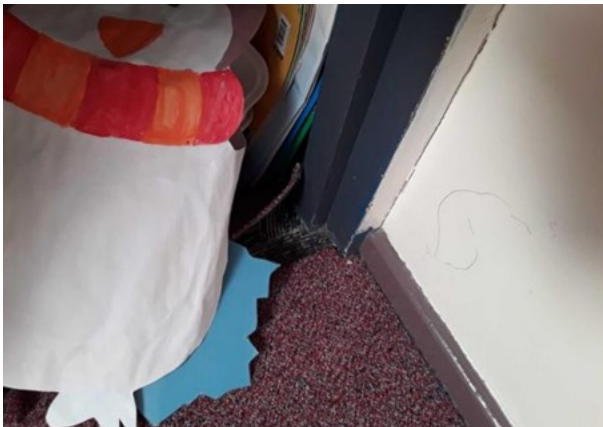
Item 166 – Ref: 22-50659-12

The floor residue to the Year 2 classroom and cupboards (Area 18) does to contain asbestos.

Any change in appearance should be reported to Property Services.

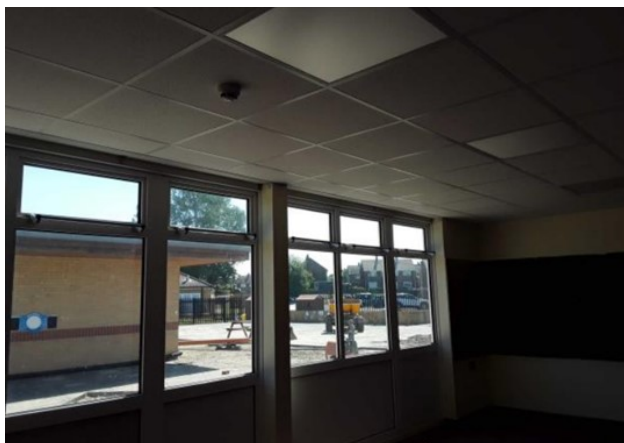
Item 167 – Ref: Presumed

The lining inside clasp columns in the Year 2 Classroom and cupboards (Area 18) is presumed to contain asbestos.

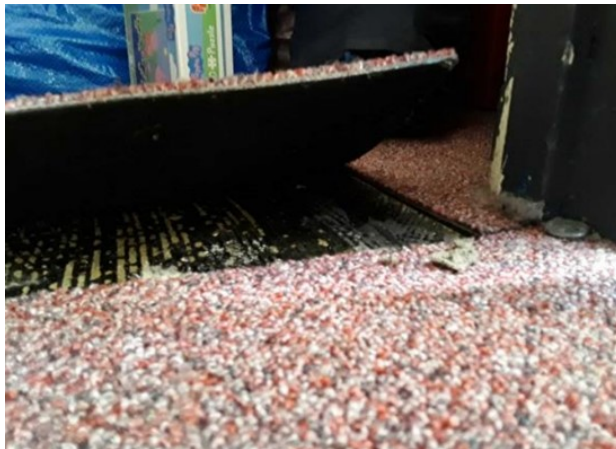
Item 169 – Ref: 22-50659-13

The floor adhesive to the Year 1 classroom and cupboards (Area 19) does to contain asbestos.

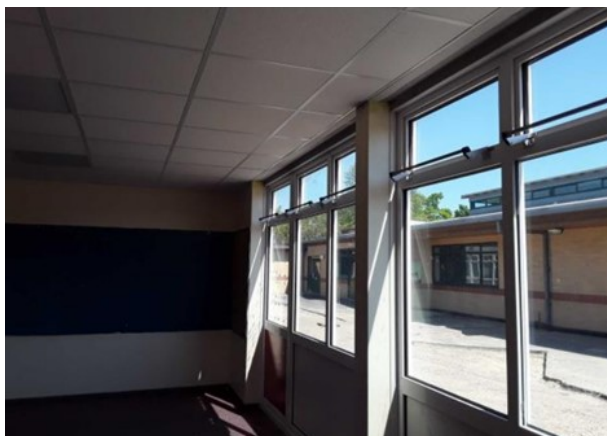
Item 170 – Ref: Presumed

The lining inside clasp columns in the Year 1 Classroom and cupboards (Area 19) is presumed to contain asbestos.

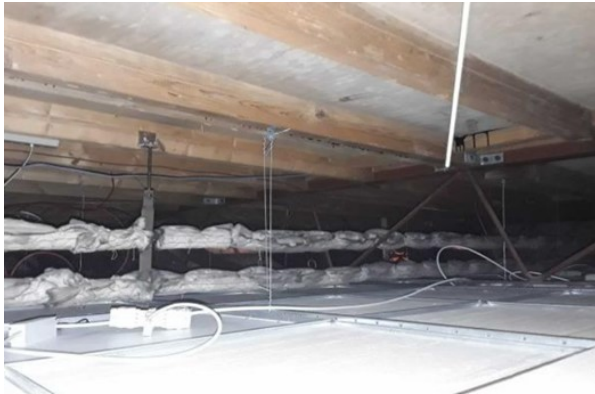
Item 171 – Ref: 22-50659-3

The string wrap to mmmf lagged pipes in the Year 2 Classroom and cupboards (Area 18) does not contain asbestos.

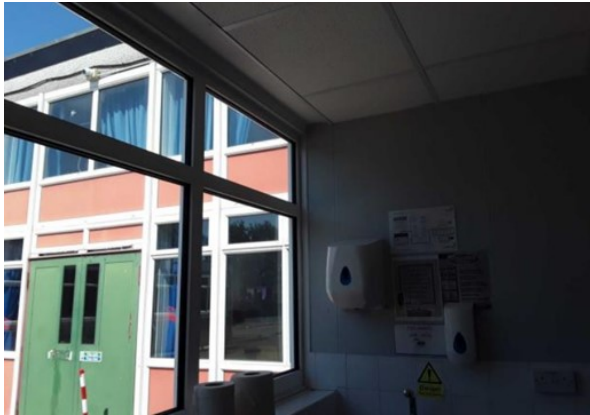
Item 172 – Ref: Presumed

The lining inside clasp columns in the utility room (Area 20) is presumed to contain asbestos.

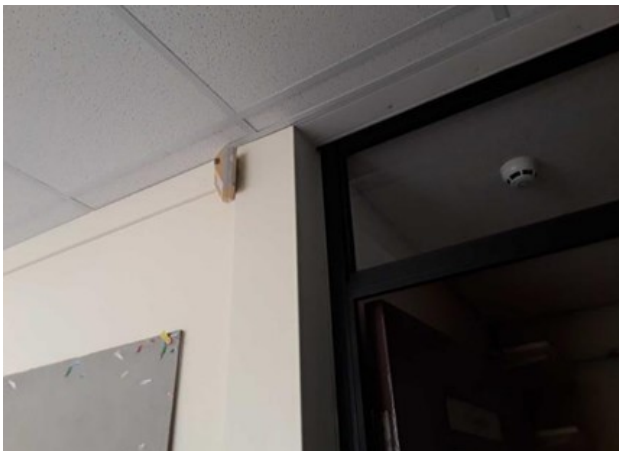
Item 173 – Ref: Presumed

The lining inside clasp columns in the cleaners cupboard (Area 21) is presumed to contain asbestos.

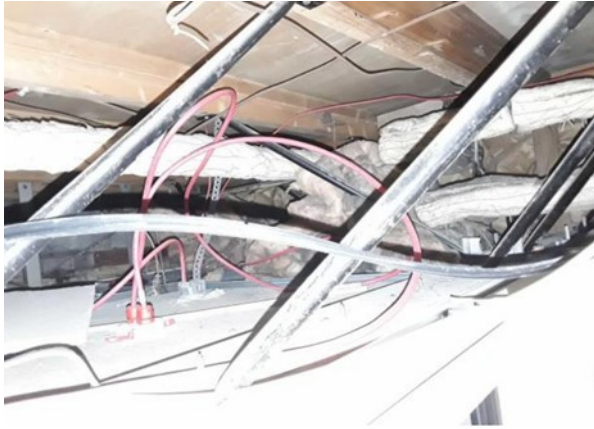
Item 174 – Ref: 22-50659-3

The string wrap to mmmf lagged pipes in the Year 2 Classroom and cupboards (Area 18) does not contain asbestos.

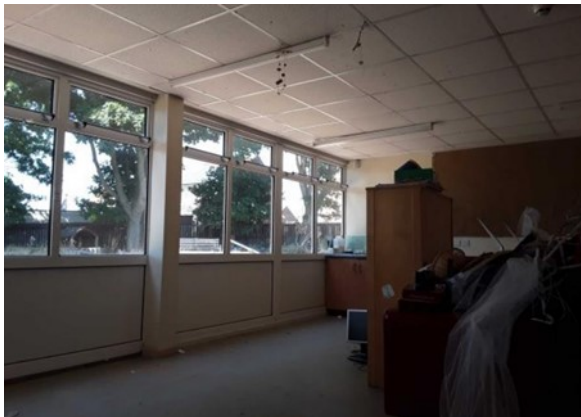
Item 175 – Ref: Presumed

The lining inside clasp columns in the foundation stage classroom (Area 20) is presumed to contain asbestos.

Item 174	No asbestos	Is present		
Item 175	Lining inside clasp columns (Foundation Stage Classroom/Area 22)	Low	6 monthly	Do not inspect
Item 176	Residual adhesive beneath floor screed (Foundation Office 1/Area 23)	Very Low Risk	12 monthly	12.07.25

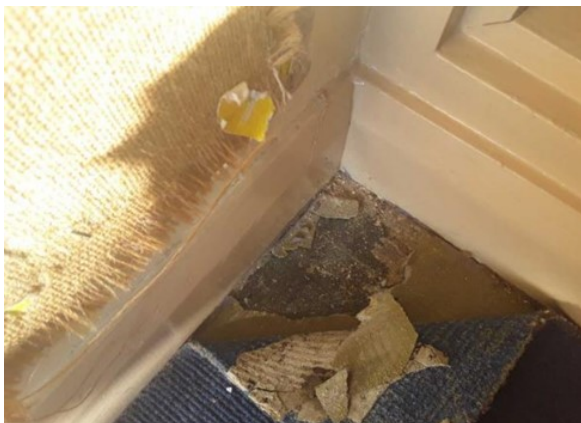
Item 176 – Ref: 22-50659-15

The residual adhesive beneath floor screed in the foundation office 1 (Area 23) contains asbestos.

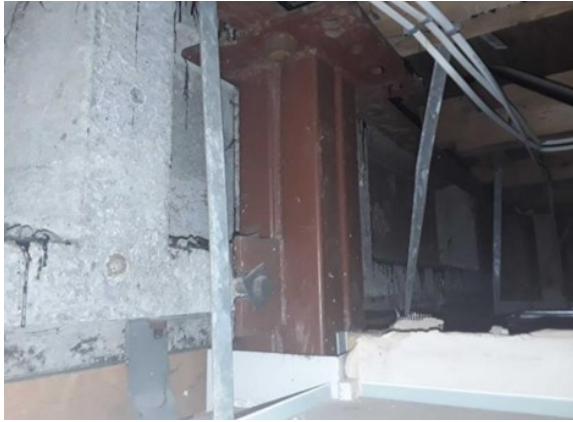
Item 177 – Ref: Presumed

The lining inside clasp columns in the foundation office 1 (Area 23) is presumed to contain asbestos.

Item 177	Lining inside clasp columns (Foundation Office 1/Area 23)	Low	6 monthly	Do not inspect
Item 178	No asbestos	Is present		
Item 179	Residual adhesive beneath floor screed (Foundation Office 2/Area 24)	Very Low Risk	12 monthly	12.07.25

Any change in appearance should be reported to Property Services.

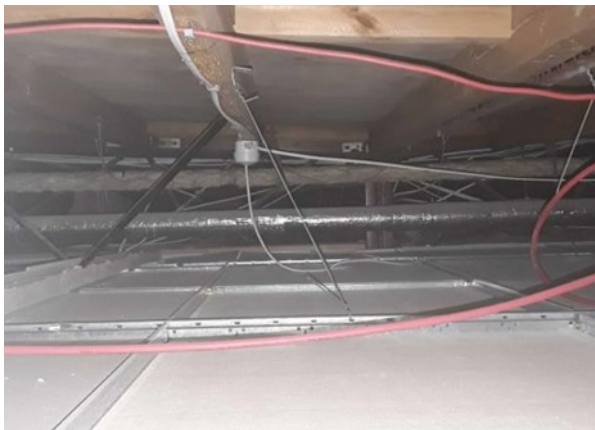
Item 178 – Ref: 22-50659-3

The string wrap to mmmf lagged pipes in the foundation office 1 (Area 23) does not contain asbestos.

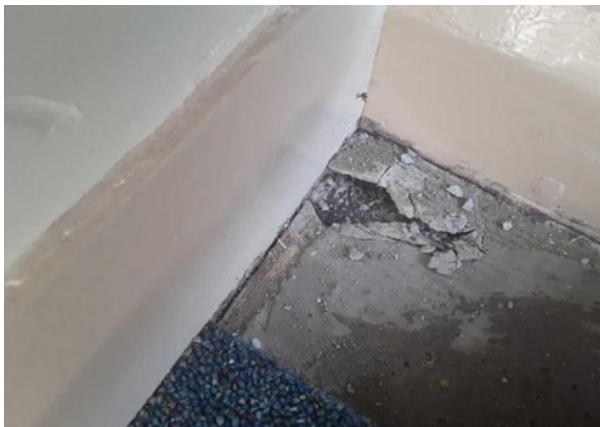
Item 179 – Ref: 22-50659-15

The residual adhesive beneath floor screed in the foundation office 2 (Area 24) contains asbestos.

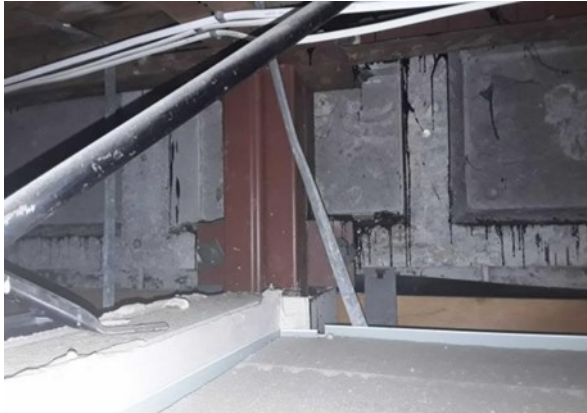
Item 180 – Ref: Presumed

The lining inside clasp columns in the foundation office 2 (Area 24) is presumed to contain asbestos.

Item 180	Lining inside clasp columns (Foundation Office 2/Area 24)	Low	6 monthly	Do not inspect

Any change in appearance should be reported to Property Services.

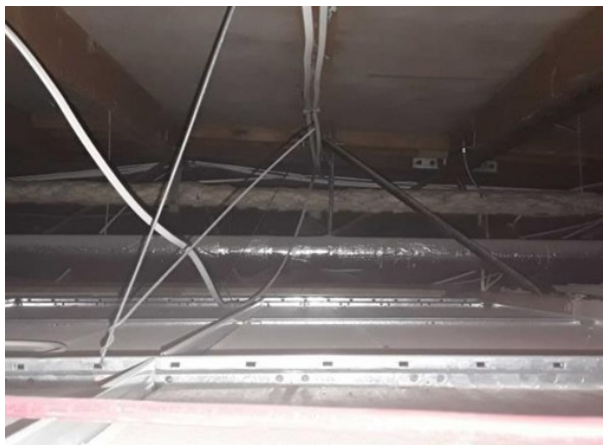
Item 181 – Ref: 22-50659-3

The string wrap to mmf lagged pipes in the foundation office 2 (Area 22) does not contain asbestos.

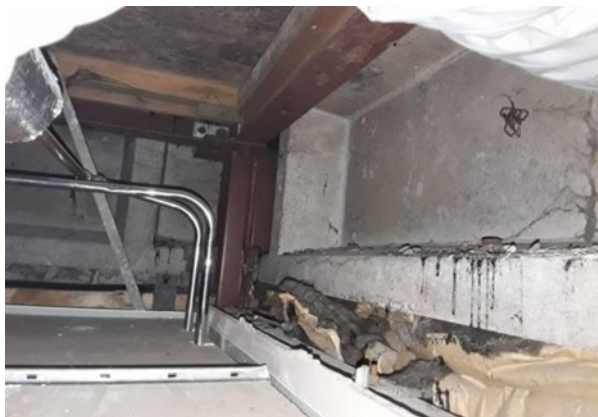
Item 182 – Ref: Presumed

The lining inside clasp columns in the foundation bathroom (Area 25) is presumed to contain asbestos.

<i>Item 181</i>	<i>No asbestos</i>	<i>Is present</i>		
Item 182	Lining inside clasp columns (Foundation Bathroom/Area 25)	Low	6 monthly	Do not inspect
<i>Item 183</i>	<i>No asbestos</i>	<i>Is present</i>		
<i>Item 184</i>	<i>No asbestos</i>	<i>Is present</i>

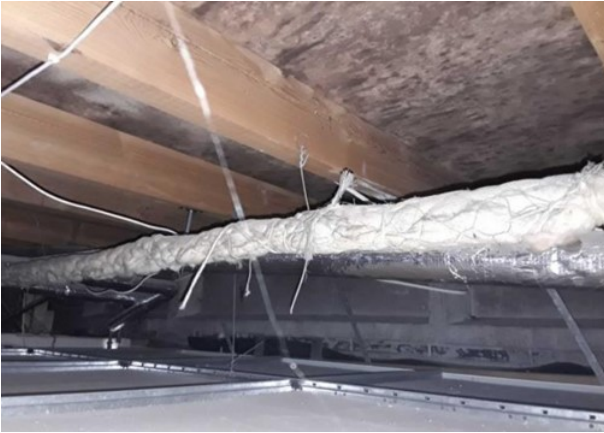
Item 183 – Ref: 22-50659-3

The string wrap to mmmf lagged pipes in the foundation bathroom (Area 25) does not contain asbestos.

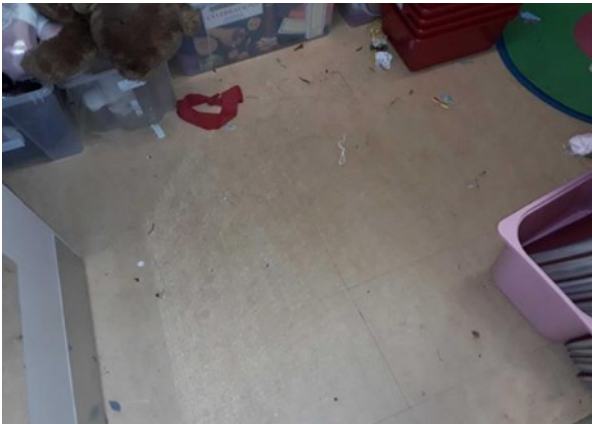
Item 184 – Ref: 22-50659-14

The floor adhesive to the foundation store room (Area 26) does to contain asbestos.

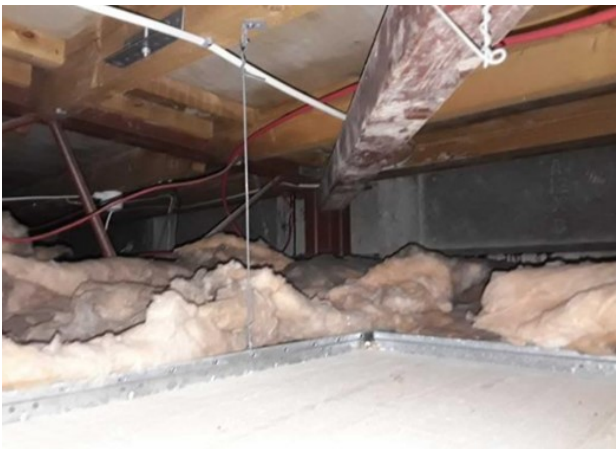
Item 185 – Ref: Presumed

The lining inside clasp columns in the foundation store room (Area 26) is presumed to contain asbestos.

Item 185	Lining inside clasp columns (Foundation store room/Area 26)	Low	6 monthly	Do not inspect
<i>Item 186</i>	<i>No asbestos</i>	<i>Is present</i>

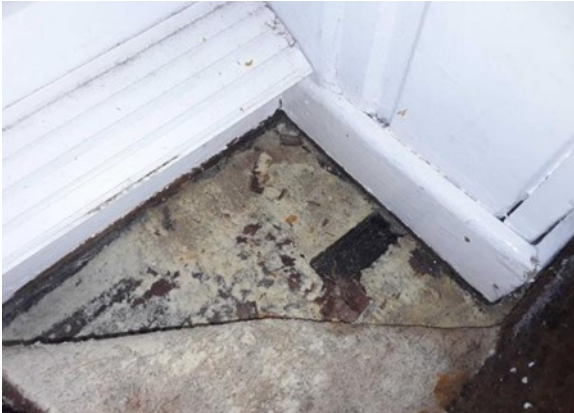
Item 186 – Ref: 22-50659-16

The residual adhesive below parquet flooring and carpet in the Hall (Area 27) does not contain asbestos.

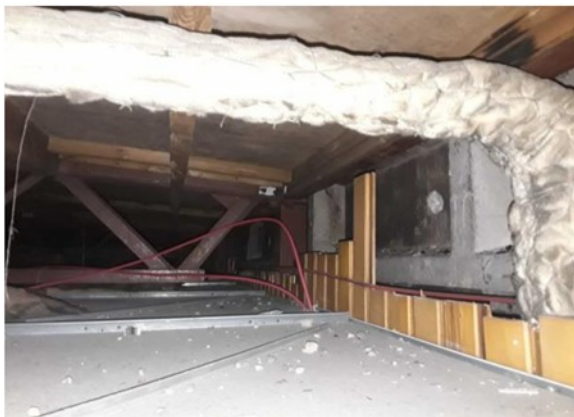
Item 187 – Ref: Presumed

The lining inside clasp columns in the hall (Area 27) is presumed to contain asbestos.

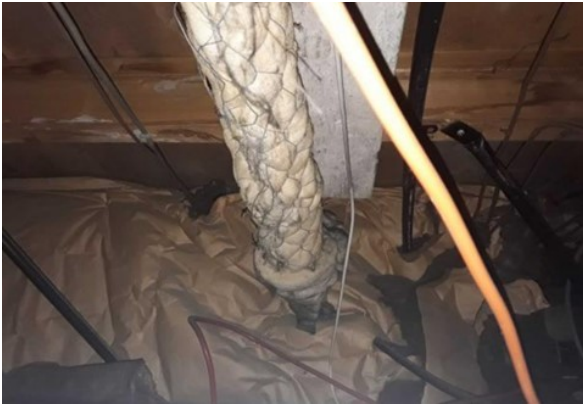
Item 192 – Ref: 22-50659-3

The string wrap to mmmf lagged pipes in the hall store 2 (Area 29) does not contain asbestos.

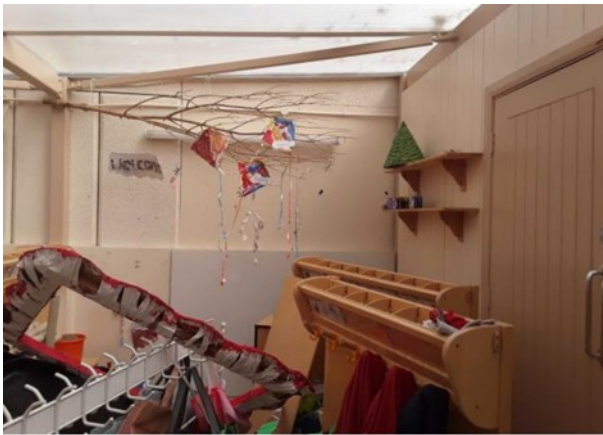
Item 193 – Ref: 22-50659-17

The boards to walls in the conservatory and store cupboard (Area 31) do not contain asbestos.

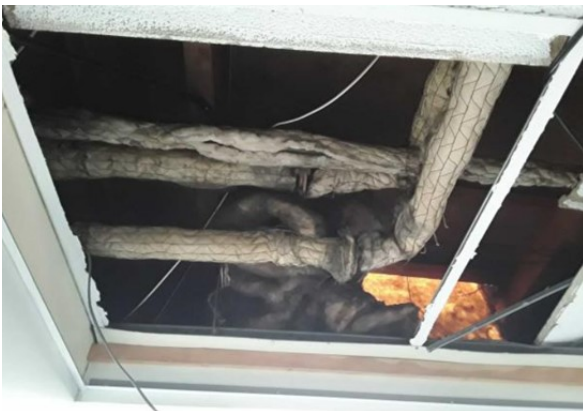
Item 194 – Ref: Presumed

The lining inside clasp columns in the conservatory and store cupboard (Area 31) is presumed to contain asbestos.

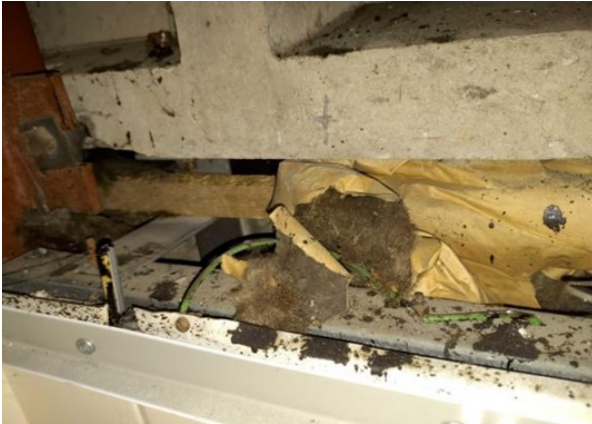
Item 195 – Ref: 22-53465-1

The cavity wall insulation to the internal wall void (Area 2) does not contain asbestos.

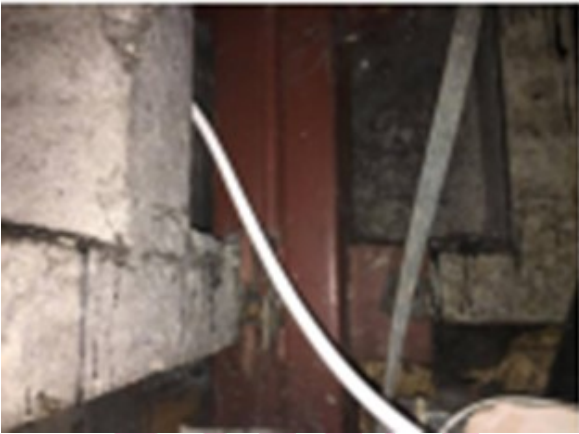
Item 196– Ref: Presumed

The column cladding in Classroom (G/002) is presumed to contain asbestos.
