ASBESTOS SURVEY REPORT FOR BURNSIDE ACADEMY, BURNSIDE ESTATE, HOUGHTON LE SPRING

**BURNSIDE ACADEMY, BURNSIDE ESTATE, HOUGHTON LE
SPRING**

Date: 18th June 2025

Burnside Academy - Last updated 18/06/2025 – Version 2

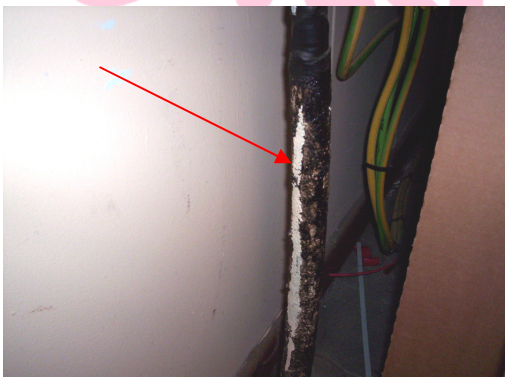
Item 5 - Ref: Presumed

The main cable sheath was inaccessible as it was live during the survey therefore it has to be presumed that there could be asbestos within.

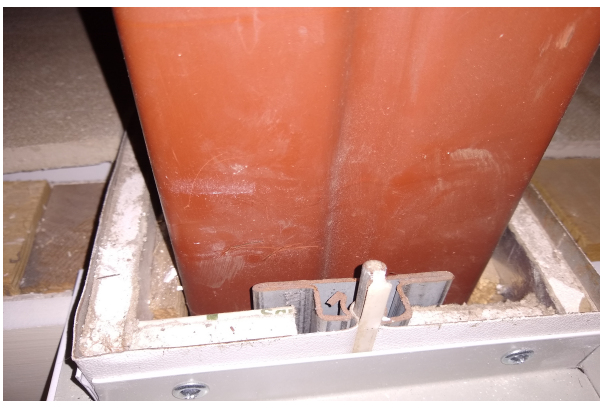
Item 50 – Ref: As 366050-2

The cladding to the beams in the corridor (Room 021 void above suspended ceiling) does not contain asbestos.

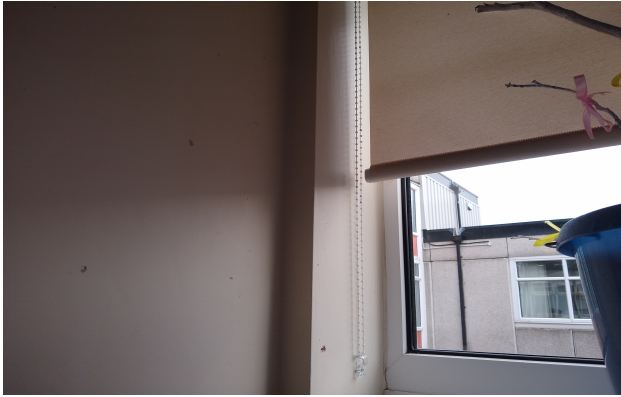
Item 51 – Ref: As 366050-3

The cladding to the beams in the classroom (Room 028) localised to wall does not contain asbestos.

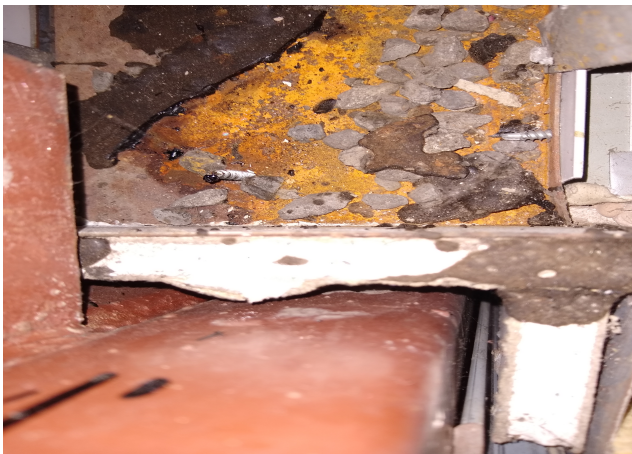
Item 52 – Ref: As 366050-3

The cladding to the beams in the classroom (Room 029) void above suspended ceiling does not contain asbestos.

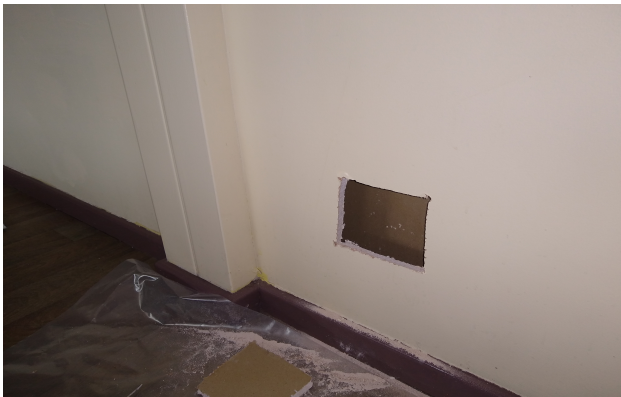
Item 55 – Ref: As 366050-2

The cladding to the columns in the corridor (Room 021) localised to wall does not contain asbestos.

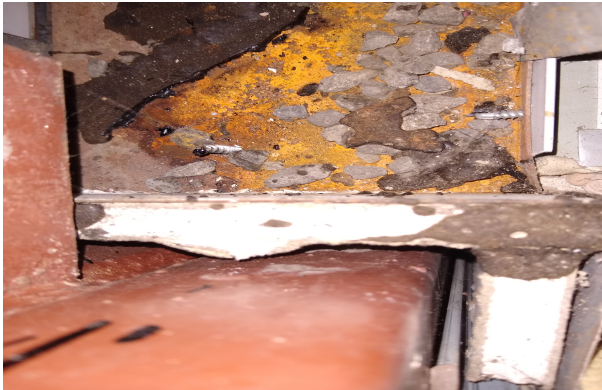
Item 57 – Ref: 345636-2

The remnant adhesive to the floor in classroom (room 028) does contain asbestos.

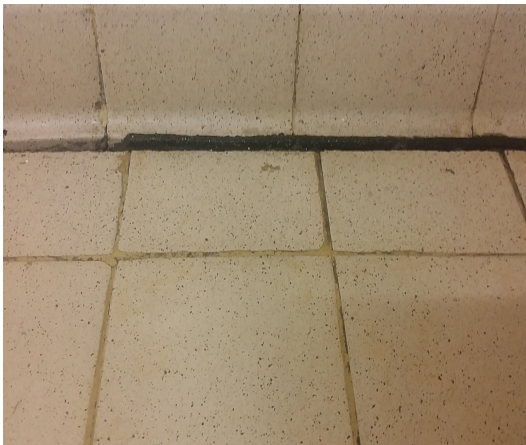
Item 61 – Ref: 209851-1

The filer to floor covering edges in the kitchen (Room 001) does not contain asbestos.

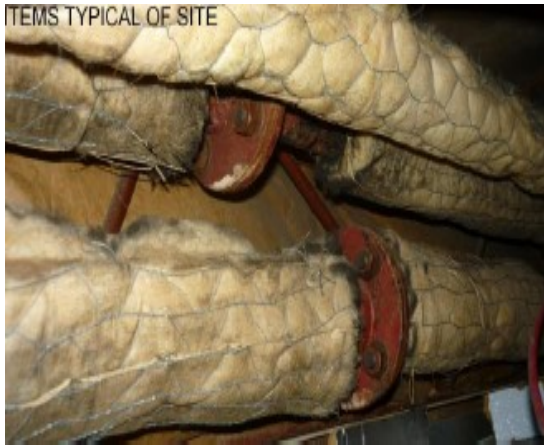
Item 120 – Ref: Presumed

The pipework flange gasket in the ceiling void in the staff room (Rm 008) is presumed to contain asbestos.

Further investigation is required before works should be carried out in this area.

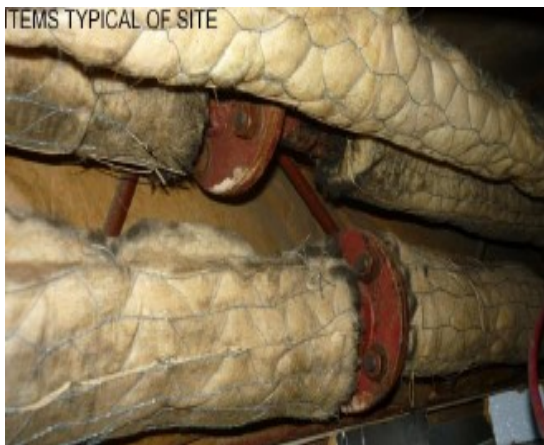
Item 121 – Ref: Presumed

The pipework flange gasket in the ceiling void in the office (Rm 011) is presumed to contain asbestos.

Further investigation is required before works should be carried out in this area.

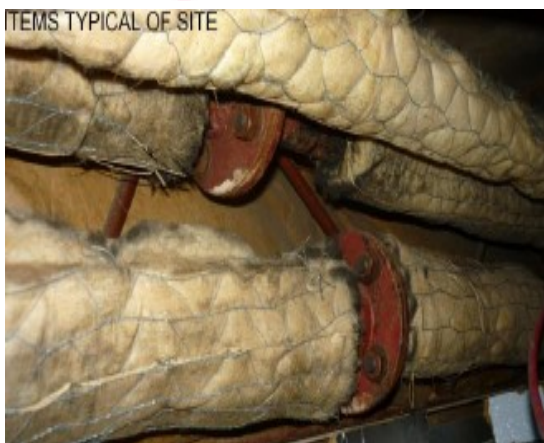
Item 125 – Ref: Presumed

The gasket in the ceiling void in the corridor/cloakroom (Rm 041) is presumed to contain asbestos.

Further investigation is required before works should be carried out in this area.

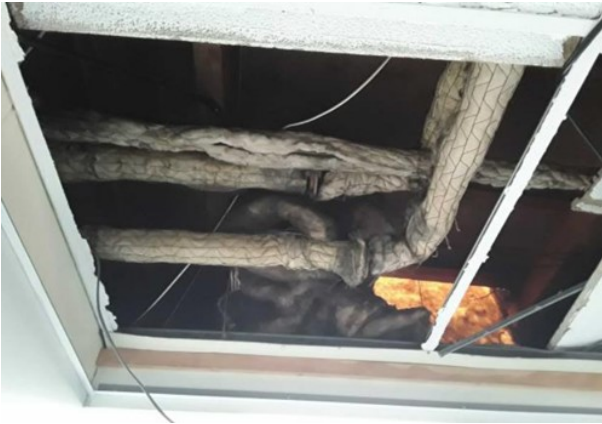
Item 129 – Ref: 22-50659-3

The string wrap to mmmf lagged pipes in the fire exit hallway (Area 5) does not contain asbestos.

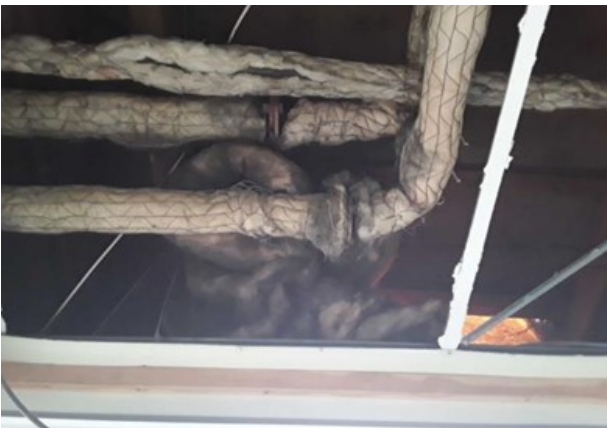
Item 130 – Ref: Presumed

The pipe flanges (gaskets) in the fire exit hallway (Area 5) is presumed to contain asbestos.

Any change in appearance should be reported to Property Services.

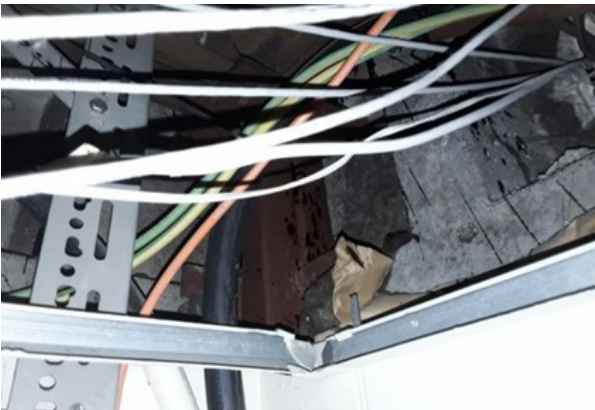
Item 131 – Ref: Presumed

The lining inside clasp columns in the electric meter cupboard (Area 6) is presumed to contain asbestos.

Any change in appearance should be reported to Property Services.

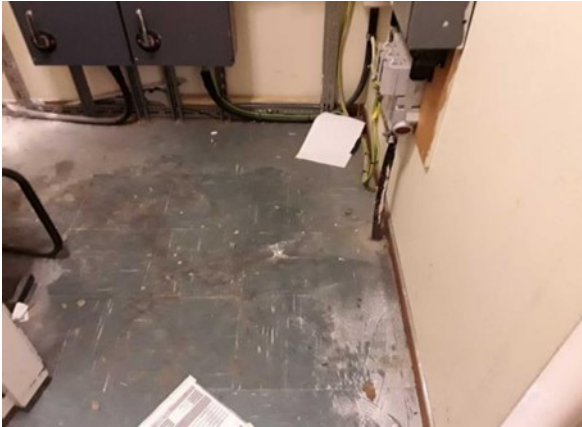
Item 132 – Ref: 22-50659-5

The floor tiles and adhesive in the electric meter cupboard (Area 6) does contain asbestos.

(Screeded over Oct 22 – But residual still in place)

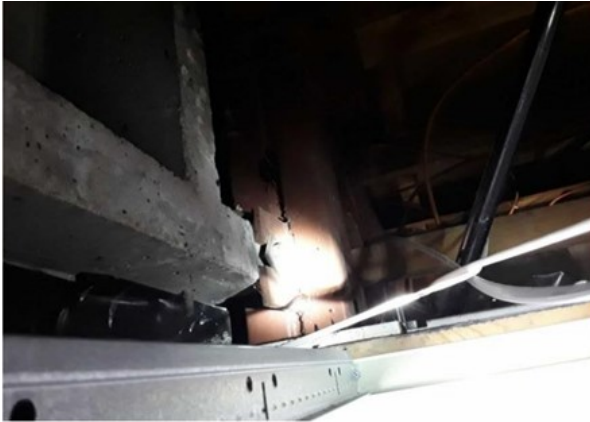
Item 133 – Ref: Presumed

The lining inside clasp columns in the staff room (Area 7) is presumed to contain asbestos.

Any change in appearance should be reported to Property Services.

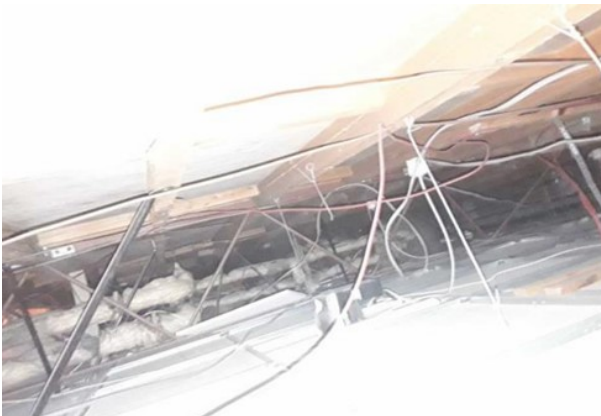
Item 134 – Ref: 22-50659-3

The string wrap to mmmf lagged pipes in the staff room (Area 7) does not contain asbestos.

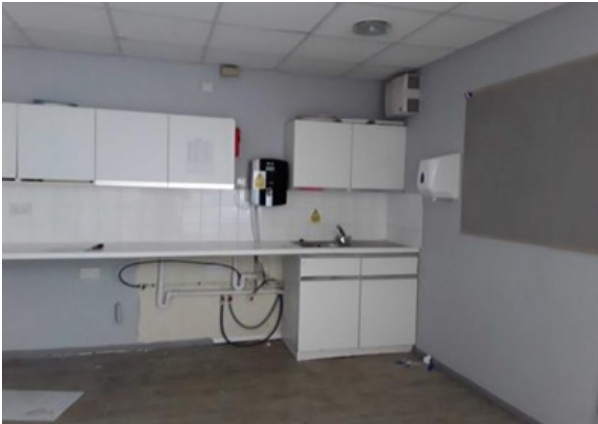
Item 135 – Ref: 22-50659-6

The ceramic tile adhesive to the walls in the staff room (Area 7) does not contain asbestos.

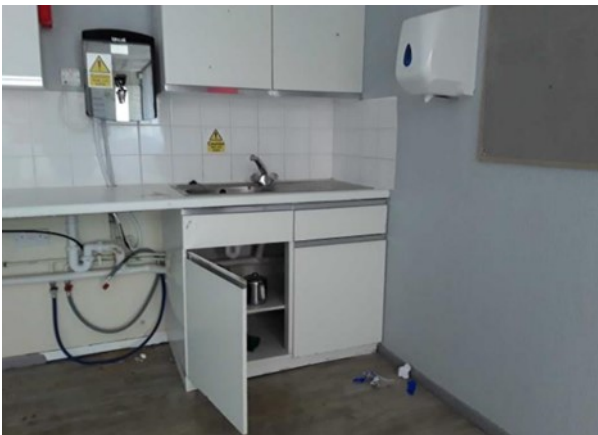
Item 136 – Ref: 22-50659-7

The sink pad in the staff room (Area 7) does not contain asbestos.

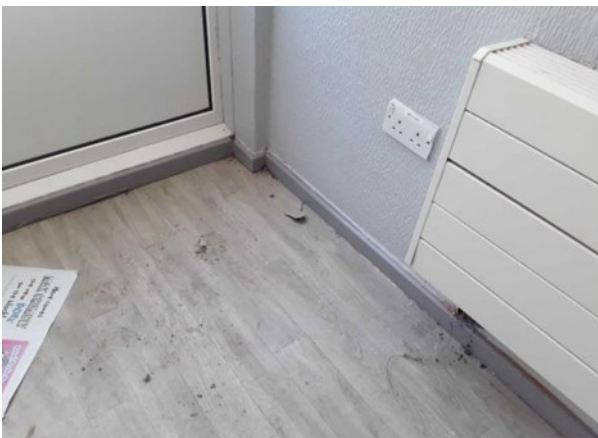
Item 137 – Ref: 22-50659-8

The adhesive beneath screed on the floor in the staff room (Area 7) does contains asbestos.

Any change in appearance should be reported to Property Services.

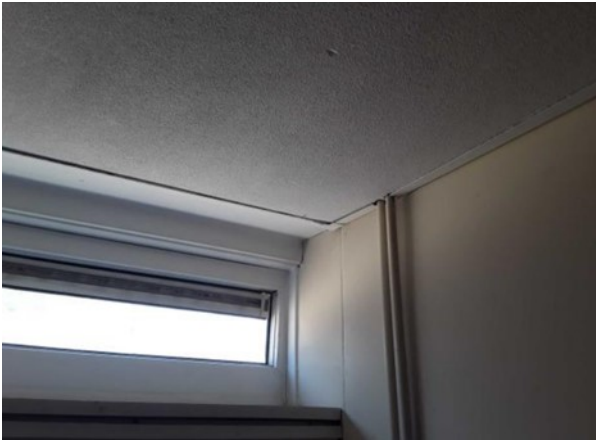
Item 138 – Ref: Presumed

The lining inside clasp columns in gents toilets (Area 8) is presumed to contain asbestos.

Any change in appearance should be reported to Property Services.

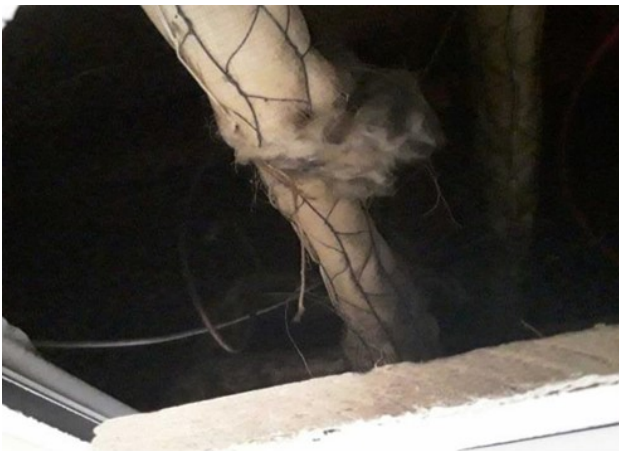
Item 139 – Ref: Presumed

The string wrap to mmmf lagged pipes in the gents toilet (Area 8) does not contain asbestos.

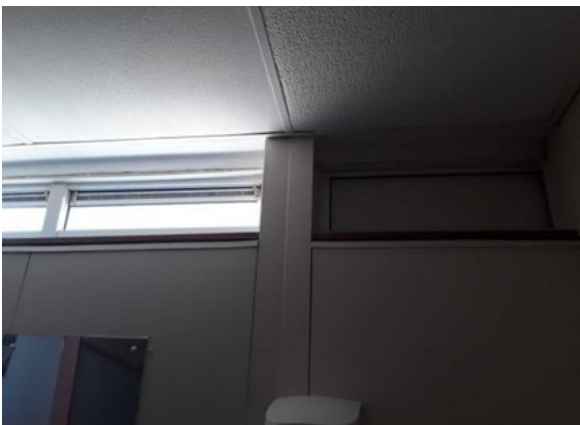
Item 140 – Ref: Presumed

The lining inside clasp columns in ladies toilet (Area 9) is presumed to contain asbestos.

Any change in appearance should be reported to Property Services.

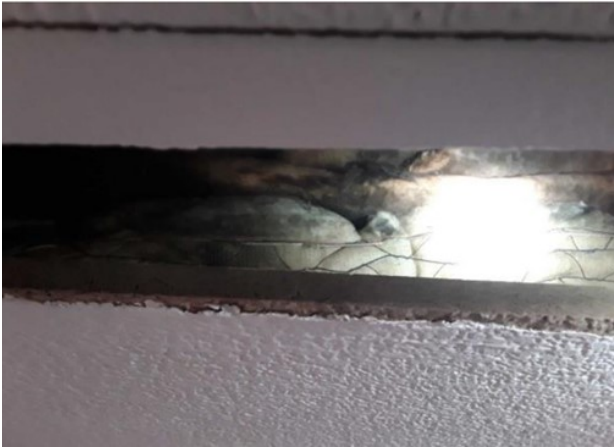
Item 141 – Ref: 22-50659-3

The string wrap to mmmf lagged pipes in the ladies toilet (Area 9) does not contain asbestos.

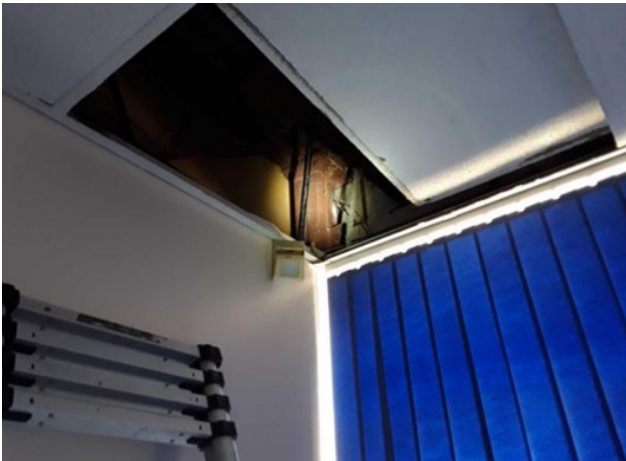
Item 142 – Ref: Presumed

The lining inside clasp columns in the meeting room (Area 10) is presumed to contain asbestos.

Any change in appearance should be reported to Property Services.

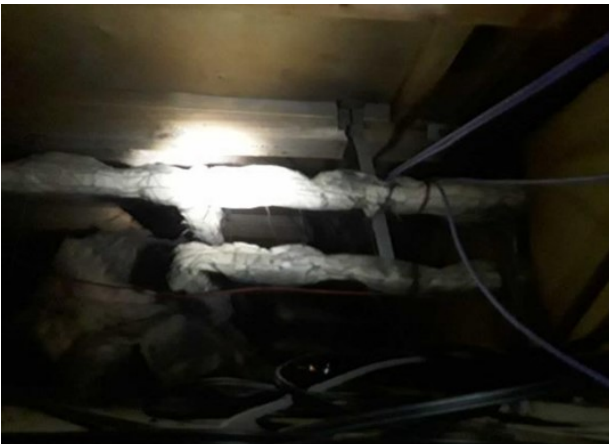
Item 143 – Ref: 22-50659-3

The string wrap to mmmf lagged pipes in the meeting room (Area 10) does not contain asbestos.

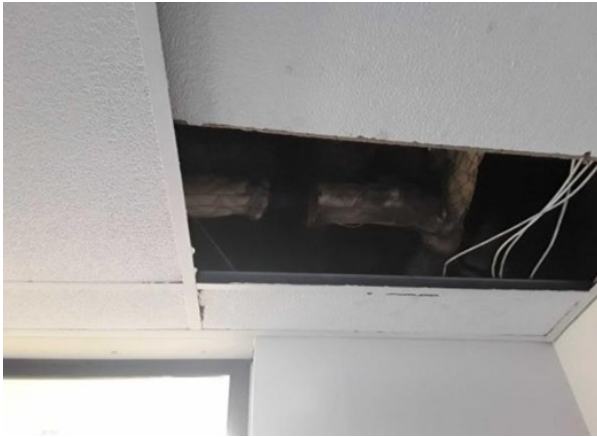
Item 144 – Ref: Presumed

The pipe flanges (gaskets) in the meeting room (Area 10) is presumed to contain asbestos.

Any change in appearance should be reported to Property Services.

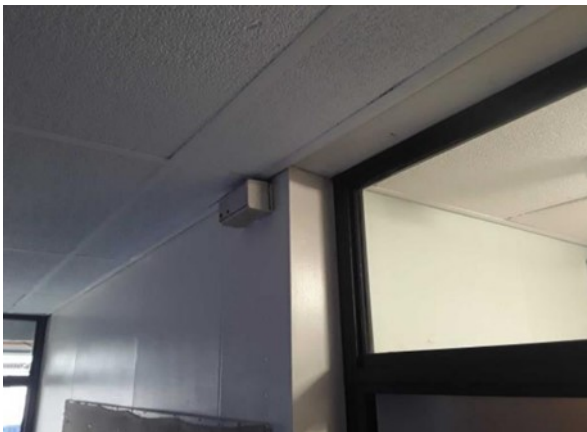
Item 145 – Ref: Presumed

The lining inside clasp columns in the store cupboard (Area 11) is presumed to contain asbestos.

Any change in appearance should be reported to Property Services.

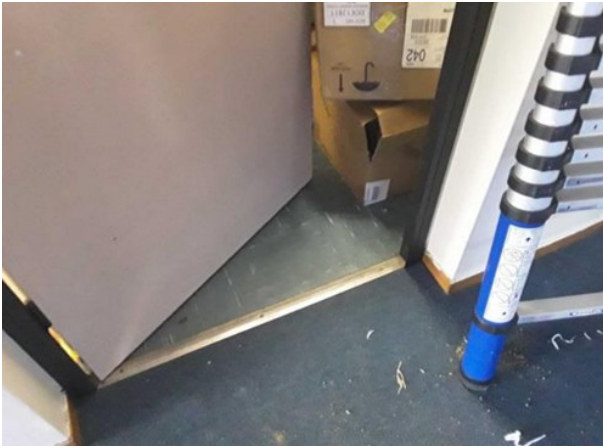
Item 147 – Ref: 22-50659-9

The floor tiles and adhesive in the store cupboard (Area 11) does contain asbestos.

Any change in appearance should be reported to Property Services.

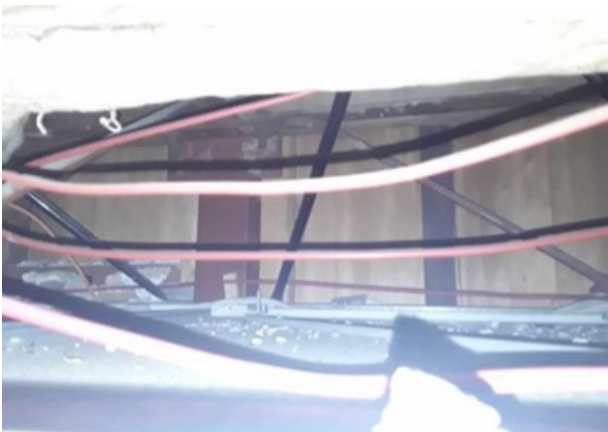
Item 148 – Ref: Presumed

The lining inside clasp columns in the store cupboard (Area 11) is presumed to contain asbestos.

Any change in appearance should be reported to Property Services.

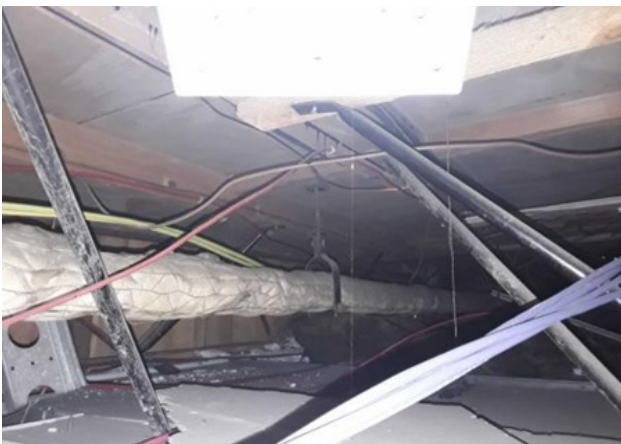
Item 149 – Ref: 22-50659-3

The string wrap to mmf lagged pipes in the store cupboard (Area 12) does not contain asbestos.

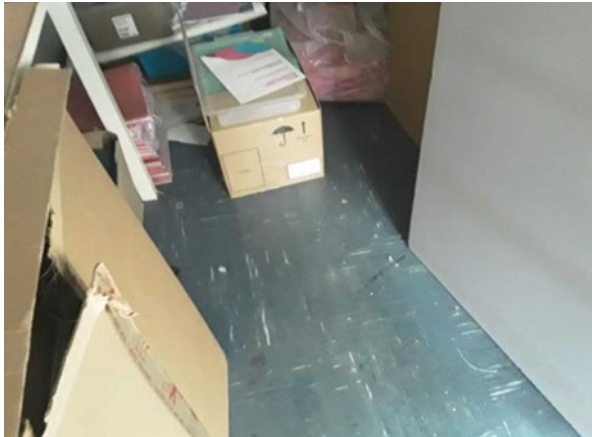
Item 150 – Ref: 22-50659-9

The floor tiles and adhesive in the store cupboard (Area 12) does contain asbestos.

Any change in appearance should be reported to Property Services.

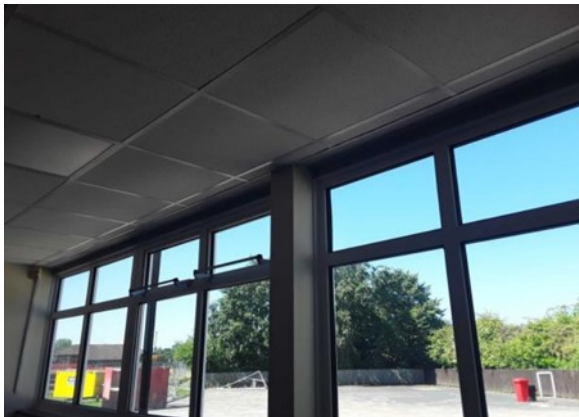
Item 151 – Ref: Presumed

The lining inside clasp columns in the corridor (Area 13) is presumed to contain asbestos.

Any change in appearance should be reported to Property Services.

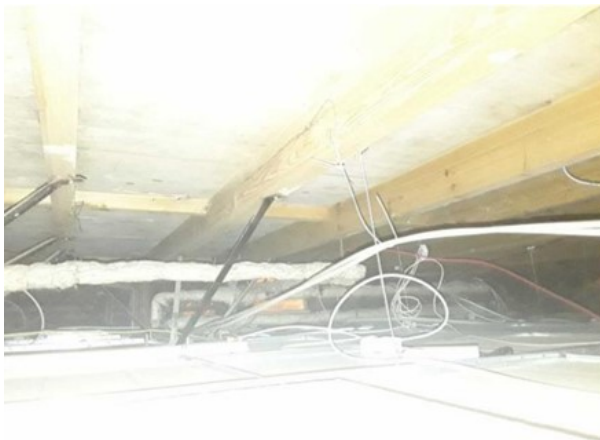
Item 152 – Ref: 22-50659-3

The string wrap to mmmf lagged pipes in the corridor (Area 13) does not contain asbestos.

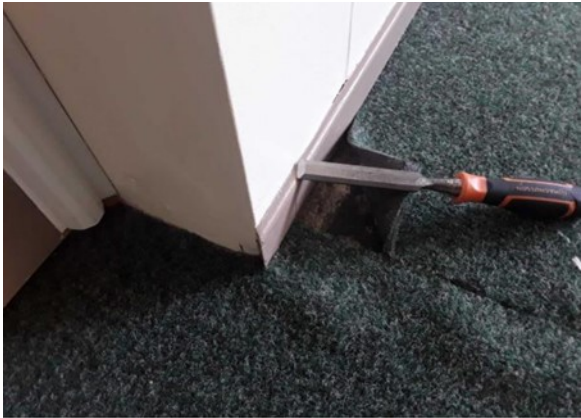
Item 153 – Ref: 22-50659-10

The residual adhesive beneath the screed in the head teachers office (Area 14) does contain asbestos.

Any change in appearance should be reported to Property Services.

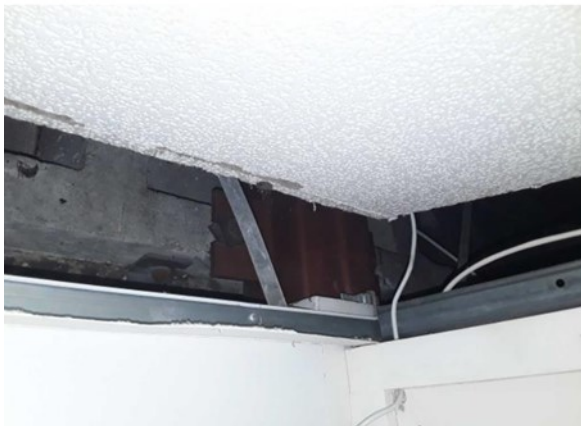
Item 154 – Ref: Presumed

The lining inside clasp columns in the headteachers office (Area 14) is presumed to contain asbestos.

Any change in appearance should be reported to Property Services.

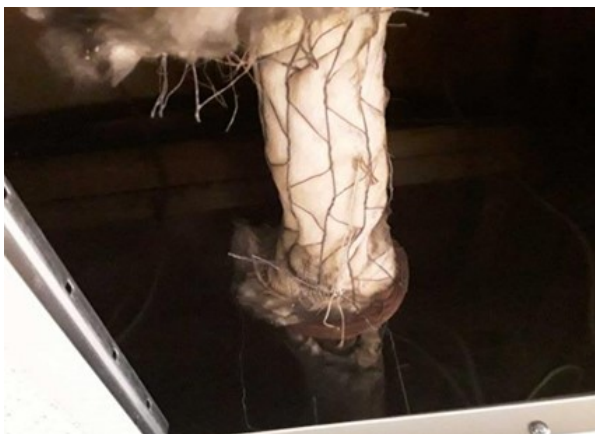
Item 158 – Ref: 22-50659-3

The string wrap to mmmf lagged pipes in the corridor (Area 13) does not contain asbestos.

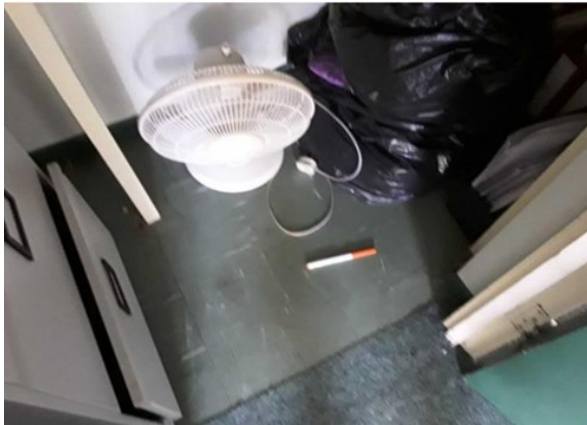
Item 160 – Ref: 22-50659-9

The floor tiles and adhesive in the headteachers store (Area 15) does contain asbestos.

(Screeded over Oct 22 – But residual still in place)

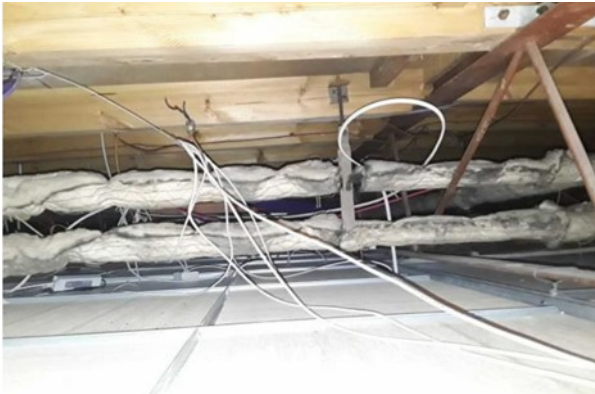
Item 162 – Ref: 22-50659-3

The string wrap to mmmf lagged pipes in the deputy headteachers office and cupboard (Area 16) does not contain asbestos.

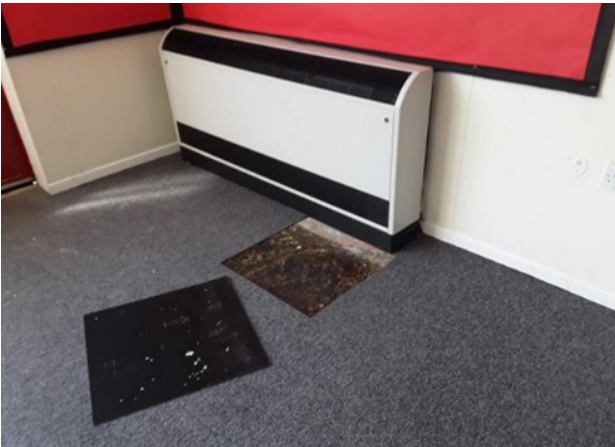
Item 163 – Ref: 22-50659-11

The floor residue to the ICT room and cupboards (Area 17) does to contain asbestos.

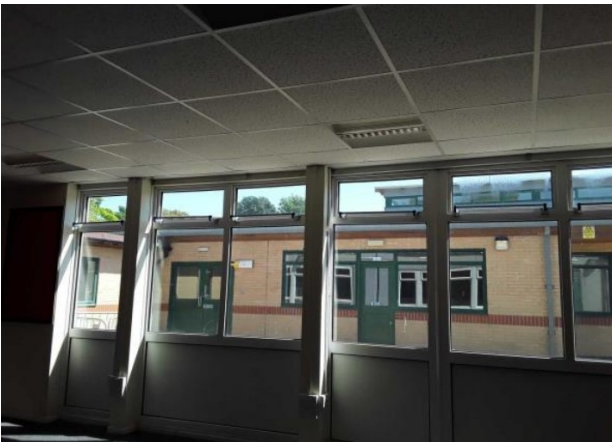
Item 164 – Ref: Presumed

The lining inside clasp columns in the ICT room and cupboards (Area 17) is presumed to contain asbestos.

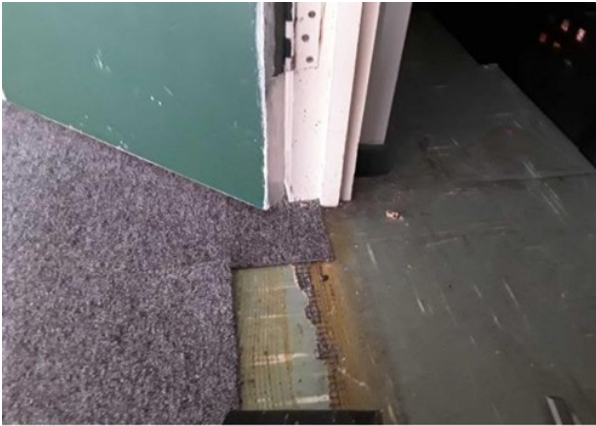
Item 165 – Ref: 22-50659-9

The floor tiles and adhesive in the ICT room and cupboards (Area 17) does contain asbestos.

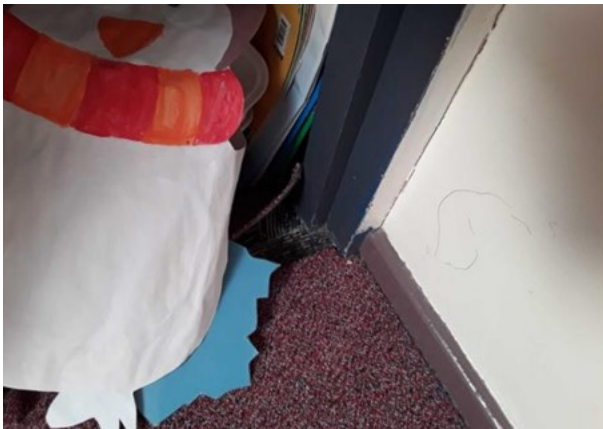
Item 166 – Ref: 22-50659-12

The floor residue to the Year 2 classroom and cupboards (Area 18) does to contain asbestos.

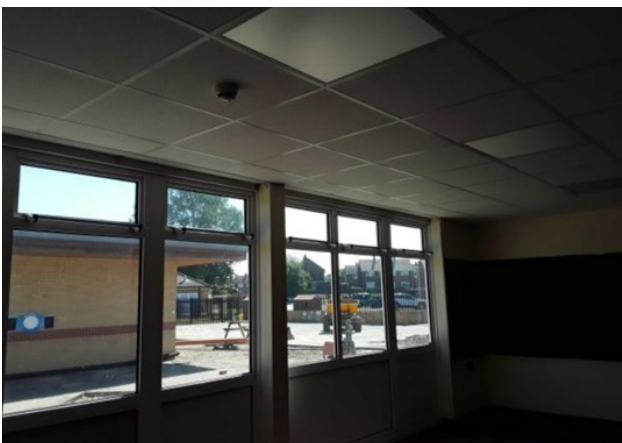
Item 167 – Ref: Presumed

The lining inside clasp columns in the Year 2 Classroom and cupboards (Area 18) is presumed to contain asbestos.

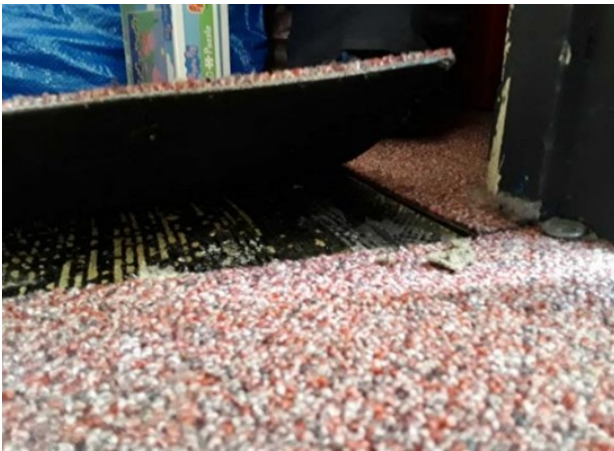
Item 169 – Ref: 22-50659-13

The floor adhesive to the Year 1 classroom and cupboards (Area 19) does to contain asbestos.

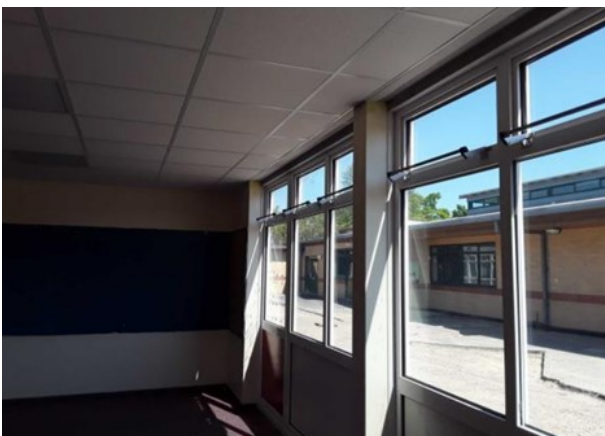
Item 170 – Ref: Presumed

The lining inside clasp columns in the Year 1 Classroom and cupboards (Area 19) is presumed to contain asbestos.

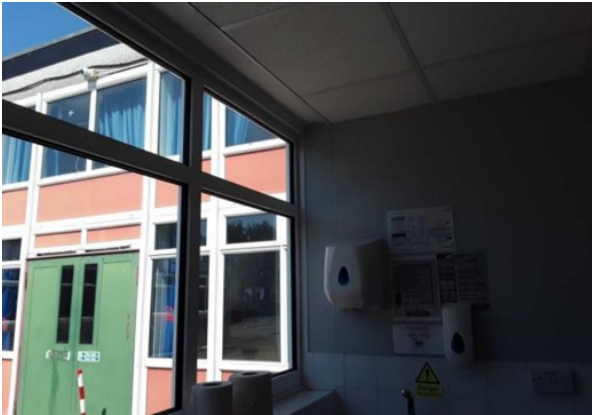
Item 172 – Ref: Presumed

The lining inside clasp columns in the utility room (Area 20) is presumed to contain asbestos.

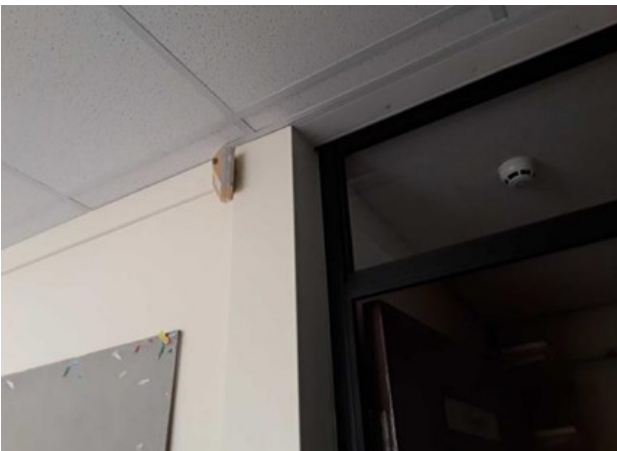
Item 173 – Ref: Presumed

The lining inside clasp columns in the cleaners cupboard (Area 21) is presumed to contain asbestos.

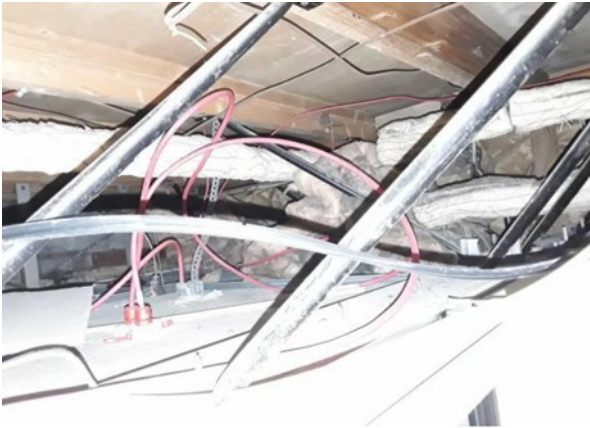
Item 174 – Ref: 22-50659-3

The string wrap to mmmf lagged pipes in the Year 2 Classroom and cupboards (Area 18) does not contain asbestos.

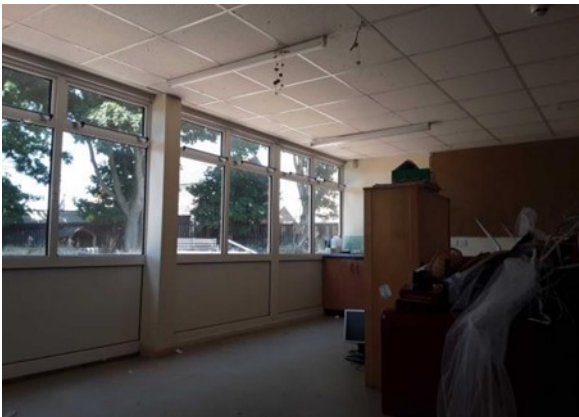
Item 175 – Ref: Presumed

The lining inside clasp columns in the foundation stage classroom (Area 20) is presumed to contain asbestos.

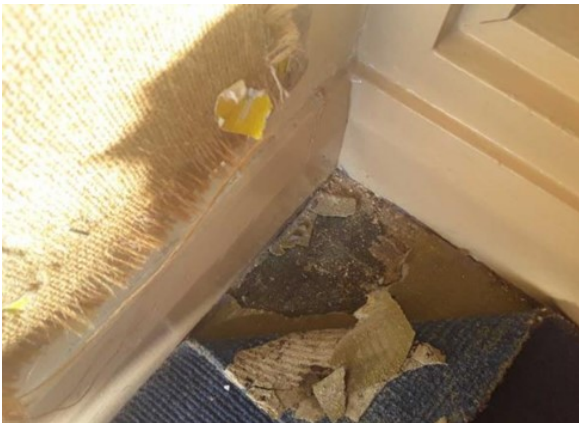
Item 176 – Ref: 22-50659-15

The residual adhesive beneath floor screed in the foundation office 1 (Area 23) contains asbestos.

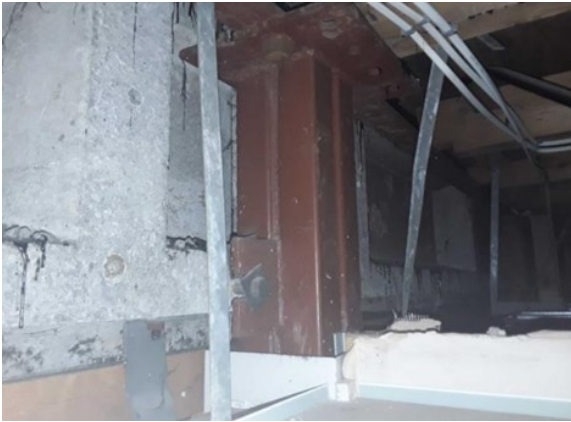
Item 177 – Ref: Presumed

The lining inside clasp columns in the foundation office 1 (Area 23) is presumed to contain asbestos.

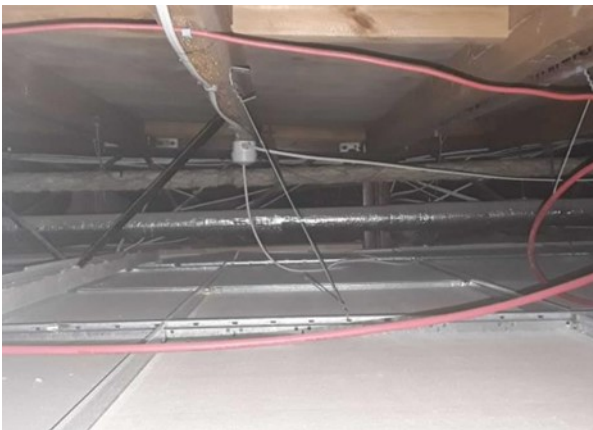
Item 178 – Ref: 22-50659-3

The string wrap to mmmf lagged pipes in the foundation office 1 (Area 23) does not contain asbestos.

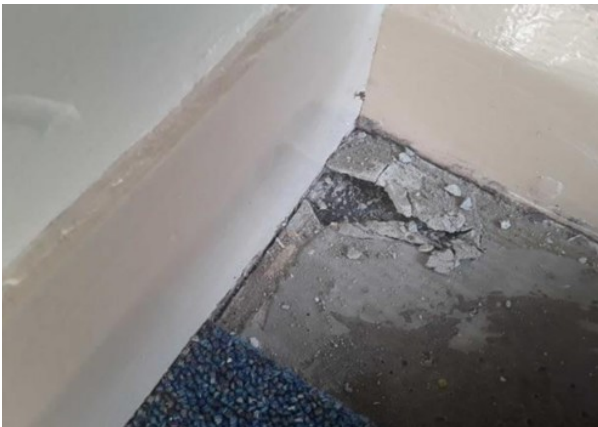
Item 179 – Ref: 22-50659-15

The residual adhesive beneath floor screed in the foundation office 2 (Area 24) contains asbestos.

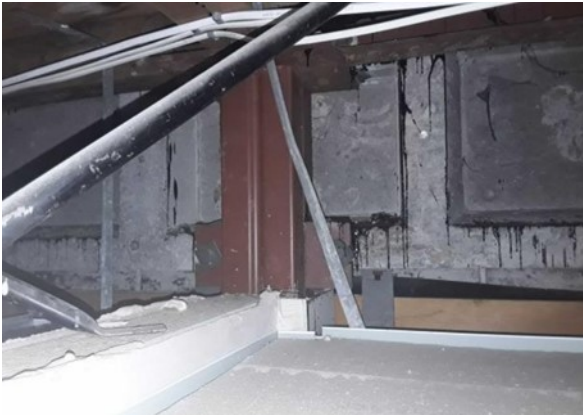
Item 180 – Ref: Presumed

The lining inside clasp columns in the foundation office 2 (Area 24) is presumed to contain asbestos.

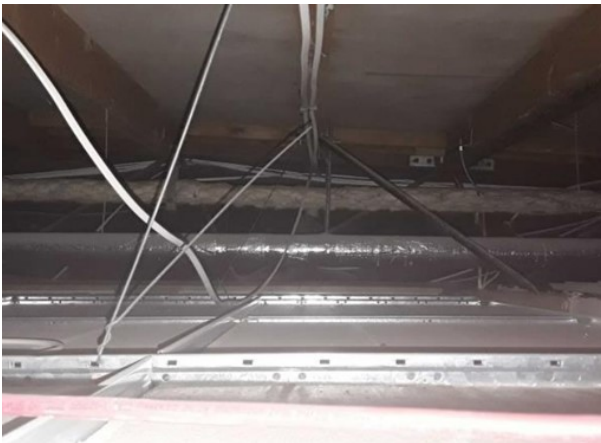
Item 181 – Ref: 22-50659-3

The string wrap to mmmf lagged pipes in the foundation office 2 (Area 22) does not contain asbestos.

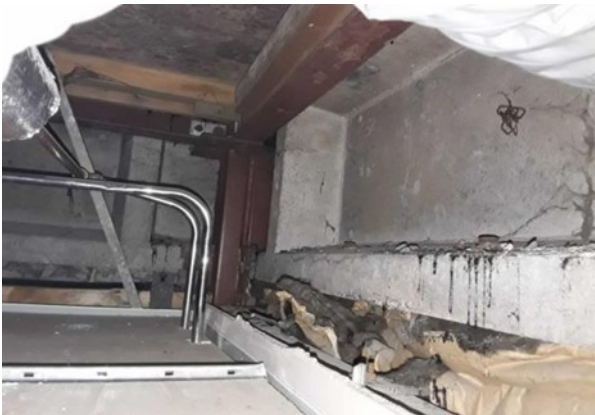
Item 182 – Ref: Presumed

The lining inside clasp columns in the foundation bathroom (Area 25) is presumed to contain asbestos.

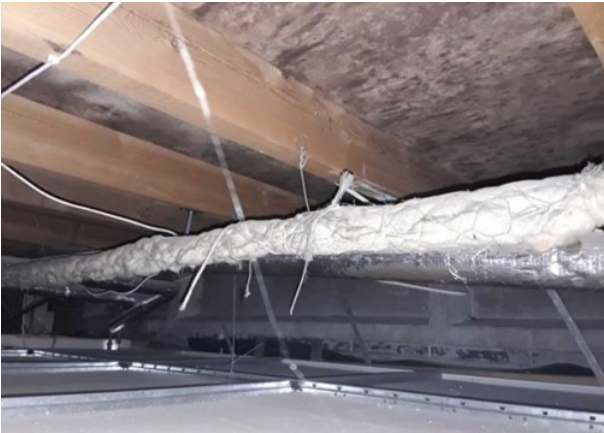
Item 183 – Ref: 22-50659-3

The string wrap to mmmf lagged pipes in the foundation bathroom (Area 25) does not contain asbestos.

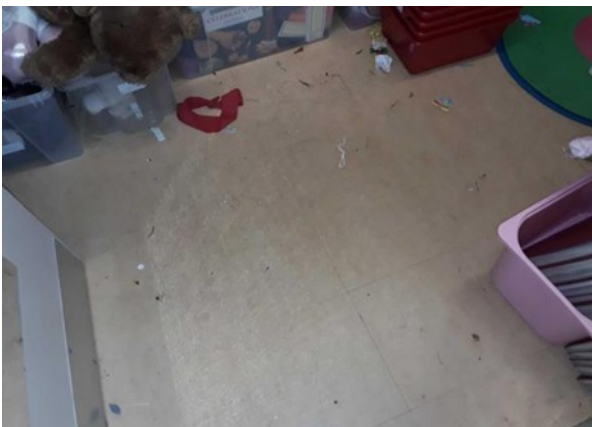
Item 184 – Ref: 22-50659-14

The floor adhesive to the foundation store room (Area 26) does to contain asbestos.

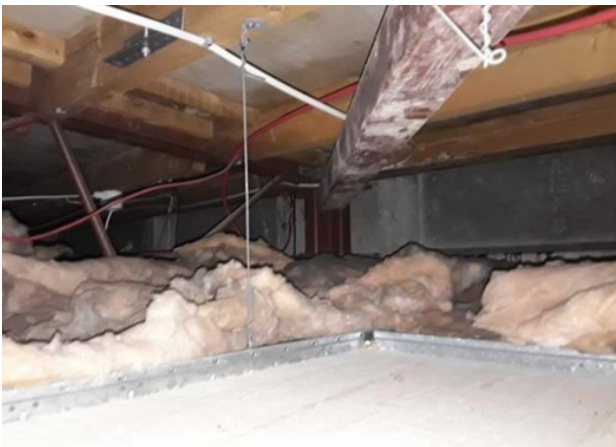
Item 185 – Ref: Presumed

The lining inside clasp columns in the foundation store room (Area 26) is presumed to contain asbestos.

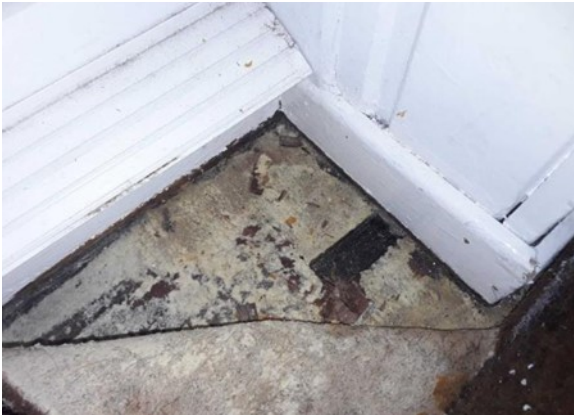
Item 186 – Ref: 22-50659-16

The residual adhesive below parquet flooring and carpet in the Hall (Area 27) does not contain asbestos.

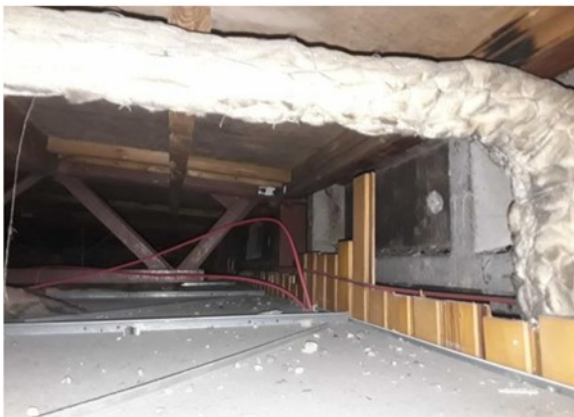
Item 187 – Ref: Presumed

The lining inside clasp columns in the hall (Area 27) is presumed to contain asbestos.

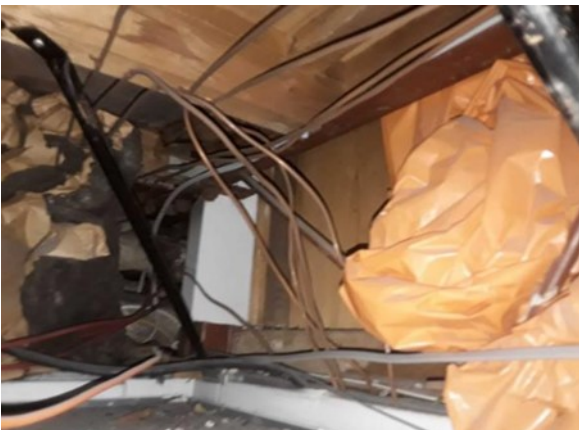
Item 191 – Ref: Presumed

The lining inside clasp columns in the hall store 2 (Area 29) is presumed to contain asbestos.

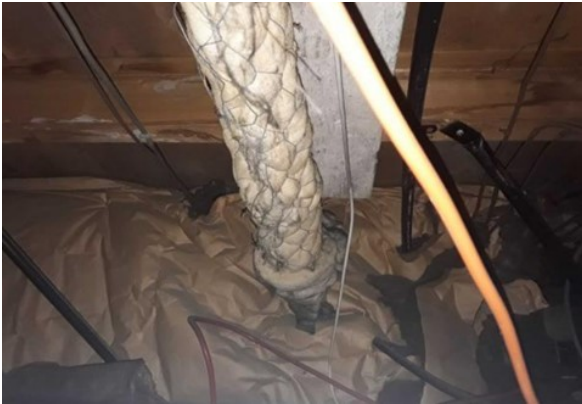
Item 192 – Ref: 22-50659-3

The string wrap to mmmf lagged pipes in the hall store 2 (Area 29) does not contain asbestos.

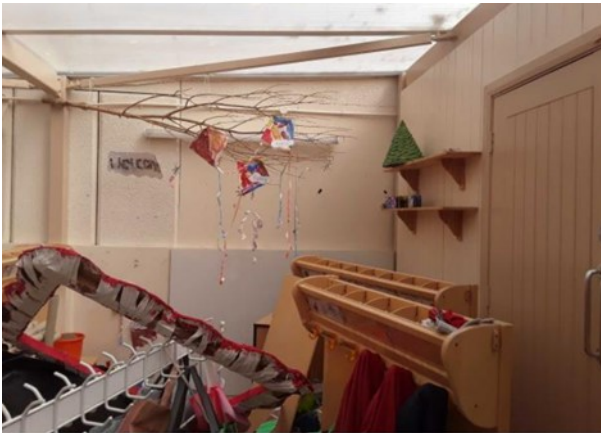
Item 193 – Ref: 22-50659-17

The boards to walls in the conservatory and store cupboard (Area 31) do not contain asbestos.

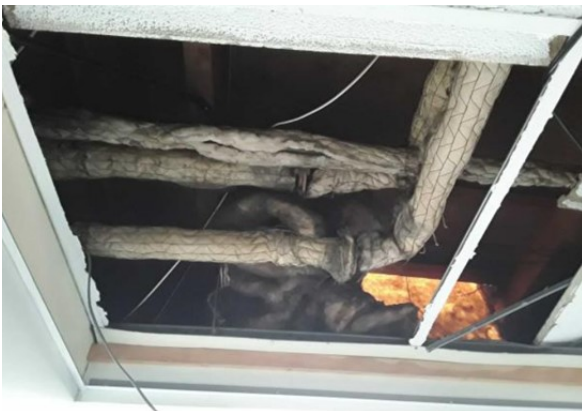
Item 194 – Ref: Presumed

The lining inside clasp columns in the conservatory and store cupboard (Area 31) is presumed to contain asbestos.

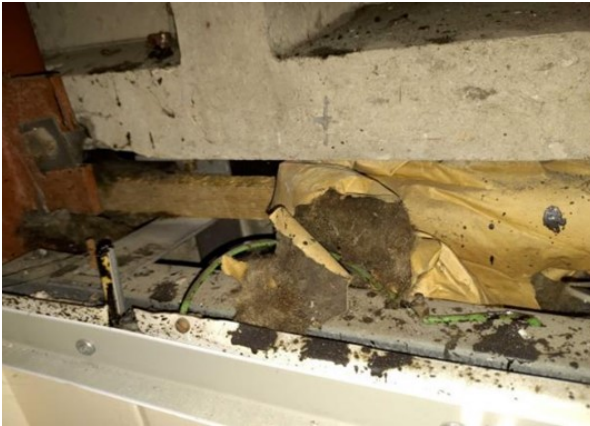
Item 195 – Ref: 22-53465-1

The cavity wall insulation to the internal wall void (Area 2) does not contain asbestos.

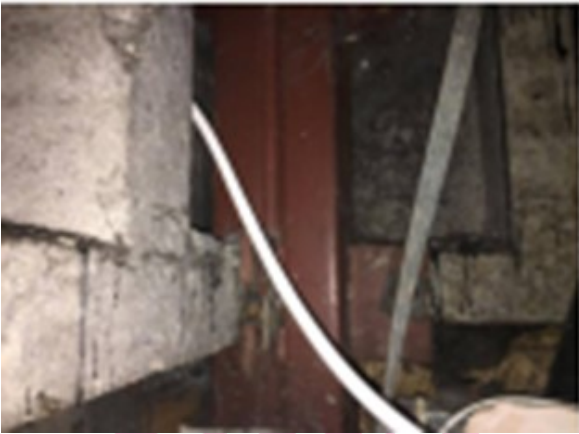
Item 196– Ref: Presumed

The column cladding in Classroom (G/002) is presumed to contain asbestos.
