ASBESTOS SURVEY REPORT FOR FARRINGDON ACADEMY SCHOOL, SUNDERLAND

Asbestos Register for

**FARRINGTON ACADEMY SCHOOL,
SUNDERLAND**

Date: 31 July 2025

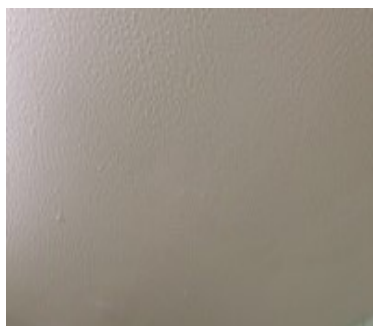
Item 11 As: 101894-1

The textured coating to the ceiling in the time out room in the behaviour unit (Rm 008) contains asbestos.

Any change in its appearance should be recorded and passed to Property Services.

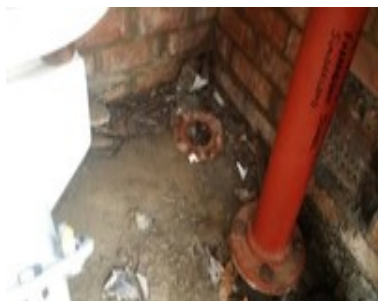
Item 17 Ref: 101894-9

The loose lying gasket to the gas meter house contains asbestos.

Any change in its appearance should be recorded and passed to Property Services.

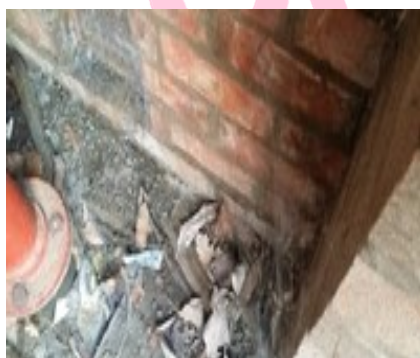
Item 18 Ref: 101894-10

The damp proof course to the gas meter house does not contain asbestos.

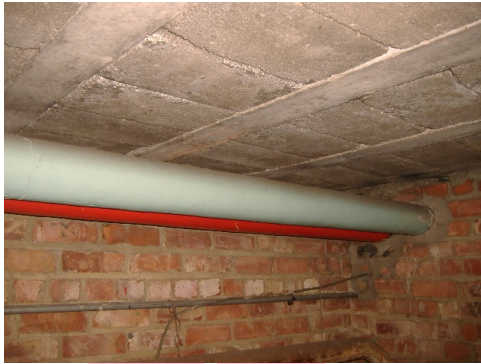
Item 39 - Ref: Presumed

The pipework insulation to the tank room (Rm 0/110) is presumed to contain asbestos.

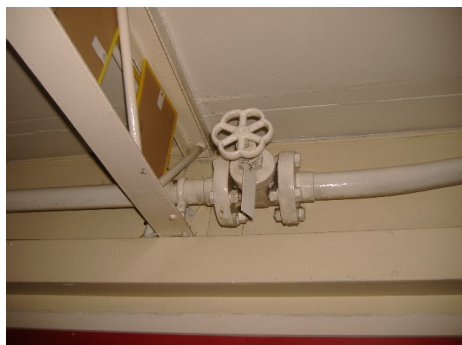
Item 44- Ref: Presumed

The gaskets to the corridor/first aid area (Rm 0/114) are presumed to contain asbestos.

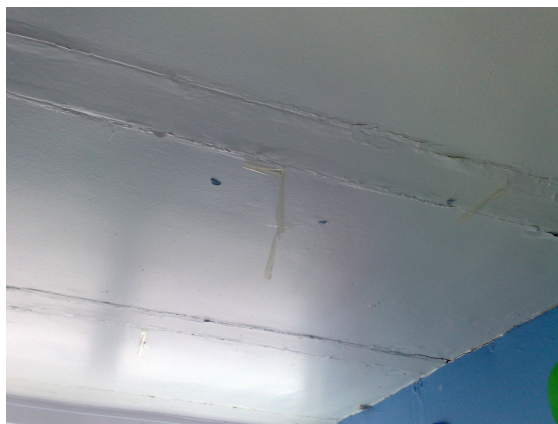
Item 54 - Ref: KR09/47

The ceiling in cloakroom 1 (Room 0/01) does not contain asbestos.

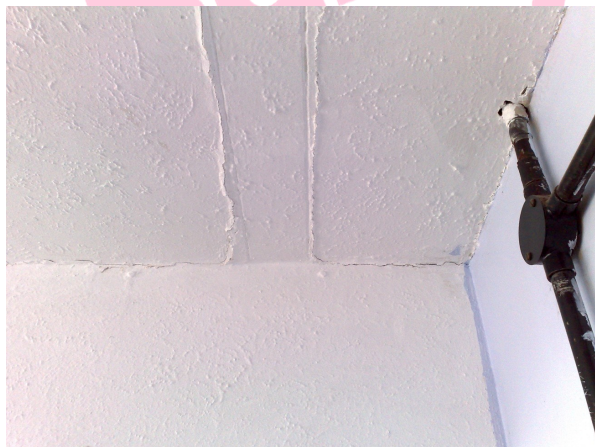
Item 56 - Ref: KR09/46

The textured coating to the ceiling in Store B (Room 0/03) contains asbestos.

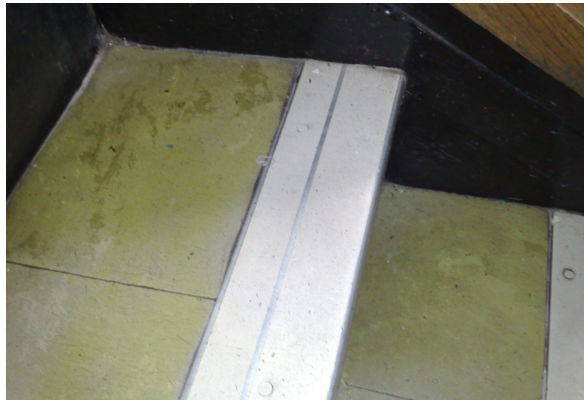
Item 85 - Ref: KR09/54

The stair nosing in the stairwell and landings (Room 0/37) contains asbestos.

Any change in its appearance should be recorded and passed to Property Services.

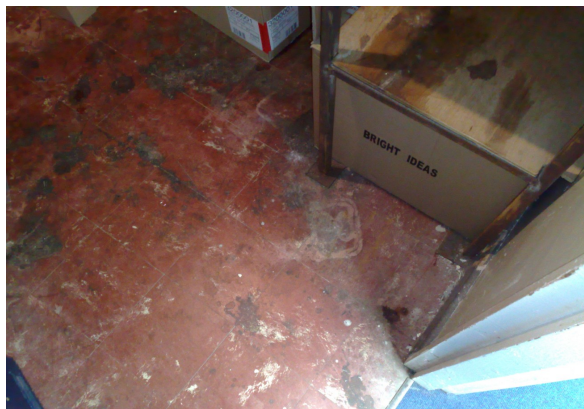
Item 93 - Ref: KR09/58

The floor tiles and adhesive in Store D (Room 0/47) contains asbestos.

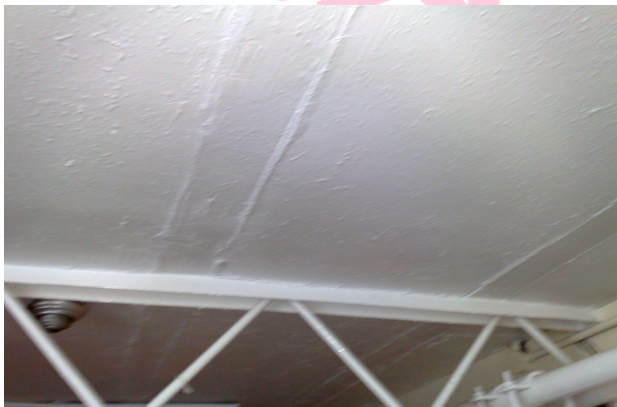
Item 109 - Ref: KR09/60

The textured coating to the ceiling Kitchen area corridor (Room 0/69) contains asbestos.

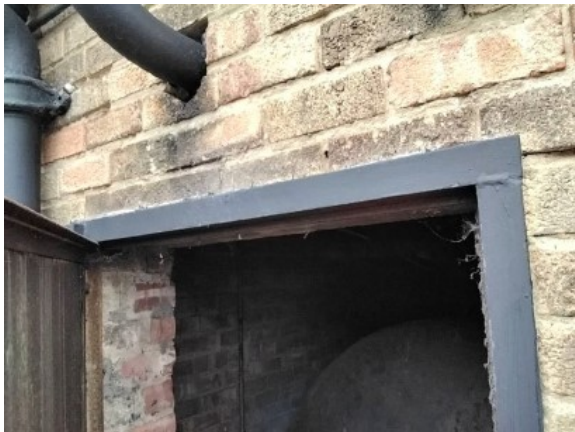
Item 186 - Ref: SC005254

The door seal gasket in the Boiler Room (External) does contain asbestos.

Any change in appearance should be reported to Property Services.

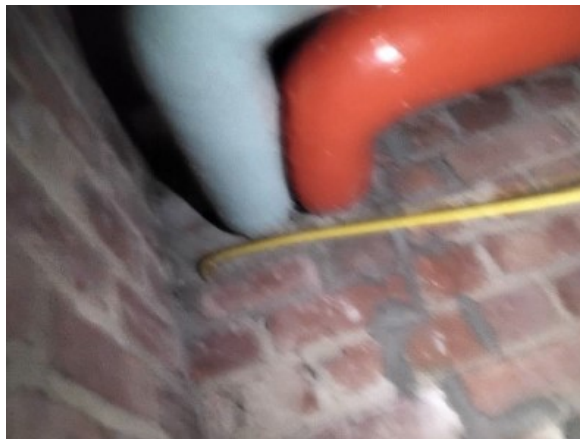
Item 188 - Ref: SC005250

The pipework insulation in the Boiler Room (External) does contain asbestos.

Any change in appearance should be reported to Property Services.

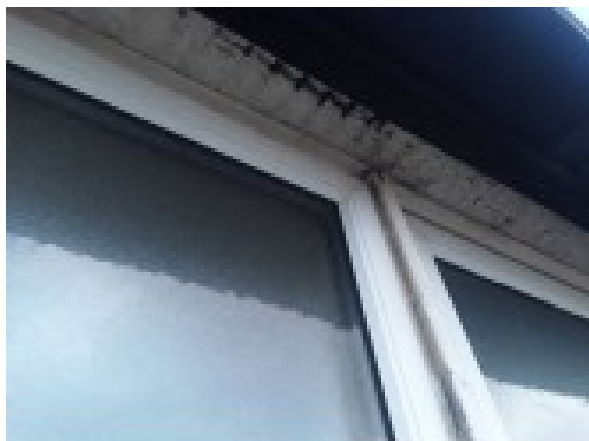
Item 224 - Ref: NZ001568

The Soffits (External area 4 Roof E/005)

Any change in appearance should be reported to Property Services.

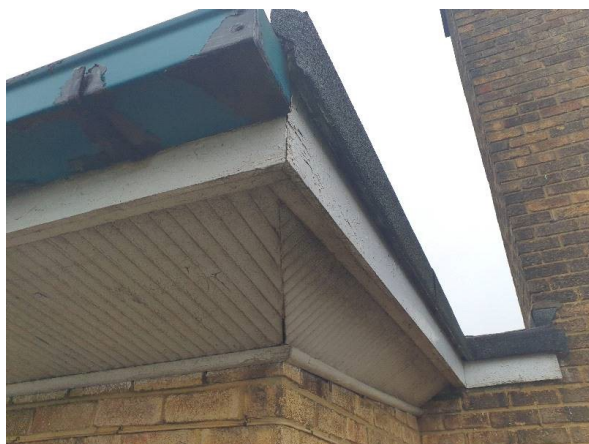
Item 225 - Ref: OU003187

The Cement Soffits (External E/001) contain asbestos.

Any change in appearance should be reported to Property Services.

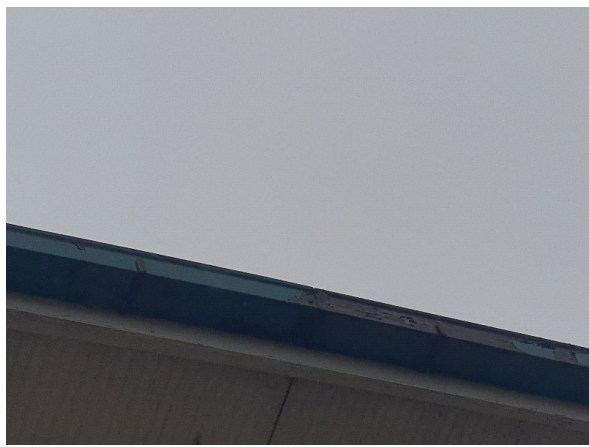
Item 226 - Ref: OU003187

The joint capping – rainwater goods (External E/001) contain asbestos.

Any change in appearance should be reported to Property Services.

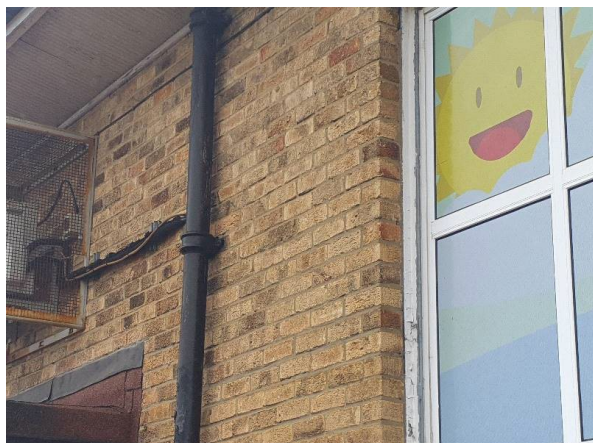
Item 227 - Ref: OU003187

The joint capping – downpipes (External E/001) contain asbestos.

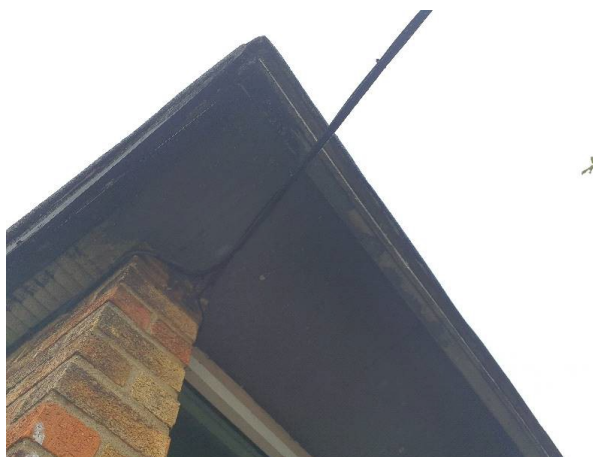
Item 229 - Ref: OU003192

The Cement Soffits (External E/001) contains asbestos.

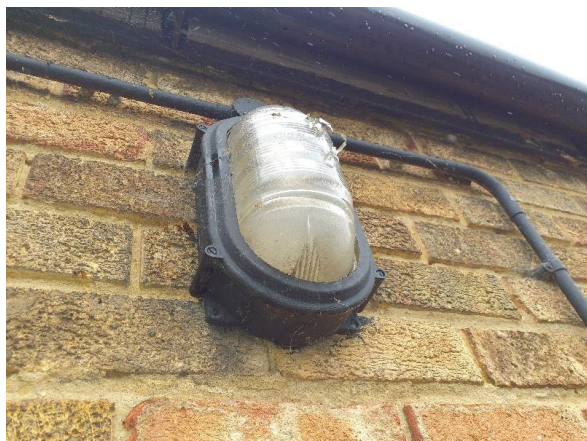
Item 230 - Ref: OU003194

The sealant around oval spot light (External E/001) contain asbestos.

Any change in appearance should be reported to Property Services.

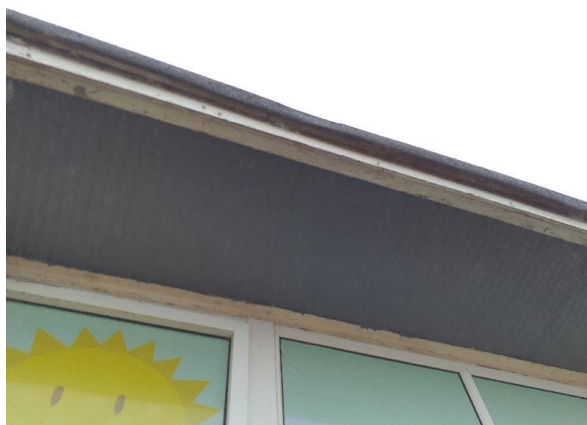
Item 231 - Ref: OU003195

The Cement Soffits (External E/001) contain asbestos.

Any change in appearance should be reported to Property Services.

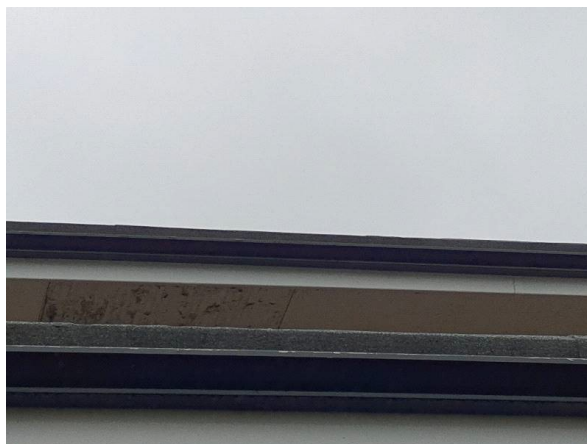
Item 232 - Ref: OU003197

The Cement Soffits (External E/001) contains asbestos.
