ASBESTOS SURVEY REPORT FOR FARRINGDON ACADEMY SCHOOL, SUNDERLAND

Asbestos Register for

**FARRINGTON ACADEMY SCHOOL,
SUNDERLAND**

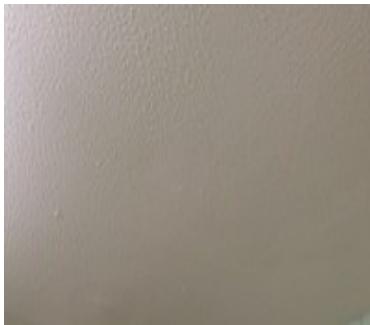
Item 11 As: 101894-1

The textured coating to the ceiling in the time out room in the behaviour unit (Rm 008) contains asbestos.

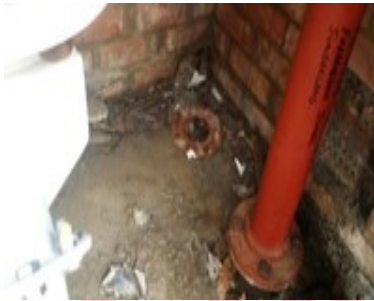
Item 17 Ref: 101894-9

The loose lying gasket to the gas meter house contains asbestos.

Any change in its appearance should be recorded and passed to Property Services.

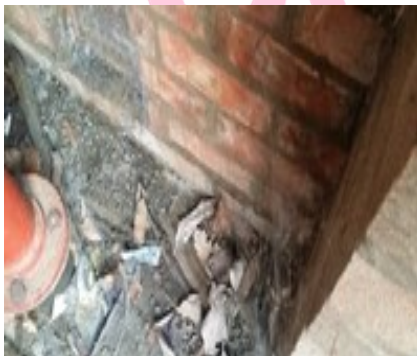
Item 18 Ref: 101894-10

The damp proof course to the gas meter house does not contain asbestos.

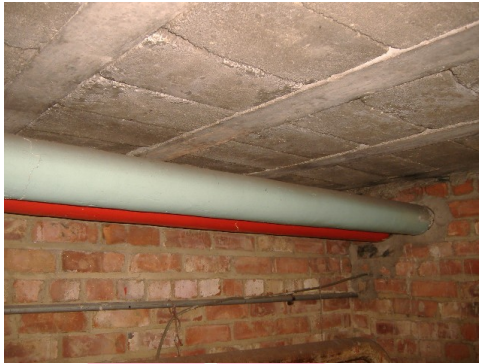
Item 39 - Ref: Presumed

The pipework insulation to the tank room (Rm 0/110) is presumed to contain asbestos.

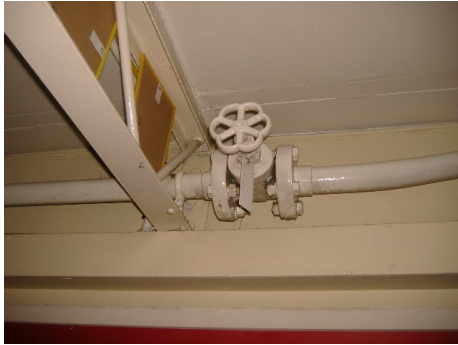
Item 44- Ref: Presumed

The gaskets to the corridor/first aid area (Rm 0/114) are presumed to contain asbestos.

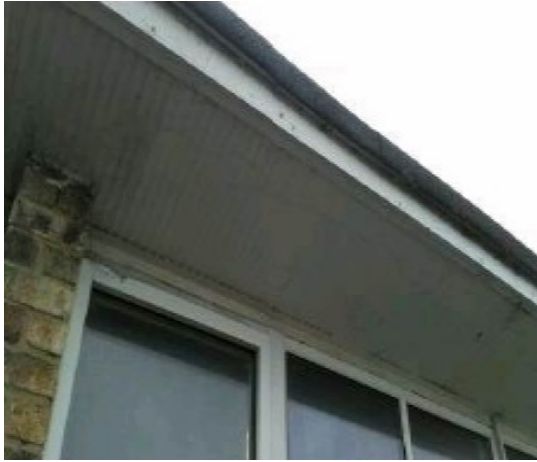
Item 47 - Ref: WC0483/08

The soffits to the exterior of the building contain asbestos.

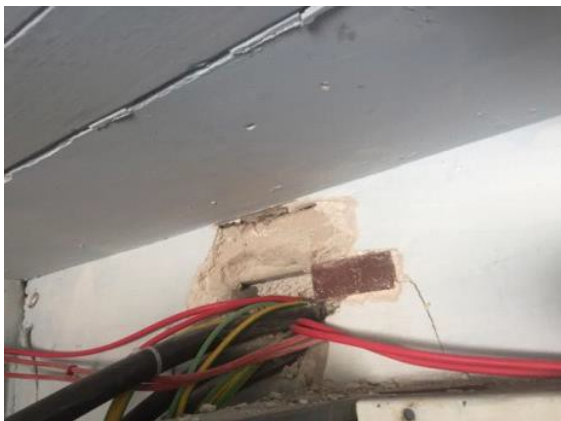
Item 49 – Ref: 741267-2

The ceiling in the Switch Room does not contain asbestos.

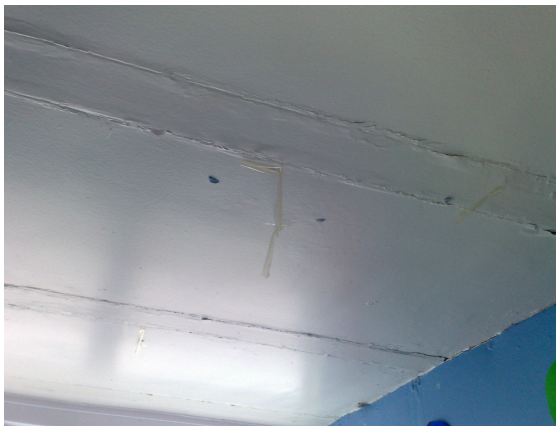
Item 54 - Ref: KR09/47

The ceiling in cloakroom 1 (Room 0/01) does not contain asbestos.

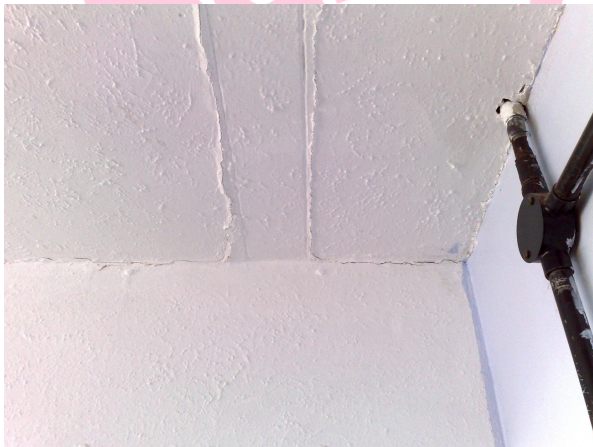
Item 56 - Ref: KR09/46

The textured coating to the ceiling in Store B (Room 0/03) contains asbestos.

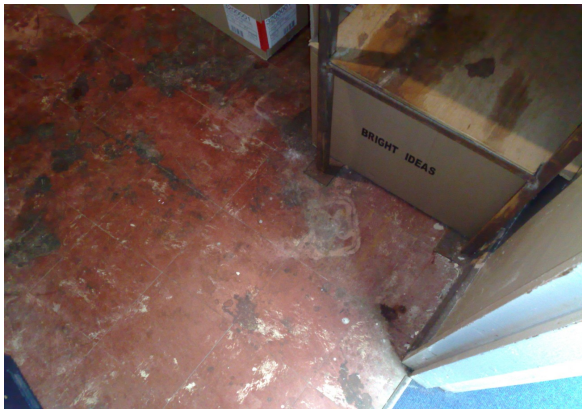
Item 93 - Ref: KR09/58

The floor tiles and adhesive in Store D (Room 0/47) contains asbestos.

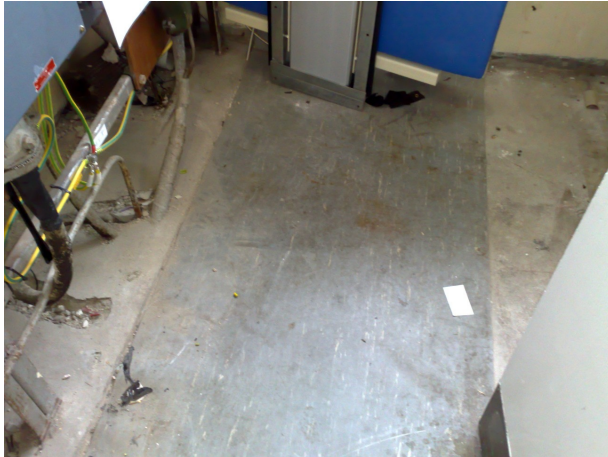
Item 103 - Ref: KR09/59

The vinyl floor strip in the electrical intake 2 (Room 0/63) does not contain asbestos.

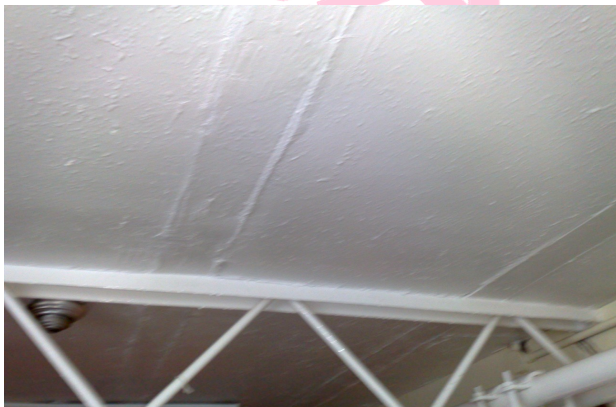
Item 109 - Ref: KR09/60

The textured coating to the ceiling Kitchen area corridor (Room 0/69) contains asbestos.

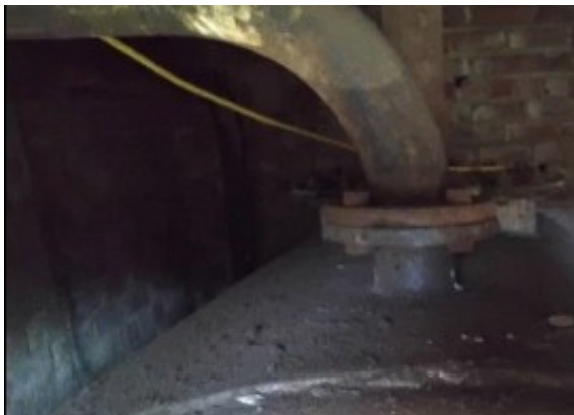
Item 184 - Ref: SC005251

The debris/residue to tank in the Boiler Room (External) does contain asbestos.

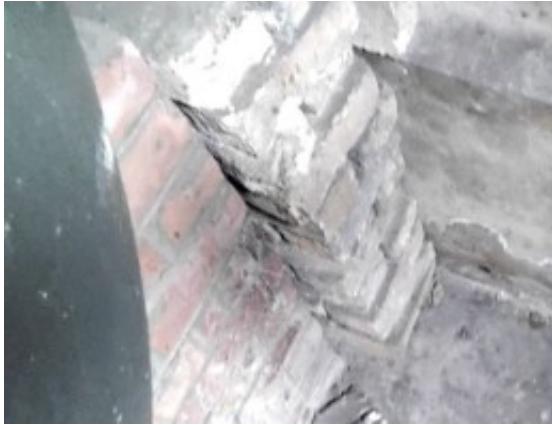
Item 185 - Ref: SC005252

The debris/residue to the floor in the Boiler Room (External) does contain asbestos.

This should be removed asap.

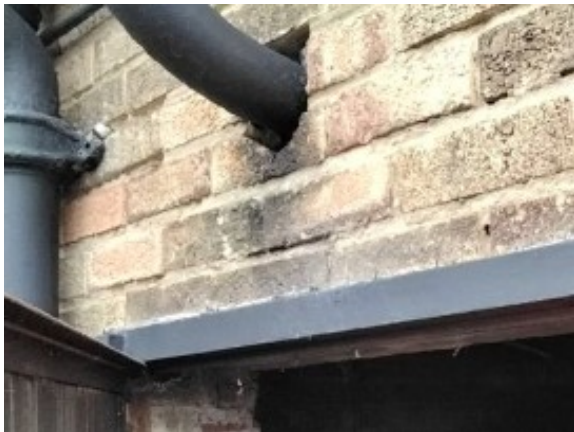
Item 186 - Ref: SC005254

The door seal gasket in the Boiler Room (External) does contain asbestos.

Any change in appearance should be reported to Property Services.

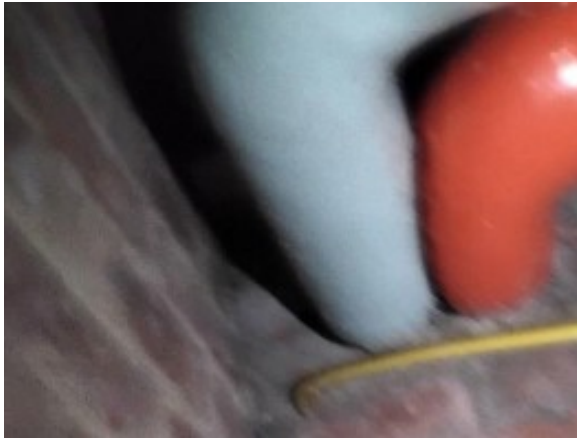
Item 188 - Ref: SC005250

The pipework insulation in the Boiler Room (External) does contain asbestos.

Any change in appearance should be reported to Property Services.

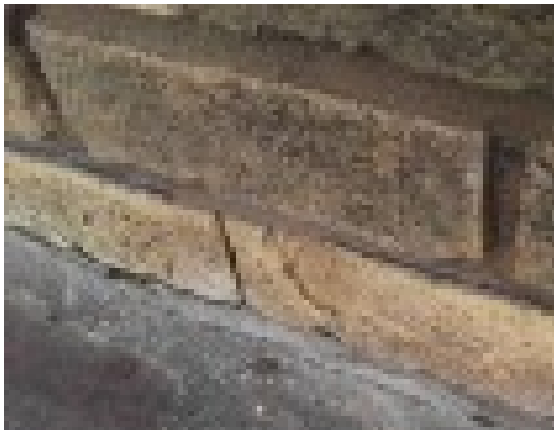
Item 216 - Ref: NZ001564

The Damp proof course (External area 3 pointing area 2 roof E/001).

Any change in appearance should be reported to Property Services

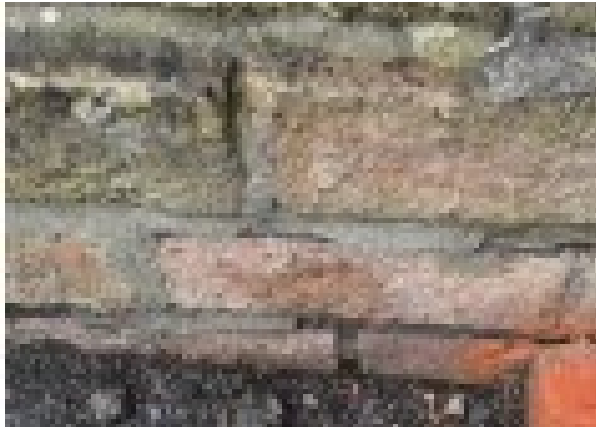
Item 219 - Ref: NZ001567

The Damp proof course (External area 1 pointing E/003).

Any change in appearance should be reported to Property Services.

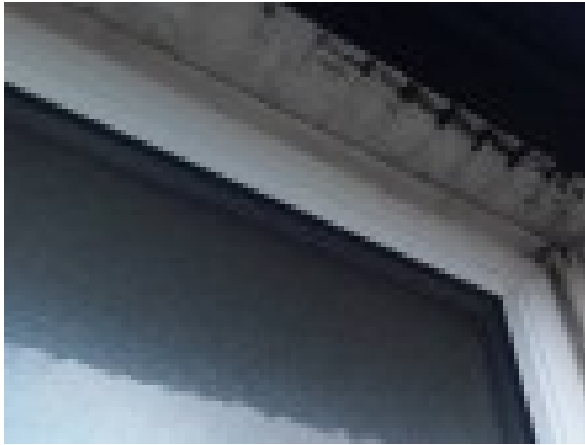
Item 224 - Ref: NZ001568

The Soffits (External area 4 Roof E/005)

Any change in appearance should be reported to Property Services.

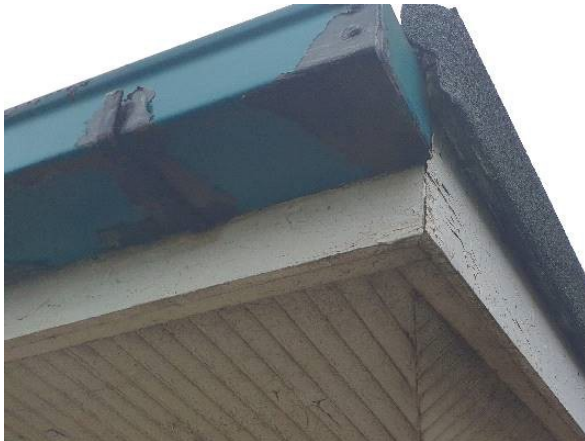
Item 225 - Ref: OU003187

The Cement Soffits (External E/001) contain asbestos.

Any change in appearance should be reported to Property Services.

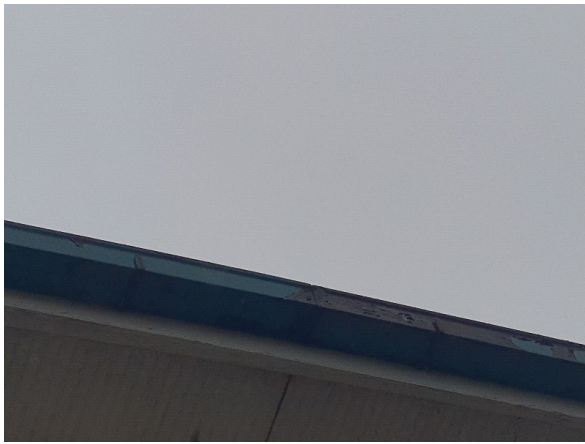
Item 226 - Ref: OU003187

The joint capping – rainwater goods (External E/001) contain asbestos.

Any change in appearance should be reported to Property Services.

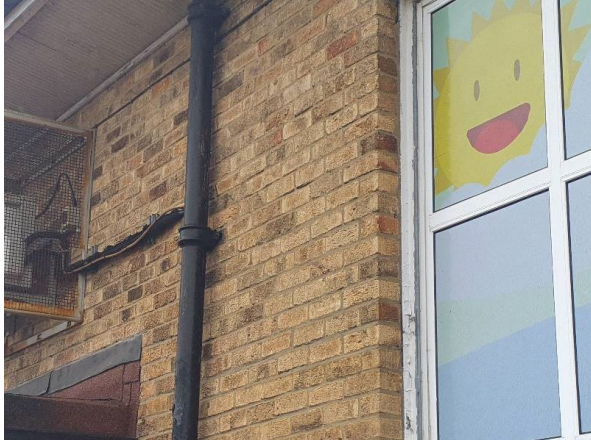
Item 227 - Ref: OU003187

The joint capping – downpipes (External E/001) contain asbestos.

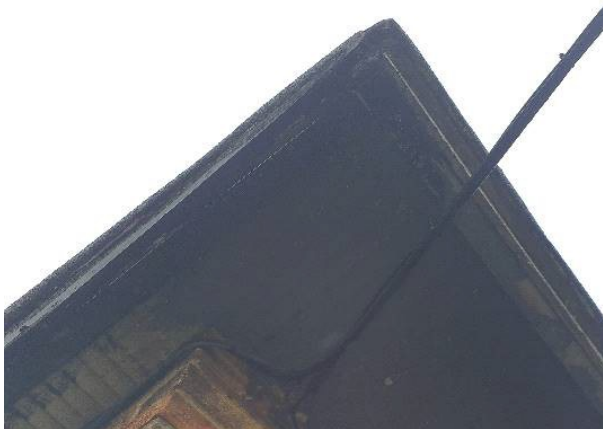
Item 229 - Ref: OU003192

The Cement Soffits (External E/001) contains asbestos.

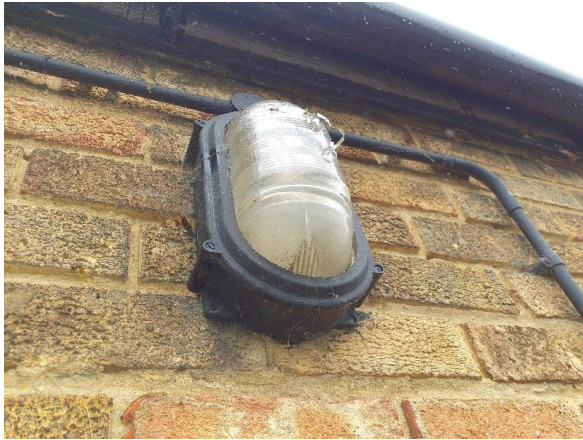
Item 230 - Ref: OU003194

The sealant around oval spot light (External E/001) contain asbestos.

Any change in appearance should be reported to Property Services.

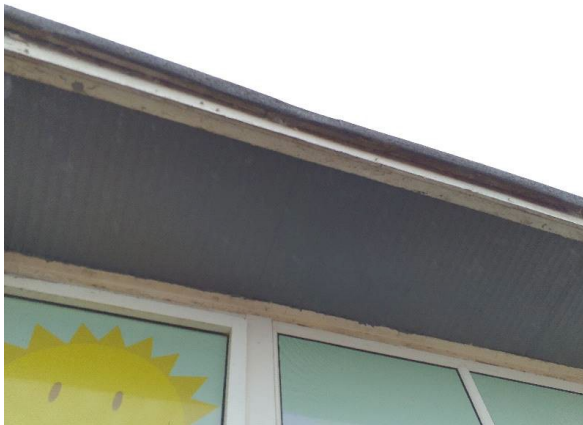
Item 231 - Ref: OU003195

The Cement Soffits (External E/001) contain asbestos.

Any change in appearance should be reported to Property Services.

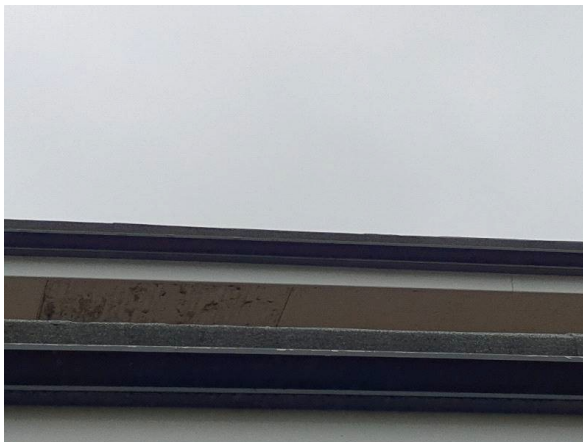
Item 232 - Ref: OU003197

The Cement Soffits (External E/001) contains asbestos.
