ASBESTOS SURVEY REPORT FOR NEW PENSHAW ACADEMY, NEW PENSHAW, SUNDERLAND, DH4 7HY

Asbestos Register for New Penshaw Academy

Date: 17 October 2024

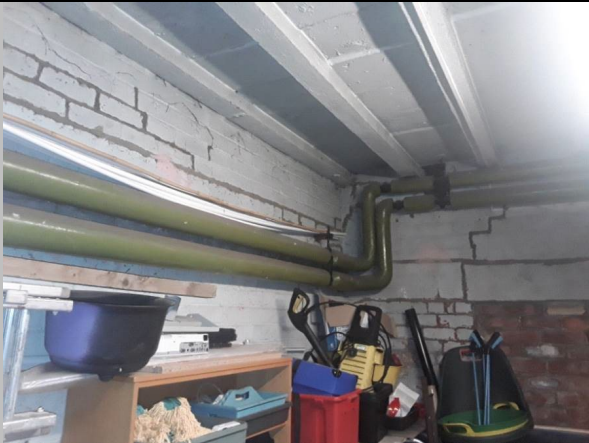
2	NZ000609	Pipework insulation bottom pipe painted green	Boiler Room Entrance Z1/001	No Risk

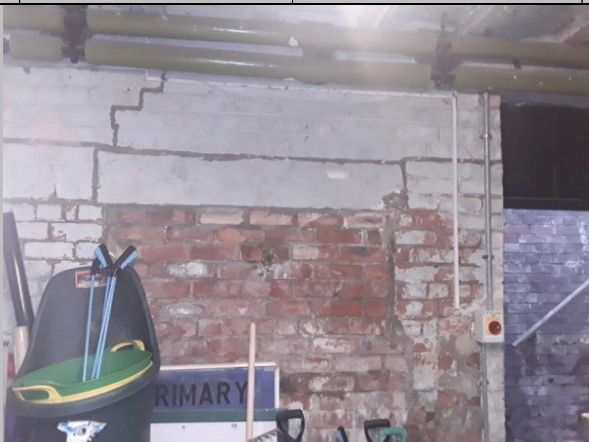
3	NZ000610	Debris/Residue to entrance wall	Boiler Room Entrance Z1/001	No Risk

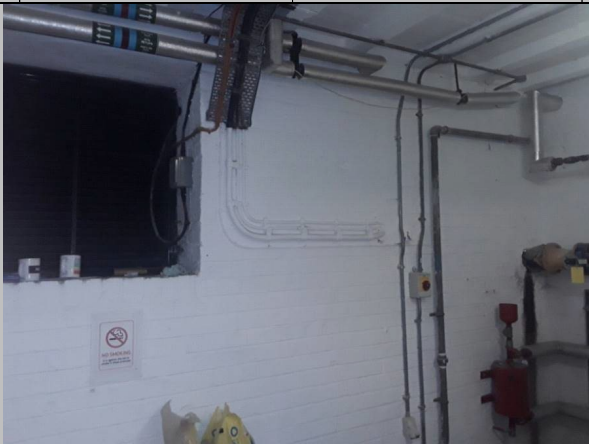
10	NZ000616	Debris/residue to entrance wall	Boiler Room Z1/002	No Risk

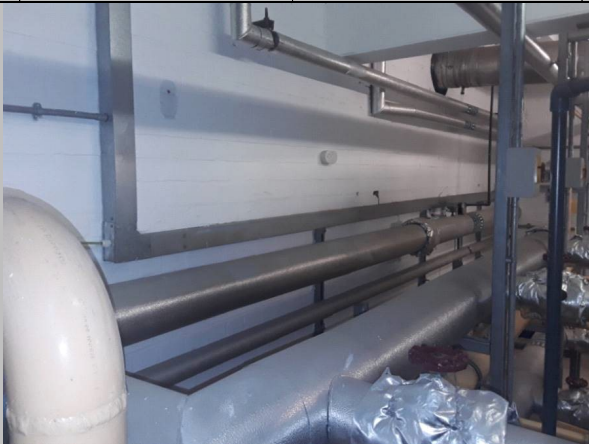
11	NZ000617	Debris/residue to left hand wall rear of boilers and on cable conduit	Boiler Room Z1/002	No Risk

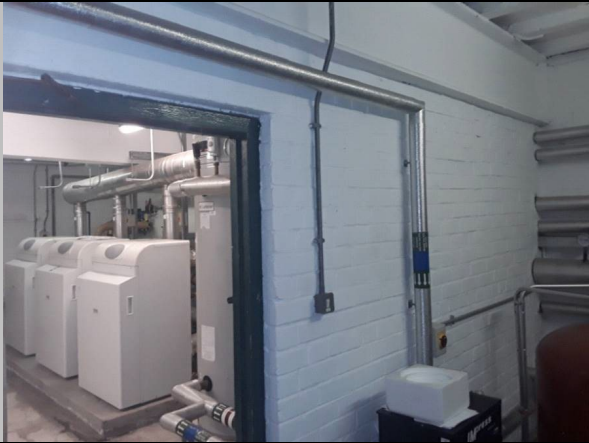
16	NZ000622	Debris/residue to entrance and left-hand wall	Boiler Room Rear Z1/003	No Risk

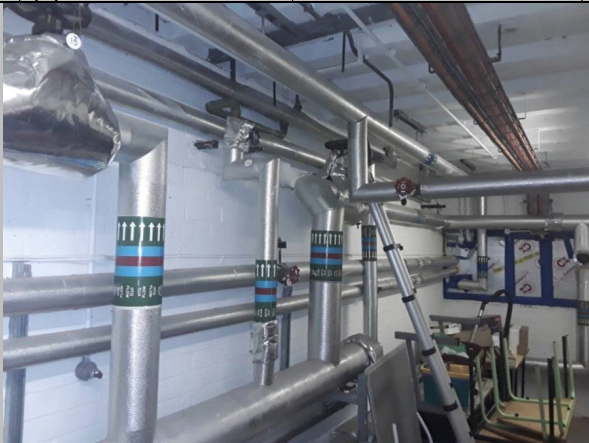
17	NZ000623	Debris/residue to rear and right-hand wall including pipework brackets	Boiler Room Rear Z1/003	No Risk

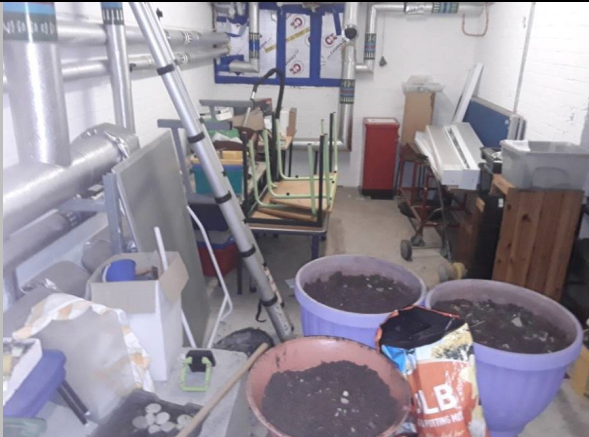
18	NZ000624	Debris/residue to floor	Boiler Room Rear Z1/003	No Risk

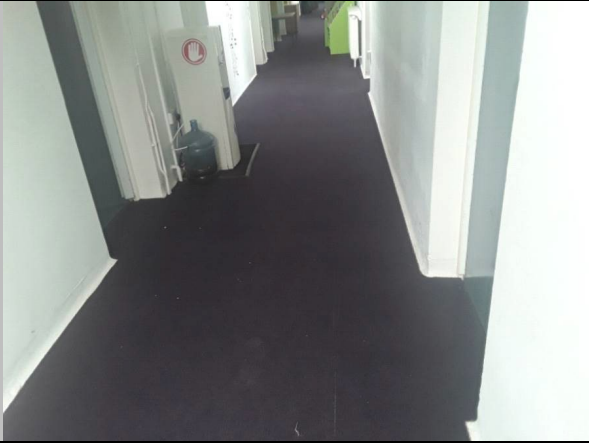
25	NZ000599	Floor tile with adhesive remnants under carpet	Corridor G/021	No Risk

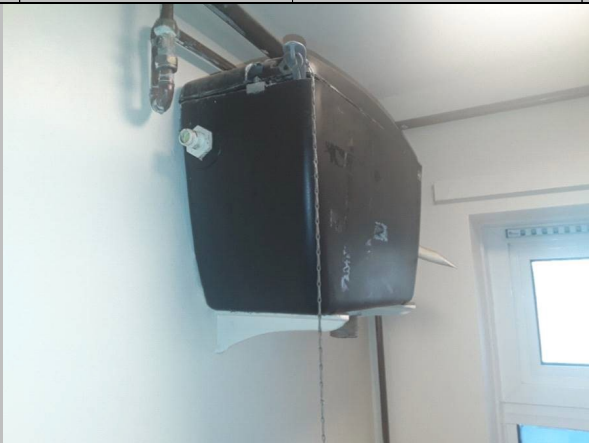
26	NZ000600	Toilet cisterns redundant	Toilets G/024	No Risk

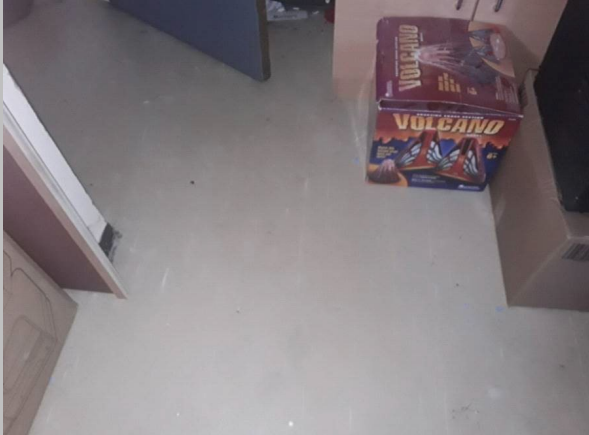
27	NZ000601	Floor covering	Store Room G/030	No Risk

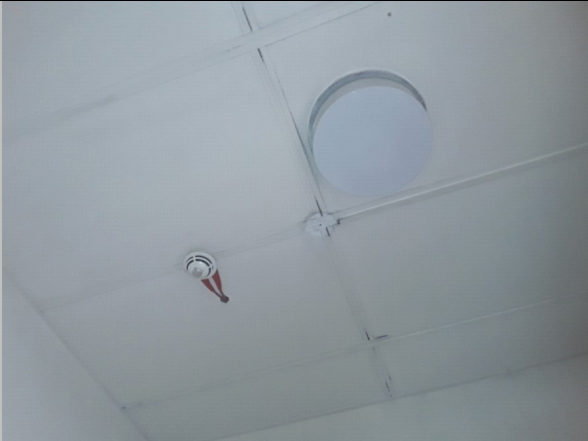
31	As NZ000603	Ceiling Tile suspended solid	Store room left hand within Classroom 7 G/036	No Risk

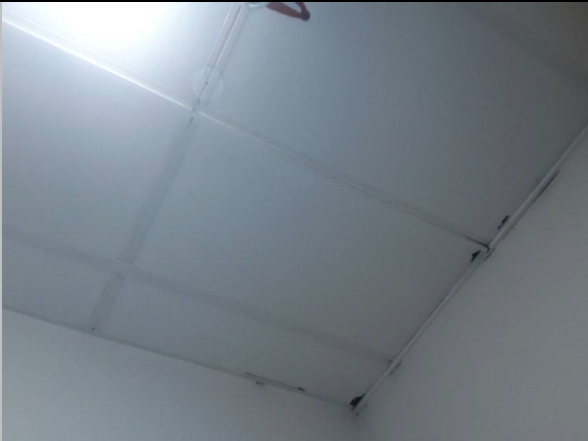
32	As NZ000603	Ceiling Tile suspended solid	Store room within Classroom 6 G/037	No Risk

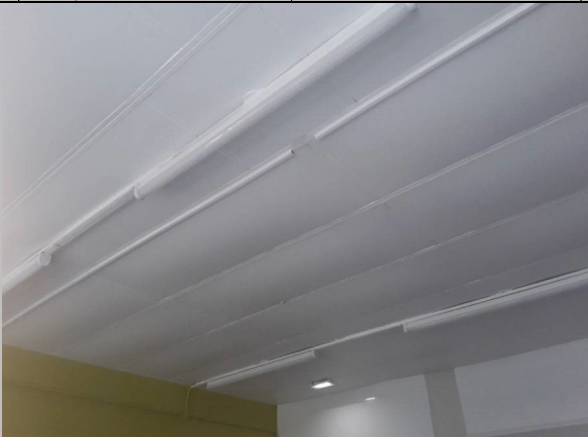
33	As NZ000603	Ceiling Tile suspended solid	Classroom 6 G/038	No Risk

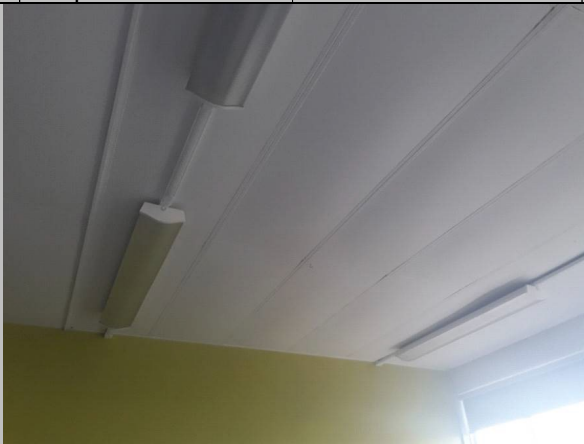
43	As NZ000606	Ceiling tile suspended solid	Classroom 2 G/083	No Risk

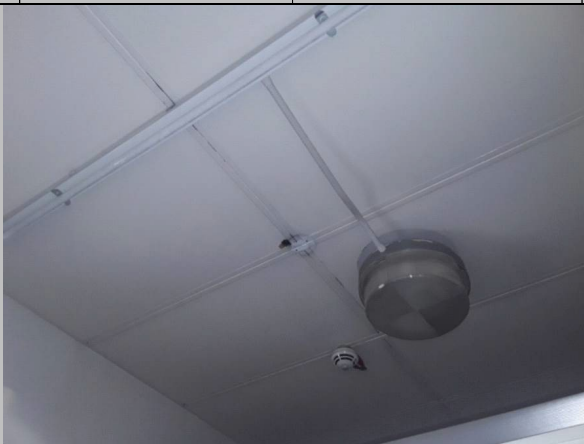
44	As NZ000606	Ceiling tile suspended solid	Store room right hand within Classroom 2 G/084	No Risk

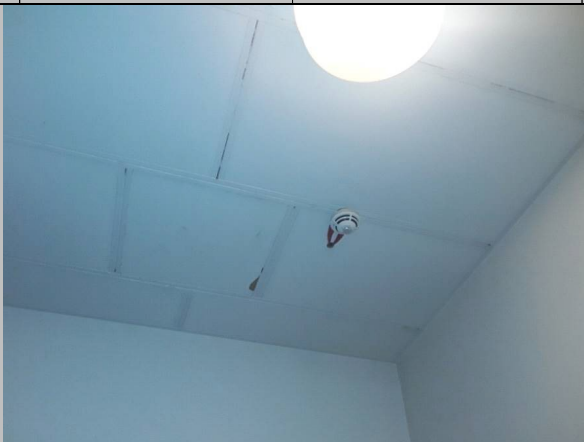
45	As NZ000606	Ceiling tile suspended solid	Store room left hand within Classroom 2 G/085	No Risk

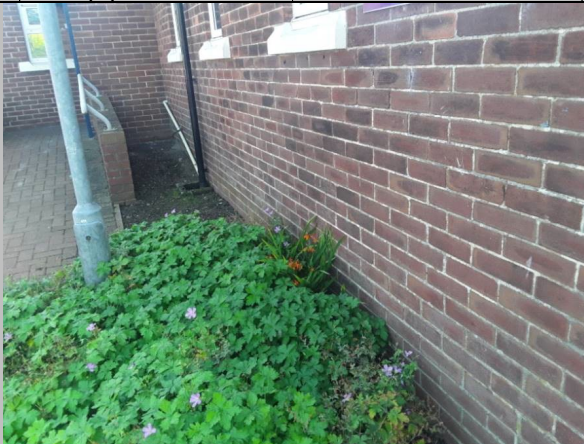
49	NZ000628	Damp proof course	External E/001	No Risk

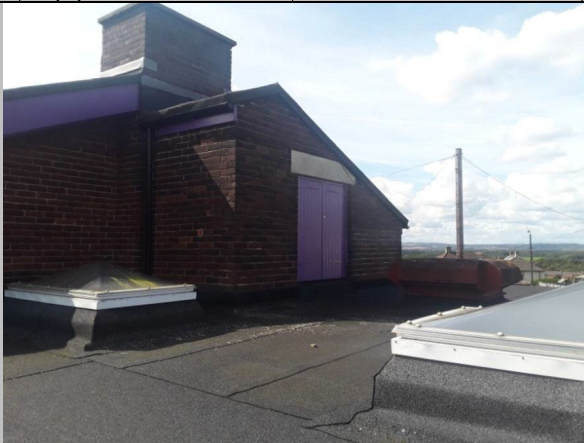
50	NZ000629	Roof flashing to roof top plant room	External E/001	No Risk

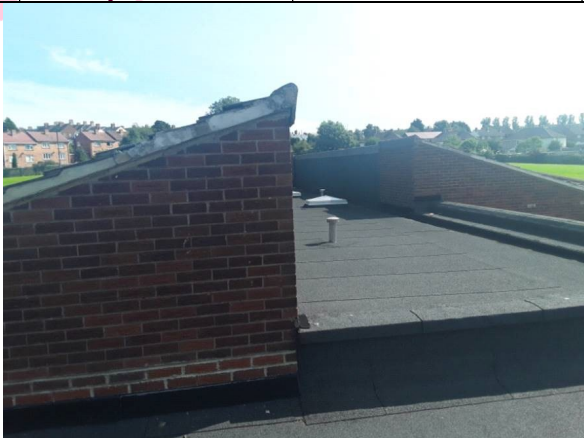
51	NZ000630	Undercloak to nursery block	External E/001	Very Low Risk – inspect 12 monthly
