ASBESTOS SURVEY REPORT FOR ALBANY PRIMARY SCHOOL, CROSSGILL, WASHINGTON, NE37 1UA.

### **Asbestos Register for Albany Primary School, Crossgill, Washington**

**Date: 02 April 2025**

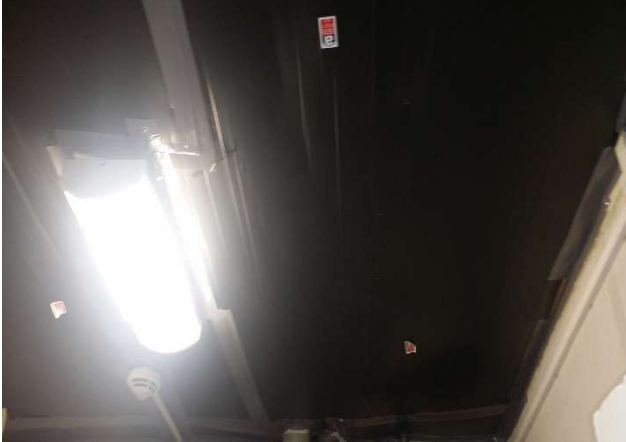
### **Item 31 Ref: Presumed**

The ceiling in Rm 020/Cleaners Store contains asbestos.

Any change in its appearance should be recorded and passed to Property Services.

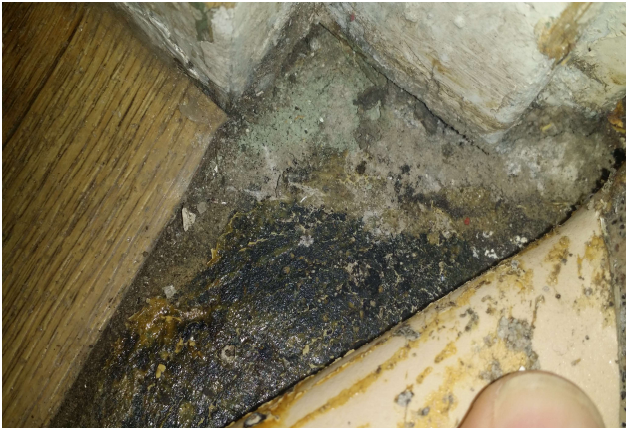
### **Item 32 Ref: As 369386-30**

The remnant adhesive backing to floor in Rm 020/Cleaners Store contains asbestos.

Any change in its appearance should be recorded and passed to Property Services.

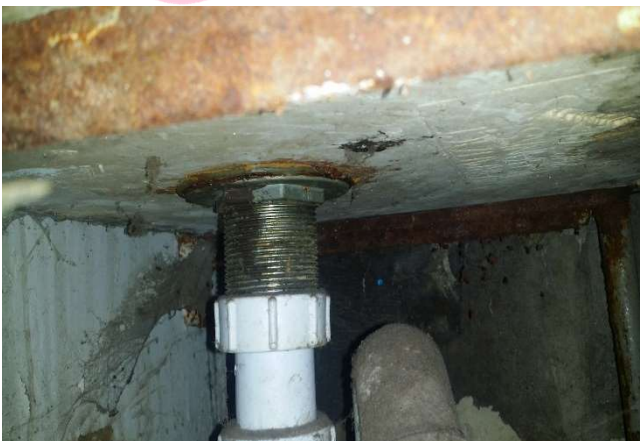
### **Item 33 Ref: 369386-43**

The mastic to soil pipe at basin in Rm 020/Cleaners Store does not contain asbestos.

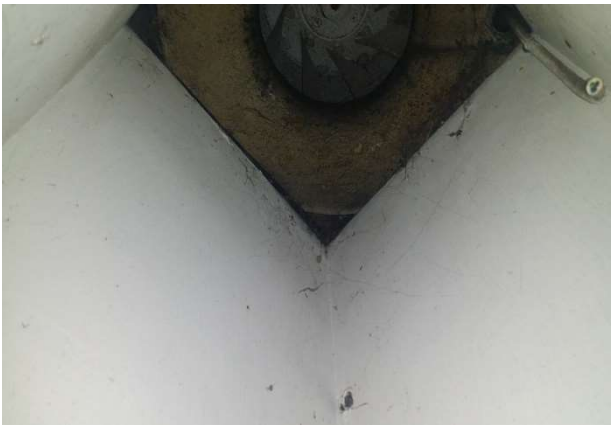
#### **Item 35 Ref: 369386-48**

The packing to skylight top in Rm 021/Hall Store does not contain asbestos.

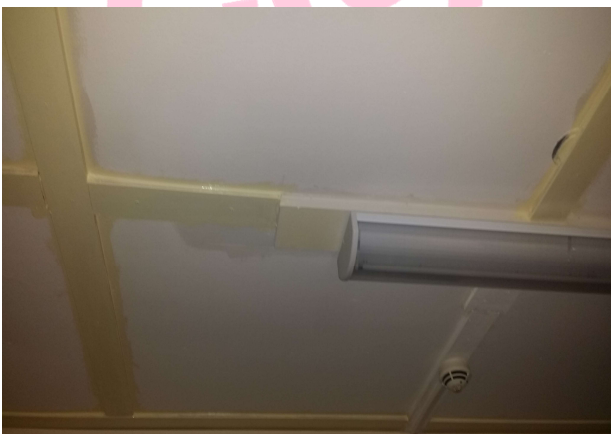
#### **Item 36 Ref: 369386-49**

The ceiling in Rm 022/Hall Store contains asbestos.

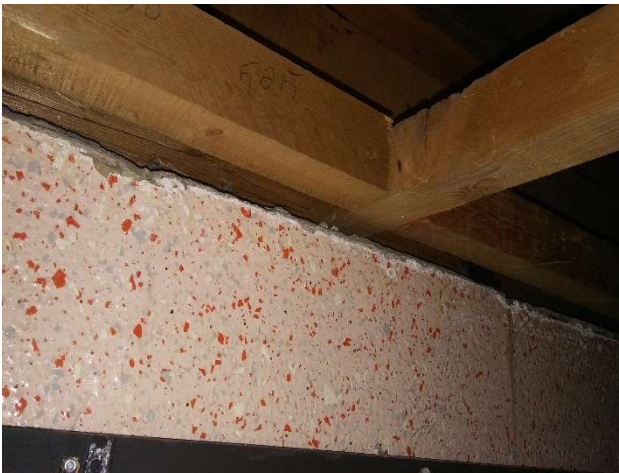
#### **Item 38 Ref: 369386-89**

The debris to perimeter wall in Rm 023A/Girls WC – void above contains asbestos.

Any change in its appearance should be recorded and passed to Property Services.

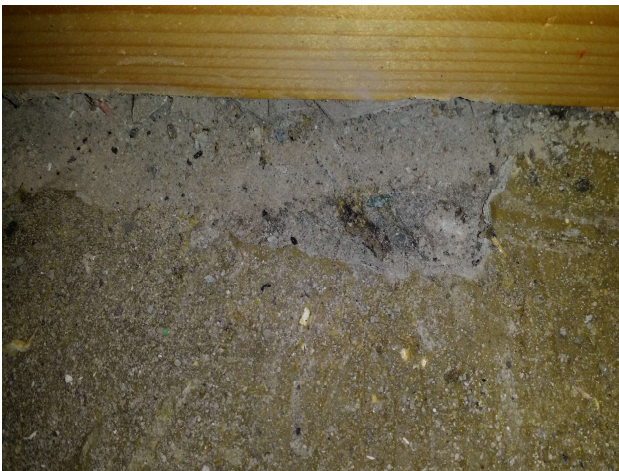
#### **Item 39 Ref: 369386-90**

The adhesive backing to floor in Rm 024/Classroom contains asbestos.

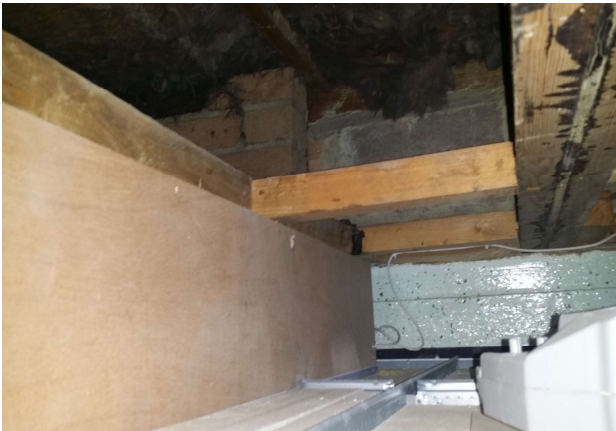
### **Item 41 Ref: 369386-92**

The packing to joists in Rm 024/Classroom – void above does not contain asbestos.

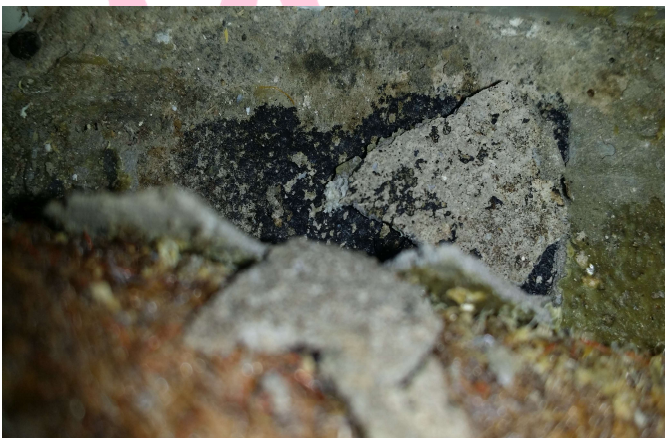
### **Item 42 Ref: As 369386-90**

The remnant adhesive backing to floor in Rm 024a/Lobby contains asbestos.

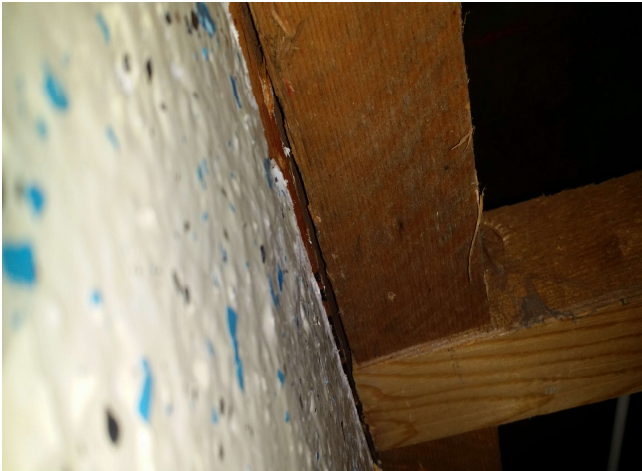
#### **Item 43 Ref: 369386-105**

The residue to joists in Rm 025a/WC – void above contains asbestos.

Any change in its appearance should be recorded and passed to Property Services.

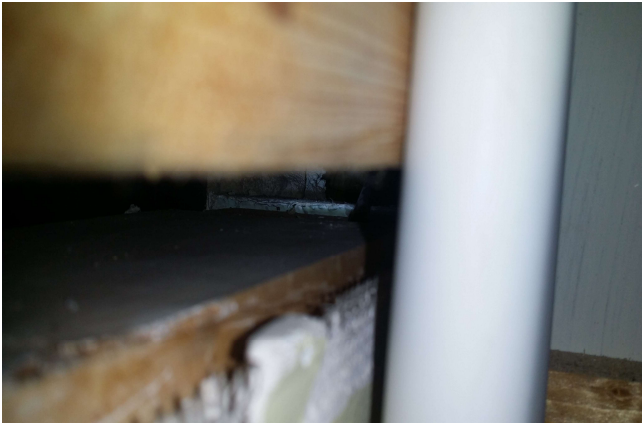
#### **Item 44 Ref: 369386-94**

The remnant ceiling in Rm 026a/Baby changing – void above contains asbestos.

Any change in its appearance should be recorded and passed to Property Services.

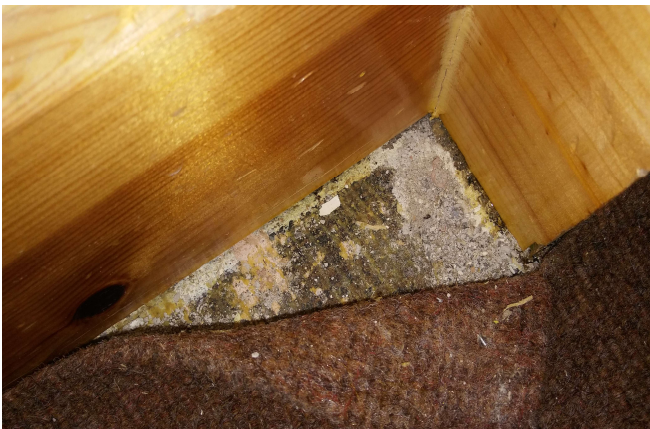
#### **Item 45 Ref: As 369386-90**

The remnant adhesive to floor under carpet in Rm 026b/Classroom contains asbestos.

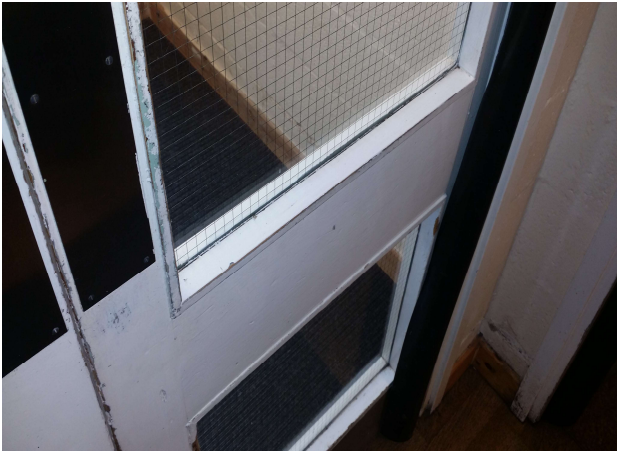
#### **Item 47 Ref: As 369386-5**

The mastic to fire doors in Rm 030/Cloakroom contains asbestos.

Any change in its appearance should be recorded and passed to Property Services.

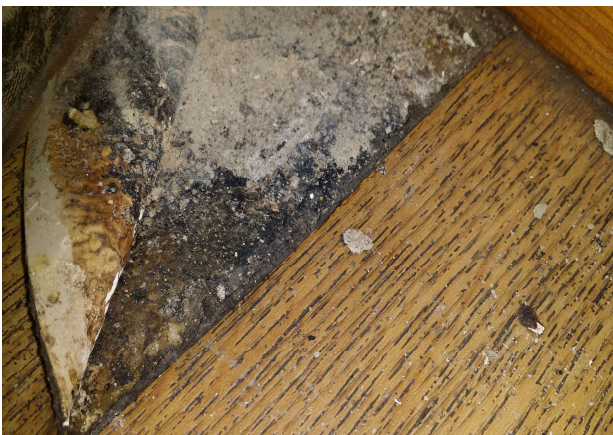
#### **Item 48 Ref: 369386-25**

The remnant adhesive backing to floor in Rm 030/Cloakroom contains asbestos.

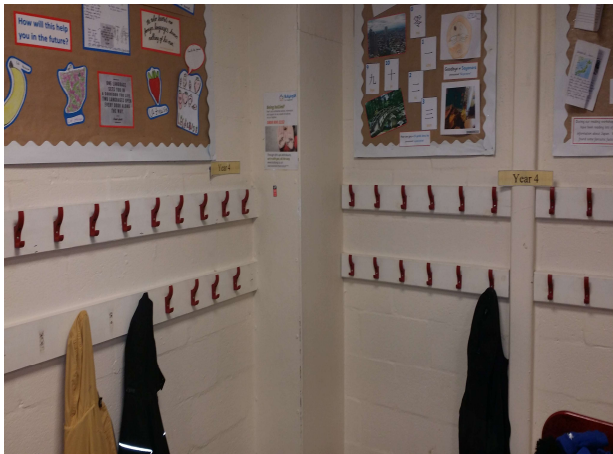
### **Item 49 Ref: As 369386-24**

The boxing to LHS and RHS of entrance doors in Rm 030/Cloakroom contains asbestos.

Any change in its appearance should be recorded and passed to Property Services.

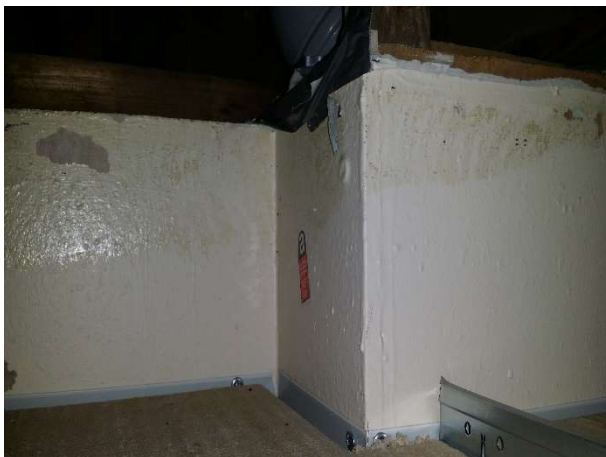
### **Item 50 Ref: 369386-24**

The boxing to LHS and RHS of entrance doors in Rm 030/Cloakroom contains asbestos.

Any change in its appearance should be recorded and passed to Property Services.

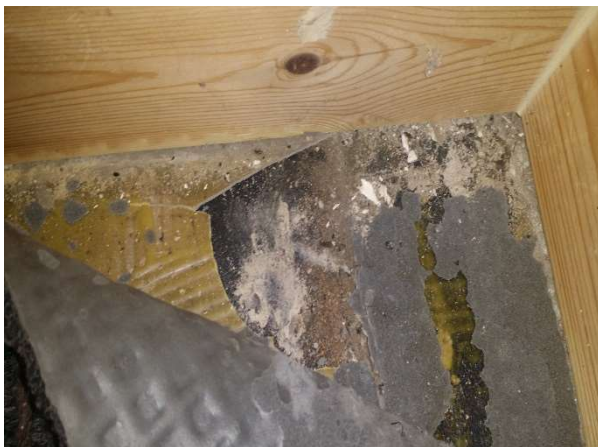
### **Item 51 Ref: 369386-17**

The subfloor in Rm 030a/Corridor lobby contains asbestos.

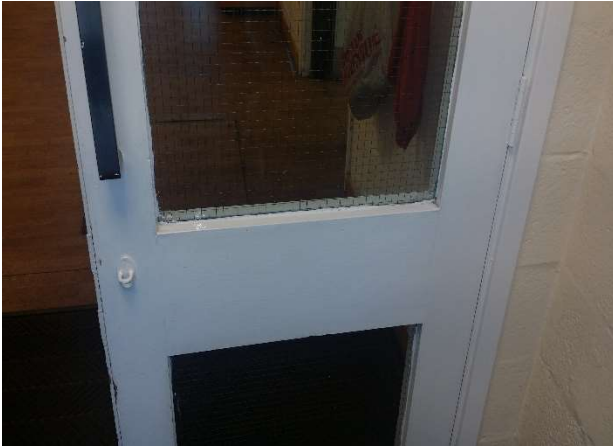
### **Item 52 Ref: 369386-16**

The mastic to fire doors in Rm 030a/Corridor lobby does not contain asbestos.

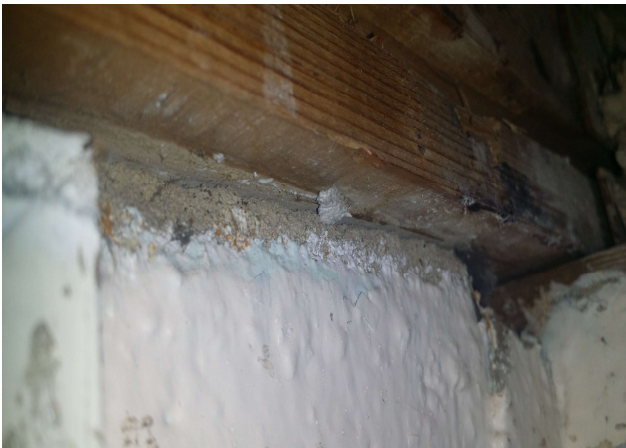
### **Item 53 Ref: 369386-18**

The residue above door frames subfloor in Rm 030a/Corridor lobby – void above contains asbestos.

Any change in its appearance should be recorded and passed to Property Services.

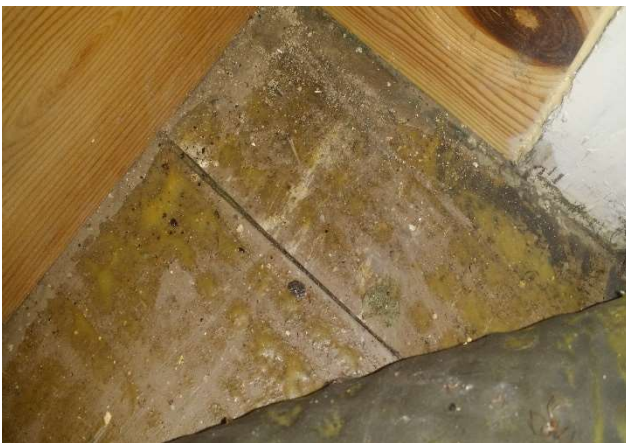
### **Item 54 Ref: As 369386-17**

The subfloor in Rm 030b/Corridor lobby contains asbestos.

Any change in its appearance should be recorded and passed to Property Services.

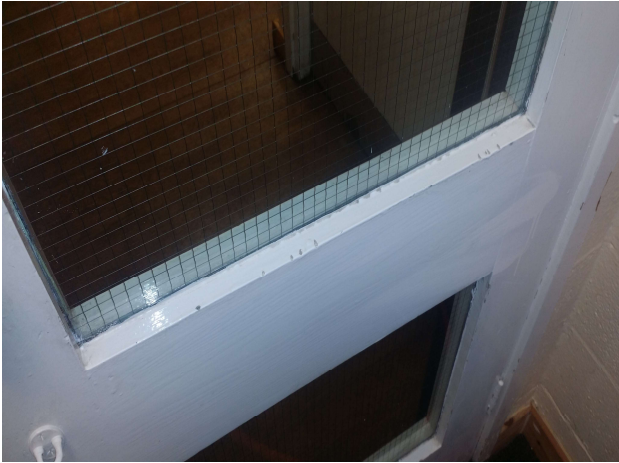
### **Item 55 Ref: As 369386-16**

The mastic to fire doors in Rm 030b/Corridor lobby does not contain asbestos

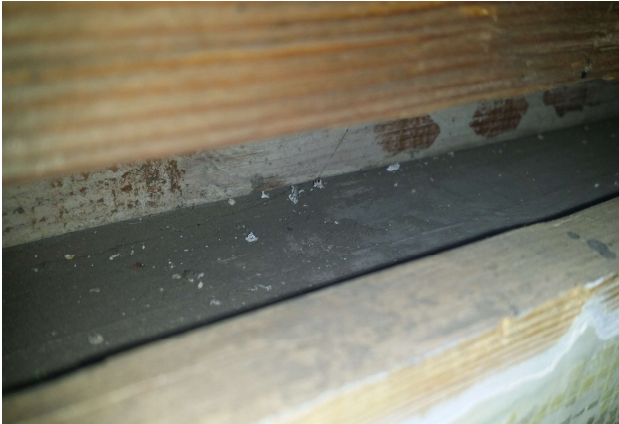
### **Item 56 Ref: 369386-19**

The debris above inner door frame in Rm 030b/Corridor lobby – void above contains asbestos.

Any change in its appearance should be recorded and passed to Property Services.

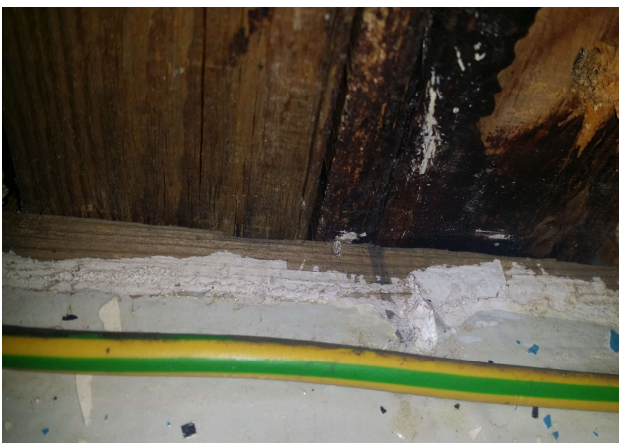
### **Item 57 Ref: 369386-20**

The residue to beam at wall to RHS of column in Rm 031/Boys toilet – void above contains asbestos.

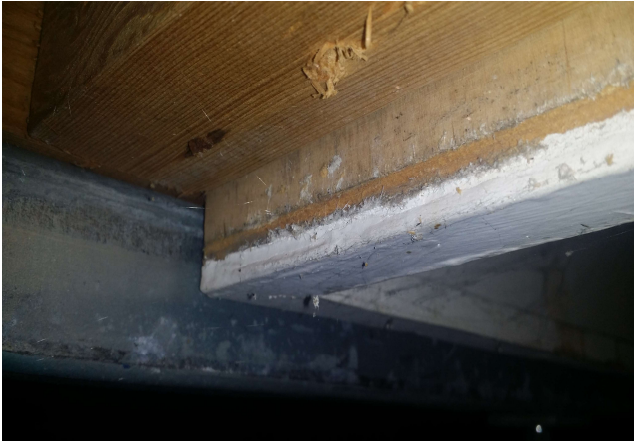
### **Item 58 Ref: 369386-21**

The residue to skylight surround in Rm 031/Boys toilet – void above contains asbestos.

Any change in its appearance should be recorded and passed to Property Services.

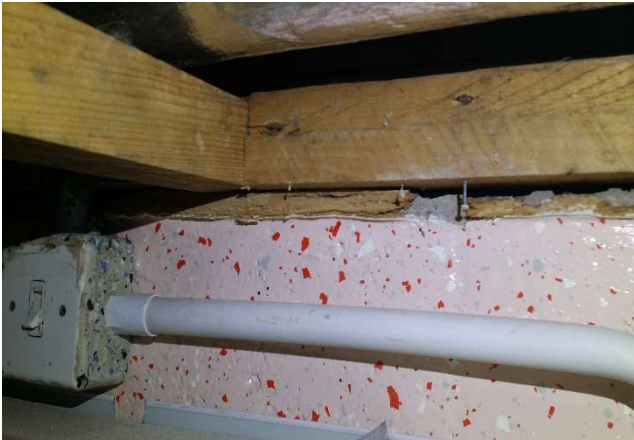
### **Item 59 Ref: 369386-22**

The remnant to ceiling to wall tops in Rm 032/Girls toilet – void above contains asbestos.

Any change in its appearance should be recorded and passed to Property Services.

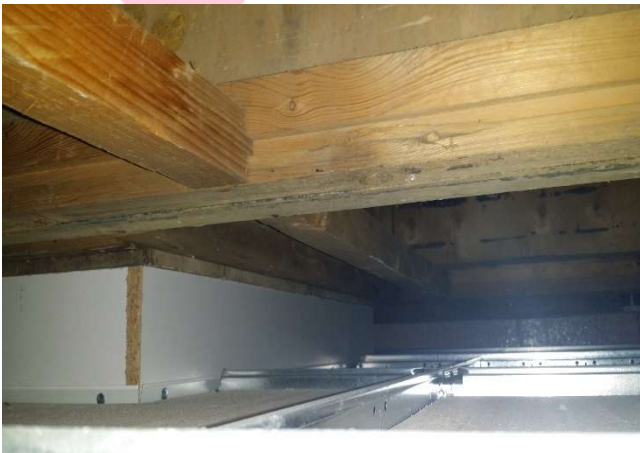
### **Item 60 Ref: 369386-23**

The residue to beams including nail holes in Rm 032/Girls toilet – void above contains asbestos.

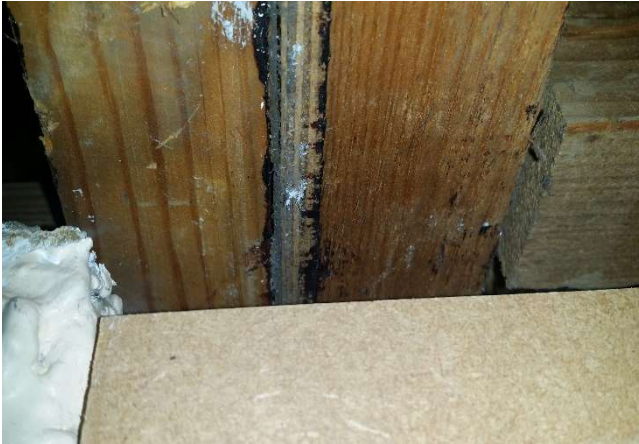
### **Item 61 Ref: As 369386-12**

The residue to beams in Rm 033/Classroom – void above contains asbestos.

Any change in its appearance should be recorded and passed to Property Services.

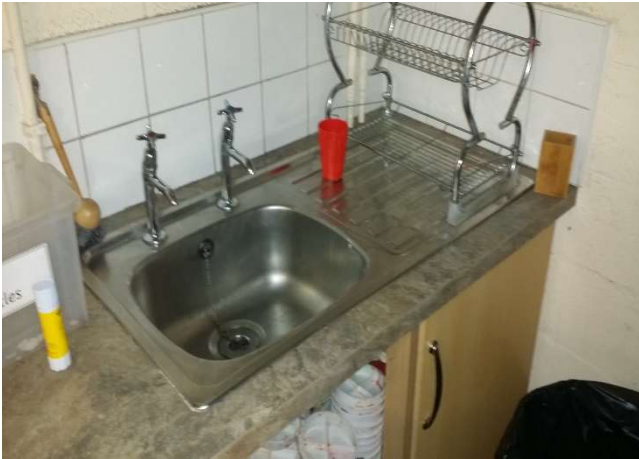
### **Item 62 Ref: 369386-7**

The sink pad in Rm 034/Classroom does not contain asbestos.

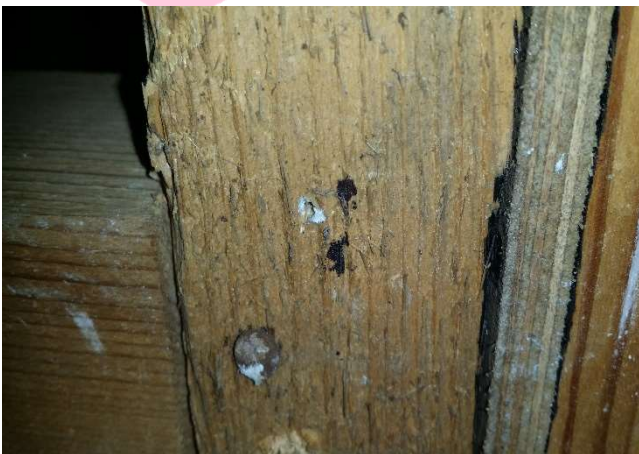
### **Item 63 Ref: 369386-8**

The residue to beams and nail holes in Rm 034/Classroom – void above contains asbestos.

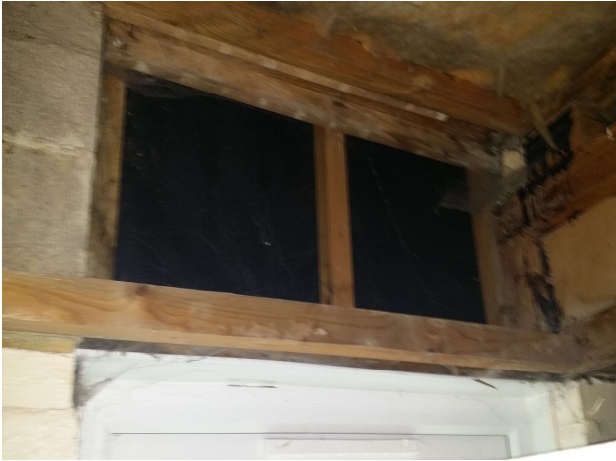
#### **Item 64 Ref: As 369386-9**

The membrane above window in Rm 034/Classroom – void above does not contain asbestos.

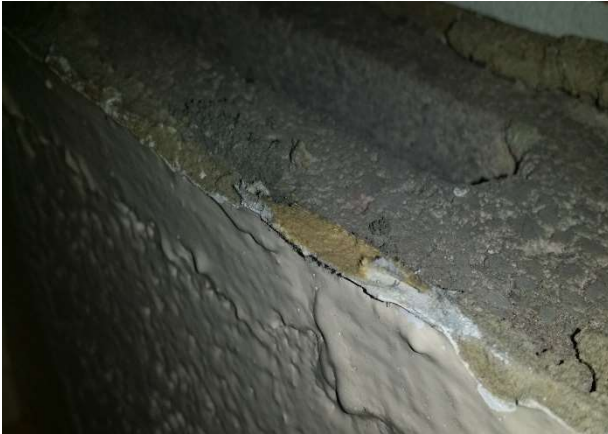
#### **Item 65 Ref: 369386-10**

The remnant fireboard to cupboard wall top at rear LHS in Rm 034/Classroom – void above contains asbestos.

Any change in its appearance should be recorded and passed to Property Services.

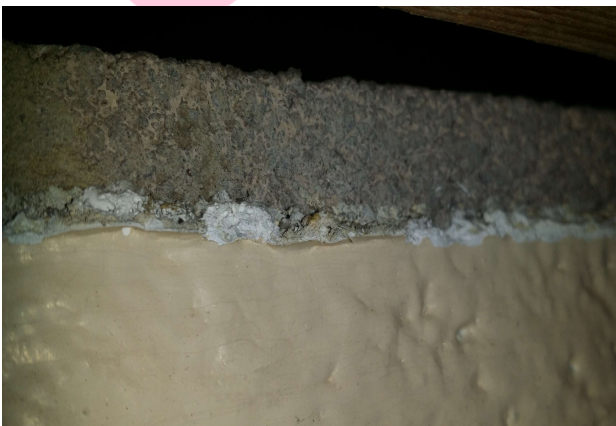
#### **Item 66 Ref: 369386-11**

The remnant fireboard to perimeter walls in Rm 034/Classroom – void above contains asbestos.

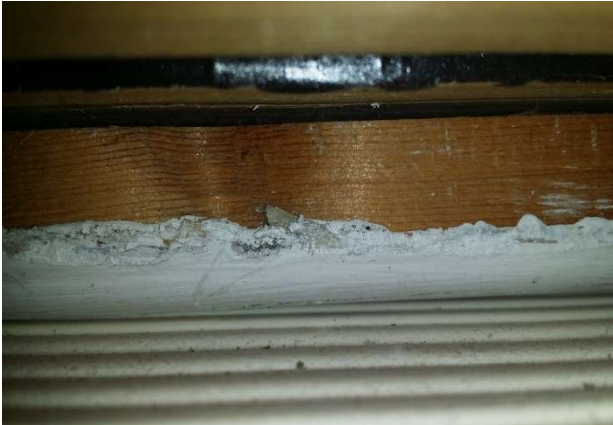
#### **Item 67 Ref: 369386-12**

The residue above windows in Rm 034/Classroom – void above contains asbestos.

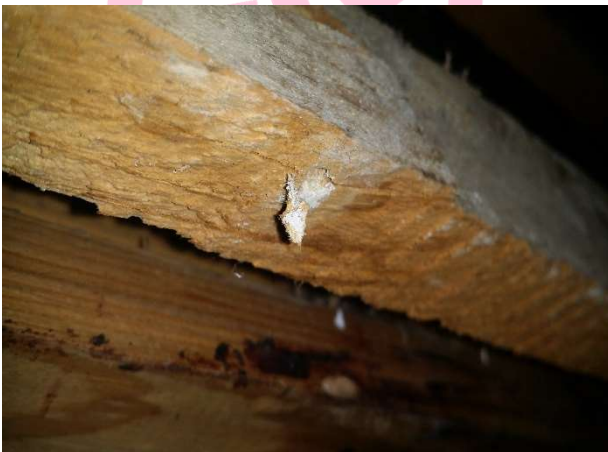
#### **Item 69 Ref: As 369386-8**

The residue to beams and nail holes in Rm 035/Classroom – void above contains asbestos.

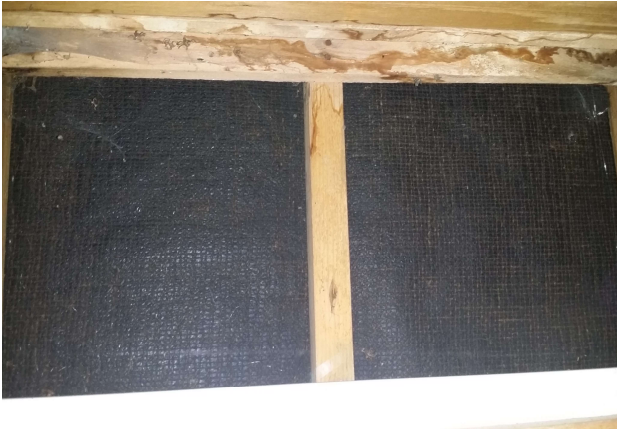
### **Item 70 Ref: As 369386-9**

The membrane above window in Rm 035/Classroom – void above does not contain asbestos.

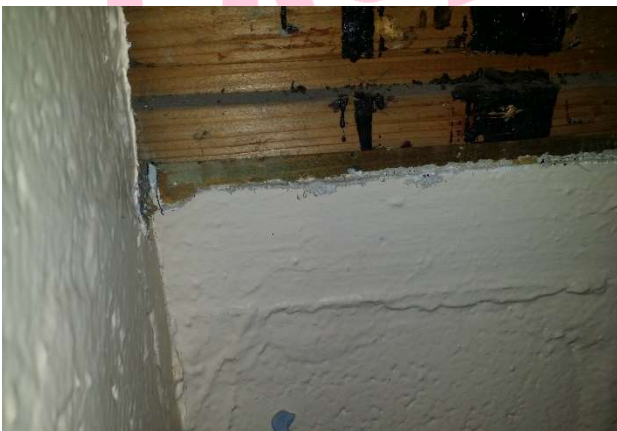
### **Item 72 Ref: 369386-14**

The remnant fibreboard ceiling above heater adj entrance door in Rm 036/Classroom – void above contains asbestos.

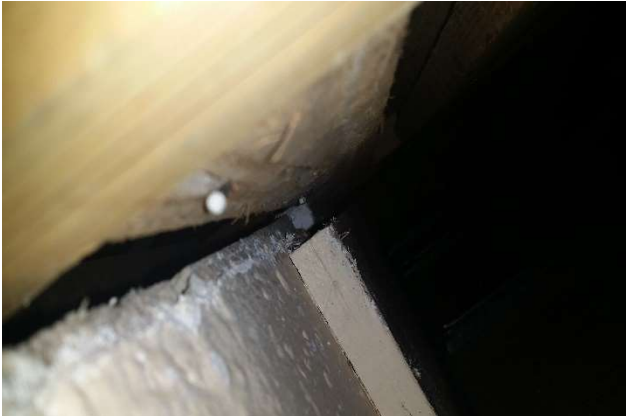
#### **Item 73 Ref: 369386-13**

The remnant fibreboard to cupboard wall tops in Rm 036/Classroom – void above contains asbestos.

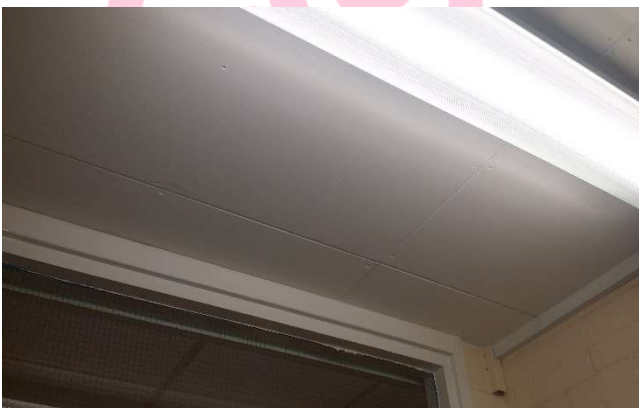
#### **Item 75 Ref: As 369386-2**

The ceiling in Rm 037a/Corridor contains asbestos.

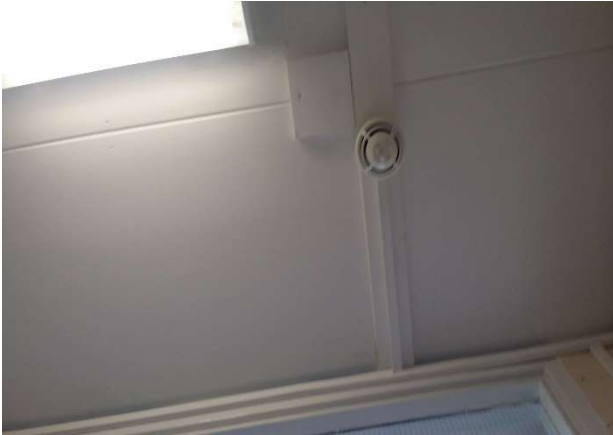
### **Item 79 Ref: 369386-2**

The ceiling in Rm 038a/Corridor lobby contains asbestos.

Any change in its appearance should be recorded and passed to Property Services.

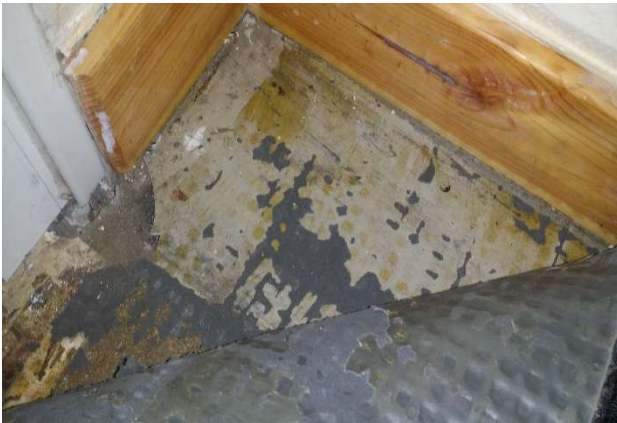
### **Item 80 Ref: 369386-3**

The subfloor in Rm 038a/Corridor lobby contains asbestos.

Any change in its appearance should be recorded and passed to Property Services.

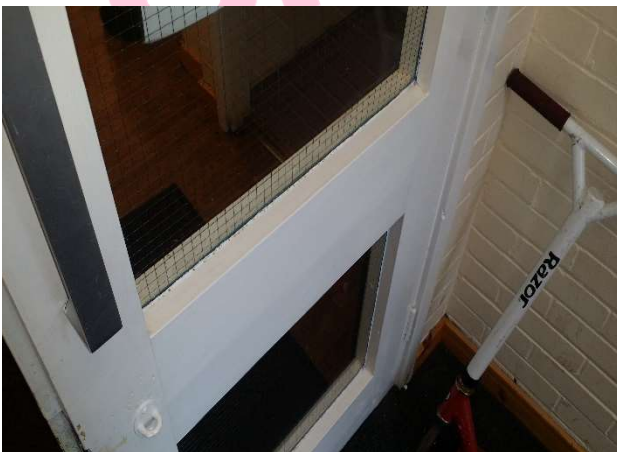
### **Item 81 Ref: As 369386-5**

The mastic to fire doors in Rm 038a/Corridor lobby contains asbestos.

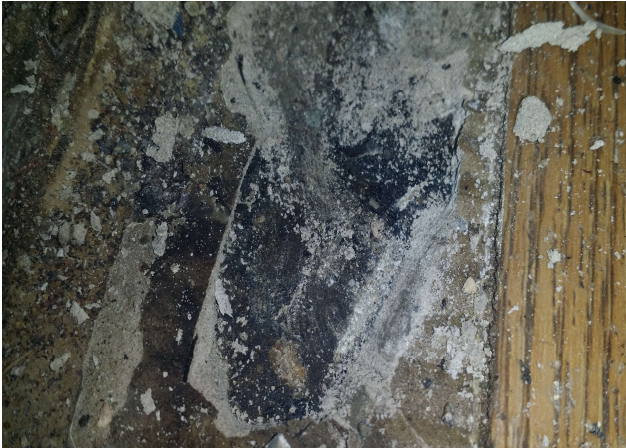
### **Item 82 Ref: 369386-59**

The remnant adhesive backing to floor in Rm 039/Classroom contains asbestos.

Any change in its appearance should be recorded and passed to Property Services.

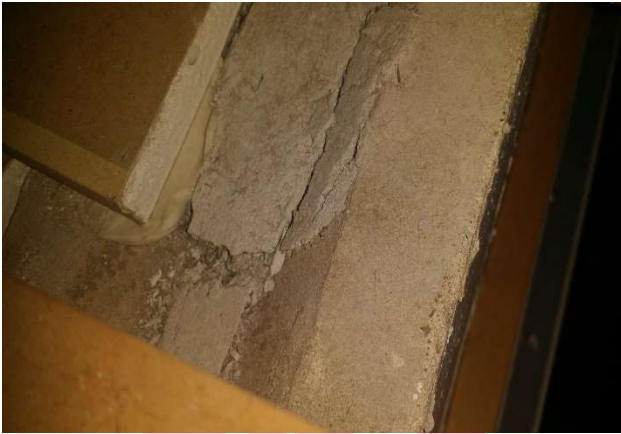
### **Item 83 Ref: 369386-60**

The debris to wall top around cupboard in Rm 039/Classroom – void above contains asbestos.

Removed August 2023

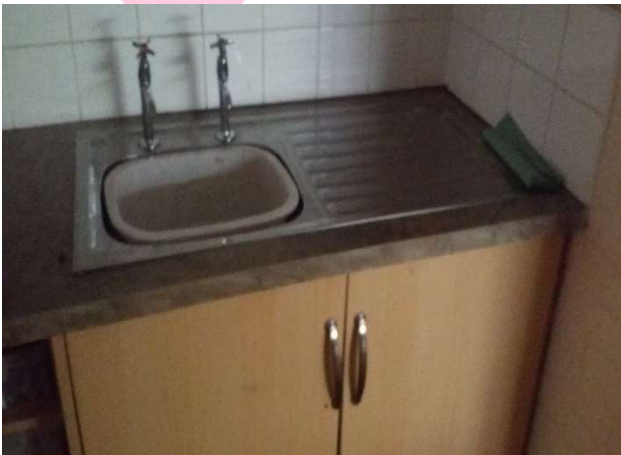
### **Item 84 Ref: 369386-1**

The sink pad in Rm 040/Classroom does not contain asbestos.

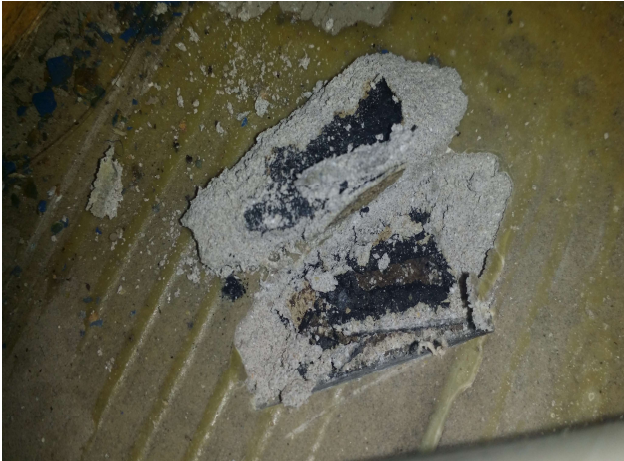
#### **Item 85 Ref: As 369386-59**

The remnant adhesive backing to floor in Rm 040/Classroom contains asbestos.

Any change in its appearance should be recorded and passed to Property Services.

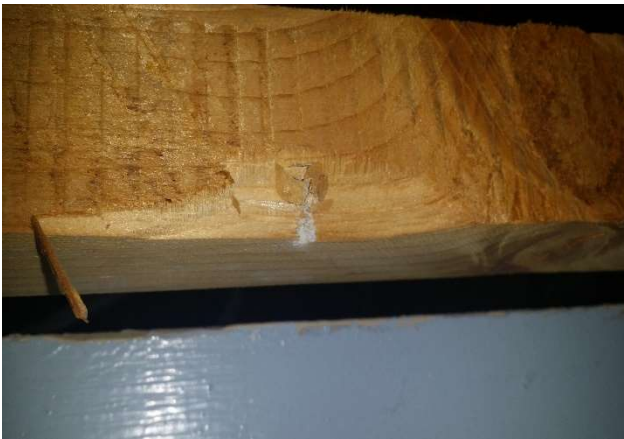
#### **Item 86 Ref: 369386-81**

The residue to beams and joists in Rm 040/Classroom – void above contains asbestos.

Removed August 2023

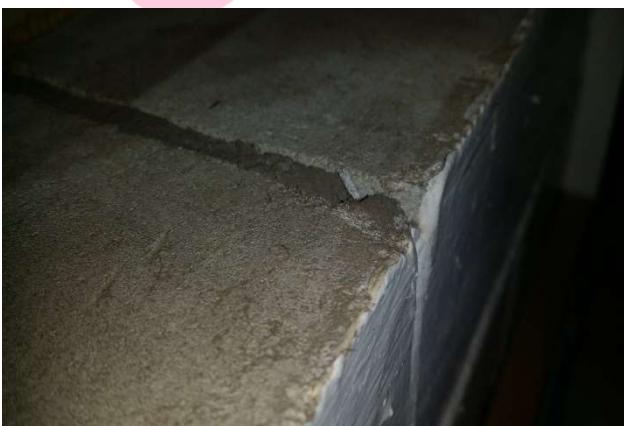
#### **Item 87 Ref: As 369386-83**

The debris to cupboard wall top in Rm 040/Classroom – void above contains asbestos.

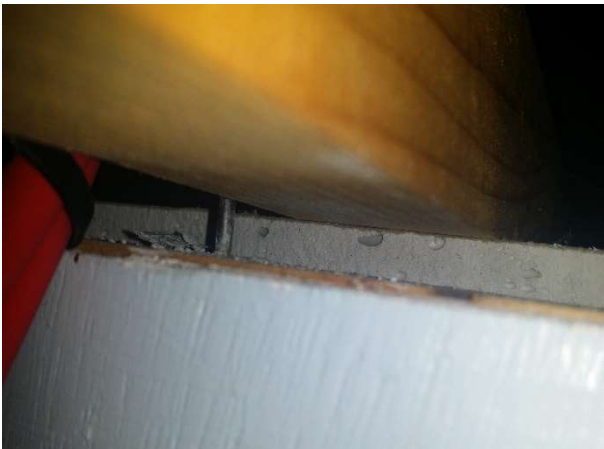
#### **Item 89 Ref: 369386-83**

The debris to wall tops around cupboards in Rm 041/Classroom – void above contains asbestos.

Removed August 2023

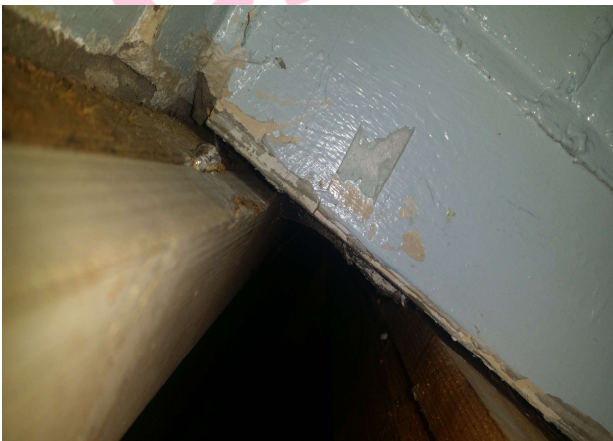
#### **Item 90 Ref: As 369386-83**

The debris to wall top above reading area in Rm 041/Classroom – void above contains asbestos.

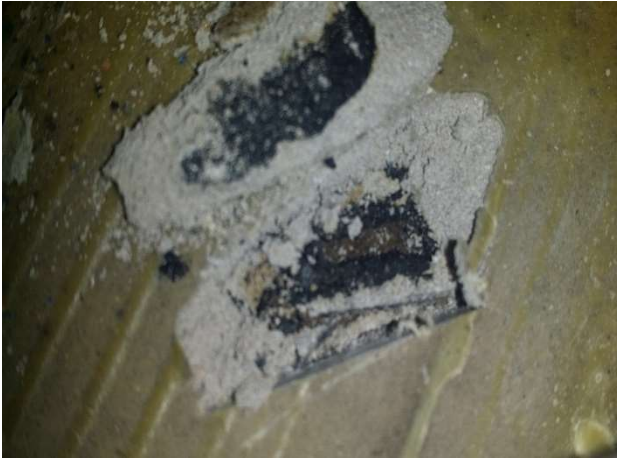
### **Item 91 Ref: As 369386-59**

The remnant adhesive backing to floor in Rm 042/Classroom contains asbestos.

Any change in its appearance should be recorded and passed to Property Services.

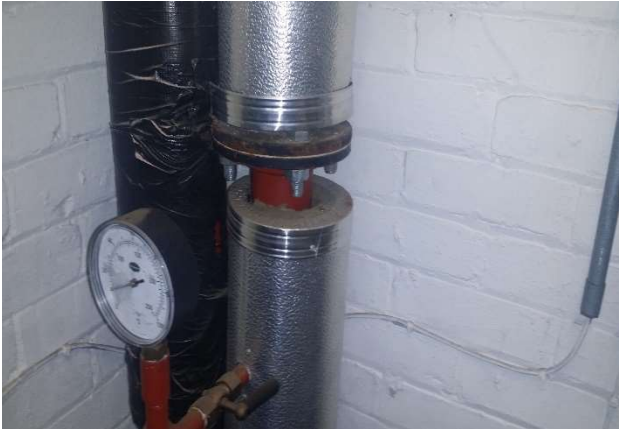
**Item 94 Ref: 369386-53**

The gaskets to pipework in Rm 043/Boiler Room does not contain asbestos.

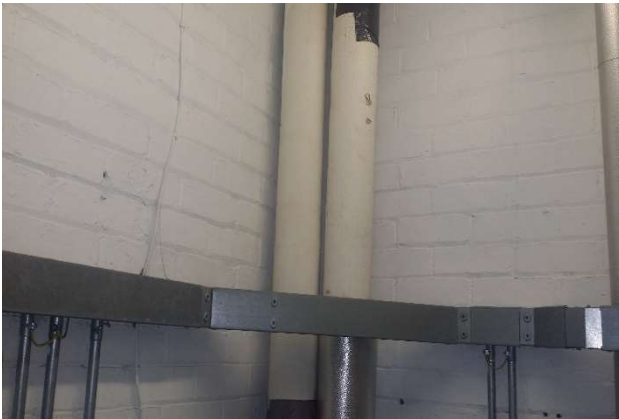
**Item 95 Ref: 369386-54**

The pipe lagging in Rm 043/Boiler Room does not contain asbestos.

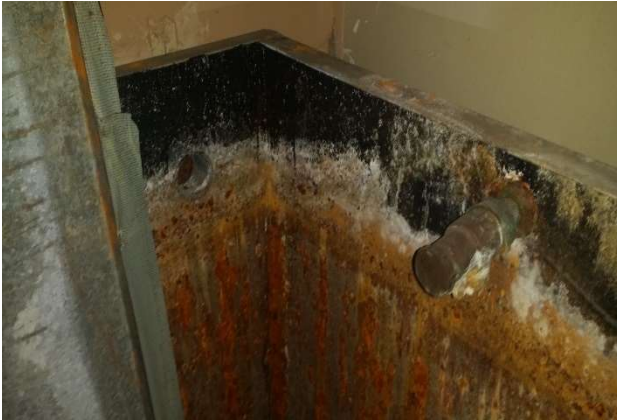
#### **Item 97 Ref: 369386-57**

The paint to metal tanks in Rm 043/Boiler Room – void above does not contain asbestos.

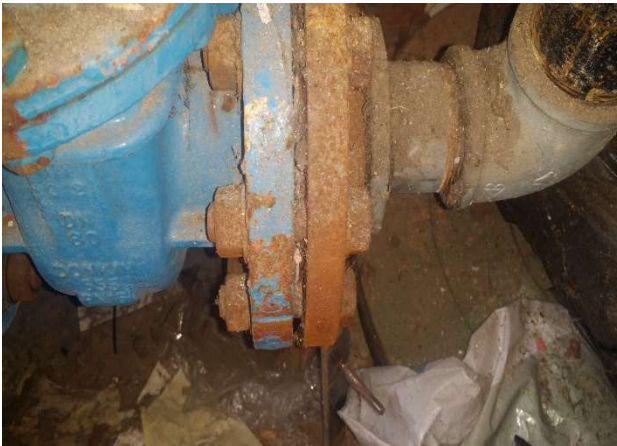
#### **Item 98 Ref: 369386-52**

The gasket to pipework in Rm 043a/Gas Meter Room does not contain asbestos.
