ASBESTOS SURVEY REPORT FOR ALBANY PRIMARY SCHOOL, CROSSGILL, WASHINGTON, NE37 1UA.

Asbestos Register for Albany Primary School, Crossgill, Washington

Date: 13 February 2025

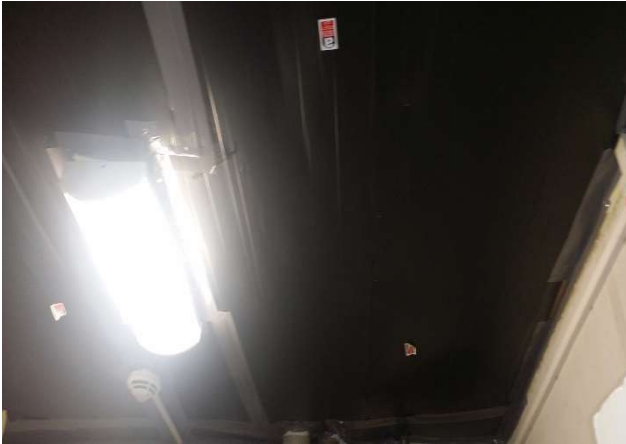
Item 31 Ref: Presumed

The ceiling in Rm 020/Cleaners Store contains asbestos.

Any change in its appearance should be recorded and passed to Property Services.

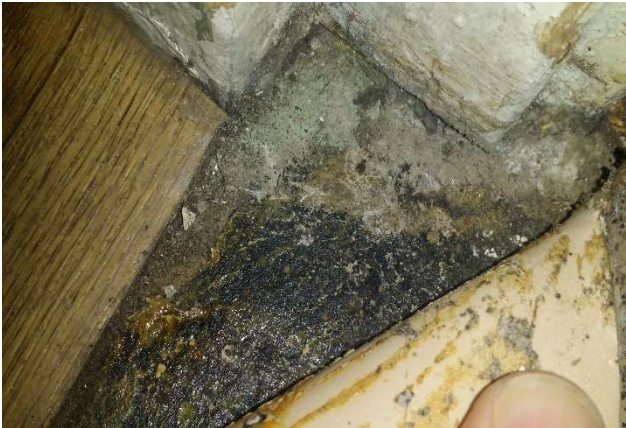
Item 32 Ref: As 369386-30

The remnant adhesive backing to floor in Rm 020/Cleaners Store contains asbestos.

Any change in its appearance should be recorded and passed to Property Services.

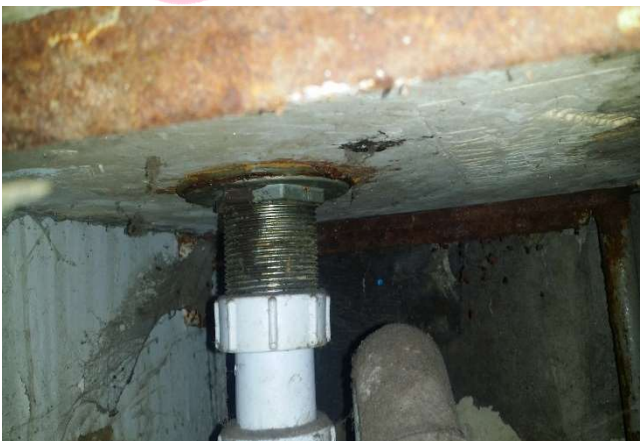
Item 33 Ref: 369386-43

The mastic to soil pipe at basin in Rm 020/Cleaners Store does not contain asbestos.

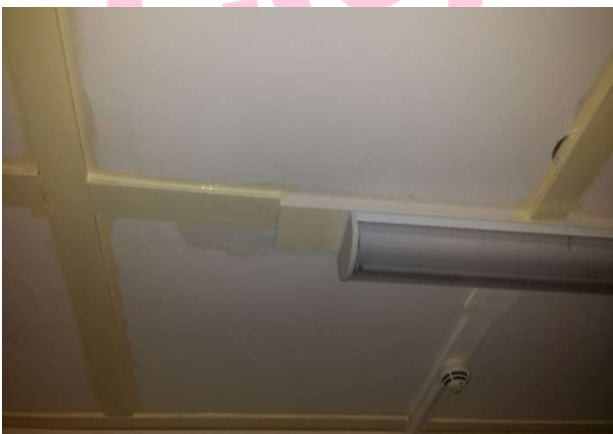
Item 36 Ref: 369386-49

The ceiling in Rm 022/Hall Store contains asbestos.

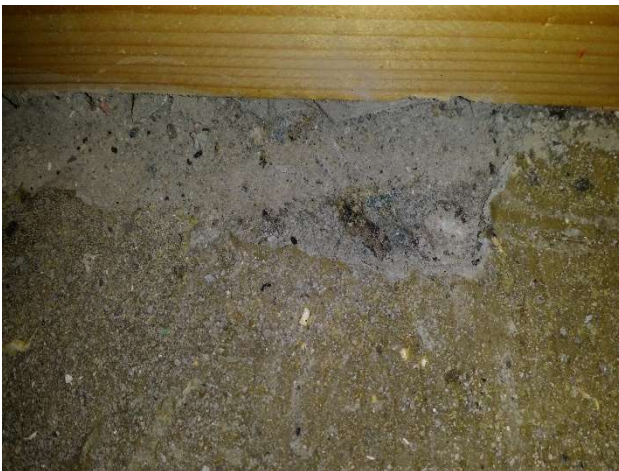
Item 39 Ref: 369386-90

The adhesive backing to floor in Rm 024/Classroom contains asbestos.

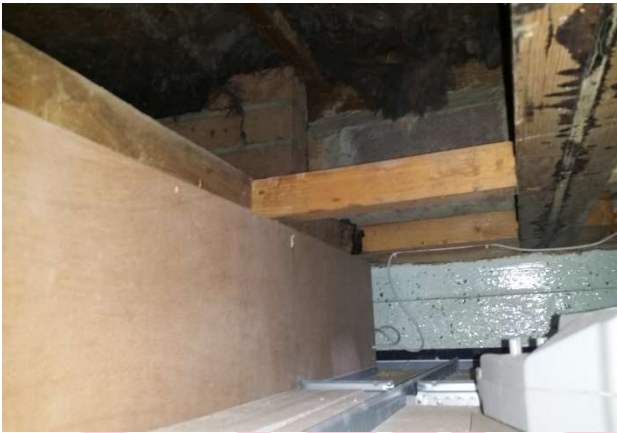
Item 41 Ref: 369386-92

The packing to joists in Rm 024/Classroom – void above does not contain asbestos.

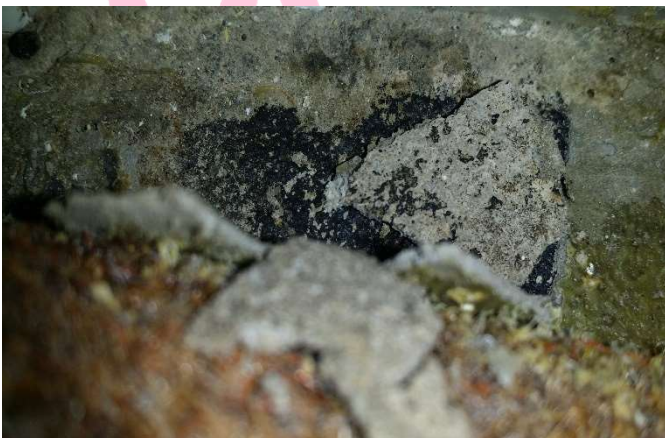
Item 42 Ref: As 369386-90

The remnant adhesive backing to floor in Rm 024a/Lobby contains asbestos.

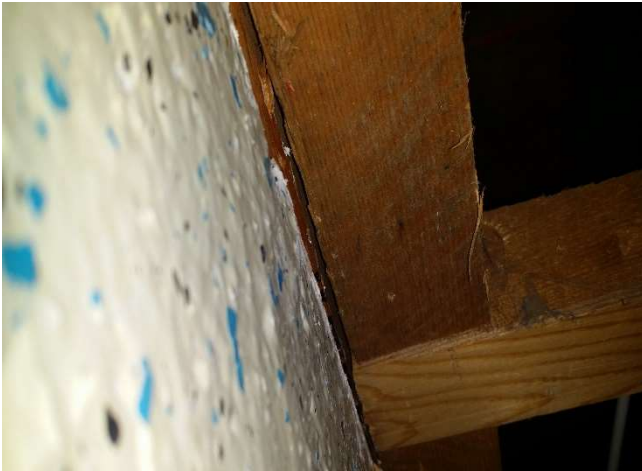
Item 43 Ref: 369386-105

The residue to joists in Rm 025a/WC – void above contains asbestos.

Any change in its appearance should be recorded and passed to Property Services.

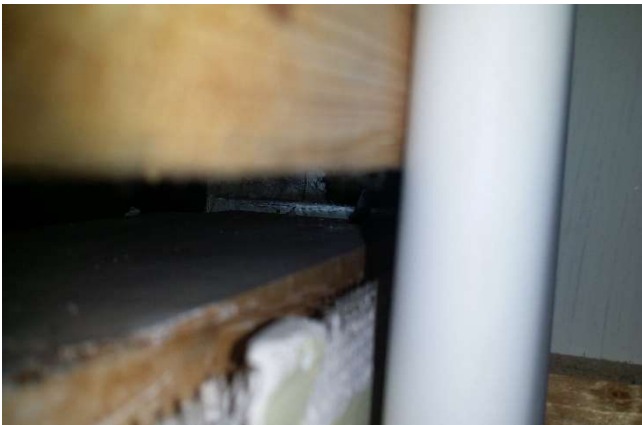
Item 44 Ref: 369386-94

The remnant ceiling in Rm 026a/Baby changing – void above contains asbestos.

Any change in its appearance should be recorded and passed to Property Services.

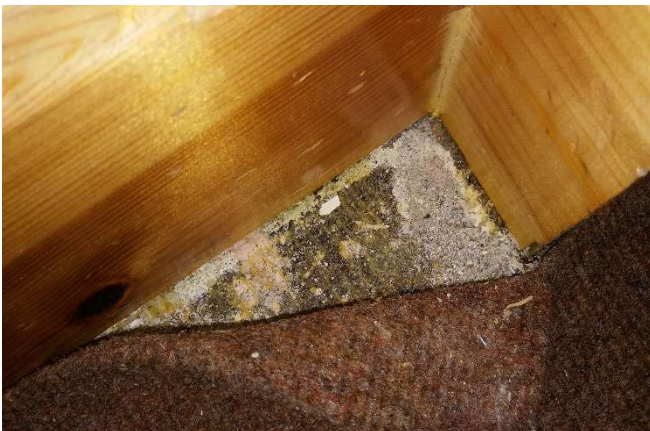
Item 45 Ref: As 369386-90

The remnant adhesive to floor under carpet in Rm 026b/Classroom contains asbestos.

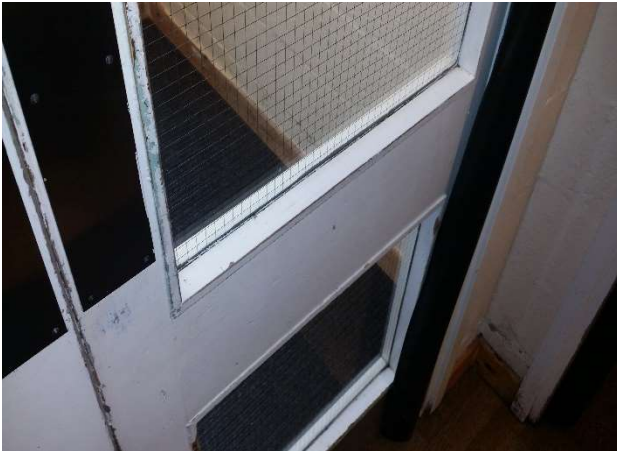
Item 47 Ref: As 369386-5

The mastic to fire doors in Rm 030/Cloakroom contains asbestos.

Any change in its appearance should be recorded and passed to Property Services.

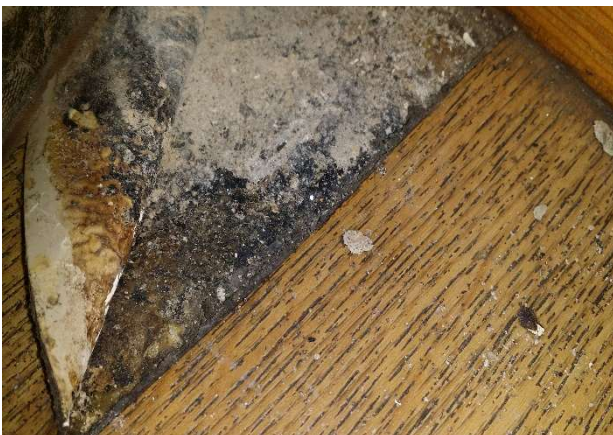
Item 48 Ref: 369386-25

The remnant adhesive backing to floor in Rm 030/Cloakroom contains asbestos.

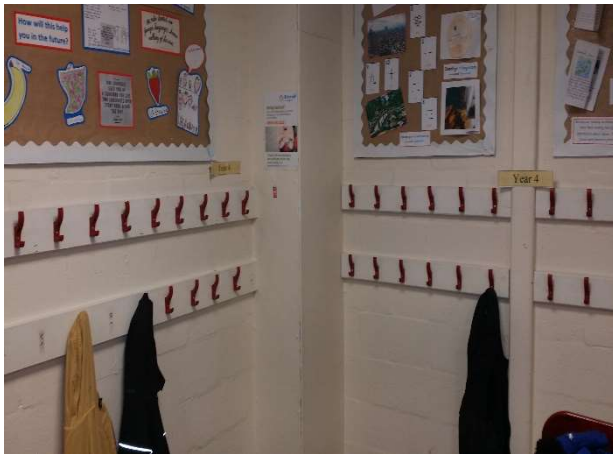
Item 49 Ref: As 369386-24

The boxing to LHS and RHS of entrance doors in Rm 030/Cloakroom contains asbestos.

Any change in its appearance should be recorded and passed to Property Services.

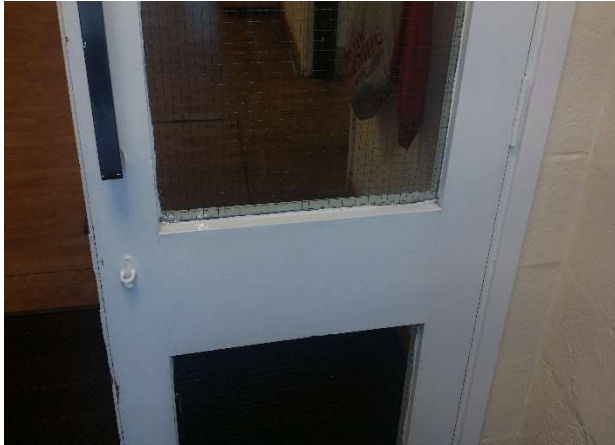
Item 52 Ref: 369386-16

The mastic to fire doors in Rm 030a/Corridor lobby does not contain asbestos.

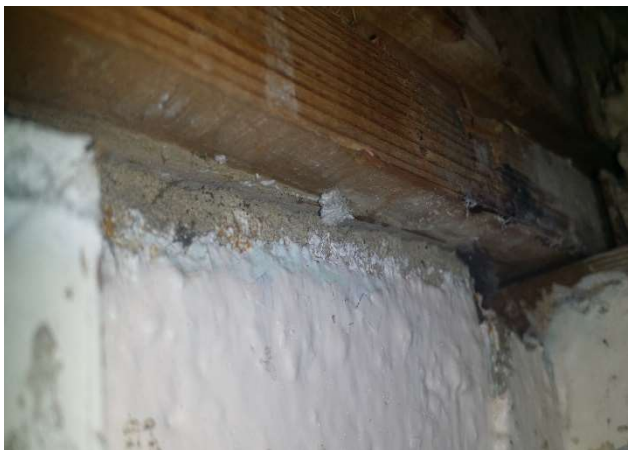
Item 53 Ref: 369386-18

The residue above door frames subfloor in Rm 030a/Corridor lobby – void above contains asbestos.

Any change in its appearance should be recorded and passed to Property Services.

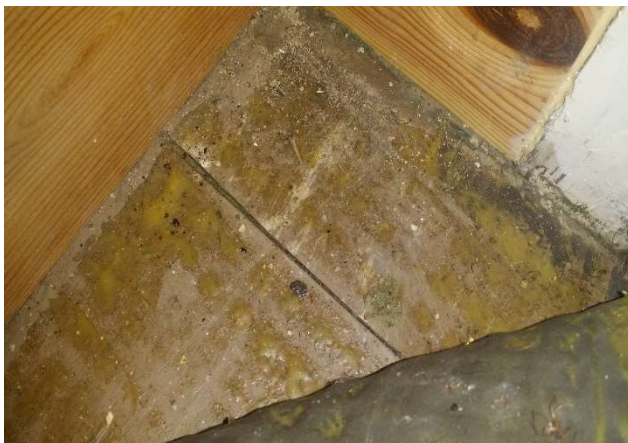
Item 54 Ref: As 369386-17

The subfloor in Rm 030b/Corridor lobby contains asbestos.

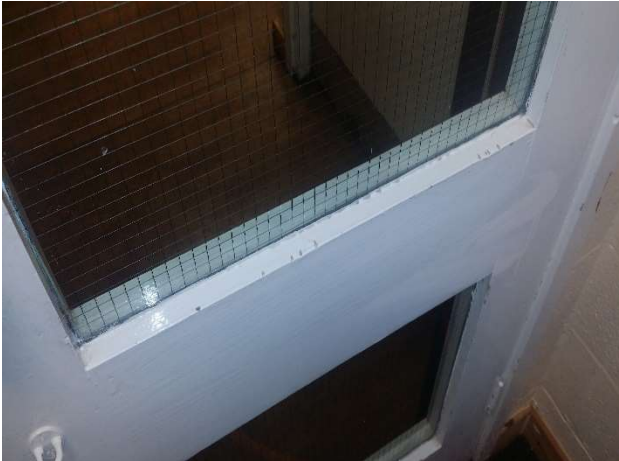
Item 55 Ref: As 369386-16

The mastic to fire doors in Rm 030b/Corridor lobby does not contain asbestos

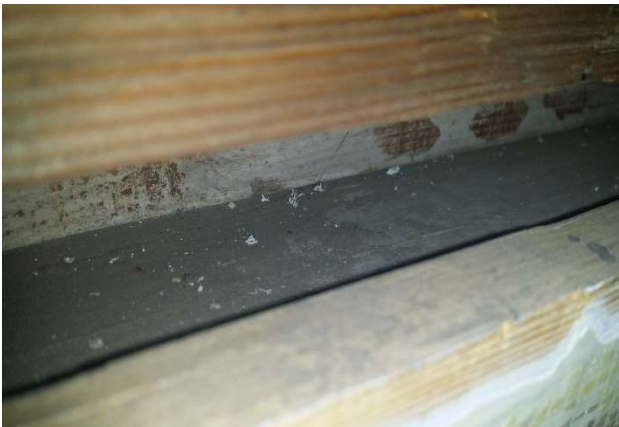
Item 56 Ref: 369386-19

The debris above inner door frame in Rm 030b/Corridor lobby – void above contains asbestos.

Any change in its appearance should be recorded and passed to Property Services.

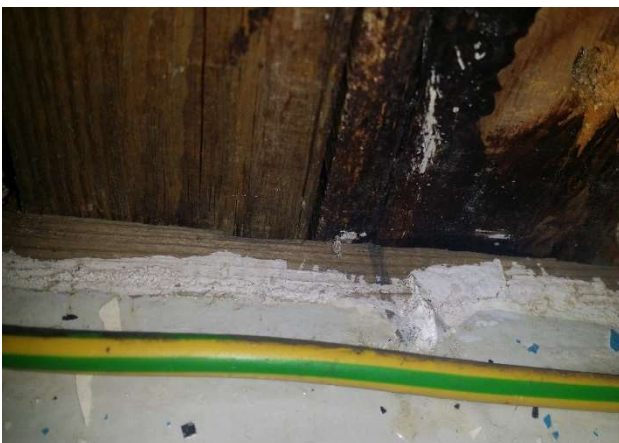
Item 57 Ref: 369386-20

The residue to beam at wall to RHS of column in Rm 031/Boys toilet – void above contains asbestos.

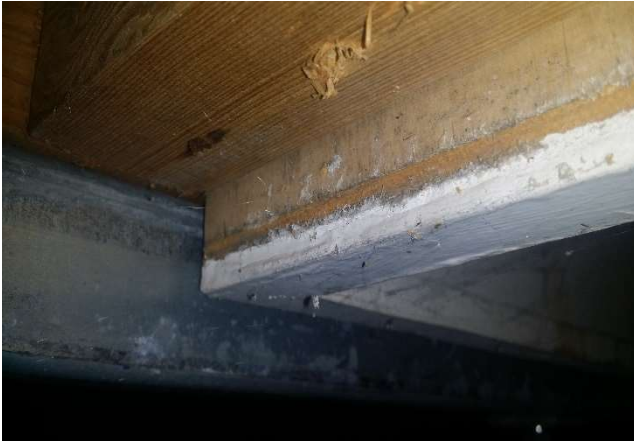
Item 58 Ref: 369386-21

The residue to skylight surround in Rm 031/Boys toilet – void above contains asbestos.

Any change in its appearance should be recorded and passed to Property Services.

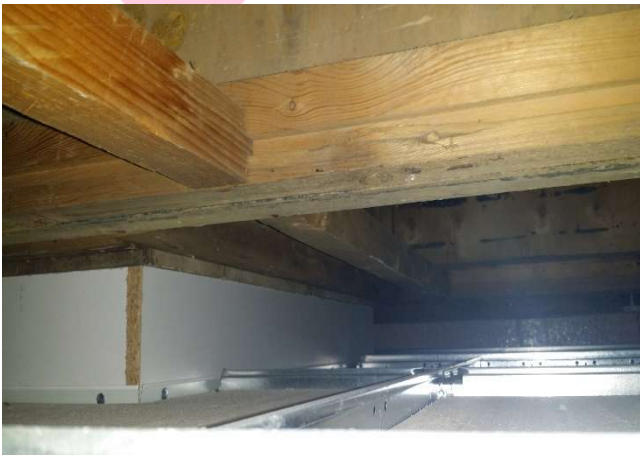
Item 60 Ref: 369386-23

The residue to beams including nail holes in Rm 032/Girls toilet – void above contains asbestos.

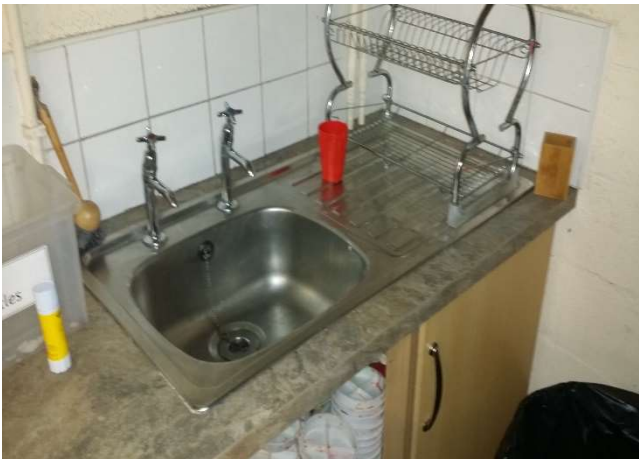
Item 62 Ref: 369386-7

The sink pad in Rm 034/Classroom does not contain asbestos.

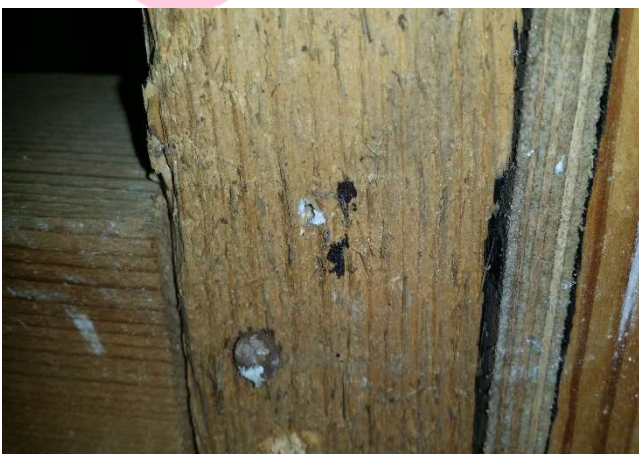
Item 63 Ref: 369386-8

The residue to beams and nail holes in Rm 034/Classroom – void above contains asbestos.

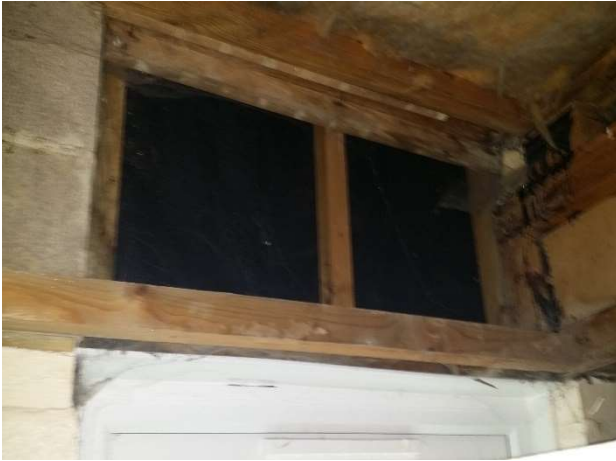
Item 64 Ref: As 369386-9

The membrane above window in Rm 034/Classroom – void above does not contain asbestos.

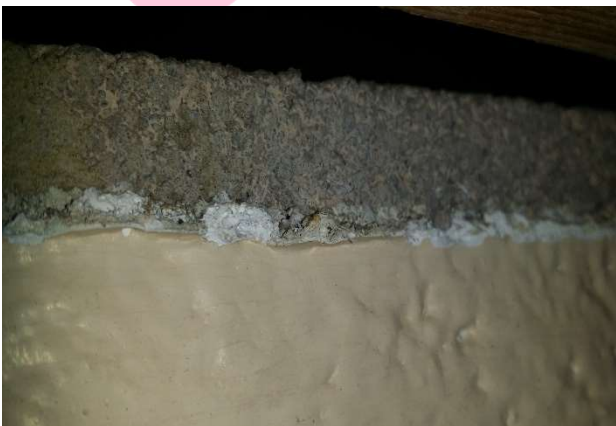
Item 66 Ref: 369386-11

The remnant fireboard to perimeter walls in Rm 034/Classroom – void above contains asbestos.

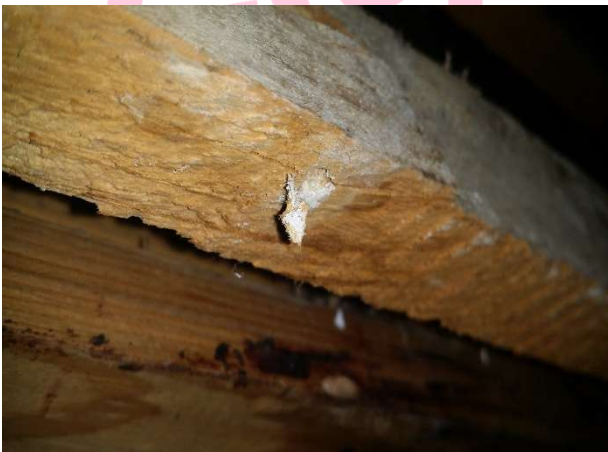
Item 69 Ref: As 369386-8

The residue to beams and nail holes in Rm 035/Classroom – void above contains asbestos.

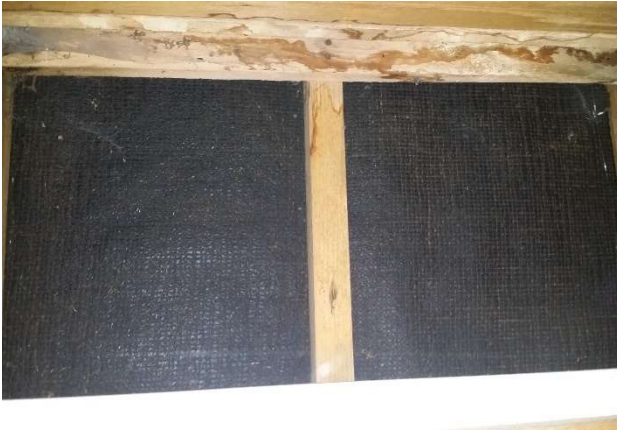
Item 70 Ref: As 369386-9

The membrane above window in Rm 035/Classroom – void above does not contain asbestos.

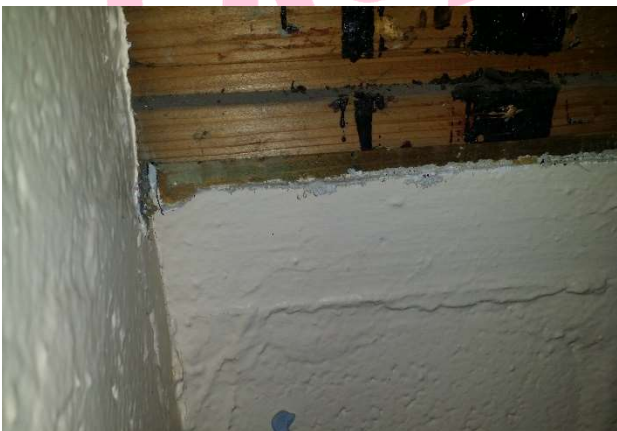
Item 72 Ref: 369386-14

The remnant fibreboard ceiling above heater adj entrance door in Rm 036/Classroom – void above contains asbestos.

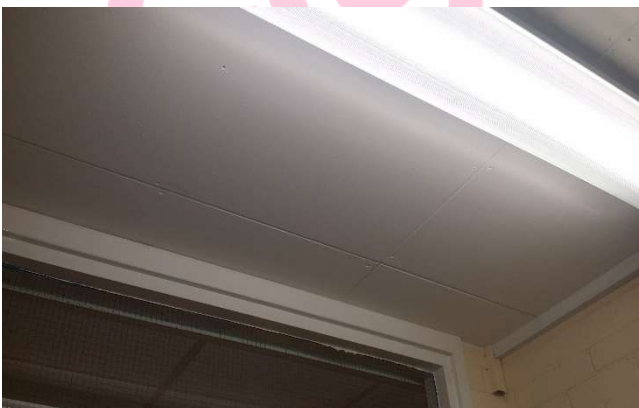
Item 75 Ref: As 369386-2

The ceiling in Rm 037a/Corridor contains asbestos.

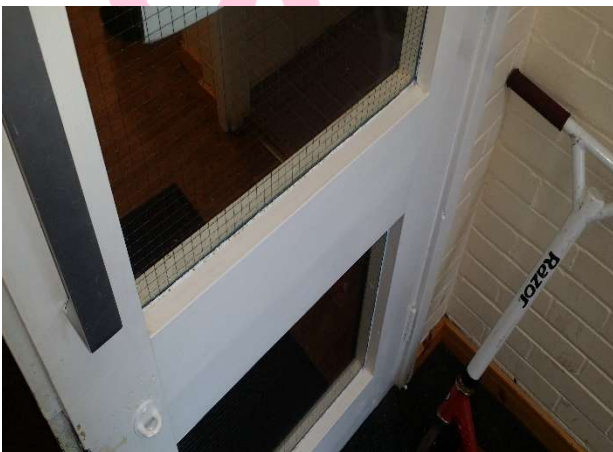
Item 81 Ref: As 369386-5

The mastic to fire doors in Rm 038a/Corridor lobby contains asbestos.

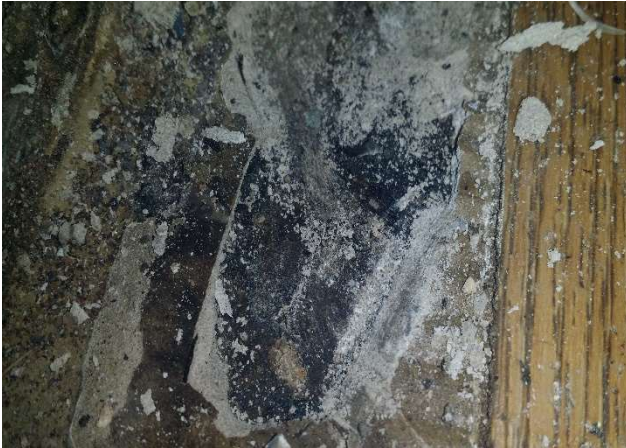
Item 82 Ref: 369386-59

The remnant adhesive backing to floor in Rm 039/Classroom contains asbestos.

Any change in its appearance should be recorded and passed to Property Services.

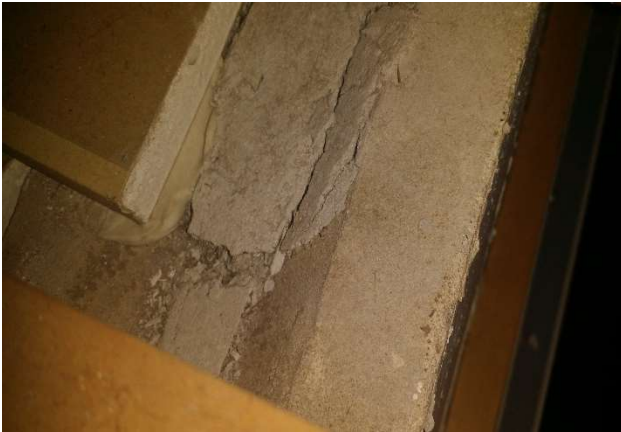
Item 83 Ref: 369386-60

The debris to wall top around cupboard in Rm 039/Classroom – void above contains asbestos.

Removed August 2023

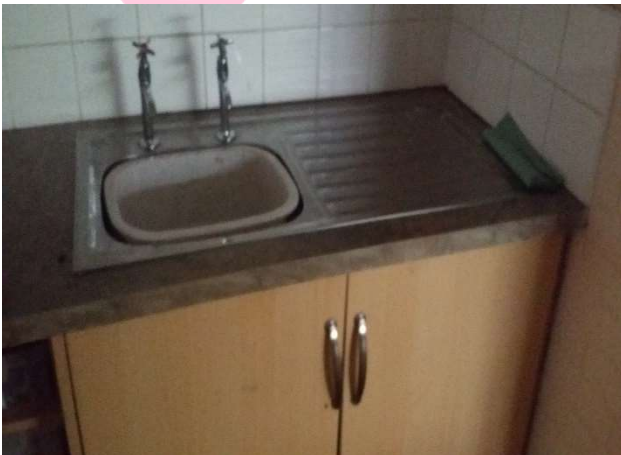
Item 84 Ref: 369386-1

The sink pad in Rm 040/Classroom does not contain asbestos.

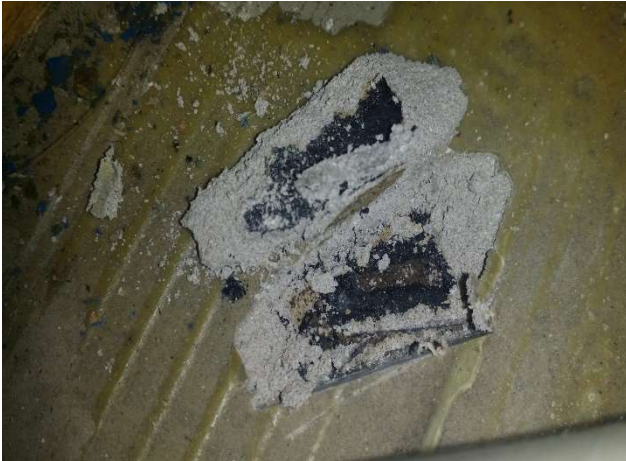
Item 85 Ref: As 369386-59

The remnant adhesive backing to floor in Rm 040/Classroom contains asbestos.

Any change in its appearance should be recorded and passed to Property Services.

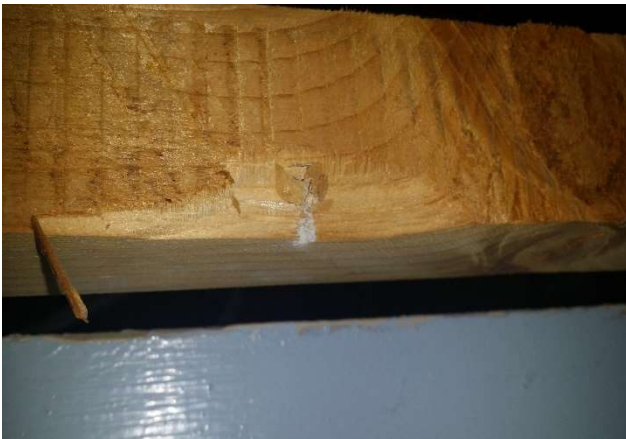
Item 86 Ref: 369386-81

The residue to beams and joists in Rm 040/Classroom – void above contains asbestos.

Removed August 2023

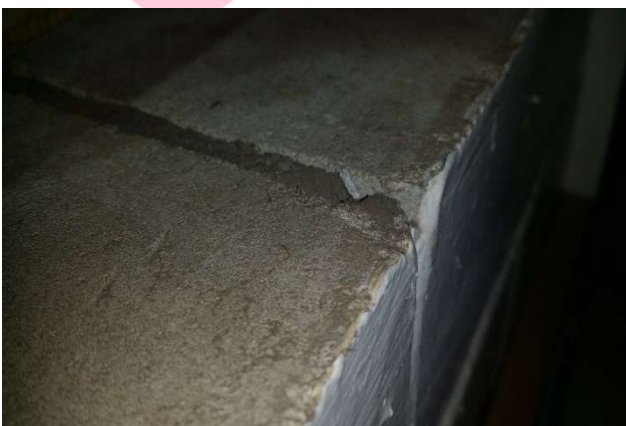
Item 87 Ref: As 369386-83

The debris to cupboard wall top in Rm 040/Classroom – void above contains asbestos.

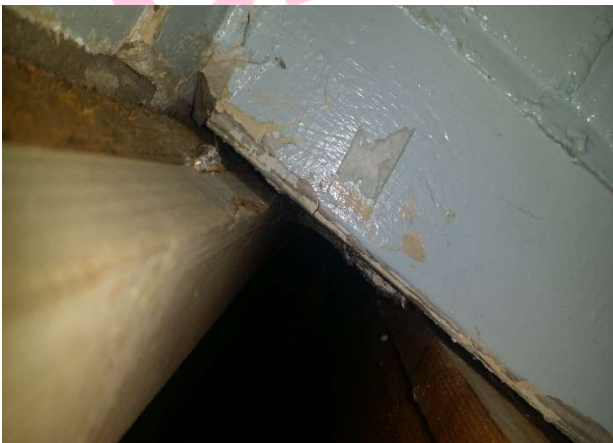
Item 90 Ref: As 369386-83

The debris to wall top above reading area in Rm 041/Classroom – void above contains asbestos.

Removed August 2023

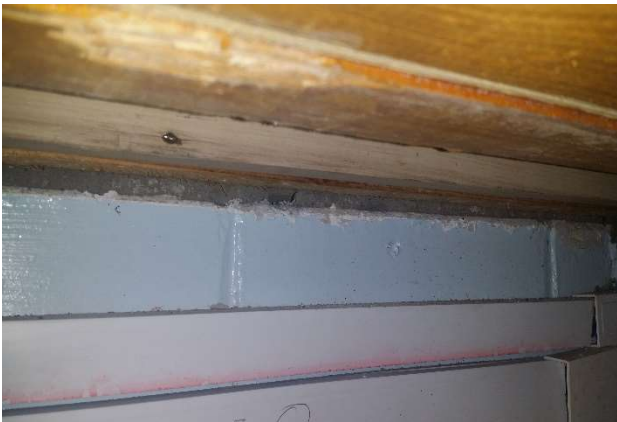
Item 92 Ref: 369386-82

The debris to perimeter wall in Rm 042/Classroom – void above contains asbestos.

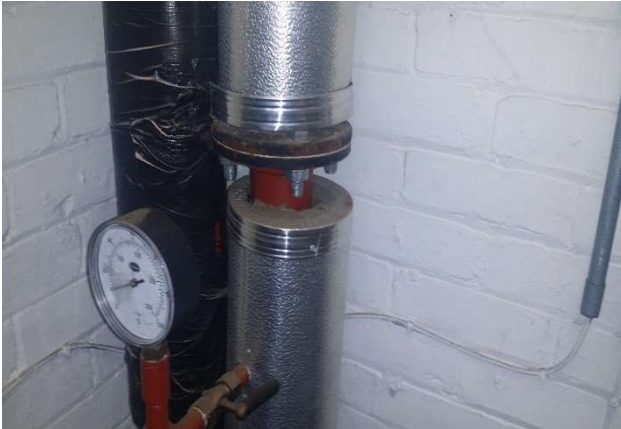
Item 94 Ref: 369386-53

The gaskets to pipework in Rm 043/Boiler Room does not contain asbestos.

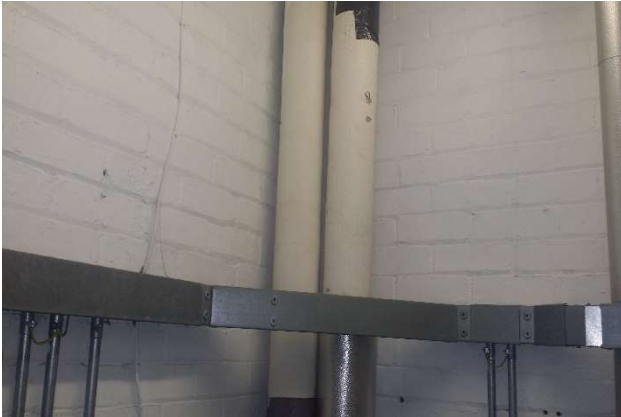
Item 95 Ref: 369386-54

The pipe lagging in Rm 043/Boiler Room does not contain asbestos.

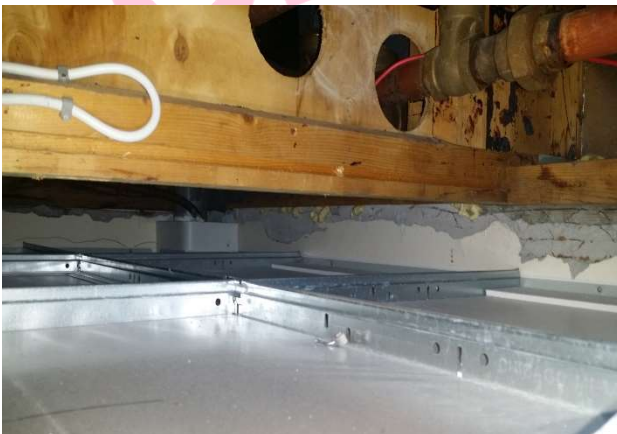
Item 99 Ref: Presumed

The debris to wall gap in Rm 044/Boys Toilet – void above contains asbestos.

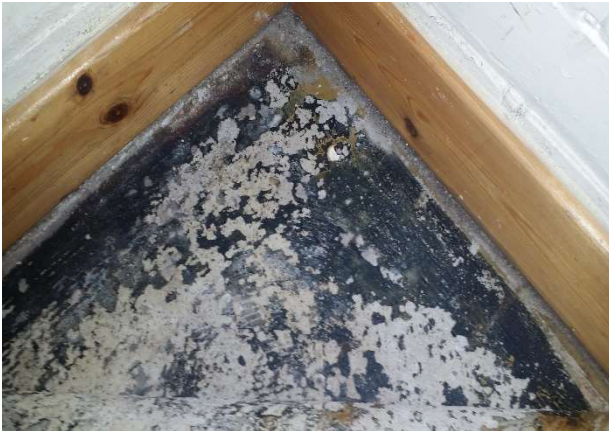
Item 101 Ref: 369386-85

The remnant adhesive backing to floor in Rm 047/Hall contains asbestos.

Any change in its appearance should be recorded and passed to Property Services.

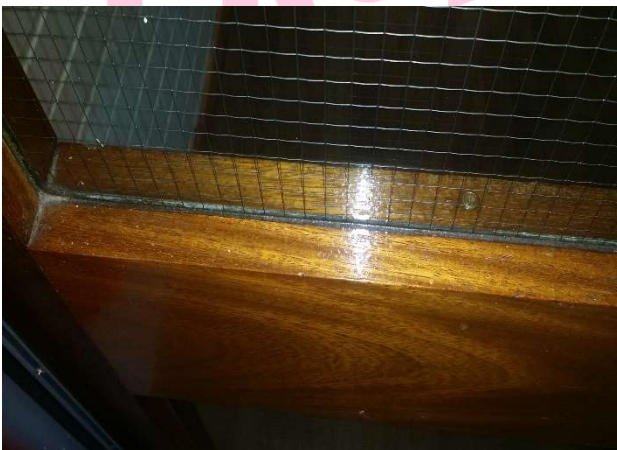
Item 102 Ref: 369386-84

- (Item 102) Ref: 369386-84 – Mastic to glazing at doors (047/Hall) – No Risk
- (Item 103) Ref: 369386-86 - Underside to roof to hall (047/Hall) -No Risk

The mastic to glazing at doors in Rm 047/Hall does not contain asbestos.

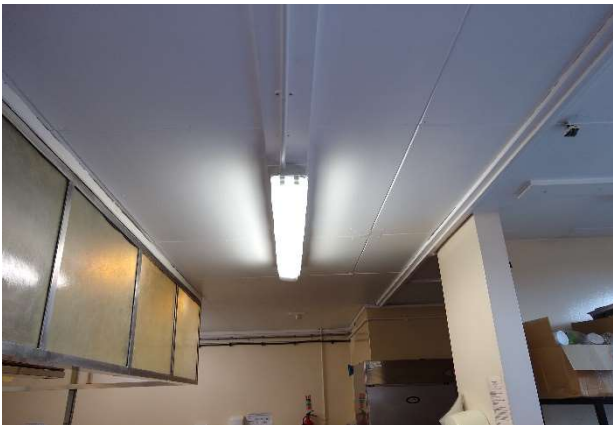
Item 104 Ref: 369386-74

The fixed ceiling tiles in Rm 048/Kitchen contains asbestos.

Any change in its appearance should be recorded and passed to Property Services.

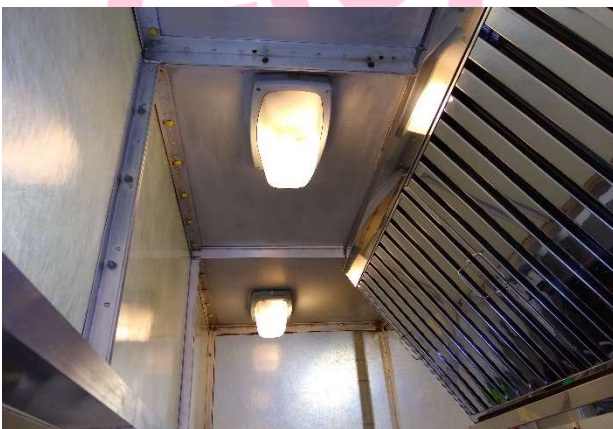
Item 105 Ref: 369386-73

The sealant to lights within extraction bulkhead in Rm 048/Kitchen contains asbestos.

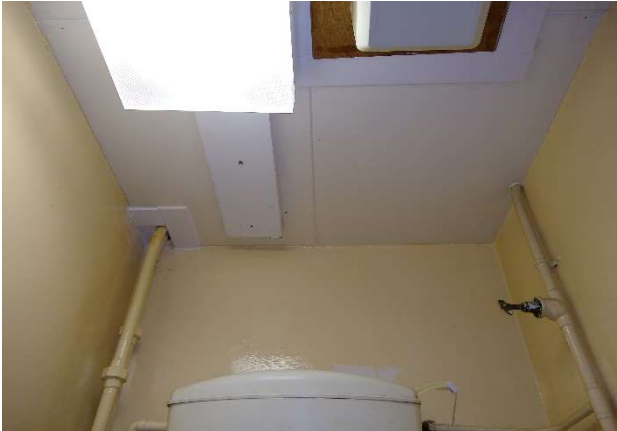
Item 109 Ref: 369386-61

The fixed ceiling tiles in Rm 048b/Kitchen Toilet contains asbestos.

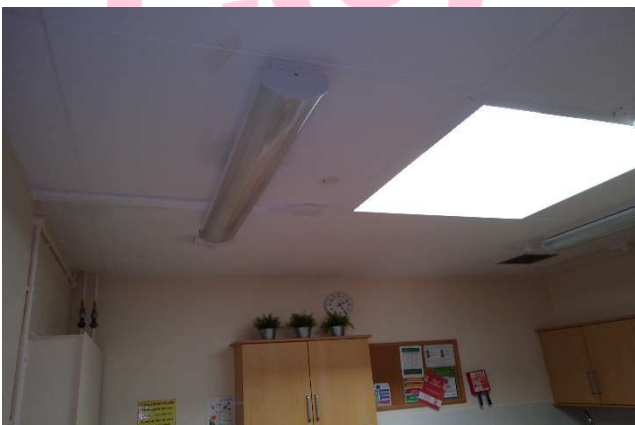
Item 111 Ref: 369386-68

The fixed ceiling tiles in Rm 050/Breakfast Room contains asbestos.

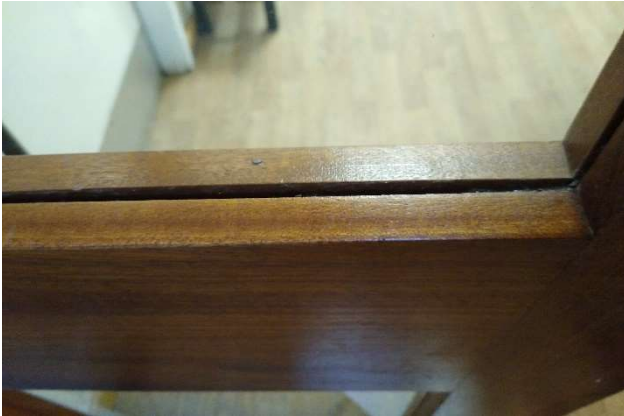
Item 115 Ref: As 369386-84

The sealant to doors in Rm 051/Corridor does not contain asbestos.
