ASBESTOS SURVEY REPORT FOR KEPIER ACADEMY, DAIRY LANE,
HOUGHTON LE SPRING, DH5 9JZ

Asbestos Register for

Kepier Academy School

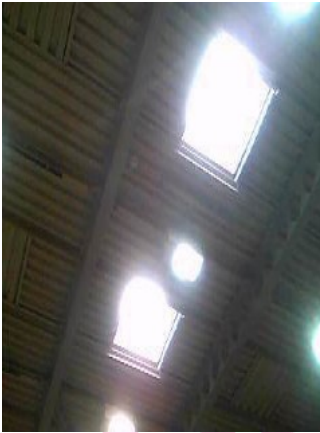
Item 2 – Presumed

- (Item 1) Ref: Presumed – Packing to clasp columns (Sports Building) (R197) – Low Risk
- (Item 2) Ref: Presumed – Skylight Fascia (Sports Building) (R206) – Medium Risk

The skylight fascia in R206 is presumed to contain asbestos. (Due to inaccessible due to height)

Any change in its appearance should be noted and reported to Property Services.

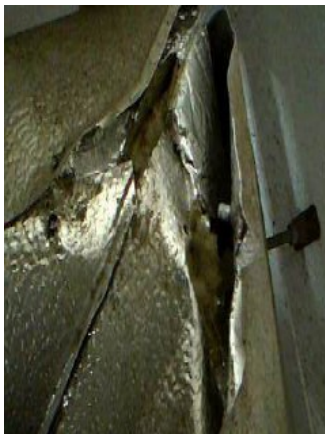
Item 3 – Ref: BB003120

The pipe insulation in R219 does not contain asbestos.

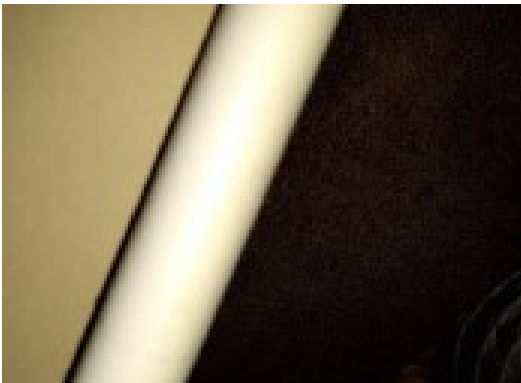
Item 15 – Ref: 21-38551-1

The bitumen to the ceiling in the Recording Studio ceiling void (Area 13) does not contain asbestos.

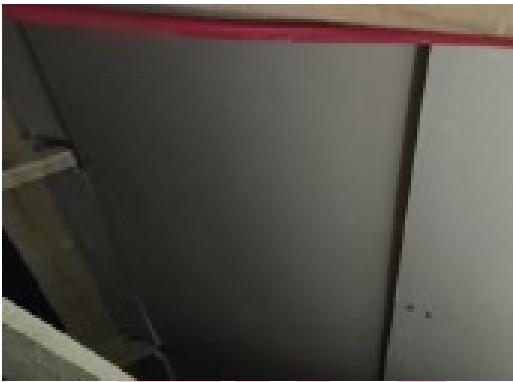
Item 17 – Ref: 21-38551-2

The bitumen to the ceiling in the Head of music ceiling void (Area 15) does not contain asbestos.

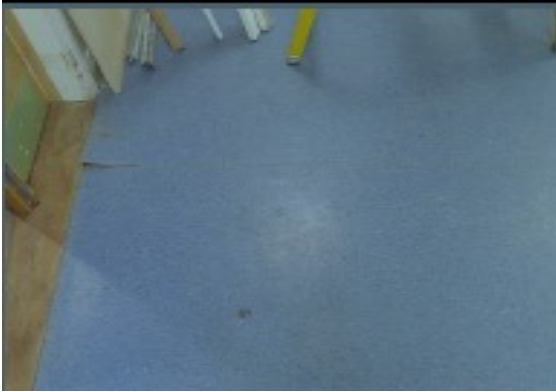
Item 22 – Ref: PK001652

The black screed – floor below modern lino to doorway in the Exam Store (G/02) does not contain asbestos.
