ASBESTOS SURVEY REPORT FOR BROADWAY JUNIOR SCHOOL,  
SPRINGWELL ROAD, SUNDERLAND, SR4 8NW.

**Broadway Junior School, Springwell Road, SR4 8NW**

**Date: 12 February 2025**

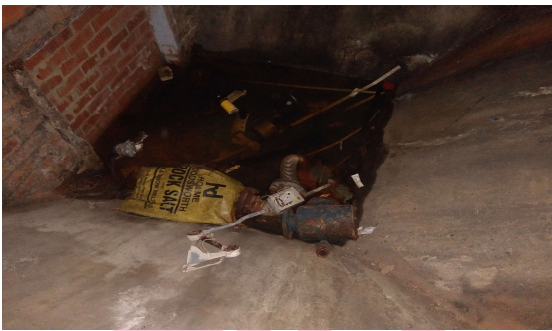
### **Item 2 Ref: As 417799-1**

The gaskets to loose lying flanges in Rm -1/001 Former Coal Bunker contains asbestos.

Any change in its appearance should be recorded and passed to Property Services.

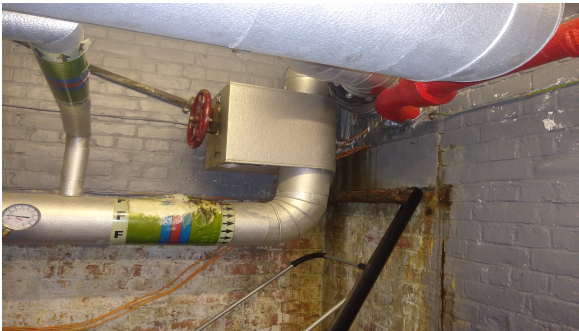
### **Item 5 Ref: 417799-3**

The heating pipework flange gaskets in Rm -1/002 Boiler House do not contain asbestos.

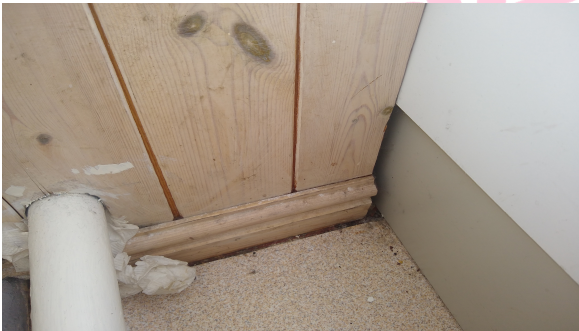
### **Item 8 Ref: 417799-5**

The floor tile with bitumen adhesive in Rm 0/001 canteen contains asbestos.

Any change in its appearance should be recorded and passed to Property Services.

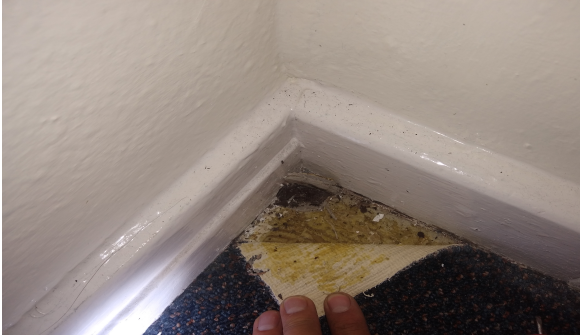
### Item 10 Ref: 417799-4

The brown floor screed in Rm 0/001b Corridor contains asbestos.

Any change in its appearance should be recorded and passed to Property Services.

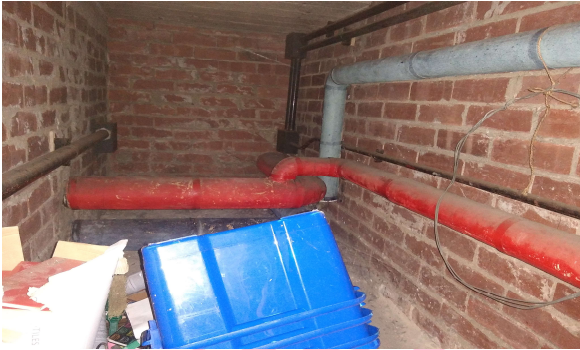
### Item 11 Ref: 417799-7

- (Item 9) Ref: Presumed – Floor duct (0/001 Canteen) - Low Risk
- (Item 10) Ref: 417799-4 – Brown floor screed (0/001b Corridor) – Very Low Risk
- (Item 11) Ref: 417799-7 – Pipe lagging (0/004a Switch room void below stairs) – Medium Risk

The pipe lagging in Rm 0/004a Switch Room – void below stairs contains asbestos.

**This area should not be inspected.**

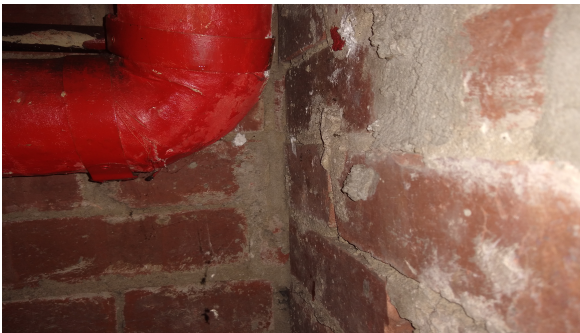
### Item 12 Ref: 417799-8

- (Item 12) Ref: 417799-8 – Debris to walls (0/004a Switch room void below stairs) – Medium Risk
- (Item 13) Ref: 417799-9 – Debris to floor (0/004a Switch room void below stairs) – Medium Risk

The debris to walls in Rm 0/004a Switch Room – void below stairs contains asbestos.

**This area should not be inspected.**

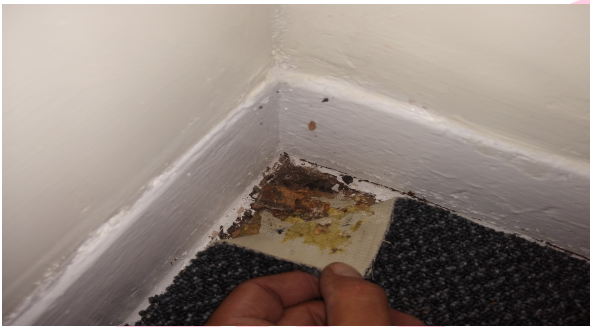
### **Item 14 Ref: As 417799-4**

The brown floor screed in Rm 0/005 Head Teachers contains asbestos.

Any change in its appearance should be recorded and passed to Property Services.

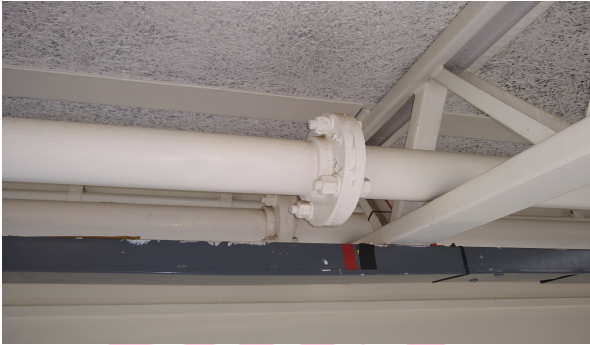
### **Item 17 Ref: Presumed**

The close coupled pipework flange gaskets in 0/007b Corridor contains asbestos.

Any change in its appearance should be recorded and passed to Property Services.

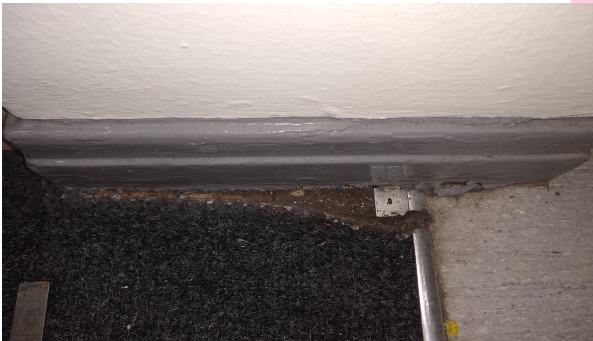
### **Item 20 Ref: As 417799-17**

The floor tile with bitumen adhesive beneath carpeted area in 0/007b Corridor contains asbestos.

Any change in its appearance should be recorded and passed to Property Services.

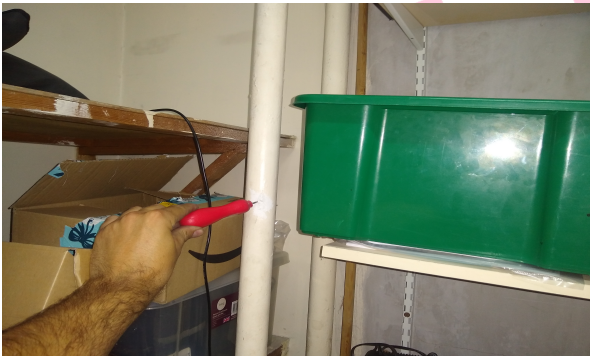
### **Item 23 Ref: 417799-14**

The residue to pipework in 0/008a Store contains asbestos.

Any change in its appearance should be recorded and passed to Property Services.

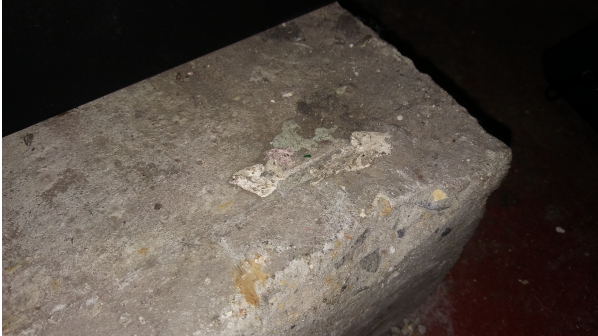
### **Item 25 Ref: 417799-13**

The residue to heater plinth in 0/009 Store does not contain asbestos.

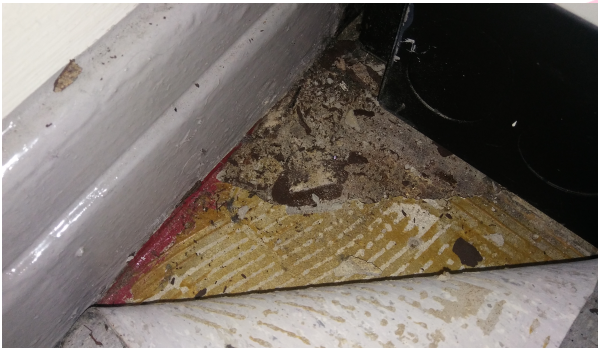
### **Item 26 Ref: As 417799-12**

The floor tile with bitumen adhesive in 0/010 Classroom contains asbestos.

Any change in its appearance should be recorded and passed to Property Services.

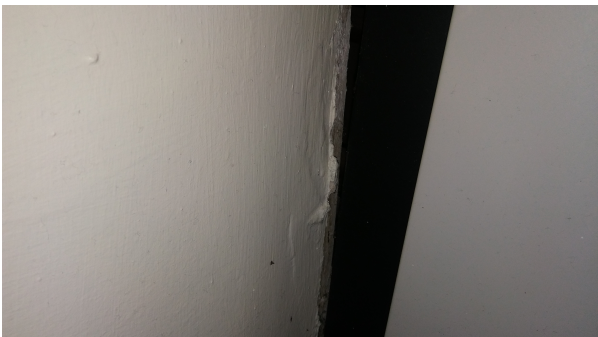
### **Item 27 Ref: 417799-15**

The remnant plaster to wall from former heater (behind modern heater) in Rm 0/010 Classroom does not contain asbestos.

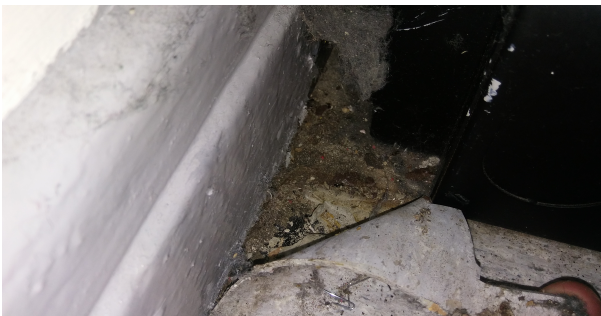
**Item 29 Ref: As 417799-12**

The floor tile with bitumen adhesive in 0/012 Classroom contains asbestos.

Any change in its appearance should be recorded and passed to Property Services.

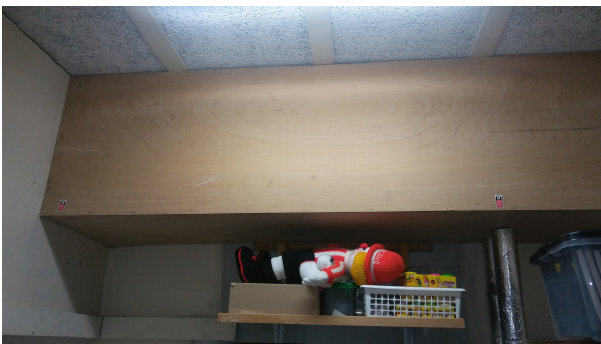
**Item 30 Ref: Presumed**

The pipe lagging within high level boxing in Rm 0/012a Store is presumed to contain asbestos.

Any change in its appearance should be recorded and passed to Property Services.

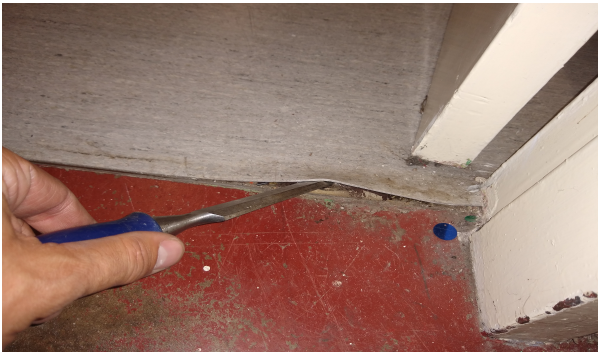
**Item 32 Ref: 417799-17**

The floor tile with bitumen adhesive in 0/013 Classroom contains asbestos.

Any change in its appearance should be recorded and passed to Property Services.

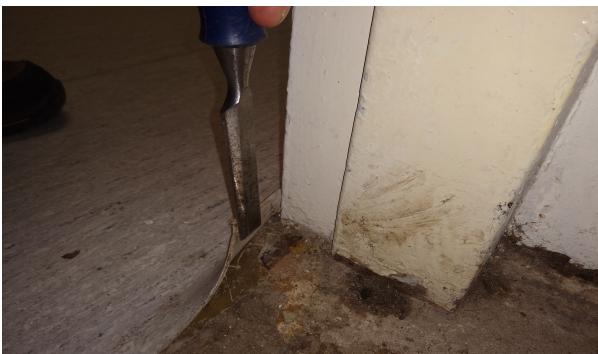
**Item 33 Ref: As 417799-17**

The floor tile with bitumen adhesive in 0/014 Kitchen contains asbestos.

Any change in its appearance should be recorded and passed to Property Services.

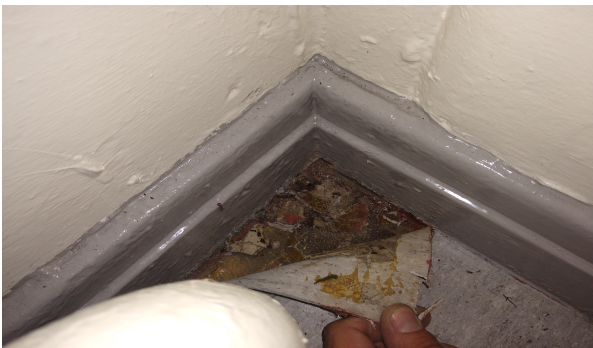
**Item 35 Ref: 417799-20**

The floor tile with bitumen adhesive in 0/018 Classroom contains asbestos.

Any change in its appearance should be recorded and passed to Property Services.

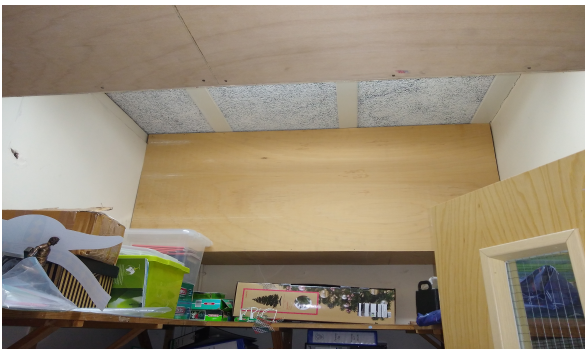
**Item 36 Ref: Presumed**

The pipe lagging enclosed within boxings in 0/018a Store is presumed to contain asbestos.

Any change in its appearance should be recorded and passed to Property Services.

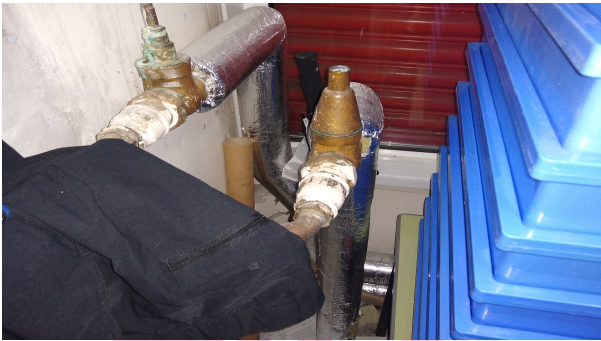
**Item 38 Ref: 417799-21**

The adhered debris to pipework in 0/019a Store contains asbestos.

Any change in its appearance should be recorded and passed to Property Services.

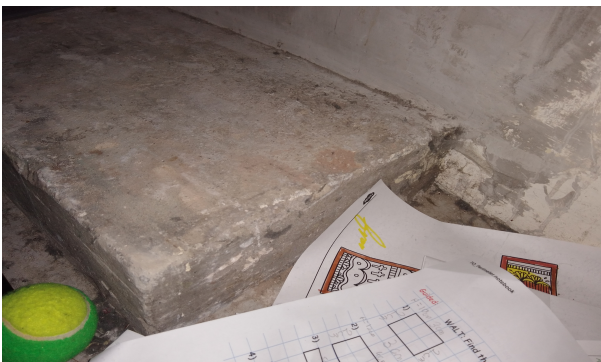
**Item 39 Ref: 417799-22**

The adhered debris to former heater plinth in 0/019a Store contains asbestos.

Any change in its appearance should be recorded and passed to Property Services.

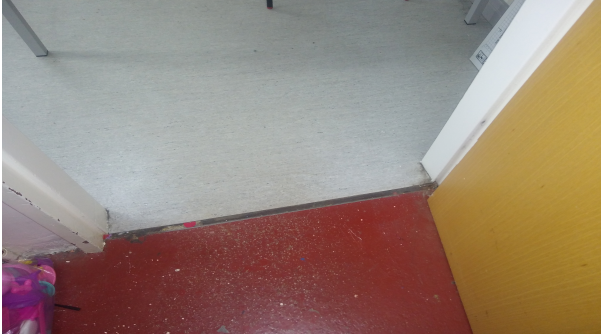
**Item 40 Ref: As 417799-20**

The floor tile with bitumen adhesive in 0/020 Classroom contains asbestos.

Any change in its appearance should be recorded and passed to Property Services.

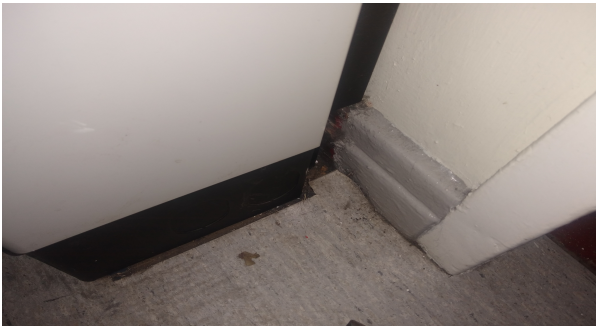
**Item 41 Ref: As 417799-20**

The floor tile with bitumen adhesive in 0/021 Classroom contains asbestos.

Any change in its appearance should be recorded and passed to Property Services.

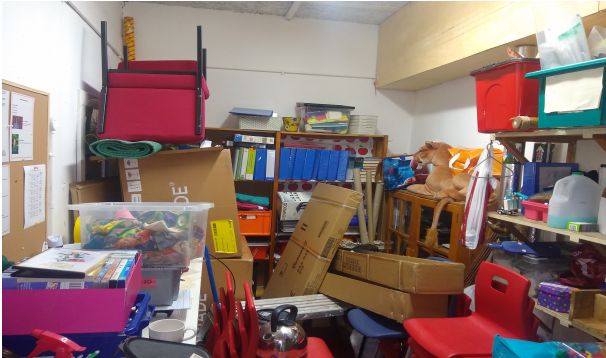
### **Item 47 Ref: 417799-32**

The adhered debris to former heater plinths in 0/023a Store does not contain asbestos.

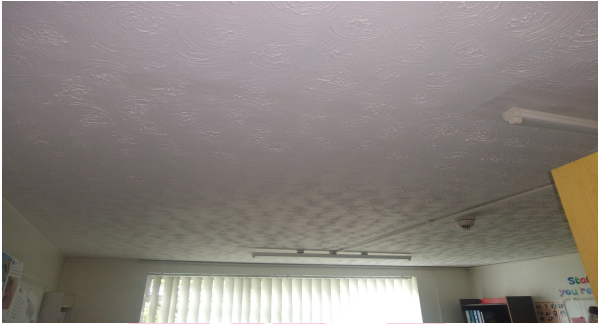
**Item 53 Ref: 417799-10**

The textured coating ceiling in 0/028 Staff Room does not contain asbestos.

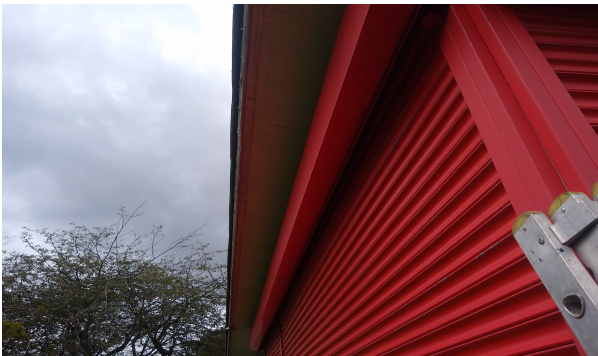
**Item 54 Ref: 417799-27**

The soffit (External) contains asbestos.

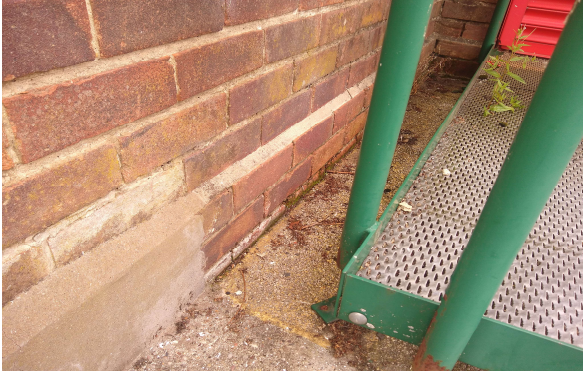
### **Item 55 Ref: 417799-28**

The damp proof course (External) contains asbestos.

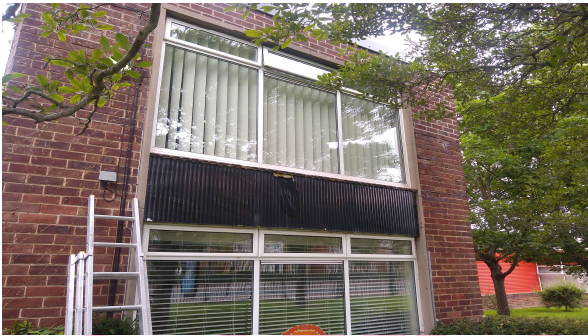
### **Item 56 Ref: 417799-29**

The panels below windows - 1/028 (External) contains asbestos.

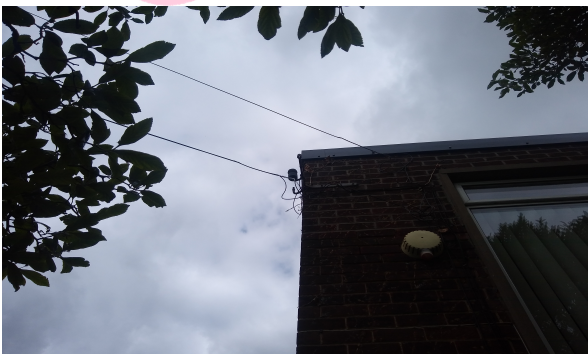
### **Item 57 Ref: Presumed**

The telephone insulator (External) is presumed to contain asbestos.

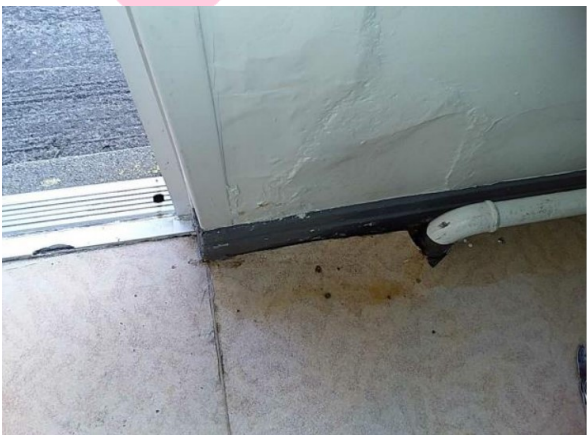
**Item 60 Ref: 21-32170-1**

The flooring around the pipe in the Dining Room (Area 1) does not contain asbestos.

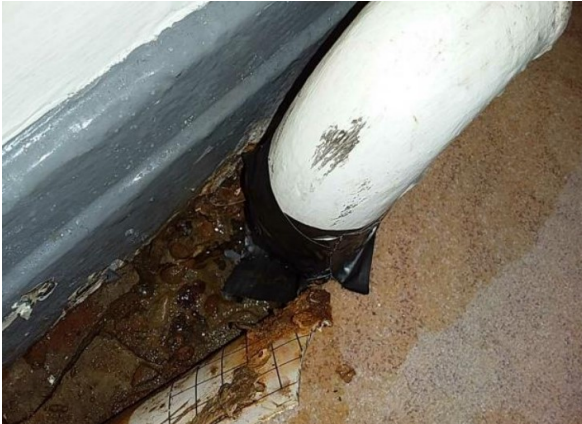
**Item 61 Ref: 21-32170-2**

The residual adhesive follow the flooring around the pipe in the Dining Room (Area 1) does not contain asbestos.

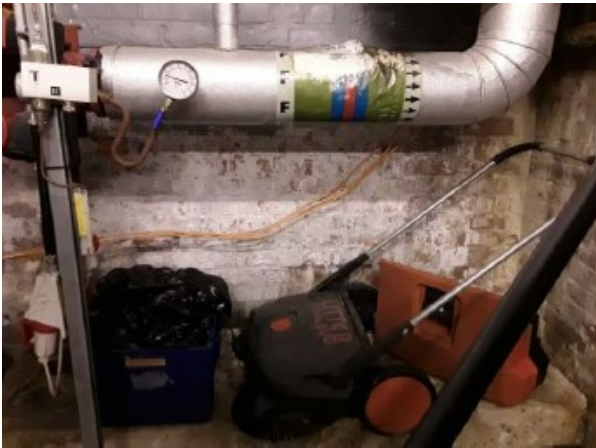
**Item 62 Ref: 22-45075-3**

The debris to un-encapsulated area of the Boiler Room walls (Area 1) does not contain asbestos.
