### **ASBESTOS SURVEY REPORT FOR THE PALLION CENTRE, WAVERLEY TERRACE, SUNDERLAND**

## **Asbestos Register for The Pallion Centre**

**UPRN: - J565255**

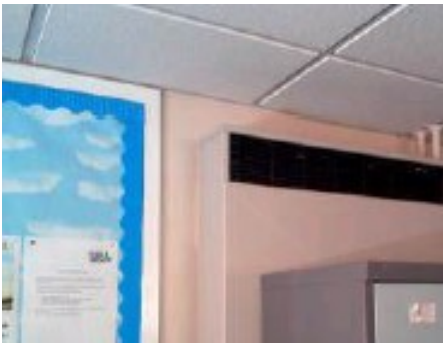
There was no access to the storage heater in the staff room (Room 4) as it was live plant.

Prior to any works, there needs to be further investigation.

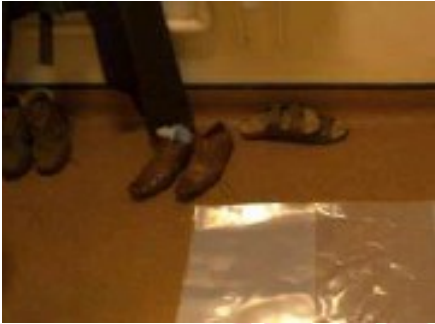
There was no access beneath the modern lino in the male / disabled WC (Room 6) due to possible damage.

Prior to any works, there needs to be further investigation.

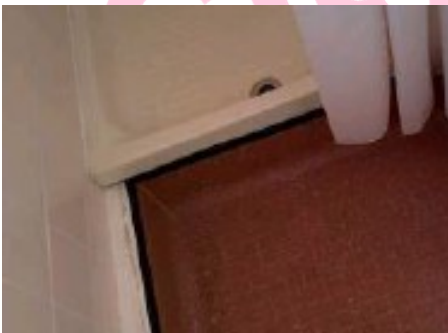
There was no access beneath the modern lino in the male / disabled shower (Room 7) due to possible damage.

Prior to any works, there needs to be further investigation.

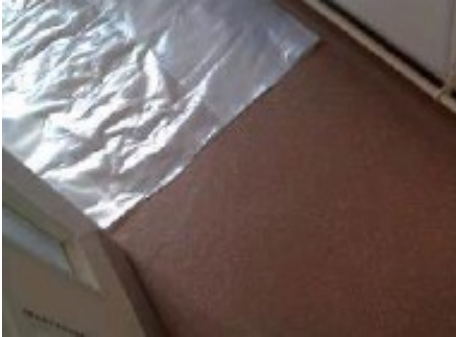
There was no access beneath the modern lino in the female wc (Room 8) due to possible damage.

Prior to any works, there needs to be further investigation.

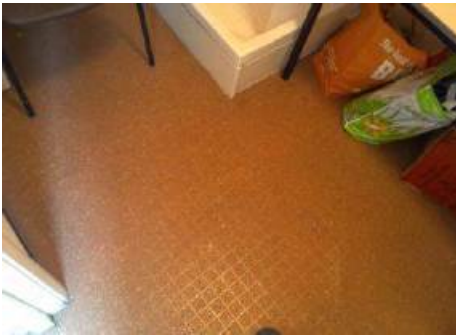
There was no access beneath the modern lino in the female shower (Room 9) due to possible damage.

Prior to any works, there needs to be further investigation.

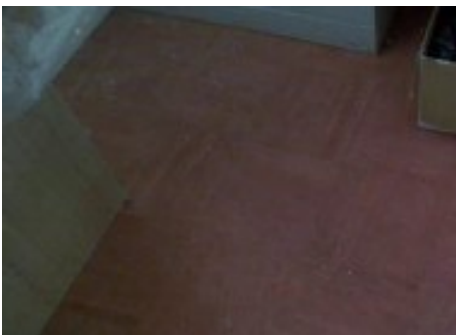
There was no access beneath the modern floor tiles to the resource room (Room 10) due to possible damage.

Prior to any works, there needs to be further investigation.

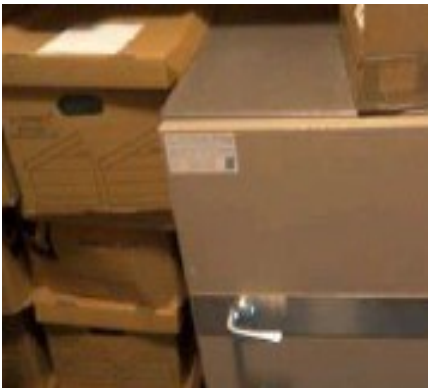
There was no access to the safe in the safe store (Room 27) prior to any works taking place, further checks will be necessary.

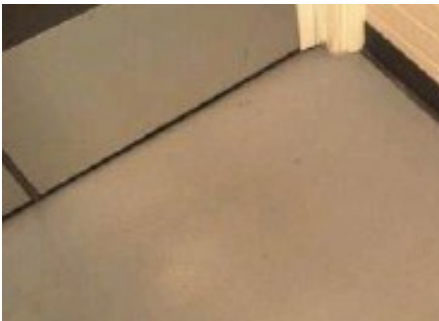
There was no access beneath the modern lino in the corridor (Room 31) as it may have caused damage.

Prior to any works, there should be additional checks carried out.

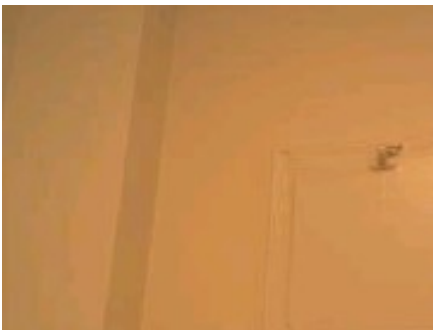
There was no access behind the metal hatch in the community room wc (Room 37) without causing damage.

Therefore, prior to any work, further checks need to be carried out.

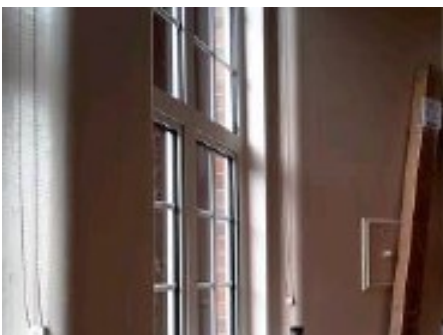
There was no access behind the metal hatch within the plumbing room (Room 38), without causing further damage.

Prior to any work, this needs to be checked out.

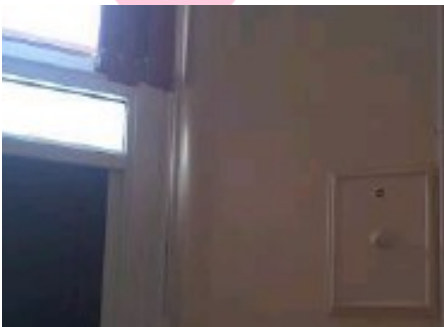
There was no access behind the metal hatch within the joinery machine area (Room 39), without causing further damage.

Prior to any work, this needs to be checked out.

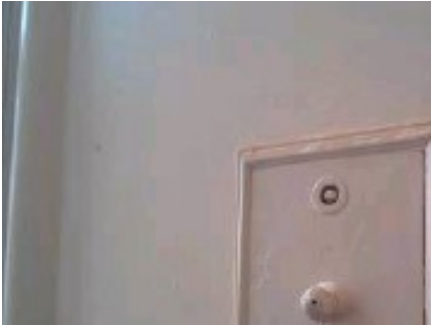
There was no access behind the metal hatch within the joinery area (Room 40), without causing further damage.

Prior to any work, this needs to be checked out.

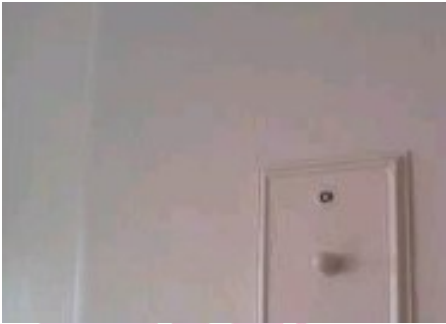
There was no access behind the metal hatches within the restaurant (Room 41), without causing further damage.

Prior to any work, this needs to be checked out.

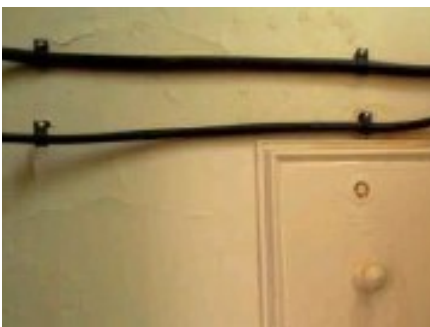
There was no access behind the metal access hatch to the dry store (Room 47) without causing damage.

Prior to any works, additional checks may need to be carried out.

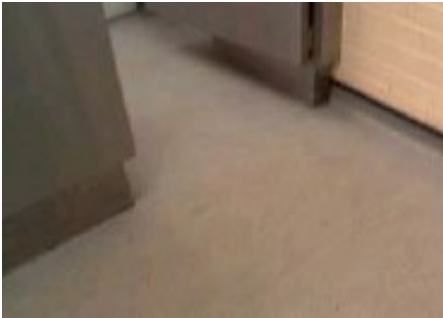
There was no access beneath the modern lino in the servery (Room 48) as it would cause damage.

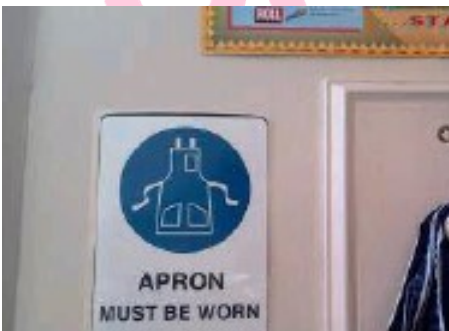
There was no access behind the metal access hatch to the cookery area (Room 51) without causing damage.

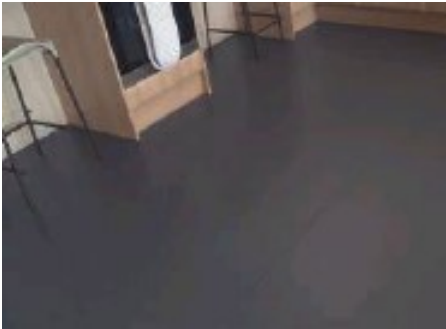
There was no access beneath the modern lino in the cookery (Room 51) as it would cause damage.

Prior to any works, additional checks may need to be carried out.

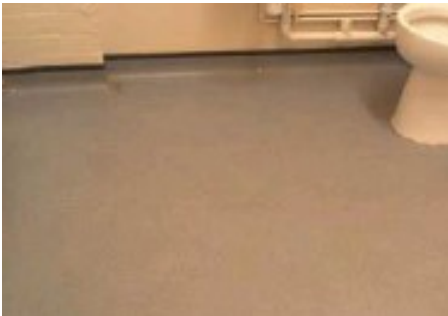
There was no access beneath the modern lino in the disabled wc (Room 53) as it would cause damage.

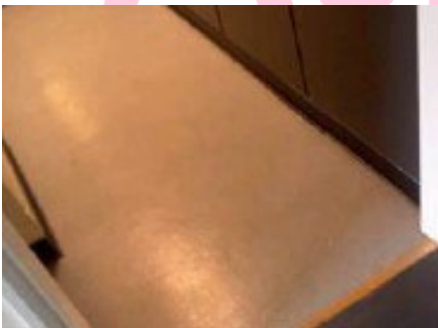
There was no access beneath the modern lino in the female wc (Room 56) as it would cause damage. Prior to any works, additional checks may need to be carried out.

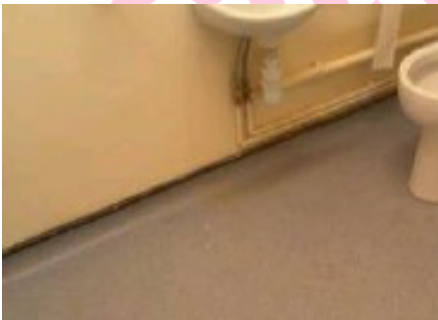
There was no access beneath the modern lino to the disabled wc (Room 1/02) as it would cause damage.

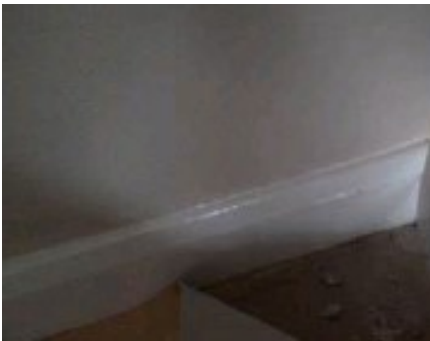
### **Item 59 As : AP001903**

The bitumen adhesive to the concrete beneath the modern lino and screed floor in the meeting room (Room 1/11) contains asbestos.

Any change in its appearance should be noted and passed to Property Services.

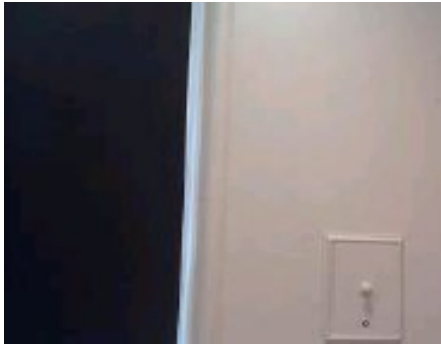
There was no access within the metal hatches to the wall in ICT (Room 1/14) without causing possible damage.

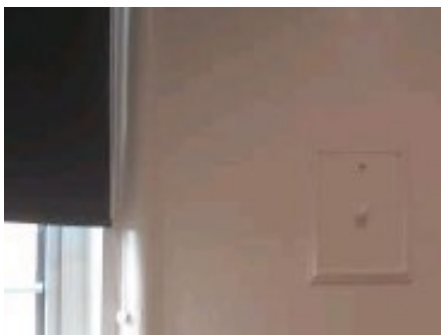
There was no access within the metal hatches to the wall in the classroom (Room 1/15) without causing possible damage.

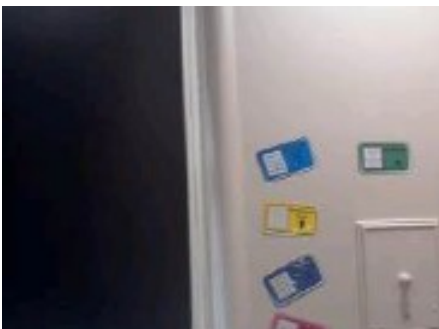
There was no access within the metal hatches to the wall in classroom (Room 1/22) without causing possible damage.

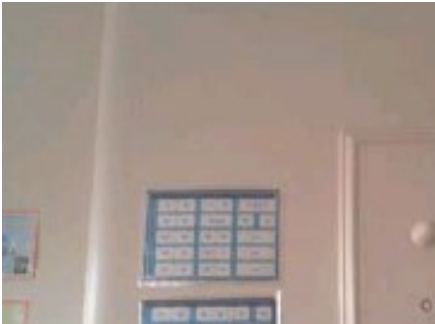
There was no access within the metal hatches to the wall in classroom (Room 1/23) without causing possible damage.

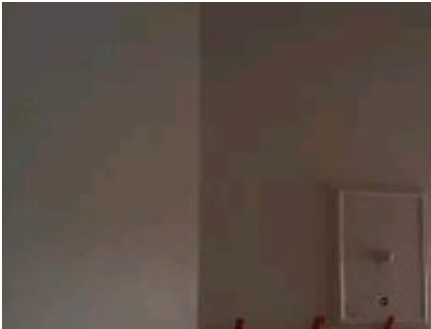
There was no access within the metal hatches to the wall in classroom (Room 1/26) without causing possible damage.

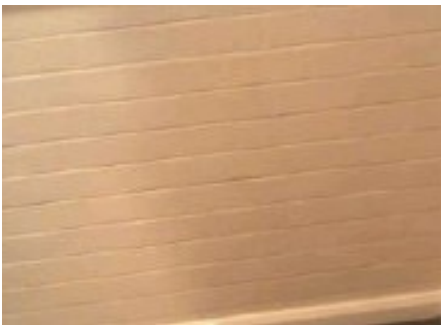
There was no access beneath the newly fitted carpet to the stairwell (Room 1/27) without causing possible damage.

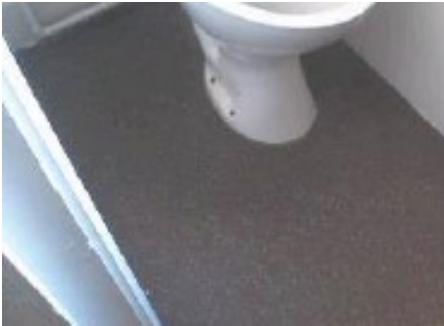
There was no access beneath the lino to the gents WC (Room 1/29) without causing possible damage.

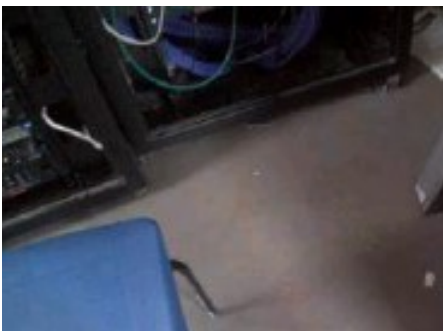
There was no access beneath the modern lino to the server room (Room 1/32) without causing possible damage.

Prior to any works, further checks may need to be carried out.

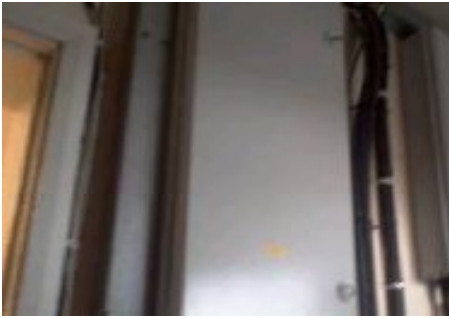
There was no access within the electrics in the office (Room 1/34) due to live plant.

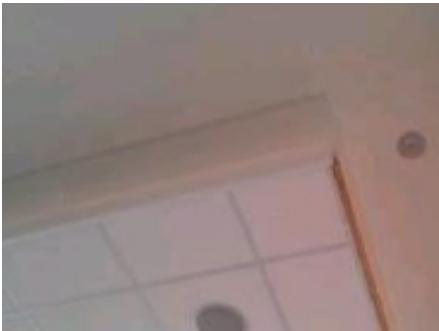
There was no access above the suspended ceiling in the seminar room (Room 1/40) due to height restrictions.

Prior to any works, further checks may need to be carried out.

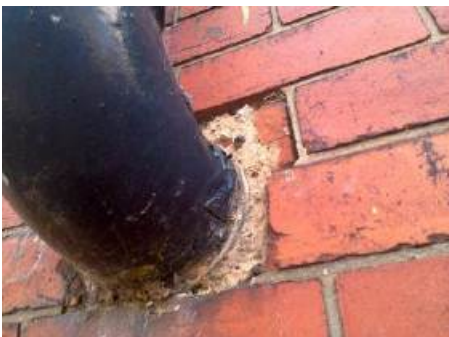
#### **Item 71 Ref: AP001923**

The cement sleeve to the north elevation to the external contains asbestos.

Any change in its appearance should be noted and passed to Property Services.

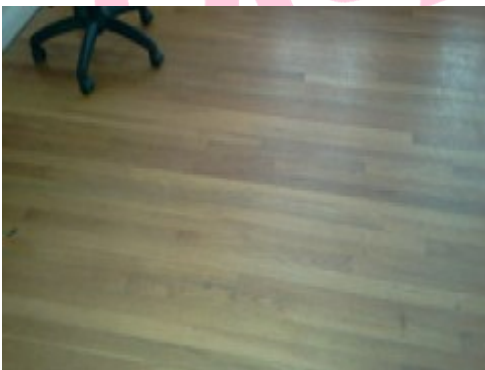
### **Item 122 Ref: Presumed**

The adhesive to parquet flooring in Classroom/Rm 1/016 is presumed to contain asbestos.

Any change in its appearance should be noted and passed to Property Services.

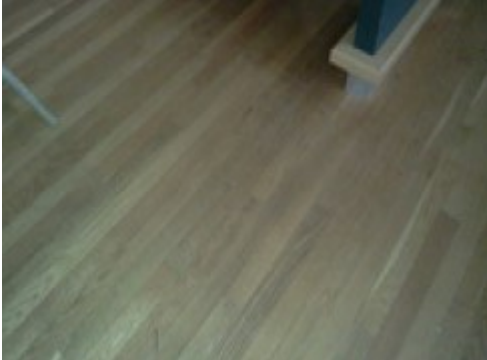
### **Item 123 Ref: Presumed**

The adhesive to parquet flooring in Classroom/Rm 1/017 is presumed to contain asbestos.

Any change in its appearance should be noted and passed to Property Services.

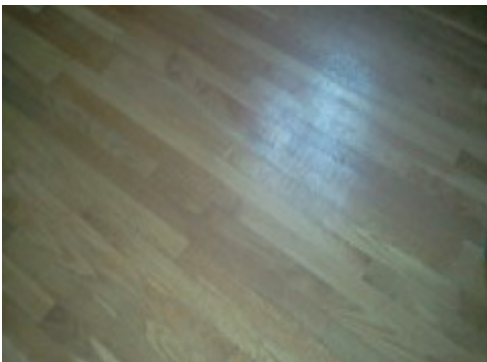
### **Item 124 Ref: Presumed**

The adhesive to parquet flooring in Classroom/Rm 1/020 is presumed to contain asbestos.

Any change in its appearance should be noted and passed to Property Services.

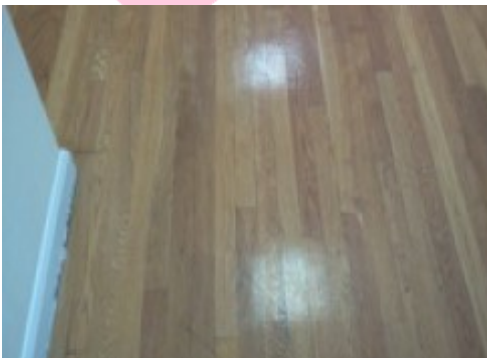
### **Item 125 Ref: Presumed**

The adhesive to parquet flooring in Classroom/Rm 1/021 is presumed to contain asbestos.

Any change in its appearance should be noted and passed to Property Services.

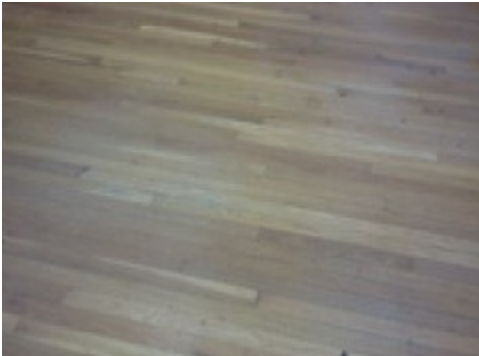
### **Item 126 Ref: Presumed**

The adhesive to parquet flooring in Classroom/Rm 1/022 is presumed to contain asbestos.

Any change in its appearance should be noted and passed to Property Services.

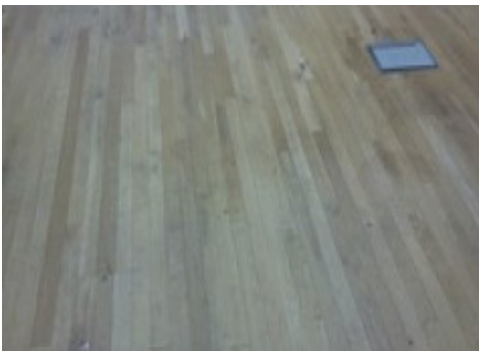
### **Item 127 Ref: Presumed**

The adhesive to parquet flooring in Classroom/Rm 1/023 is presumed to contain asbestos.

Any change in its appearance should be noted and passed to Property Services.

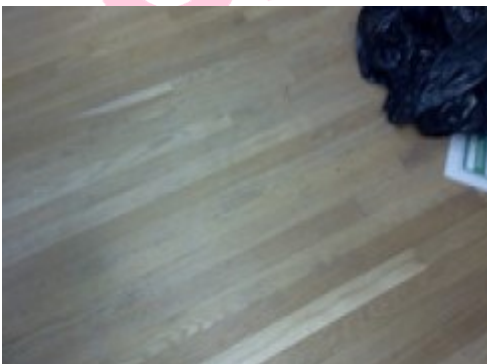
### **Item 128 Ref: Presumed**

The adhesive to parquet flooring in Classroom/Rm 1/024 is presumed to contain asbestos.

Any change in its appearance should be noted and passed to Property Services.

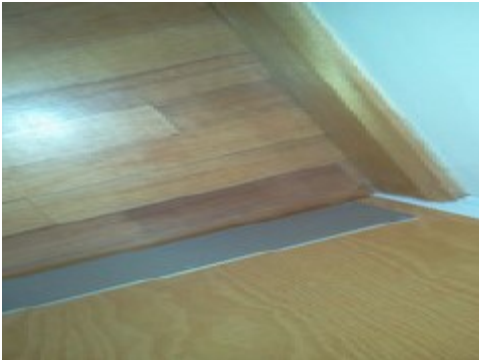
### **Item 132 Ref: Presumed**

The adhesive to parquet flooring in the Store/Rm 1/040 is presumed to contain asbestos.

Any change in its appearance should be noted and passed to Property Services.

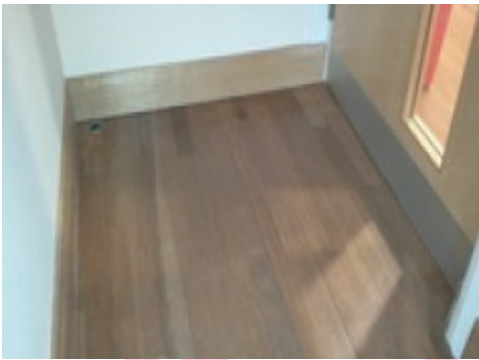
### **Item 133 Ref: Presumed**

The adhesive to parquet flooring in the Stairwell/Rm 1/041 is presumed to contain asbestos.

Any change in its appearance should be noted and passed to Property Services.

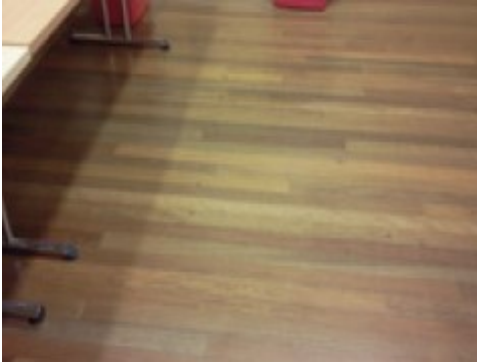
### **Item 138 Ref: Presumed**

The adhesive to parquet flooring in the Corridor/ Rm1/038 is presumed to contain asbestos.

Any change in its appearance should be noted and passed to Property Services.

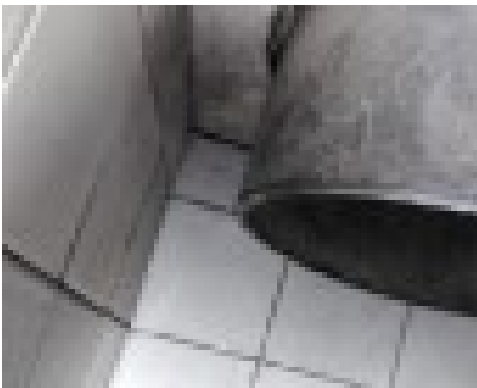
### **Item 139 Ref: Presumed**

The flue pipe in the cavity wall seen through the grilles in the Boiler Room is presumed to contain asbestos.

Any change in its appearance should be noted and passed to Property Services.

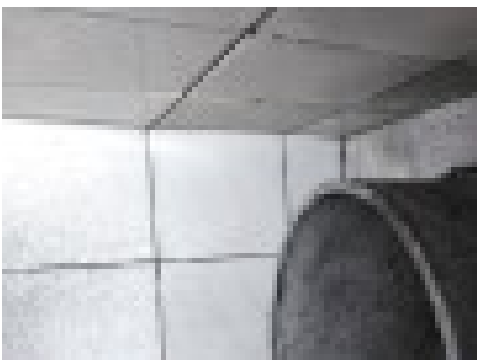
### **Item 140 Ref: Presumed**

The shuttering to flue penetrations behind wall grilles to chimney breast x 2 in the Boiler Room is presumed to contain asbestos.

Any change in its appearance should be noted and passed to Property Services.

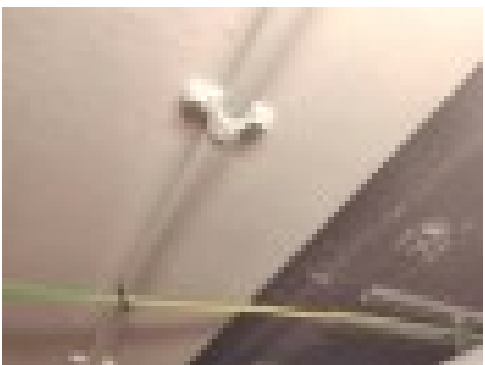
### **Item 143 Ref: KX001003**

The debris/residue to the concrete ceiling above pipes in the area not covered by supalux in the Boiler Room contain asbestos.

Any change in its appearance should be noted and passed to Property Services.
