### ASBESTOS SURVEY REPORT FOR THE PALLION CENTRE, WAVERLEY TERRACE, SUNDERLAND

## **Asbestos Register for The Pallion Centre**

**Date: 26 September 2024**

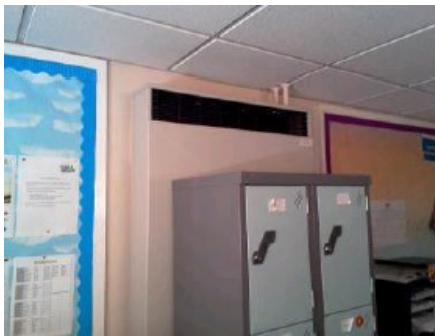
There was no access to the storage heater in the staff room (Room 4) as it was live plant.

Prior to any works, there needs to be further investigation.

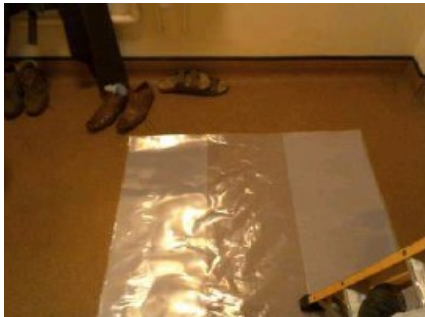
There was no access beneath the modern lino in the male / disabled WC (Room 6) due to possible damage.

Prior to any works, there needs to be further investigation.

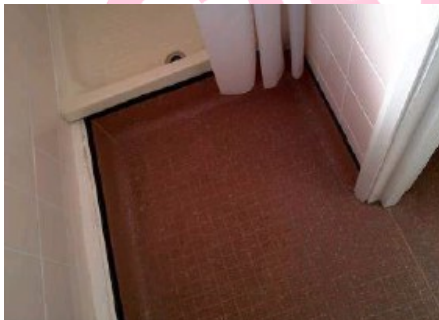
There was no access beneath the modern lino in the male / disabled shower (Room 7) due to possible damage.

Prior to any works, there needs to be further investigation.

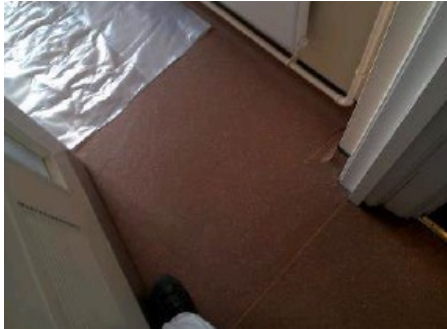
There was no access beneath the modern lino in the female wc (Room 8) due to possible damage.

Prior to any works, there needs to be further investigation.

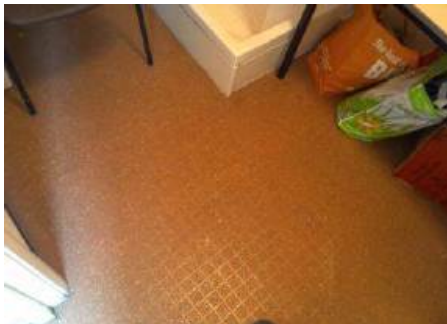
There was no access beneath the modern lino in the female shower (Room 9) due to possible damage.

Prior to any works, there needs to be further investigation.

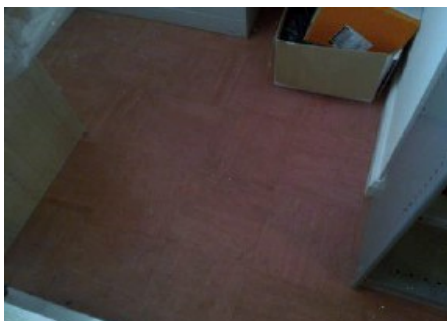
There was no access beneath the modern floor tiles to the resource room (Room 10) due to possible damage.

Prior to any works, there needs to be further investigation.

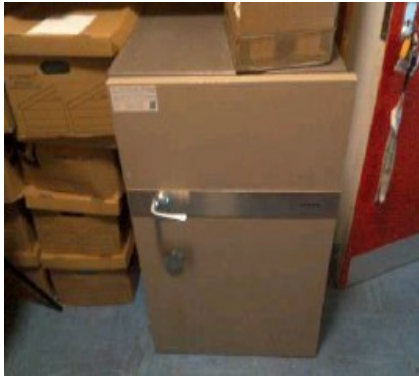
There was no access to the safe in the safe store (Room 27) prior to any works taking place, further checks will be necessary.

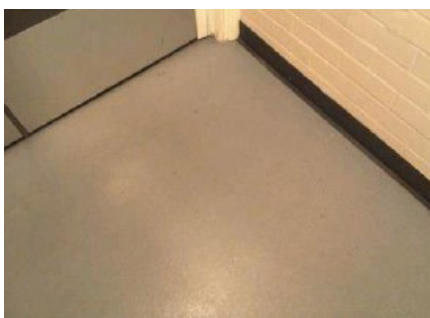
There was no access beneath the modern lino in the corridor (Room 31) as it may have caused damage.

Prior to any works, there should be additional checks carried out.

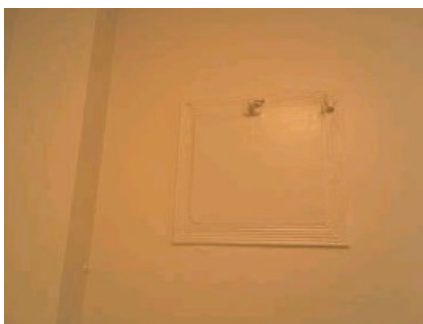
There was no access behind the metal hatch in the community room wc (Room 37) without causing damage.

Therefore, prior to any work, further checks need to be carried out.

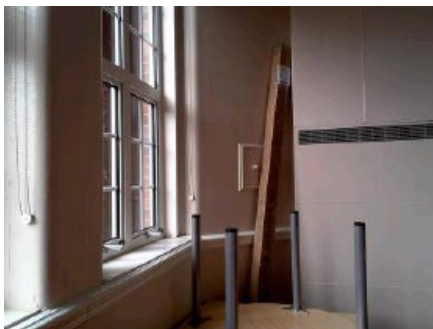
There was no access behind the metal hatch within the plumbing room (Room 38), without causing further damage.

Prior to any work, this needs to be checked out.

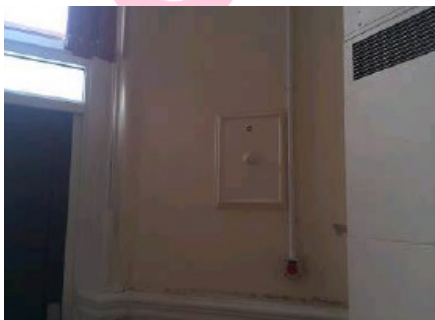
There was no access behind the metal hatch within the joinery machine area (Room 39), without causing further damage.

Prior to any work, this needs to be checked out.

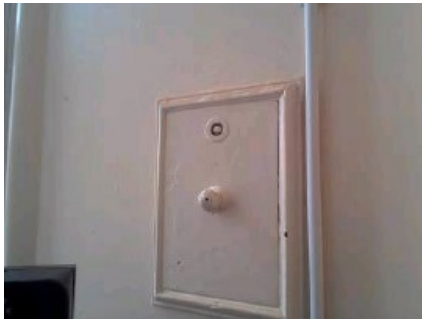
There was no access behind the metal hatch within the joinery area (Room 40), without causing further damage.

Prior to any work, this needs to be checked out.

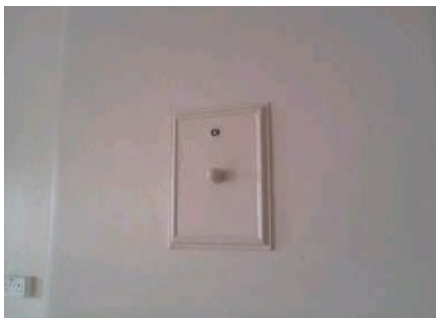
There was no access behind the metal hatches within the restaurant (Room 41), without causing further damage.

Prior to any work, this needs to be checked out.

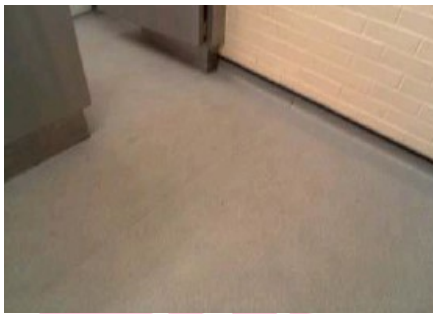
There was no access beneath the modern lino in the server room (Room 48) as it would cause damage.

Prior to any works, additional checks may need to be carried out.

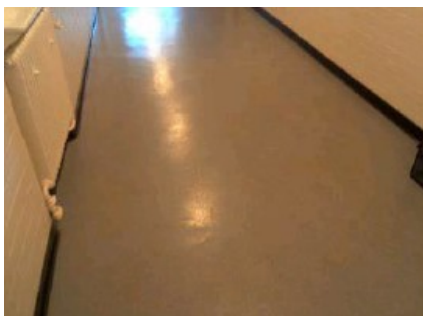
There was no access beneath the modern lino in the corridor (Room 50) as it would cause damage.

Prior to any works, additional checks may need to be carried out.

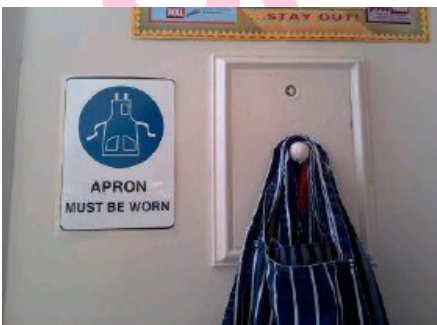
There was no access behind the metal access hatch to the cookery area (Room 51) without causing damage.

Prior to any works, additional checks may need to be carried out.

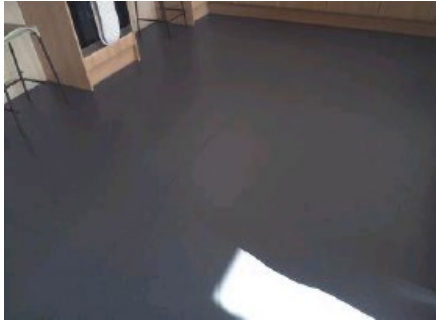
There was no access beneath the modern lino in the cookery (Room 51) as it would cause damage.

Prior to any works, additional checks may need to be carried out.

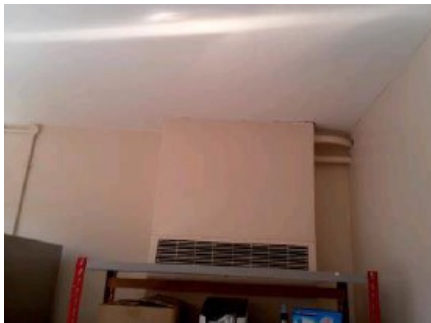
There was no access within the storage heater to the cookery store (Room 52) as it was live plant.

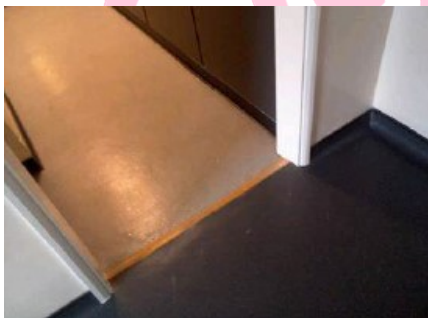
There was no access beneath the modern lino in the female wc (Room 56) as it would cause damage. Prior to any works, additional checks may need to be carried out.

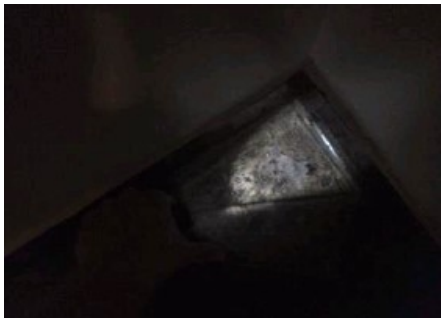
#### **Item 51 Ref: AP001900**

The bitumen adhesive to concrete beneath modern carpet to floor of the stairwell (Room 58) contains asbestos.

Any change in its appearance should be noted and passed to Property Services.

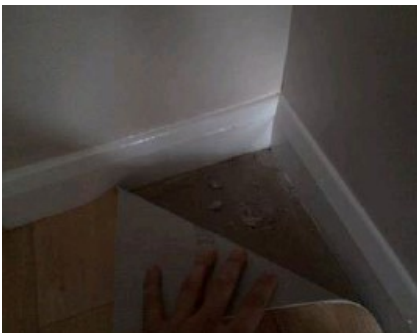
### **Item 59 As : AP001903**

The bitumen adhesive to the concrete beneath the modern lino and screed floor in the meeting room (Room 1/11) contains asbestos.

Any change in its appearance should be noted and passed to Property Services.

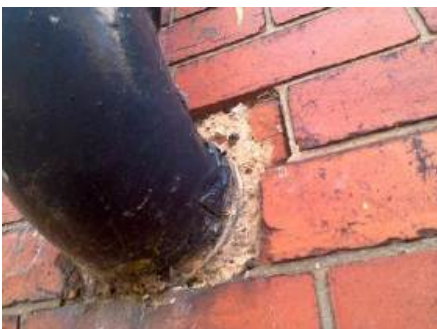
#### **Item 71 Ref: AP001923**

The cement sleeve to the north elevation to the external contains asbestos.

Any change in its appearance should be noted and passed to Property Services.

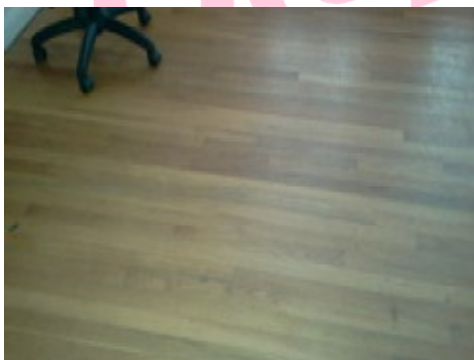
### **Item 122 Ref: Presumed**

The adhesive to parquet flooring in Classroom/Rm 1/016 is presumed to contain asbestos.

Any change in its appearance should be noted and passed to Property Services.

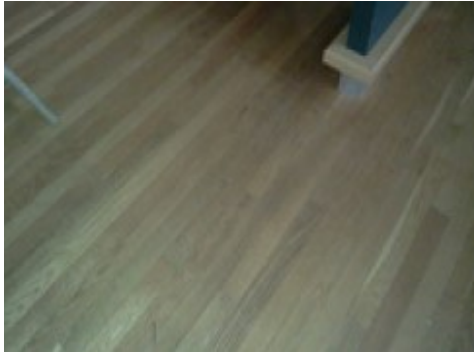
**Item 123 Ref: Presumed**

The adhesive to parquet flooring in Classroom/Rm 1/017 is presumed to contain asbestos.

Any change in its appearance should be noted and passed to Property Services.

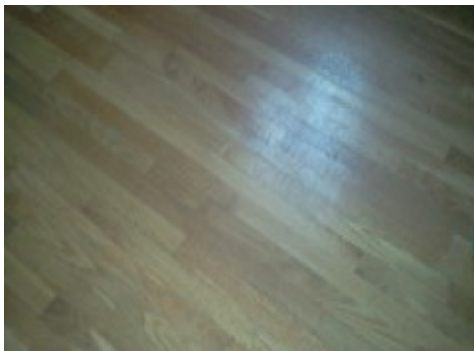
**Item 124 Ref: Presumed**

The adhesive to parquet flooring in Classroom/Rm 1/020 is presumed to contain asbestos.

Any change in its appearance should be noted and passed to Property Services.

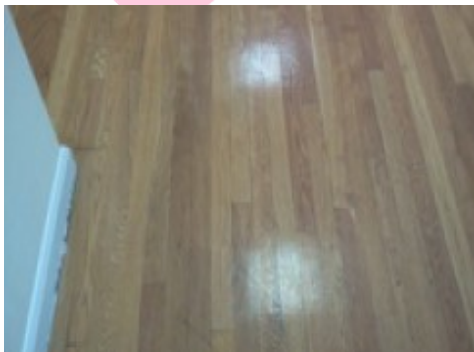
**Item 125 Ref: Presumed**

The adhesive to parquet flooring in Classroom/Rm 1/021 is presumed to contain asbestos.

Any change in its appearance should be noted and passed to Property Services.

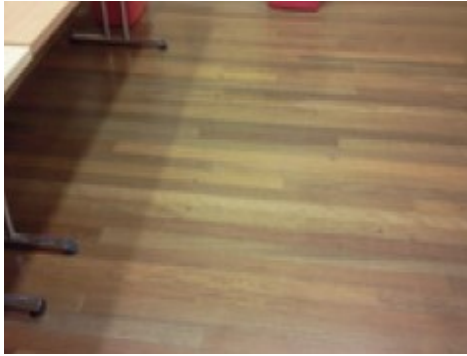
### **Item 138 Ref: Presumed**

The adhesive to parquet flooring in the Corridor/ Rm1/038 is presumed to contain asbestos.

Any change in its appearance should be noted and passed to Property Services.

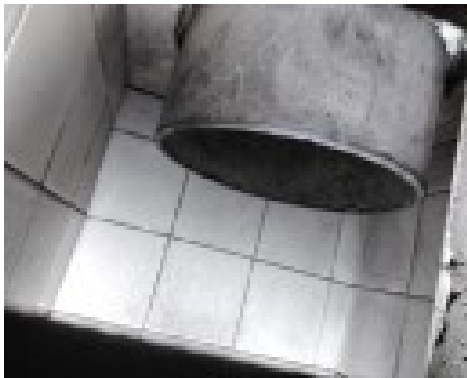
### **Item 139 Ref: Presumed**

The flue pipe in the cavity wall seen through the grilles in the Boiler Room is presumed to contain asbestos.

Any change in its appearance should be noted and passed to Property Services.

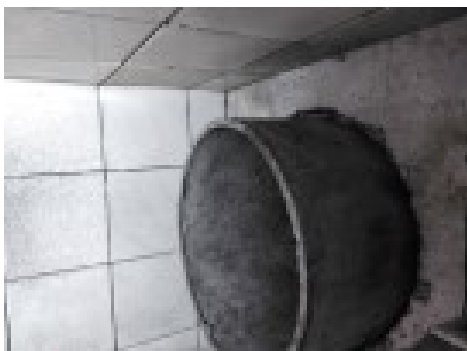
### **Item 140 Ref: Presumed**

The shuttering to flue penetrations behind wall grilles to chimney breast x 2 in the Boiler Room is presumed to contain asbestos.

Any change in its appearance should be noted and passed to Property Services.

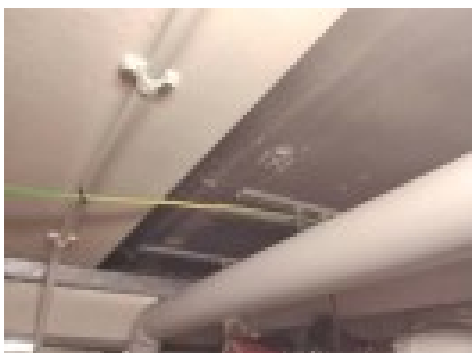
**Item 143 Ref: KX001003**

The debris/residue to the concrete ceiling above pipes in the area not covered by supalux in the Boiler Room contain asbestos.

Any change in its appearance should be noted and passed to Property Services.
