ASBESTOS SURVEY REPORT FOR NORTHERN SAINTS C OF E PRIMARY SCHOOL, SUNDERLAND

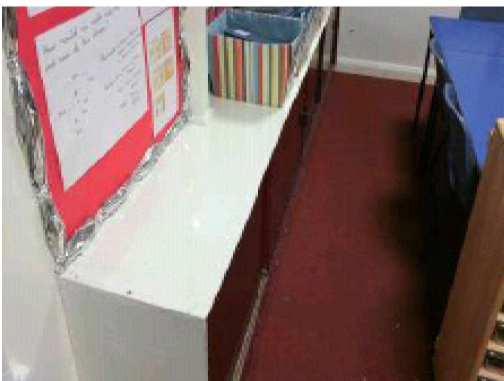
Item 33: Presumed

The skirting to the base of the wall behind the cupboards in the classroom (Room 33) was presumed to contain asbestos.

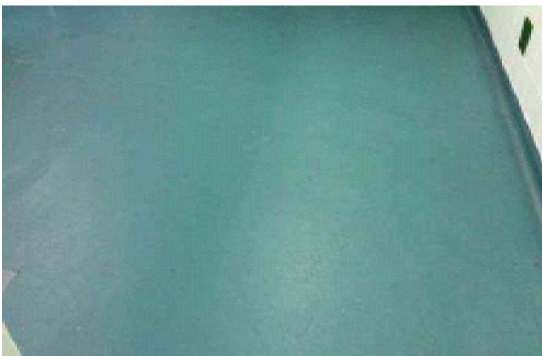
Item 42: Presumed

The bitumen adhesive beneath the modern lino in the girls wc (Room 41) is presumed to contain asbestos.

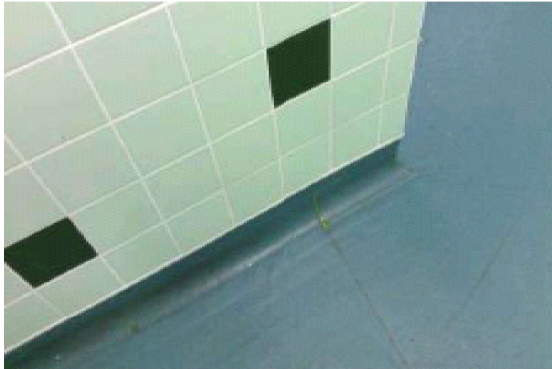
Item 43: As KR09/86

The skirting to wall beneath the lino in the Girls wc (Room 41) is presumed to contain asbestos.

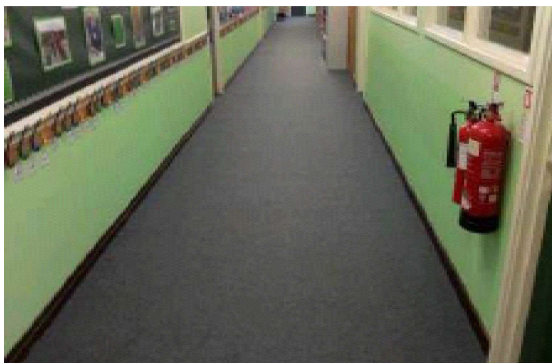
Item 44: Presumed

The vinyl floor tiles beneath the carpet in the corridor (Room 43) were presumed to contain asbestos.

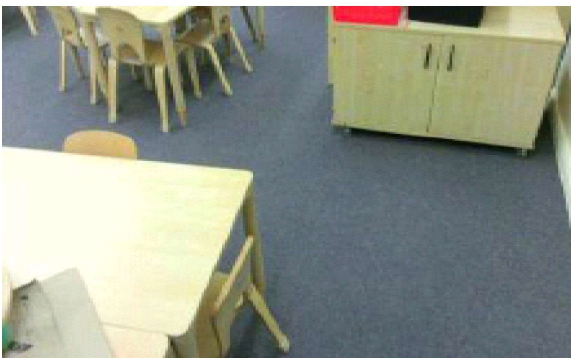
Item 50: Presumed

The vinyl floor tiles beneath the carpet in the classroom (Room 46) are presumed to contain asbestos.

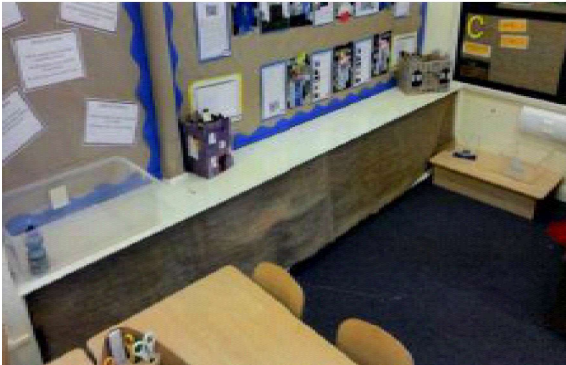
Item 55: Presumed

The skirting to wall beneath the lino in the classroom behind the cupboards (Room 47) was presumed to contain asbestos.

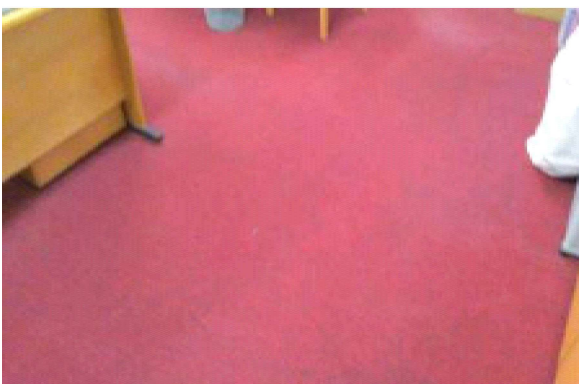
Item 57: Presumed

The bitumen adhesive to the floor in the office (Room 49) is presumed to contain asbestos.

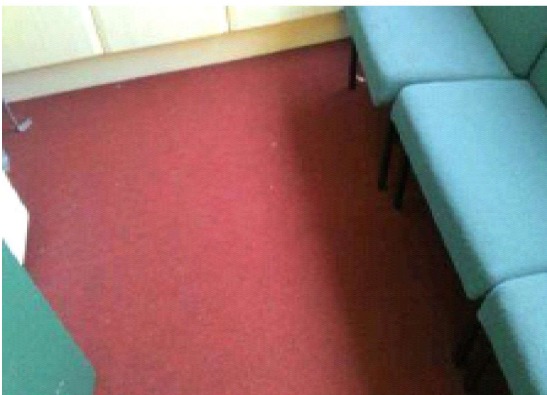
Item 59: Presumed

The bitumen adhesive to the floor below the carpet in the Medical Room (Room 50) is presumed to contain asbestos.

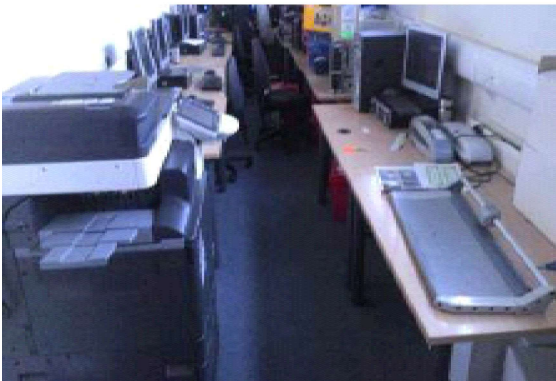
Item 60: Presumed

The bitumen adhesive to the floor below the carpet in the office (Room 51) is presumed to contain asbestos.

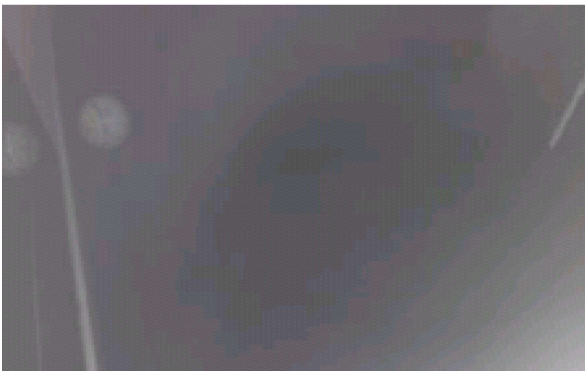
Item 65: Presumed

The vinyl floor tiles beneath the carpet in the office (Room 56) were presumed to contain asbestos.

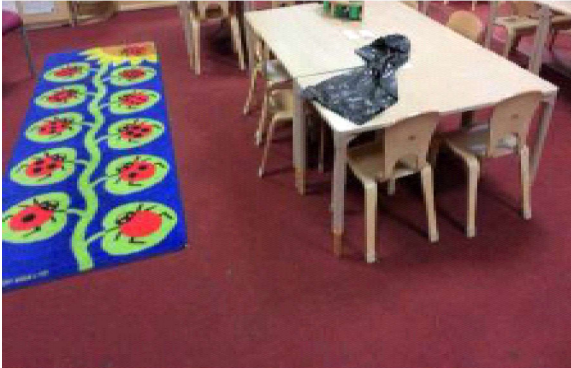
Item 67: Presumed

The bitumen adhesive to the floor below the carpet in the classroom (Room 57) is presumed to contain asbestos.

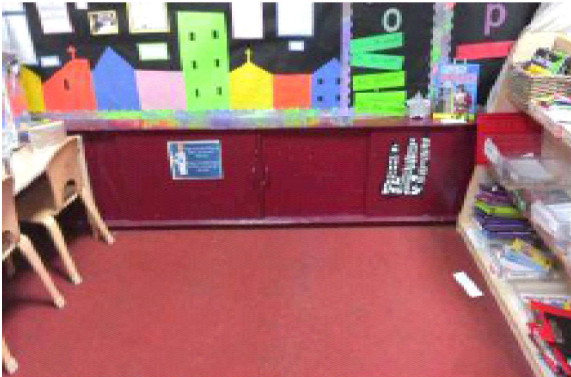
Item 68: Presumed

The skirting to base of wall behind the cupboards in the classroom (Room 57) is presumed to contain asbestos.

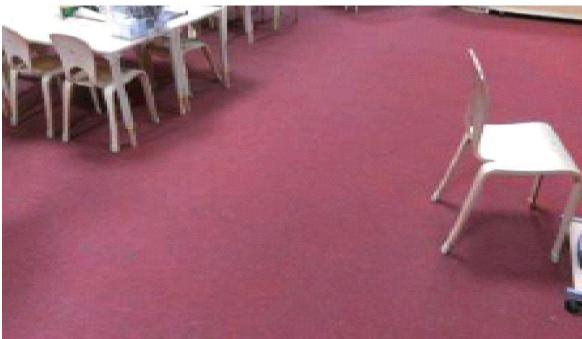
Item 69: Presumed

The bitumen adhesive below the carpet in the classroom (Room 58) is presumed to contain asbestos.

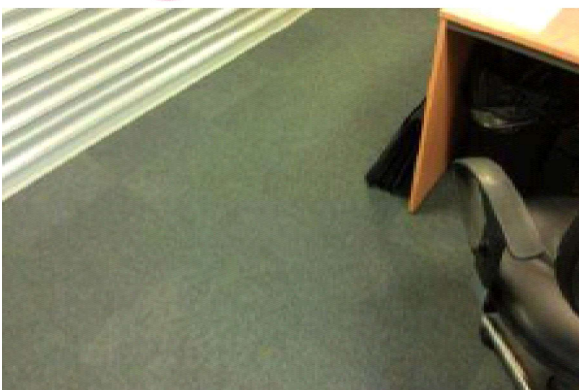
Item 72: Presumed

The bitumen adhesive to the floor below the cement skim to the floor in the reception office (Room 61) is presumed to contain asbestos.

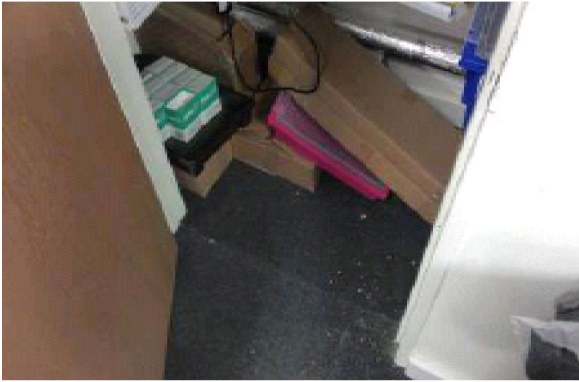
Item 73: Presumed

The bitumen adhesive to the floor below the cement skim to the floor in the reception office cupboard (Room 62) is presumed to contain asbestos.

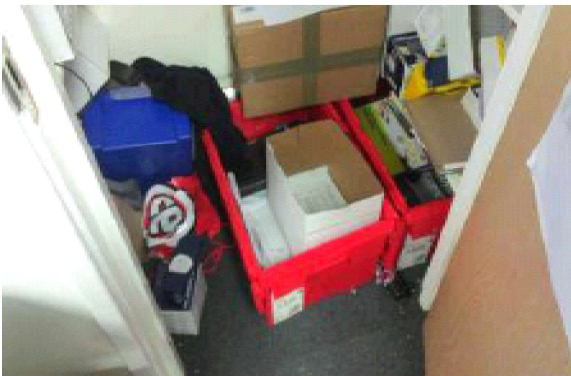
Item 74: Presumed

The bitumen adhesive to the floor below in the reception office cupboard (Room 63) is presumed to contain asbestos.

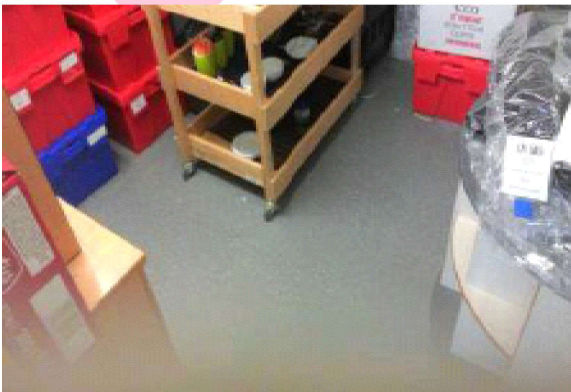
Item 75: Presumed

The bitumen adhesive to the floor below the cement skim in the store (Room 65) is presumed to contain asbestos.

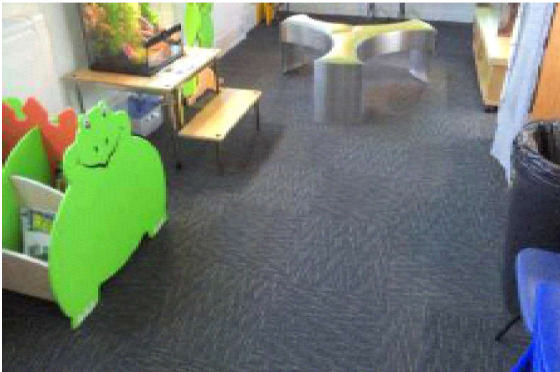
Item 76: Presumed

The bitumen adhesive to the floor below the cement skim to the floor in the reptile room (Room 66) is presumed to contain asbestos.

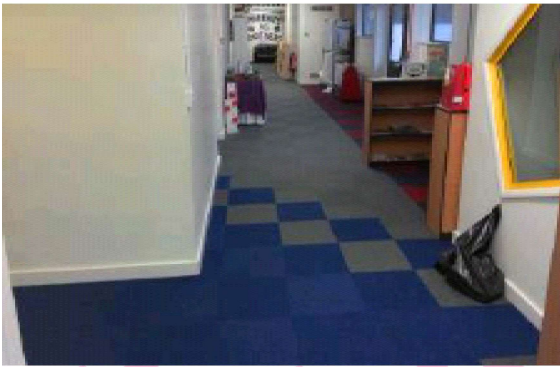
Item 77: NSPS/002

The bitumen adhesive to the floor below the cement skim to the floor in the corridor (Room G002) contains asbestos.

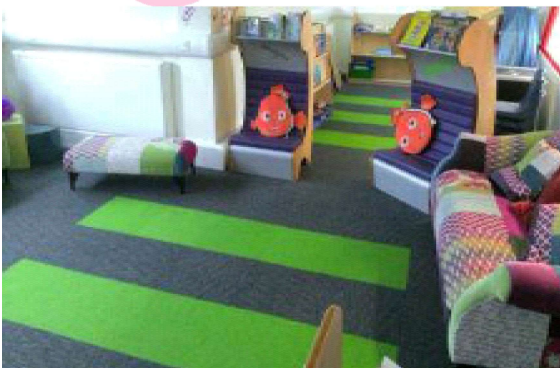
Item 78: Presumed

The bitumen adhesive to the floor below the cement skim to the floor in the library (Room 70) is presumed to contain asbestos.

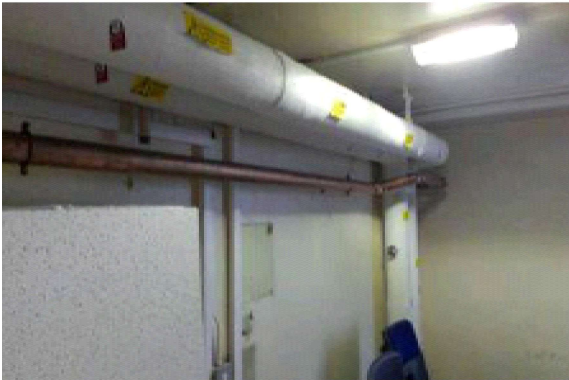
Item 79: KR09/97

The lagging to the pipework in the store (Room 73) is strongly presumed to contain asbestos.

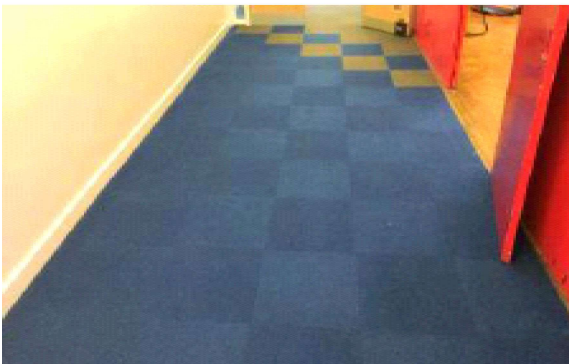
Item 80: Presumed

The vinyl floor tiles beneath the carpet in the corridor (Room 74) are presumed to contain asbestos.

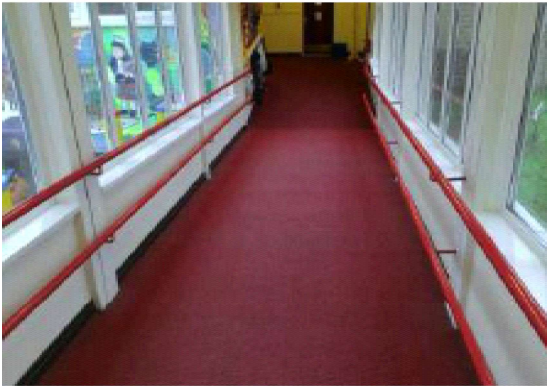
Item 82: Presumed

The vinyl floor tiles beneath the carpet in the corridor (Room 76) are presumed to contain asbestos.

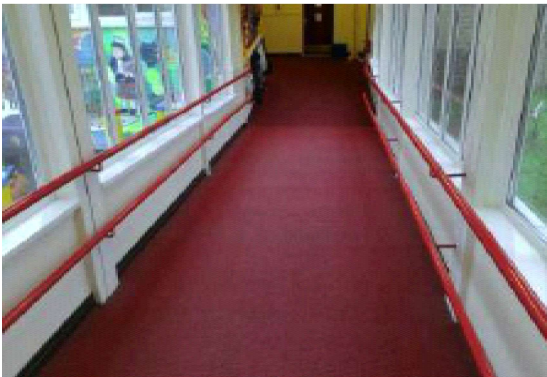
Item 83: Presumed

The bitumen adhesive to the floor in the corridor (Room 76) is presumed to contain asbestos.

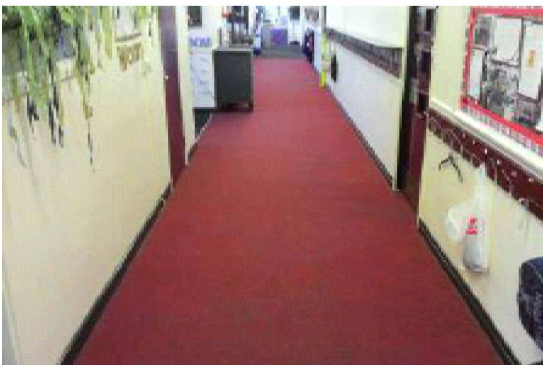
Item 84: Presumed

The vinyl floor tiles beneath the carpet in the corridor (Room 79) are presumed to contain asbestos.

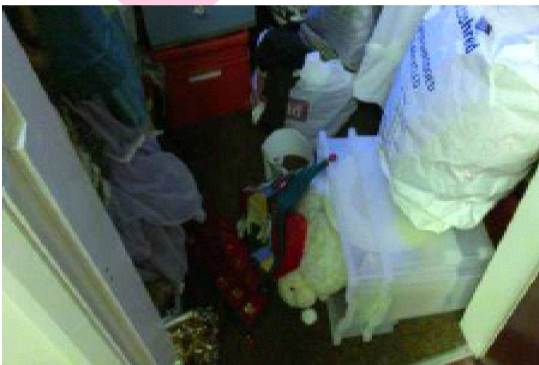
Item 90: Presumed

The vinyl floor tiles beneath the carpet in the store (Room 82) are presumed to contain asbestos.

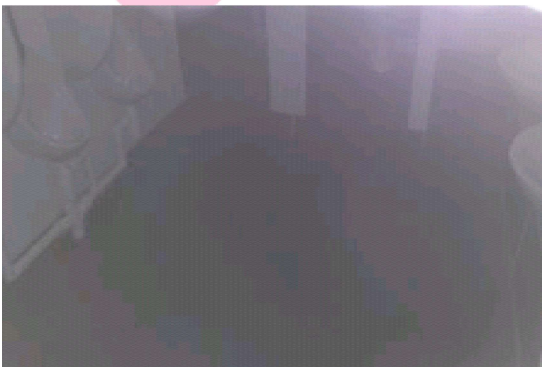
Item 93: Presumed

The bitumen adhesive to the floor below the cement skim to the floor in the Boys toilet (Room 86) is presumed to contain asbestos.

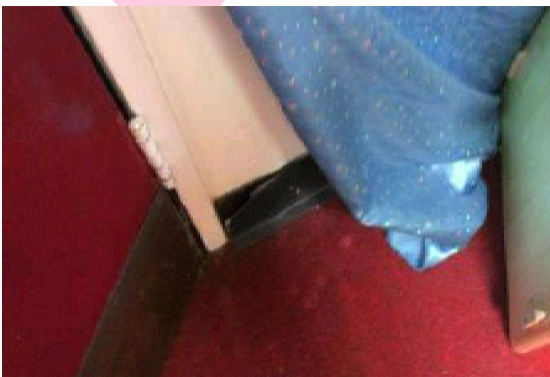
Item 96: Presumed

The skirting to base of wall behind modern in the classroom (Room 87) is presumed to contain asbestos.

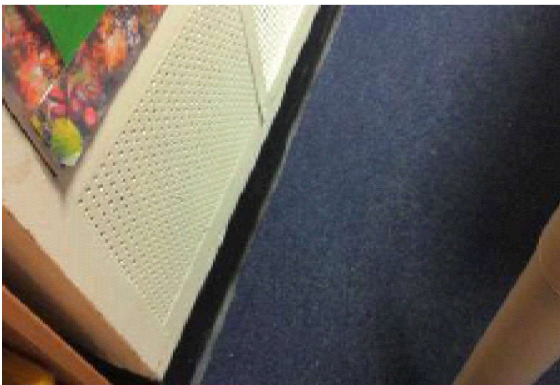
Item 98: Presumed

The skirting to base of wall behind modern in the classroom (Room 88) is presumed to contain asbestos.

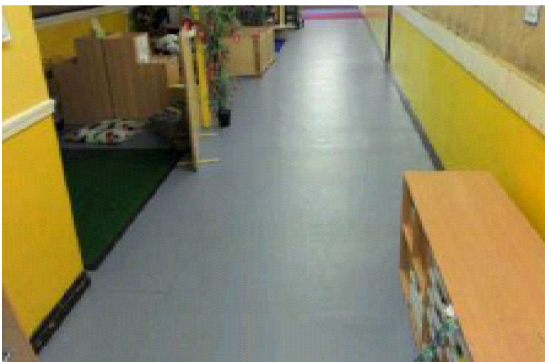
Item 102: Presumed

The vinyl floor tiles beneath the modern lino in the corridor (Room 94) are presumed to contain asbestos.

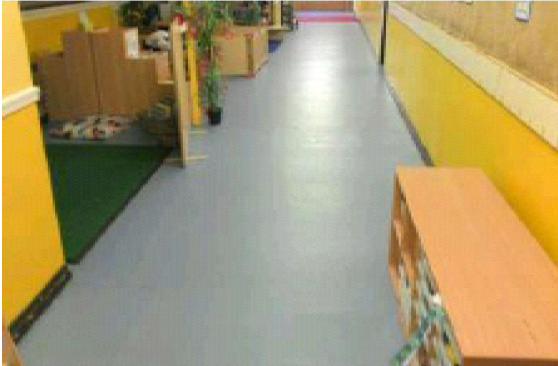
Item 103: NSPS/002

The bitumen adhesive beneath the modern lino to the corridor (Room 010) contains asbestos.

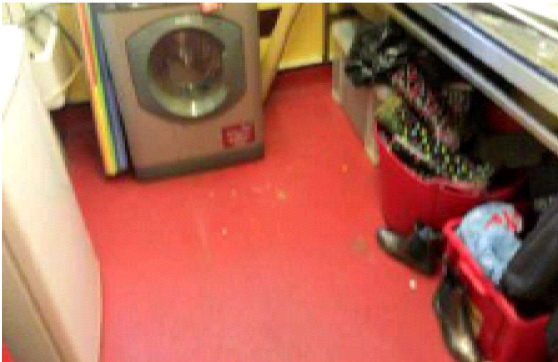
Item 104: Presumed

The bitumen adhesive to the floor in the store (Room 95) is presumed to contain asbestos.

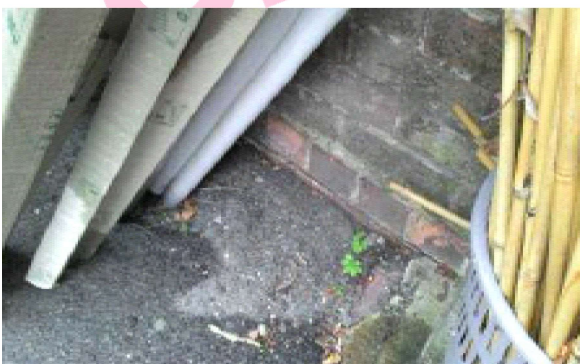
Item 129: KR09/140

The damp proof course to the external of the building contains asbestos.

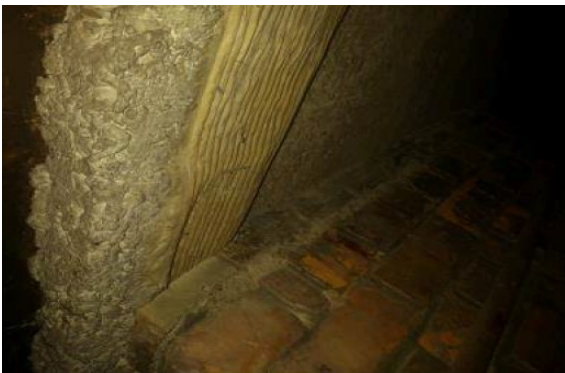
Item 134: BH000572

The insulation debris to straw/concrete duct ceiling in the duct adjacent head teacher's office contains asbestos.

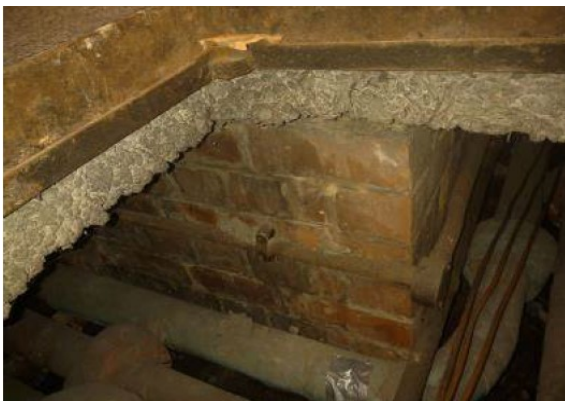
Item 135: BH000573

The insulation debris to brick walls in the duct adjacent head teacher's office contains asbestos.

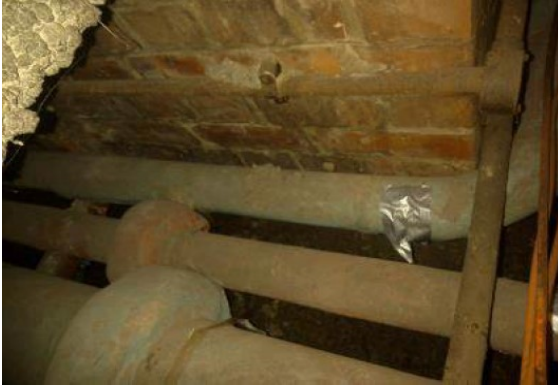
Item 136: BH000574

The small bore insulation – green pipework in the duct adjacent head teacher's office contains asbestos.

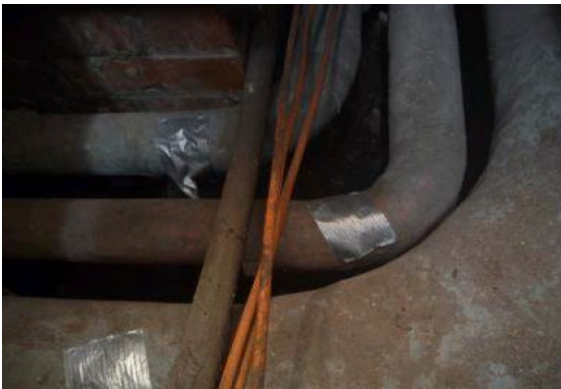
Item 137: BH000575

The small bore insulation – red pipework in the duct adjacent head teacher's office contains asbestos.

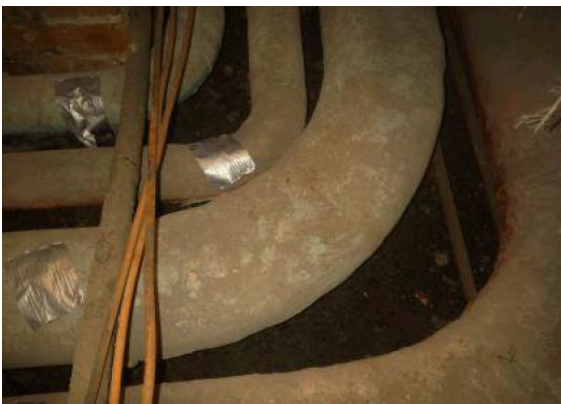
Item 138: BH000576

The large bore insulation – green pipework in the duct adjacent head teacher's office contains asbestos.

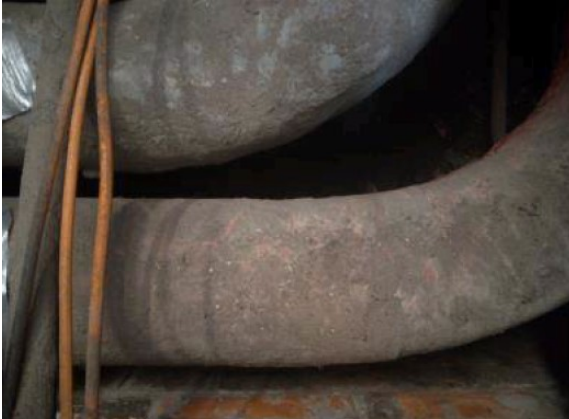
Item 139: BH000577

The large bore insulation – red pipework in the duct adjacent head teacher's office contains asbestos.

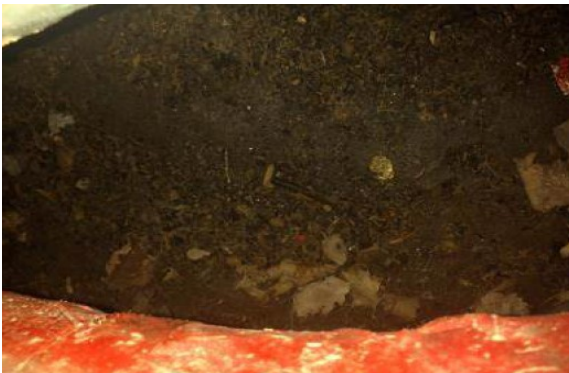
Item 140: BH000578

The insulation debris to concrete floor in the duct adjacent head teacher's office contains asbestos.

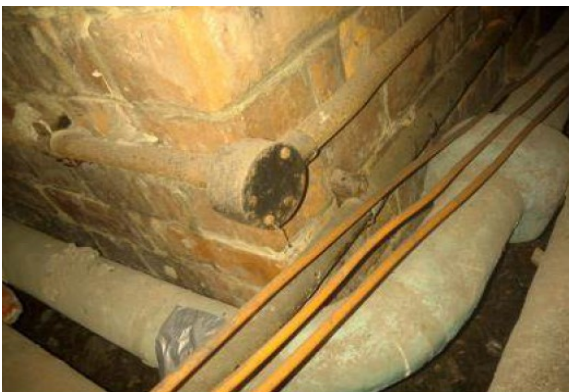
Item 141: BH000579

The insulation debris to metal trunking / cable sheath trunking in the duct adjacent head teacher's office contains asbestos.

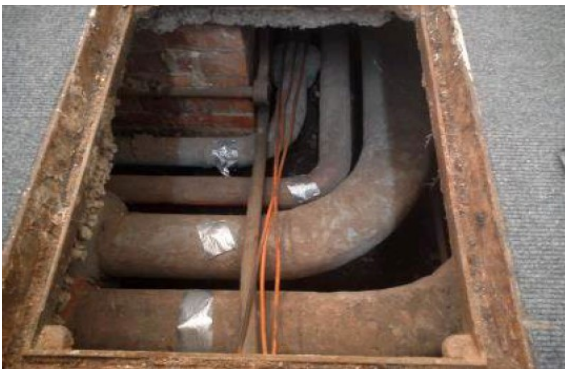
Item 143: Presumed

The mains cable sheath running high level in duct in the duct adjacent head teacher's office is presumed to contain asbestos.

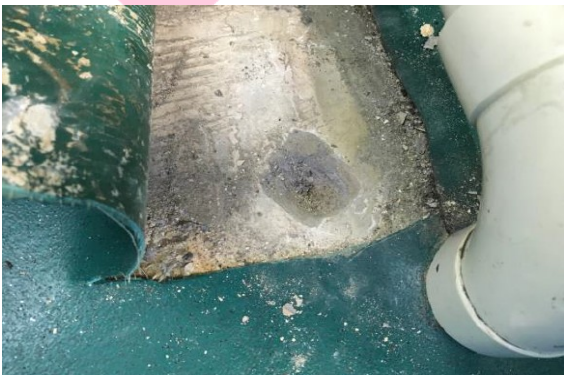
Item 144: BS001666

The floor screed in year 6 Girls toilets does not contain asbestos.
