ASBESTOS SURVEY REPORT FOR GILLAS LANE PRIMARY SCHOOL, HOUGHTON

**GILLAS LANE PRIMARY SCHOOL
HOUGHTON**

Date: 08 January 2025

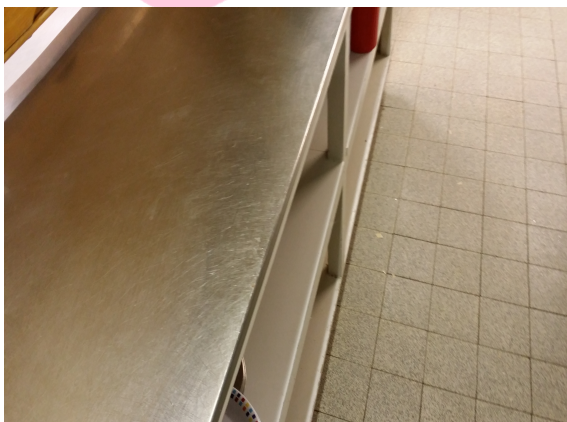
Item 71 – 148020-3

Liner to counter top under stainless steel in the kitchen area does not contain asbestos.

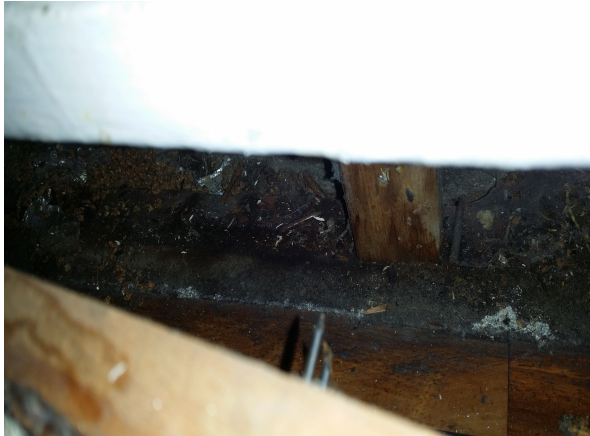
Item 72 – 148020-4

Debris under plinth in the kitchen area does not contain asbestos.

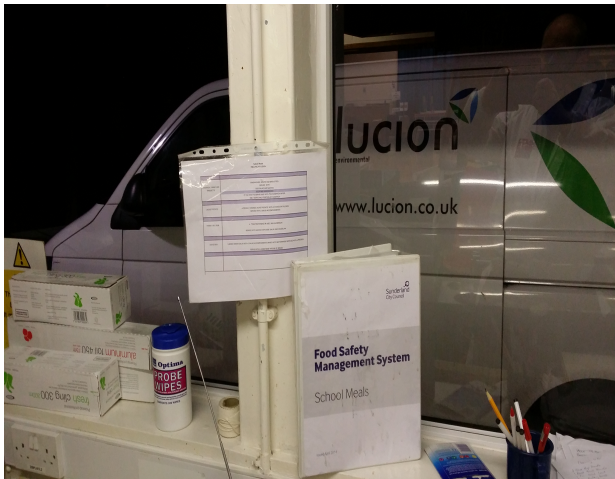
Item 73 - Presumed

Insulation board within columns to rear of the kitchen area. This is presumed to contain asbestos.

Any change should be recorded and passed to Property Services.

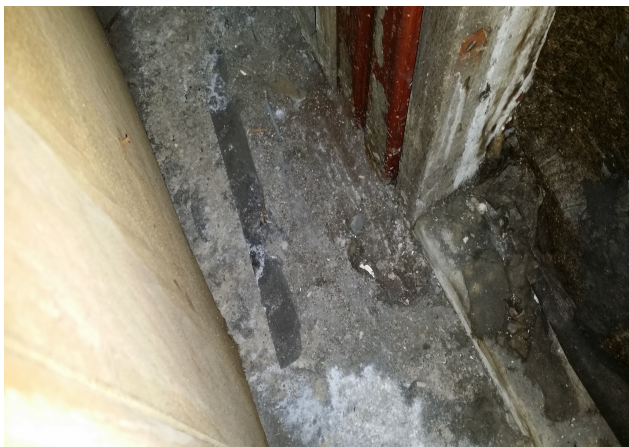
Item 74 – 148020-5

Debris behind rear benches in the kitchen area does not contain asbestos

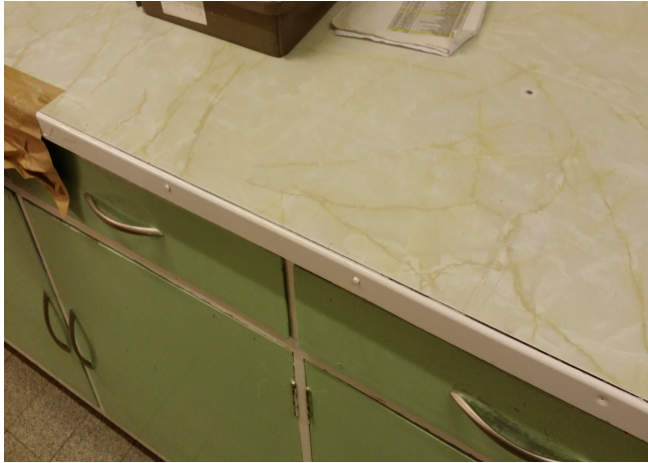
Item 75 – 148020-3

Bench linings in the kitchen area does not contain asbestos

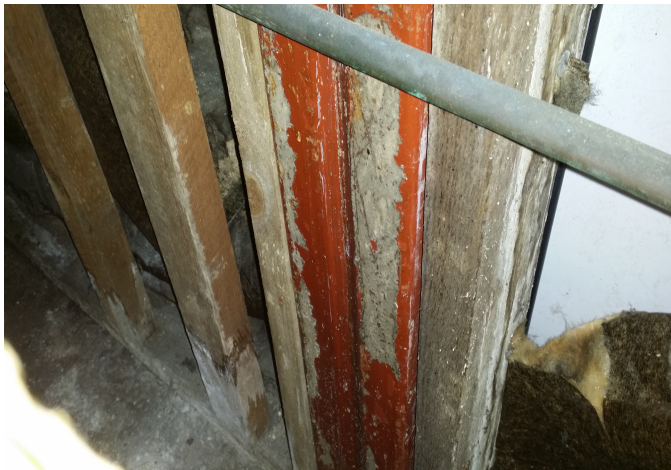
Item 76 – 148020-6

Insulating board debris to column face behind rear benches in the kitchen area does not contain asbestos

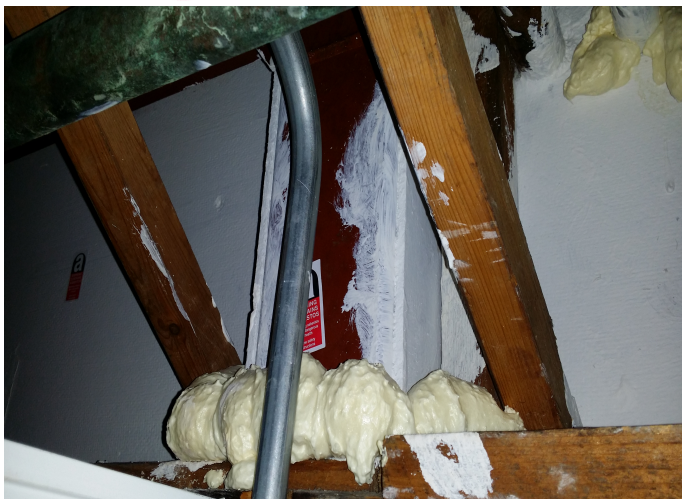
Item 77 – 148020-1

Packers to columns in the void above the suspended ceiling in the kitchen area. This is presumed to contain asbestos.

Any change should be recorded and passed to Property Services.

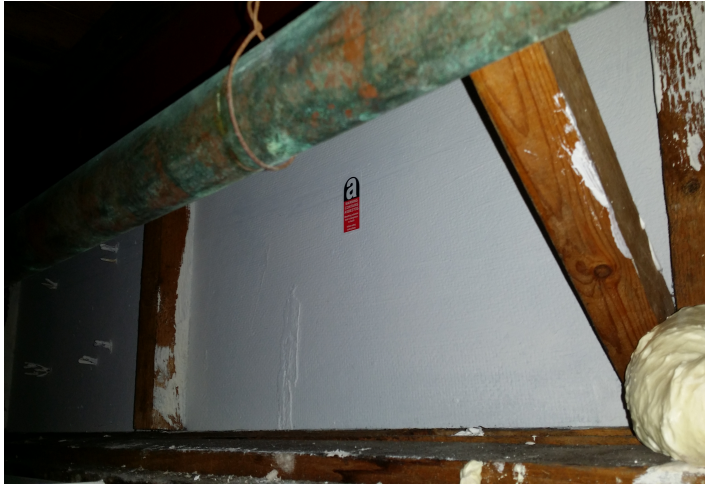
Item 78 – 148020-1

Firebreak to hall in the void above the suspended ceiling in the kitchen area. This is presumed to contain asbestos.

Any change should be recorded and passed to Property Services.

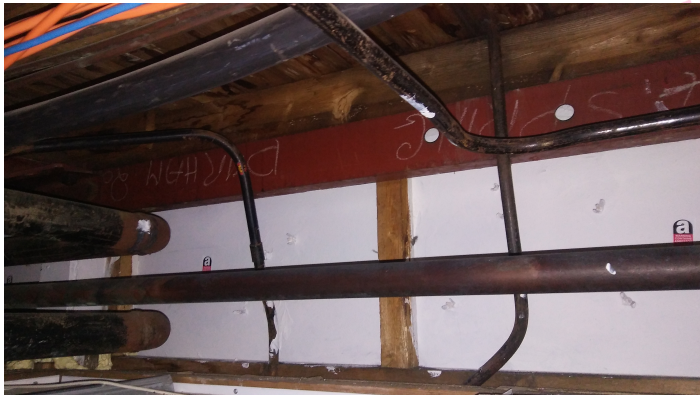
Item 79 – Presumed

Firebreak and packers at column tops in the void above suspension ceiling in the dry store is presumed to contain asbestos.

Any change should be recorded and passed to Property Services.

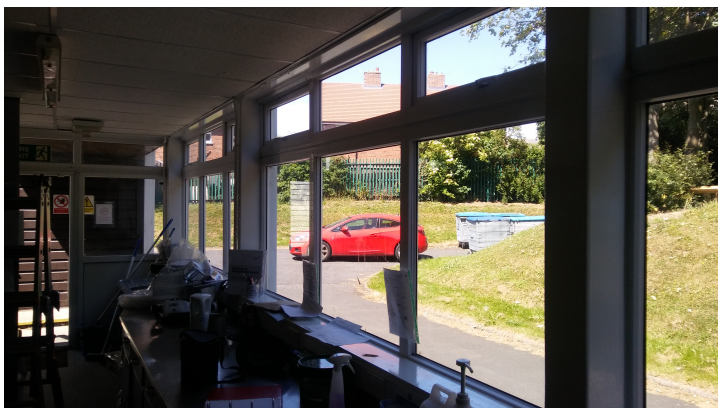
Item 80 – Presumed

The packers within column cladding in the kitchen are presumed to contain asbestos.

Any change should be recorded and passed to Property Services.

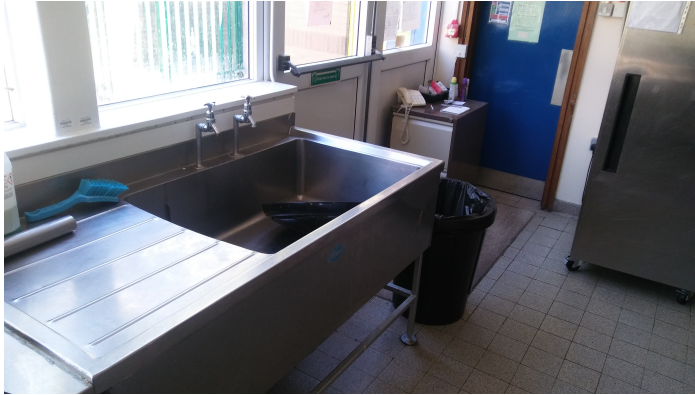
Item 81 – 273862-2

The sink pad in the kitchen contains asbestos.

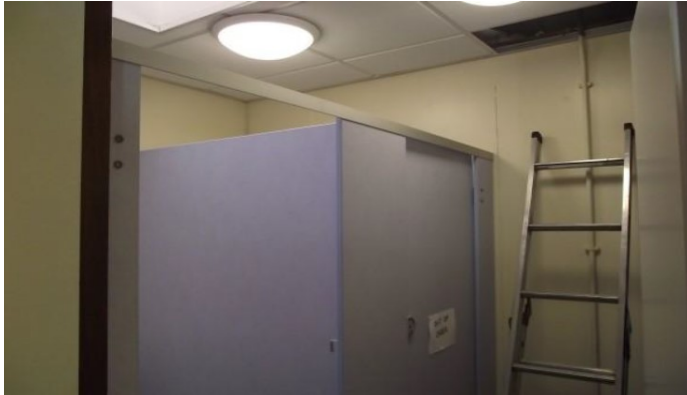
Item 84 – Presumed

The two black toilet seats in KS1 Boys WC's are presumed to contain asbestos.

Removed 2019

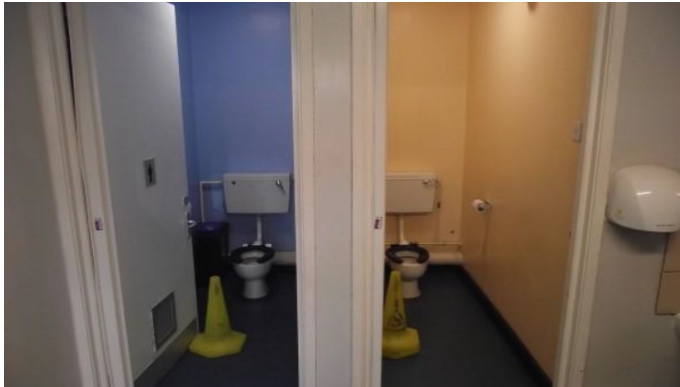
Item 85 – Presumed

The two black toilet seats in East End WC's are presumed to contain asbestos.

Removed 2019

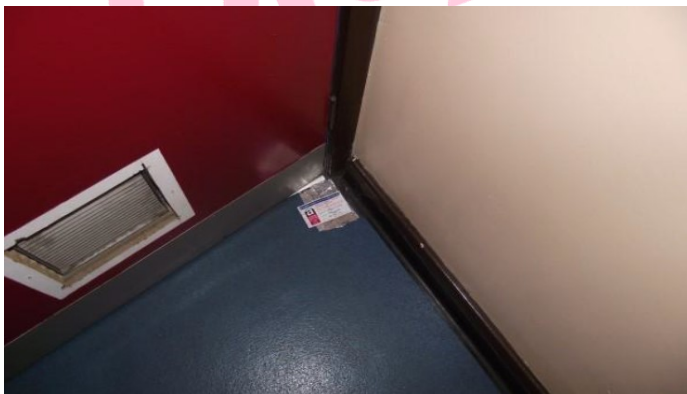
Item 86 – AB487192 476

The floor and adhesive in KS1 Girls Toilets do not contain asbestos.

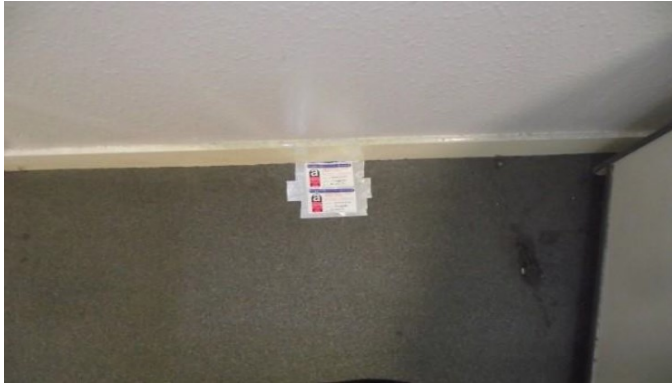
Item 87 – AB487192477

The vinyl sheet in the KS2 WC's corridor does not contain asbestos.

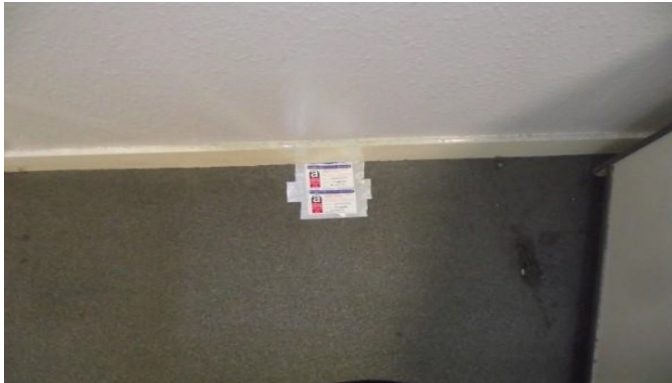
Item 88 – AB487192478

The floor covering adhesive/screed in the KS2 WC's corridor does not contain asbestos.

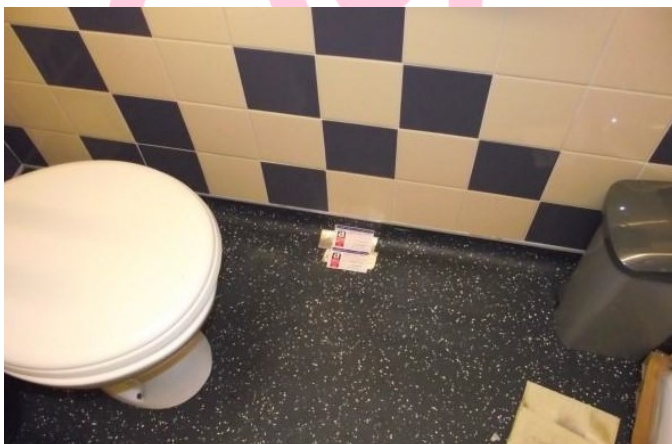
Item 89 – AB487192479

The vinyl sheet in KS2 WC's do not contain asbestos.

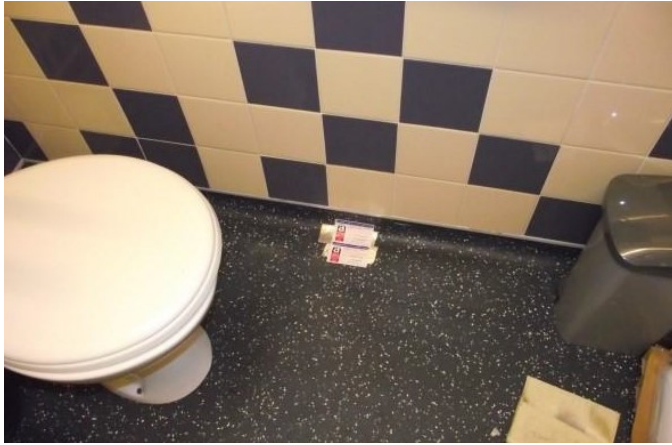
Item 90 – AB487192480

The floor covering adhesive/screed in the KS2 WC's corridor does not contain asbestos.

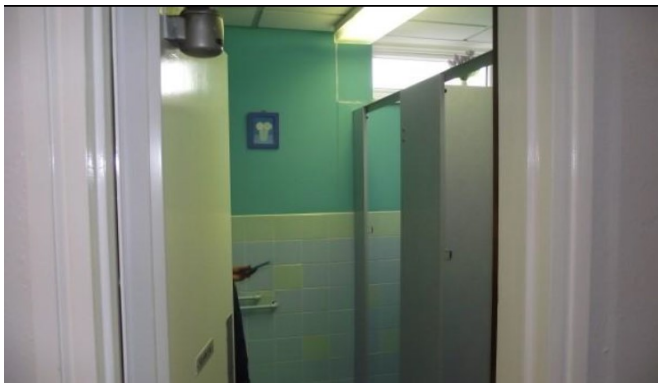
Item 91 – Presumed

The two black toilet seats in KS2 Girls WC's are presumed to contain asbestos.

Removed 2019

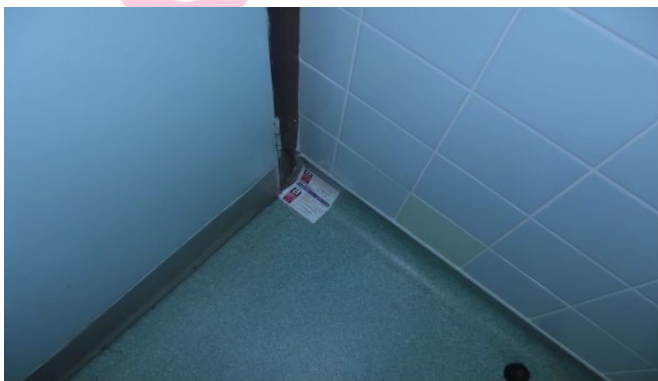
Item 92 – AB487192481

The vinyl sheet in the KS2 Girls WC's does not contain asbestos.

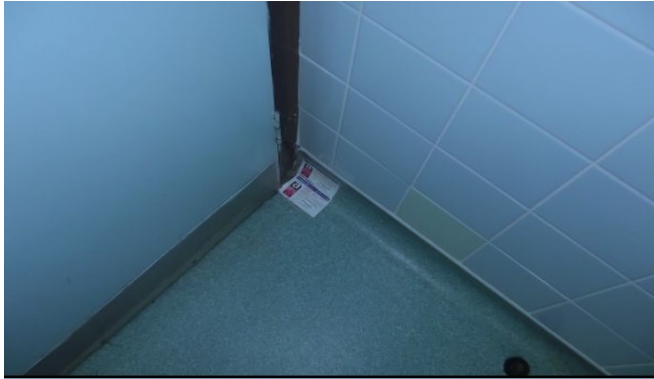
Item 93 – AB487192482

The floor covering adhesive/screed in the KS2 Girls WC's does not contain asbestos.

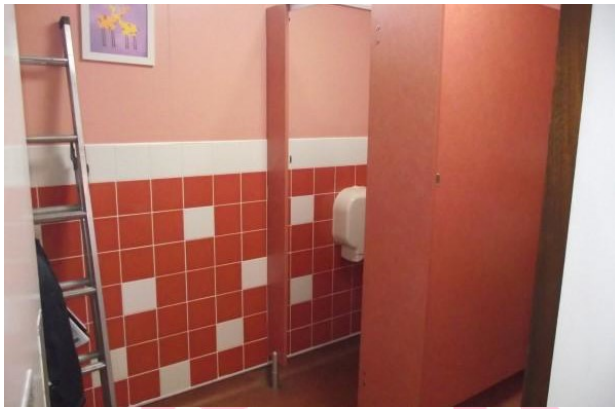
Item 97 – Presumed

The two black toilet seats in KS2 Girls WC's are presumed to contain asbestos.

Removed 2019

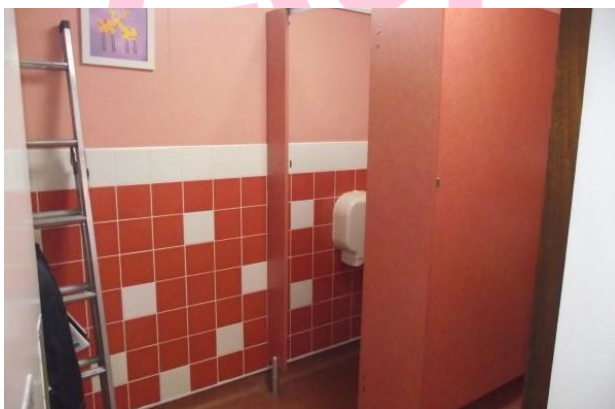
Item 98 – As AB487192483

The vinyl sheet in the KS2 Girls WC's does not contain asbestos.

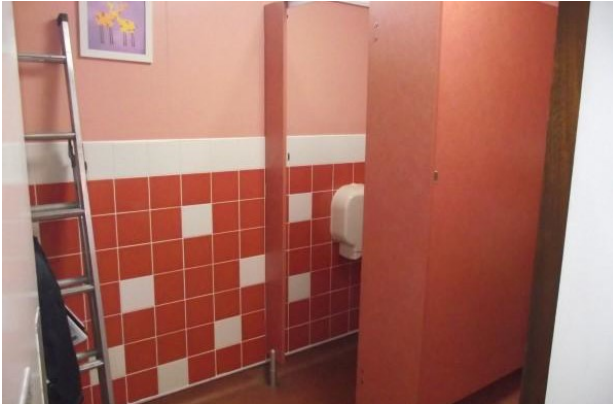
Item 99 – AsAB487192484

The floor covering adhesive/screed in the KS2 Girls WC's does not contain asbestos.

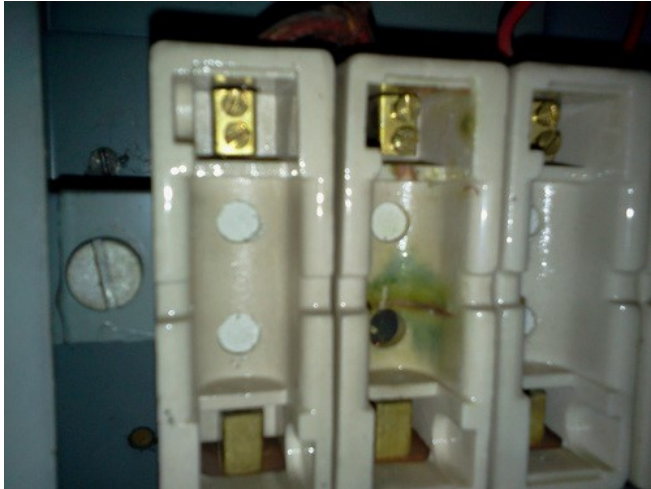
Item 114 – 47413-2

The electrics in Classroom/Rm 011 contain asbestos.

Any change should be recorded and passed to Property Services.

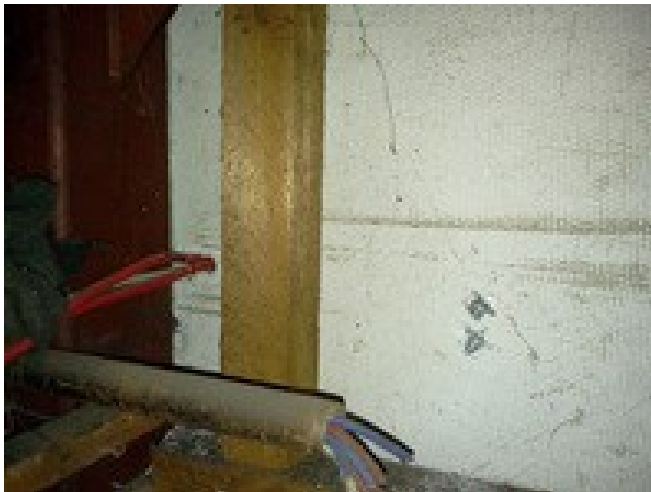
Item 115 – As 47413-4

The unsealed board to rear of main hall in Lobby and reception void above contain asbestos.

Any change should be recorded and passed to Property Services.

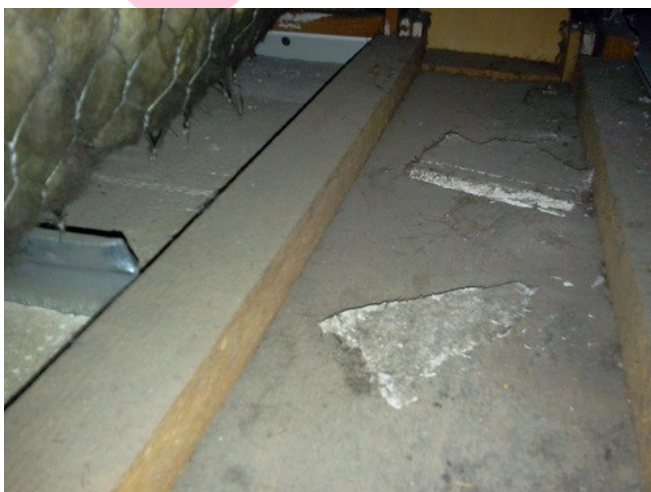
Item 116 – 47413-5

The debris to door frame in Lobby and reception void above/Rm 025 contained asbestos.

Removed 2014

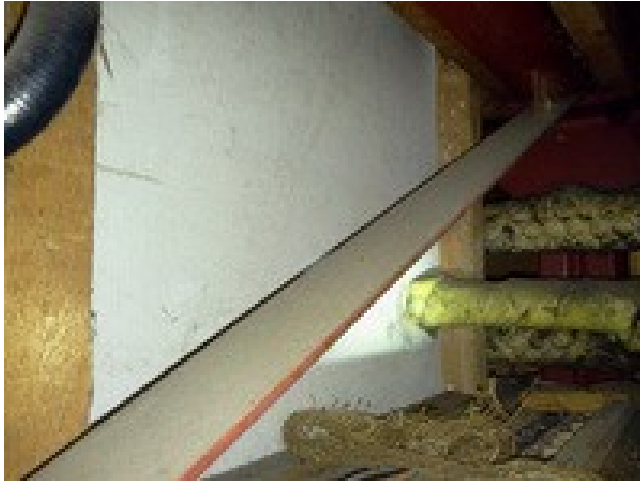
Item 117 – 47413-6

The extract surround in the Store void above/Rm 026 contains asbestos.

Any change should be recorded and passed to Property Services.

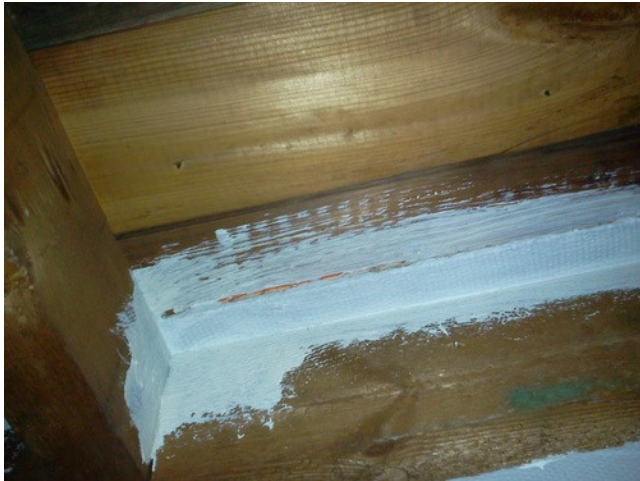
Item 118 – As 47413-6

The fillet above metal extract plate in the Store void above/Rm 026 contains asbestos.

Any change should be recorded and passed to Property Services.

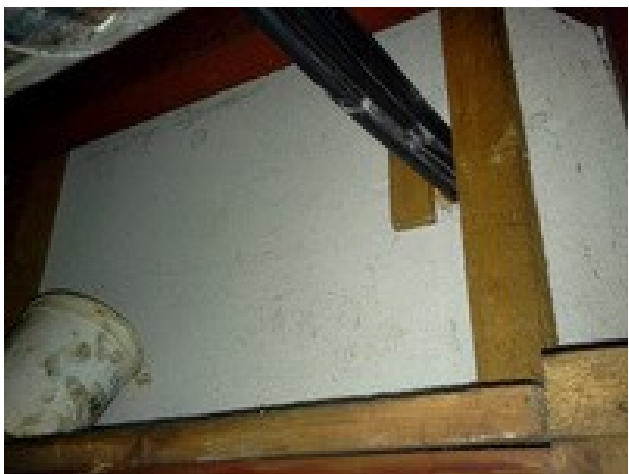
Item 119 – As 47413-7

The unsealed board to rear of main hall in the Corridor void above/Rm 037 contains asbestos.

Any change should be recorded and passed to Property Services.

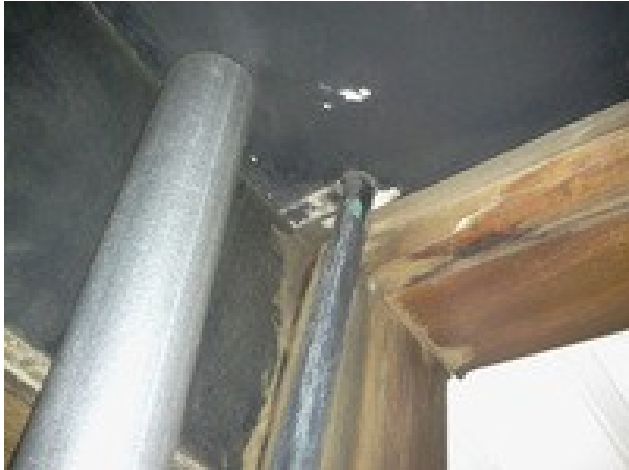
Item 120 – As 47413-3

The ceiling boards in former heater cupboard/Rm 038 contains asbestos.

Any change should be recorded and passed to Property Services.

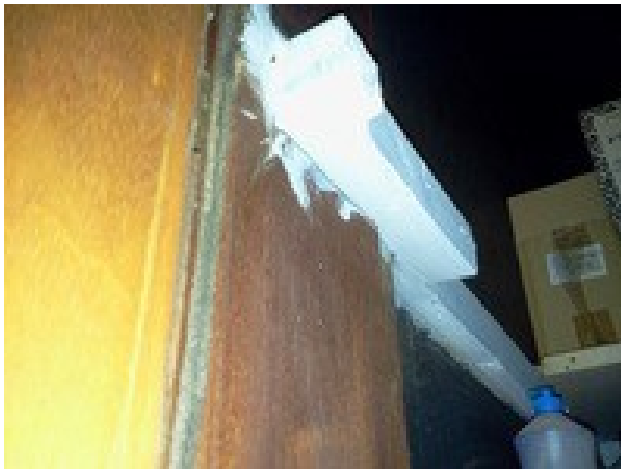
Item 121 – Presumed

The debris in nail holes to battens in the Former heater cupboard/Rm 038 is presumed to contain asbestos.

Removed 2014

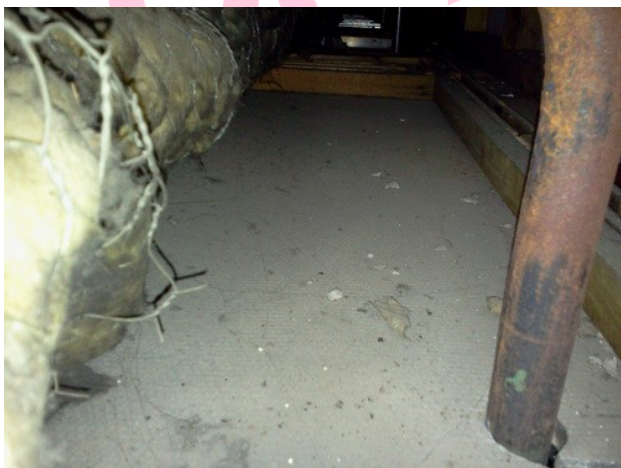
Item 122 – As 47413-3

As 47413-3 – Loose debris (Former heater cupboard void above/Rm 038) (Item 122) – Removed 2014

The loose debris in the Former heater cupboard void above/Rm 038 is presumed to contain asbestos.

| <i>Item 122</i> | <i>Loose debris (Former heater cupboard void above/Rm 038)</i> | <i>Low</i> | | <i>Removed 2014</i> |

Removed 2014

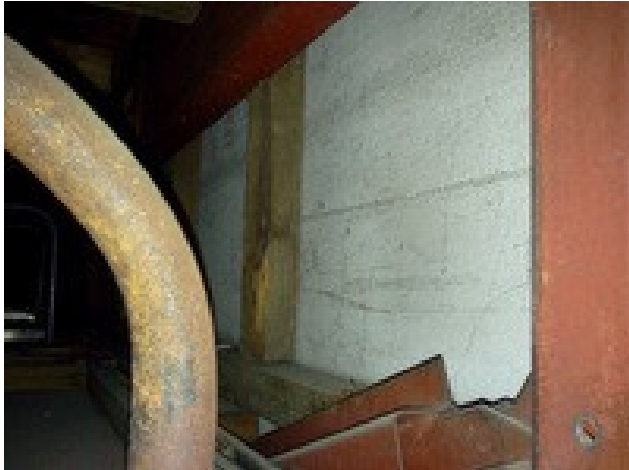
Item 123 – As 47413-7

The unsealed board to rear of main hall in the Former heater cupboard void above/Rm 038 contains asbestos.

Any change should be recorded and passed to Property Services.

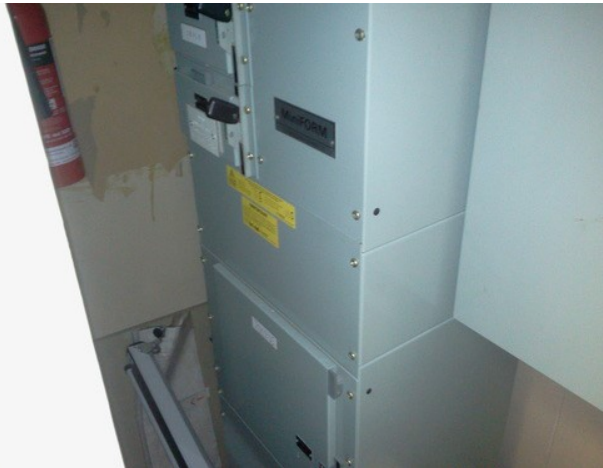
Item 124 – Presumed

The Electrics in the Switch cupboard/Rm 039 is presumed to contain asbestos.

Any change should be recorded and passed to Property Services.

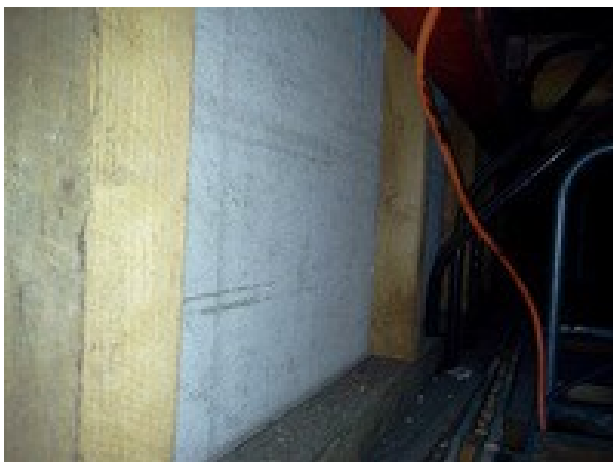
Item 125 – As 47413-7

The unsealed board to rear of main hall wall in Cleaner void above/Rm 040 contains asbestos.

Any change should be recorded and passed to Property Services.

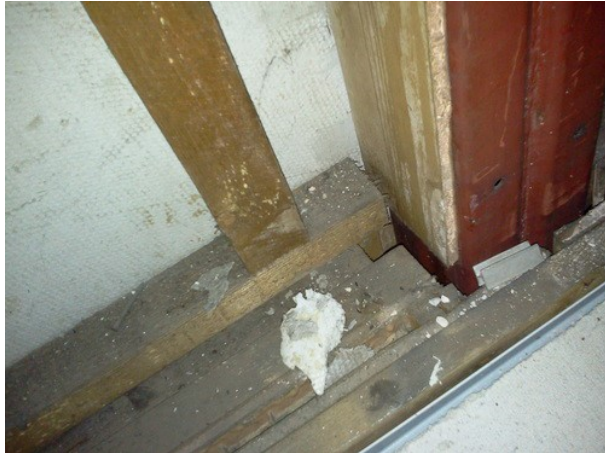
Item 126 – As 47413-3

As 47413-3 – Loose debris (Boys WC void above/Rm 041) (Item 126) – Removed 2014

The loose debris in the Boys WC void above/Rm 041 contains asbestos.

| <i>Item 126</i> | <i>Loose debris (Boys WC void above/Rm 041)</i> | <i>Low</i> | | <i>Removed 2014</i> |

Any change should be recorded and passed to Property Services.

Removed 2014

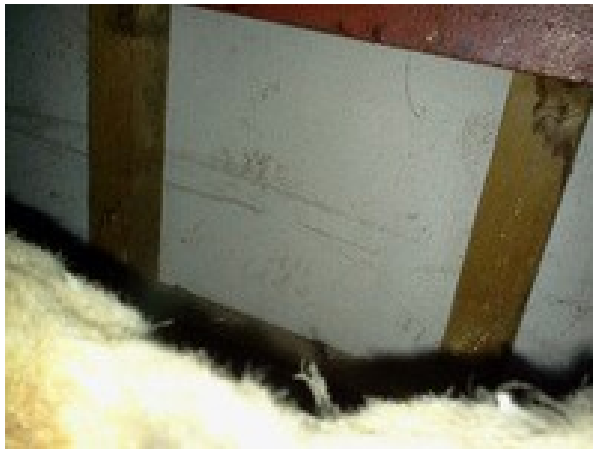
Item 127 – As 47413-7

The unsealed board to rear of main hall wall in the Boys WC void above/Rm 041 contains asbestos.

Any change should be recorded and passed to Property Services.

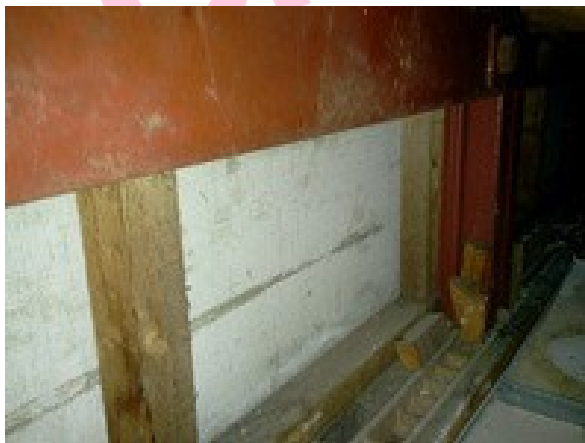
Item 128 – As 47413-7

The unsealed board to rear of main hall wall in the Girls WC void above/Rm 042 contains asbestos.

Any change should be recorded and passed to Property Services.

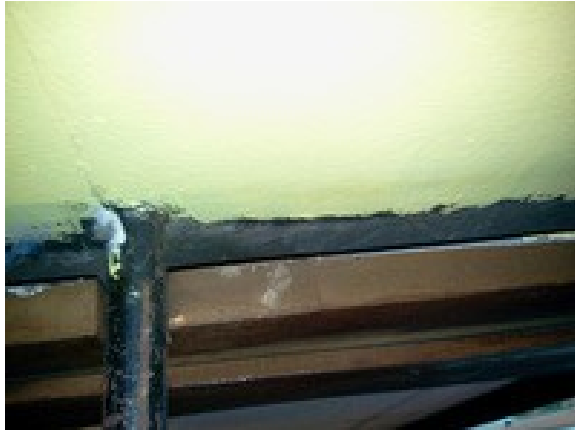
Item 129 – As 47413-3

The ceiling boards in the Former heater cupboard/Rm 043 contain asbestos.

Any change should be recorded and passed to Property Services.

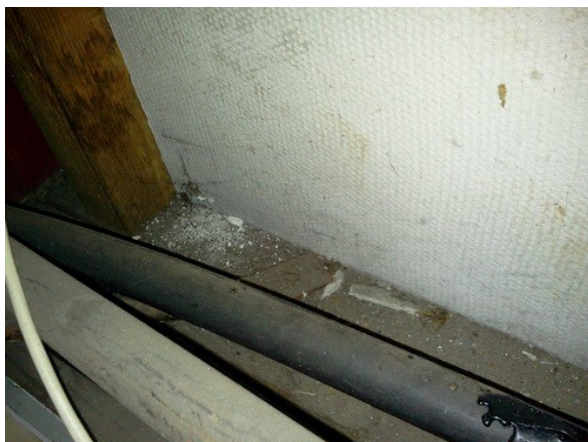
Item 132 – As 47413-3

As 47413-3 – Loose debris (Gym store void above/Rm 045) (Item 132) – Removed 2014

The loose debris in the Gym store void above/Rm 045 contains asbestos.

| <i>Item 132</i> | <i>Loose debris (Gym store void above/Rm 045)</i> | <i>Low</i> | | <i>Removed 2014</i> |

Any change should be recorded and passed to Property Services.

Removed 2014

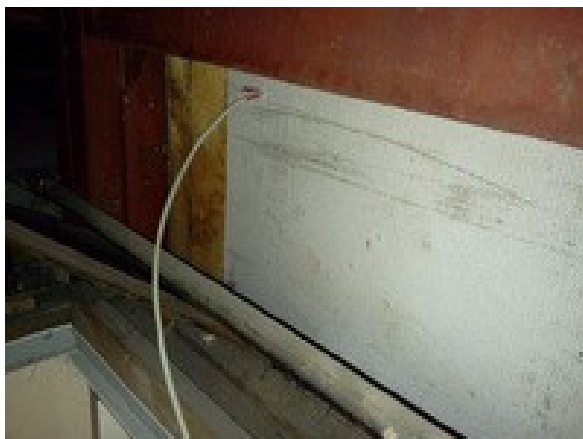
Item 133 – As 47413-3

The unsealed board to rear of main hall wall in the Gym store void above/Rm 045 contains asbestos.

Any change should be recorded and passed to Property Services.

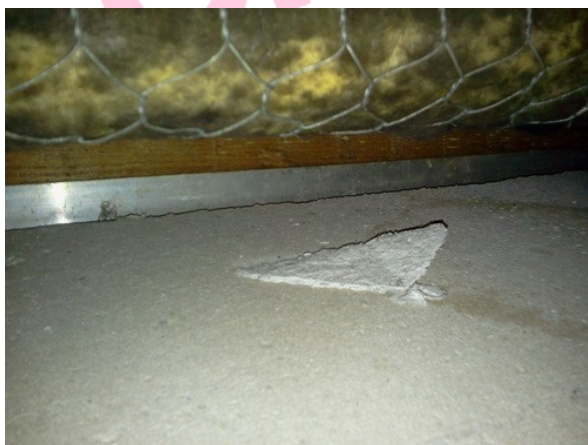
Item 134 – As 47413-7

As 47413-7 – Loose debris (Chair store void above/Rm 046) (Item 134) – Removed 2014

The loose debris in the Chair store void above/Rm 046 contains asbestos.

| <i>Item 134</i> | <i>Loose debris (Chair store void above/Rm 046)</i> | <i>Low</i> | | <i>Removed 2014</i> |

Any change should be recorded and passed to Property Services.

Removed 2014

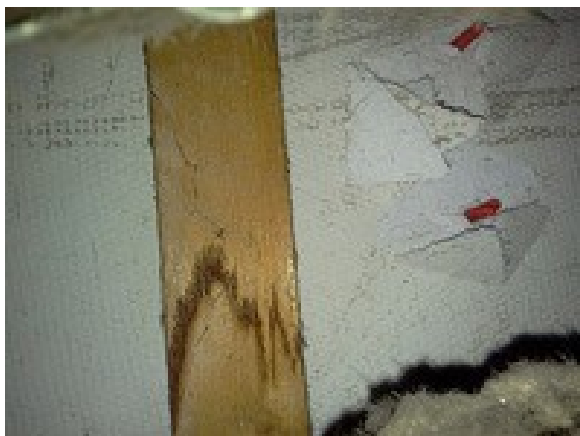
Item 135 – As 47413-7

The unsealed board to rear of main hall wall in the Chair store void above/Rm 046 contains asbestos.

Any change should be recorded and passed to Property Services.

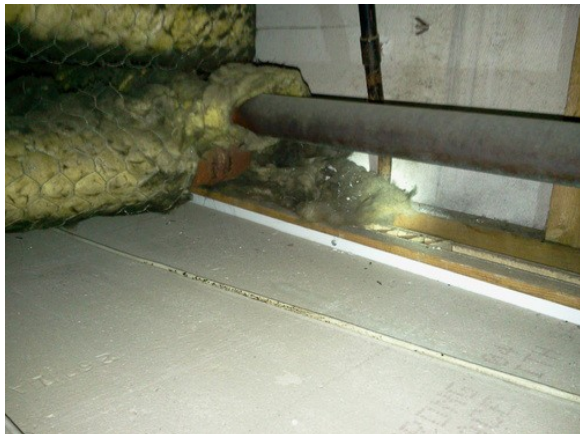
Item 136 – As 47413-7

As 47413-7 – Loose debris (Dry Store void above/Rm 048) (Item 136) – Removed 2014

The loose debris in the Dry Store void above/Rm 048 contains asbestos.

| <i>Item 136</i> | <i>Loose debris (Dry Store void above/Rm 048)</i> | <i>Low</i> | | <i>Removed 2014</i> |

Any change should be recorded and passed to Property Services.

Removed 2014

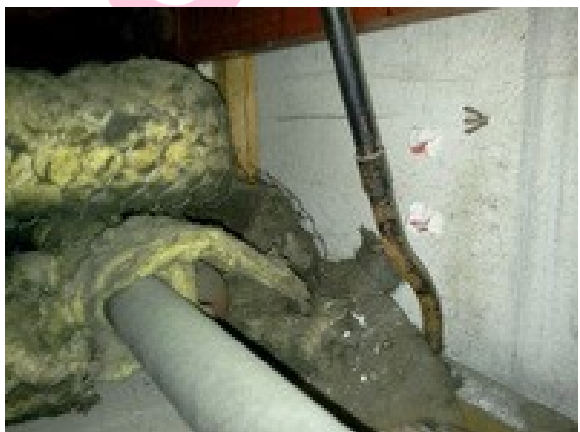
Item 137 – As 47413-7

The unsealed board to rear of main hall wall in the Dry Store void above/Rm 048 contains asbestos.

Any change should be recorded and passed to Property Services.

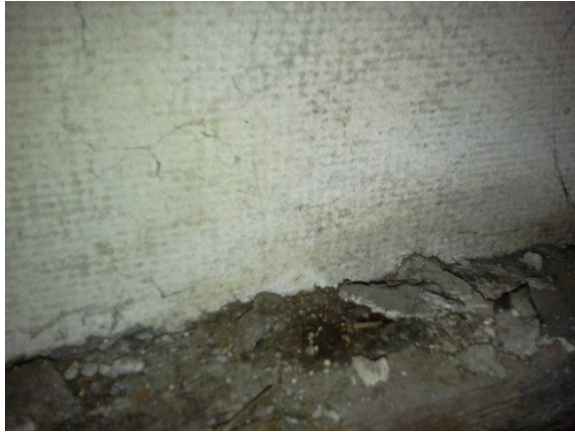
Item 138 – As 47413-7

As 47413-7 – Loose debris (Kitchen void above/Rm 049) (Item 138) – Removed 2014

The loose debris in the Kitchen void above/Rm 049 contains asbestos.

| <i>Item 138</i> | <i>Loose debris (Kitchen void above/Rm 049)</i> | <i>Low</i> | | <i>Removed 2014</i> |

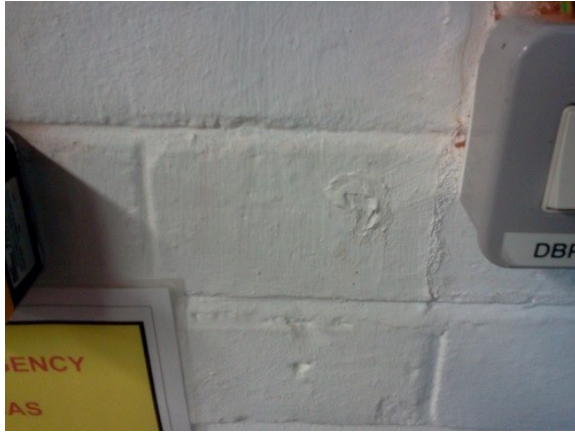
Item 141 – 47413-15

The debris to walls in the Boiler Room/Rm 051 contains asbestos.

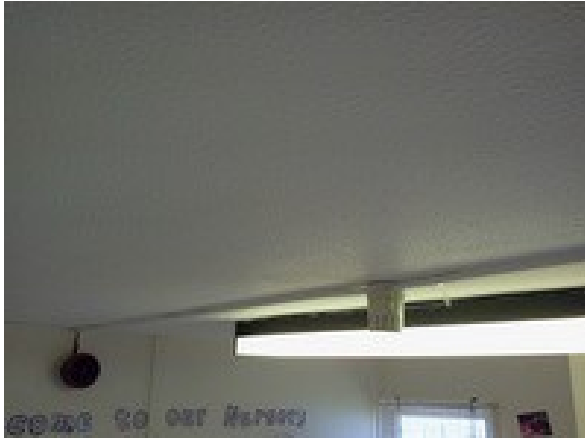
Item 144 – As 47413-13

The coating to plasterboard ceiling in the Entrance Lobby/Rm 002 contains asbestos.

Any change should be recorded and passed to Property Services.

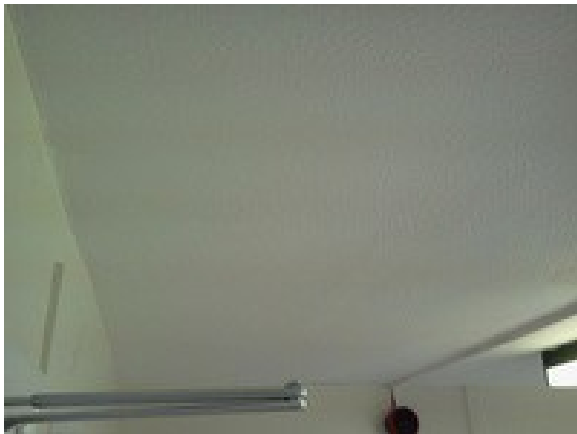
Item 145 – Presumed

The void above fixed ceiling in the Entrance Lobby/Rm 002 is presumed to contain asbestos.

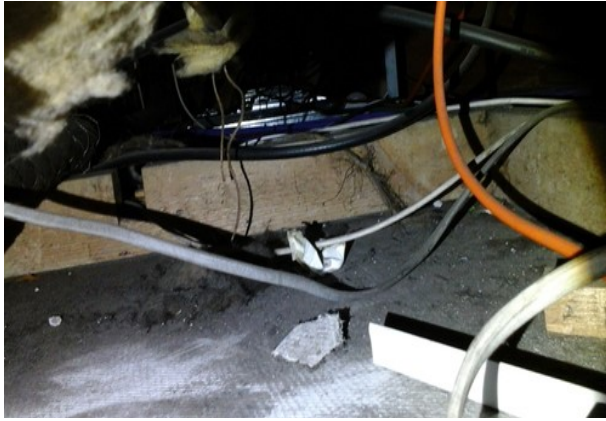
Item 159 – 74282-1

The loose debris in the former staff cloaks void above/Rm 017 contains asbestos.

Any change should be recorded and passed to Property Services.

Removed 2015

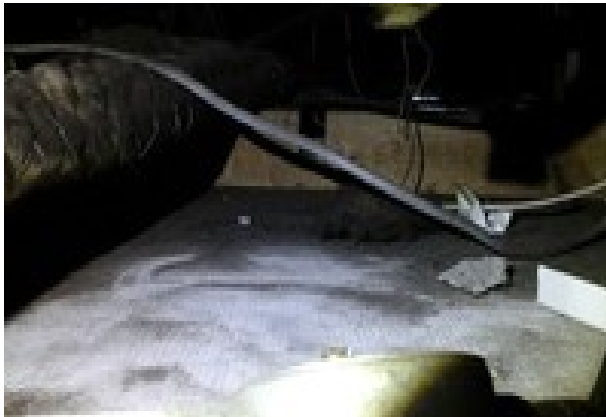
Item 160 – 74282-2

The top of ceiling to redundant heater in the former staff cloaks void above/Rm 017 contains asbestos.

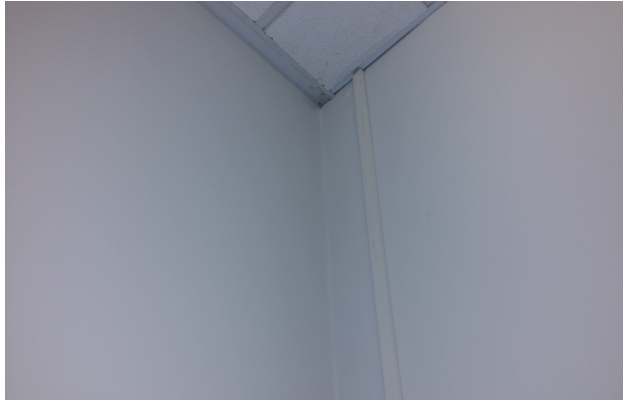
Item 171 – As 230423-1

The cladding to columns behind plasterboard walls in the Corridor/Rm 008 contains asbestos.

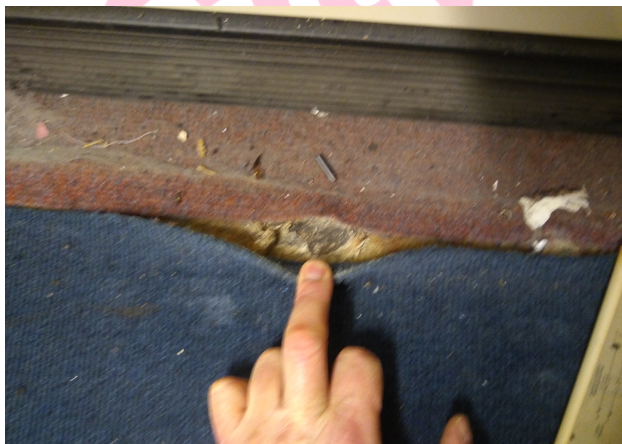
Item 176 – 386839-1

The floor screed in the Classroom/Office Rm 0/001 does not contain asbestos.

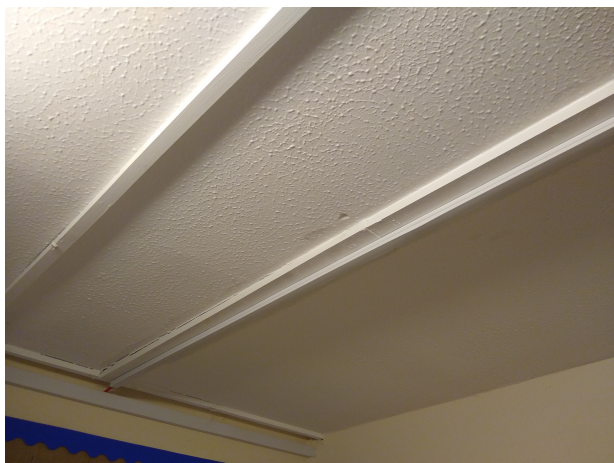
Item 177 – As 47413-13

The coating to plasterboard ceiling in the Entrance Lobby/Rm 0/002 contains asbestos.

Any change should be recorded and passed to Property Services.

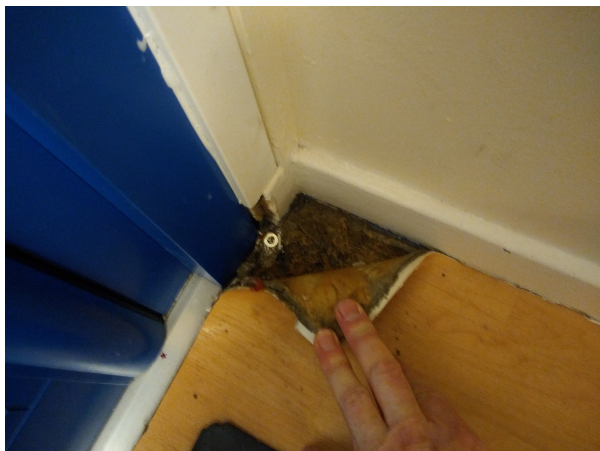
Item 178 – As 386839-1

The floor screed in the Entrance Lobby/Rm 0/002 does not contain asbestos.

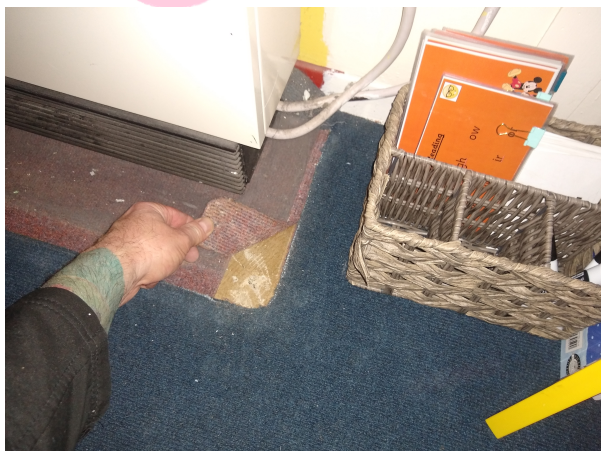
Item 179 – As 386839-1

The floor screed in the Entrance Lobby/Rm 0/002 does not contain asbestos.

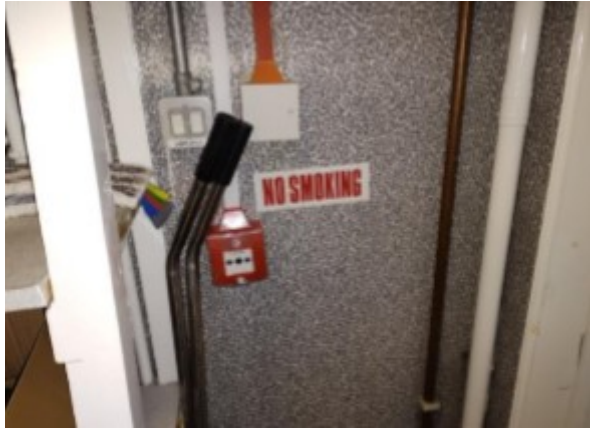
Item 180 – 20-28742-1

The walls in the kitchen do not contain asbestos.

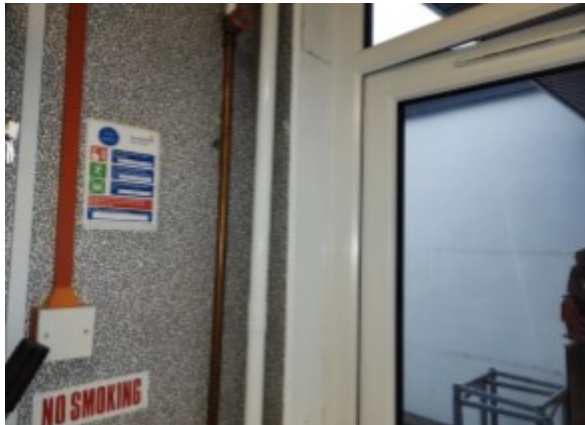
Item 181 – 20-28742-2

The boxing in the kitchen does not contain asbestos.

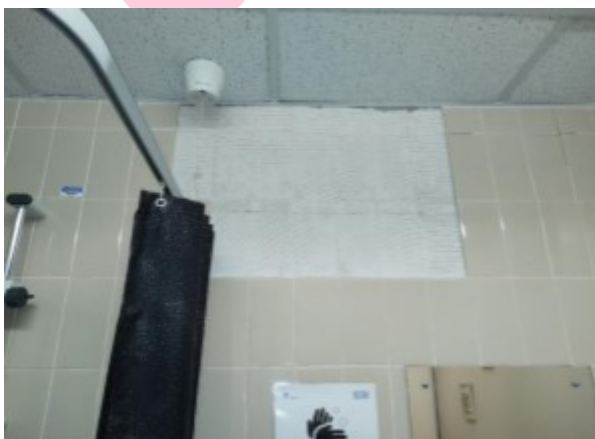
Item 182 – 2-31309-1

The ceramic tile adhesive to the walls in the WC/Shower Room (Area 1) does not contain asbestos.

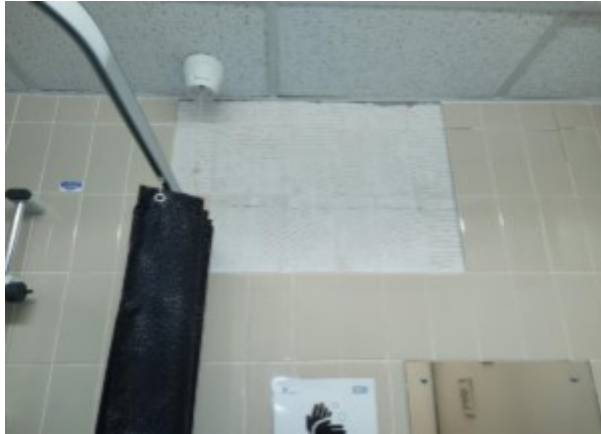
Item 183 – 21-31309-2

The putty to the shower tray in the WC/Showers Room (Area 1) does not contain asbestos.

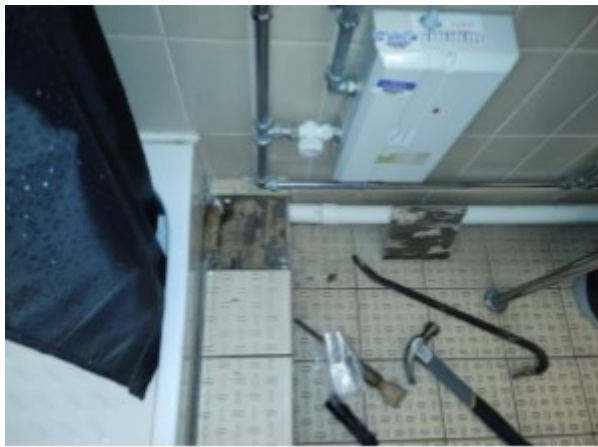
Item 184 – 21-31309-3

The ceramic tile adhesive to the floor in the WC/Showers Room (Area 1) does not contain asbestos.

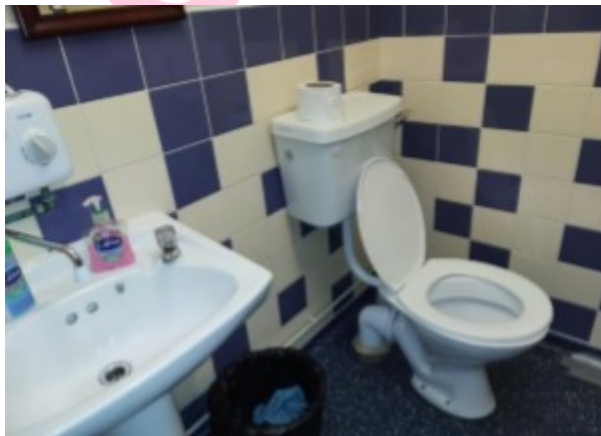
Item 185 – 21-31309-3

The ceramic tile adhesive to the walls in the Toilet (Area 3) does not contain asbestos.
