ASBESTOS SURVEY REPORT FOR REDBY PRIMARY SCHOOL, SUNDERLAND

Asbestos Register for REDBY ACADEMY

Date: 07/07/2025

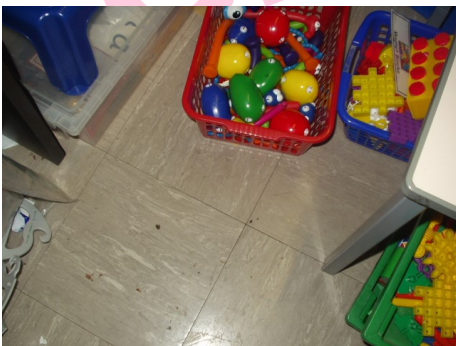
Various - Ref:AW0842/08

The grey floor tile to the store cupboard (Rm 0/07) does not contain asbestos.

Similar flooring is located in rooms 0/08, 0/09, 0/11, 0/12, 0/17, 0/93, 0/102, 0/105 and 0/108.

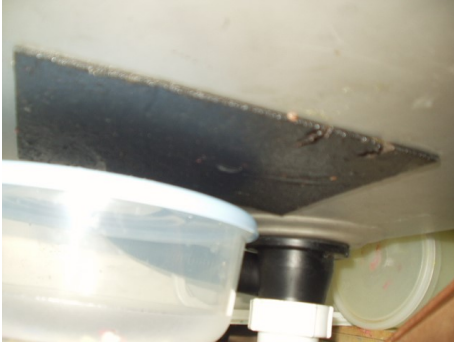
Item 8 - Ref: AW0843/08

The sink pad to the classroom (Rm 0/14) does not contain asbestos.

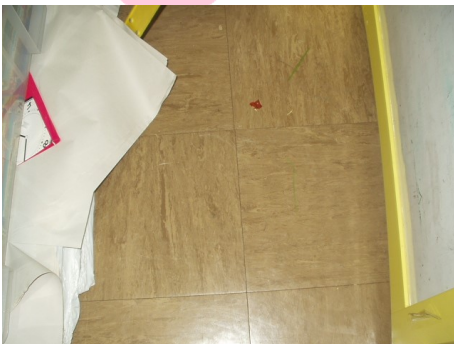
Item 11 - Ref:AW0845/08

The brown floor tiles to the store cupboard (Rm 0/24) do not contain asbestos.

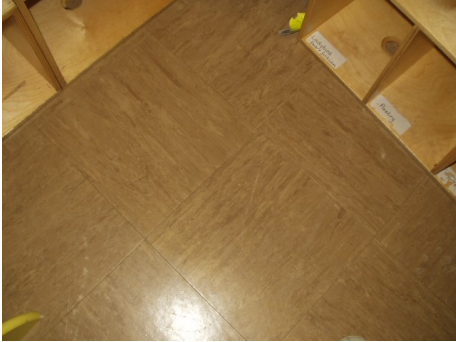
Various- Ref: AW0846/08

The brown floor tiles to the store cupboard (Rm 0/27) do not contain asbestos.

Similar floor tiles are located in rooms 0/30, 0/33, 0/37, 0/44, 0/46, 0/48, 0/88, 0/89 and 0/101.

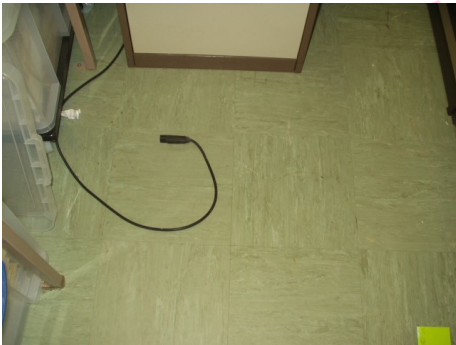
Various- Ref: AW0847/08

The green floor tiles to the store cupboard (Rm 0/31) do not contain asbestos.

Similar flooring is located in rooms 0/64 and 0/74.

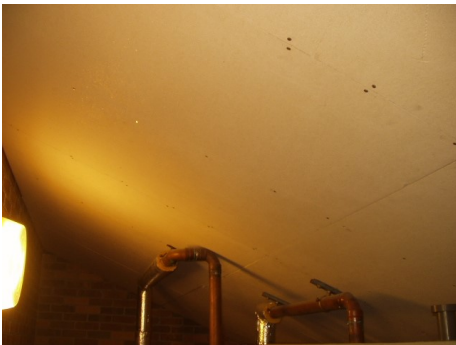
Item 29 - Ref: AW0848/08

The ceiling to the boiler room (Rm 0/84) does not contain asbestos.

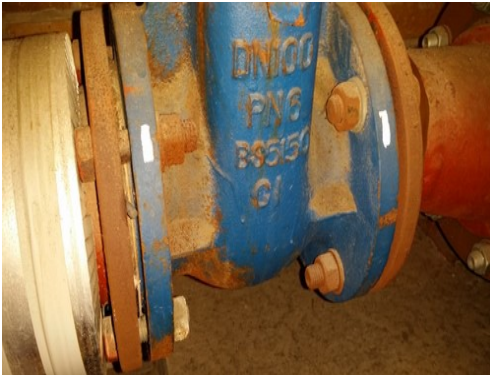
Item 30 – Ref: 102024-1

The 2 gaskets to the pipework in the boiler room (Rm 0/84 – location 1) contain asbestos.

Removed July 2022

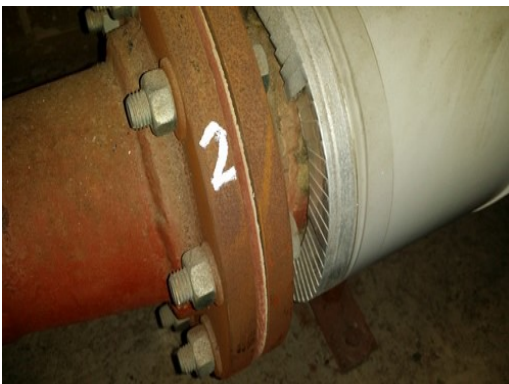
Item 31 – Ref: 102024-2

The gasket to the pipework in the boiler room (Rm 0/84 – location 2) contains asbestos.

Removed July 2022

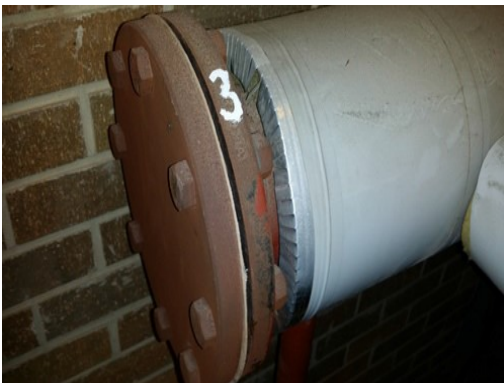
Item 32 – Ref: 102024-3

The gasket to the pipework in the boiler room (Rm 0/84 – location 3) contains asbestos.

Removed July 2022

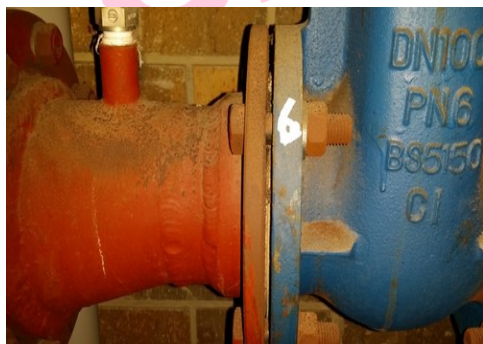
Item 35 – Ref: 102024-6

The gasket to the pipework in the boiler room (Rm 0/84 – location 6) contains asbestos.

Removed July 2022

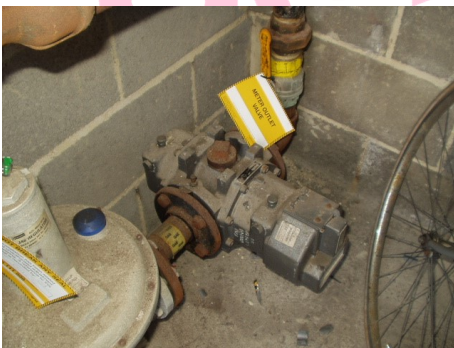
Item 38 - Ref: 102024-8

The flange gaskets to the pipework in the gas intake room (Rm 0/85) do not contain asbestos.

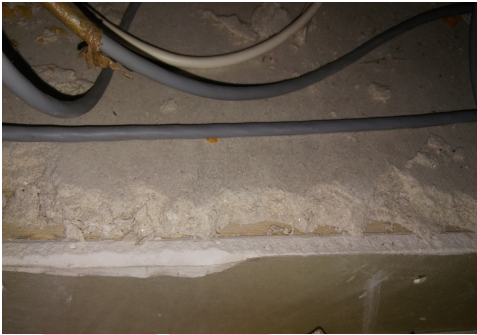
Item 48 Ref: As 278204-1

The topside of the fixed ceiling in the void above the kitchen cloakroom (Room 082) does not contain asbestos.

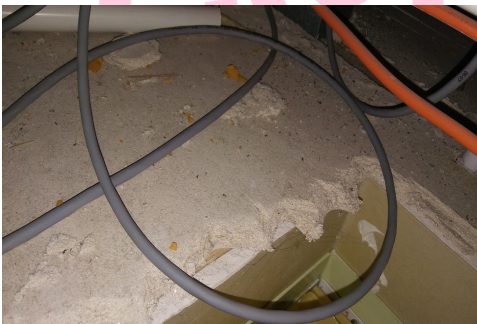
Item 49 Ref: As 278204-1

The topside of the fixed ceiling in the void above the kitchen wc (Room 083) does not contain asbestos.

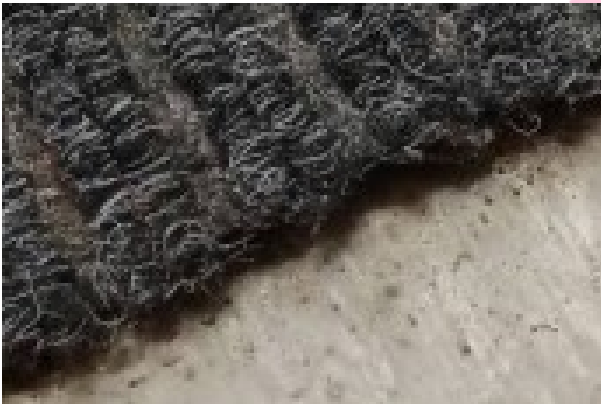
Item 54 Ref: AT000102

The floor covering and adhesive in the Nursery Cloakroom does not contain asbestos.

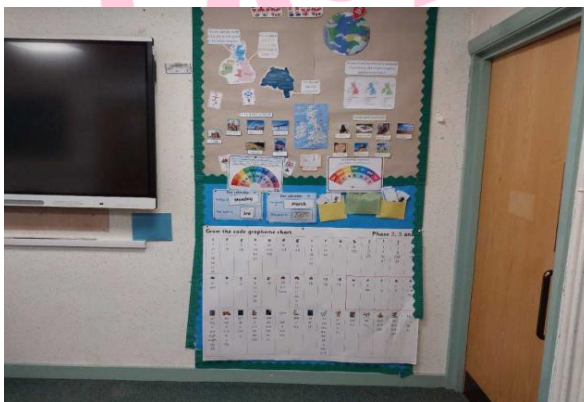
Item 58 Ref: 25-84779-4

The textured coating to walls (Rainbow Room Rm 001) do not contain asbestos.

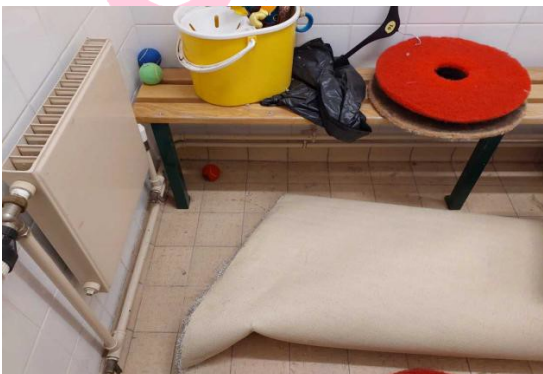
Item 61 Ref: 25-84779-3

The ceramic tiles to floor (adhesive) (Shower Rm 004) do not contain asbestos.
