ASBESTOS SURVEY REPORT FOR REDBY PRIMARY SCHOOL, SUNDERLAND

Asbestos Register for REDBY ACADEMY

Redby Academy - Last updated 30/09/2024 – Version 2

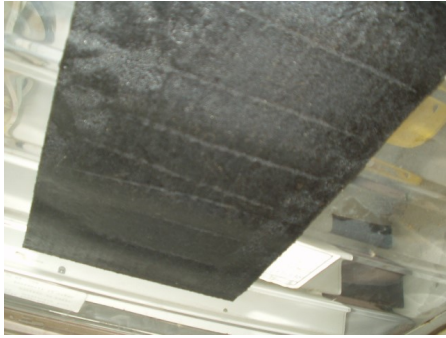
Item 1 Ref: AW0861/08

The sink pad to the Reception Classroom (Rm 0/05) does not contain asbestos.

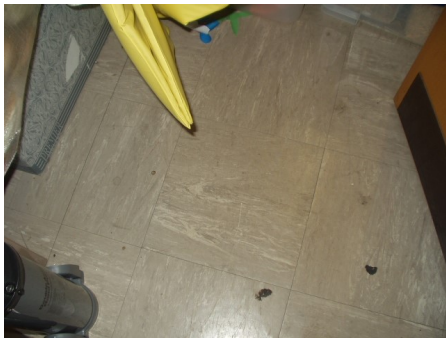
Item 2 - Ref: AW0841/08

The grey floor tiles to the store cupboard (Rm 0/06) do not contain asbestos.

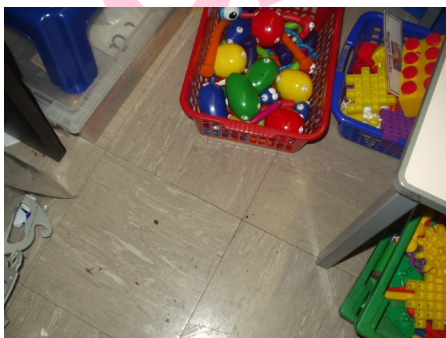
Various - Ref:AW0842/08

The grey floor tile to the store cupboard (Rm 0/07) does not contain asbestos.

Similar flooring is located in rooms 0/08, 0/09, 0/11, 0/12, 0/17, 0/93, 0/102, 0/105 and 0/108.

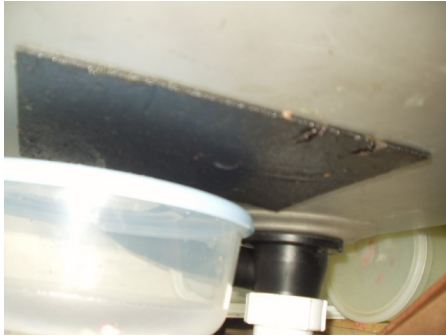
Item 8 - Ref: AW0843/08

The sink pad to the classroom (Rm 0/14) does not contain asbestos.

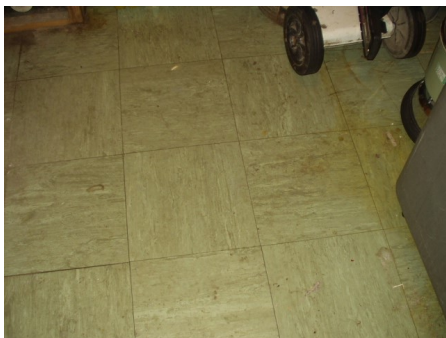
Various - Ref:AW0844/08

The green floor tiles to the cleaners cupboard (Rm 0/22) do not contain asbestos.

Similar floor tiles are located in rooms 0/39, 0/52, 0/55, 0/56, 0/65, 0/70 and 0/71.

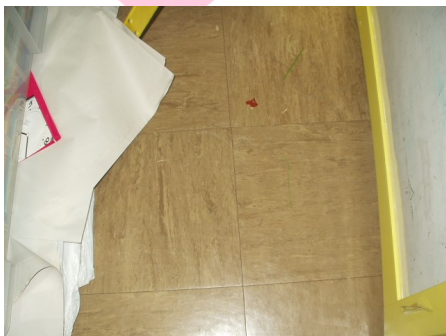
Item 11 - Ref:AW0845/08

The brown floor tiles to the store cupboard (Rm 0/24) do not contain asbestos.

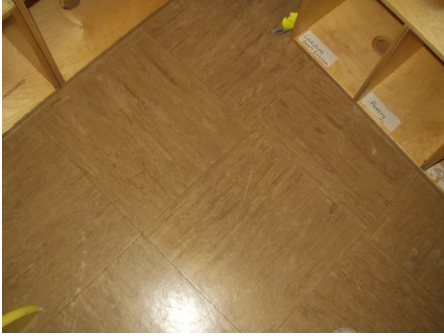
Various- Ref: AW0846/08

The brown floor tiles to the store cupboard (Rm 0/27) do not contain asbestos.

Similar floor tiles are located in rooms 0/30, 0/33, 0/37, 0/44, 0/46, 0/48, 0/88, 0/89 and 0/101.

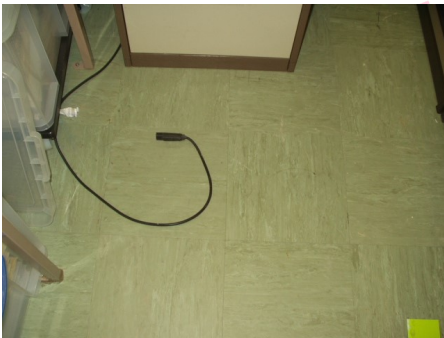
Various- Ref: AW0847/08

The green floor tiles to the store cupboard (Rm 0/31) do not contain asbestos.

Similar flooring is located in rooms 0/64 and 0/74.

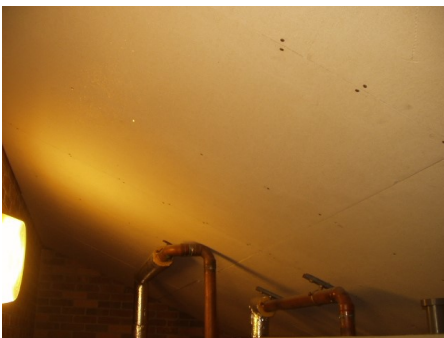
Item 29 - Ref: AW0848/08

The ceiling to the boiler room (Rm 0/84) does not contain asbestos.

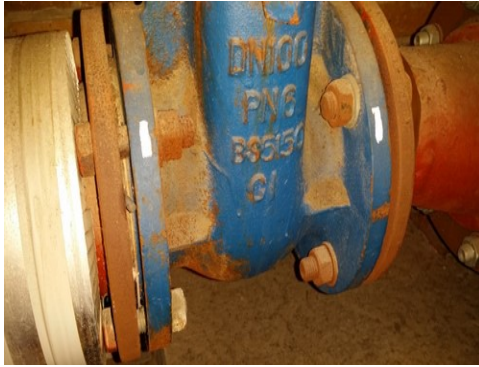
Item 30 – Ref: 102024-1

The 2 gaskets to the pipework in the boiler room (Rm 0/84 – location 1) contain asbestos.

Removed July 2022

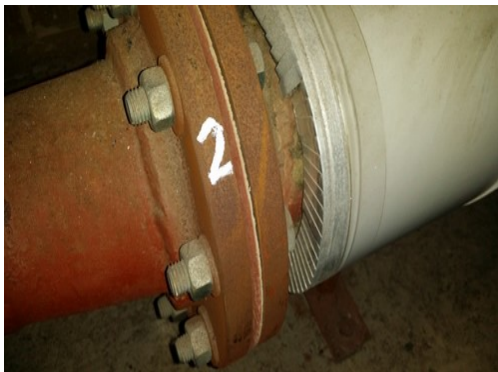
Item 31 – Ref: 102024-2

The gasket to the pipework in the boiler room (Rm 0/84 – location 2) contains asbestos.

Removed July 2022

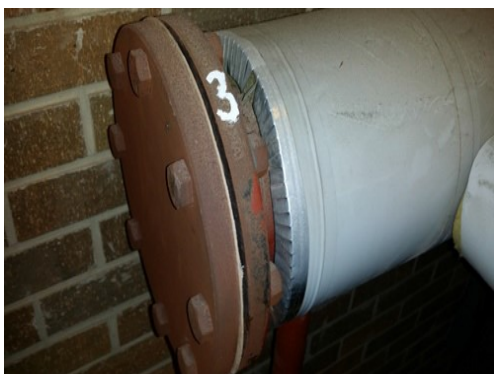
Item 32 – Ref: 102024-3

The gasket to the pipework in the boiler room (Rm 0/84 – location 3) contains asbestos.

Removed July 2022

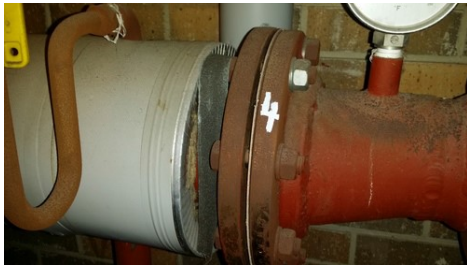
Item 33 – Ref: 102024-4

The gasket to the pipework in the boiler room (Rm 0/84 – location 4) contains asbestos.

Removed July 2022

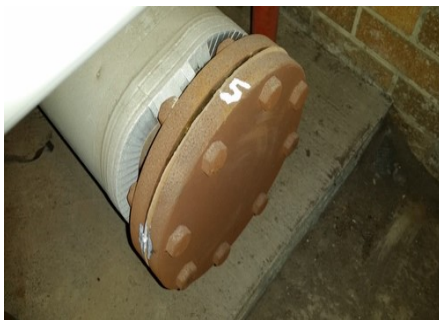
Item 34 – Ref: 102024-5

The gasket to the pipework in the boiler room (Rm 0/84 – location 5) contains asbestos.

Removed July 2022

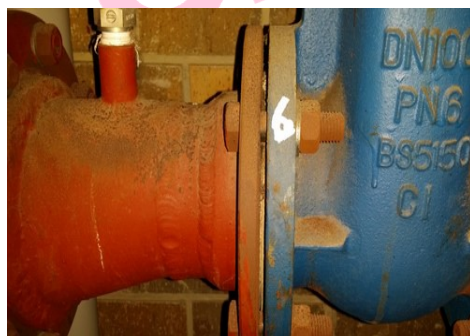
Item 35 – Ref: 102024-6

The gasket to the pipework in the boiler room (Rm 0/84 – location 6) contains asbestos.

Removed July 2022

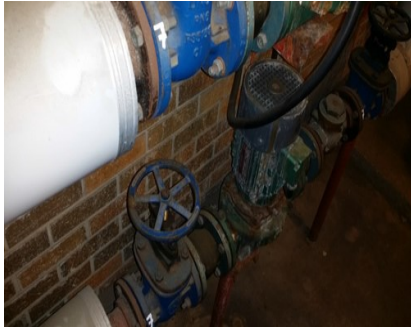
Item 36 – Ref: 102024-7

The gaskets (x4) to the pipework in the boiler room (Rm 0/84 – location 7) contain asbestos.

Removed July 2022

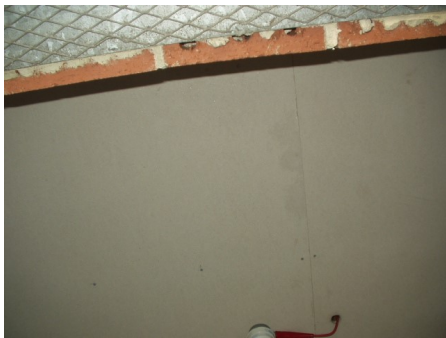
Item 37 - Ref: AW0850/08

The ceiling to the gas intake room (Rm 0/85) does not contain asbestos.

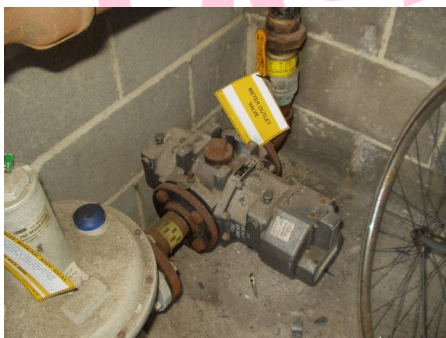
Item 38 - Ref: 102024-8

The flange gaskets to the pipework in the gas intake room (Rm 0/85) do not contain asbestos.

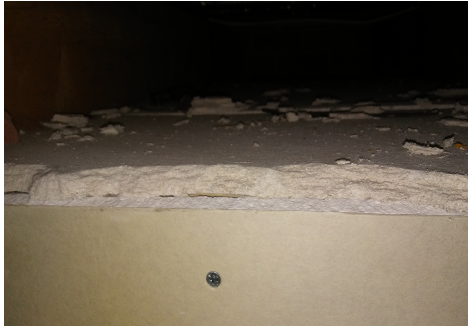
Item 47 Ref: 278204-1

The topside of the fixed ceiling in the void above the kitchen office (Room 081) does not contain asbestos.

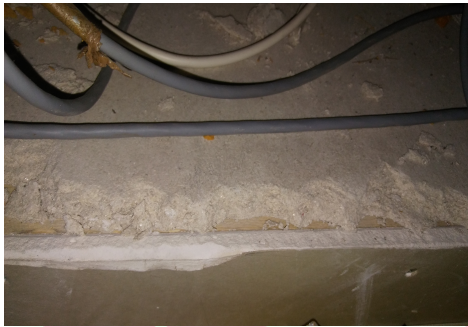
Item 48 Ref: As 278204-1

The topside of the fixed ceiling in the void above the kitchen cloakroom (Room 082) does not contain asbestos.

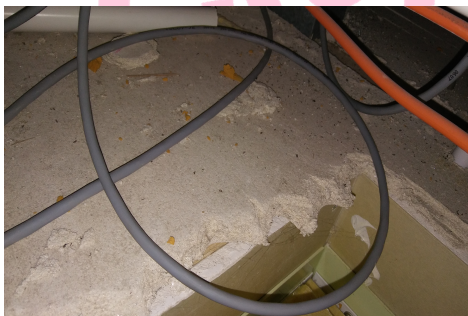
Item 49 Ref: As 278204-1

The topside of the fixed ceiling in the void above the kitchen wc (Room 083) does not contain asbestos.

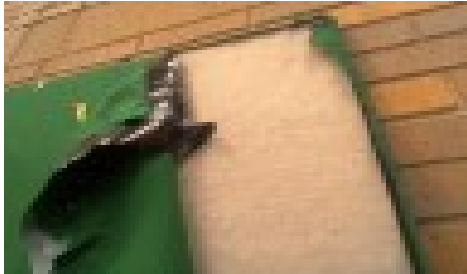
Item 50 Ref: AP004221

The Notice board in Room 1/Hall does not contain asbestos.

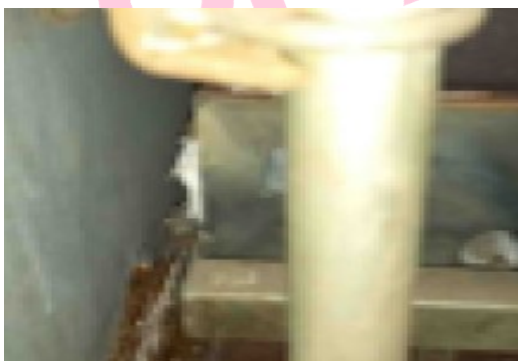
Item 52 Ref: S003

The insulation to pipe/boiler lagging in the boiler room (Rm 0/84) does not contain asbestos.

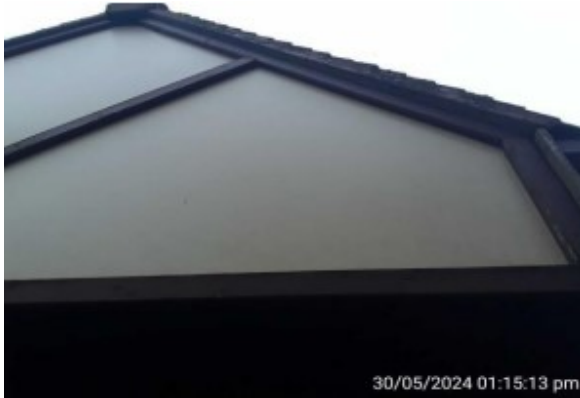
Item 53 Ref: 24-76365-1

The roof - undercloak to entrance roof apexes (x5) (Cement) (Rm 004 External) do not contain asbestos.

Item 53	Roof - Undercloak to Entrance roof apexes (x5) (Cement) (Rm 004 External)	Very Low	12 Monthly	29/05/2025
Item 54	No asbestos	Is present		
Item 55	No asbestos	Is present

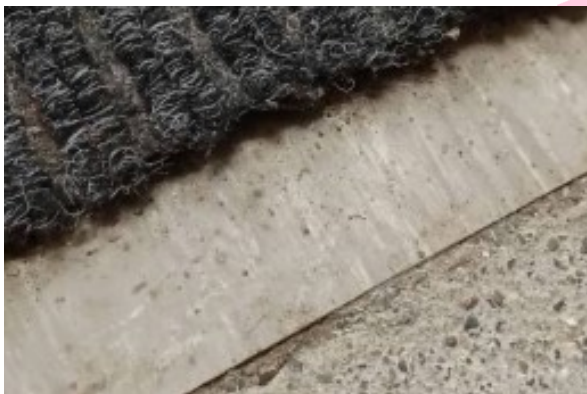
Item 54 Ref: AT000102

The floor covering and adhesive in the Nursery Cloakroom does not contain asbestos.

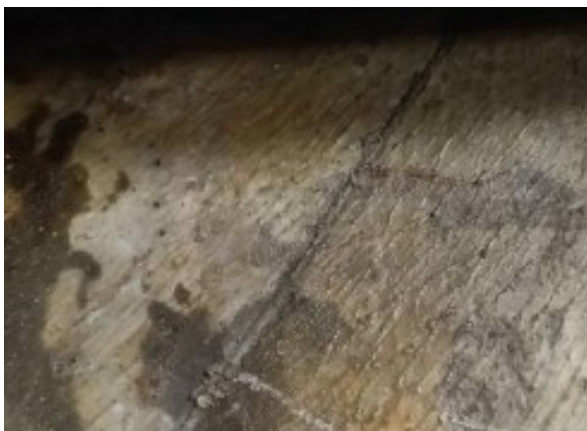
Item 55 Ref: AT000103

The floor screed in the main reception does not contain asbestos.

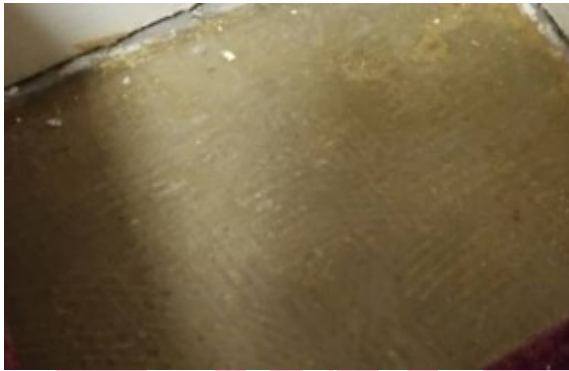
Item 57 Ref: AT000105

The floor screed in the main office does not contain asbestos.
