### ASBESTOS SURVEY REPORT FOR RICHARD AVENUE PRIMARY SCHOOL, SUNDERLAND

**RICHARD AVENUE PRIMARY SCHOOL**

**Date: 14 April 2025**

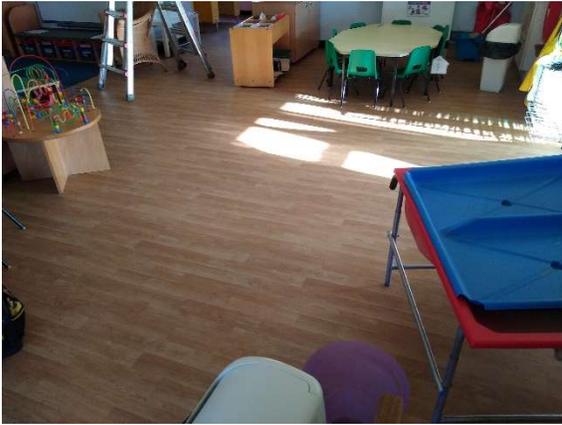
### **Item 1 - Ref: 369924-5**

The screed under modern screed (001/nursery) does not contain asbestos.

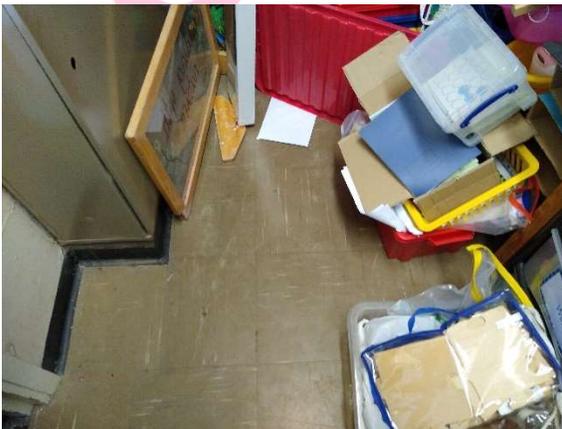
### **Item 3 - Ref: 369924-4**

The floor tile with bitumen adhesive (001A/electric cupboard) contains asbestos.

Any change in its appearance should be recorded and passed to Property Services.

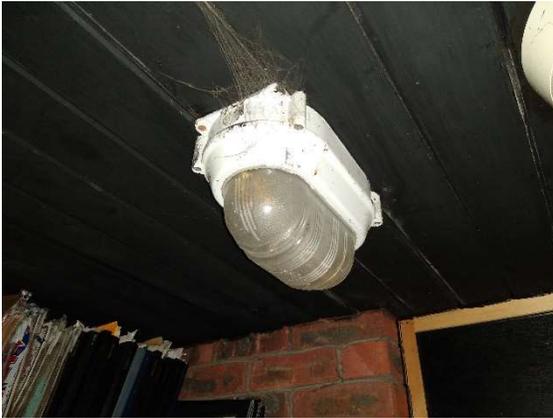
### **Item 4 - Ref: 369924-2**

The sealant to light (001C/store) does not contain asbestos.

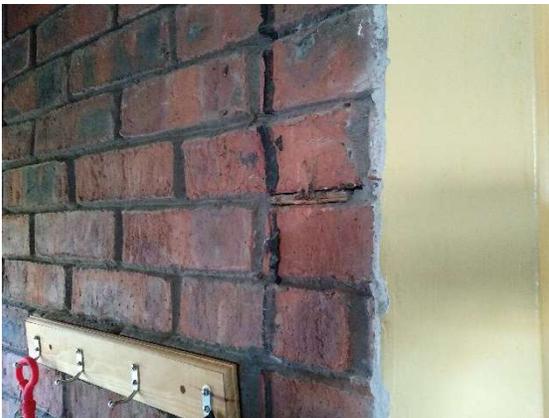
### **Item 5 - Ref: 369924-3**

The remnant sealant to brickwork from former door frame (001C/store) contains asbestos.

Any change in its appearance should be recorded and passed to Property Services.

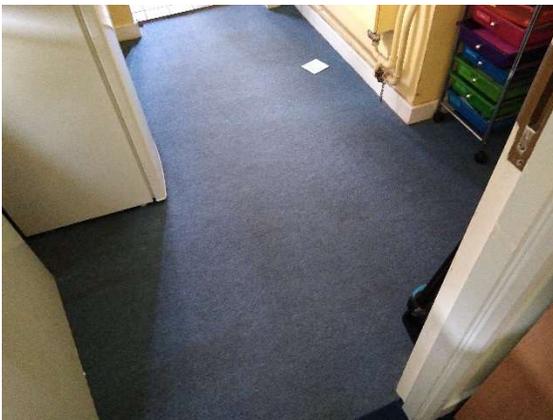
### **Item 6 - Ref: As 369924-5**

The screed under modern screed (001C/store) does not contain asbestos.

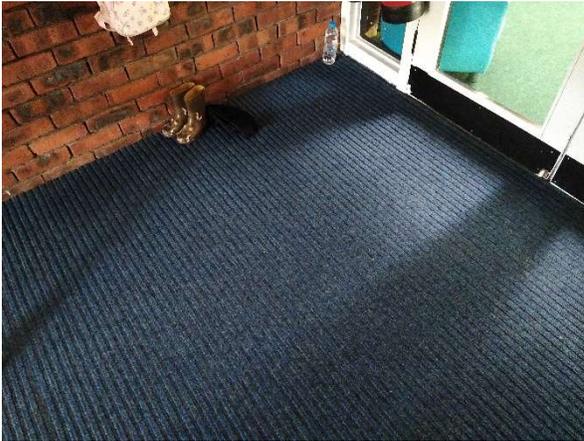
### **Item 7 - Ref: As 369924-5**

The screed under modern covering (002/lobby) does not contain asbestos.

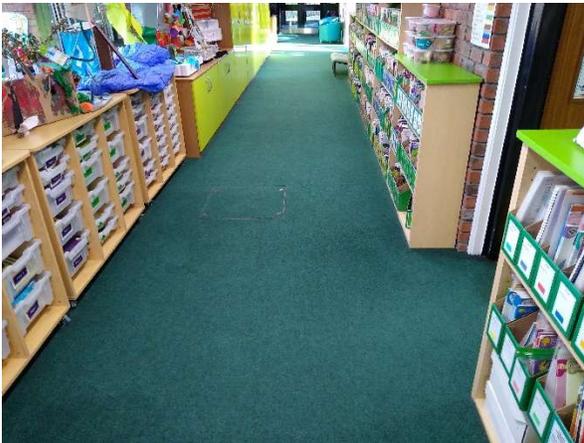
### **Item 8 - Ref: As 369924-5**

The screed under modern covering (003/corridor) does not contain asbestos.

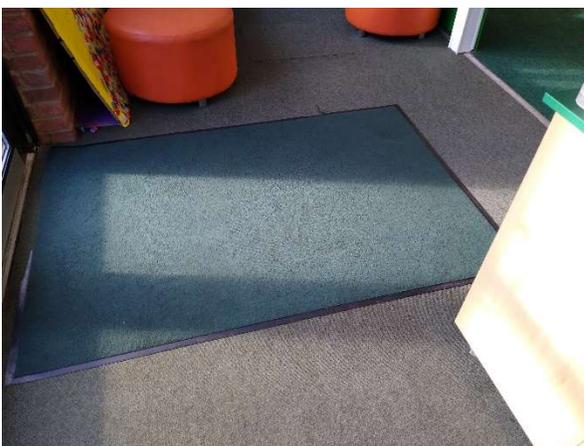
### **Item 9 - Ref: As 369924-5**

The screed under modern covering (004/conservatory) does not contain asbestos.

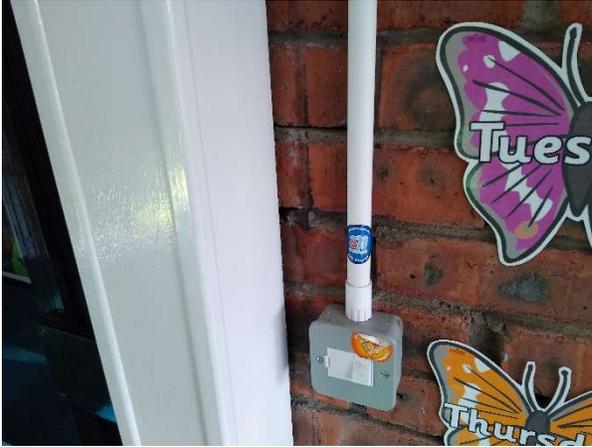
### **Item 10 - Ref: As 369924-3**

The remnant sealant from removed frame (004/conservatory) contains asbestos.

Any change in its appearance should be recorded and passed to Property Services.

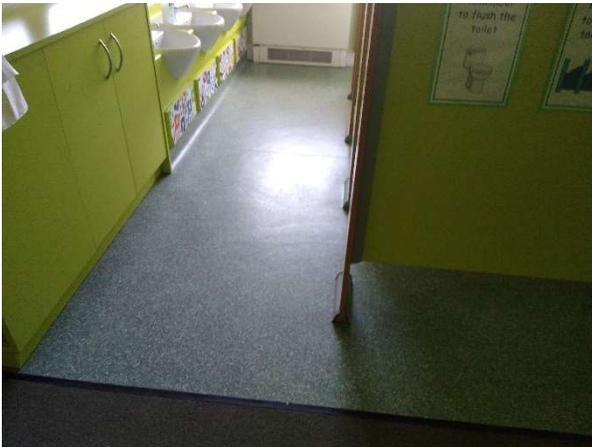
### **Item 11 - Ref: As 369924-5**

The screed under modern screed (005/WC) does not contain asbestos.

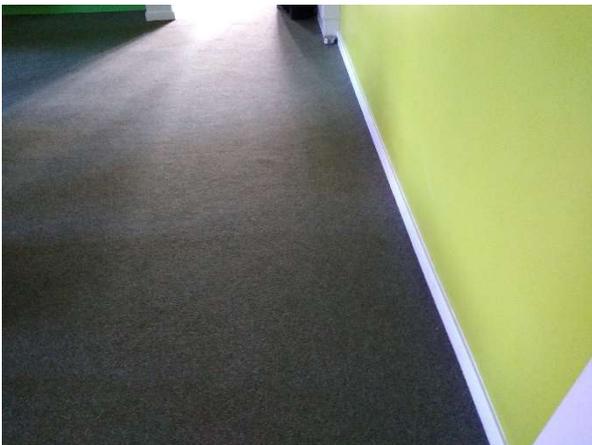
### **Item 12 - Ref: As 369924-5**

The screed under modern screed (006/corridor) does not contain asbestos.

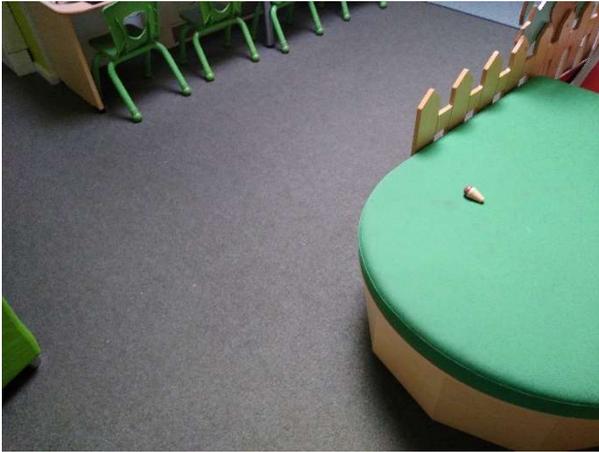
### **Item 13 - Ref: As 369924-5**

The screed under modern screed (006A/library area) does not contain asbestos.

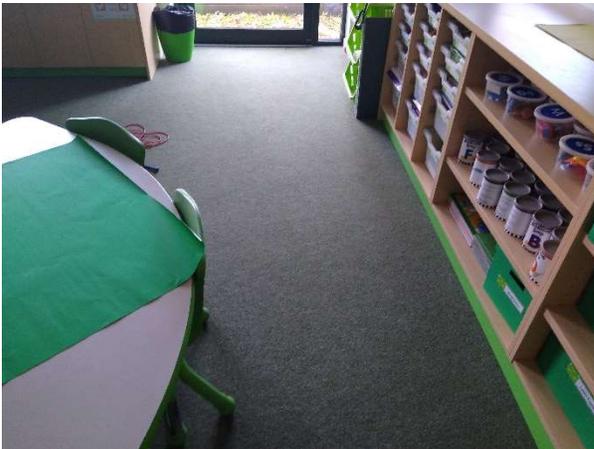
### **Item 14 - Ref: As 369924-5**

The screed under modern screed (007/classroom) does not contain asbestos.

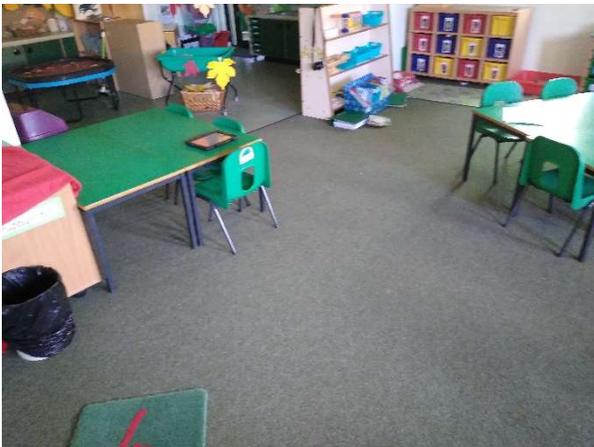
### **Item 15 - Ref: As 369924-5**

The screed under modern screed (008/classroom) does not contain asbestos.

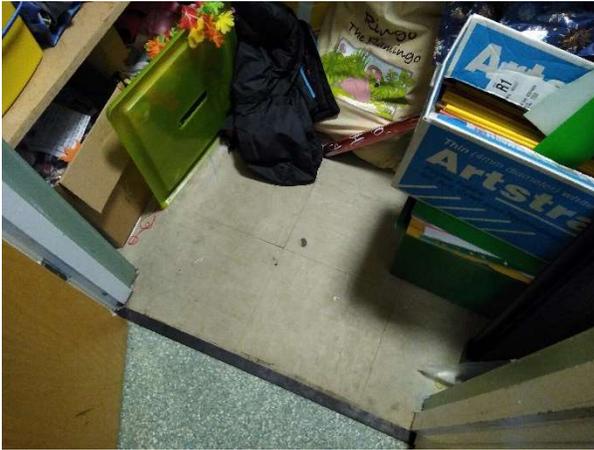
**Item 16 - Ref: As 369924-5**

The screed (009/store) does not contain asbestos.

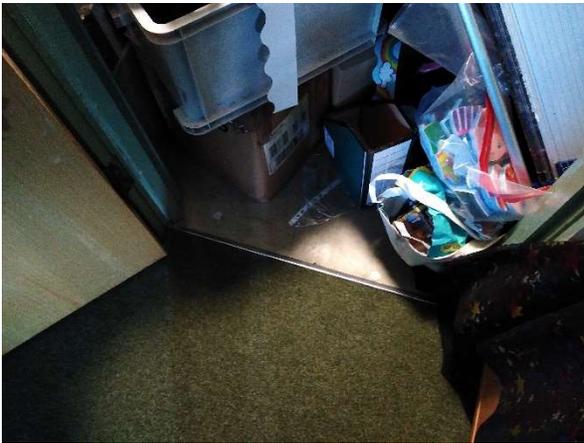
**Item 17 - Ref: As 369924-5**

The screed under modern tiles (010/store) does not contain asbestos.

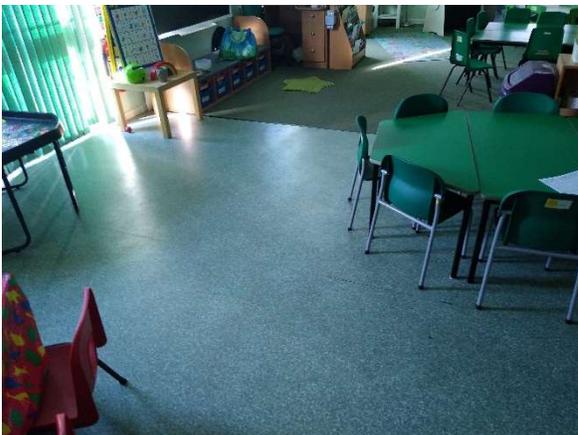
**Item 18 - Ref: As 369924-5**

The screed under modern screed (010/classroom) does not contain asbestos.

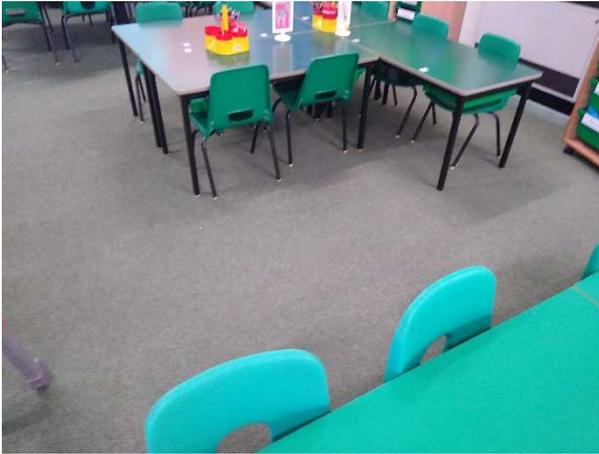
### **Item 19 - Ref: As 369924-5**

The screed under modern screed (013/classroom) does not contain asbestos.

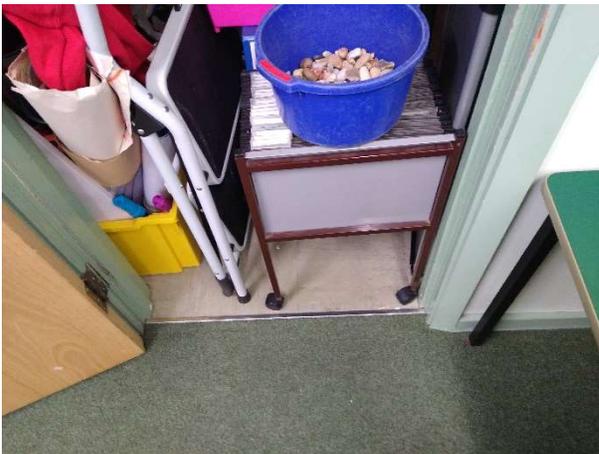
### **Item 20 - Ref: As 369924-5**

The screed (014/store) does not contain asbestos.

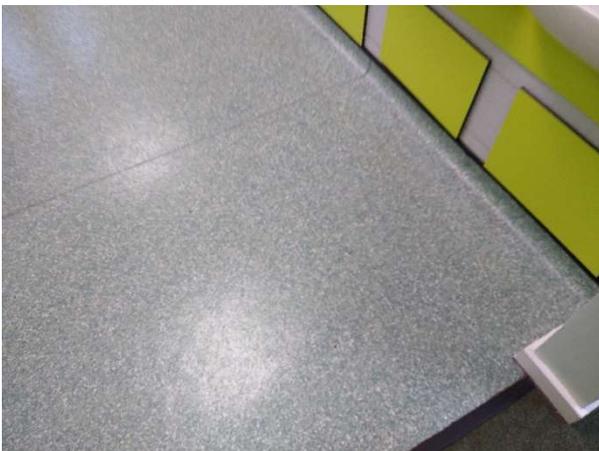
### **Item 21 - Ref: As 369924-5**

The screed under modern screed (015/WC) does not contain asbestos.

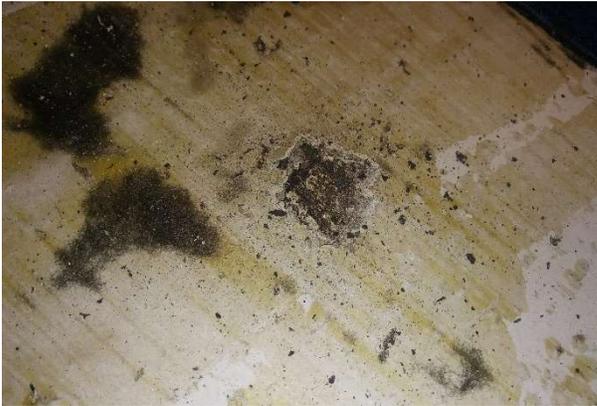
### **Item 22 - Ref: 369924-6**

The floor screed beneath modern screed (015A/ corridor) does not contain asbestos.

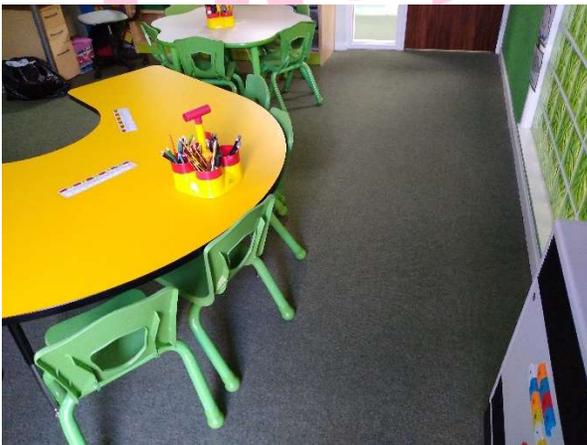
### **Item 24 - Ref: As 369924-5**

The screed under modern screed (016/classroom) does not contain asbestos.

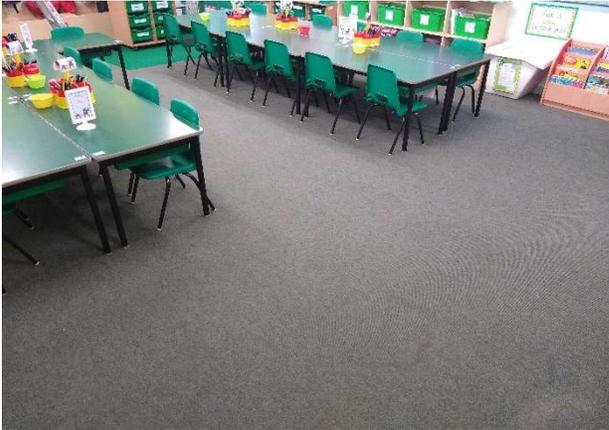
### **Item 25 - Ref: As 369924-5**

The screed under modern screed (017/classroom) does not contain asbestos.

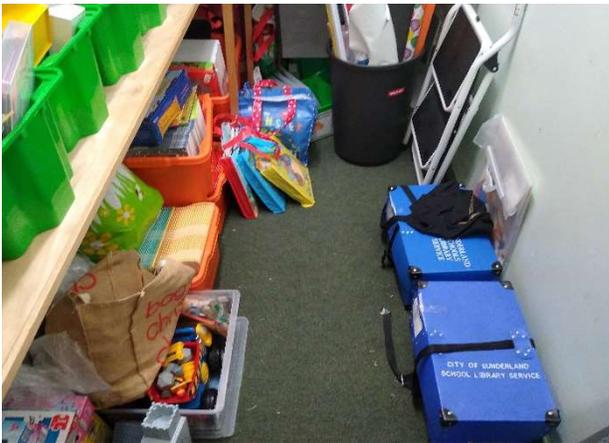
### **Item 26 - Ref: As 369924-5**

The screed under modern screed (018/store) does not contain asbestos.

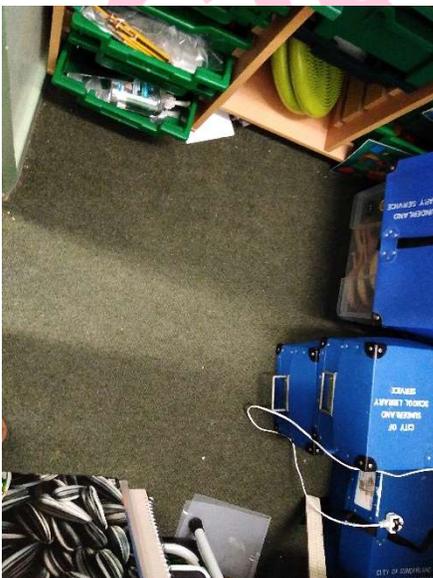
### **Item 27 - Ref: As 369924-5**

The screed under modern screed (019/store) does not contain asbestos.

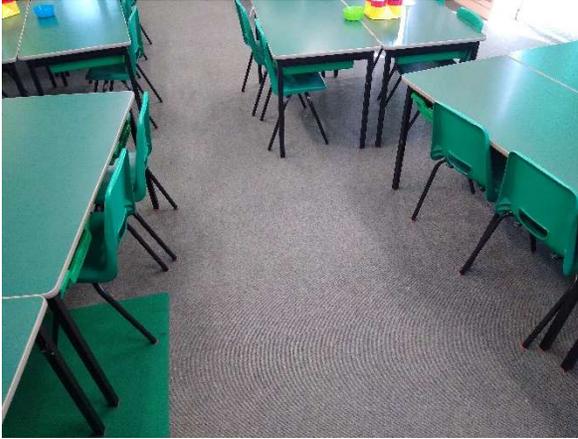
### **Item 28 - Ref: As 369924-5**

The screed under modern screed (020/classroom) does not contain asbestos.

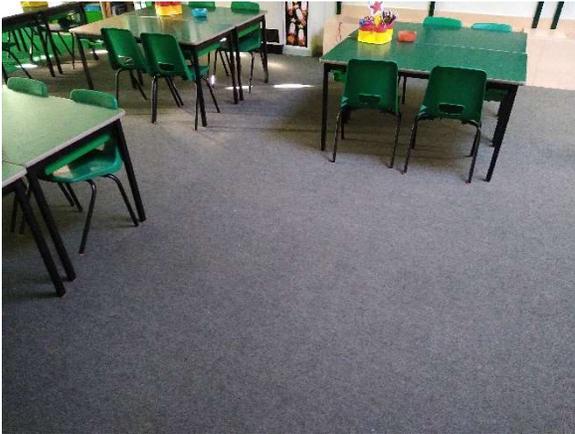
### **Item 29 - Ref: As 369924-5**

The screed under modern screed (021/classroom) does not contain asbestos.

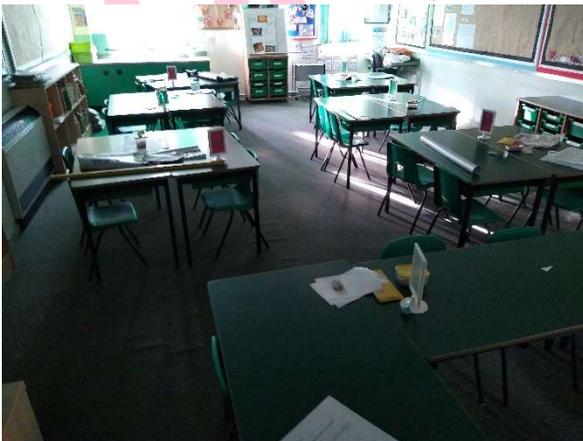
### **Item 30 - Ref: As 369924-5**

The screed under modern screed (022/classroom) does not contain asbestos.

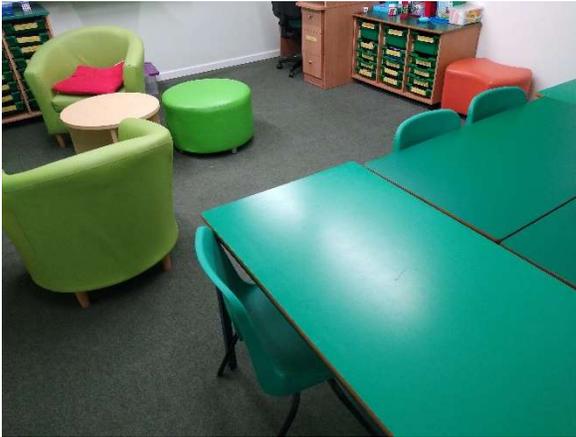
### **Item 31 - Ref: As 369924-5**

The screed under modern screed (023/classroom) does not contain asbestos.

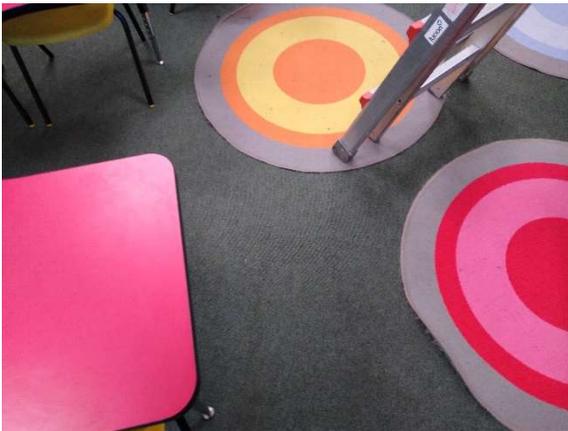
### **Item 32 - Ref: As 369924-5**

The screed under modern screed (024/classroom) does not contain asbestos.

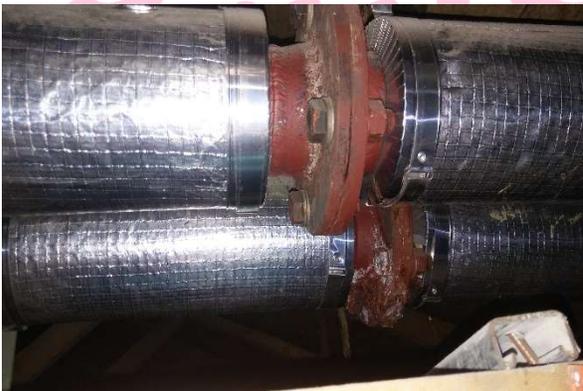
### **Item 36 - Ref: Presumed**

The closed coupled flange gasket (025/corridor-void above) is presumed to contain asbestos.

Any change in its appearance should be recorded and passed to Property Services.

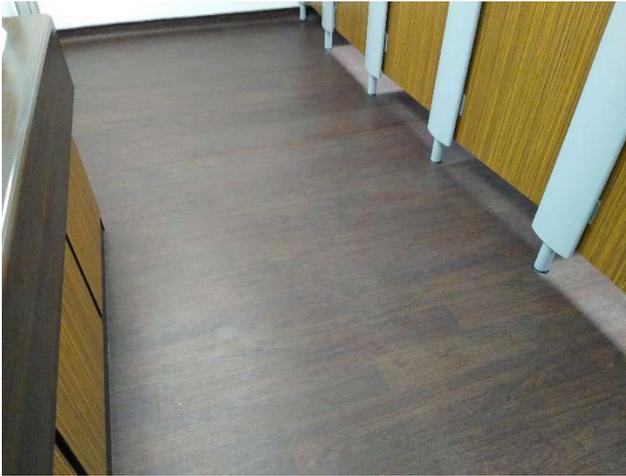
### **Item 37 - Ref: As 369924-5**

The screed under modern screed (026/staff WC) does not contain asbestos.

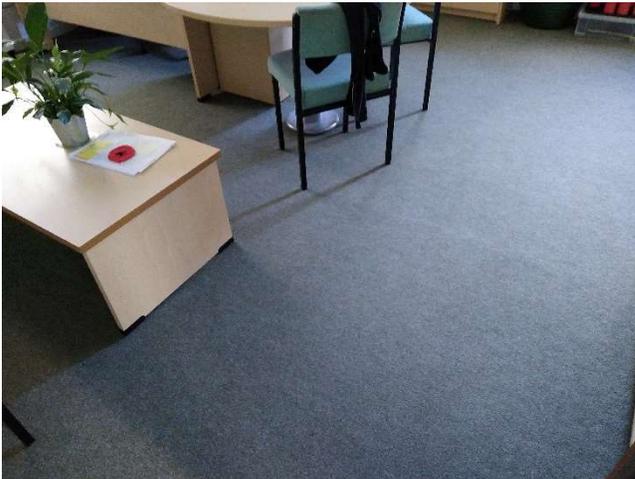
### **Item 38 - Ref: As 369924-5**

The screed under modern screed (027/head teachers office) does not contain asbestos.

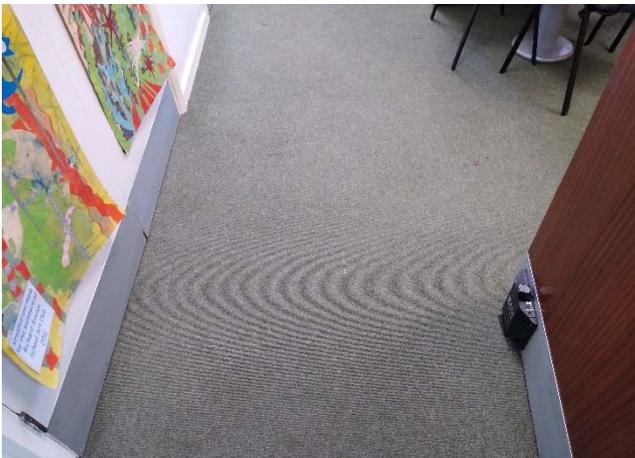
### **Item 39 - Ref: As 369924-5**

The screed under modern screed (028/office) does not contain asbestos.

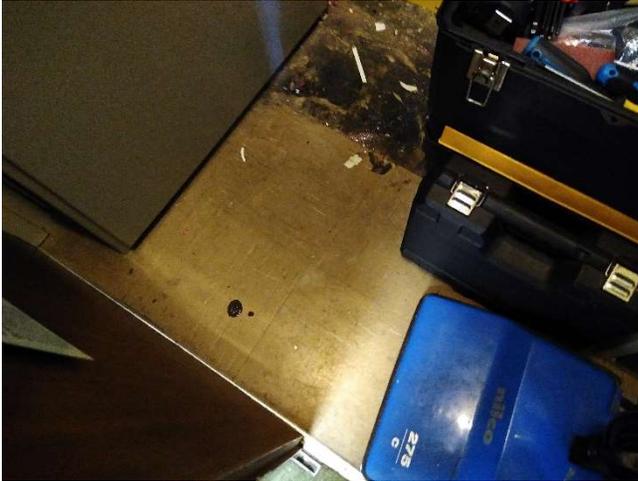
**Item 40 - Ref: 369924-9**

The floor tile without bitumen adhesive (030/store) does not contain asbestos.

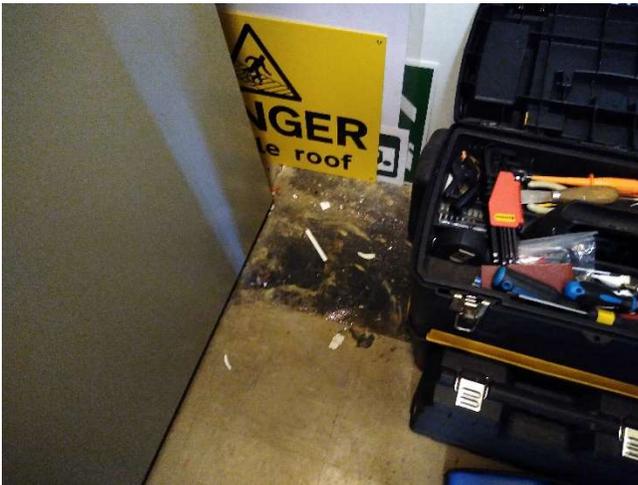
**Item 41 - Ref: As 369924-5**

The screed under floor tiles (030/store) does not contain asbestos.

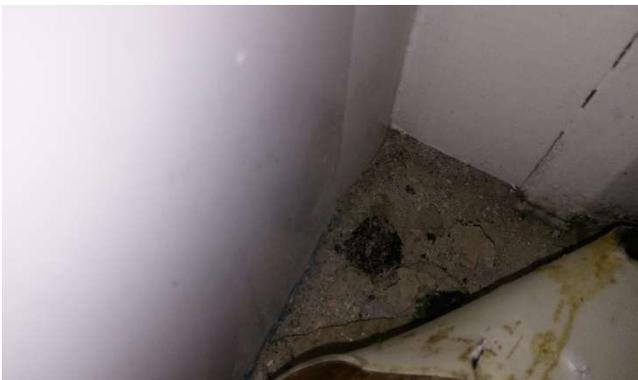
**Item 42 - Ref: As 369924-7**

The screed under floor tiles (031/staff room) does not contain asbestos.

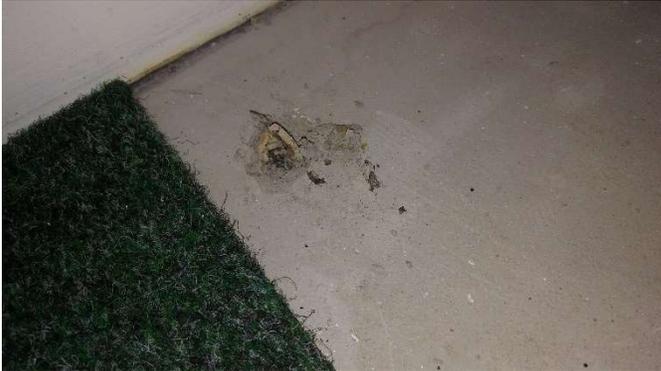
**Item 43 - Ref: As 369924-7**

The screed to floor below floor covering (032/office) does not contain asbestos.

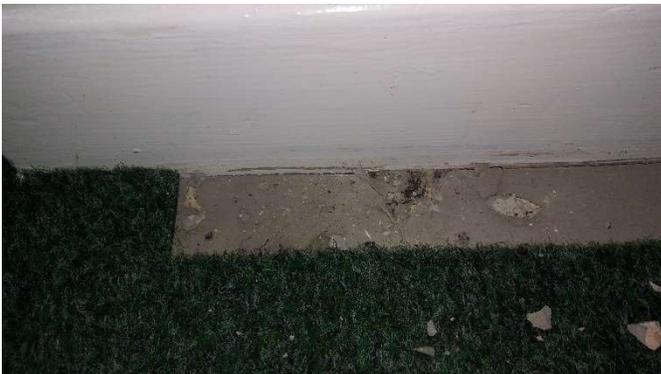
**Item 44 - Ref: As 369924-7**

The screed to floor below floor covering (033/meeting room) does not contain asbestos.

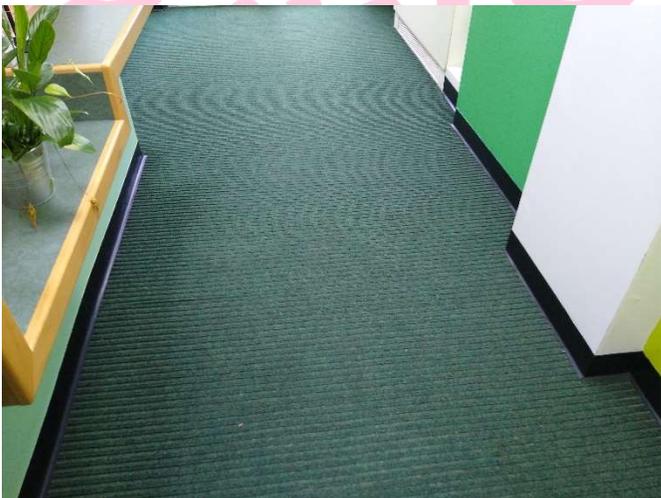
**Item 45 - Ref: As 369924-5**

The screed under modern screed (034/lobby) does not contain asbestos.

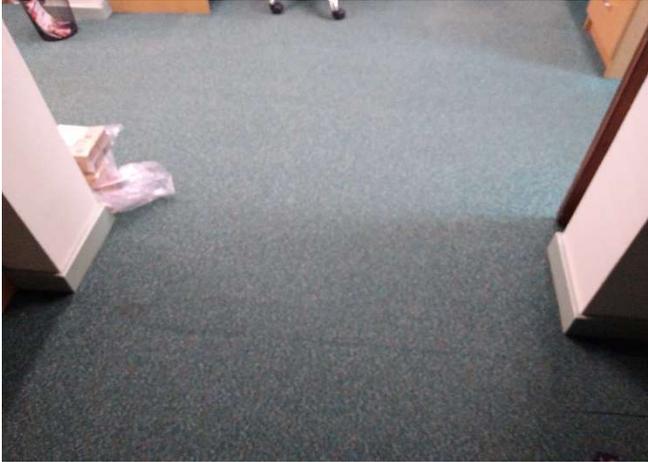
### **Item 46 - Ref: 369924-9**

The floor covering under carpet (035/reception) does not contain asbestos.

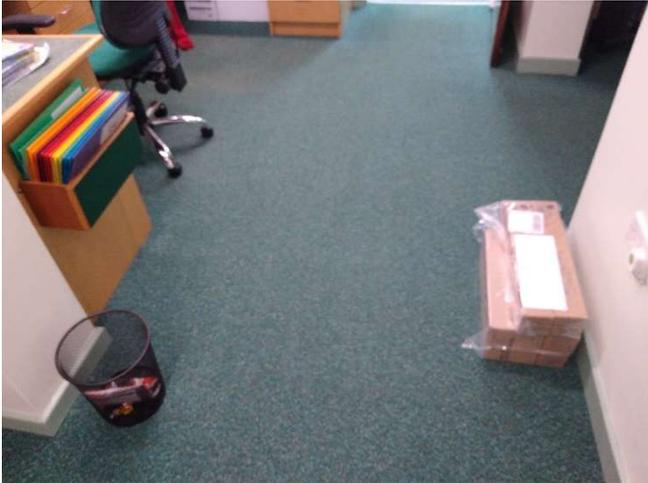
### **Item 47 - Ref: As 369924-5**

The screed under tiles (035/reception) does not contain asbestos.

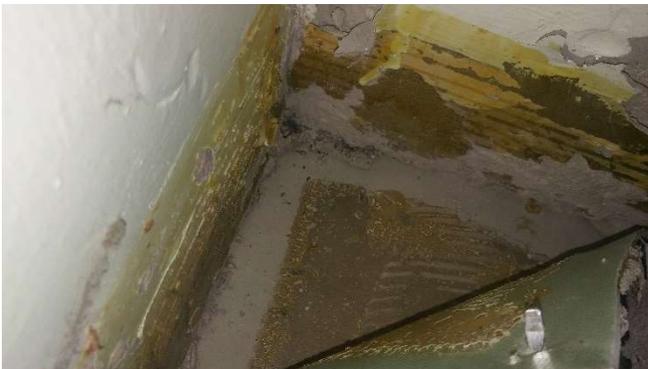
### **Item 48 - Ref: As 369924-7**

The screed to floor below floor covering (036/PE store) does not contain asbestos.

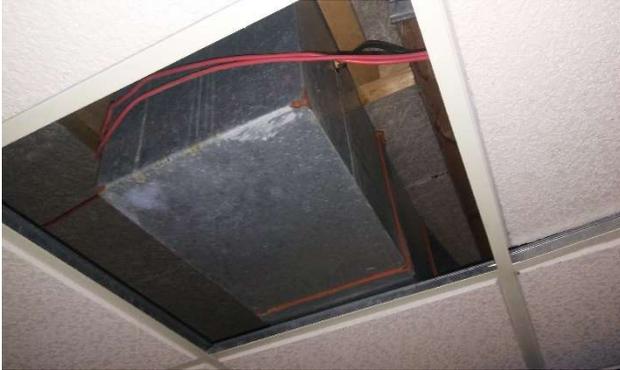
### **Item 49 - Ref: As 369924-12**

The red mastic to ductwork (036/PE store-void above) contains asbestos.

Any change in its appearance should be recorded and passed to Property Services.

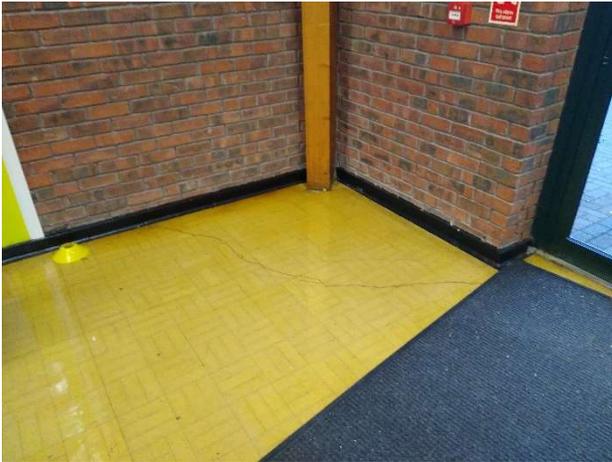
### **Item 50 - Ref: 369924-14**

The coating to skirting within centre area of hall (037/hall) does not contain asbestos.

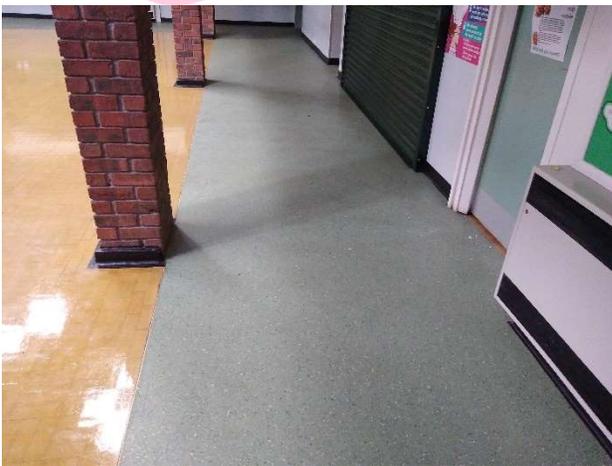
### **Item 51 - Ref: As 369924-5**

The screed under modern screed to perimeter (037/hall) does not contain asbestos.

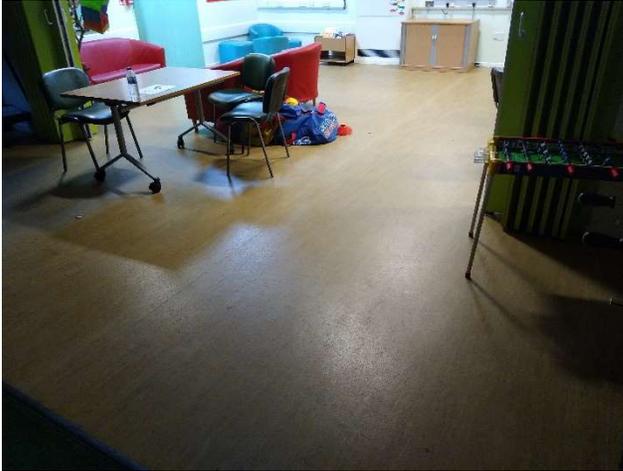
### **Item 52 - Ref: As 369924-5**

The screed under modern screed (038/community room) does not contain asbestos.

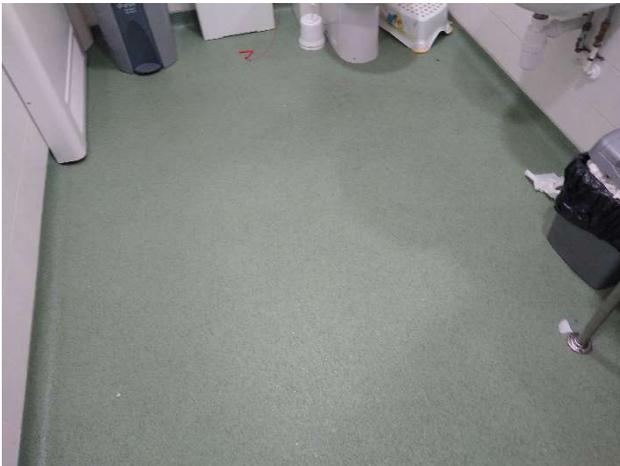
### **Item 53 - Ref: As 369924-5**

The screed under modern screed (039/community WC) does not contain asbestos.

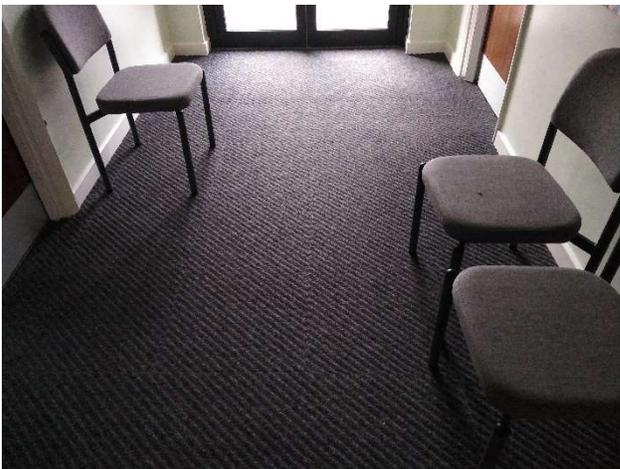
### **Item 54 - Ref: As 369924-5**

The screed under modern screed (041/lobby) does not contain asbestos.

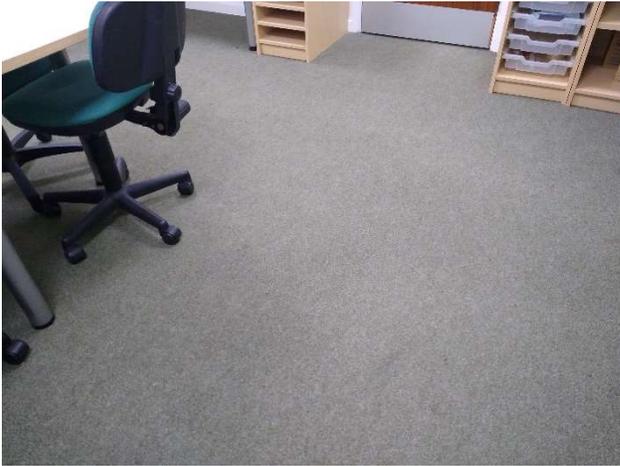
### **Item 55 - Ref: As 369924-5**

The screed under modern screed (042/PPA room) does not contain asbestos.

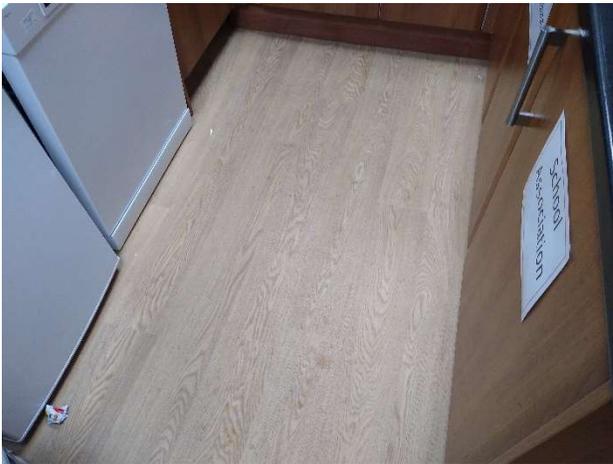
### **Item 56 - Ref: As 369924-5**

The screed under modern screed (043/community kitchen) does not contain asbestos.

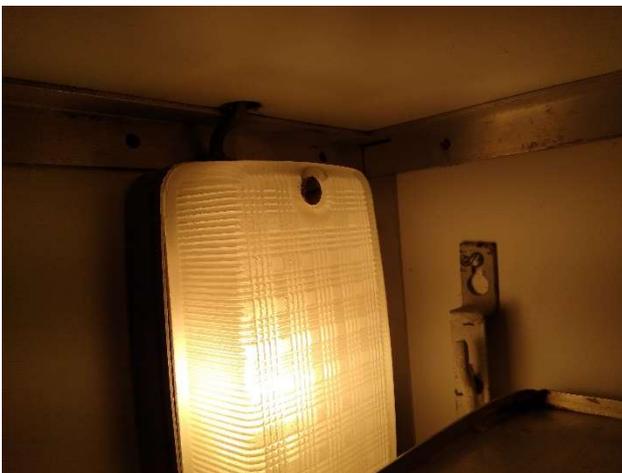
### **Item 57 - Ref: 369924-10**

The sealant around wall light screws (044/cold store) contains asbestos.

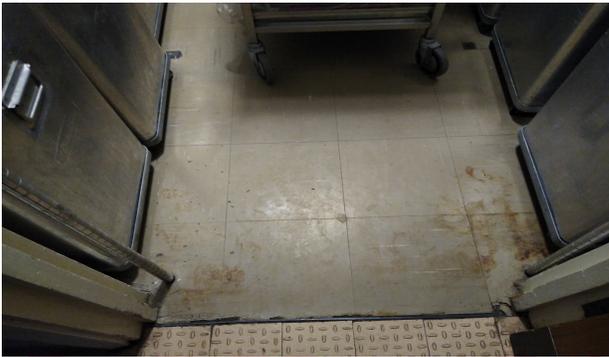
### **Item 65 - Ref: As 369924-9**

The floor covering (049/kitchen pantry) does not contain asbestos.

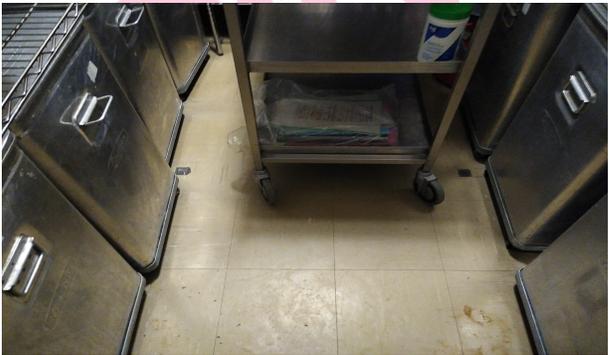
### **Item 66 - Ref: As 369924-5**

The screed under tiles (049/kitchen pantry) does not contain asbestos.

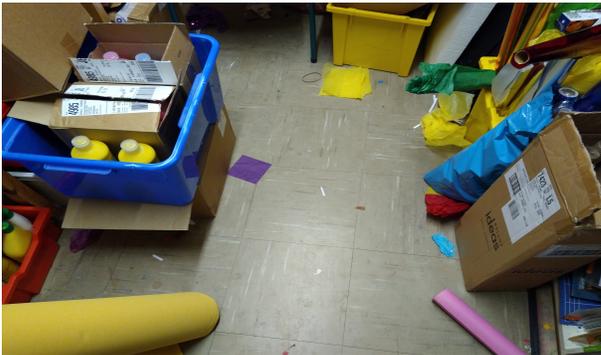
### **Item 71 - Ref: As 369924-13**

The screed under tiles (054/store) does not contain asbestos.

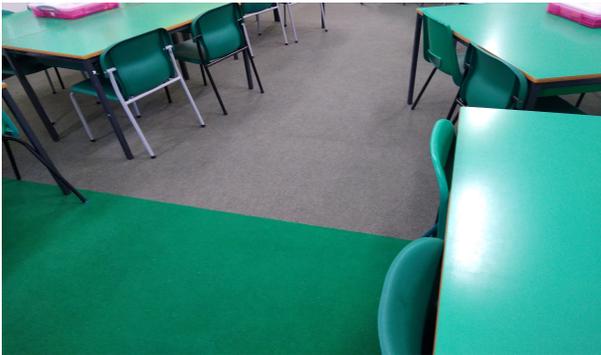
### **Item 77 - Ref: As 369924-13**

The floor covering  
(060/classroom) does not  
contain asbestos.

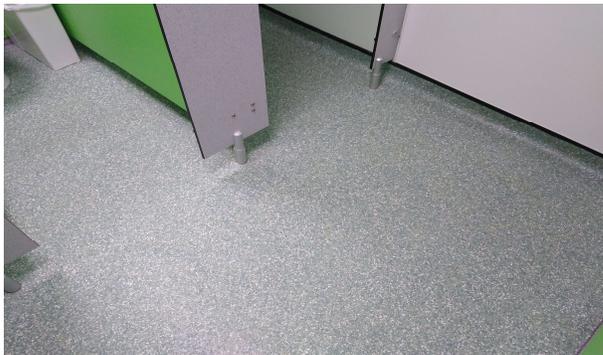
### **Item 83 - Ref: As 369924-13**

The screed under modern screed (066/female WC) does not contain asbestos.

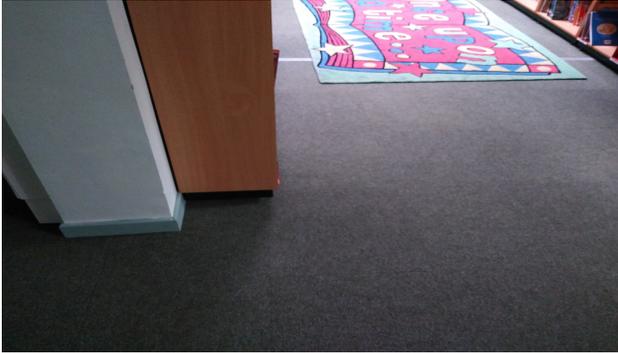
### **Item 85 - Ref: As 369924-13**

The screed under modern screed (068/classroom) does not contain asbestos.

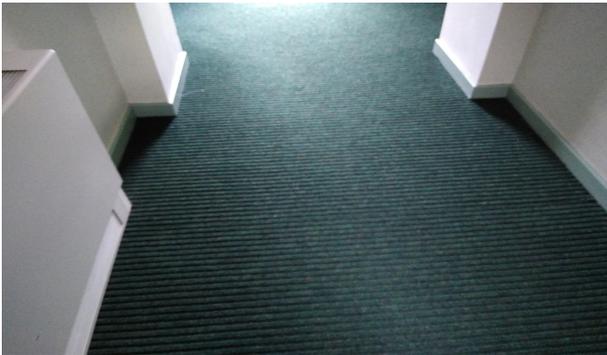
### **Item 86 - Ref: As 369924-13**

The screed under modern screed (069/lobby) does not contain asbestos.

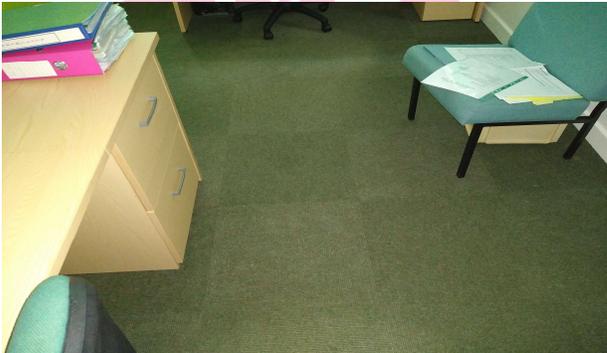
### **Item 87 - Ref: As 369924-13**

The screed under modern screed (070/office) does not contain asbestos.

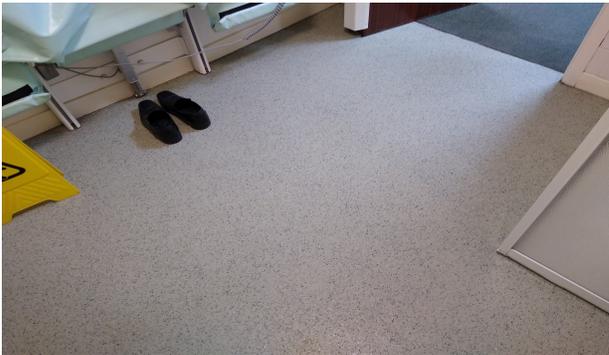
### **Item 89 - Ref: As 369924-13**

The screed under modern screed (071/accessible WC) does not contain asbestos.

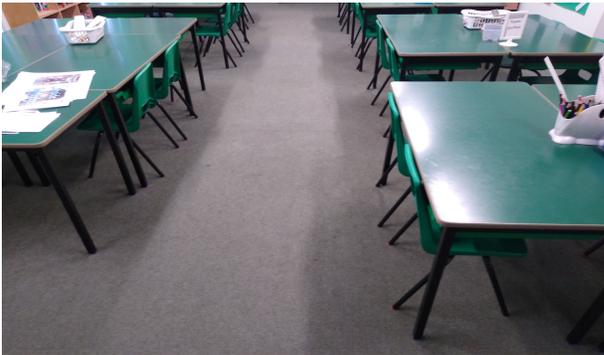
### **Item 92 - Ref: As 369924-13**

The screed under modern screed (074/classroom) does not contain asbestos.

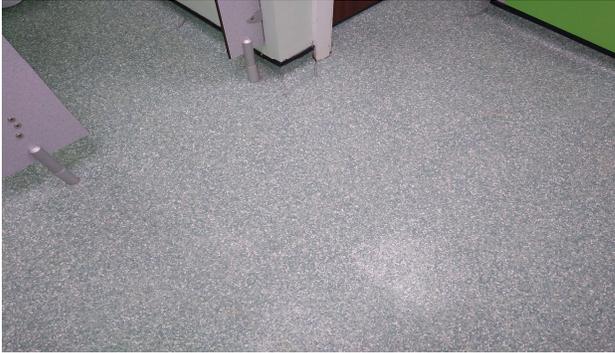
### **Item 94 - Ref: As 369924-13**

The screed under modern screed (076/male WC) does not contain asbestos.

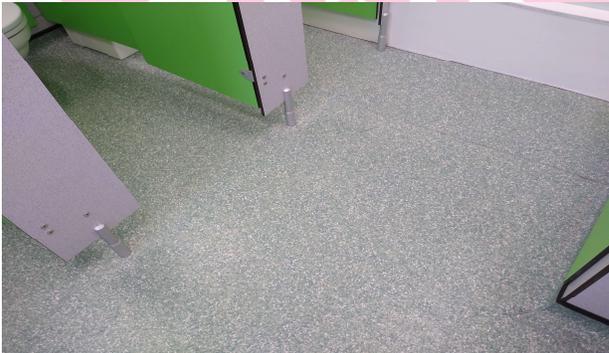
### **Item 96 - Ref: As 369924-13**

The screed under modern screed (078/female WC) does not contain asbestos.

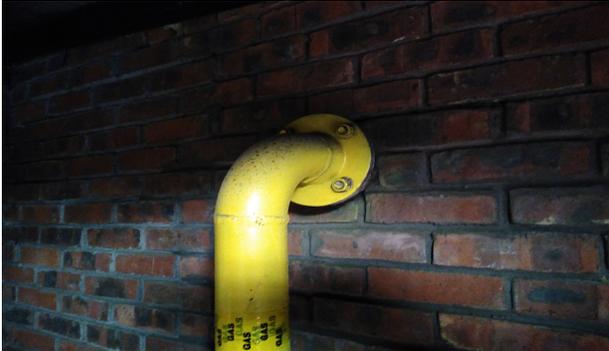
### **Item 101 - Ref: 369924-18**

The pipework flange gasket (083/gas store) does not contain asbestos.

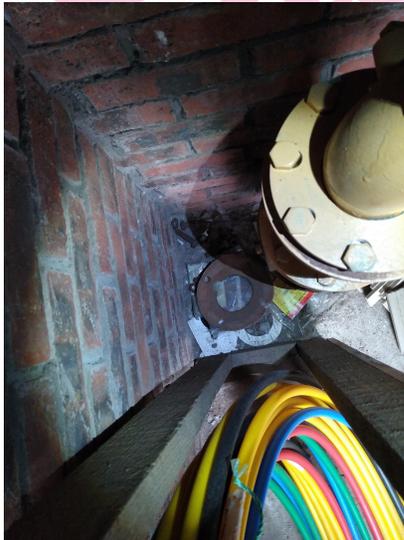
### **Item 102 - Ref: 369924-19**

The debris to floor (083/gas store) does not contain asbestos.

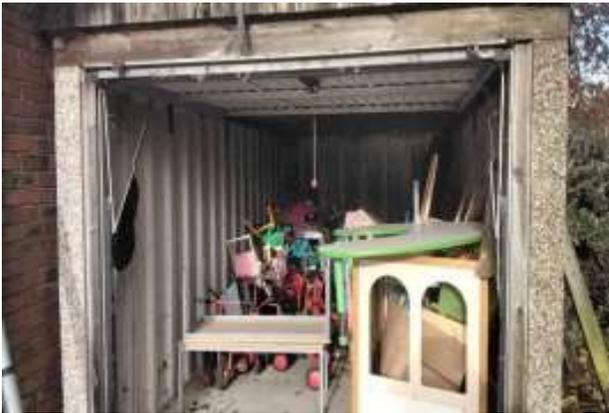
### **Item 113 - Ref: NO000636**

The sealant to door to the garage (externals E/001) does not contain asbestos.

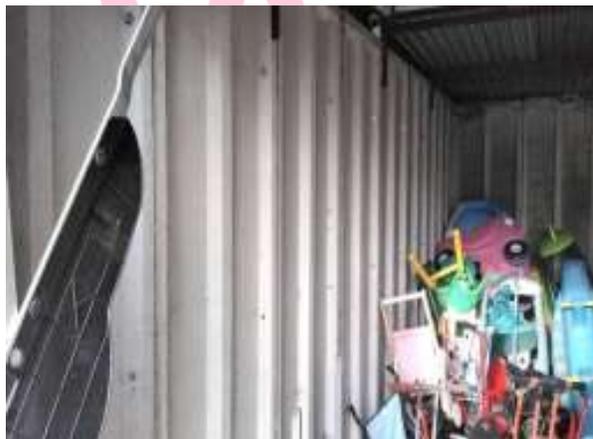
### **Item 114 - Ref: NO000637**

The wall jointing compound to the garage (externals E/001) does not contain asbestos.
