ASBESTOS SURVEY REPORT FOR SEABURN DENE PRIMARY SCHOOL, SUNDERLAND

Asbestos Register for Seaburn Dene Primary School

UPRN: - 209718

Last updated 13/03/2025 V.2.0

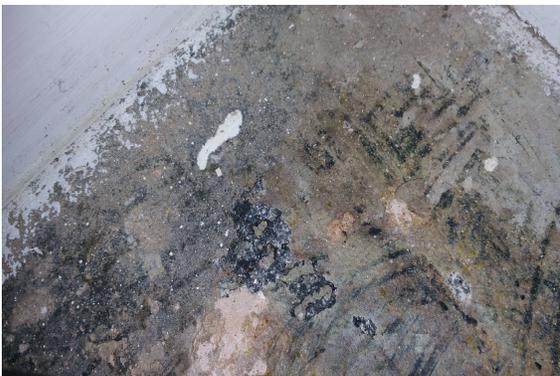
Item 6 Ref: As 179537-1

The subfloor covering (Rm 0/11) containing remnant bitumen contains asbestos.

Any change in its appearance should be recorded and passed to Property Services.

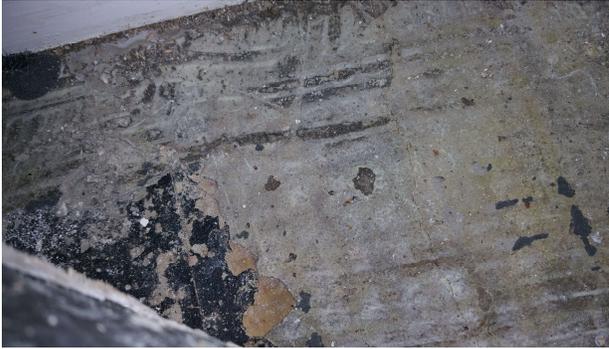
Item 7 Ref: As 179537-1

The subfloor covering (Rm 0/12) containing remnant bitumen contains asbestos.

Any change in its appearance should be recorded and passed to Property Services.

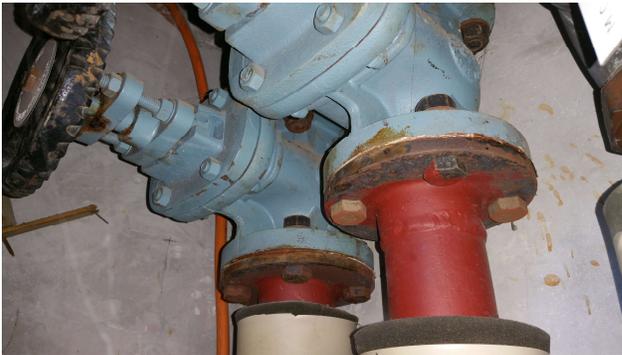
Item 8 Ref: 179537-2

The Gasket to pipework flange (Rm 0/17) contains asbestos.

Any change in its appearance should be recorded and passed to Property Services.

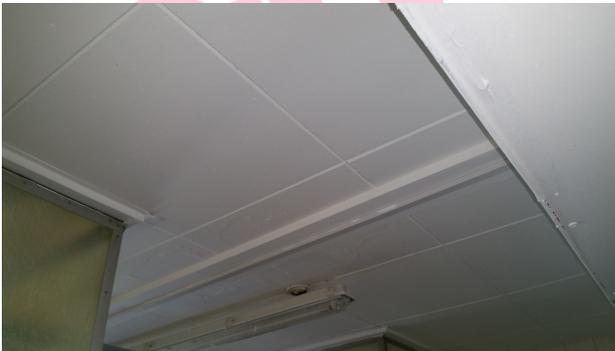
Item 9 Ref: 179537-3

The ceiling tiles (Rm 0/36) contain asbestos.

Any change in its appearance should be recorded and passed to Property Services.

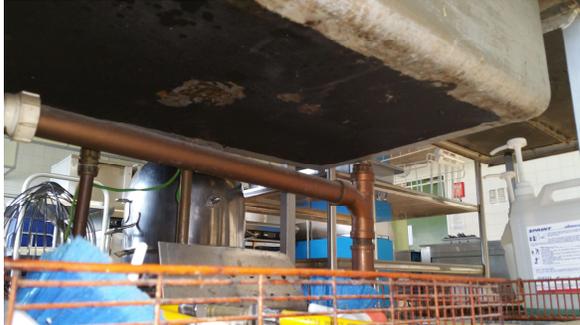
Item 10 Ref: 179537-4

The Sink Pad (Rm 0/36) does not contain asbestos.

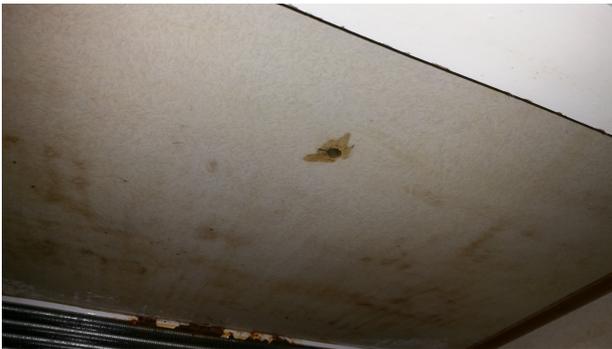
Item 11 Ref: 179537-5

The ceiling in Kitchen Fridge (Rm 0/36) contains asbestos.

Any change in its appearance should be recorded and passed to Property Services.

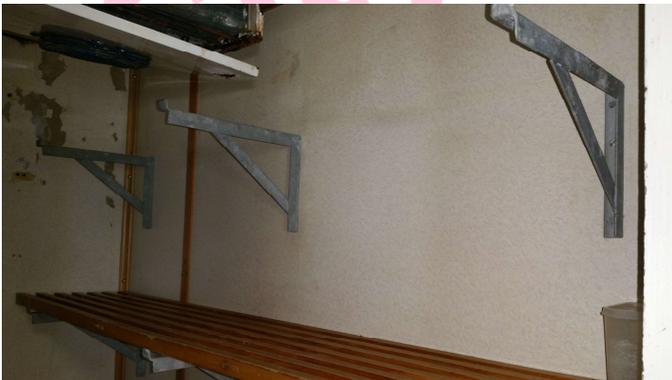
Item 12 Ref: As 179537-5

The walls in Kitchen Fridge (Rm 0/36) contain asbestos.

Any change in its appearance should be recorded and passed to Property Services.

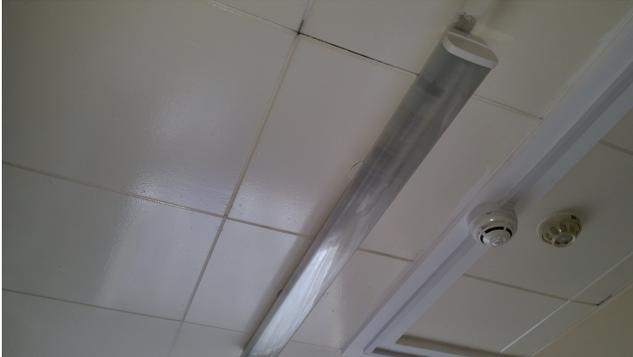
Item 13 Ref: As 179537-3

The ceiling tiles (Rm 0/39) contain asbestos.

Any change in its appearance should be recorded and passed to Property Services.

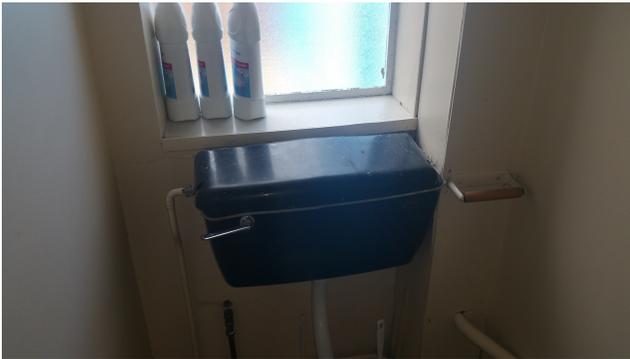
Item 14 Ref: 179537-6

The Toilet Cistern (Rm 0/40) contains asbestos.

Any change in its appearance should be recorded and passed to Property Services.

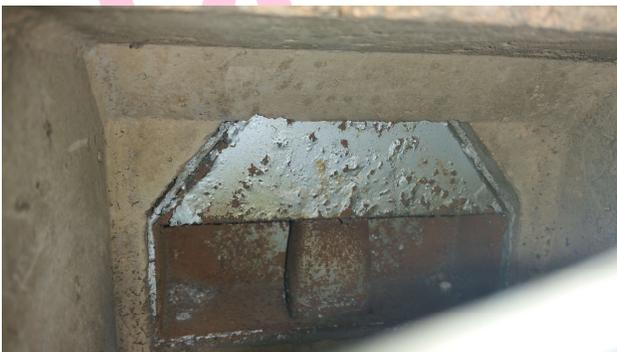
Item 15 Ref: 179537-7

The Lining to Bunnie Boiler (Rm 0/40) contains asbestos.

Any change in its appearance should be recorded and passed to Property Services.

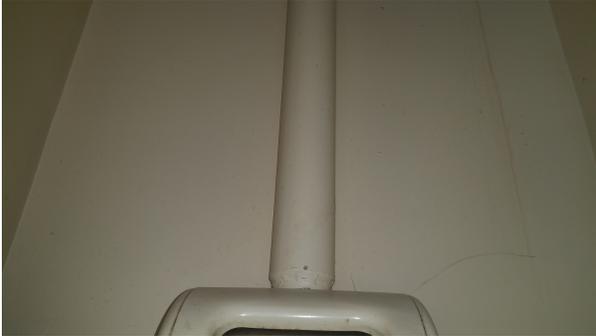
Item 16 Ref: 179537-8

The Bunnie Boiler Flue (Rm 0/40) contains asbestos.

Any change in its appearance should be recorded and passed to Property Services.

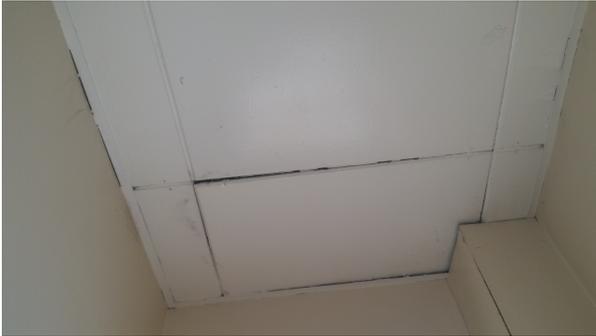
Item 17 Ref: As 179537-3

The ceiling tiles (Rm 0/40) contain asbestos.

Any change in its appearance should be recorded and passed to Property Services.

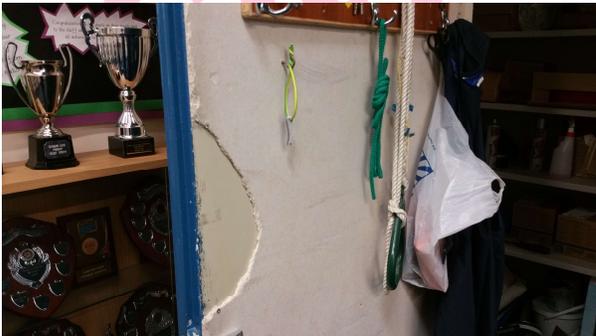
Item 18 Ref: 179537-9

The panels to back of doors (Rm 0/58) do not contain asbestos.

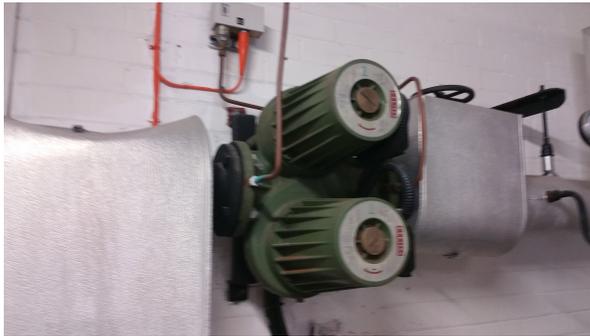
Item 20 Ref: 179537-11

The gasket (Rm 0/81) does not contain asbestos.

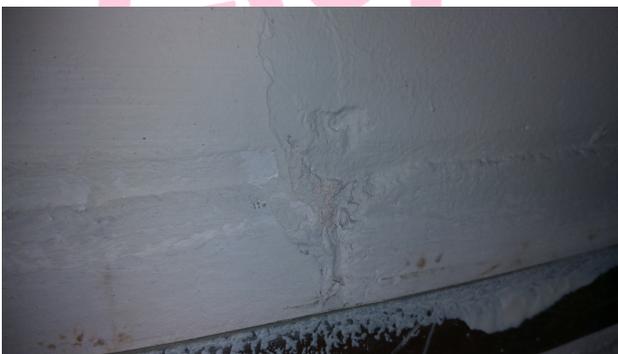
Item 21 Ref: 179537-12

The debris to walls containing lagging (Rm 0/81) contains asbestos.

Any change in its appearance should be recorded and passed to Property Services.

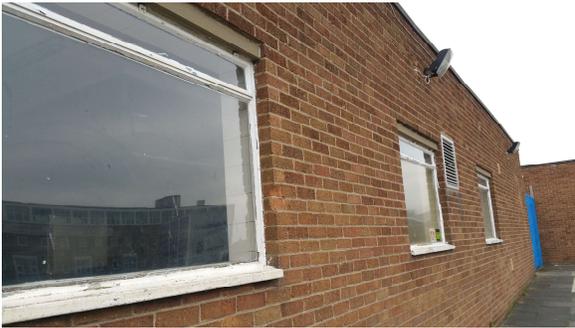
Item 23 Ref: 179537-14

The putty to windows (external) do not contain asbestos.

Removed August 2022

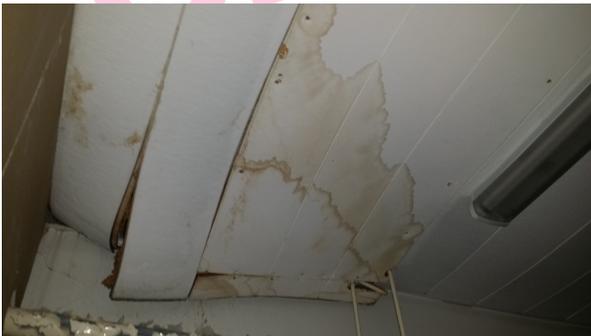
Item 24 Ref: 209718-1

The fixed ceiling (Rm 032a/Stage Store) does not contain asbestos.

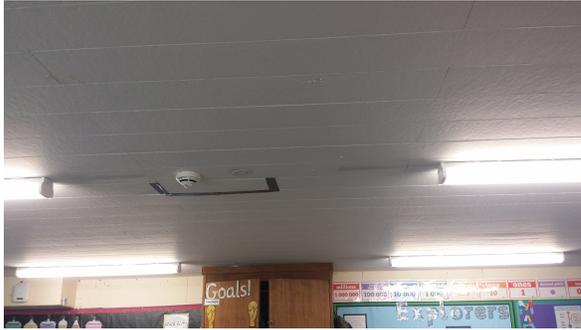
Item 25 Ref: As 209718-1

The fixed ceiling (Rm 078/Classroom) does not contain asbestos.

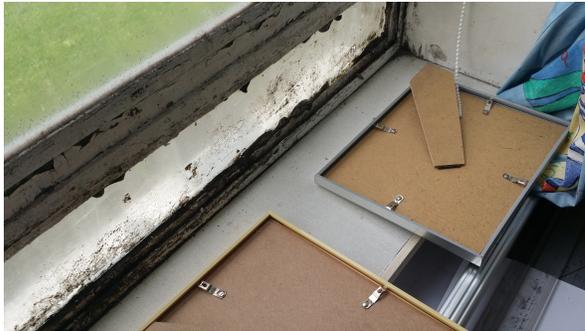
Item 26 Ref: 209718-2

The Sealant to window glazing (Rm 078/Classroom) does not contain asbestos.

Removed August 2022

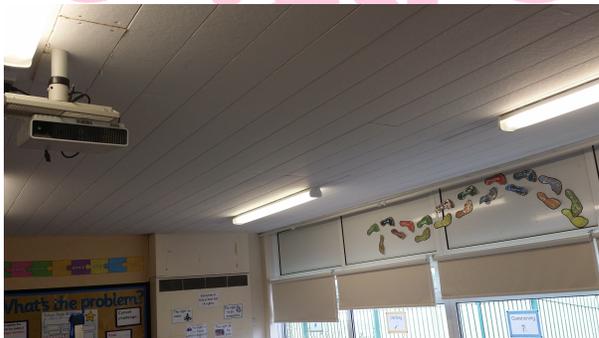
Item 27 Ref: As 209718-1

The Fixed ceiling tiles (Rm 079/Classroom) do not contain asbestos.

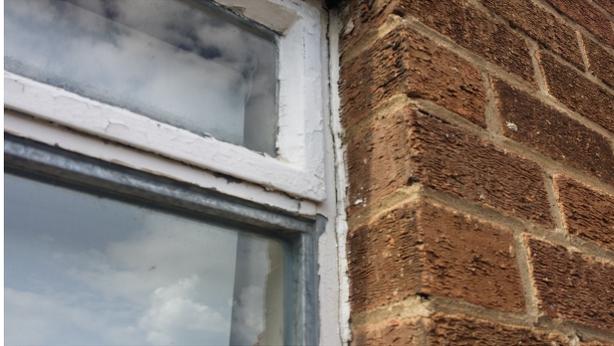
Item 28 Ref: 209718-3

The Sealant to window surround (External-localised to classroom 78 & 79 window replacement works)

Removed August 2022

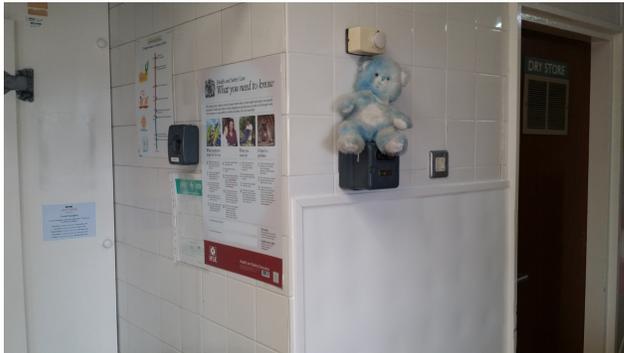
Item 29 Ref: Presumed

The electrics in the kitchen (Room 036) are presumed to contain asbestos.

Any work will require further investigation.

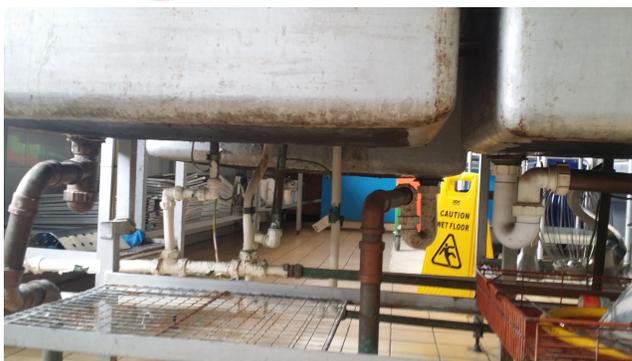
Item 30 Ref: 277554-2

The gasket to the sink waste connections in the kitchen (Room 036) does contain asbestos.

Any change in its appearance should be recorded and passed to Property Services.

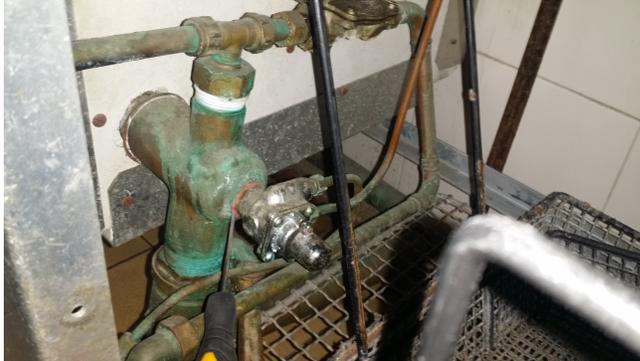
Item 34 Ref: 277554-7

The red gasket to steriliser sink waste connection in the kitchen (Room 036) does contain asbestos.

Any change in its appearance should be recorded and passed to Property Services.

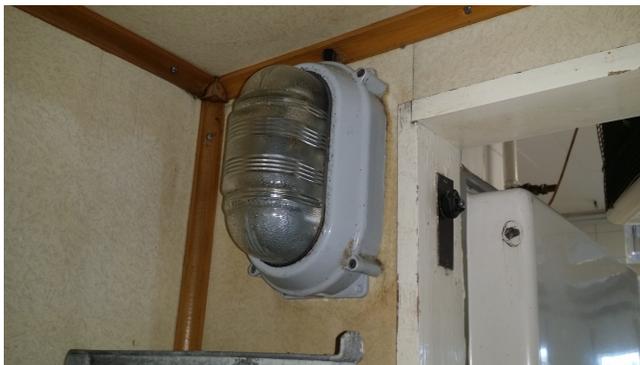
Item 35 Ref: 277554-9

The seal to diffuser of bulkhead light fitting in the kitchen fridge (Room 036a) does not contain asbestos.

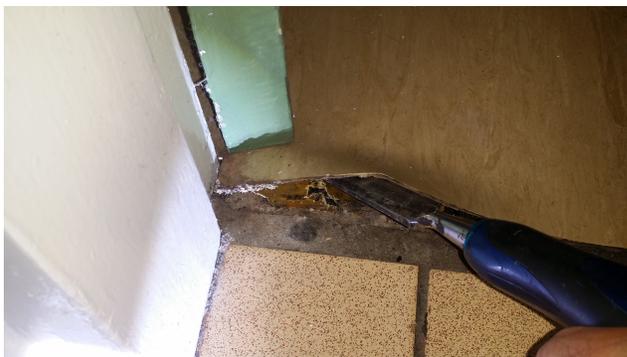
Item 36 Ref: 277554-13

The adhesive to floor beneath lino in office and store (Room 039) does contain asbestos.

Any change in its appearance should be recorded and passed to Property Services.

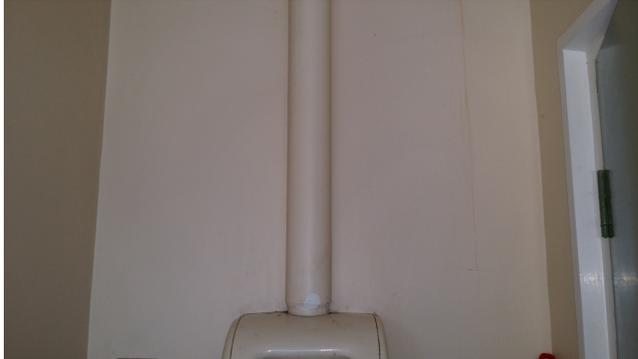
Item 37 Ref: 277554-11

The incinerator flue collar in the WC (Room 040) does not contain asbestos.

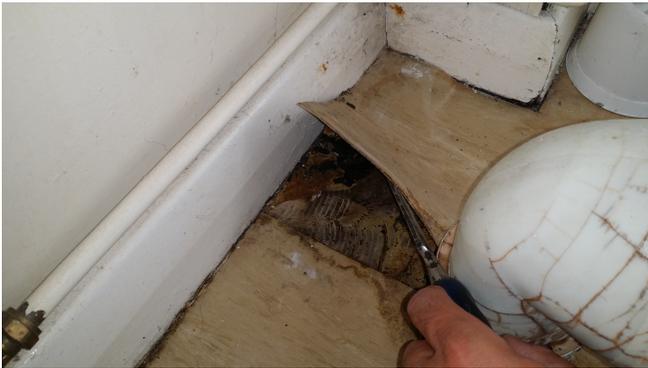
Item 38 Ref: As 277554-13

The adhesive to floor beneath lino in WC (Room 040) does contain asbestos.

Any change in its appearance should be recorded and passed to Property Services.

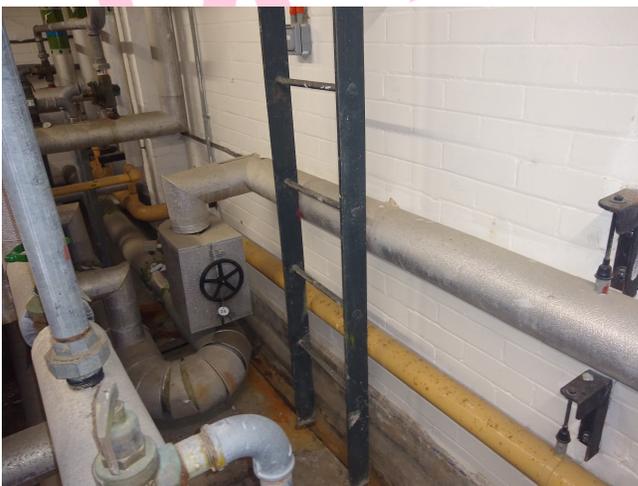
Item 39 Ref: 342052-1

The debris to the walls at low level (encapsulated) in the Boiler Room (Room 0/81) contain asbestos.

Any change in its appearance should be recorded and passed to Property Services.

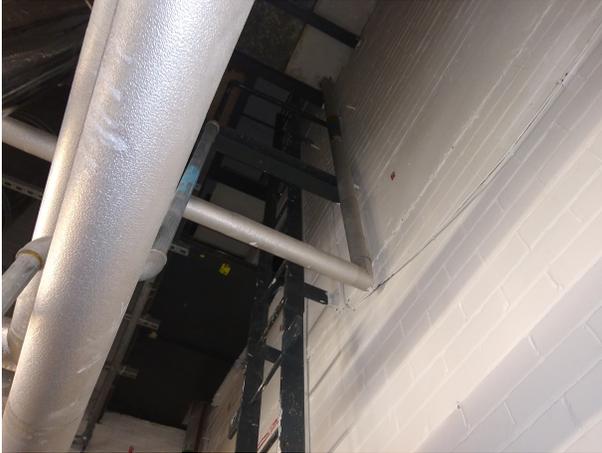
Item 40 Ref: 342052-2

The debris to the walls at high level (encapsulated) in the Boiler Room (Room 0/81) contain asbestos.

Any change in its appearance should be recorded and passed to Property Services.

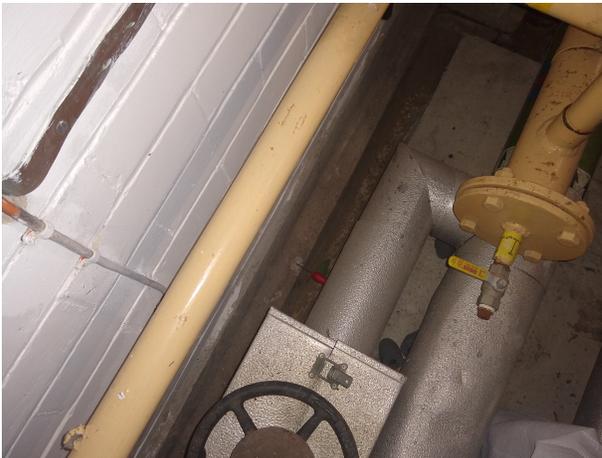
Item 41 Ref: 342052-3

The debris to the ledge behind the boiler in the Boiler Room (Room 0/81) does contain asbestos.

Any change in its appearance should be recorded and passed to Property Services.

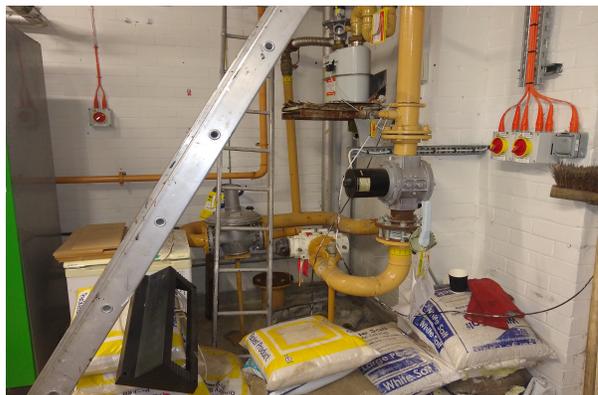
Item 42 Ref: 342052-4

The gas pipework and flange gasket in the Boiler Room (Room 0/81) does not contain asbestos.

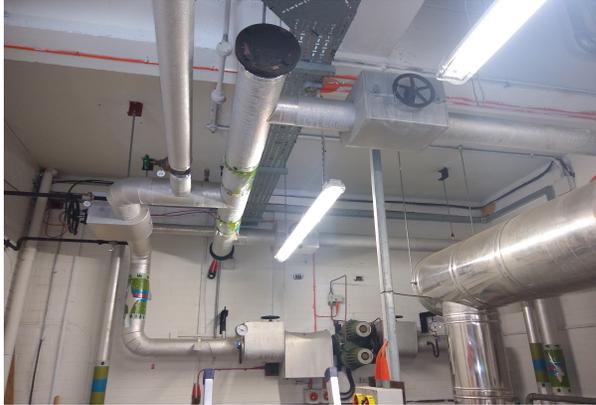
Item 43 Ref: 342052-5

The HTG pipework and flange gasket in the Boiler Room (Room 0/81) does not contain asbestos.

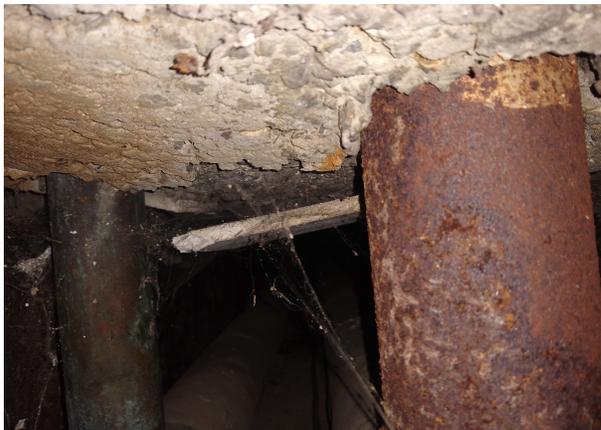
Item 44 Ref: 342052-6

The shuttering to underside of floor above in the Boiler Room floor duct (Room 0/81) does contain asbestos.

Any change in its appearance should be recorded and passed to Property Services.

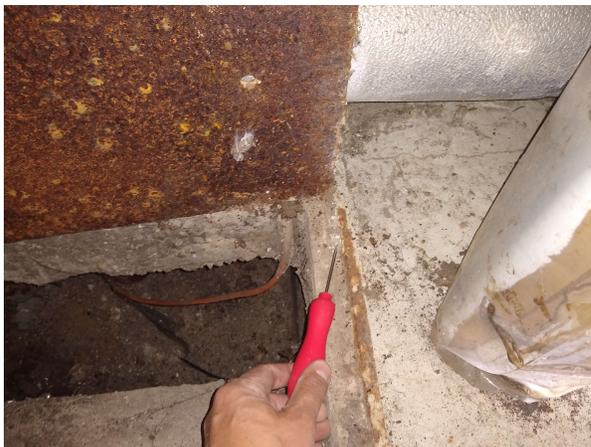
Item 45 Ref: 342052-7

The debris to edge of wall top beneath metal cover plate in the Boiler Room floor duct (Room 0/81) does contain asbestos.

Any change in its appearance should be recorded and passed to Property Services.

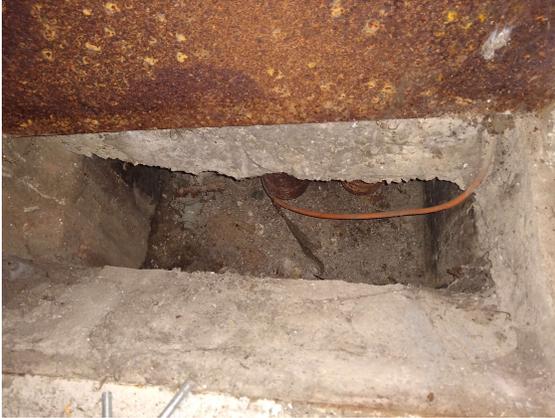
Item 46 Ref: 342052-8

The general debris to the floor in the Boiler Room floor duct (Room 0/81) does contain asbestos.

Any change in its appearance should be recorded and passed to Property Services.

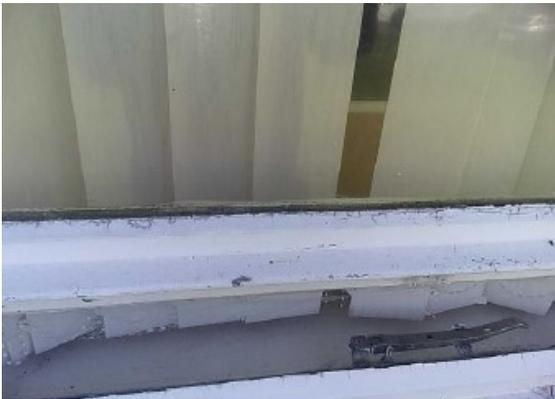
Item 47 Ref: 22-47237-1

The putty around the glass in the windows in Area 2 – Junior Class 1 /Point A does not contain asbestos.

Removed August 2022

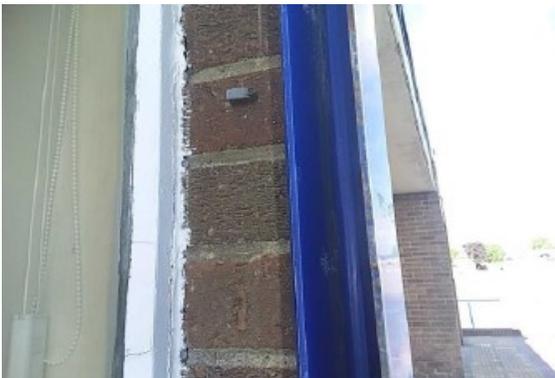
Item 48 Ref: 22-47237-2

The residual frame sealant around windows in Area 2 – Junior Class 1 /Point A does contain asbestos.

Removed August 2022

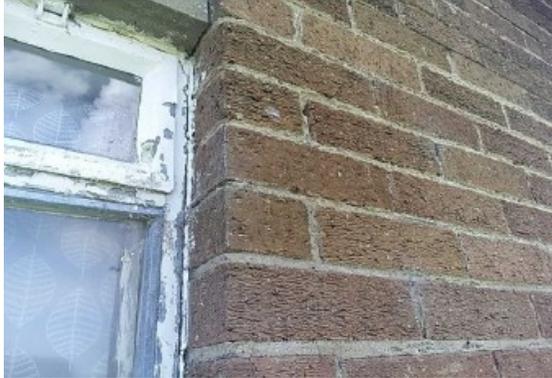
Item 49 Ref: 22-47237-2

The residual frame sealant around windows in Area 3 – Junior Class 3 /Point B does contain asbestos.

Removed August 2022

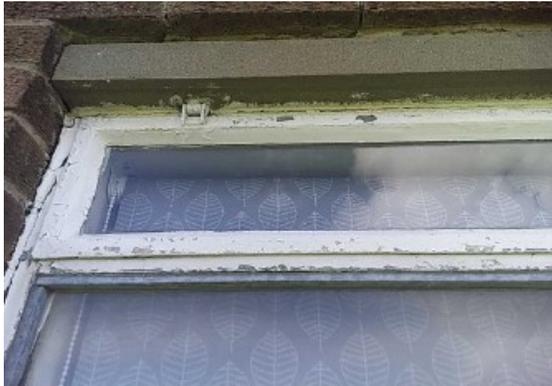
Item 50 Ref: 22-47237-4

The putty around the window in Area 3 – Junior Class 3 /Point B does not contain asbestos.

Removed August 2022

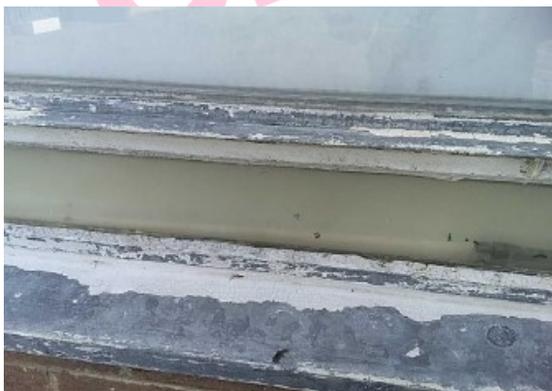
Item 51 Ref: 22-47237-5

The putty around the glass in the windows in Area 4 – Junior Class 4 /Point B does not contain asbestos.

Removed August 2022

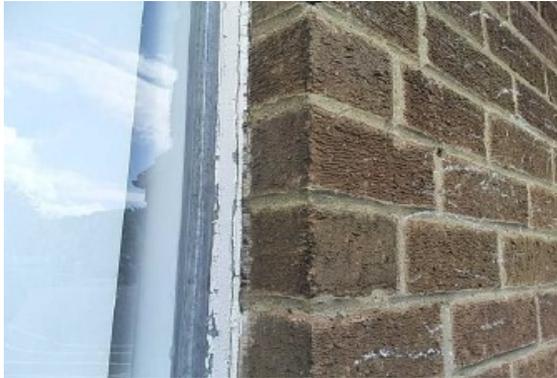
Item 52 Ref: 22-47237-6

The residual frame sealant around windows in Area 4 – Junior Class 4 /Point B does contain asbestos.

Removed August 2022

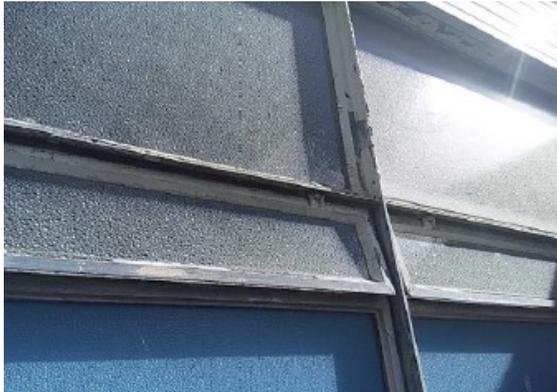
Item 53 Ref: 22-47237-5

The putty around the glass in the windows in Area 5 – WC 1 /Point C does not contain asbestos.

Removed August 2022

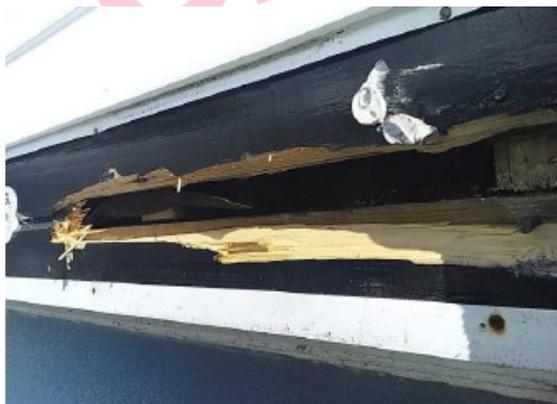
Item 54 Ref: 22-47237-7

The felt behind pvc and wood headers in Area 5 – WC 1 /Point C does not contain asbestos.

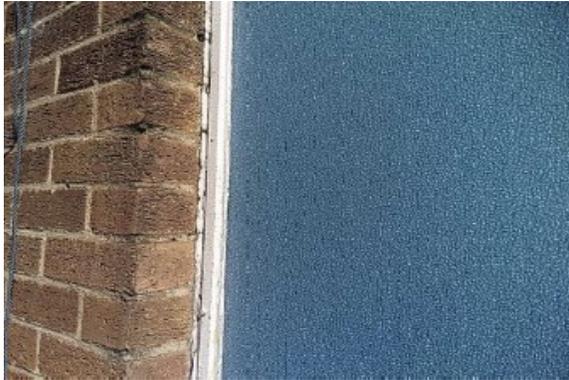
Item 55 Ref: 22-47237-6

The residual frame sealant around windows in Area 6 – WC 2 /Point C does contain asbestos.

Removed August 2022

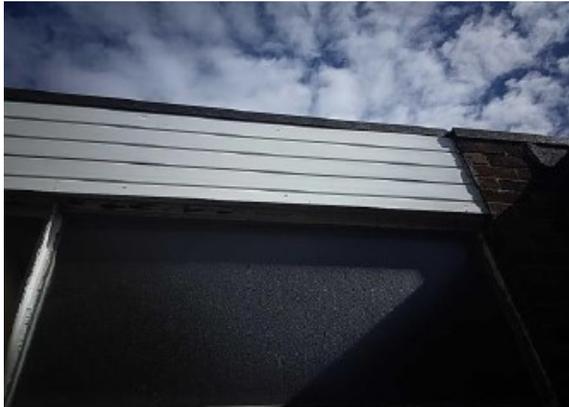
Item 56 Ref: 22-47237-7

The felt behind pvc and wood headers in Area 6 – WC 2 /Point C does not contain asbestos.

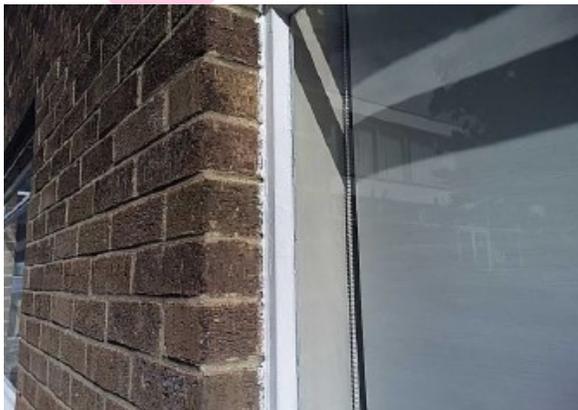
Item 57 Ref: 22-47237-3

The residual frame sealant around windows in Area 7 – Head Teacher /Point D does contain asbestos.

Removed August 2022

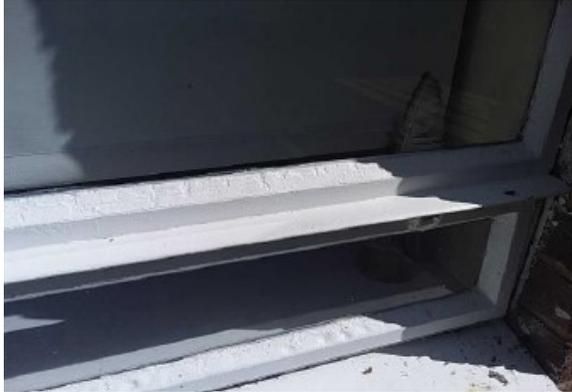
Item 58 Ref: 22-47237-4

The putty around the window in Area 7 – Head Teacher /Point D does not contain asbestos.

Removed August 2022

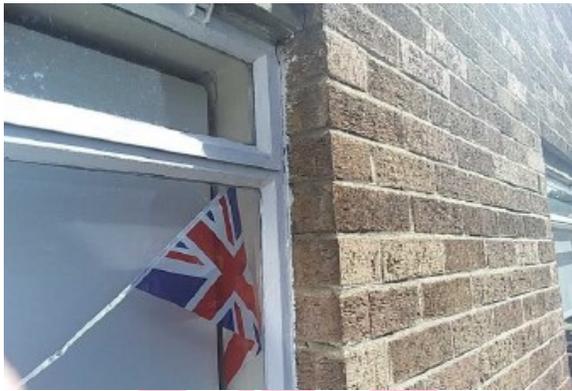
Item 59 Ref: 22-47237-3

The residual frame sealant around windows in Area 8 – Bursar /Point D does contain asbestos.

Removed August 2022

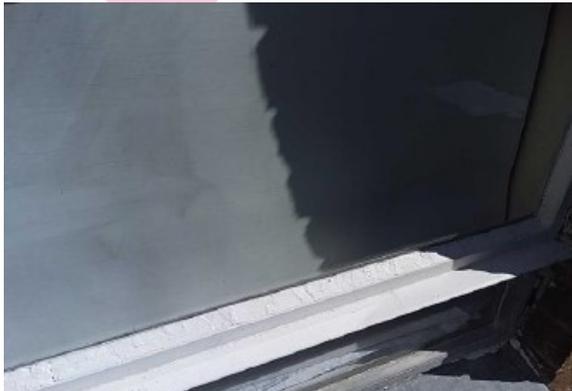
Item 60 Ref: 22-47237-4

The putty around the window in Area 8 – Bursar /Point D does not contain asbestos.

Removed August 2022

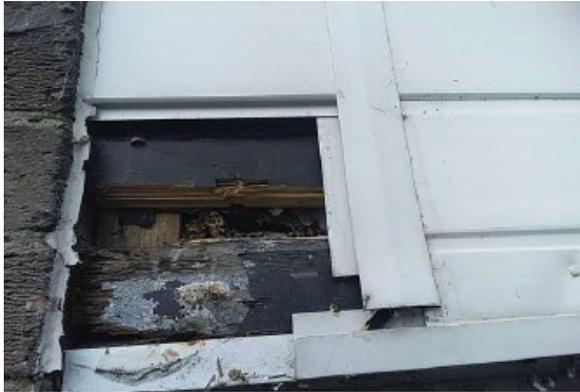
Item 61 Ref: 22-47237-8

The felt behind pvc and wood headers in Area 9 – Main Hall /Point E does not contain asbestos.

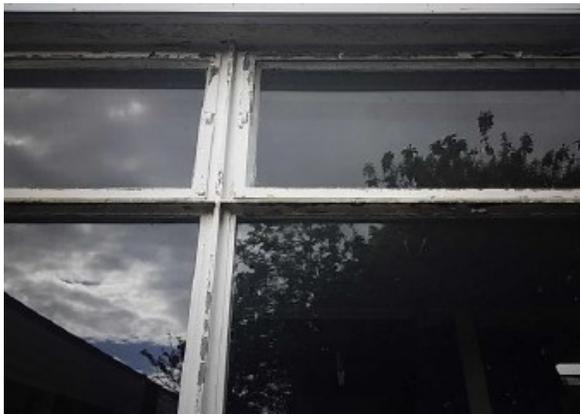
Item 62 Ref: 22-47237-9

The putty around the glass in the windows in Area 9 – Main Hall /Point E does not contain asbestos.

Removed August 2022

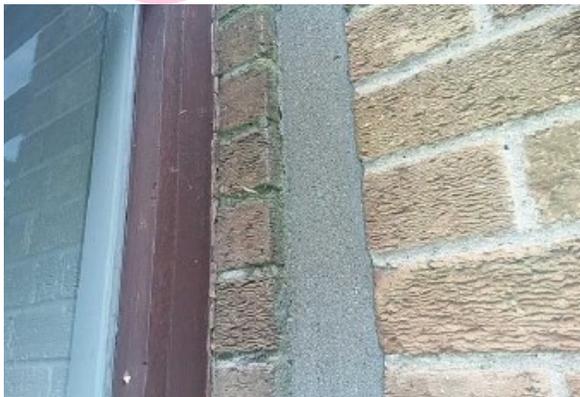
Item 63 Ref: 22-47237-10

The residual frame sealant around windows in Area 10 – Point F does not contain asbestos.

Removed August 2022

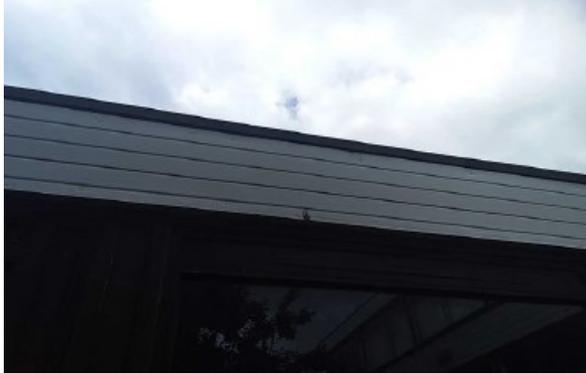
Item 64 Ref: 22-47237-7

The felt behind pvc and wood headers in Area 10 – Point F does not contain asbestos.

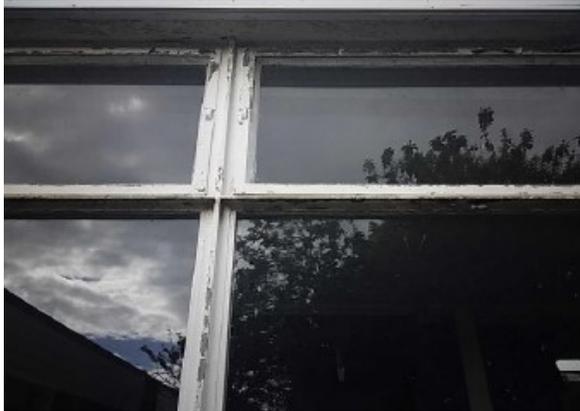
Item 65 Ref: 22-47237-6

The residual frame sealant around windows in Area 11 – Library /Point G does contain asbestos.

Removed August 2022

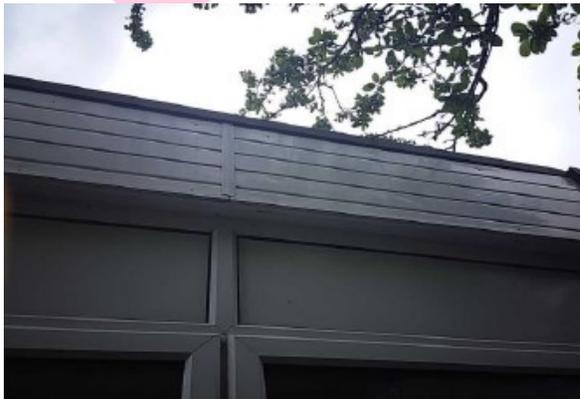
Item 66 Ref: 22-47237-8

The felt behind pvc and wood headers in Area 11 – Library /Point G does not contain asbestos.

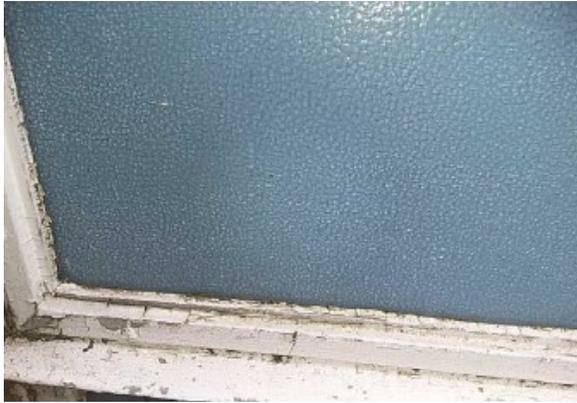
Item 67 Ref: 22-47237-9

The putty around the glass in the windows in Area 11 – Library /Point G does not contain asbestos.

Removed August 2022

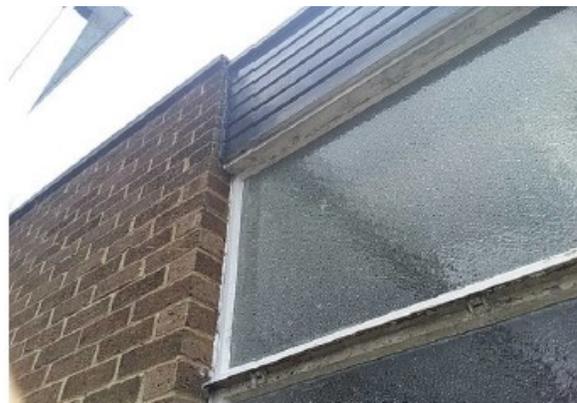
Item 68 Ref: 22-47237-11

The residual frame sealant around windows in Area 12 – Kitchen 1 /Point H does contain asbestos.

Removed August 2022

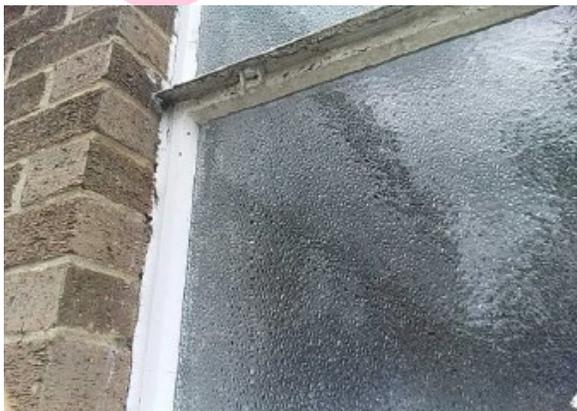
Item 69 Ref: 22-47237-12

The putty around the glass in the windows in Area 12 – Kitchen 1 /Point H does not contain asbestos.

Removed August 2022

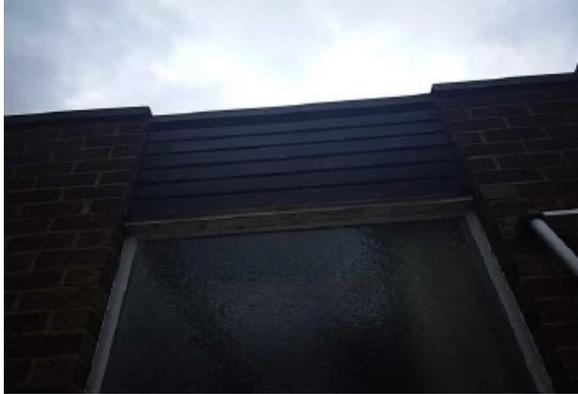
Item 70 Ref: 22-47237-8

The felt behind wood headers in Area 12 – Kitchen 1 /Point H does not contain asbestos.

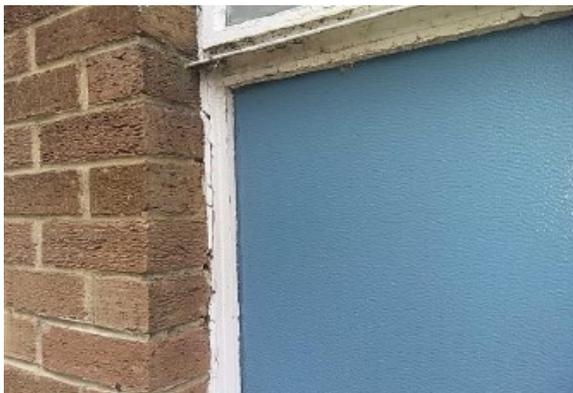
Item 71 Ref: 22-47237-11

The residual frame sealant around window and wood panelling in Area 13 – WC 3 /Point H does contain asbestos.

Removed August 2022

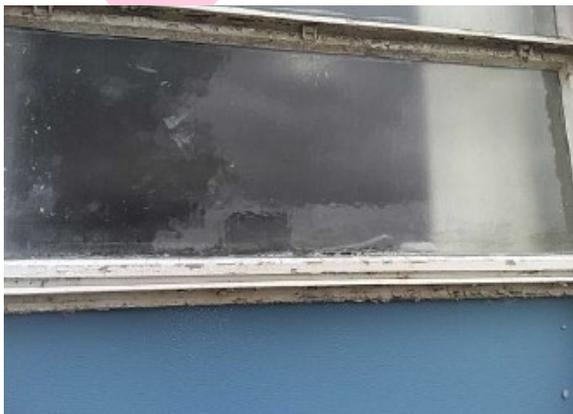
Item 72 Ref: 22-47237-12

The putty around the glass in the windows in Area 13 – WC 3 /Point H does not contain asbestos.

Removed August 2022

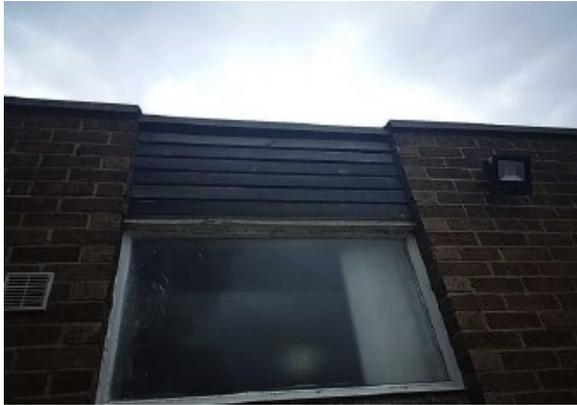
Item 73 Ref: 22-47237-8

The felt behind wood headers in Area 13 – WC 3 /Point H does not contain asbestos.

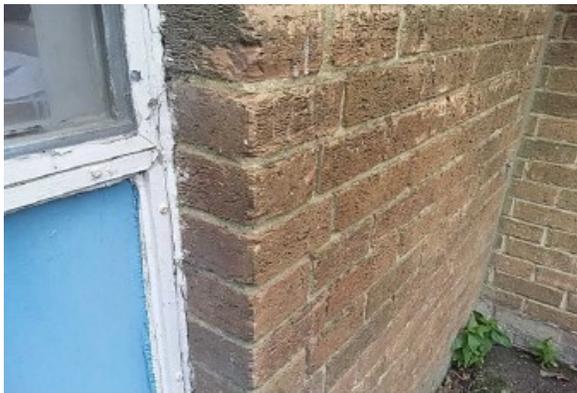
Item 74 Ref: 22-47237-13

The residual frame sealant around windows in Area 15 – Point I, J, K does contain asbestos.

Removed August 2022

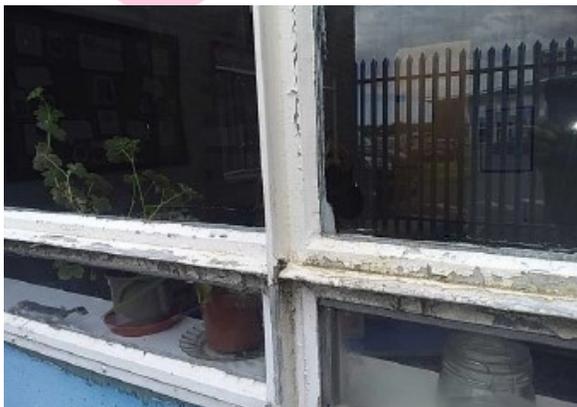
Item 75 Ref: 22-47237-14

The putty around the glass in the windows in Area 15 – Point I, J, K does not contain asbestos.

Removed August 2022

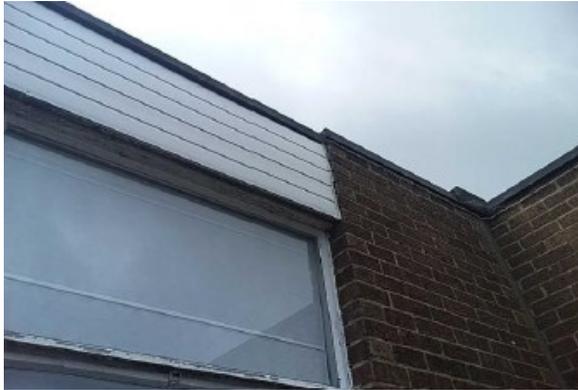
Item 76 Ref: 22-47237-8

The felt behind pvc and wood headers in Area 15 – Point I, J, K does not contain asbestos.

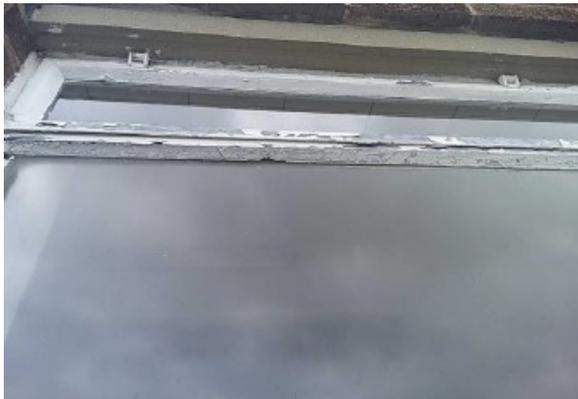
Item 77 Ref: 22-47237-15

The putty around the glass in the windows in Area 16 – Kitchen 2 /Point J does not contain asbestos.

Removed August 2022

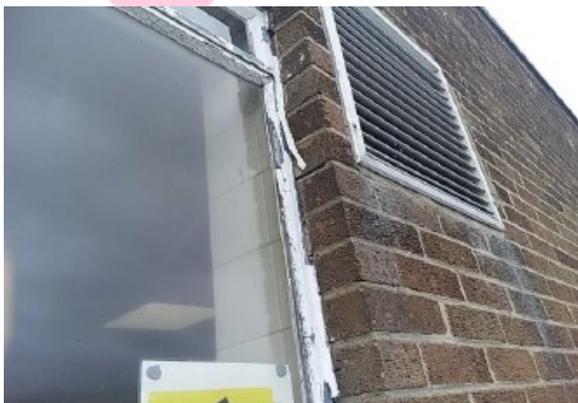
Item 78 Ref: 22-47237-16

The residual frame sealant around windows in Area 16 – Kitchen 2 /Point J does not contain asbestos.

Removed August 2022

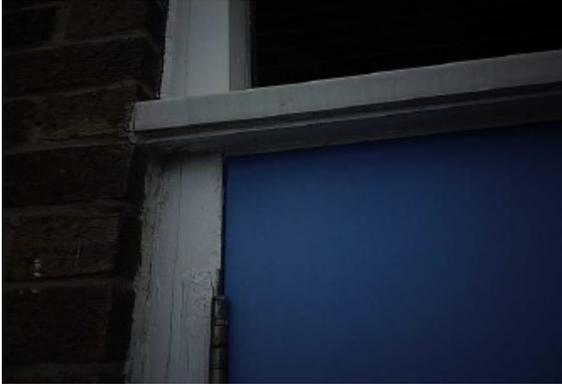
Item 79 Ref: 22-47237-17

The residual frame sealant around door in Area 17 – D1 does not contain asbestos.

Removed August 2022
