ASBESTOS SURVEY REPORT FOR BIDDICK PRIMARY SCHOOL, KIRKHAM BIDDICK VILLAGE, WASHINGTON

Asbestos Register for Biddick Primary School

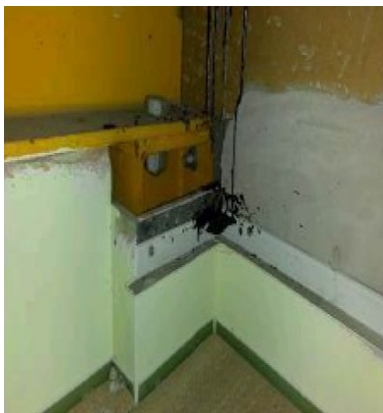
Item 1 As EB002449

Any change in its appearance should be noted and reported to Property Services.

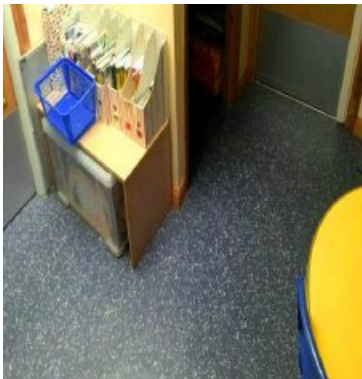
Item 6 As EB002450

The blue vinyl floor covering to the lobby (Room 4) does not contain asbestos.

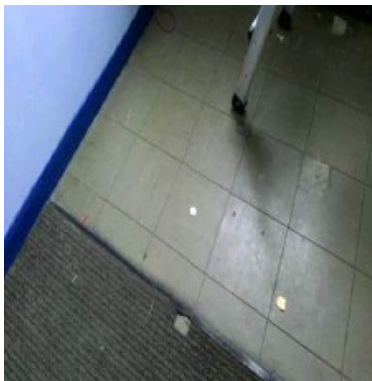
Item 8 As: EB002451

The green floor tiles to the cloak room (Room 5) do not contain asbestos.

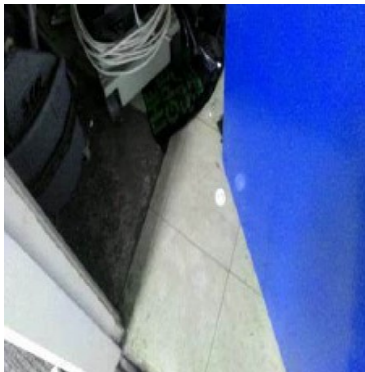
Item 12 As: EB002451

The green floor tiles to the cleaner's cupboard (Room 9) do not contain asbestos.

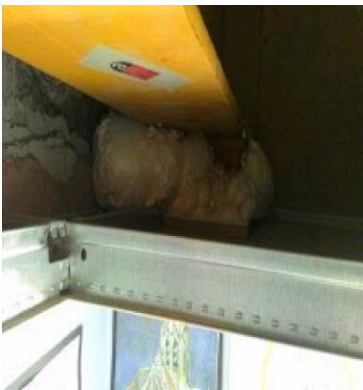
Item 14 As: EB002449

The insulating board cladding to the metal columns within the Cloak area (Room 10) contains asbestos.

Any change in its appearance should be noted and reported to Property Services.

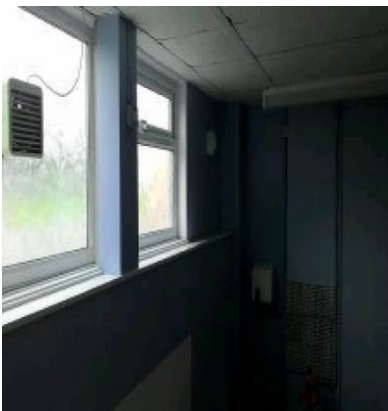
Item 15 As: EB002449

The insulating board cladding to the metal columns within the Boys WC area (Room 11) contains asbestos.

Any change in its appearance should be noted and reported to Property Services.

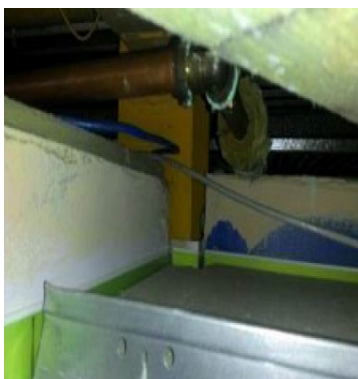
Item 17 As: EB002449

The insulating board cladding to the metal columns Classroom 6 (Room 13) contains asbestos.

Any change in its appearance should be noted and reported to Property Services.

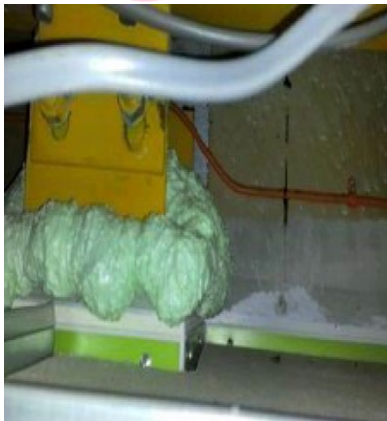
Item 24 As: EB002449

The insulating board cladding to the metal columns within Classroom 9 (Room 17) contains asbestos.

Any change in its appearance should be noted and reported to Property Services.

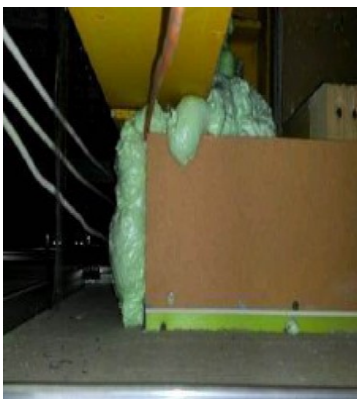
Item 27 As: EB002449

The insulating board cladding to the metal columns within Classroom 7 (Room 18) contains asbestos.

Any change in its appearance should be noted and reported to Property Services.

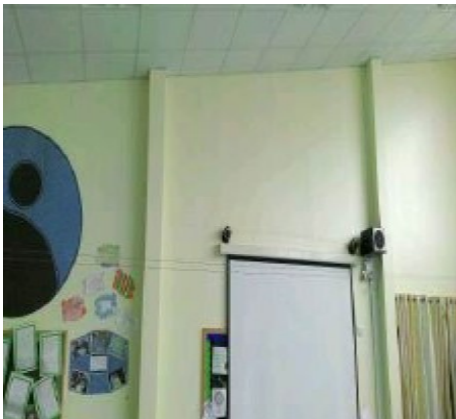
Item 32 Ref: EB002453

The insulating board cladding to the metal columns within the assembly hall (Room 37) contains asbestos.

Any change in its appearance should be noted and reported to Property Services.

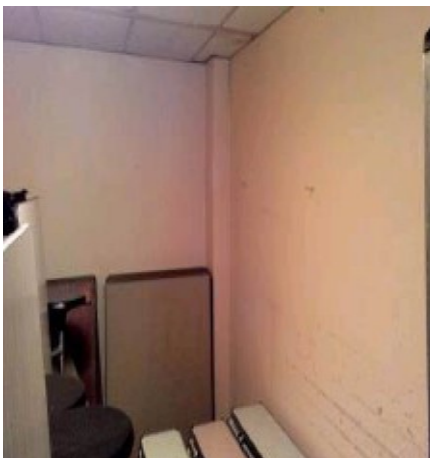
Item 33 As: EB002454

The insulating board cladding to the columns within the chair store (Room 38) contains asbestos.

Any change in its appearance should be noted and reported to Property Services.

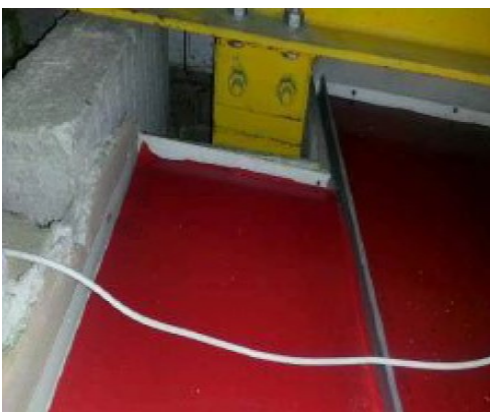
Item 37 Ref: EB002453

The insulating board cladding to the metal columns within the kitchen store (Room 40) contains asbestos.

Any change in its appearance should be noted and reported to Property Services.

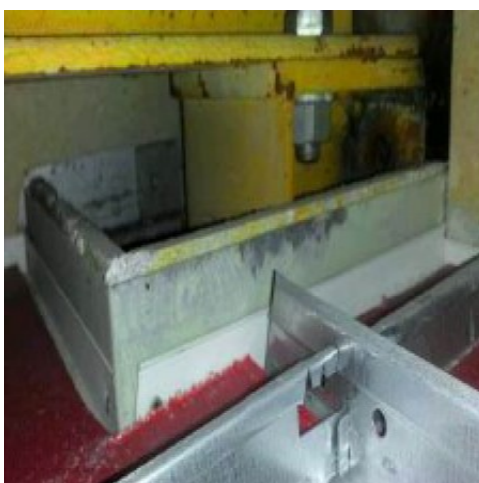
Item 38 Ref: EB002453

The insulating board cladding to the metal columns within the kitchen WC and Larder (Room 40) contains asbestos.

Any change in its appearance should be noted and reported to Property Services.

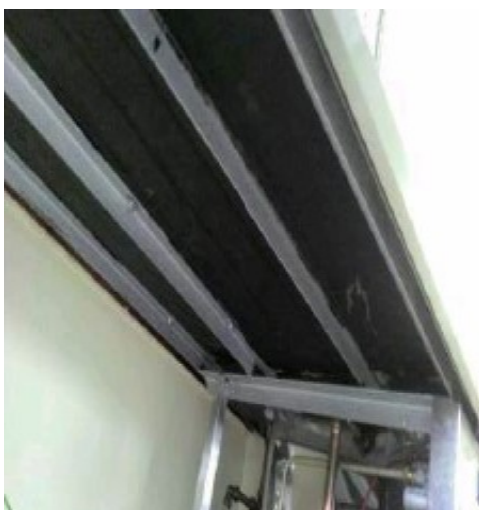
Item 39 As: EB002456

The bitumen coating below the sink units in the kitchen (Room 40) do not contain asbestos.

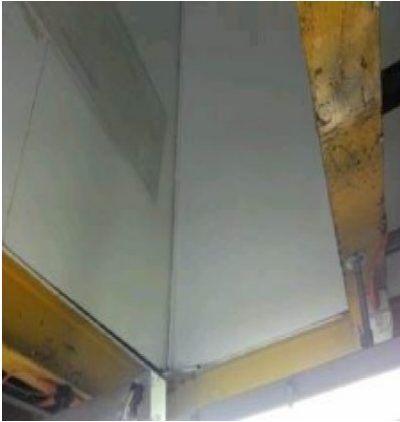
Item 49 Ref: EB002462

The insulating board panels to the wall at high level in the boiler room (External Room 1) contain asbestos.

Any change in its appearance should be noted and reported to Property Services.

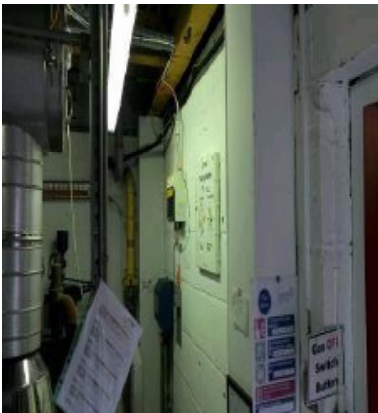
Item 50 Ref: EB002463

The insulating board boxing to metal columns (x2) in the Boiler Room (External Room 1) does not contain asbestos.

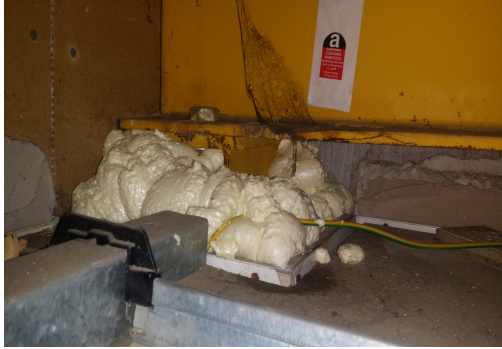
Item 52 Ref: 203580-1

The insulating board in the boys toilet ceiling void (Room 015) contains asbestos.
