ASBESTOS SURVEY REPORT FOR BIDDICK PRIMARY SCHOOL, KIRKHAM BIDDICK VILLAGE, WASHINGTON

Asbestos Register for Biddick Primary School

UPRN: - 208189

Premises Manager / Samo: - Tenant Date: 08 August 2025

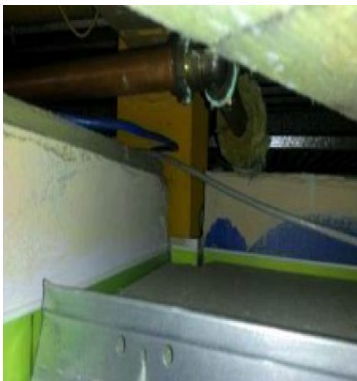
Item 17 As: EB002449

The insulating board cladding to the metal columns Classroom 6 (Room 13) contains asbestos.

Any change in its appearance should be noted and reported to Property Services.

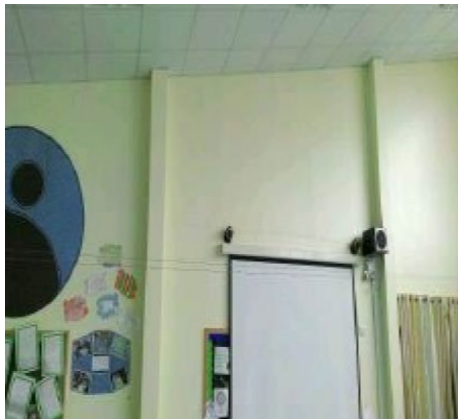
Item 32 Ref: EB002453

The insulating board cladding to the metal columns within the assembly hall (Room 37) contains asbestos.

Any change in its appearance should be noted and reported to Property Services.

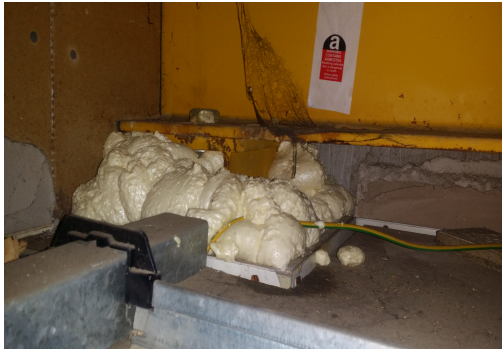
Item 52 Ref: 203580-1

The insulating board in the boys toilet ceiling void (Room 015) contains asbestos.
