ASBESTOS SURVEY REPORT FOR BLACKFELL PRIMARY SCHOOL,
BLACKFELL VILLAGE, WASHINGTON, NE37 1HA.

Asbestos Register for

**Blackfell Primary School, Blackfell Village, Washington,
NE37 1HA**

Date: 04 February 2025

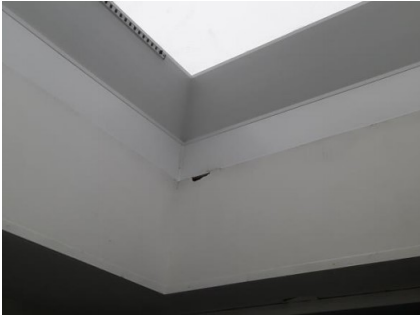
Item 1 Ref: 20-28461-1

- (Item 1) Ref: 20-28461-1 – Walls (Area 5/Girls Toilet) – No Risk
- (Item 2) Ref: 20-28461-7 – Textured coating to walls (Area 7/Hallway and Cloakroom) – No Risk

The walls (Area 5/Girls Toilet) does not contain asbestos.

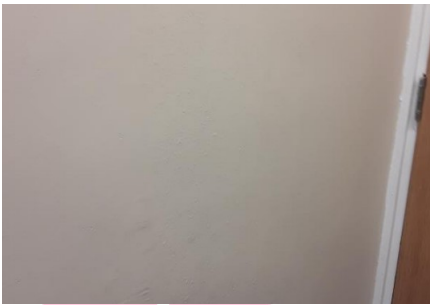
Item 2 Ref: 20-28461-7

The textured coating to walls (Area 7/Hallway and Cloakroom) does not contain asbestos.

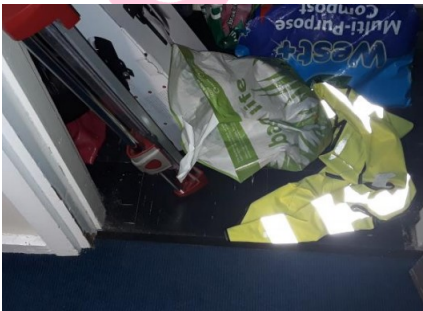
Item 3 Ref: 20-28461-2

- (Item 3) Ref: 20-28461-2 – Floor tiles and adhesive (Area 8/Store Cupboard) – Very Low Risk
- (Item 4) Ref: 20-28461-3 – Floor tiles and adhesive (Area 9/Dining Room) – Low Risk

The floor tiles and adhesive (Area 8/Store Cupboard) contain asbestos.

Any change in its appearance should be recorded and passed to Property Services.

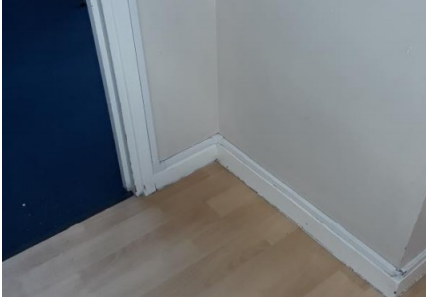
Item 4 Ref: 20-28461-3

The floor tiles and adhesive (Area 9/Dining Room) contain asbestos.

Any change in its appearance should be recorded and passed to Property Services.

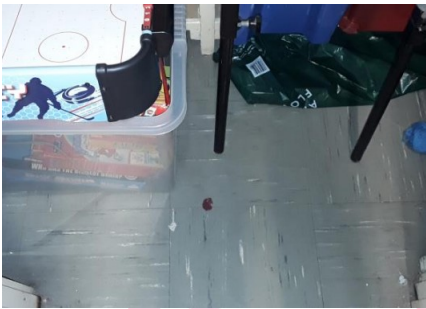
Item 5 Ref: 20-28461-3

- (Item 5) Ref: 20-28461-3 – Floor tiles and adhesive (Area 10/Store cupboard) – Very Low Risk
- (Item 6) Ref: 20-28461-4 – Floor tiles and adhesive (Area 11/Hallway) – Low Risk

The floor tiles and adhesive (Area 10/Store cupboard) contain asbestos.

Any change in its appearance should be recorded and passed to Property Services.

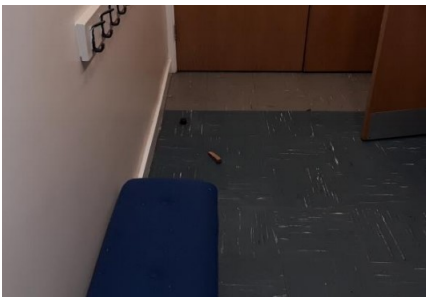
Item 6 Ref: 20-28461-4

The floor tiles and adhesive (Area 11/Hallway) contain asbestos.

Any change in its appearance should be recorded and passed to Property Services.

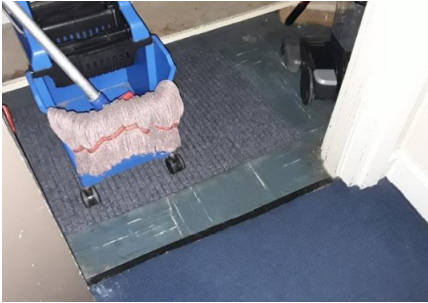
Item 7 Ref: 20-28461-4

- (Item 7) Ref: 20-28461-4 – Floor tiles and adhesive (Area 18/Cleaners cupboard) – Very Low Risk
- (Item 8) Ref: 20-28461-5 – Floor tiles and adhesive (Area 20/Year 4 Classroom cupboard) – Removed April 2023

The floor tiles and adhesive (Area 18/Cleaners cupboard) contain asbestos.

Any change in its appearance should be recorded and passed to Property Services.

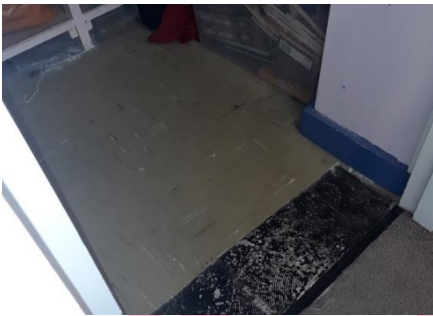
Item 8 Ref: 20-28461-5

The floor tiles and adhesive (Area 20/Year 4 Classroom cupboard) contain asbestos.

Removed April 2023

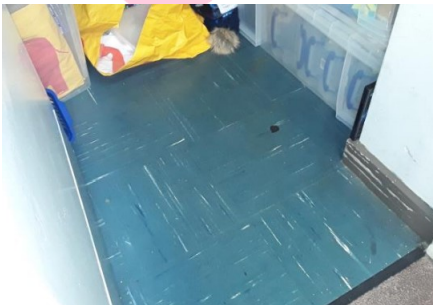
Item 9 Ref: 20-28461-4

- (Item 9) Ref: 20-28461-4 – Floor tiles and adhesive (Area 2/Year 3 cupboard) – Very Low Risk
- (Item 10) Ref: 20-28461-2 – Floor tiles and adhesive (Area 25/Store cupboard) – Very Low Risk

The floor tiles and adhesive (Area 2/Year 3 cupboard) contain asbestos.

Any change in its appearance should be recorded and passed to Property Services.

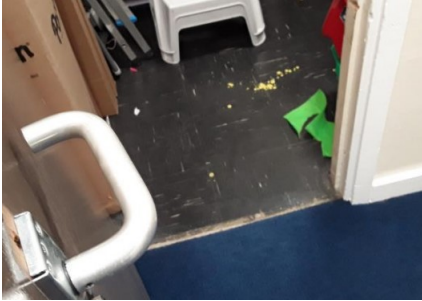
Item 10 Ref: 20-28461-2

The floor tiles and adhesive (Area 25/Store cupboard) contain asbestos.

Any change in its appearance should be recorded and passed to Property Services.

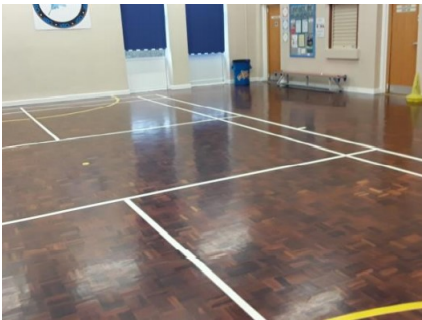
Item 11 Ref: PRESUMED

- (Item 11) Ref: Presumed – Floor beneath fitted parquet flooring (Area 26/Hall) – No Risk
- (Item 12) Ref: 20-28461-7 – Textured coating to walls (Area 26/Hall) – No Risk

The floor beneath fitted parquet flooring (Area 26/Hall) is presumed to contain asbestos.

Noted as not asbestos – see SGS survey J205006 and Ref: Item 63 & 64

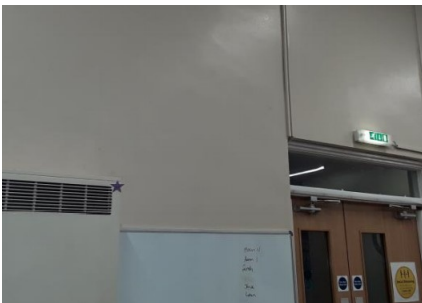
Item 12 Ref: 20-28461-7

The textured coating to walls (Area26/Hall) does not contain asbestos.

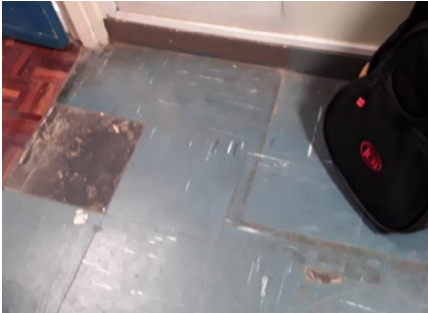
Item 13 Ref: 20-28461-4

- (Item 13) Ref: 20-28461-4 - Floor tiles and adhesive (Area 27/Cupboard Electric Meter) – Very Low Risk
- (Item 14) Ref: 20-28461-4 - Floor tiles and adhesive (Area 35/Classroom cupboard) – Very Low Risk

The floor tiles and adhesive (Area 27/Cupboard Electric Meter) contain asbestos.

Any change in its appearance should be recorded and passed to Property Services.

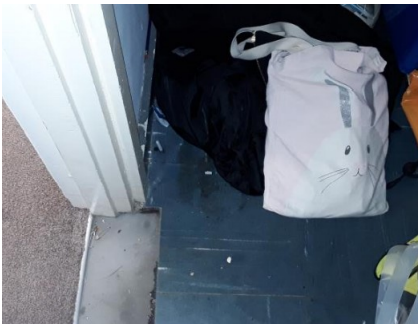
Item 14 Ref: 20-28461-4

The floor tiles and adhesive (Area 35/Classroom cupboard) contain asbestos.

Any change in its appearance should be recorded and passed to Property Services.

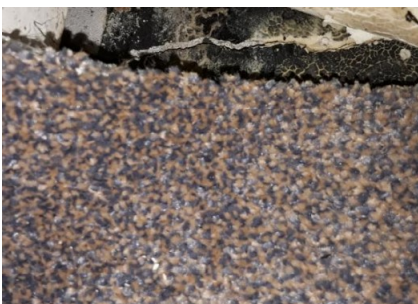
Item 15 Ref: 20-28461-8

- (Item 15) Ref: 20-28461-8 – Floor (Area 37/Classroom cupboard) – Very Low Risk
- (Item 16) Ref: 20-28461-5 - Floor tiles and adhesive (Area 39/Store Cupboard) – Very Low Risk

The floor (Area 37/Classroom cupboard) contains asbestos.

Any change in its appearance should be recorded and passed to Property Services.

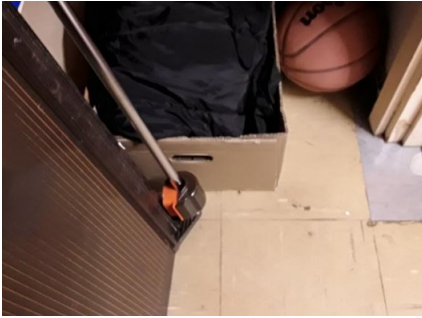
Item 16 Ref: 20-28461-5

The floor tiles and adhesive (Area 39/Store Cupboard) contain asbestos.

Any change in its appearance should be recorded and passed to Property Services.

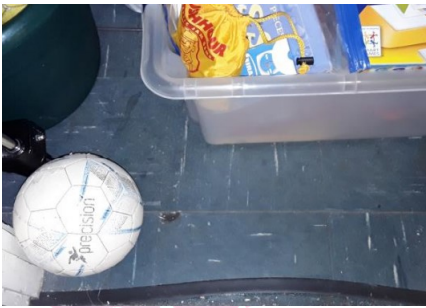
Item 17 Ref: 20-28461-4

- (Item 17) Ref: 20-28461-4 - Floor tiles and adhesive (Area 40/Store cupboard) – Very Low Risk
- (Item 18) Ref: 20-28461-8 – Floor (Area 42/Store cupboard, Year 6 Classroom) – Very Low Risk

The floor tiles and adhesive (Area 40/Store cupboard) contain asbestos.

Any change in its appearance should be recorded and passed to Property Services.

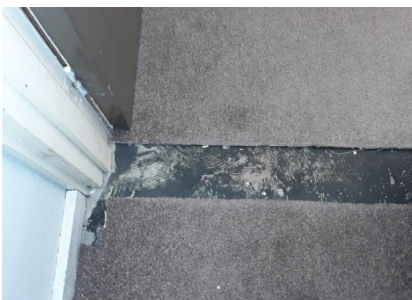
Item 18 Ref: 20-28461-8

The floor (Area 42/Store cupboard, Year 6 Classroom) contains asbestos.

Any change in its appearance should be recorded and passed to Property Services.

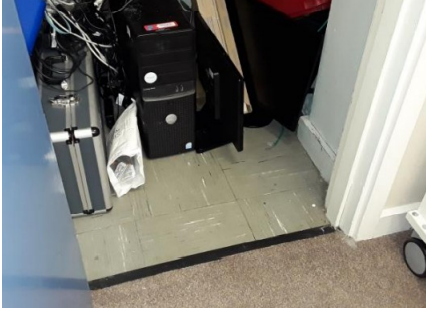
Item 19 Ref: 20-28461-3

- (Item 19) Ref: 20-28461-3 – Floor tiles and adhesive (Area 44/Store cupboard and IT Room) – Very Low Risk
- (Item 20) Ref: 20-28461-4 - Floor tiles and adhesive (Area 45/Cleaners cupboard) – Very Low Risk

The floor tiles and adhesive (Area 44/Store cupboard and IT Room) contain asbestos.

Any change in its appearance should be recorded and passed to Property Services.

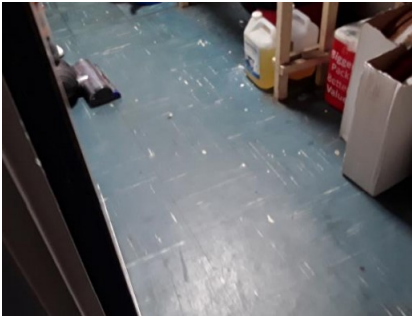
Item 20 Ref: 20-28461-4

The floor tiles and adhesive (Area 45/Cleaners cupboard) contain asbestos.

Any change in its appearance should be recorded and passed to Property Services.

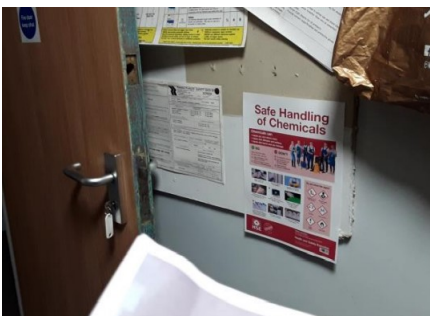
Item 21 Ref: 20-28461-9

- (Item 21) Ref: 20-28461-9 – Walls notice board (Area 45/Cleaners cupboard) – No Risk
- (Item 22) Ref: 20-28461-4 – Floor tiles and adhesive (Area 46/Hall Store) – Very Low Risk

The walls notice board (Area 45/Cleaners cupboard) does not contain asbestos.

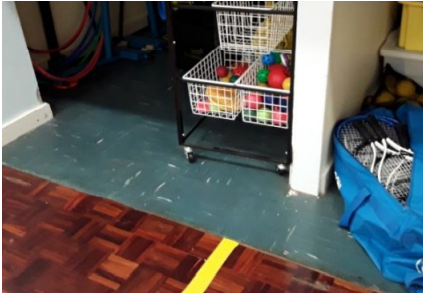
Item 22 Ref: 20-28461-4

The floor tiles and adhesive (Area 46/Hall Store) contain asbestos.

Any change in its appearance should be recorded and passed to Property Services.

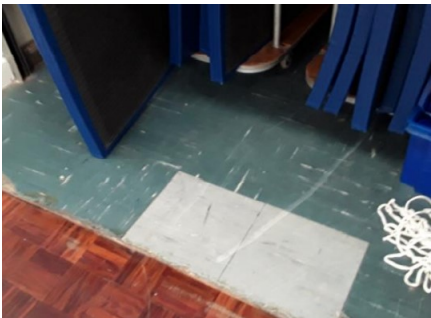
Item 23 Ref: 20-28461-4

- (Item 23) Ref: 20-28461-4 – Floor tiles and adhesive (Area 47/Hall Store) – Very Low Risk
- (Item 24) Ref: 20-28461-7 – Textured coating to walls (Area 54/Corridor) – No Risk

The floor tiles and adhesive (Area 47/Hall Store) contain asbestos.

Any change in its appearance should be recorded and passed to Property Services.

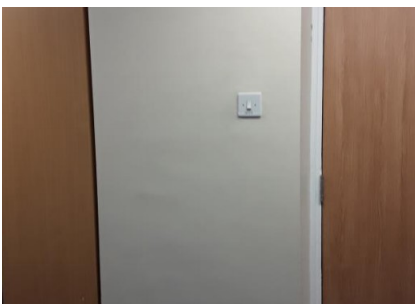
Item 24 Ref: 20-28461-7

The textured coating to walls (Area 54/Corridor) do not contain asbestos.

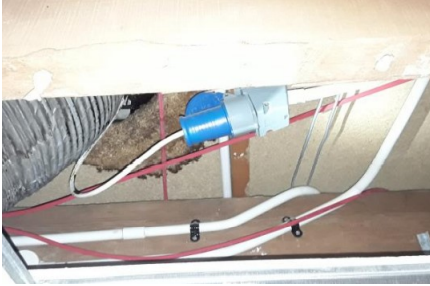
Item 25 Ref: 20-28461-10

- (Item 25) Ref: 20-28461-10 – Ceiling (Area 55/Medical Room) – No Risk
- (Item 26) Ref: 20-28461-11 – Sink Pad (Area 55/Medical Room) – No Risk

The ceiling (Area 55/Medical Room) does not contain asbestos.

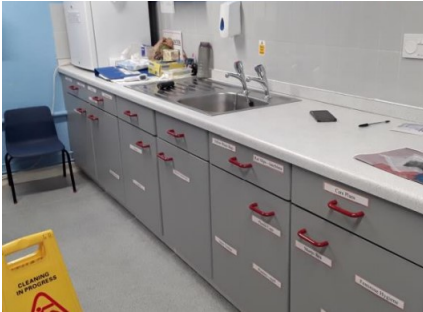
Item 26 Ref: 20-28461-11

The sink pad (Area 55/Medical Room) does not contain asbestos.

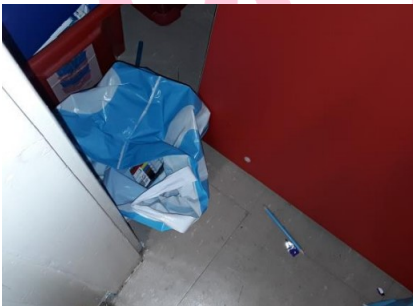
Item 27 Ref: 20-28461-5

- (Item 27) Ref: 20-28461-5 – Floor tiles and adhesive (Area 65/Year 1 Classroom cupboard) – Very Low Risk
- (Item 28) Ref: 20-28461-12 – Floor tiles and adhesive (Area 66/Year 1 Classroom cupboard) – Very Low Risk

The floor tiles and adhesive (Area 65/Year 1 Classroom cupboard) contain asbestos.

Any change in its appearance should be recorded and passed to Property Services.

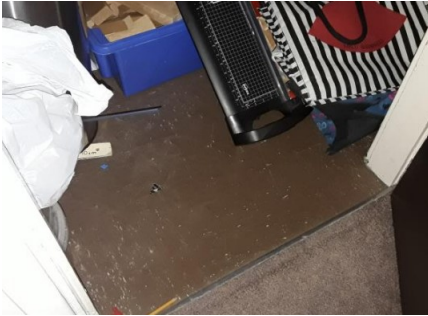
Item 28 Ref: 20-28461-12

The floor tiles and adhesive (Area 66/Year 1 Classroom cupboard) contain asbestos.

Any change in its appearance should be recorded and passed to Property Services.

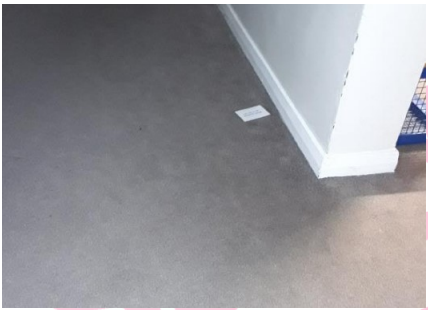
Item 29 Ref: 20-28461-8

- (Item 29) Ref: 20-28461-8 – Floor (Area 69/Year 2 Classroom) – Low Risk
- (Item 30) Ref: 20-28461-13 – Floor tiles and adhesive (Area 71/Year 2 Classroom cupboard) – Very Low Risk

The floor (Area 69/Year 2 Classroom) contains asbestos.

Any change in its appearance should be recorded and passed to Property Services.

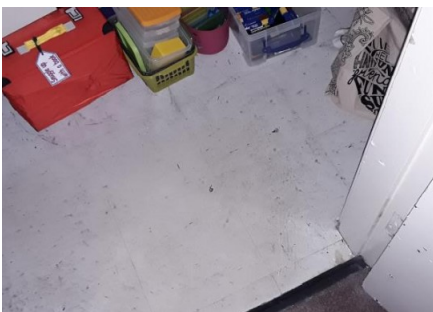
Item 30 Ref: 20-28461-13

The floor tiles and adhesive (Area 71/Year 2 Classroom cupboard) contain asbestos.

Any change in its appearance should be recorded and passed to Property Services.

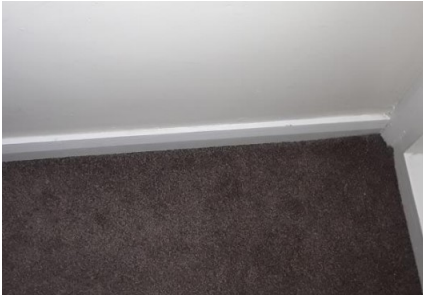
Item 31 Ref: 20-28461-8

- (Item 31) Ref: 20-28461-8 – Floor (Area 72/Year 2 Classroom) – Low Risk
- (Item 32) Ref: 20-28461-13 – Floor tiles and adhesive (Area 73/Year 2 Classroom cupboard) – Very Low Risk

The floor (Area 72/Year 2 Classroom) contains asbestos.

Any change in its appearance should be recorded and passed to Property Services.

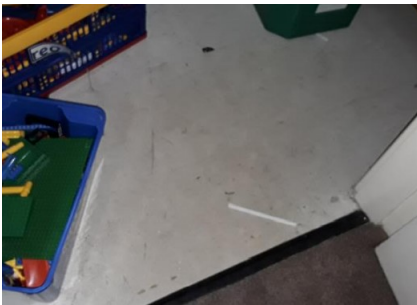
Item 32 Ref: 20-28461-13

The floor tiles and adhesive (Area 73/Year 2 Classroom cupboard) contain asbestos.

Any change in its appearance should be recorded and passed to Property Services.

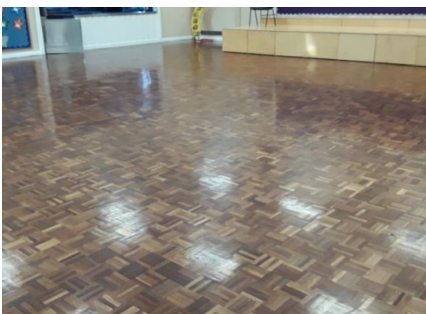
Item 33 Ref: PRESUMED

- (Item 33) Ref: Presumed – Floor (Area 78/Hall) – Low Risk
- (Item 34) Ref: 20-28461-15 – Floor tiles and adhesive (Area 78/Hall) – Low Risk
- (Item 35) Ref: 20-28461-16 – Floor tiles and adhesive (Area 91/Cupboard Cleaners) – Very Low Risk

The floor (Area 78/Hall) is presumed to contain asbestos.

Any change in its appearance should be recorded and passed to Property Services.

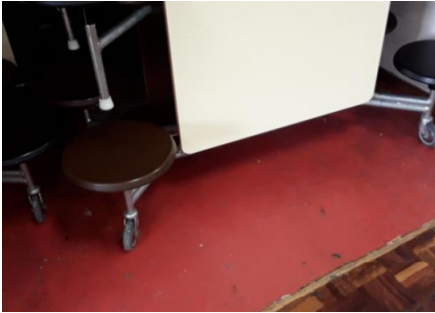
Item 34 Ref: 20-28461-15

The floor tiles and adhesive (Area 78/Hall) contain asbestos.

Any change in its appearance should be recorded and passed to Property Services.

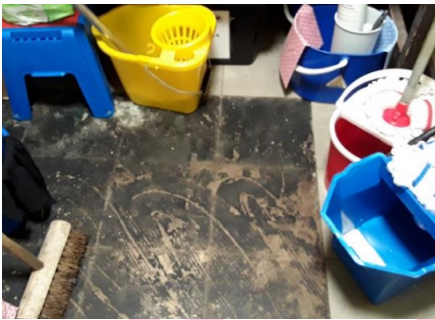
Item 35 Ref: 20-28461-16

The floor tiles and adhesive (Area 91/Cupboard Cleaners) contain asbestos.

Any change in its appearance should be recorded and passed to Property Services.

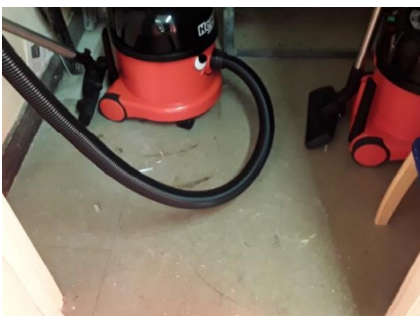
Item 36 Ref: 20-28461-17

- (Item 36) Ref: 20-28461-17 – Floor tiles and adhesive (Area 92/Electrical Cupboard) – Very Low Risk
- (Item 37) Ref: 20-28461-18 – Ceiling (Area 93/Kitchen) – Low Risk

The floor tiles and adhesive (Area 92/Electrical Cupboard) contain asbestos.

Any change in its appearance should be recorded and passed to Property Services.

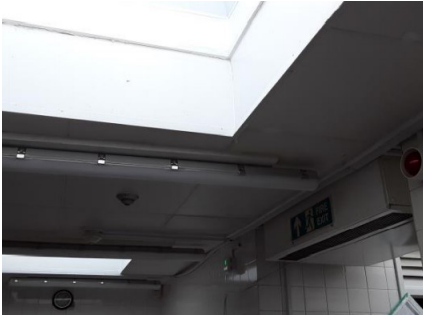
Item 37 Ref: 20-28461-18

The ceiling (Area 93/Kitchen) contains asbestos.

Any change in its appearance should be recorded and passed to Property Services.

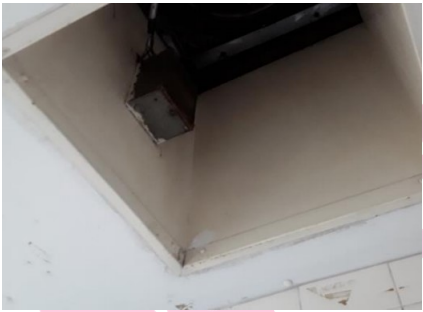
Item 38 Ref: 20-28461-19

- (Item 38) Ref: 20-28461-19 – Upstands to old extraction unit (Area93/Kitchen) – Low Risk
- (Item 39) Ref: 20-28461-20 – Sink pad (Area 93/Kitchen) – No Risk

The upstands to old extraction unit (Area93/Kitchen) contain asbestos.

Any change in its appearance should be recorded and passed to Property Services.

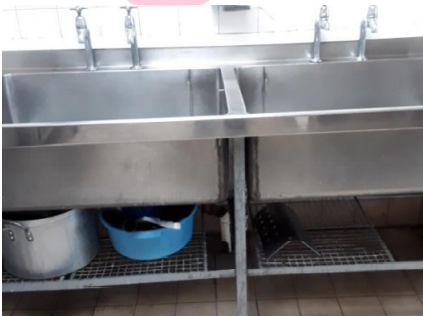
Item 39 Ref: 20-28461-20

The sink pad (Area 93/Kitchen) does not contain asbestos.

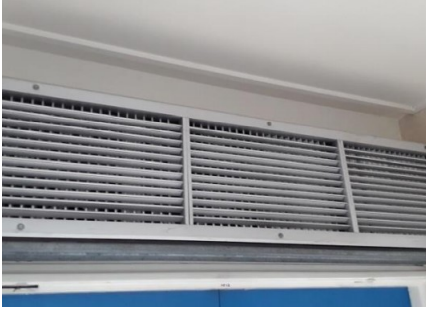
Item 40 Ref: 20-28461-21

- (Item 40) Ref: 20-28461-21 – Door header (Area 95/Rear Entrance) – No Risk
- (Item 41) Ref 20-28461-22 – Undercloaking (External) – Very Low Risk
- (Item 42) Ref: 20-28461-23 – Canopy (External) – Very Low Risk

The door header (Area 95/Rear Entrance) does not contain asbestos.

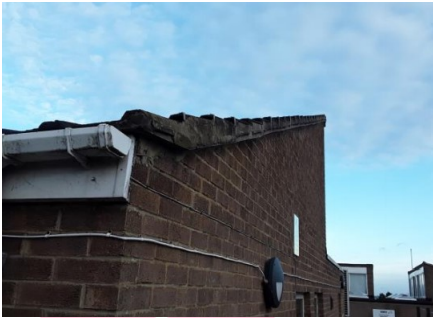
Item 41 Ref: 20-28461-22

The undercloaking (External) contains asbestos.

Any change in its appearance should be recorded and passed to Property Services.

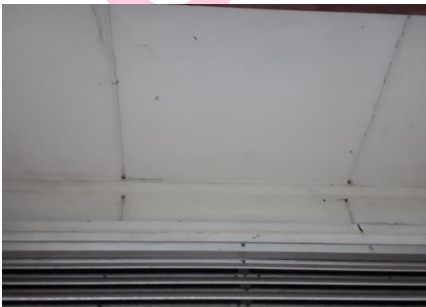
Item 42 Ref: 20-28461-23

The canopy (External) contains asbestos.

Any change in its appearance should be recorded and passed to Property Services.

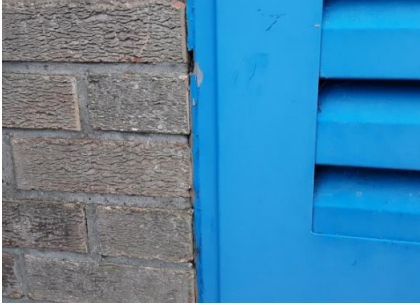
Item 43 Ref: 20-28461-24

- (Item 43) Ref: 20-28461-24 – Door frame sealant (External) – No Risk
- (Item 44) Ref: 20-28461-25 – Damp proof course (External) – No Risk
- (Item 45) Ref: 20-28461-26 – Window frame sealant (External) – No Risk

The door frame sealant (External) does not contain asbestos.

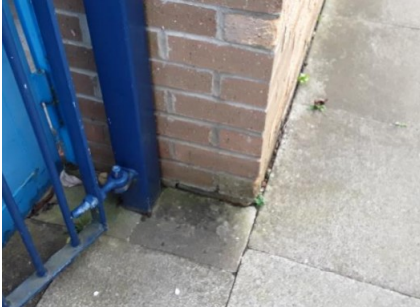
Item 44 Ref: 20-28461-25

The damp proof course (External) does not contain asbestos.

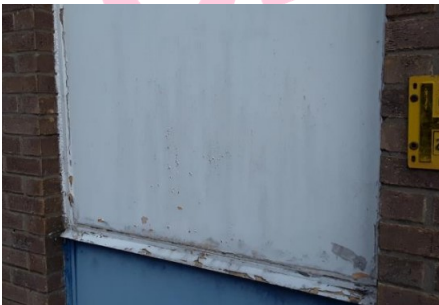
Item 45 Ref: 20-28461-26

The window frame sealant (External) does not contain asbestos.

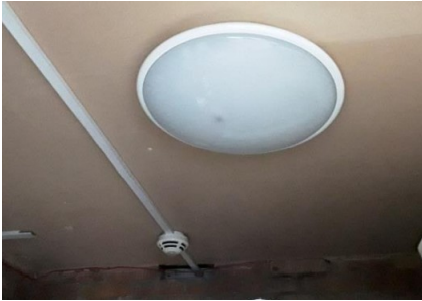
Item 46 Ref: 20-28461-27

- (Item 46) Ref: 20-28461-27 – Ceiling (Area 100/Store) – No Risk
- (Item 47) Ref: 20-28461-28 – Bitumen behind door frame (Area 100/Store) – No Risk
- (Item 48) Ref: Presumed – Gaskets (Area 102/Plant Room) – Very Low Risk

The ceiling (Area 100/Store) does not contain asbestos.

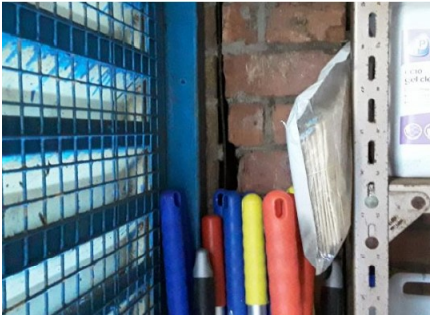
Item 47 Ref: 20-28461-28

The bitumen behind door frame (Area 100/Store) does not contain asbestos.

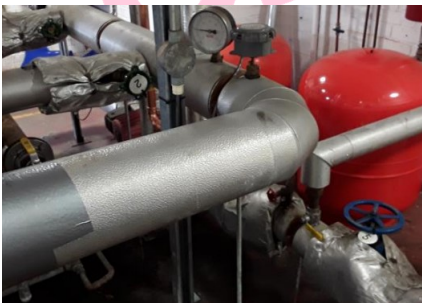
Item 48 Ref: PRESUMED

The gaskets (Area 102/Plant Room) are presumed to contain asbestos.

Any change in its appearance should be recorded and passed to Property Services.

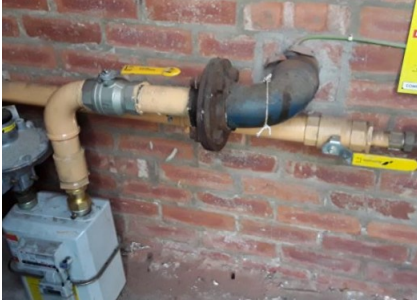
Item 49 Ref: 20-28461-30

- (Item 49) Ref: 20-28461-30 – Gaskets (Area 103/Gas Room) No Risk
- (Item 50) Ref: 20-28461-31 – Gaskets (Area 104/Plant Room) – No Risk
- (Item 51) 20-27752-2 – Debris behind water tank (Infant Nursery Boiler Room) – No Risk

The gaskets (Area 103/Gas Room) do not contain asbestos.

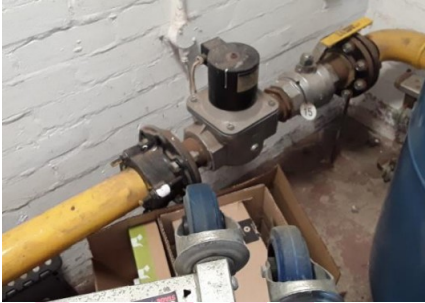
Item 50 Ref: 20-28461-31

The gaskets (Area 104/Plant Room) do not contain asbestos.

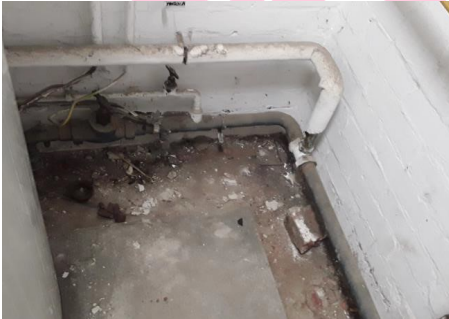
Item 51 – Ref: 20-27752-2

The debris to floor behind the water tank in the Infant/Nursery Boiler Room does not contain asbestos.

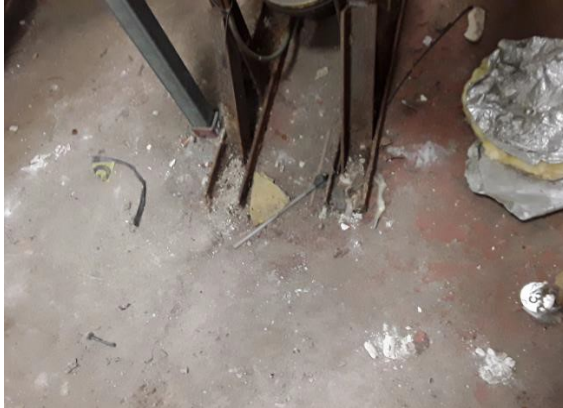
Item 52 – Ref: 20-27752-3

- (Item 52) 20-27752-3 – Debris adjacent to water tank (Infant Nursery Boiler Room) – No Risk
- (Item 53) *Presumed – Stop tap gaskets (Infant Nursery Boiler Room) – Removed July 2021*

The debris to floor adjacent the water tank in the Infant/Nursery Boiler Room does not contain asbestos.

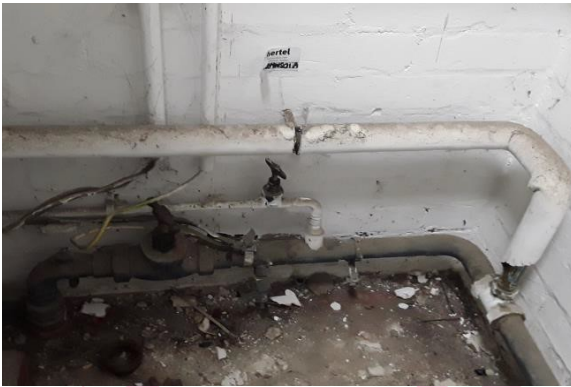
Item 53 – Ref: Presumed

The stop tap gaskets in the Infant/Nursery Boiler Room is presumed to contain asbestos.

Removed July 2021

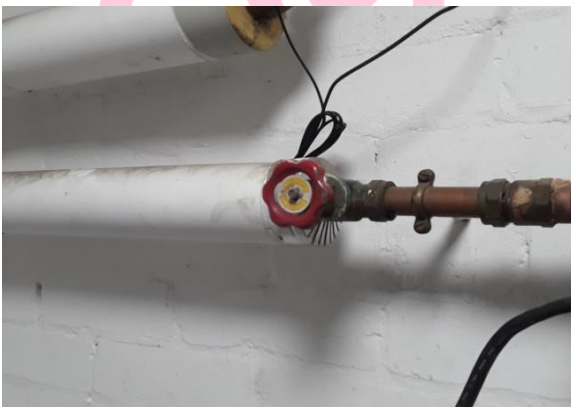
Item 54 – Ref: Presumed

- (Item 54) *Presumed – Gate valves gaskets (Infant Nursery Boiler Room) – Removed July 2021*
- (Item 55) 20-27752-6 – Residual insulation to main wall (Infant Nursery Boiler Room) – No Risk

The gate valve gaskets in the Infant/Nursery Boiler Room is presumed to contain asbestos.

Removed July 20201

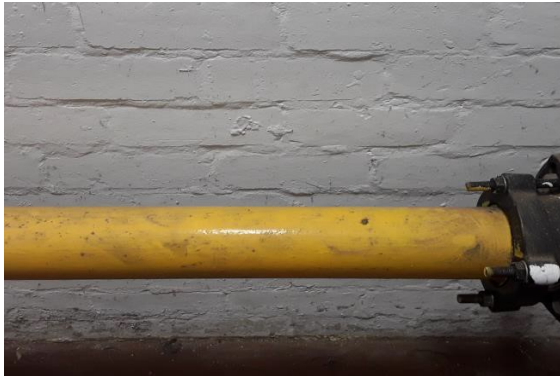
Item 55 – Ref: 20-27752-6

The residual insulation to the main wall in the Infant/Nursery Boiler Room does not contain asbestos.

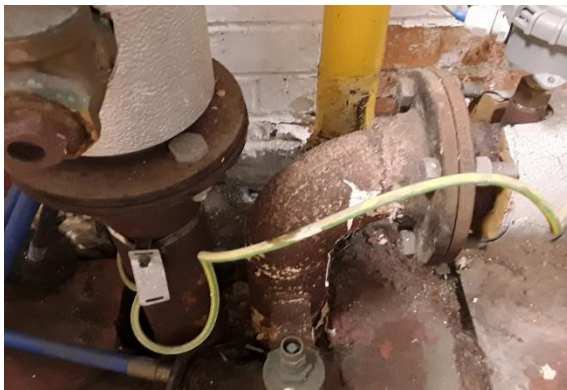
Item 56 – Ref: Presumed

The gaskets in the Primary Boiler Room are presumed to contain asbestos.

Removed July 2021

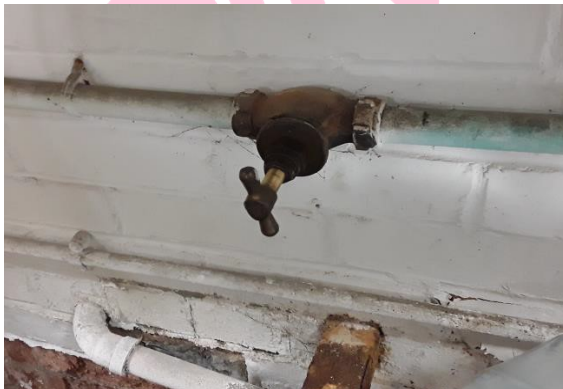
Item 57 – Ref: Presumed

The stop gap gaskets in the Primary Boiler Room are presumed to contain asbestos.

Removed July 20201

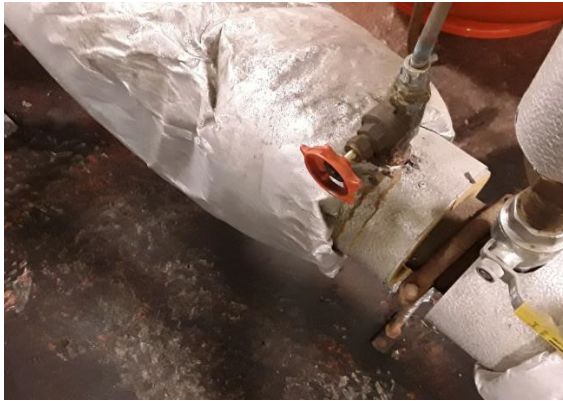
Item 58 – Ref: Presumed

The gate valve gaskets in the Primary Boiler Room is presumed to contain asbestos.

Removed July 2021

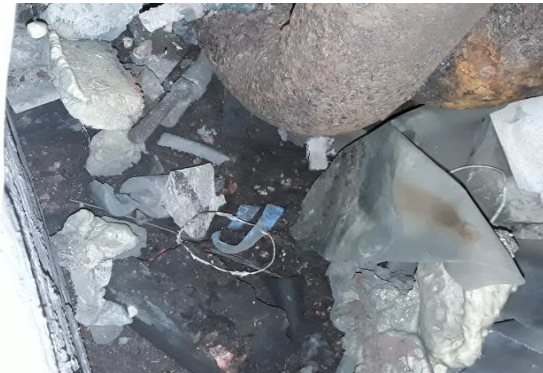
Item 59 – Ref: 20-27752-4

The cement debris within the pipe duct in the Primary Boiler Room contains asbestos.

Removed July 2021

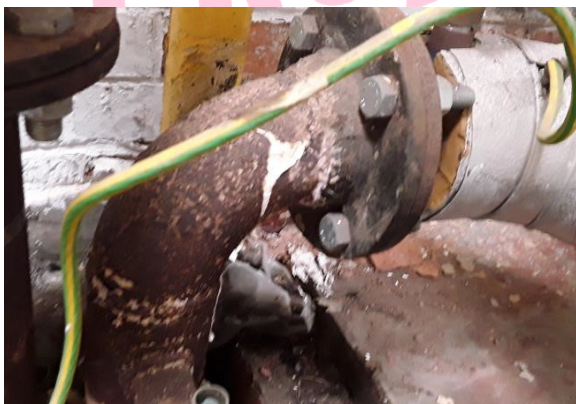
Item 60 – Ref: 20-27752-5

The insulation debris within the pipework duct in the Primary Boiler Room does not contain asbestos.

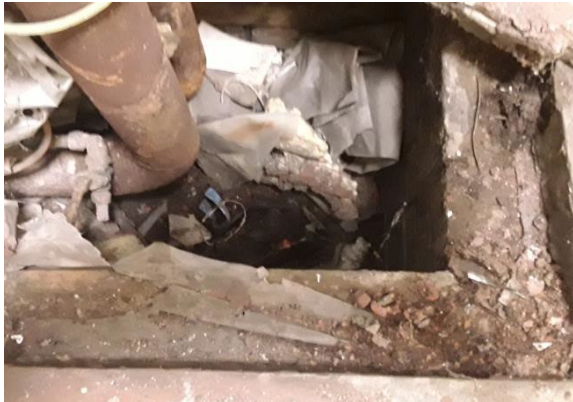
Item 61 – Ref: 20-27752-6

The debris within the pipework duct in the Primary Boiler Room does not contain asbestos.

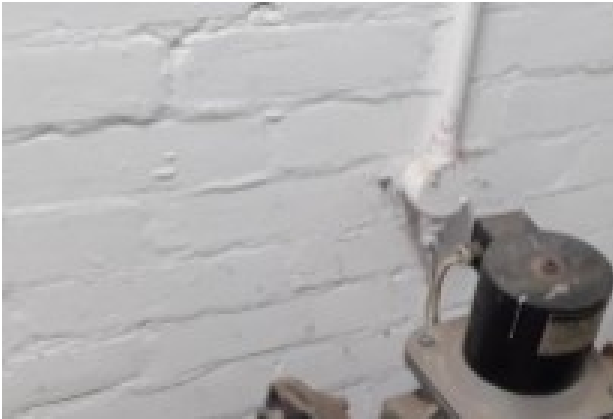
Item 62 – Ref: 20-27752-1

The pipework throughout x 7 gaskets in the Infant – Nursery Boiler Room are contain asbestos.

Removed July 2021

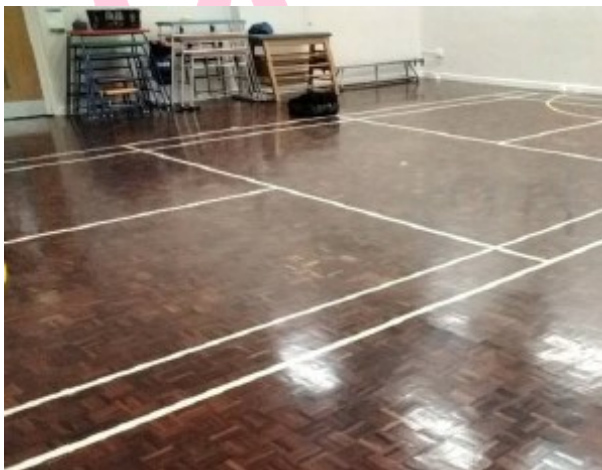
Item 63 – Ref: DC003094

The floor covering adhesive to parquet flooring does not contain asbestos.

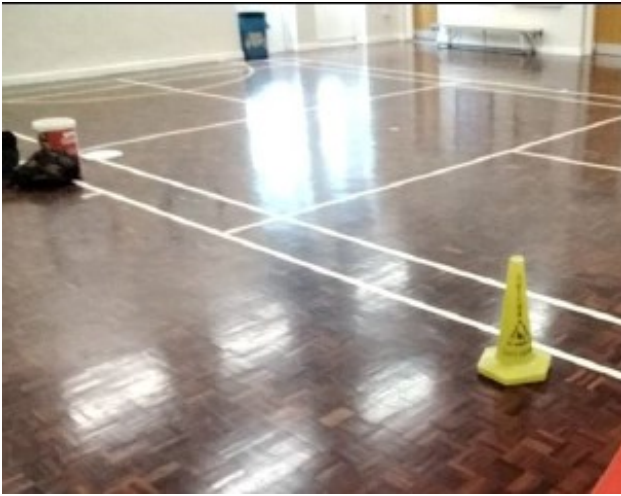
Item 64 – Ref: DC003095

The floor covering adhesive to parquet flooring does not contain asbestos.
