ASBESTOS SURVEY REPORT FOR RYHOPE JUNIOR SCHOOL,  
SHAFTESBURY AVENUE, SUNDERLAND, SR2 0RT.

### **Asbestos Register for Ryhope Junior School**

**Date: 04 February 2025**

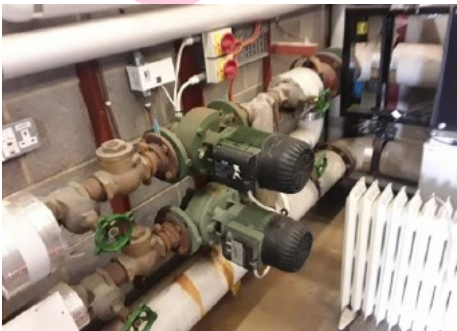
### **Item 3 Ref: 21-33697-4**

The pipe flange gaskets (area 53 boiler room) does not contain asbestos.

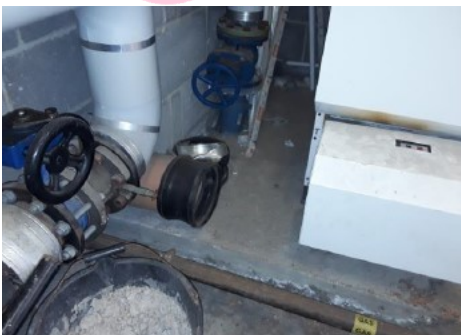
**Item 6 Ref: 21-33697-7**

The floor – debris (insulating board) (area 53 boiler room) does not contain asbestos.

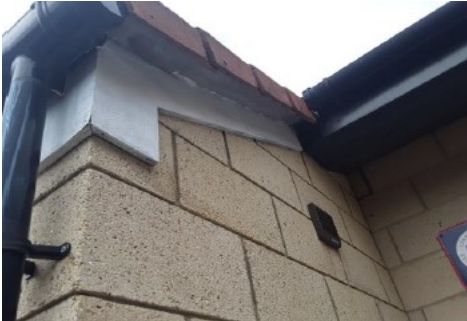
**Item 7 Ref: 21-33697-1**

The roof undercloaks (cement) (area 100 external) do not contain asbestos.

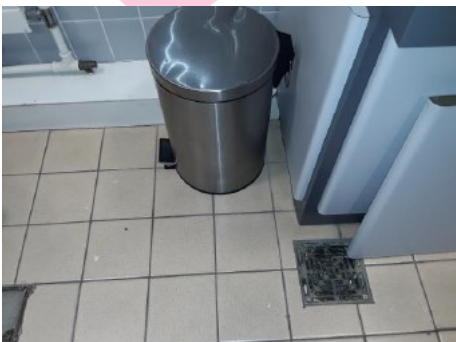
**Item 9 Ref: 21-33510-2**

The ceramic tiles to floor (area 1 ladies toilet) do not contain asbestos.

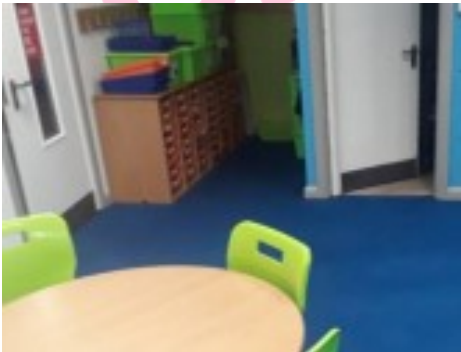
### **Item 12 Ref: NZ001198**

The screed under modern flooring and carpet in Classroom (G/001) does not contain asbestos.

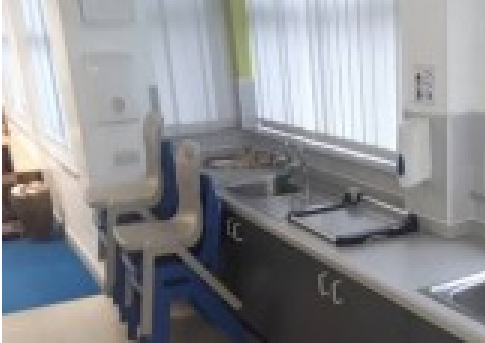
**Item 13 Ref: NZ001199**

The under sink mat within walkway been classrooms in Classroom (G/001) does not contain asbestos.
