### **ASBESTOS SURVEY REPORT FOR SPRINGWELL DENE SCHOOL, SUNDERLAND**

## **Asbestos Register for SPRINGWELL DENE SCHOOL, SUNDERLAND**

**Date: 13 August 2025**

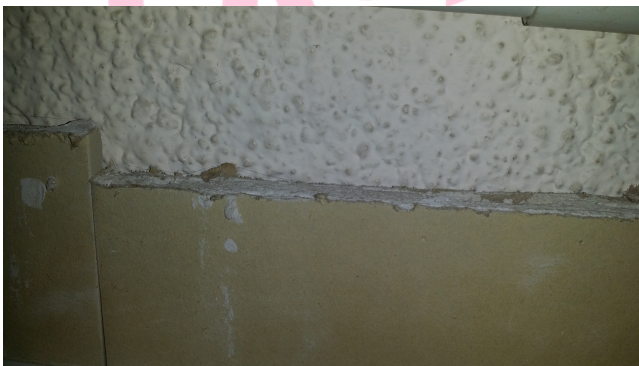
### **Item 18 Ref: As 291230-10**

Sprayed coating to walls behind PVC & plasterboard in 017/kitchen contains asbestos.

Any change in its appearance should be recorded and passed to Property Services.

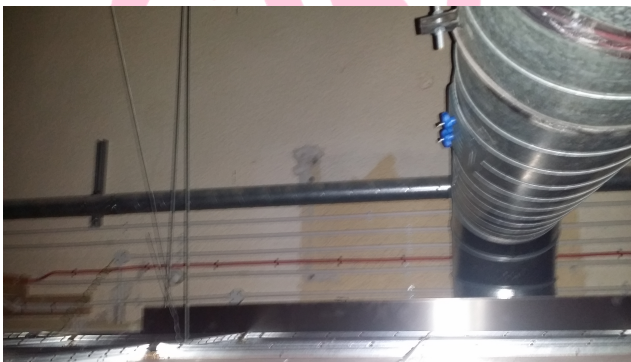
### **Item 21 Ref: As 291230-5**

Mastic to ductwork in 017/kitchen-void above does not contain asbestos.

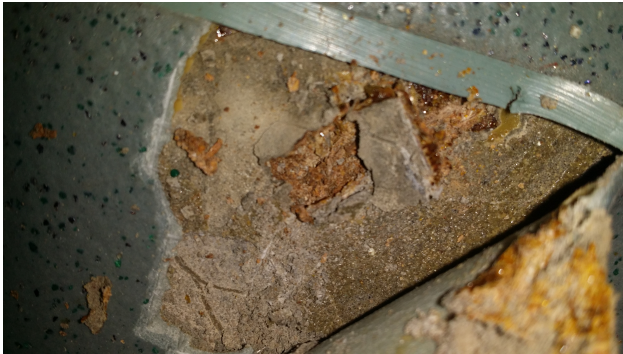
#### **Item 23 Ref: As 291230-7**

Subfloor in 018/kitchen toilet does not contain asbestos.

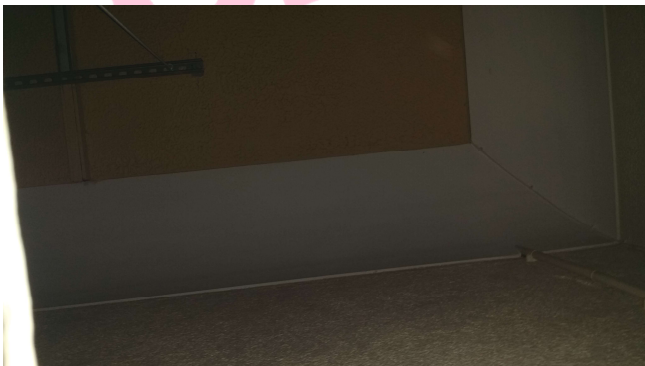
#### **Item 24 Ref: As 291230-9**

Ceiling in 018/kitchen toilet-void above contains asbestos.

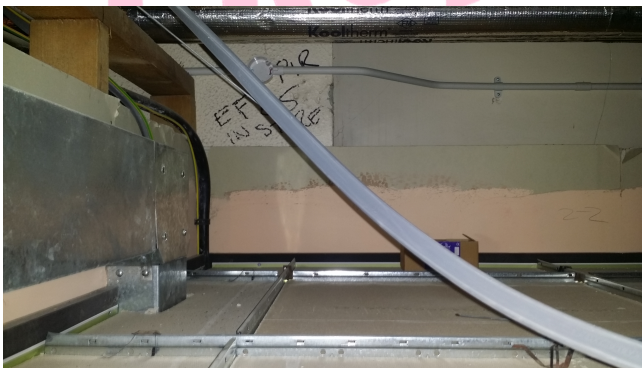
### **Item 30 Ref: 291230-12**

Debris to tops of surfaces in 019/kitchen office-void above contain asbestos.

**Removed June 2019**

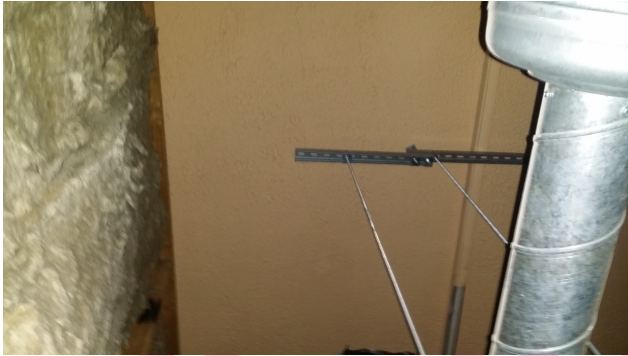
#### **Item 32 Ref: As 291230-9**

Ceiling in 020/kitchen store-void above contain asbestos.

**Removed June 2019.**

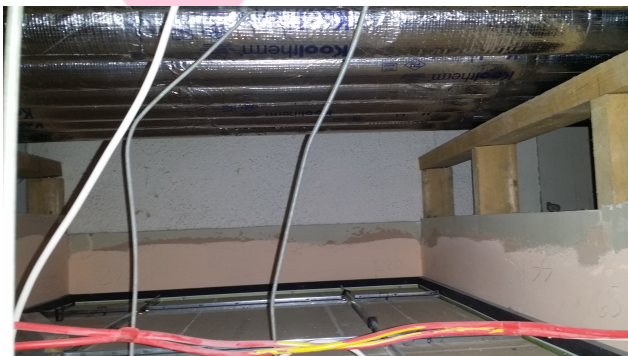
#### **Item 33 Ref: As 291230-10**

Sprayed coating to walls in 020/kitchen store-void above contain asbestos.

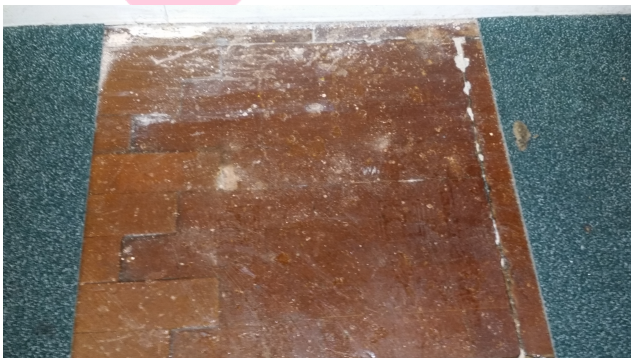
### **Item 36 Ref: 291230-15**

Subfloor in 021/recreational hall does not contain asbestos.

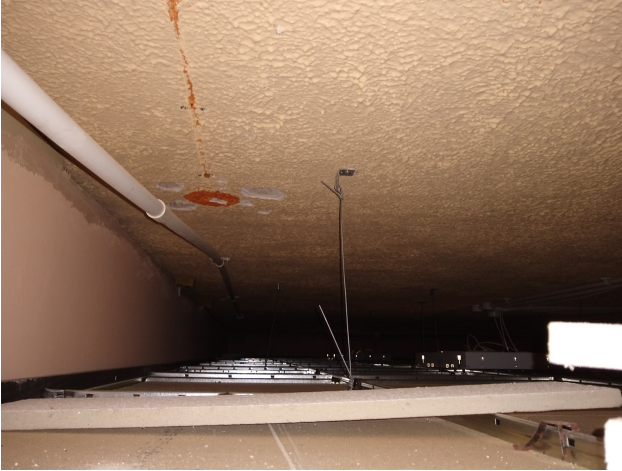
**Item 40 Ref: 299208-4**

Textured coating on plaster on mesh ceiling in 021/recreation hall-void above does not contain asbestos.

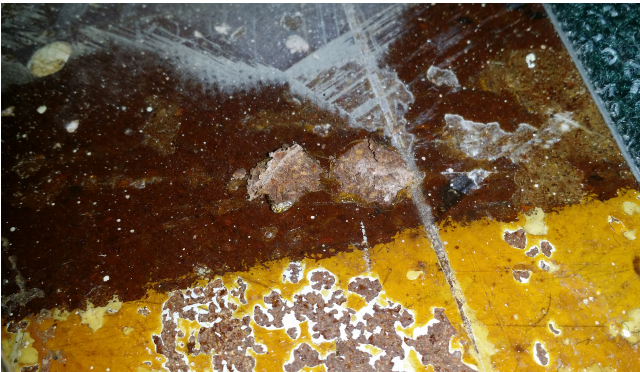
**Item 41 Ref: As 291230-15**

Subfloor in 022/store does not contain asbestos.

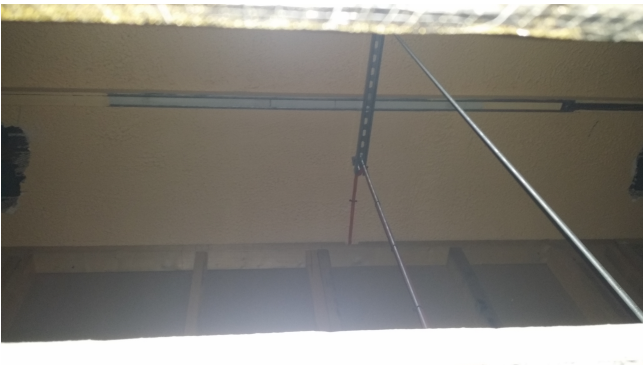
**Item 42 Ref: As 291230-9**

Ceiling in 022/kitchen store-void above contain asbestos.

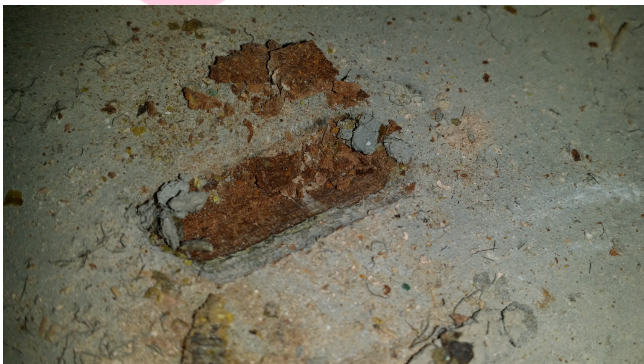
### **Item 51 Ref: As 291230-18**

Subfloor in 028/classroom contains asbestos.

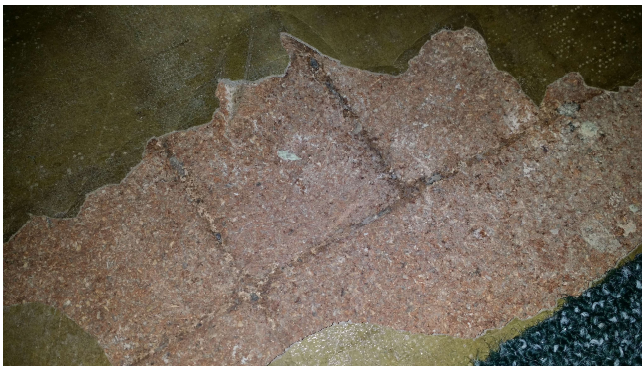
### **Item 54 Ref: As 291230-18**

Subfloor in 031/classroom contains asbestos.

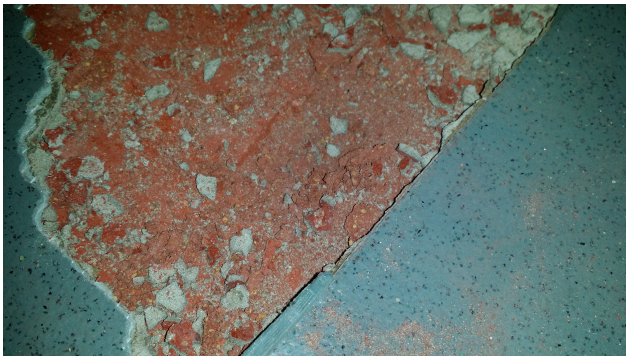
### **Item 59 Ref: 291230-20**

Subfloor in 036/snack bar does not contain asbestos.

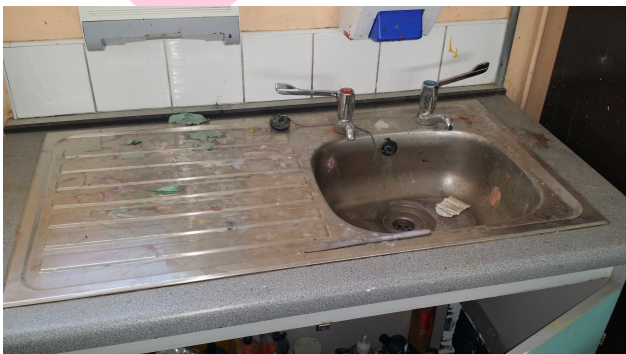
### **Item 60 Ref: 291230-21**

Sink pads in 043/woodshop does not contain asbestos.

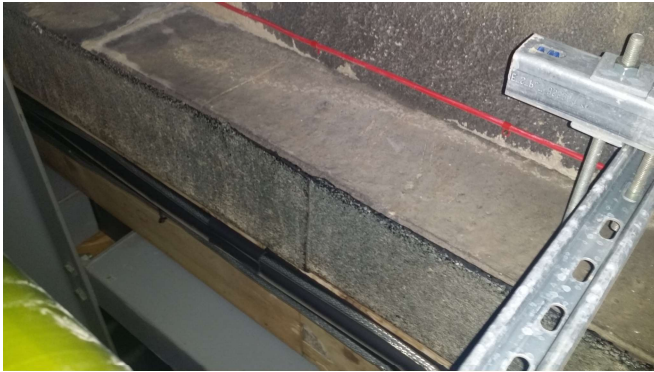
### **Item 64 Ref: As 291230-22**

Roof covering to flat roof in 064/corridor-void above does not contain asbestos.

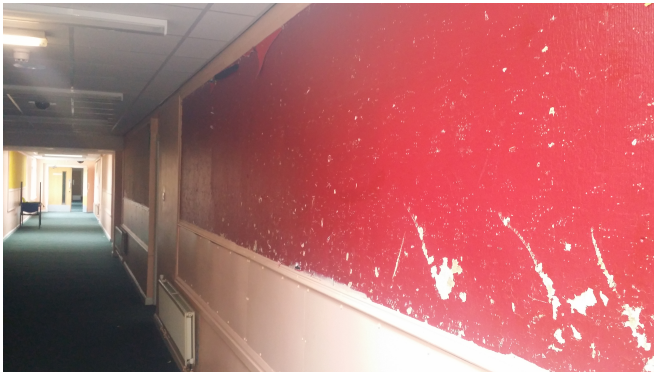
### **Item 65 Ref: 291230-23**

Pinboards to walls in 065/corridor does not contain asbestos.

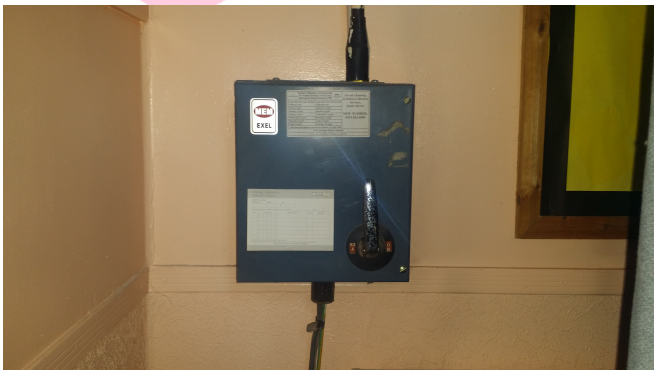
### **Item 66 Ref: Presumed**

Electrics MEM box in 066/stairwell is presumed to contain asbestos.

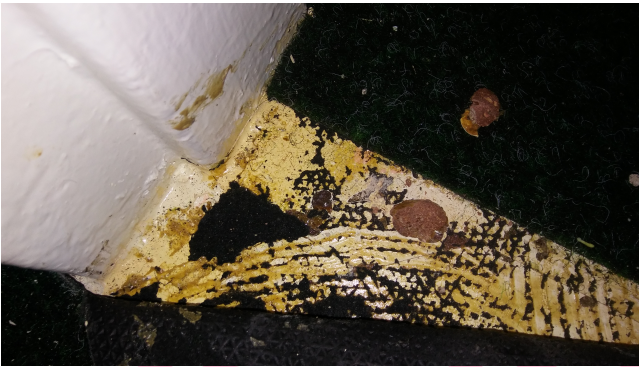
**Item 68 Ref: As 291230-26**

Floor covering below carpet in Level 1/002/corridor does not contain asbestos.

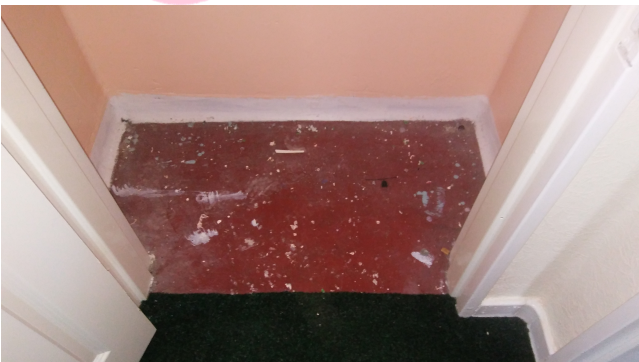
**Item 69 Ref: As 291230-26**

Floor covering below carpet in Level 1/003/bedroom does not contain asbestos.

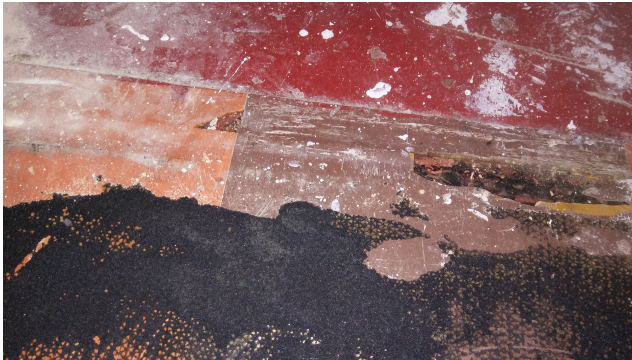
#### **Item 70 Ref: 291230-27**

Floor covering below carpet in Level 1/008/kitchen contains asbestos.

*Removed July 2020*

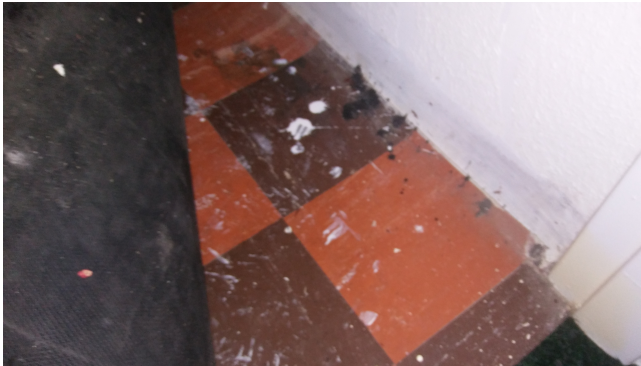
#### **Item 71 Ref: As 291230-27**

Floor covering below carpet in Level 1/008b/cupboard contains asbestos.

*Removed July 2020*

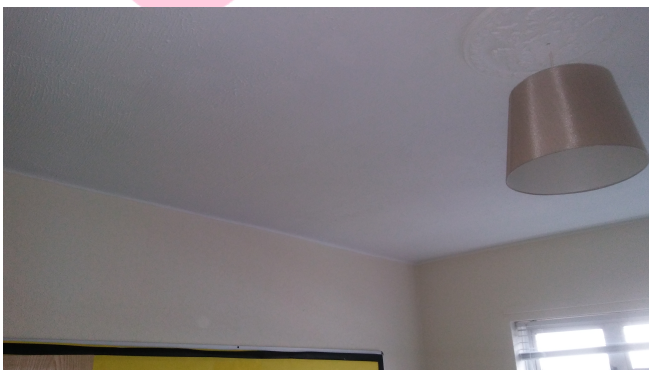
#### **Item 72 Ref: 291230-28**

Coating to ceiling in Level 1/009/living room does not contain asbestos.

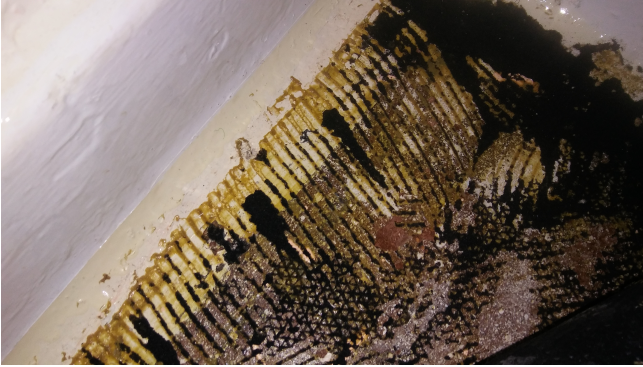
### **Item 73 Ref: As 291230-26**

Floor covering below carpet in Level 1/009/living room does not contain asbestos.

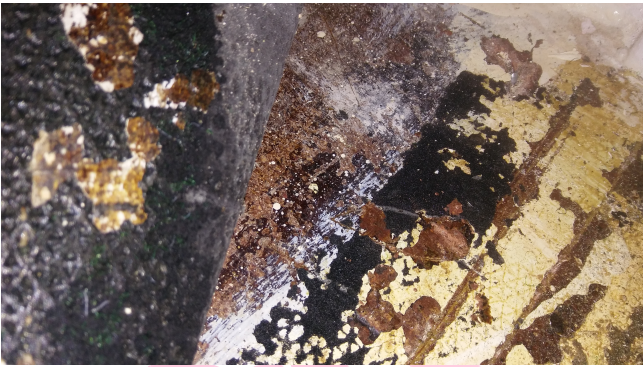
### **Item 74 Ref: As 291230-26**

Floor covering below carpet in Level 1/010/room does not contain asbestos.

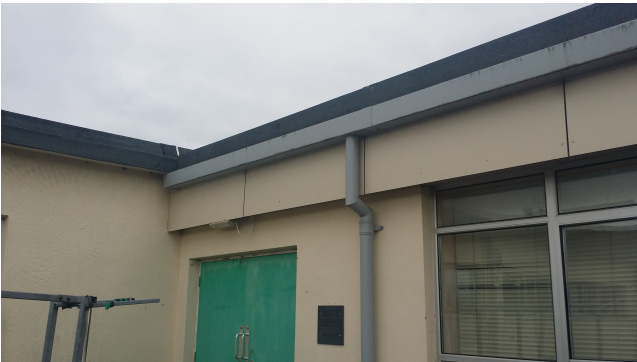
### **Item 75 Ref: 291230-24**

The external fascia to proposed art room extension does not contain asbestos.

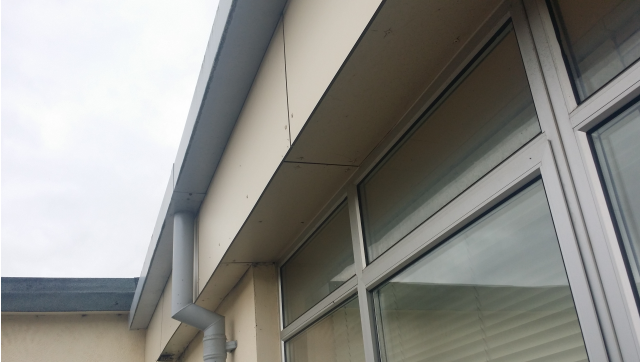
### **Item 76 Ref: As 291230-24**

The external soffit to proposed art room extension does not contain asbestos.

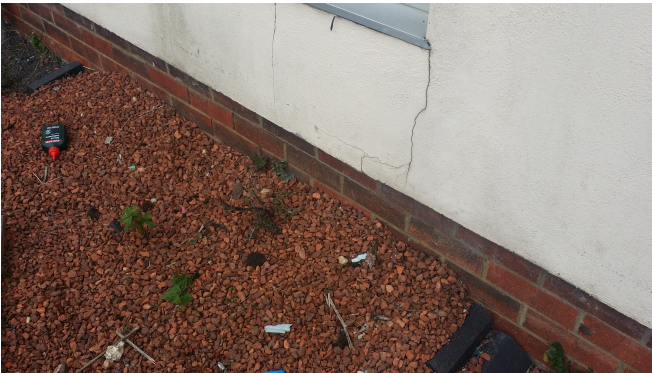
### **Item 77 Ref: 291230-25**

The external damp proof course does not contain asbestos.

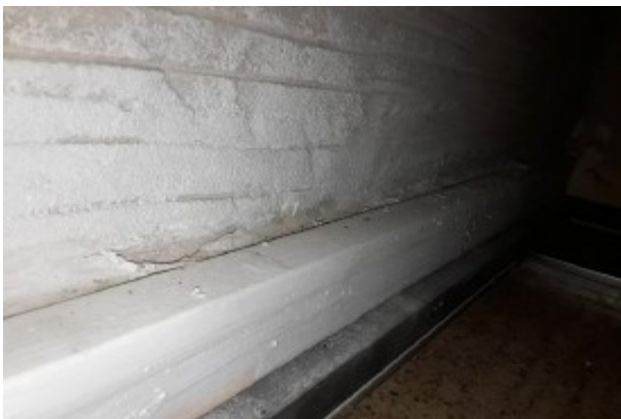
### **Item 96 Ref: LK003510**

The sprayed coating debris in the Kitchen Office Toilet (041) does contain asbestos.

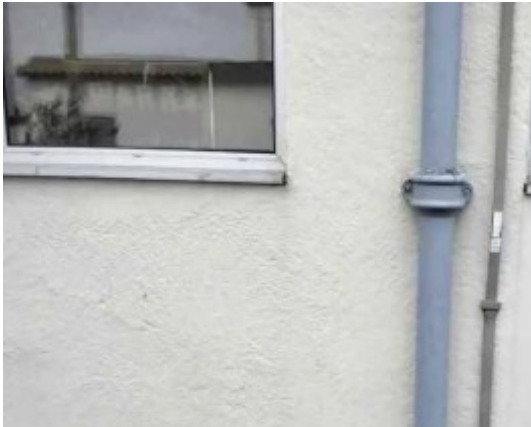
### **Item 104 - Ref: AW005907**

The drain pipe packing (composite mastic) (External E/004) does not contain asbestos.

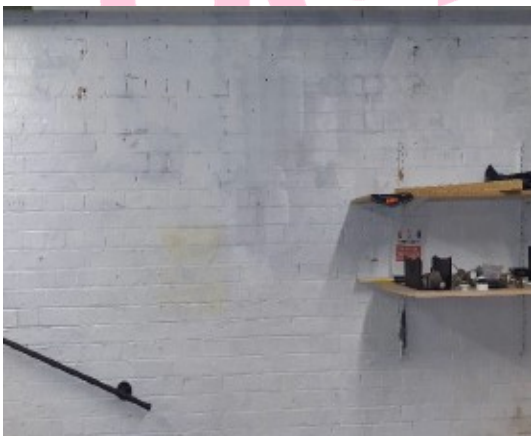
### **Item 105 - Ref: PK002318**

The residue to wall 1 in the Plant Room (Z1/01) contains asbestos.

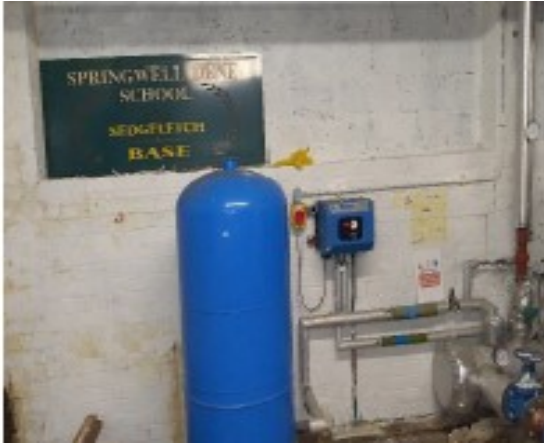
### **Item 106 - Ref: PK002139**

The residue to wall 2 in the Plant Room (Z1/01) does not contain asbestos.

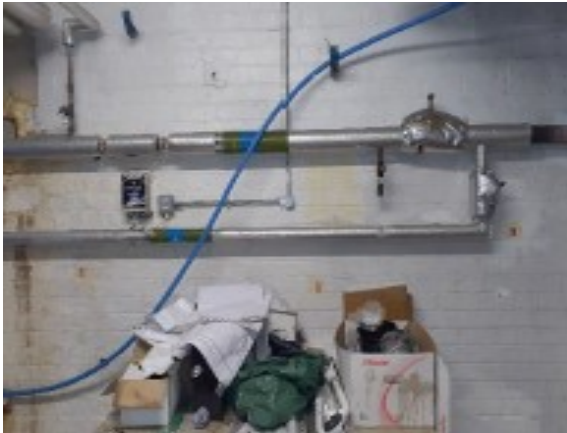
### **Item 107 - Ref: PK002140**

The residue to wall 3 in the Plant Room (Z1/01) does not contain asbestos.

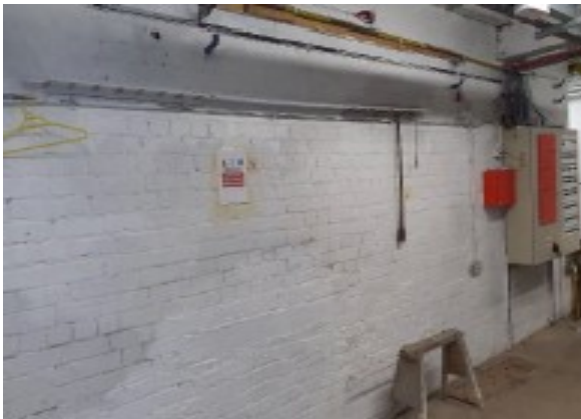
### **Item 108 - Ref: PK002141**

The residue to wall 4 in the Plant Room (Z1/01) does not contain asbestos.

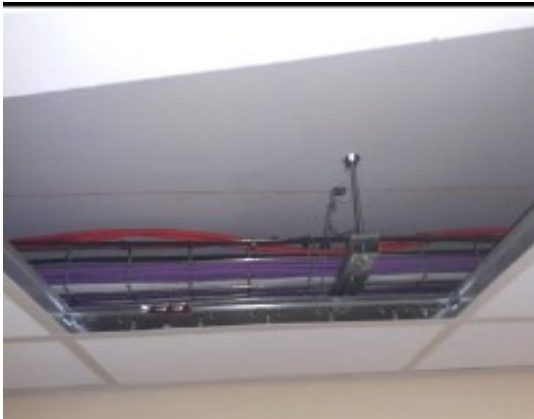
#### **Item 113 - Ref: As PK002132**

The spray coating remnants to the wall in the Corridor 6 (G/12) does not contain asbestos.

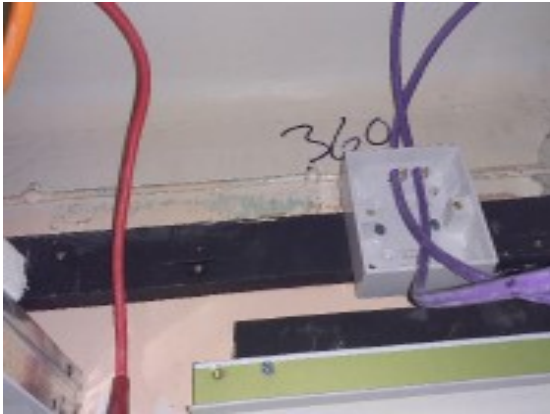
#### **Item 115 - Ref: As PK002132**

The spray coating remnants to the wall in the Lobby to recording studio (G/15) does not contain asbestos.

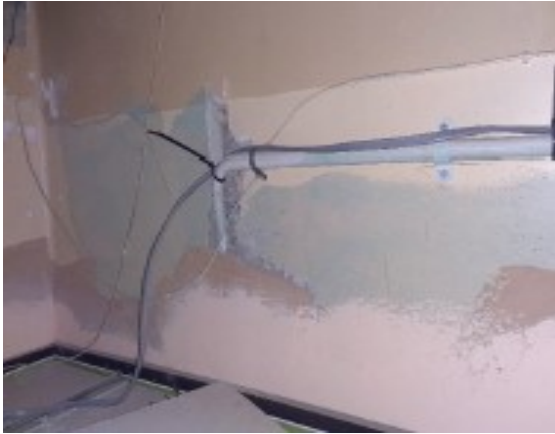
### **Item 118 - Ref: As PK002132**

The spray coating remnants to the wall in the Staff Tea Point (G/02) does not contain asbestos.

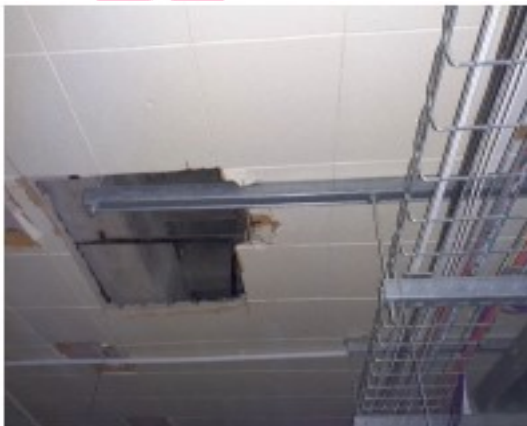
### **Item 120 - Ref: PK002143**

The fibreboard ceiling tiles – upper ceiling within void in KS1 Classroom 12 (G/23) does not contain asbestos.

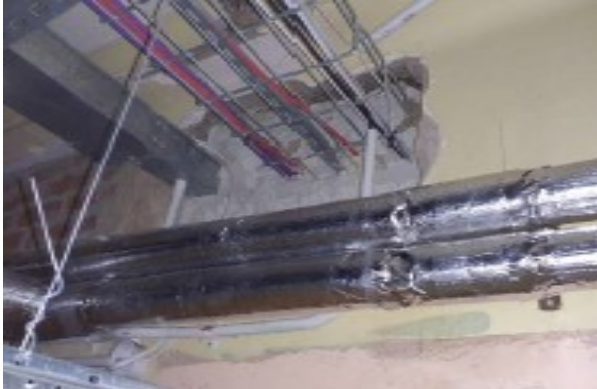
#### **Item 121 - Ref: PK002144**

The spray coating remnants to the wall in KS1 Classroom 12 (G/23) does not contain asbestos.

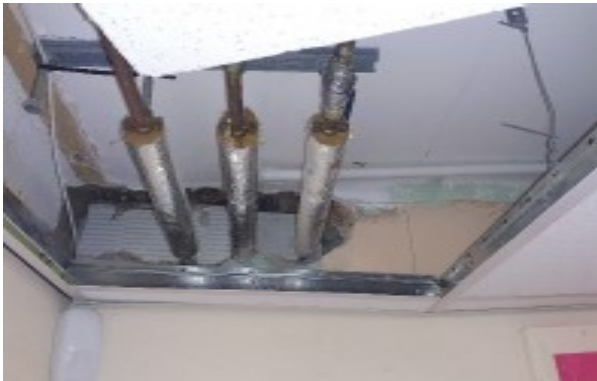
#### **Item 122 - Ref: As PK002132**

The spray coating remnants to the wall in KS1 Classroom 9 Multi purpose (G/25) does not contain asbestos.

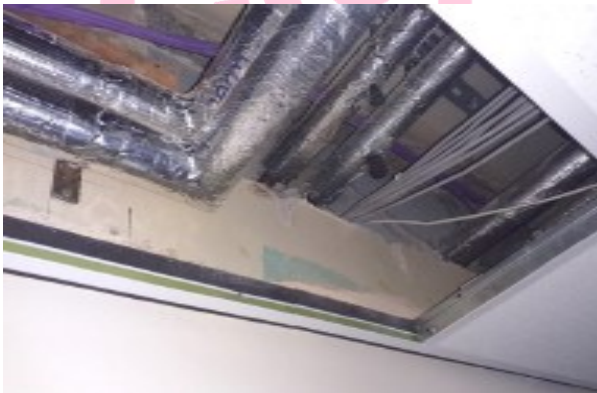
#### **Item 123 - Ref: As PK002144**

The spray coating remnants to the wall in KS3 Classroom 6 (G/27) does not contain asbestos.

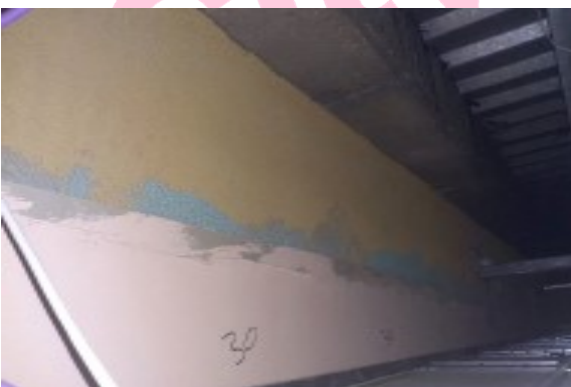
#### **Item 126 - Ref: PK002134**

The spray coating remnants to the walls in Corridor 8 (G/08) does not contain asbestos.
