### **ASBESTOS SURVEY REPORT FOR SPRINGWELL VILLAGE PRIMARY SCHOOL, WESTFIELD CRESCENT, SPRINGWELL VILLAGE, NE9 7RX.**

**Springwell Village Primary School, Westfield Crescent,  
Springwell, NE9 7RX**

**Date: 27 July 2026**

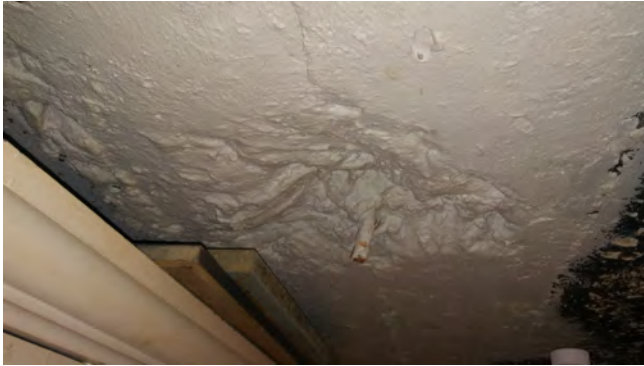
### **Item 1 Ref: 254851-28**

- (Item 1) Ref: 254851-28 – Insulation to previous pipework (Rm -1/001/Cellar) – Low Risk
- (Item 2) Ref: 254851-25 – Gasket to pipework at dark grey gas hub (Rm -1/001/Cellar) – Very Low Risk

The insulation to previous pipework/cable penetrations to underside of floor above in the cellar (Rm -1/001) does contain asbestos.

Any change in appearance should be reported to Property Services.

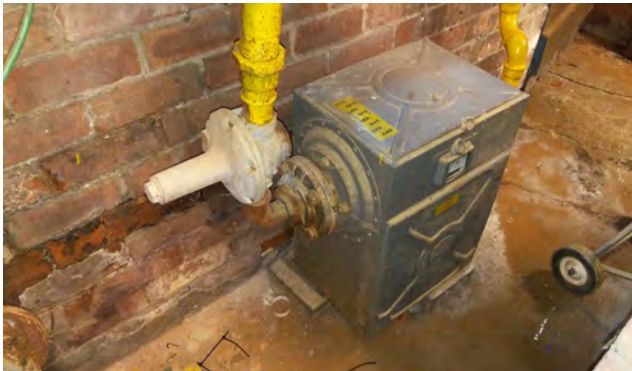
### **Item 2 Ref: 254851-25**

The gasket to pipework at dark grey gas hub in the cellar (Rm -1/001) does contain asbestos.

Any change in appearance should be reported to Property Services.

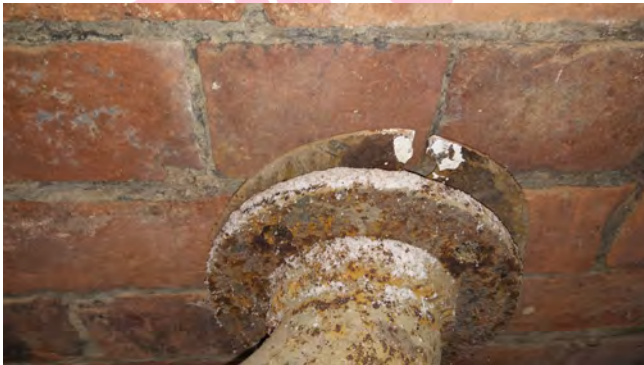
### **Item 3 Ref: 254851-27**

The gasket to loose lying pipework in the cellar (Rm -1/001) does contain asbestos.

| Picture | Location | Risk | Inspection Frequency | Date of return |
|---|---|---|---|---|
| <i>Item 3</i> | <i>Gasket to loose lying pipework (Rm - 1/001/Cellar)</i> | <i>Low Risk</i> | <i>6 monthly</i> | <i>22.02.2027</i> |

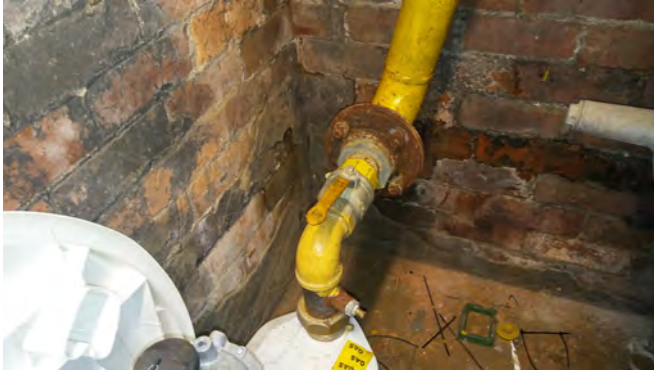
#### **Item 4 Ref: 254851-26**

The gasket to pipework at light grey gas hub in the cellar (Rm -1/001) does not contain asbestos.

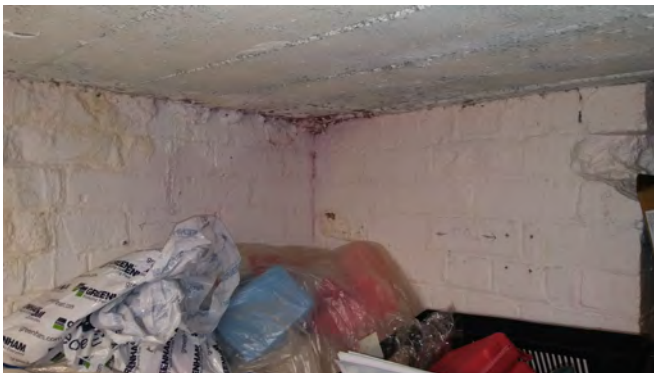
#### **Item 5 Ref: 369919-14**

The debris to walls in the cellar (Rm -1/001) does not contain asbestos.

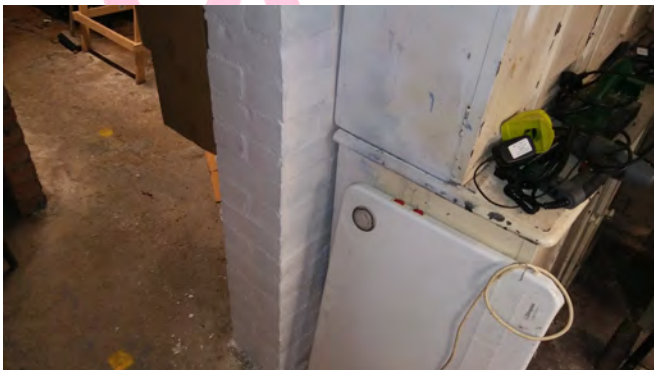
#### **Item 6 Ref: 369919-15**

The debris to walls in the cellar (Rm -1/001) does not contain asbestos.

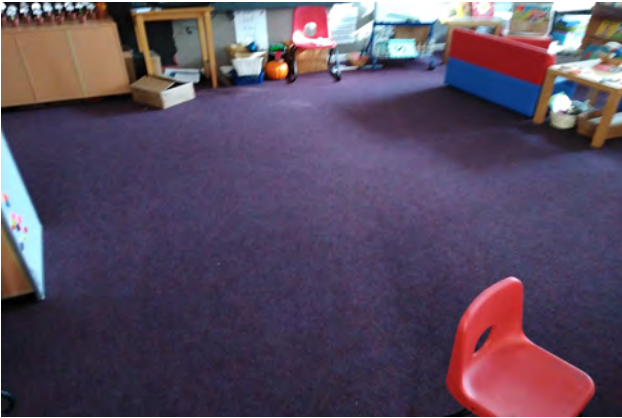
#### **Item 7 Ref: As 369919-8**

The adhesive beneath parquet flooring in the Classroom (Rm 0/001) does not contain asbestos.

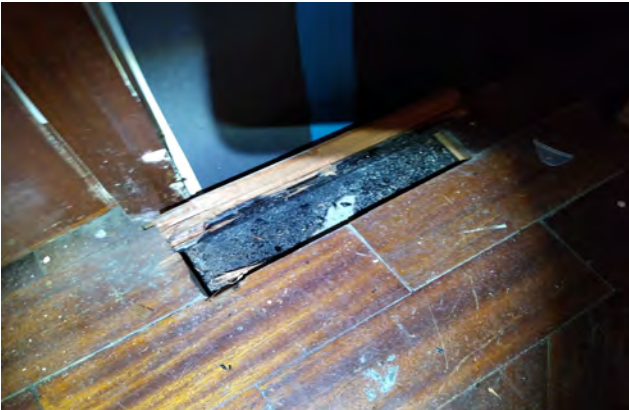
#### **Item 8 Ref: 369919-8**

The adhesive beneath parquet flooring in the Classroom store (Rm 0/002) does not contain asbestos.

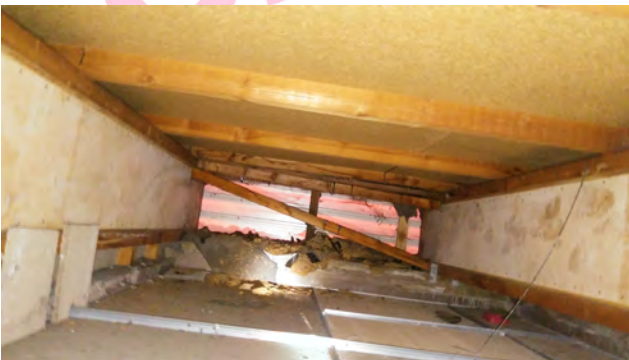
#### **Item 9 Ref: 254851-1**

- (Item 8) Ref: 369919-8 – Adhesive beneath parquet flooring (Rm 0/002/Classroom store) – No Risk
- (Item 9) Ref: 254851-1 – Debris to top side of suspended ceiling (Rm 0/002/Classroom Store void above) – removed 2019

The debris to top side of suspended ceiling in the classroom store void above (Rm 0/002) does contain asbestos.

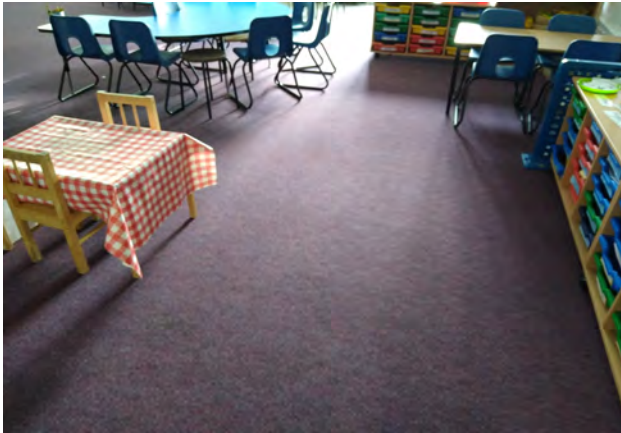
#### **Item 10 Ref: As 369919-8**

The adhesive beneath parquet flooring in the Classroom (Rm 0/006) does not contain asbestos.

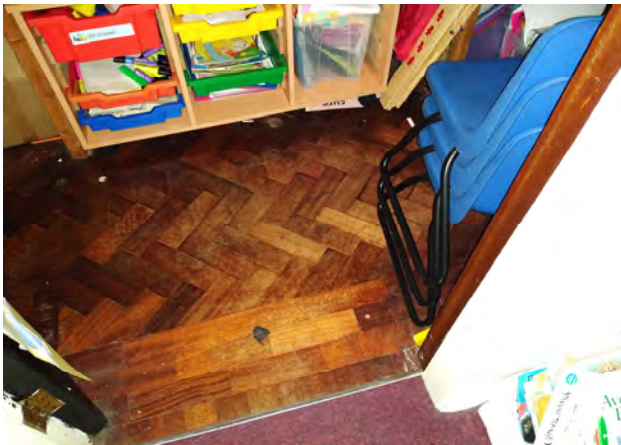
#### **Item 11 Ref: As 369919-8**

The adhesive beneath parquet flooring in the Classroom store (Rm 0/007) does not contain asbestos.

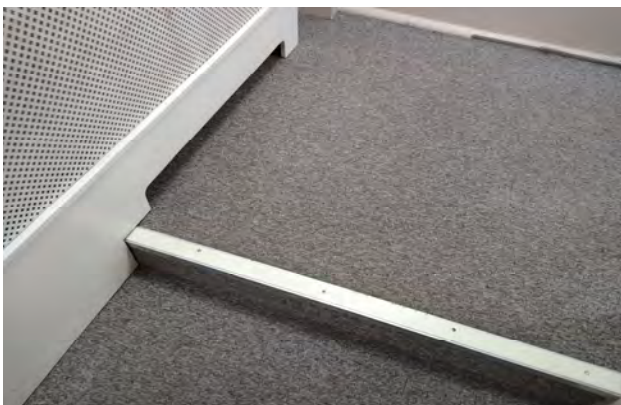
#### **Item 12 Ref: 254851-2**

The remnant adhesive to floor in the cloaks (Rm 0/008) does contain asbestos.

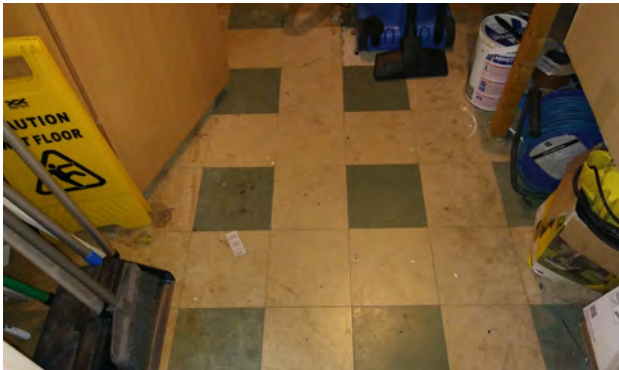
#### **Item 13 Ref: 254851-3**

The floor covering in the store (Rm 0/009) does contain asbestos.

Any change in appearance should be reported to Property Services.

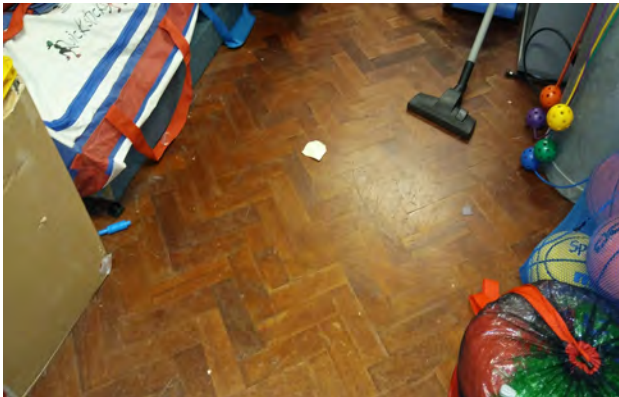
#### **Item 14 Ref: As 369919-8**

The adhesive beneath parquet flooring in the PE store (Rm 0/010) does not contain asbestos.

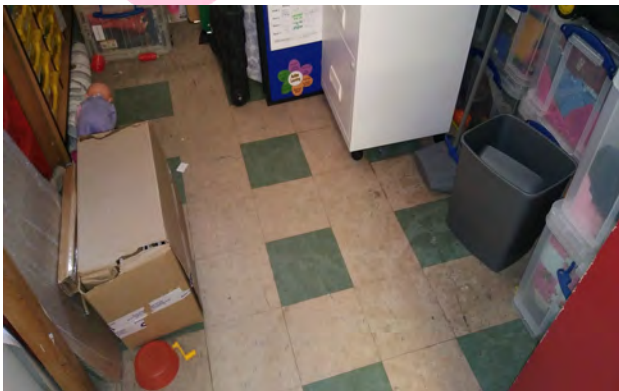
#### **Item 15 Ref: As 254851-3**

The floor covering in the store (Rm 0/011) does contain asbestos.

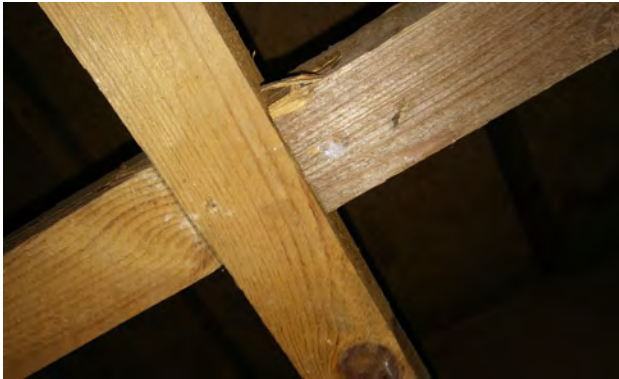
### **Item 17 Ref: 254851-1**

The residue to timber framework at former ceiling height in the main hall void above (Rm 0/012) does contain asbestos.

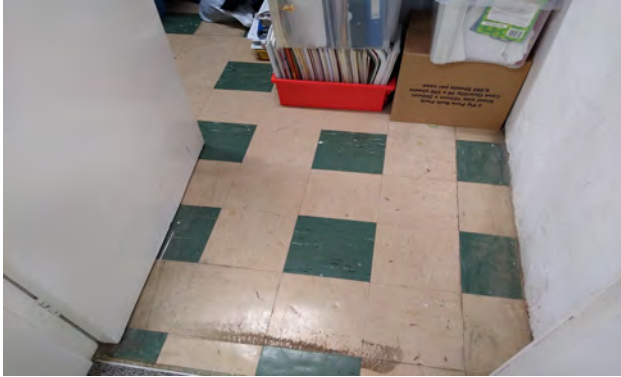
#### **Item 19 Ref: 254851-3**

The floor covering in the store (Rm 0/014) does contain asbestos.

Any change in appearance should be reported to Property Services.

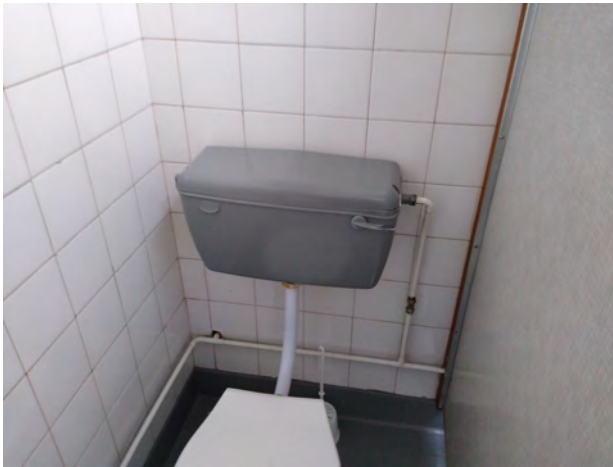
#### **Item 20 Ref: 254851-6**

The toilet cistern in the wc (Rm 0/015) does contain asbestos.

Any change in appearance should be reported to Property Services.

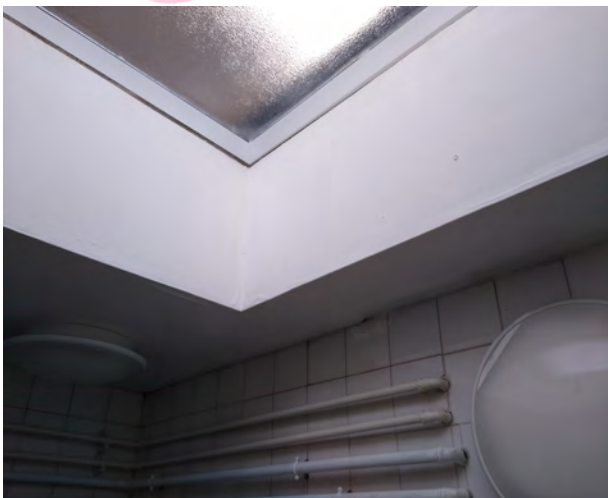
#### **Item 21 Ref: 254851-5**

The skylight surround in the wc (Rm 0/015) does contain asbestos.

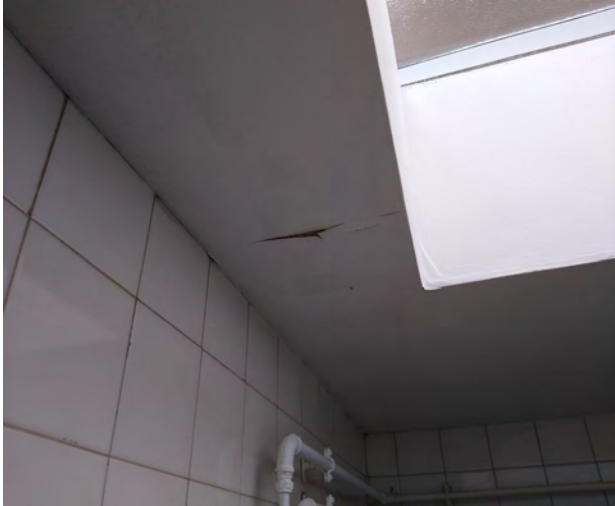
### **Item 22 Ref: 254851-4**

- (Item 20) Ref: 254851-6 – Toilet Cistern (Rm 0/15/WC) – Very Low Risk
- (Item 21) Ref: 254851-5 – Skylight surround (Rm 0/15/WC) – Low Risk
- (Item 22) Ref: 254851-4 – Ceiling (Rm 0/15/WC) – Low Risk *encapsulated Nov 2019*

The ceiling in the wc (Rm 0/015) does contain asbestos.

Any change in appearance should be reported to Property Services.

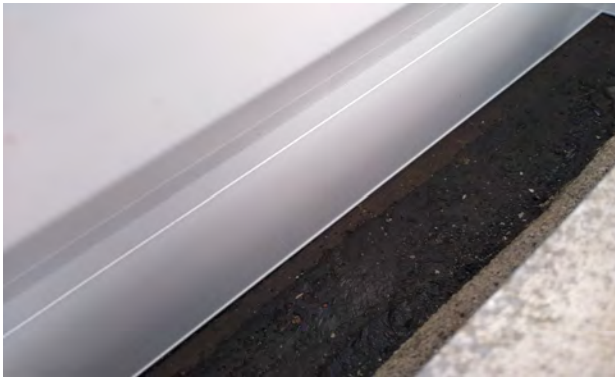
### **Item 23 Ref: 369919-4**

The roof felt to skylight in the wc (Rm 0/014) does not contain asbestos.

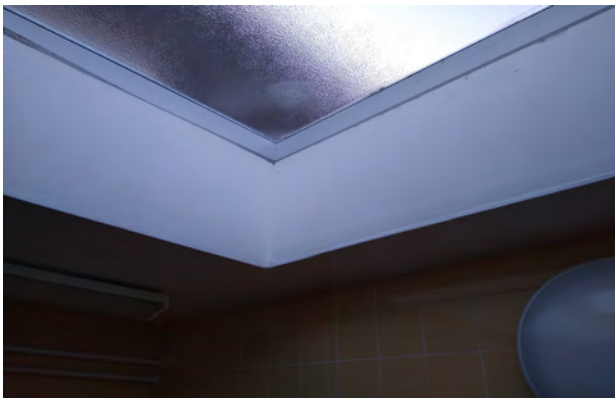
### **Item 24 Ref: 254851-5**

The skylight surround in the wc (Rm 0/016) does contain asbestos.

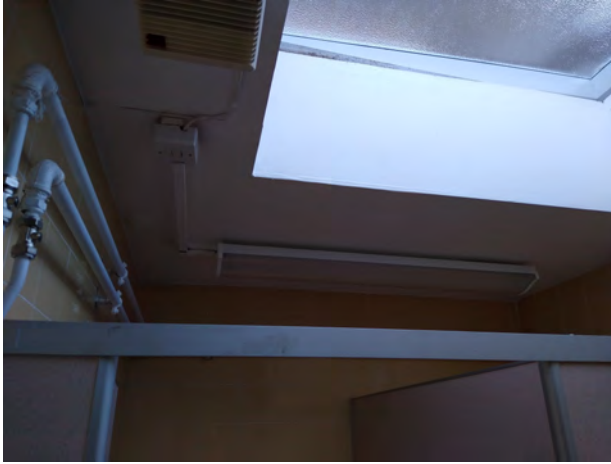
#### **Item 25 Ref: 254851-4**

The ceiling in the wc (Rm 0/016) does contain asbestos.

Any change in appearance should be reported to Property Services.

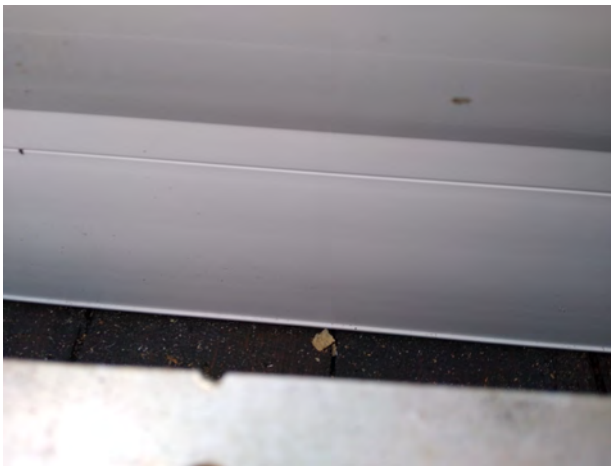
#### **Item 26 Ref: 369919-4**

The roof felt to the skylight in the wc (Rm 0/016) does not contain asbestos.

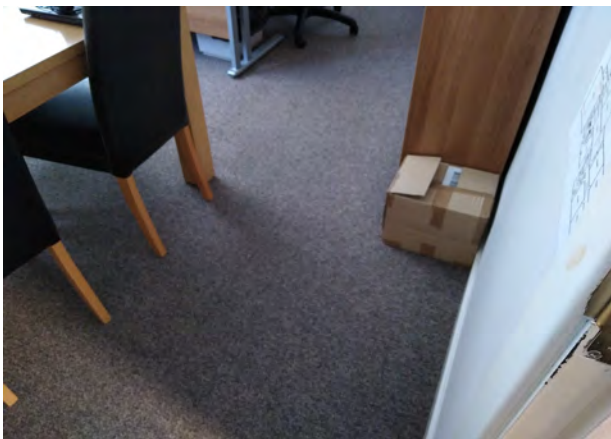
#### **Item 27 Ref: 369919-8**

The adhesive beneath parquet flooring in the office (Rm 0/17) does not contain asbestos.

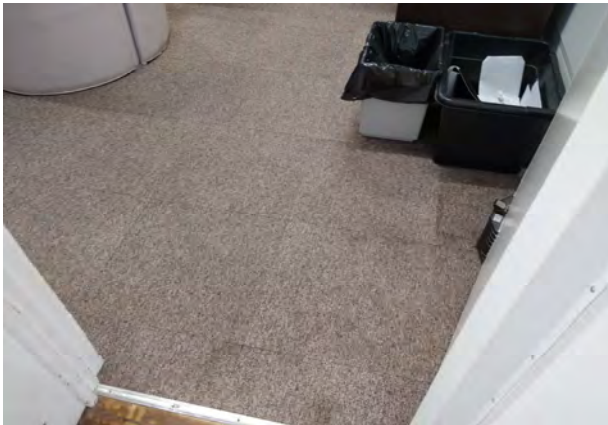
#### **Item 29 Ref: As 369919-8**

The adhesive beneath parquet flooring in the reception (Rm 0/19) does not contain asbestos.

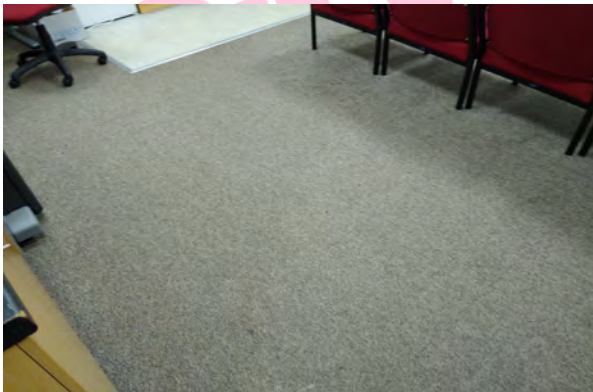
#### **Item 30 Ref: As 369919-8**

The adhesive beneath parquet flooring in the staff room (Rm 0/20) does not contain asbestos.

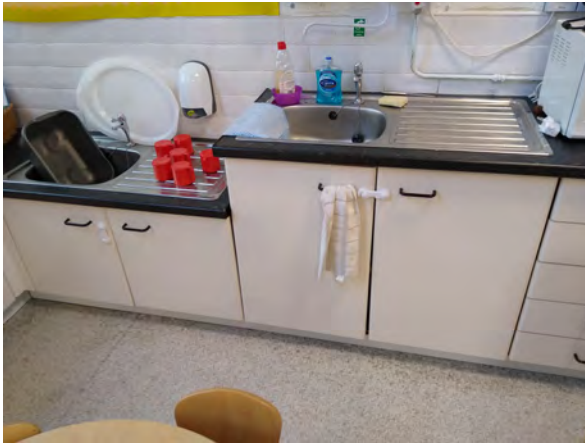
### **Item 31 Ref: 254851-21**

The acoustic pads to sinks in the nursery (Rm 0/024) do not contain asbestos.

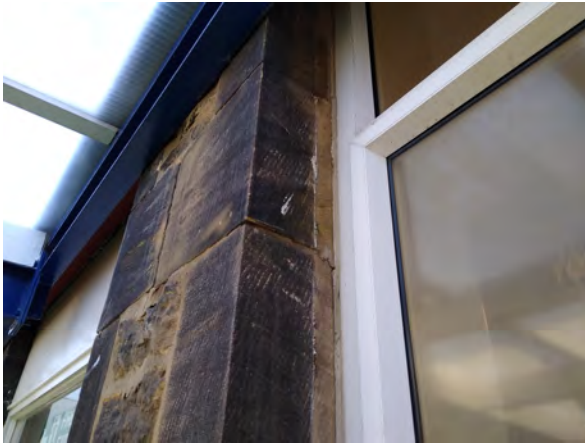
### **Item 32 Ref: 369919-7**

The remains to walls around windows (Rm 0/026) does not contain asbestos.

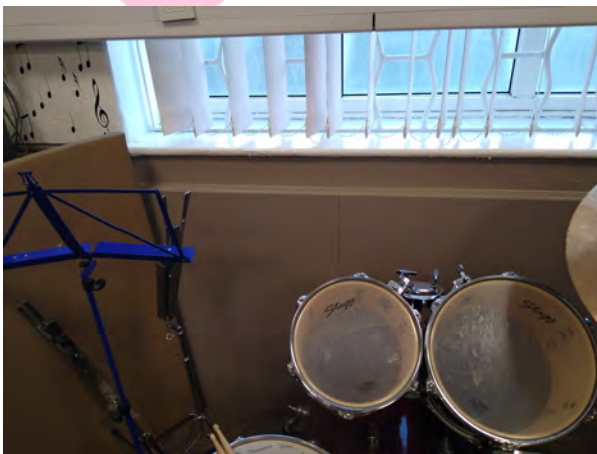
### **Item 33 Ref: 369919-1**

The boxing in the library (Rm 0/028) does not contain asbestos.

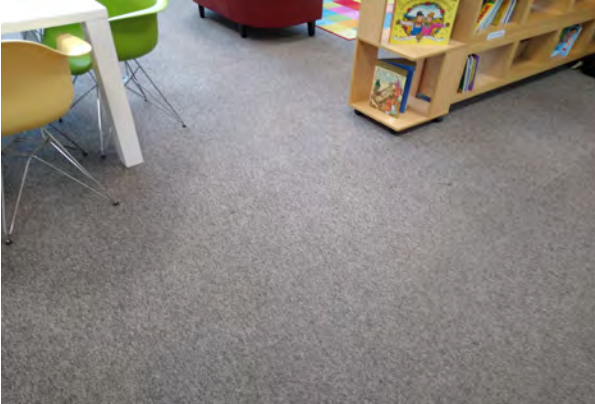
#### **Item 34 Ref: As 369919-8**

The adhesive beneath parquet flooring in the library (Rm 0/028) do not contain asbestos.

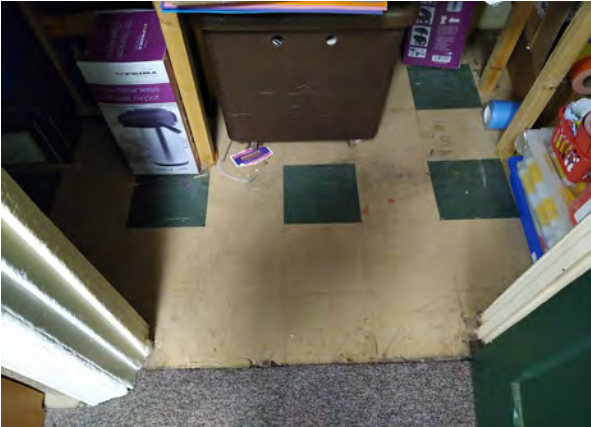
#### **Item 35 Ref: 254851-16**

The floor covering in the store cupboard (Rm 0/029) does contain asbestos.

Any change in appearance should be reported to Property Services.

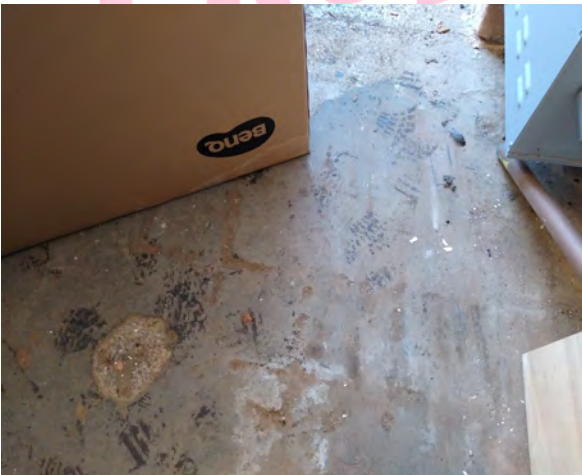
#### **Item 36 Ref: 254851-23**

- (Item 36) Ref: 254851-23 – Remnant floor adhesive (Rm 0/31/Boiler Room) – Removed November 2019
- (Item 37) Ref: 254851-24 – Debris to top of cable trunking and floor (Rm 0/31/Boiler Room) – No Risk

The remnant floor adhesive in the boiler room (Rm 0/031) does contain asbestos.

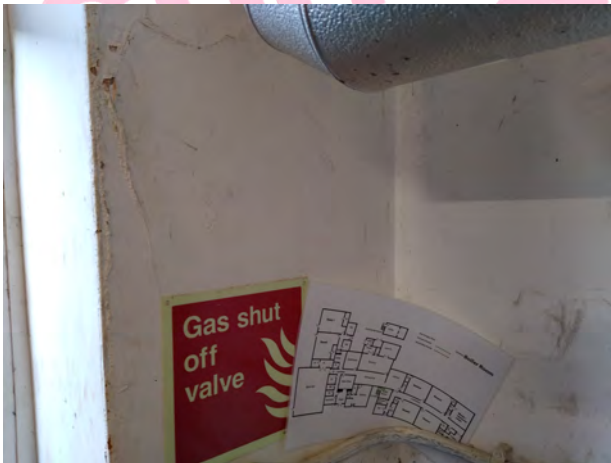
### **Item 39 Ref: 369919-10**

The debris to the walls in the boiler room (Rm 0/031) does contain asbestos.

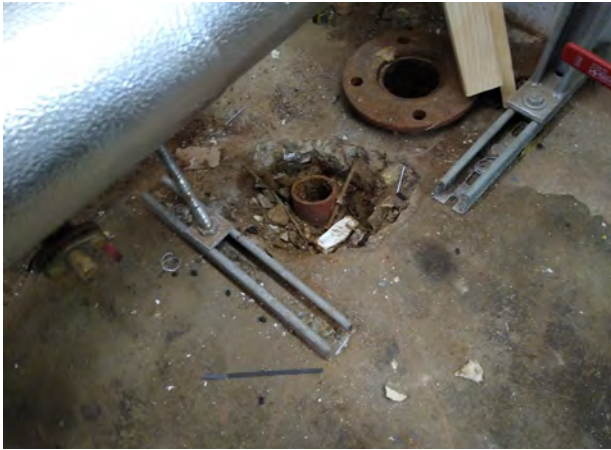
### **Item 40 Ref: 369919-13**

The debris within old pipework penetration leading to cellar below in the boiler room (Rm 0/031) does contain asbestos.

Removed November 2019

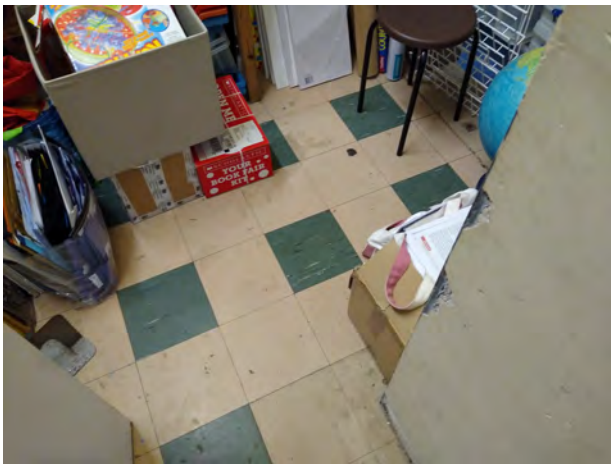
### **Item 41 Ref: 254851-11**

The floor covering in the store cupboard (Rm 0/035) does contain asbestos.

Any change in appearance should be reported to Property Services.

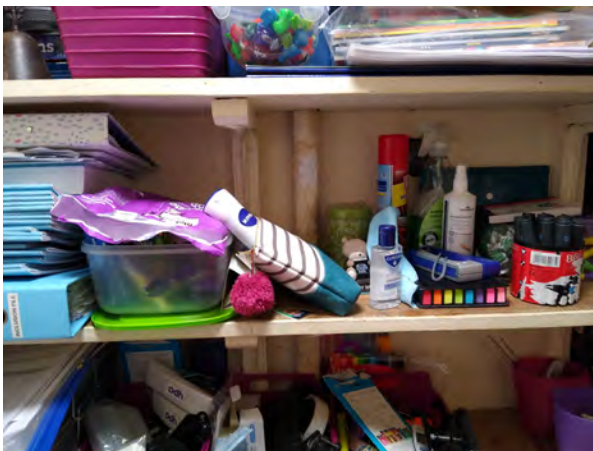
### **Item 42 Ref: 369919-2**

The coating to pipework in the store cupboard (Rm 0/035) does not contain asbestos.

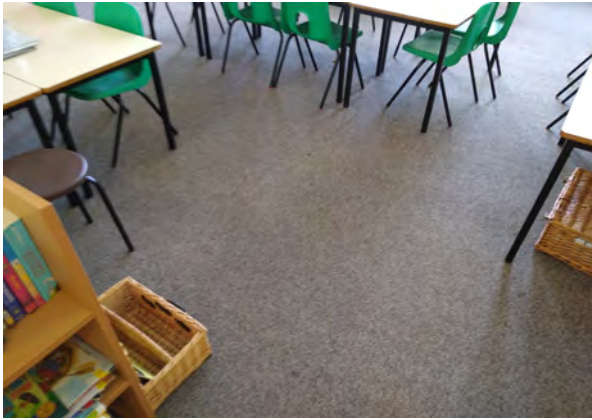
#### **Item 43 Ref: As 369919-8**

The adhesive beneath parquet flooring in the classroom (Rm 0/038) does not contain asbestos.

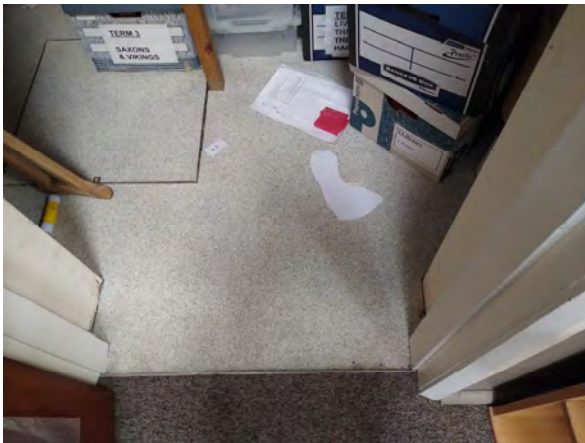
#### **Item 44 Ref: 254851-13**

The coating to the floor in the store cupboard (Rm 0/40) does contain asbestos.

Any change in appearance should be reported to Property Services.

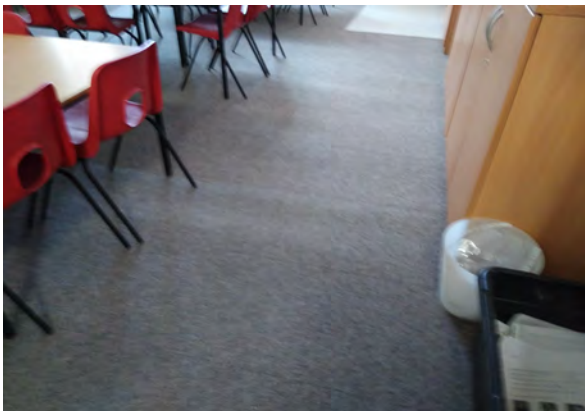
#### **Item 45 Ref: As 369919-8**

The adhesive beneath parquet flooring in the classroom (Rm 0/041) does not contain asbestos.

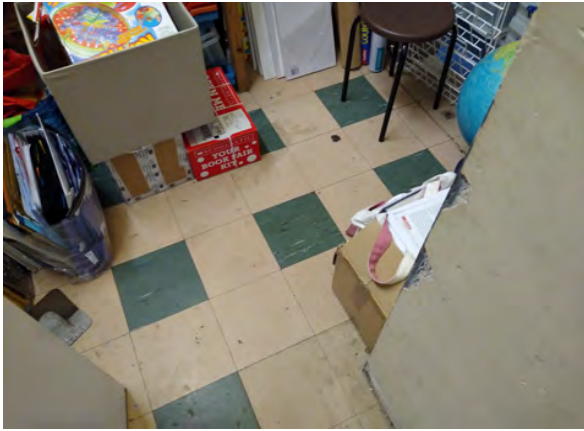
### **Item 46 Ref: 254851-11**

The floor covering in the store cupboard (Rm 0/042) does contain asbestos.

Any change in appearance should be reported to Property Services.

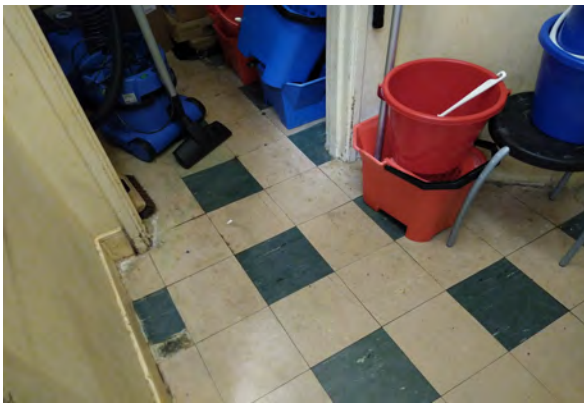
### **Item 47 Ref: As 254851-11**

The floor covering in the chemical store (Rm 0/044) does contain asbestos.

Any change in appearance should be reported to Property Services.

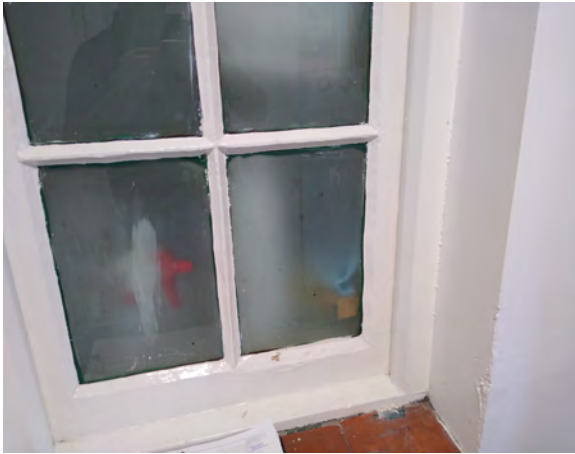
### **Item 49 Ref: 369919-5**

The putty to old external window in the lobby (Rm 0/045) does not contain asbestos.

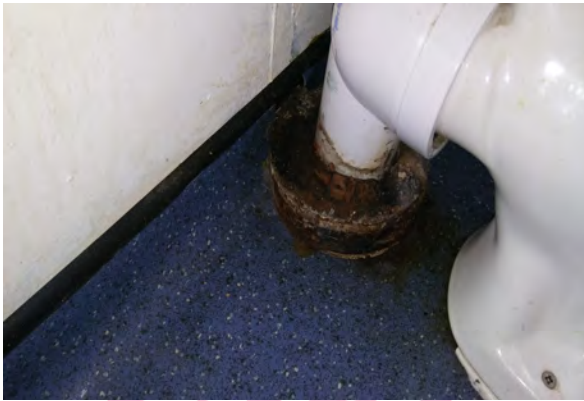
### **Item 50 Ref: 369919-3**

The seal to soil pipe in the boys wc (Rm 0/047) does not contain asbestos.

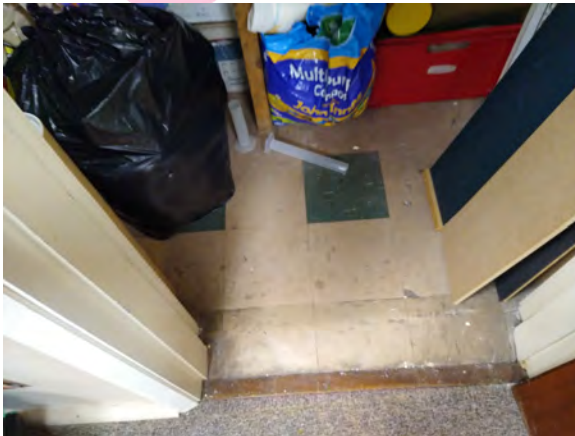
### **Item 51 Ref: 254851-12**

The floor covering in the store cupboard (Rm 0/049) does contain asbestos.

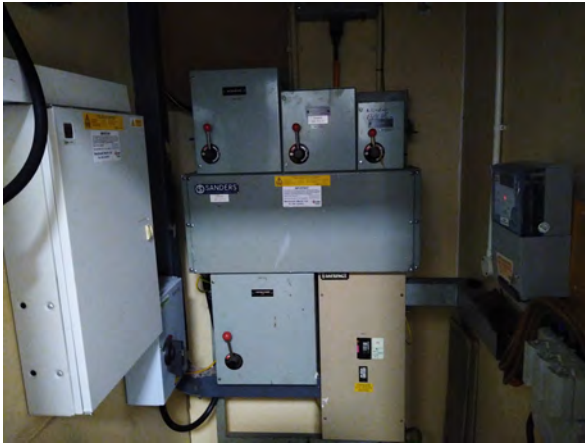
### **Item 52 Ref: Presumed**

The electrics in the electrics cupboard (Rm 0/050) is presumed to contain asbestos.

Further investigation is required before any works are carried out. Any change in appearance should be reported to Property Services.

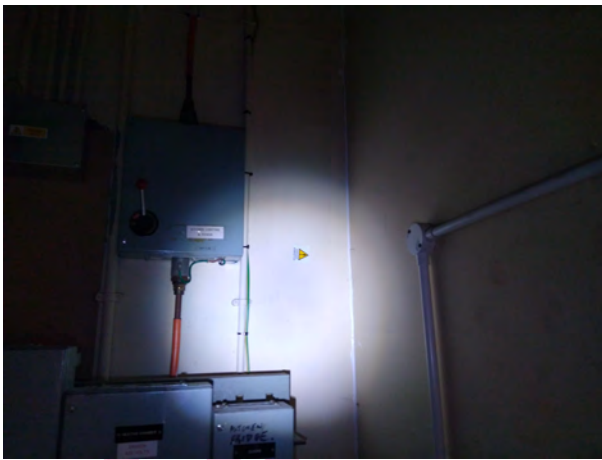
### **Item 53 Ref: 254851-15**

The walls in the electrics cupboard (Rm 0/050) does contain asbestos.

Any change in appearance should be reported to Property Services.

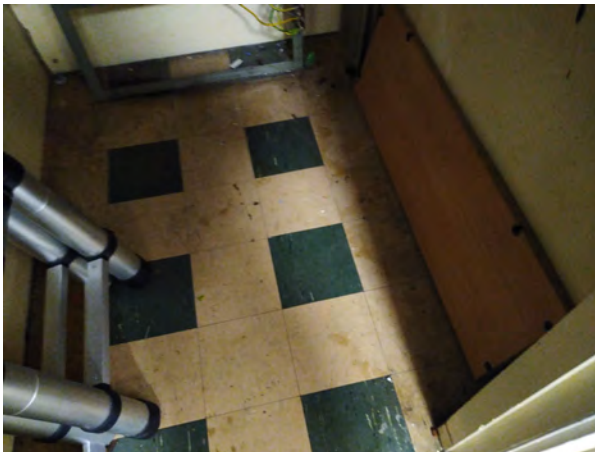
### **Item 54 Ref: As 254851-11**

The floor covering in the electrics cupboard (Rm 0/50) does contain asbestos.

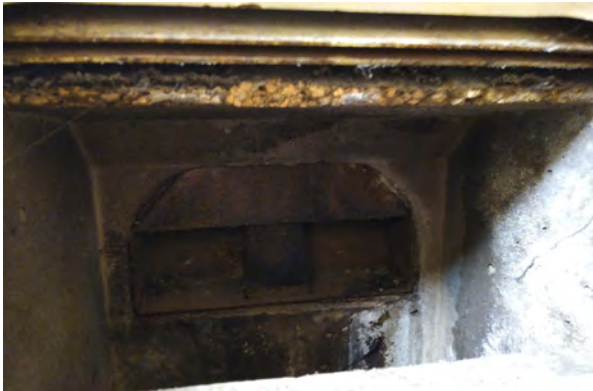
#### **Item 55 Ref: 254851-20**

The seal to bunny boiler in the wc (Rm 0/052) does contain asbestos.

Any change in appearance should be reported to Property Services.

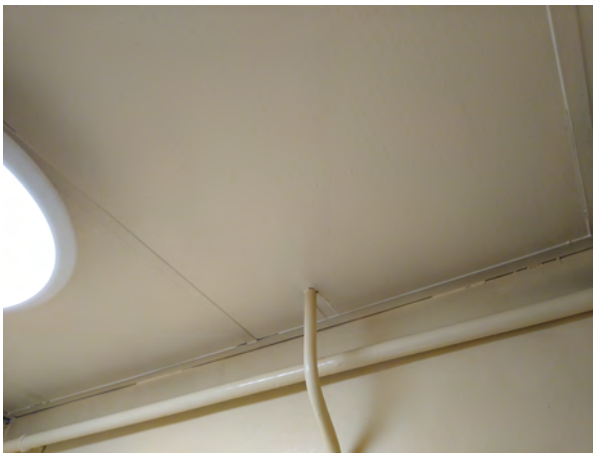
#### **Item 56 Ref: 254851-17**

The ceiling in the wc (Rm 0/052) does contain asbestos.

Any change in appearance should be reported to Property Services.

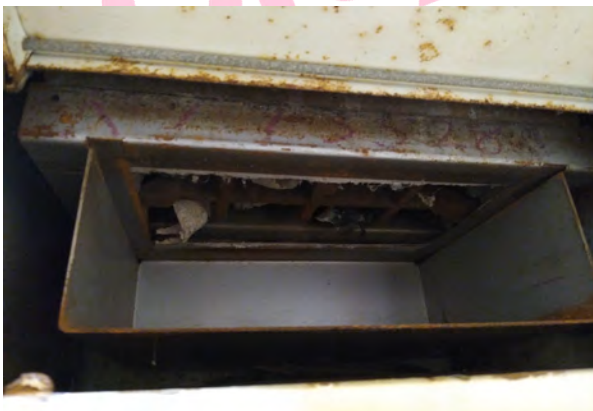
#### **Item 57 Ref: 369919-6**

The bunny incinerator internal lining in the wc (Rm 0/052) does contain asbestos.

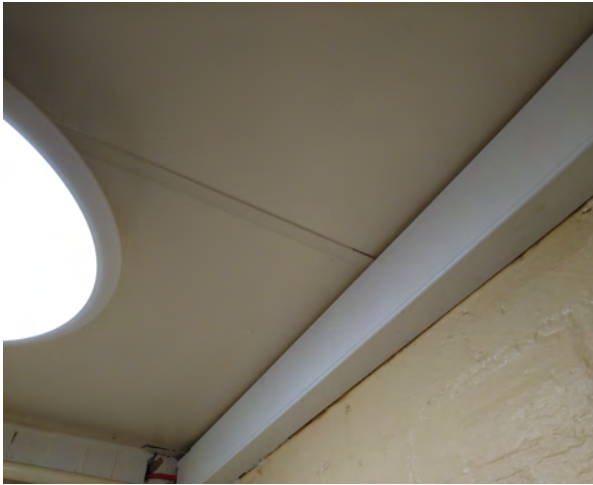
### **Item 58 Ref: As 254851-17**

The ceiling in the lobby (Rm 0/053) does contain asbestos.

Any change in appearance should be reported to Property Services.

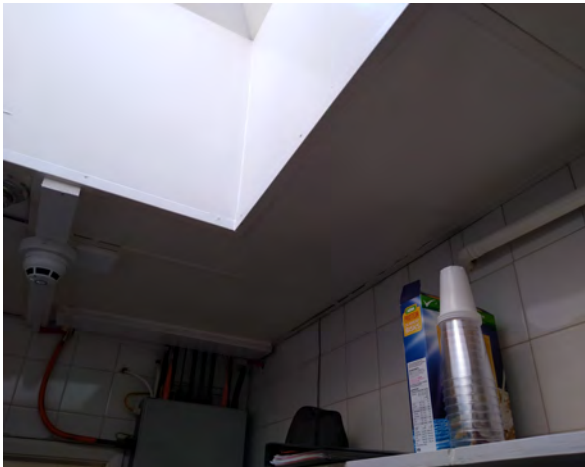
### **Item 59 Ref: As 254851-17**

The ceiling in the kitchen pantry (Rm 0/054) does contain asbestos.

Any change in appearance should be reported to Property Services.

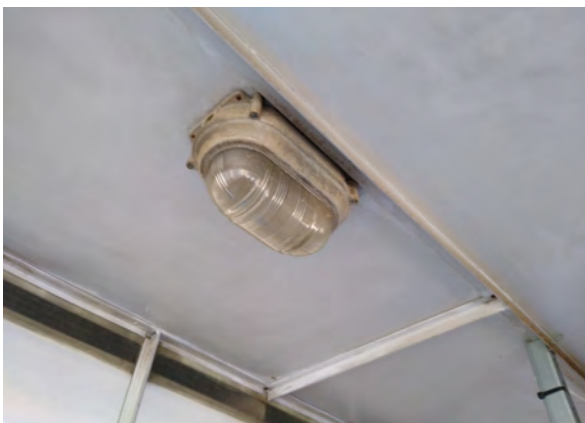
### **Item 60 Ref: 254851-18**

The gasket to oval light in the kitchen (Rm 0/055) does contain asbestos.

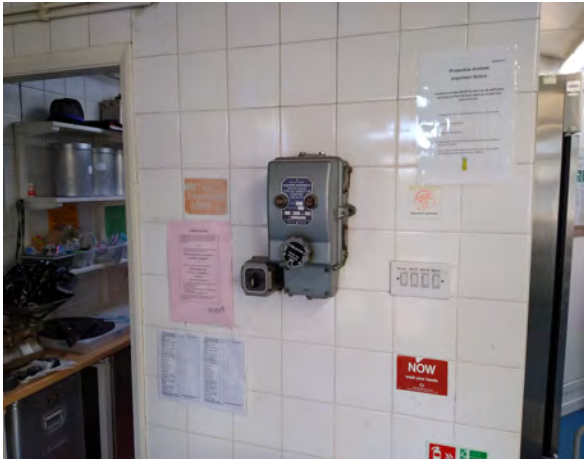
### **Item 61 Ref: Presumed**

- (Item 61) Ref: Presumed – Electrics (Rm 0/55/Kitchen) – Very Low Risk

The electrics in the kitchen (Rm 0/055) is presumed to contain asbestos.

Further investigation is required before any works are carried out. Any change in appearance should be reported to Property Services.

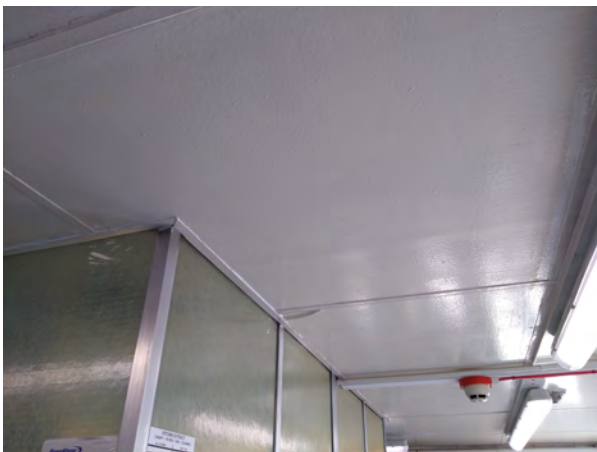
### **Item 62 Ref: As 254851-17**

The ceiling in the kitchen (Rm 0/055) does contain asbestos.

Any change in appearance should be reported to Property Services.

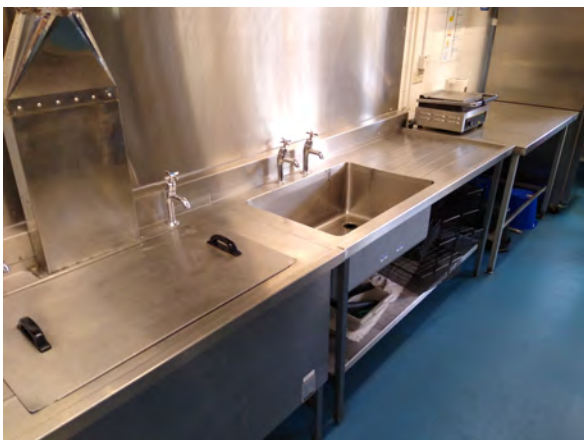
### **Item 63 Ref: 254851-19**

The acoustic paint to kitchen units in the kitchen (Rm 0/055) does contain asbestos.

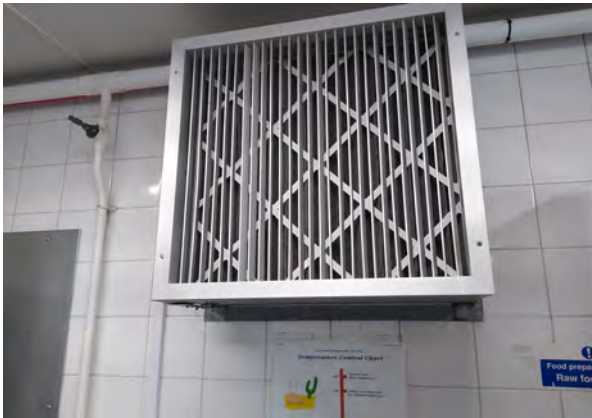
### **Item 64 Ref: 369919-9**

The sealant to extract ductwork in the kitchen (Rm 0/055) does not contain asbestos.

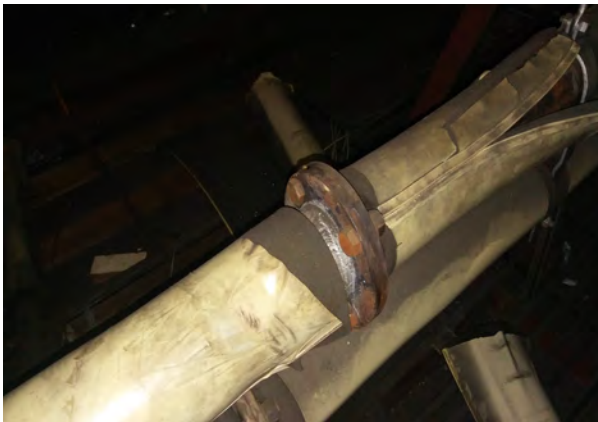
### **Item 65 Ref: Presumed**

The pipework flange gaskets in the loft void (Rm 1/001) is presumed to contain asbestos.

Further investigation is required before any works are carried out. Any change in appearance should be reported to Property Services.

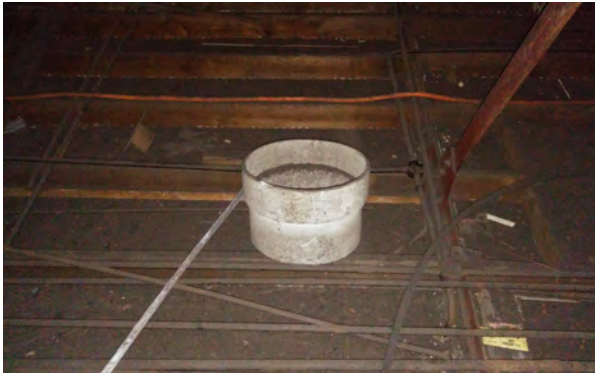
#### **Item 67 Ref: 254851-10**

The loose lying flue section in the loft void (Rm 1/002) contains asbestos.

| <i>Item 67</i> | <i>Loose lying flue section (Rm 1/002/loft void)</i> | <i>Very Low Risk</i> | <i>12 monthly</i> | <i>22.02.2027</i> |

Any change in appearance should be reported to Property Services.

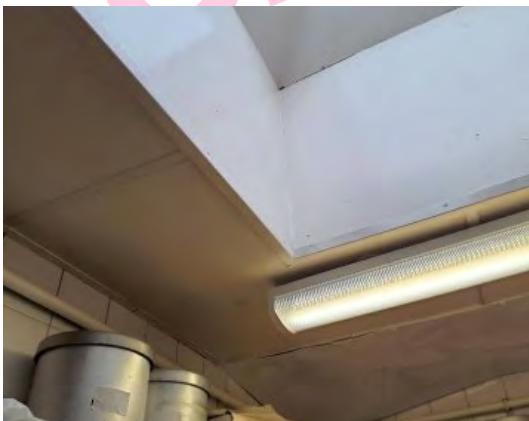
### **Item 84 Ref: KG00461**

The upstands to the skylights (Kitchen G/001) contains asbestos.
