ASBESTOS SURVEY REPORT FOR NEW SEAHAM ACADEMY, BYRON TERRACE, SEAHAM, SR7 0HX

*Control of Asbestos  
Regulations 2012*

**New Seaham Academy, Seaham, SR7 0HX**

**Date: 18 September 2024**

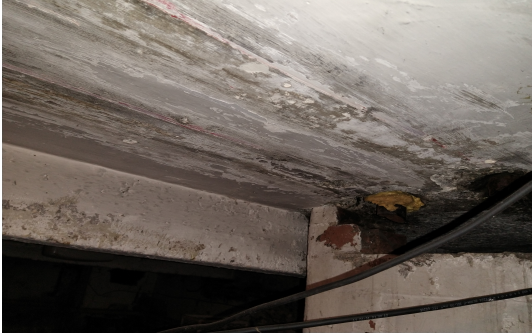
### **Item 1 Ref: 425813-14**

- (Item 1) Ref: 425813-14 – Residues to underside of floor (Basement/Rm -1/001) – No Risk
- (Item 2) Ref: 425813-15 – Residues to wall behind gas meter (Basement/Rm -1/001) – No Risk

The residues to underside of floor above adjacent door in the basement (Rm -1/001) does not contain asbestos.

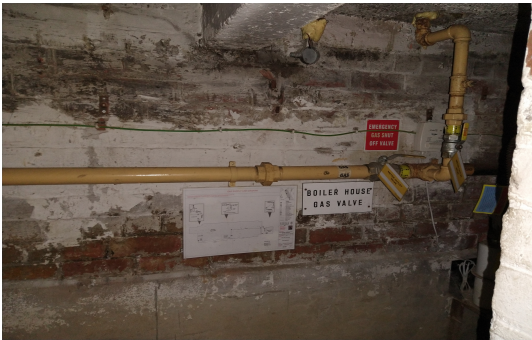
### **Item 2 Ref: 425813-15**

The residues to wall behind gas meter in the basement (Rm -1/001) does not contain asbestos.

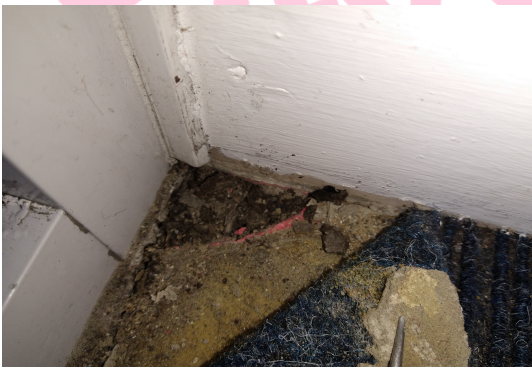
### **Item 3 Ref: 425813-1**

- (Item 3) Ref: 425813-1 – Floor covering beneath carpet (Entrance Lobby/Rm 0/001) – Very Low Risk
- (Item 4) Ref: 425813-2 – Adhesive to floor beneath linoleum and screed (Boys WC/Rm 0/004) – Very Low Risk

The floor covering beneath carpet & screed in the entrance lobby (Rm 0/001) contains asbestos.

Any change in its appearance should be recorded and passed to Property Services.

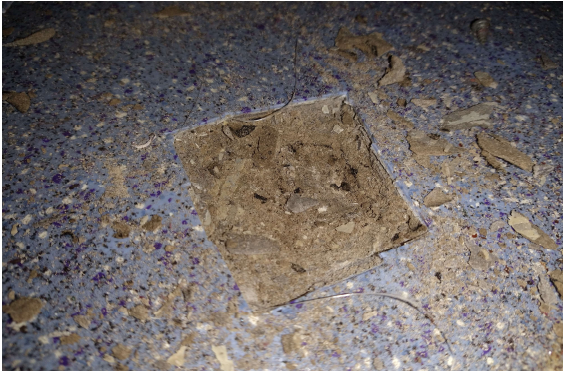
### **Item 4 Ref: 425813-2**

The remnant adhesive to floor beneath linoleum and screed in the boy's WC (Rm 0/004) does contain asbestos.

Any change in its appearance should be recorded and passed to Property Services.

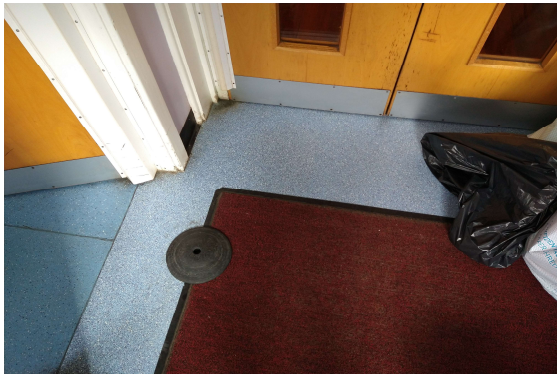
### **Item 5 Ref: 425813-2**

- (Item 5) Ref: As 425813-2 – Adhesive to floor beneath linoleum and screed (Lobby/Rm 0/005) – Very Low Risk
- (Item 6) Ref: As 425813-2 – Adhesive to floor beneath linoleum and screed (Girls WC/Rm 0/007) – Very Low Risk

The remnant adhesive to floor beneath linoleum and screed in the lobby (Rm 0/005) does contain asbestos.

Any change in its appearance should be recorded and passed to Property Services.

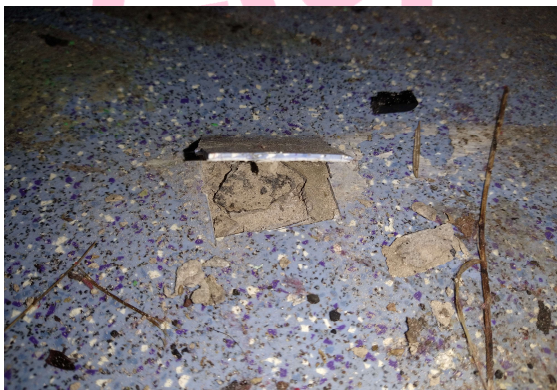
### **Item 6 Ref: As 425813-2**

The remnant adhesive to floor beneath linoleum and screed in the girl's WC (Rm 0/007) does contain asbestos.

Any change in its appearance should be recorded and passed to Property Services.

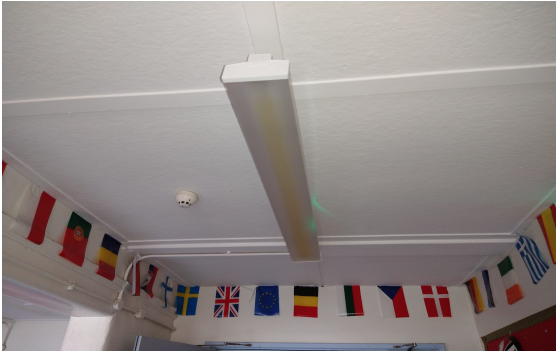
### **Item 7 Ref: 425813-3**

- (Item 7) Ref: 425813-3 – Ceiling (Lobby/Rm 0/014) – No Risk
- (Item 8) Ref: 425813-4 – Adhesive beneath screed (Cloak Room/Rm 0/015) – Very Low Risk
- (Item 9) Ref: As 425813-3 – Ceiling (Lobby/Rm 0/016) – No Risk

The ceiling in the lobby (Rm 0/014) does not contain asbestos.

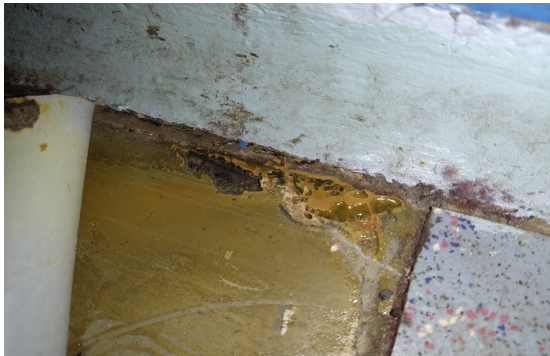
### **Item 8 Ref: 425813-4**

The remnant floor adhesive beneath screed in the cloak room (Rm 0/0015) does contain asbestos.

Any change in its appearance should be recorded and passed to Property Services.

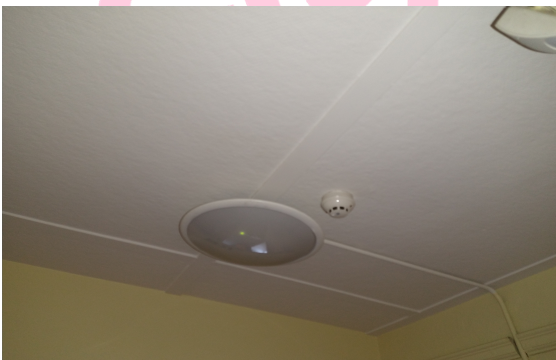
### **Item 9 Ref: As 425813-3**

The ceiling in the lobby (Rm 0/016) does not contain asbestos.

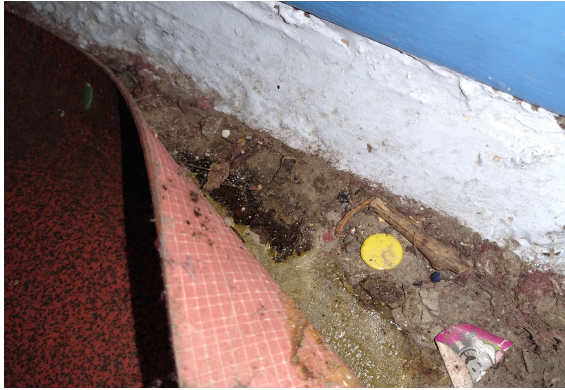
### **Item 10 Ref: As 425813-4**

- (Item 10) Ref: As 425813-4 – Adhesive beneath screed (Cloak Room/Rm 0/019) – Very Low Risk
- (Item 11) Ref: As 425813-4 – Adhesive beneath screed (Lobby/Rm 0/020) – Very Low Risk

The remnant floor adhesive beneath screed in the cloak room (Rm 0/019) does contain asbestos.

Any change in its appearance should be recorded and passed to Property Services.

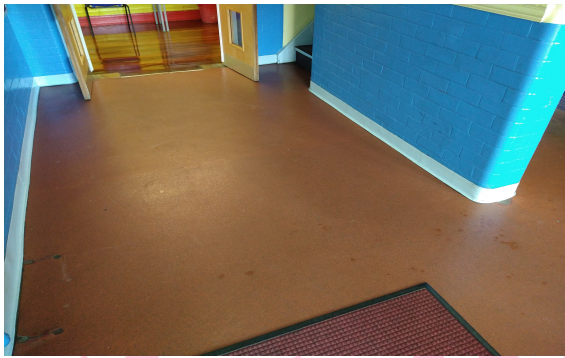
### **Item 11 Ref: As 425813-4**

The remnant floor adhesive beneath screed in the lobby (Rm 0/020) does contain asbestos.

<b>Item 11</b>	<b>Remnant adhesive (Lobby/Rm 0/020)</b>	<b>Very Low Risk</b>	<b>12 monthly</b>	<b>19/08/2025</b>
<i>Item 12</i>	<i>No asbestos</i>	<i>Is present</i>		
<i>Item 13</i>	<i>No asbestos</i>	<i>Is present</i>		
<i>Item 14</i>	<i>No asbestos</i>	<i>Is present</i>		
<i>Item 15</i>	<i>No asbestos</i>	<i>Is present</i>		
<i>Item 16</i>	<i>No asbestos</i>	<i>Is present</i>		
<i>Item 17</i>	<i>No asbestos</i>	<i>Is present</i>		
<b>Item 18</b>	<b>Flashing to window cills (External)</b>	<b>Very Low Risk</b>	<b>12 monthly</b>	<b>N/A – can not be access due</b>

Any change in its appearance should be recorded and passed to Property Services.

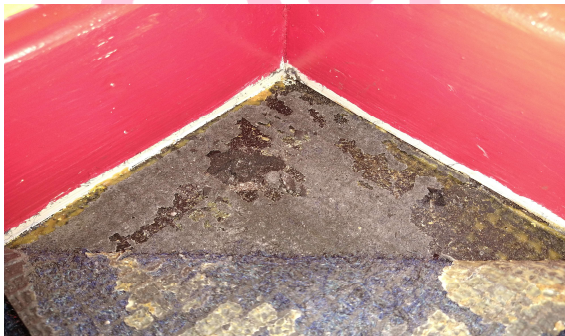
### **Item 12 Ref: 425813-5**

- (Item 12) Ref: 425813-5 – Floor screed (Classroom/Rm 0/024) – No Risk
- (Item 13) Ref: 425813-6 – Pipework flange gasket (Boiler Room/Rm 0/030A) – No Risk

The floor screed in the classroom (Rm 0/024) does not contain asbestos.

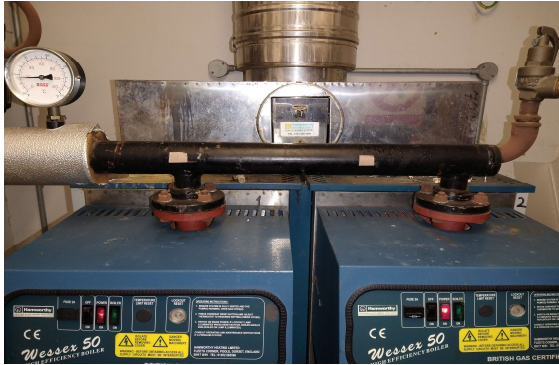
### **Item 13 Ref: 425813-6**

The pipework flange gasket in the boiler room (Rm 0/030A) does not contain asbestos.

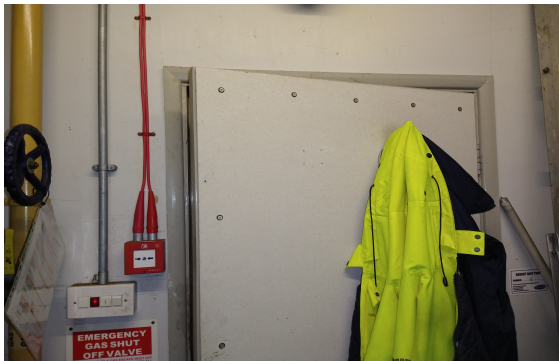
### **Item 14 Ref: 425813-7**

- (Item 14) Ref: 425813-7 – Panel to door (Boiler Room/Rm 0/030A) – No Risk
- (Item 15) Ref: 425813-9 – Floor covering beneath carpet (Office/Rm 1/002) – No Risk

The panel to door in the boiler room (Rm 0/030A) does not contain asbestos.

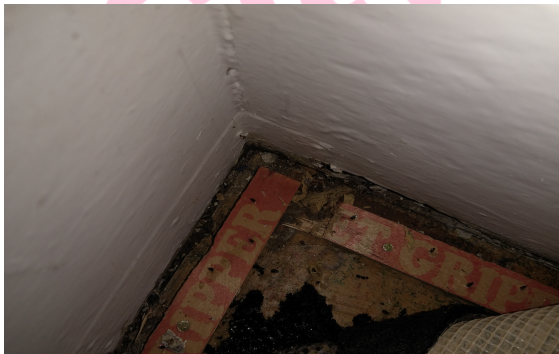
### **Item 15 Ref: 425813-9**

The floor covering beneath carpet in the boiler room (Rm 0/030A) does not contain asbestos.

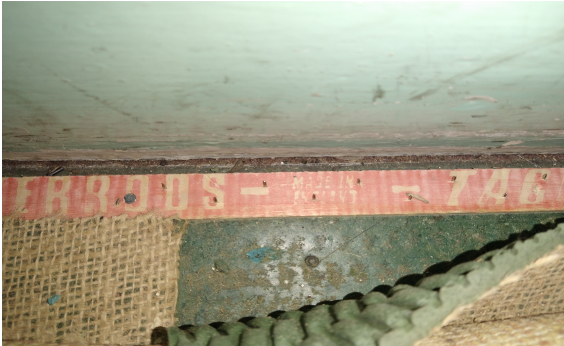
#### **Item 16 Ref: 425813-8**

- (Item 16) Ref: 425813-8 – Floor covering beneath carpet (ICT Room/Rm 1/009) – No Risk
- (Item 17) Ref: 425813-10 – Roof flashing to high level flat roof (External) – No Risk

The floor covering beneath carpet in the ICT room (Rm 1/009) does not contain asbestos.

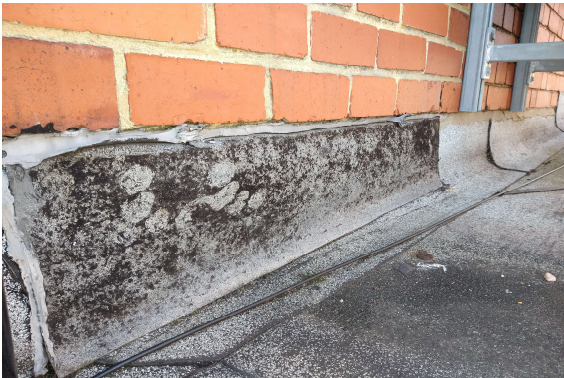
#### **Item 17 Ref: 425813-10**

The roof flashing to high level flat roof backing onto 1/001 (External) does not contain asbestos.

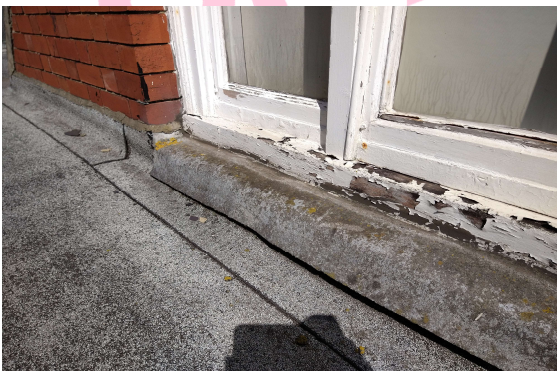
#### **Item 18 Ref: 425813-11**

- (Item 18) Ref: 425813-11 – Flashing to high level window cills (External) – Very Low Risk
- (Item 19) Ref: 425813-12 – Sealant to high level window frames (External) – No Risk

The flashing to high level window cills (External) does contain asbestos.

Any change in its appearance should be recorded and passed to Property Services.

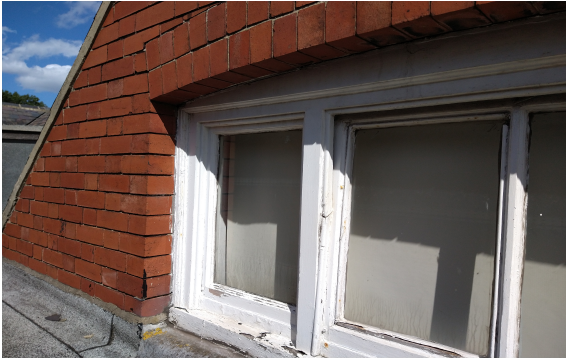
### **Item 19 Ref: 425813-12**

The sealant to high level window frames (on high level flat roof) (External) does not contain asbestos.

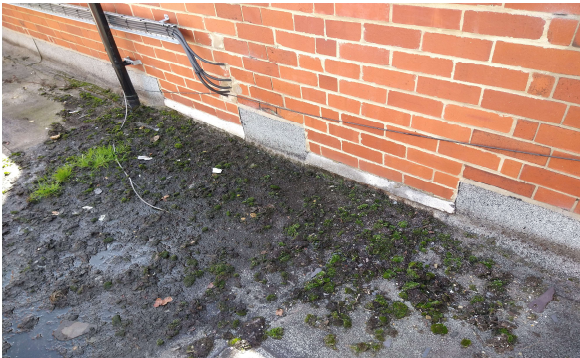
### **Item 20 Ref: As 425813-10**

- (Item 20) Ref: As 425813-10 – Roof flashing to high level flat roof (External) – No Risk
- (Item 21) Ref: As 425813-10 – Roof flashing to rear of central chimney stack (External) – No Risk

The roof flashing to high level flat roof (section adjacent dining hall) (External) does not contain asbestos.

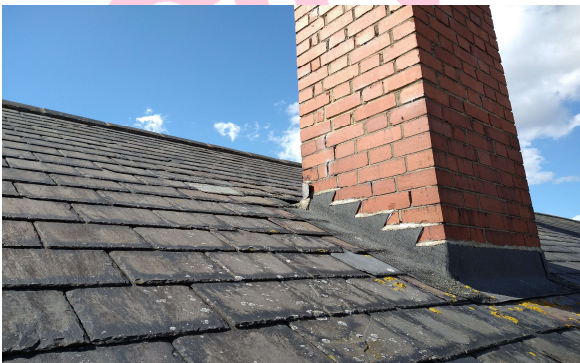
### **Item 21 Ref: As 425813-10**

The roof flashing to rear of central chimney stack (External) does not contain asbestos.

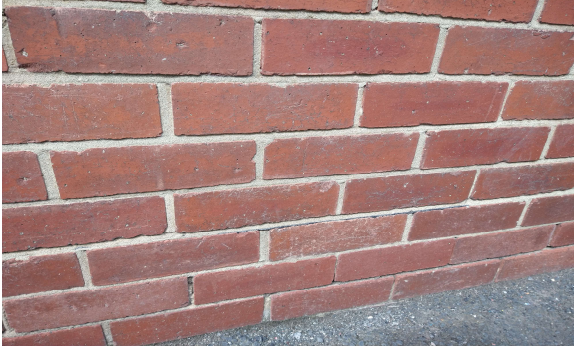
**Item 22 Ref: 425813-13**

- (Item 22) Ref: 425813-13 – Damp proof course (External) – No Risk

The damp proof course  
(External) does not contain  
asbestos.
