ASBESTOS SURVEY REPORT FOR RYHOPE INFANT SCHOOL ACADEMY, SUNDERLAND

Asbestos Register for RYHOPE INFANT SCHOOL ACADEMY, SUNDERLAND

UPRN: - J019842

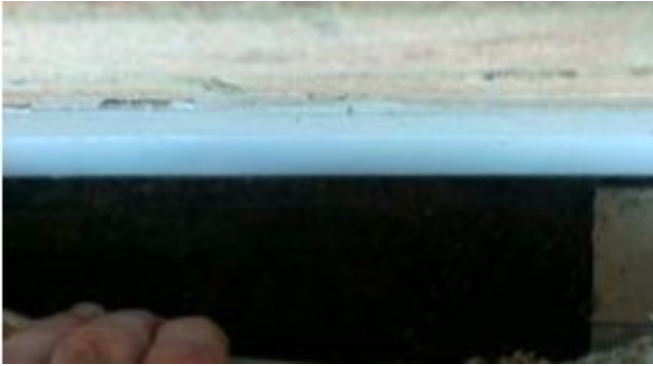
Item 1 Ref: AQ000013

Floor screed (Rm 0/01 Front Entrance Lobby) does not contain asbestos

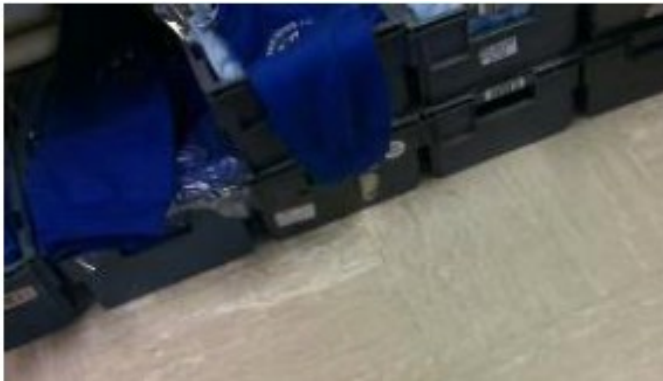
Item 2 Ref: AQ000014

Floor tiles and adhesive (Rm 0/03 Reception Office and Cupboard) do not contain asbestos.

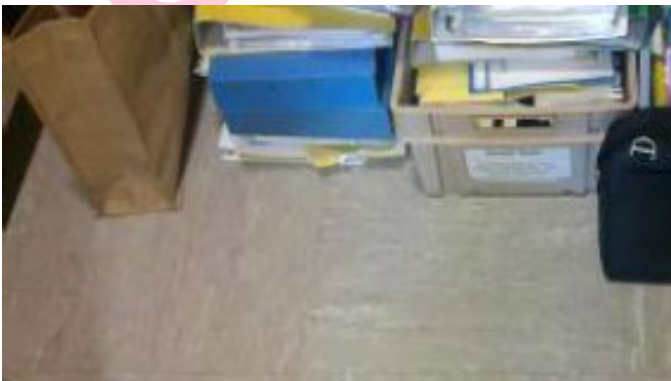
Item 3 Ref: As AQ000014

Floor tiles and adhesive (Rm 0/04 Managers Office and Cupboard) do not contain asbestos

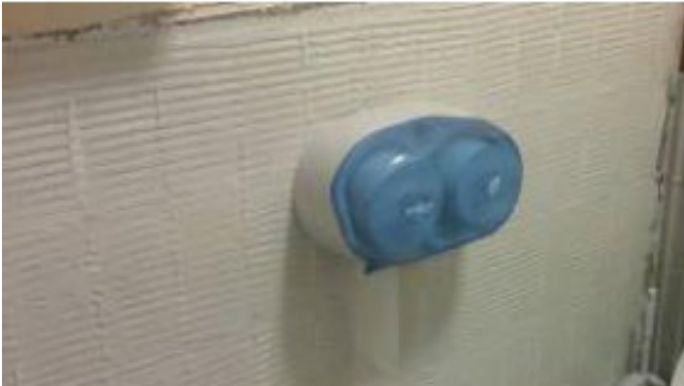
Item 4 Ref: AQ000015

Wall tile adhesive (Rm 0/10 Meeting Room WC) does not contain asbestos

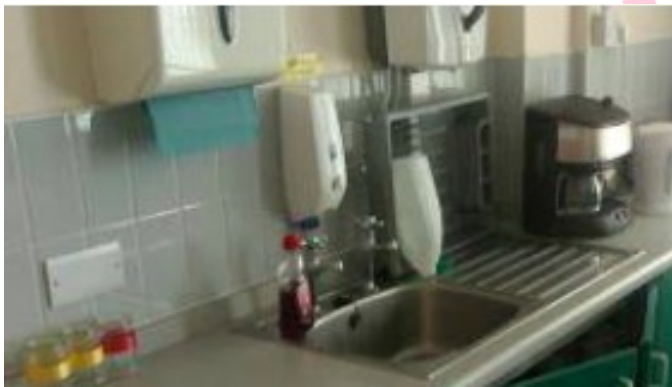
Item 5 Ref: AQ000016

Sink Pad (Rm 0/12 Training Room) does not contain asbestos

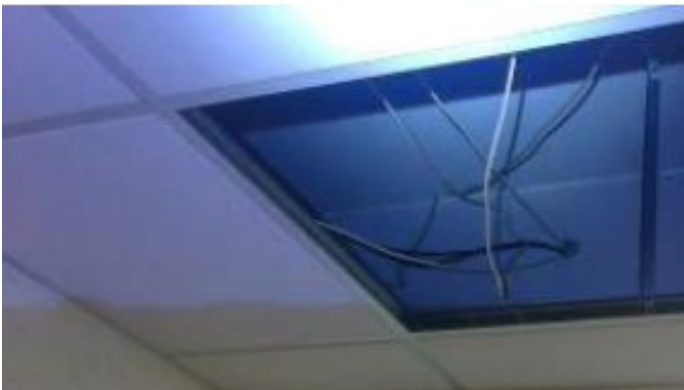
Item 6 Ref: AQ000018

Insulating Board (Rm 0/13 Corridor) does not contain asbestos

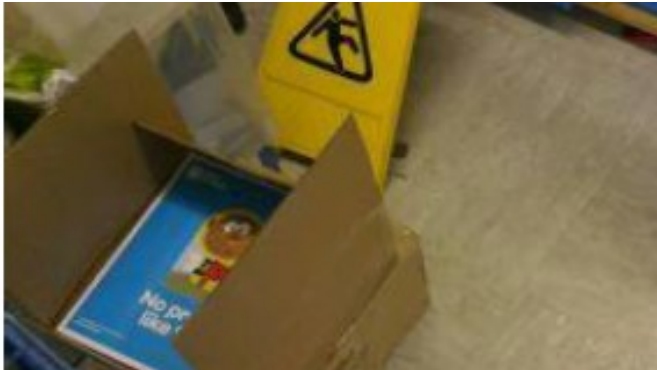
Item 7 Ref: As AQ000014

Floor tiles and adhesive (Rm 0/17 Reception Base 1&2) do not contain asbestos.

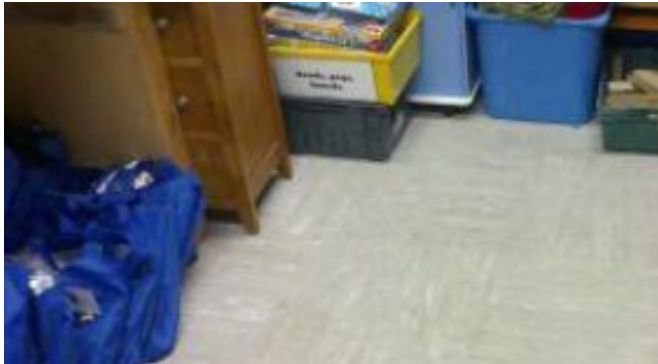
Item 8 Ref: AQ000019

Floor tiles and adhesive (Rm 0/21 Nursery Service Rooms) do not contain asbestos.

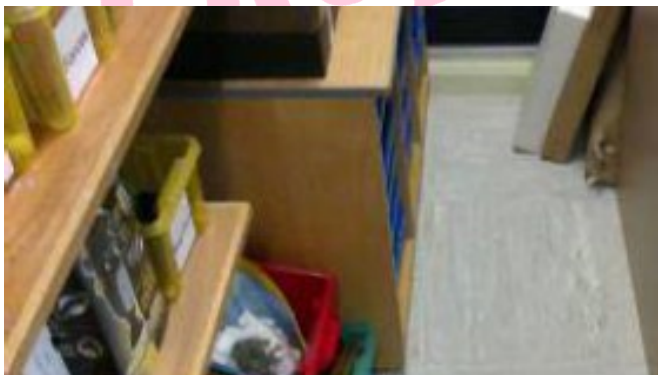
Item 9 Ref: As AQ000019

Floor tiles and adhesive (Rm 0/30 Classroom & Cupboard) do not contain asbestos.

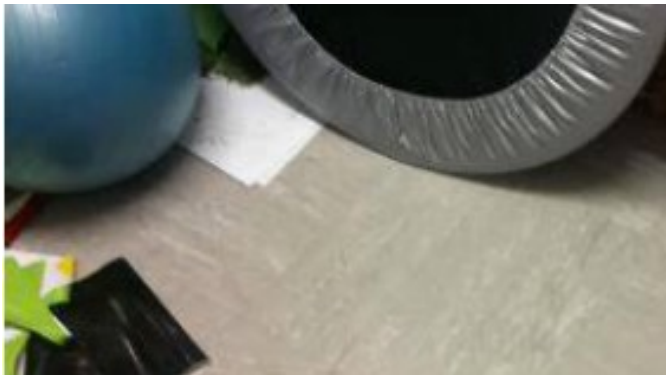
Item 10 Ref: AQ000020

Floor tiles and adhesive (Rm 0/35 Nurture Room and Cupboard) do not contain asbestos

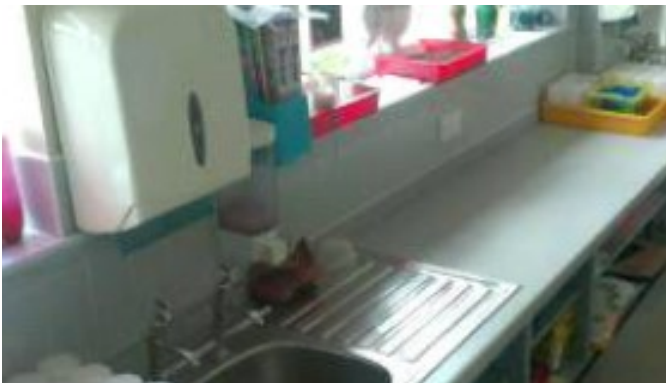
Item 11 Ref: AQ000021

Sink Pads (Rm 0/36 Year 2 Classroom & Cupboard) do not contain asbestos.

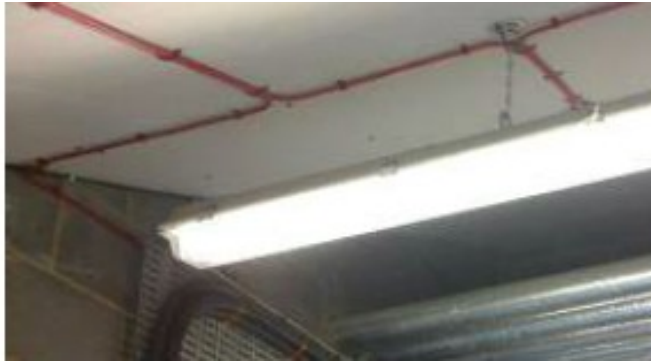
Item 13 Ref: AQ000023

Insulating Board (Rm 99/01
Electrical Room) does not
contain asbestos.

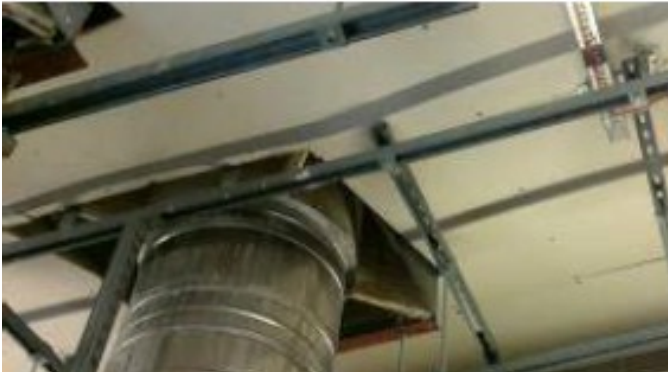
Item 14 Ref: AQ000024

Insulating Board (Rm 99/02
Plant Room) does not contain
asbestos.

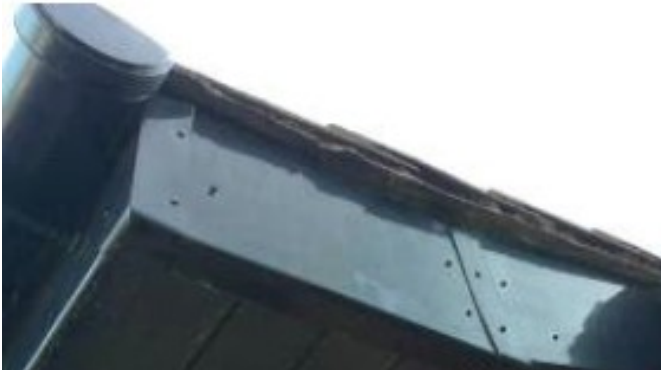
Item 17 Ref: AQ000027

Under Cloaking (Rm 99/03 Externals) does not contain asbestos.

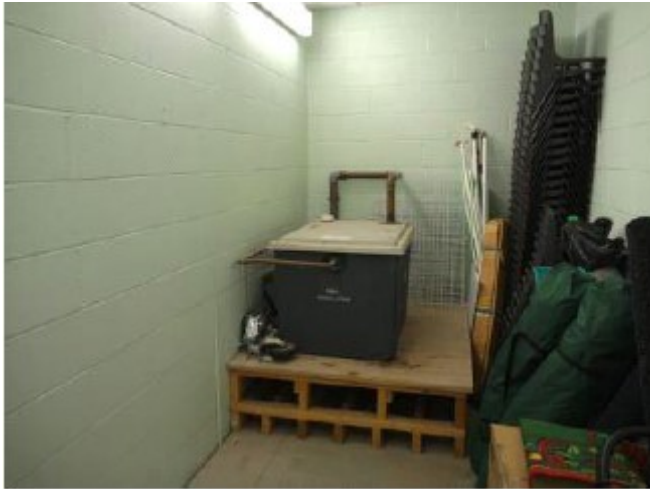
Item 20 Ref: AN000953

The coating to the water tank in the mezzanine tank room does not contain asbestos.

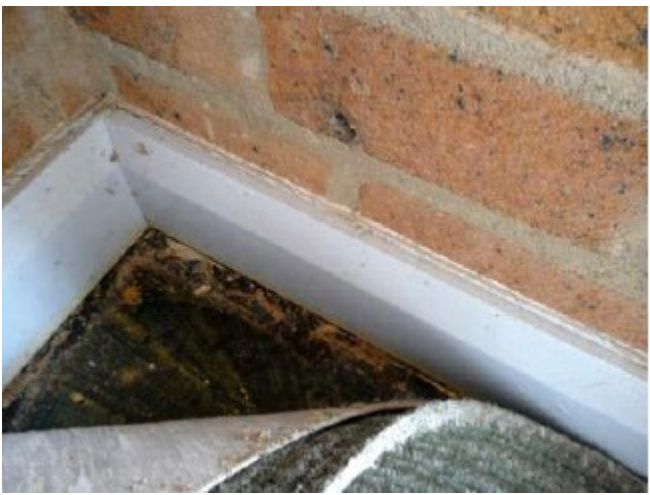
Item 21 Ref: AN000954

The adhesive below the lino in main reception entrance lobby does not contain asbestos.

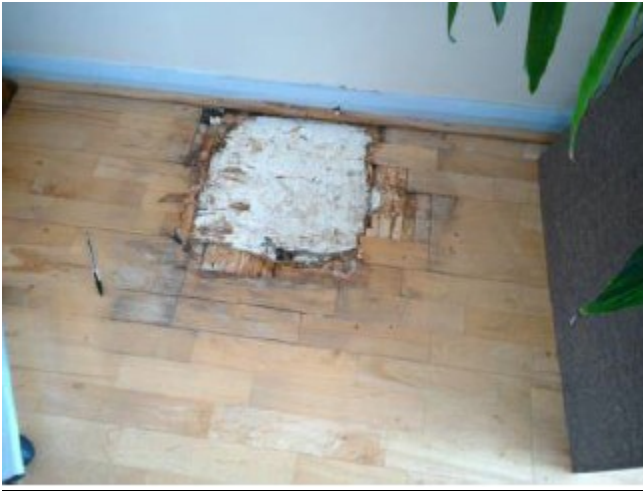
Item 22 Ref: As AN000954

The adhesive below the floor screed in main reception does not contain asbestos.

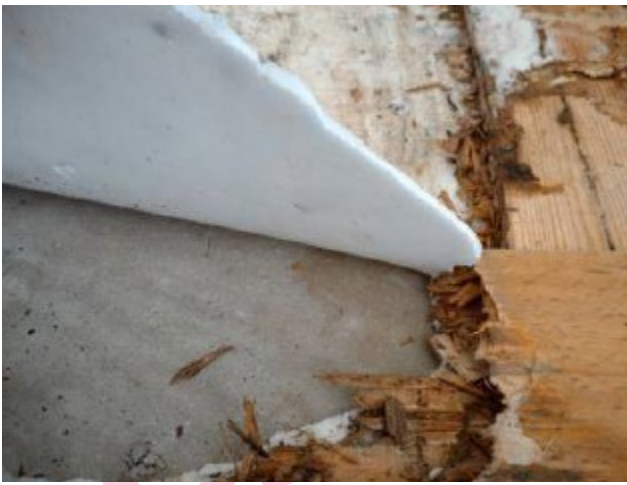
Item 23 Ref: AN000955

The screed beneath the wood flooring in main reception does not contain asbestos.

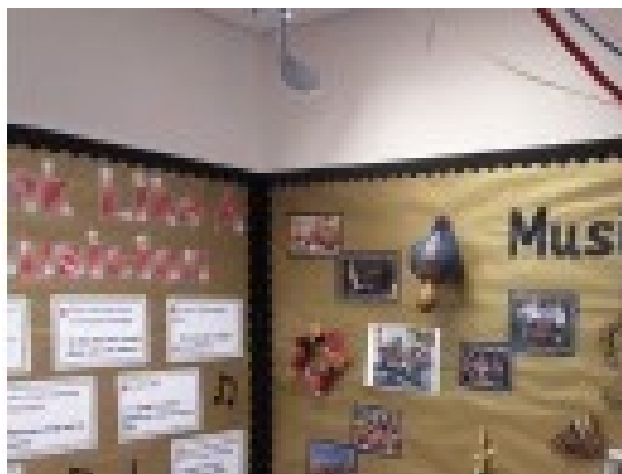
Item 24 Ref: DP002540

The core sample for the proposed new doorway in Room 0/030 does not contain asbestos.

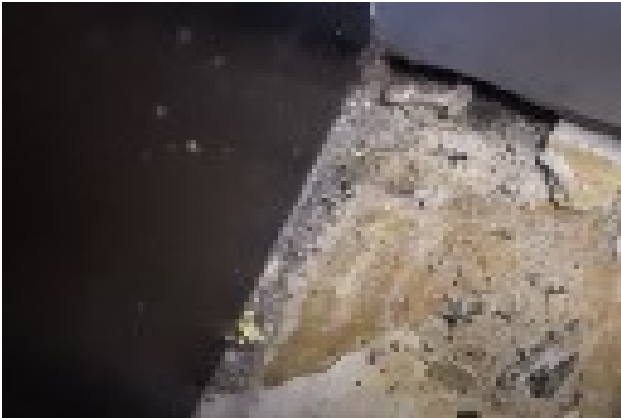
Item 25 Ref: DP002543

The bitumen screed below modern lino and modern screed in Room 0/36 does not contain asbestos.

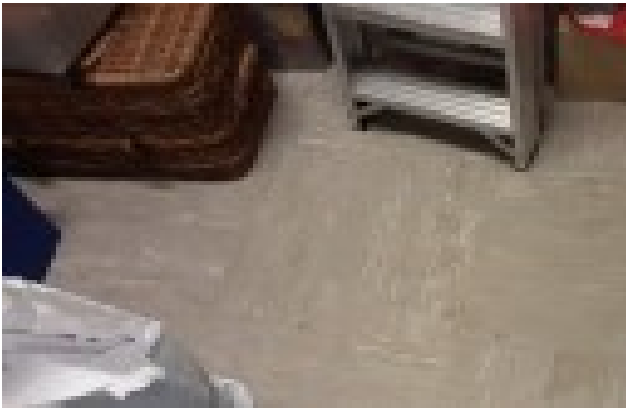
Item 26 Ref: DP002542

The vinyl floor tiles and adhesive in Room 0/36a does not contain asbestos.

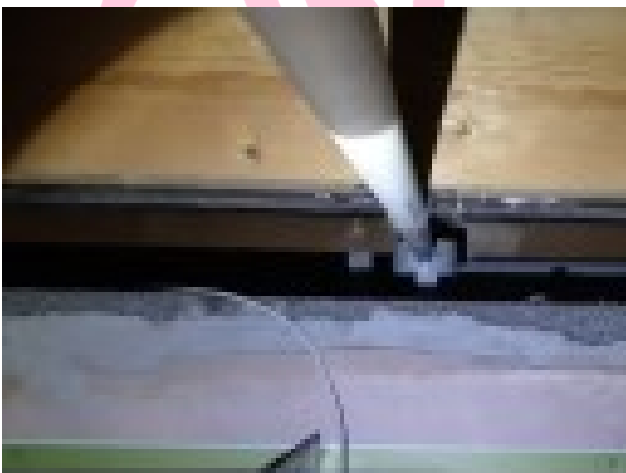
Item 27 Ref: DP002537

The core sample wall to toilet in Room 0/21 does not contain asbestos.

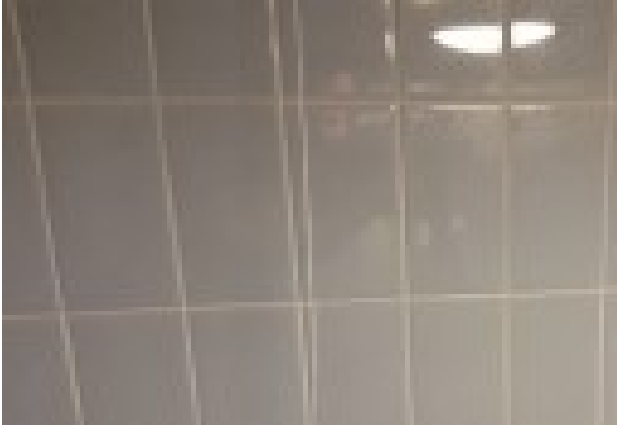
Item 28 Ref: DP002538

The grout to ceramic tiles (wall to interview room) in Room 0/21a does not contain asbestos.

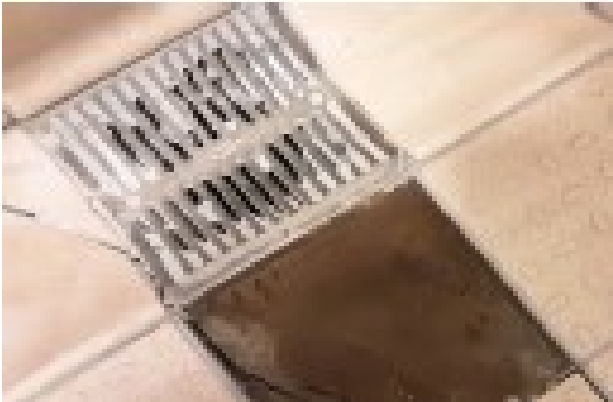
Item 29 Ref: DP002539

The screed below the quarry tiles in Room 0/21a does not contain asbestos.
