### ASBESTOS SURVEY REPORT FOR RYHOPE INFANT SCHOOL ACADEMY, SUNDERLAND

**Asbestos Register for**

**RYHOPE INFANT SCHOOL ACADEMY, SUNDERLAND**

**UPRN: - J019842**

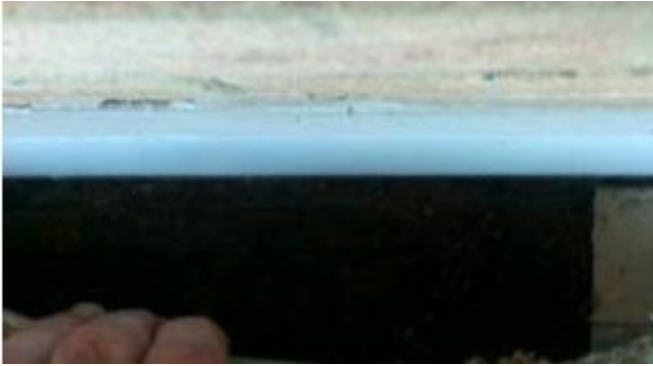
### **Item 1 Ref: AQ000013**

Floor screed (Rm 0/01 Front Entrance Lobby) does not contain asbestos

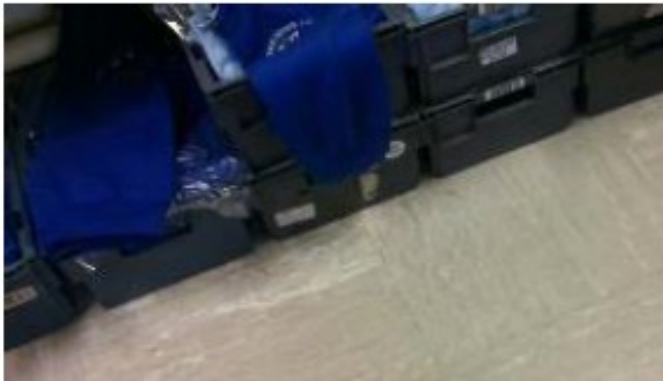
### **Item 2 Ref: AQ000014**

Floor tiles and adhesive (Rm 0/03 Reception Office and Cupboard) do not contain asbestos.

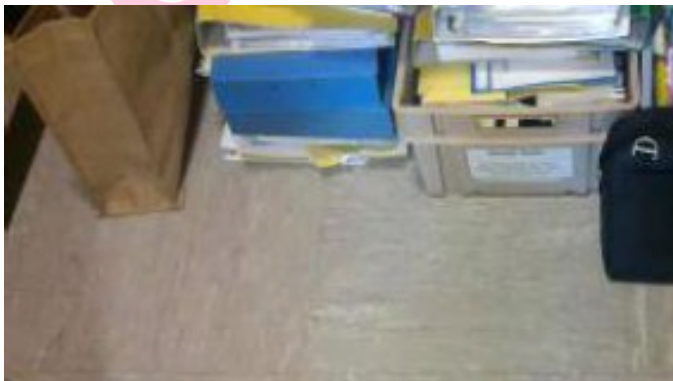
### **Item 3 Ref: As AQ000014**

Floor tiles and adhesive (Rm 0/04 Managers Office and Cupboard) do not contain asbestos

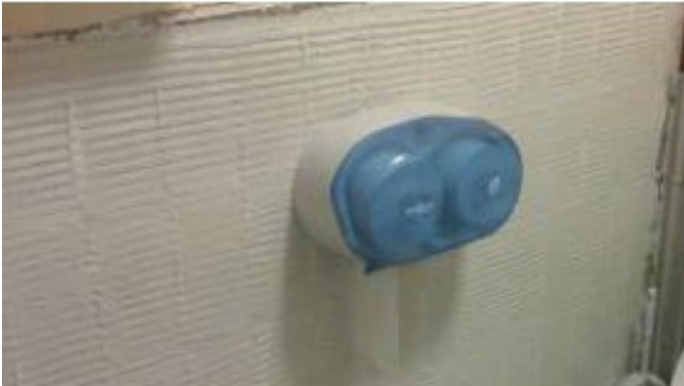
**Item 4 Ref: AQ000015**

Wall tile adhesive (Rm 0/10 Meeting Room WC) does not contain asbestos

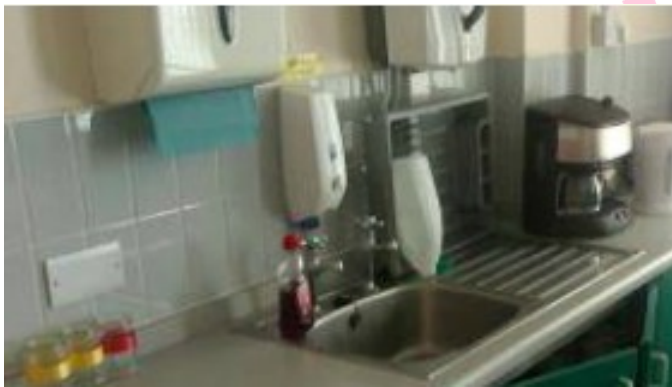
**Item 5 Ref: AQ000016**

Sink Pad (Rm 0/12 Training Room) does not contain asbestos

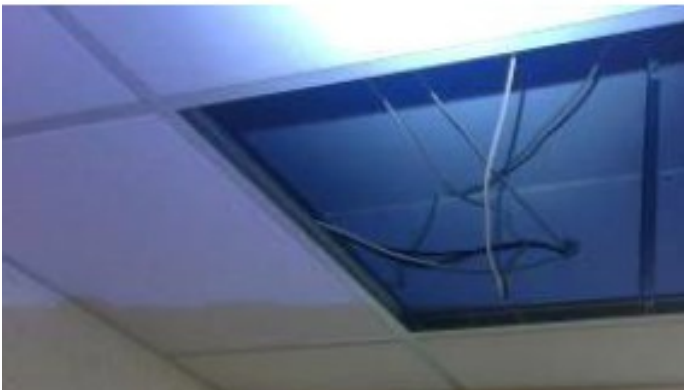
**Item 6 Ref: AQ000018**

Insulating Board (Rm 0/13 Corridor) does not contain asbestos

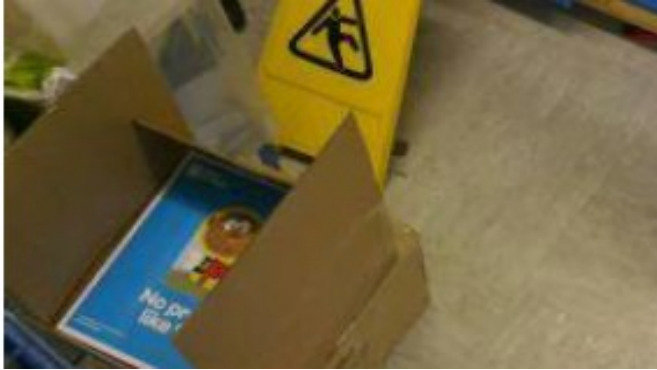
**Item 7 Ref: As AQ000014**

Floor tiles and adhesive (Rm 0/17 Reception Base 1&2) do not contain asbestos.

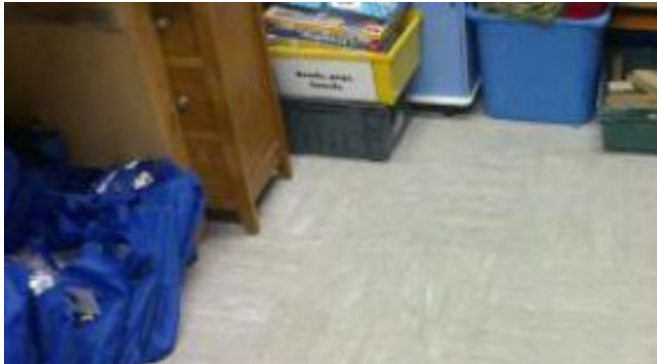
**Item 8 Ref: AQ000019**

Floor tiles and adhesive (Rm 0/21 Nursery Service Rooms) do not contain asbestos.

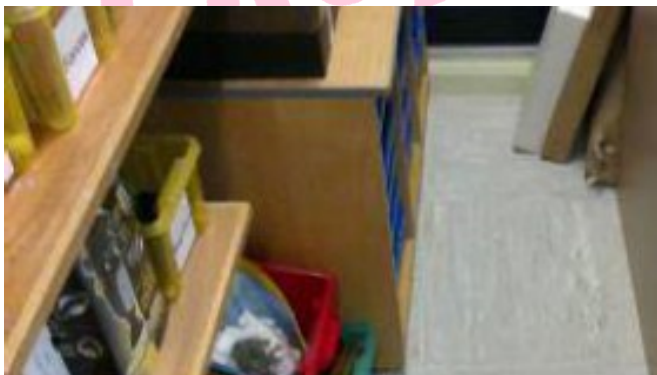
**Item 9 Ref: As AQ000019**

Floor tiles and adhesive (Rm 0/30 Classroom & Cupboard) do not contain asbestos.

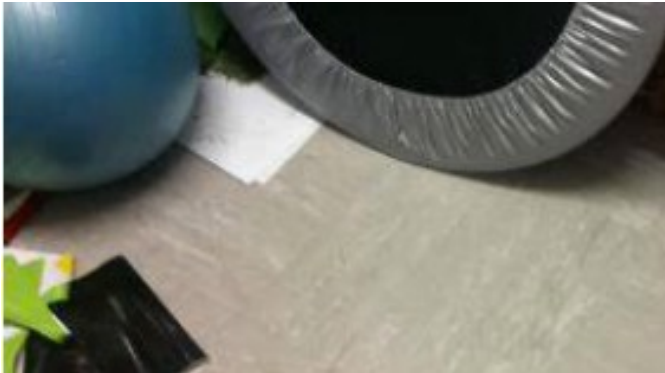
### **Item 10 Ref: AQ000020**

Floor tiles and adhesive (Rm 0/35 Nurture Room and Cupboard) do not contain asbestos

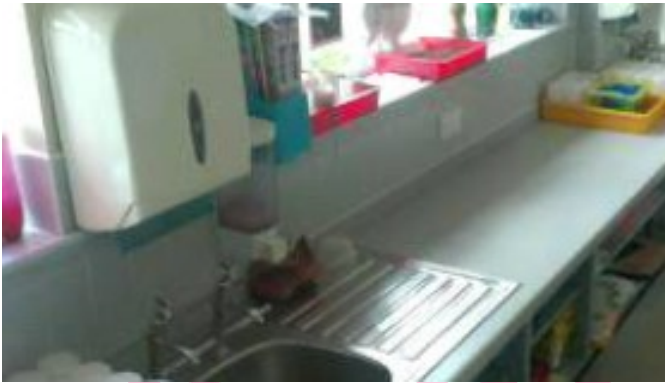
### **Item 11 Ref: AQ000021**

Sink Pads (Rm 0/36 Year 2 Classroom & Cupboard) do not contain asbestos.

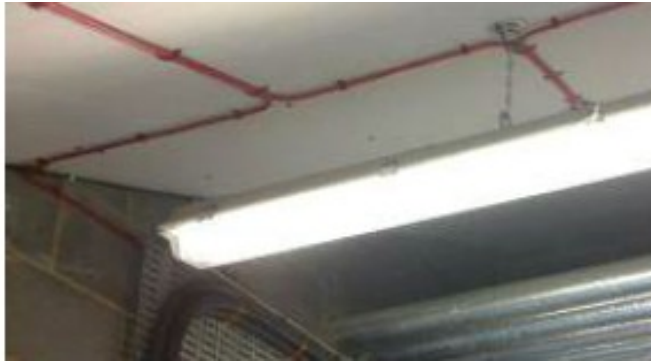
### **Item 13 Ref: AQ000023**

Insulating Board (Rm 99/01  
Electrical Room) does not  
contain asbestos.

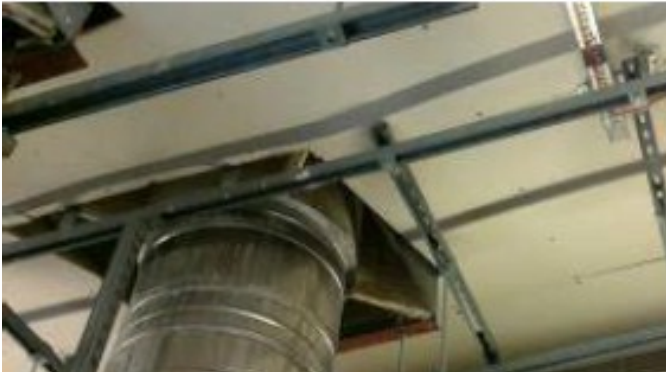
### **Item 14 Ref: AQ000024**

Insulating Board (Rm 99/02  
Plant Room) does not contain  
asbestos.

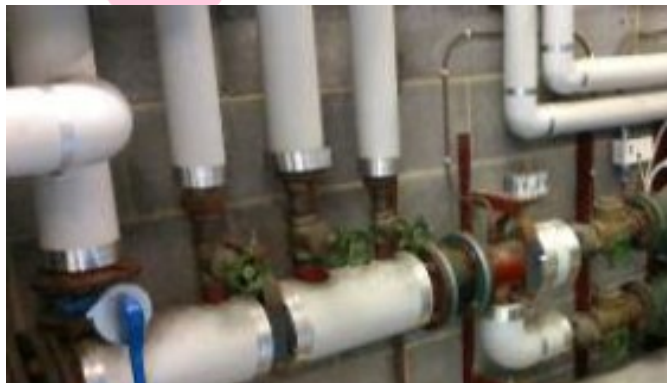
### **Item 15 Ref: AQ000025**

Gaskets (Rm 99/02 Plant Room)  
contain asbestos.

Item 10	No asbestos	Is present		
Item 11	No asbestos	Is present		
Item 12	No asbestos	Is present		
Item 13	No asbestos	Is present		
Item 14	No asbestos	Is present		
<b>Item 15</b>	<b>Gaskets – Rm 99/02 Plant Room</b>	<b>Very Low Risk</b>	<b>12 monthly</b>	<b>20.06.2027</b>

Any change in appearance  
should be recorded and passed  
to Property Services.

*(2 of the gaskets were removed  
20.6.18)*

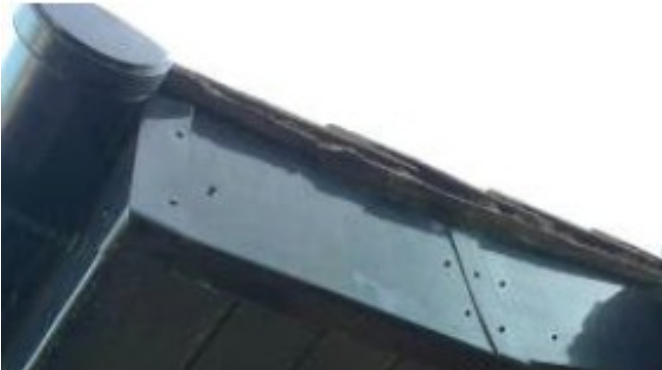
### **Item 17 Ref: AQ000027**

Under Cloaking (Rm 99/03 Externals) does not contain asbestos.

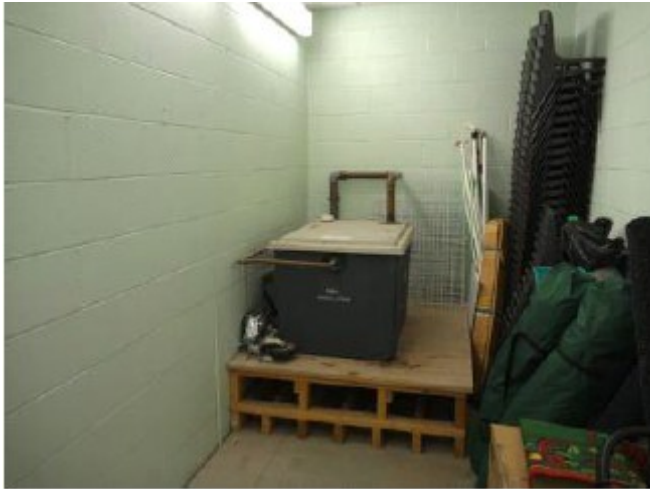
**Item 20 Ref: AN000953**

The coating to the water tank in the mezzanine tank room does not contain asbestos.

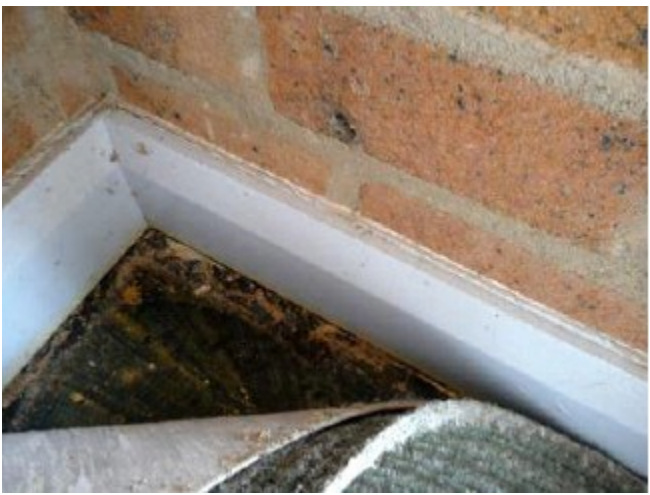
**Item 21 Ref: AN000954**

The adhesive below the lino in main reception entrance lobby does not contain asbestos.

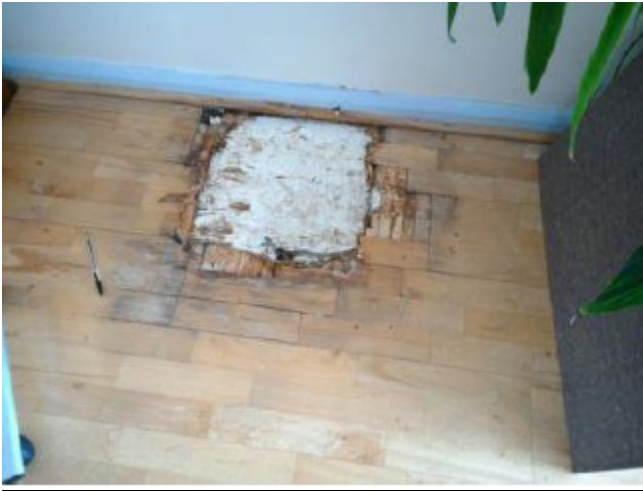
**Item 22 Ref: As AN000954**

The adhesive below the floor screed in main reception does not contain asbestos.

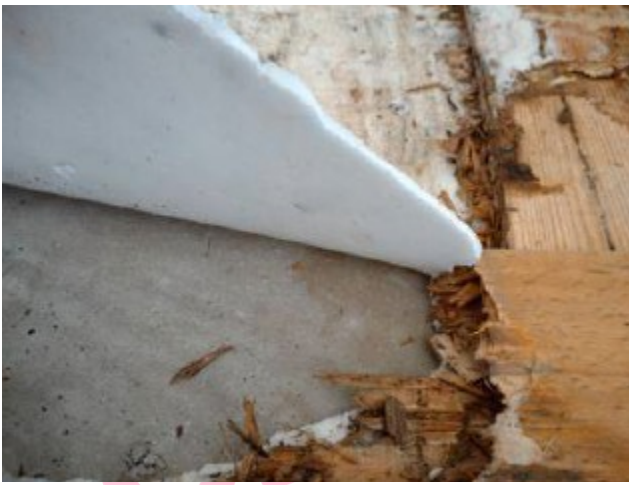
**Item 23 Ref: AN000955**

The screed beneath the wood flooring in main reception does not contain asbestos.

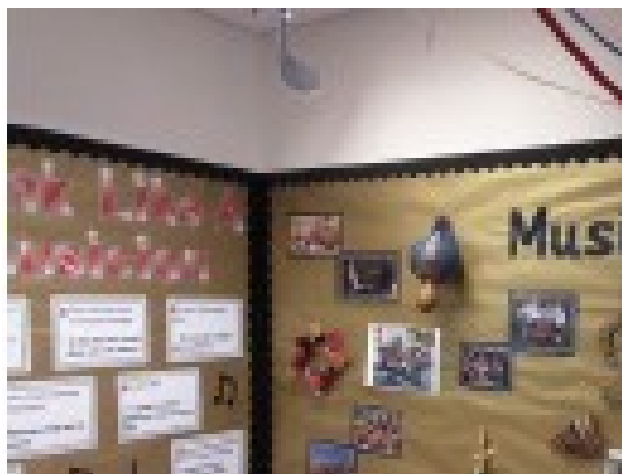
**Item 24 Ref: DP002540**

The core sample for the proposed new doorway in Room 0/030 does not contain asbestos.

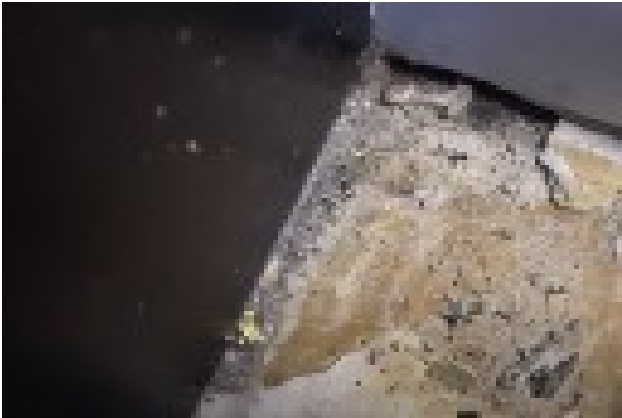
**Item 25 Ref: DP002543**

The bitumen screed below modern lino and modern screed in Room 0/36 does not contain asbestos.

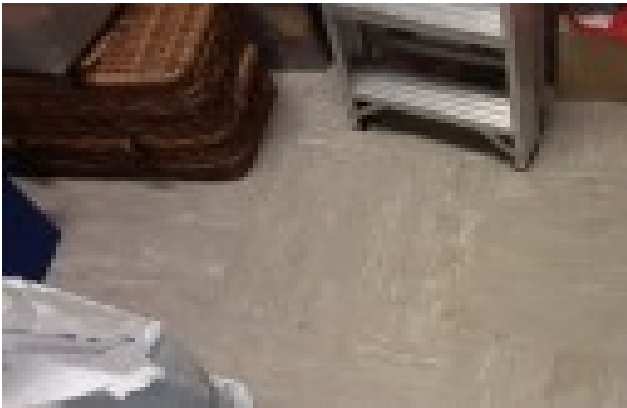
**Item 26 Ref: DP002542**

The vinyl floor tiles and adhesive in Room 0/36a does not contain asbestos.

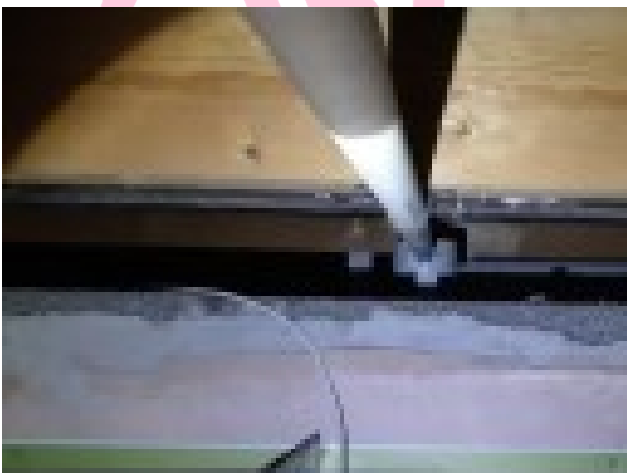
**Item 27 Ref: DP002537**

The core sample wall to toilet in Room 0/21 does not contain asbestos.

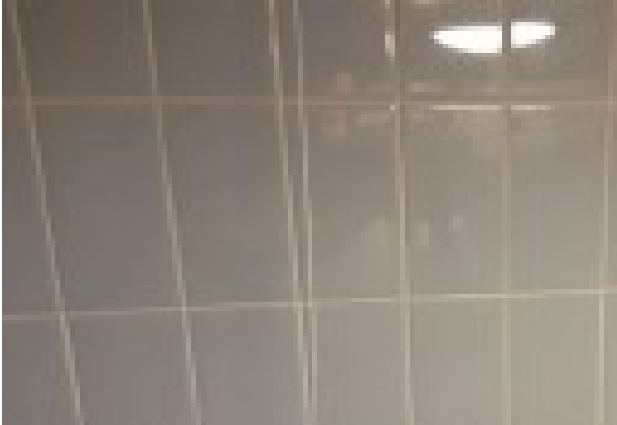
**Item 28 Ref: DP002538**

The grout to ceramic tiles (wall to interview room) in Room 0/21a does not contain asbestos.

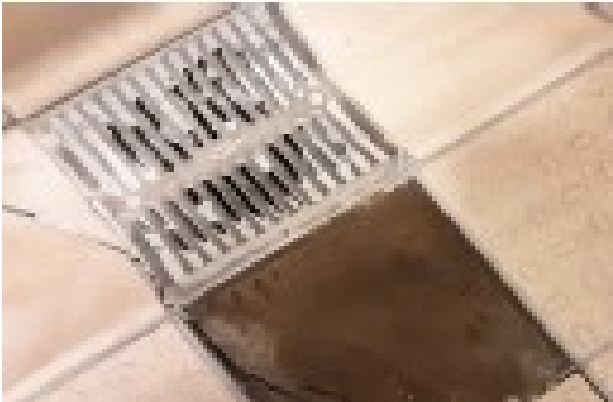
**Item 29 Ref: DP002539**

The screed below the quarry tiles in Room 0/21a does not contain asbestos.
