ASBESTOS SURVEY REPORT FOR BARNES INFANT ACADEMY, SUNDERLAND

Asbestos Register for

Barnes Infant Academy School

Date: 26 September 2024

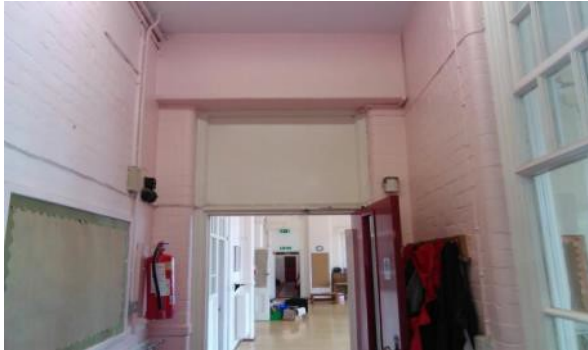
Item 1 Ref: 002

The door header panel in the corridor (Rm 008) contain asbestos.

Any change in its appearance should be recorded and passed to Property Services.

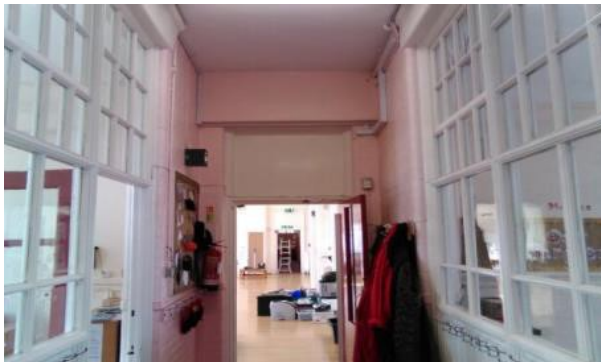
Item 2: As 002

The door header panel in the corridor (Rm 016) contain asbestos.

Any change in its appearance should be recorded and passed to Property Services.

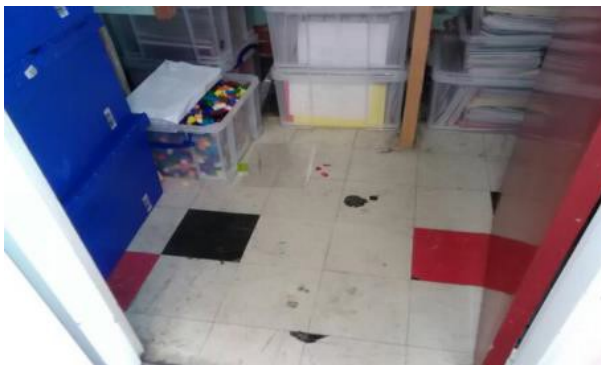
Item 3 Ref: 005

The floor adhesive in the store (Rm 022) contains asbestos.

Removed July 2019

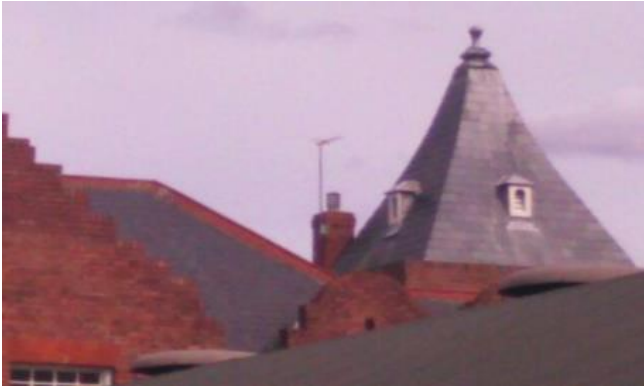
Item 4: Presumed

The cowl to the roof (External) due to height restrictions was unable to be sampled therefore it was presumed to contain asbestos.

This should be inspected from the ground only and any change in its appearance should be recorded and passed to Property Services.

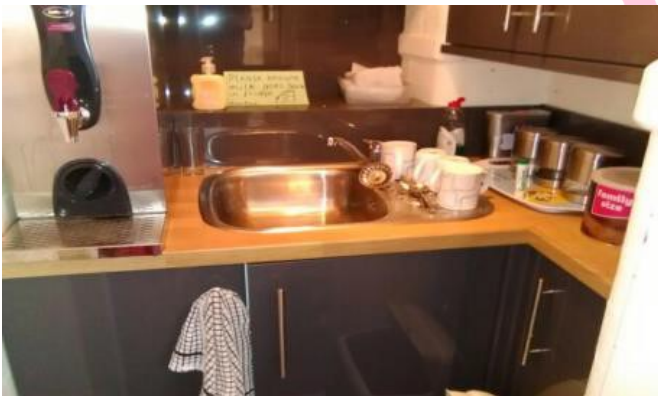
Item 5 Ref: 008

The sink pad to the kitchen (Rm 045) does not contain asbestos.

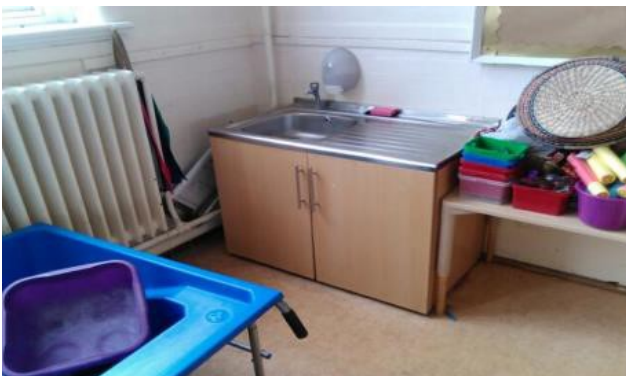
Item 6 Ref: 006

The sink pad to the classroom 8 (Rm 032) does not contain asbestos.

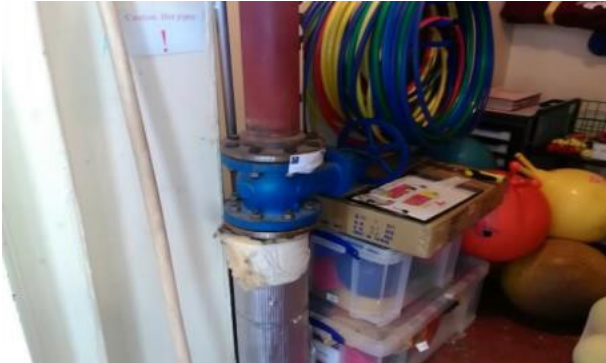
Item 7 Ref: 007

The gaskets to the store (Rm 035) does not contain asbestos.

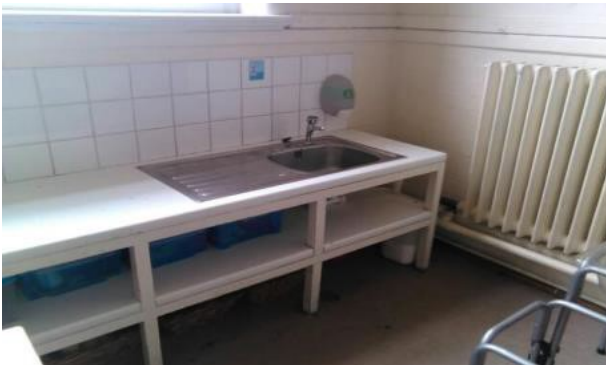
Item 8 Ref: 001

The sink pad to classroom 6 (Rm 006) does not contain asbestos.

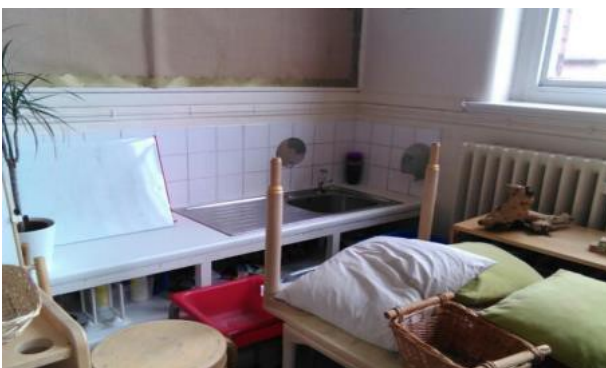
Item 9 Ref: As 001

The sink pad to classroom 5 (Rm 007) does not contain asbestos.

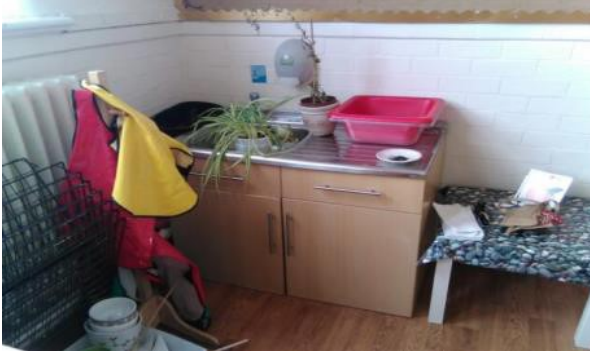
Item 10 Ref: 003

The sink pad to the classroom (Rm 014) does not contain asbestos.

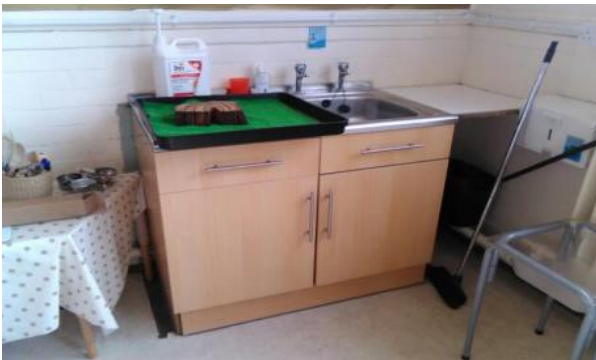
Item 11 Ref: As 003

The sink pad to classroom 3 (Rm 015) does not contain asbestos.

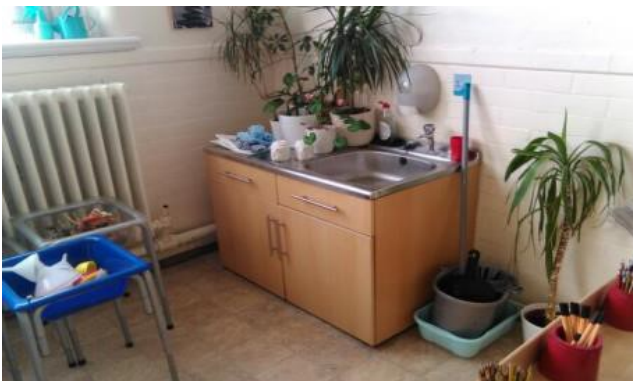
Item 12 Ref: As 003

The sink pad to classroom (Rm 017) does not contain asbestos.

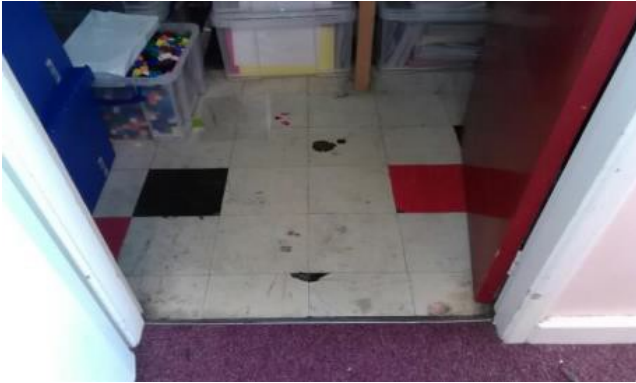
Item 13 Ref: 004

The floor tiles to the store (Rm 022) does not contain asbestos.
