ASBESTOS SURVEY REPORT FOR BARNES INFANT ACADEMY, SUNDERLAND

Asbestos Register for Barnes Infant Academy School

Date: 18 August 2025

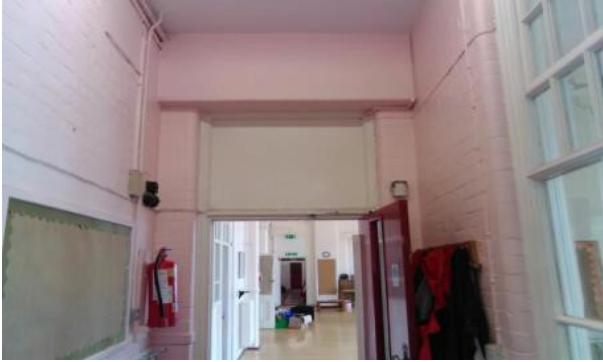
Item 1 Ref: 002

002 – Door Header Panel (Room 008) (Item 1) – Low Risk

The door header panel in the corridor (Rm 008) contain asbestos.

Any change in its appearance should be recorded and passed to Property Services.

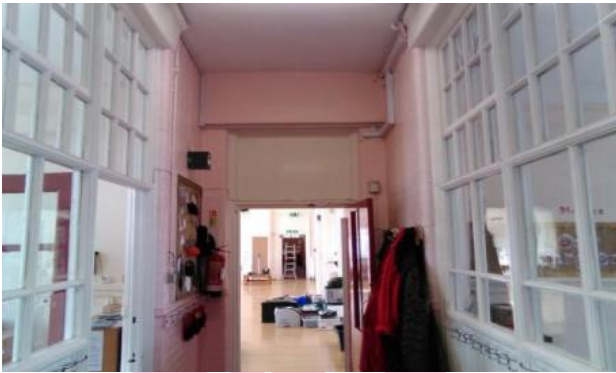
Item 2: As 002

As 002 – Door Header Panel (Room 016) (Item 2) – Low Risk

The door header panel in the corridor (Rm 016) contain asbestos.

Any change in its appearance should be recorded and passed to Property Services.

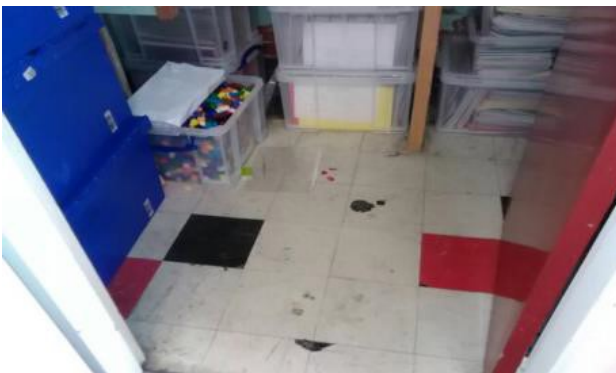
Item 3 Ref: 005

005 – Floor adhesive (Room 022) (Item 3) – Removed July 2019

The floor adhesive in the store (Rm 022) contains asbestos.

Removed July 2019

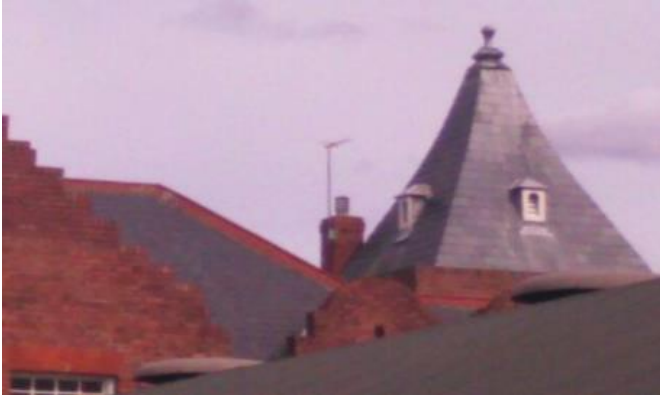
Item 4: Presumed

Presumed – Cowl (External) (Item 4) – Low Risk

The cowl to the roof (External) due to height restrictions was unable to be sampled therefore it was presumed to contain asbestos.

This should be inspected from the ground only and any change in its appearance should be recorded and passed to Property Services.

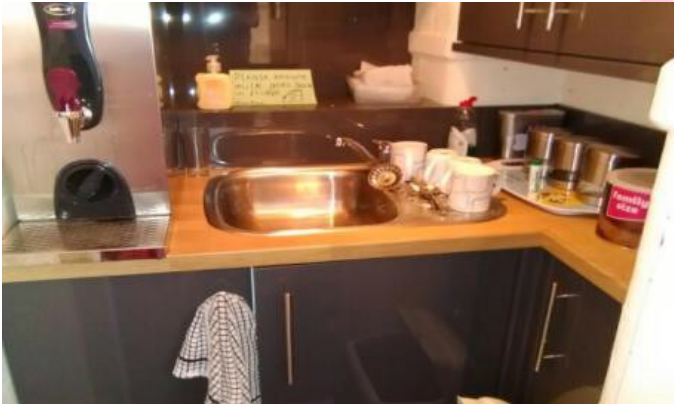
Item 5 Ref: 008

The sink pad to the kitchen (Rm 045) does not contain asbestos.

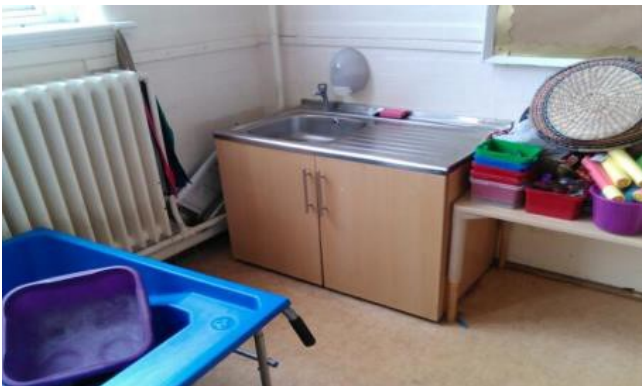
Item 6 Ref: 006

The sink pad to the classroom 8 (Rm 032) does not contain asbestos.

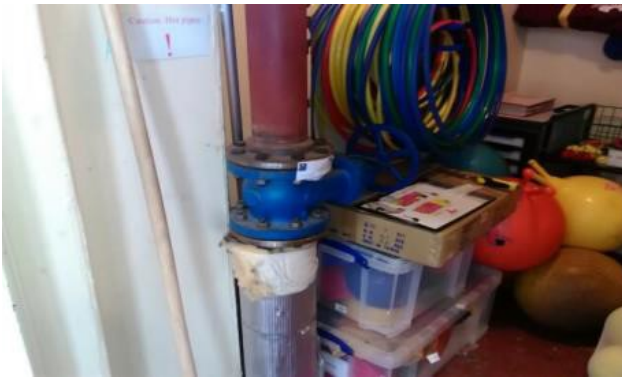
Item 7 Ref: 007

The gaskets to the store (Rm 035) does not contain asbestos.

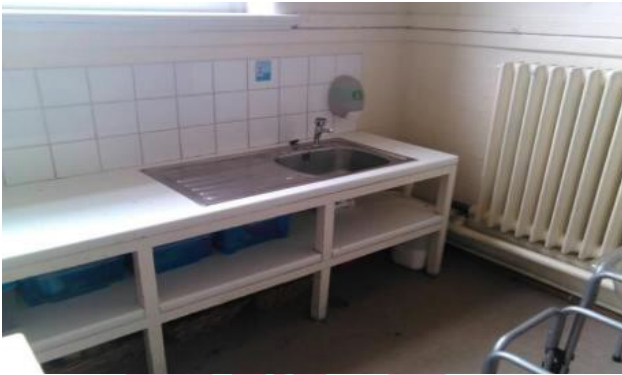
Item 8 Ref: 001

The sink pad to classroom 6 (Rm 006) does not contain asbestos.

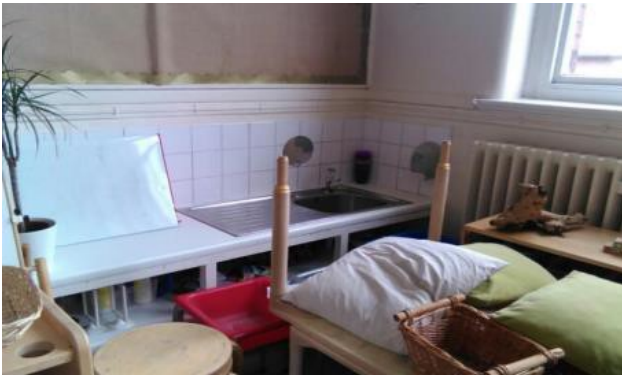
Item 9 Ref: As 001

The sink pad to classroom 5 (Rm 007) does not contain asbestos.

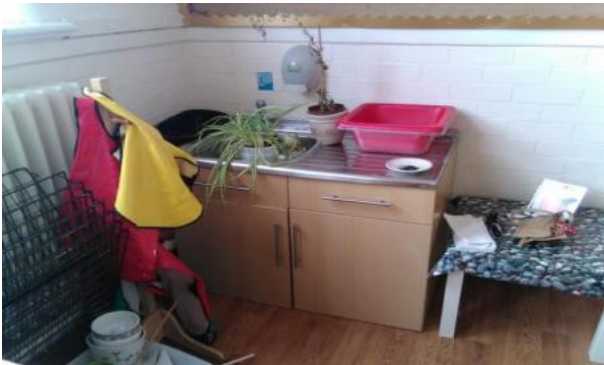
Item 10 Ref: 003

The sink pad to the classroom (Rm 014) does not contain asbestos.

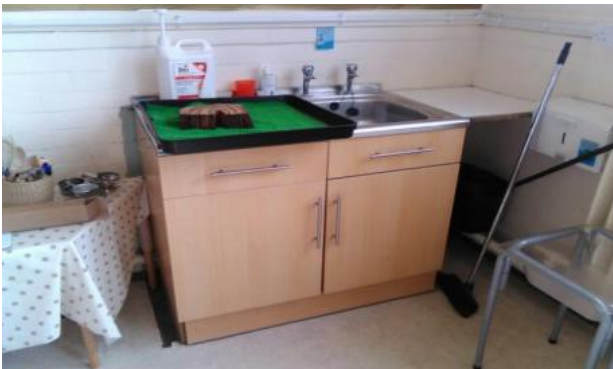
Item 11 Ref: As 003

The sink pad to classroom 3 (Rm 015) does not contain asbestos.

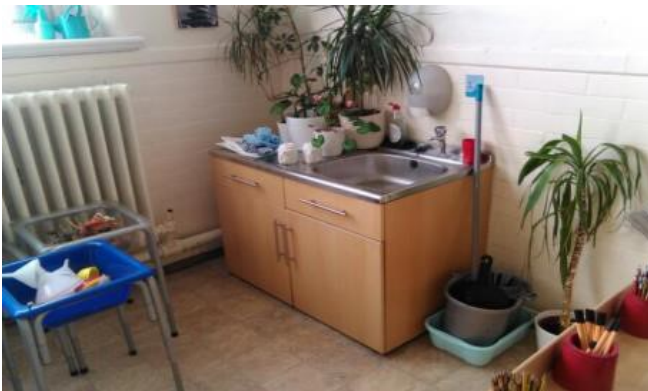
Item 12 Ref: As 003

The sink pad to classroom (Rm 017) does not contain asbestos.

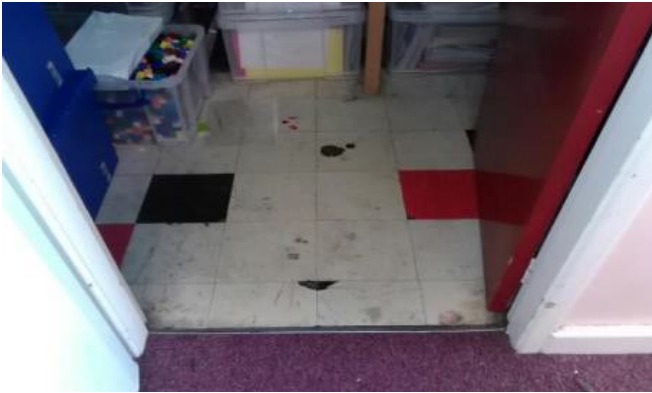
Item 13 Ref: 004

The floor tiles to the store (Rm 022) does not contain asbestos.
