### **ASBESTOS SURVEY REPORT FOR BENEDICT BISCOP, SUNDERLAND**

## **Asbestos Register for BENEDICT BISCOP, SUNDERLAND**

**Date: 11 August 2025**

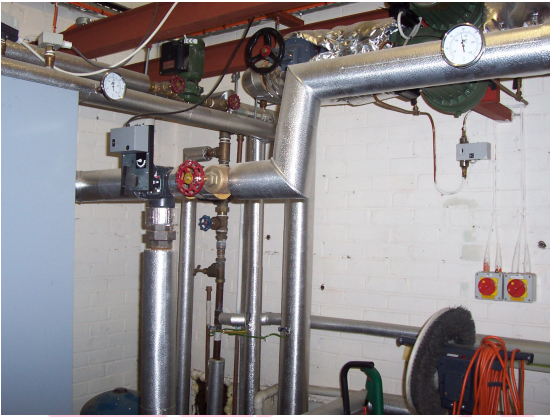
#### **Item 5 - Ref:NO06/07**

The pipe lagging in the boiler house does not contain asbestos.

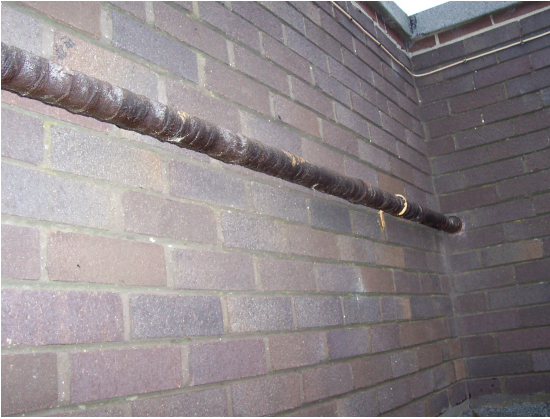
#### **Item 7 - Ref: N006/09**

The pipe insulation above the felt roof in the cleaner's store does not contain asbestos.

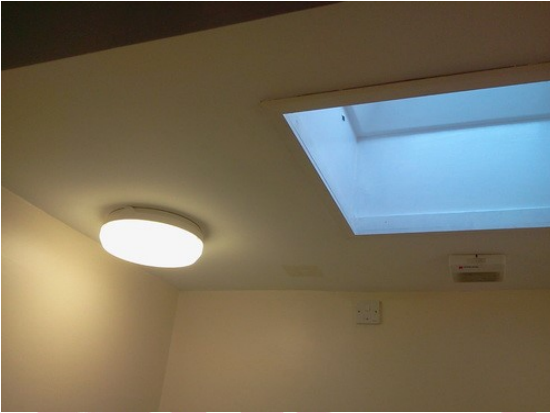
#### **Item 15 - Ref: 43039-1**

The fixed ceiling in the Disabled WC (Rm 0/003) does not contain asbestos.

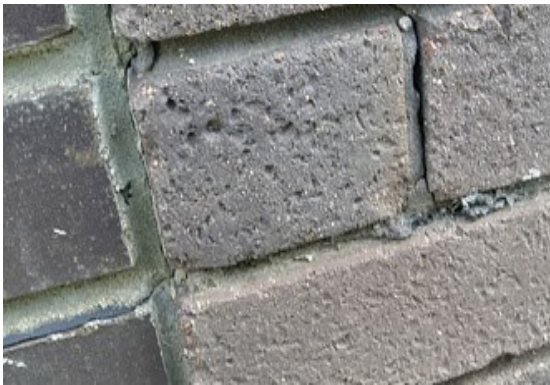
**Item 18 - Ref: 87662-1**

The damp proof course (External) does not contain asbestos.

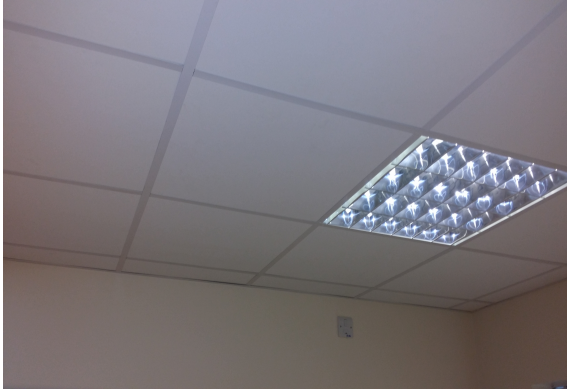
#### **Items 23 - Ref: 117404-2**

The suspended ceiling in Meeting Room (0/001) does not contain asbestos.

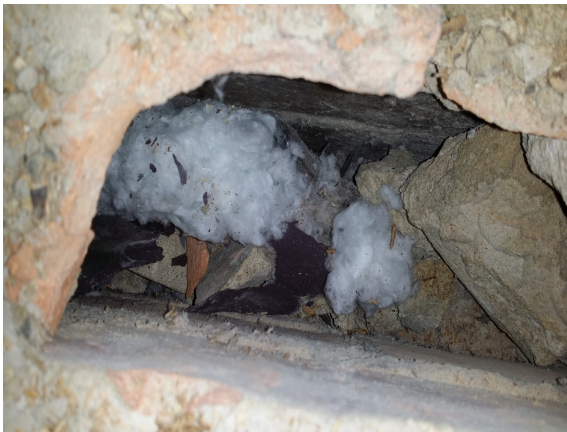
#### **Items 24 - Ref: 117404-3**

The cavity insulation in Meeting Room (0/001) does not contain asbestos.

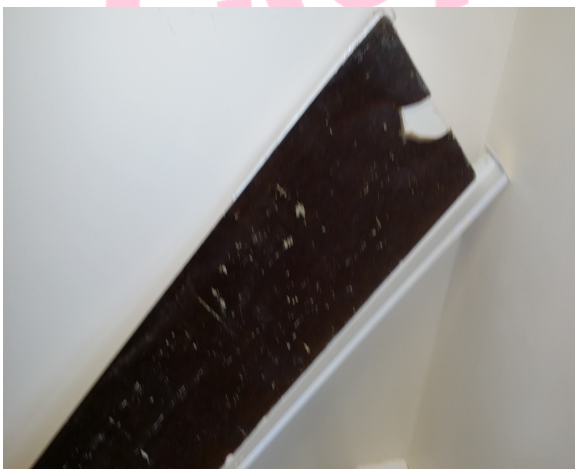
#### **Items 25 - Ref: 117404-4**

The lining to wood cill in Meeting Room (0/001) does not contain asbestos.

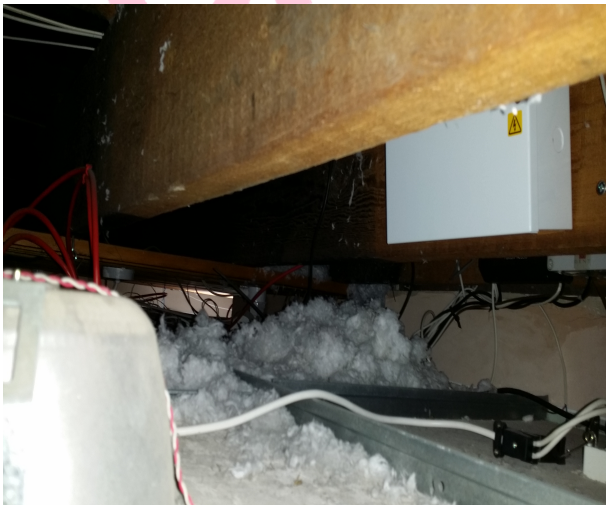
#### **Items 28-Ref:As117404-3**

The insulation in Reception Lobby ceiling void (0/003) does not contain asbestos.

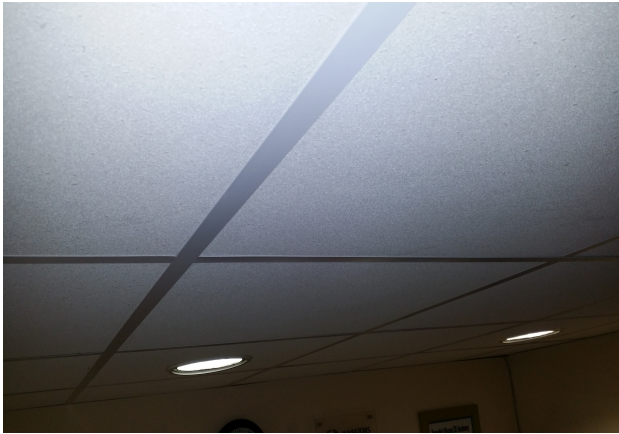
#### **Items 29-Ref:As117404-2**

The suspended ceiling in Reception Lobby (0/003) does not contain asbestos.

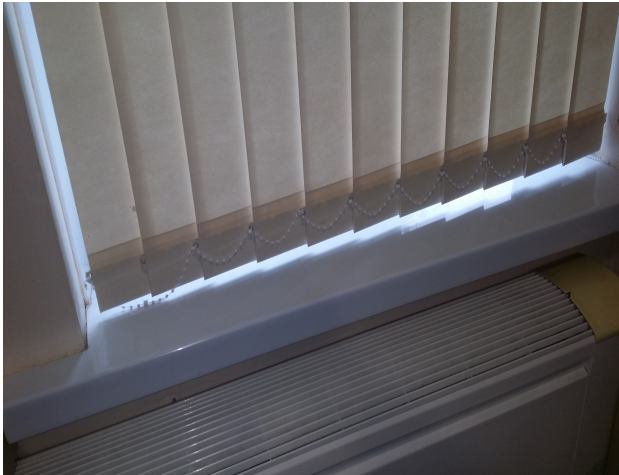
#### **Items 30-Ref:As117404-4**

The panel to original cill in Reception Lobby (0/003) does not contain asbestos.

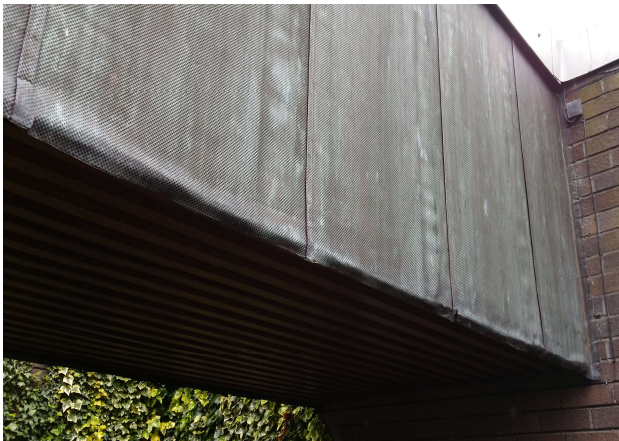
#### **Items 31-Ref:As117404-1**

The underside of roof canopy (External) does not contain asbestos.

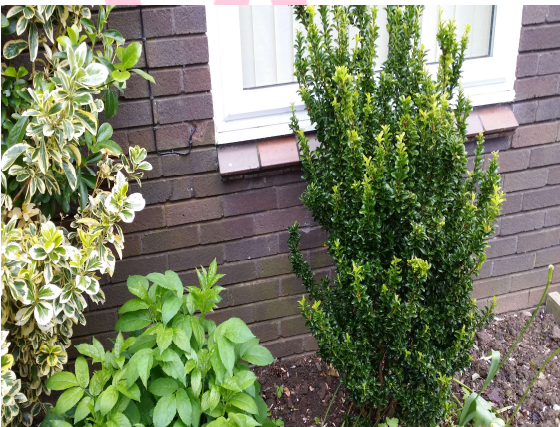
**Items 34-Ref:As117404-3**

The insulation to wall cavity  
(External) does not contain  
asbestos.

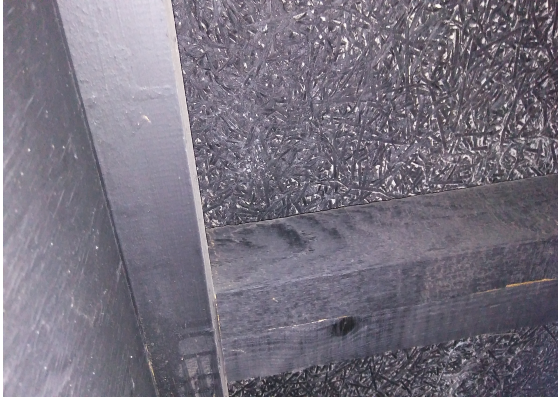
#### **Items 35 - Ref: 376631-5**

The underside of roof in Classroom (Rm 006) void above suspended ceiling does not contain asbestos.

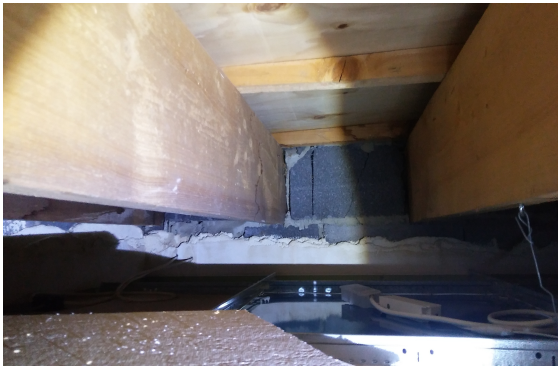
#### **Items 36 - Ref: 376631-1**

The remnant roof covering adhesive in classroom (Rm 007) void above suspended ceiling does not contain asbestos.

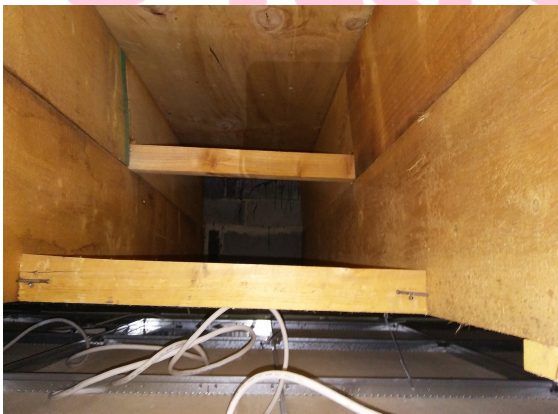
#### **Items 37 - Ref: As 376631-1**

The remnant roof covering adhesive in classroom (Rm 012) void above suspended ceiling does not contain asbestos.

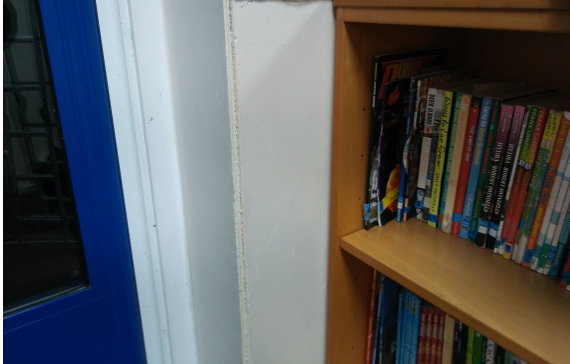
#### **Items 38 - Ref: 376631-4**

The cladding to wall in the corridor (Rm 013) does not contain asbestos.

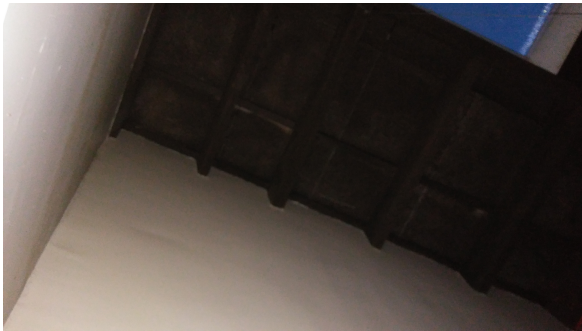
#### **Items 39 - Ref: As 376631-5**

The underside of roof in the corridor (Rm 013) void above suspended ceiling does not contain asbestos.

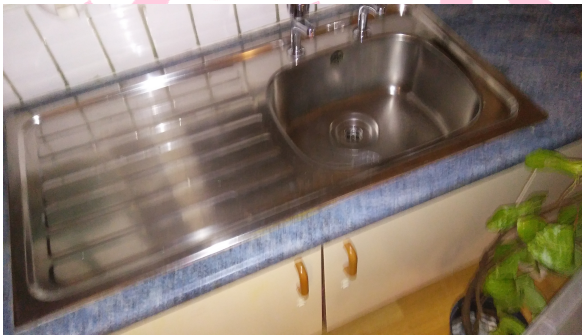
#### **Items 40 - Ref: 376631-6**

The acoustic sink pad in the nursery (Rm 014) does not contain asbestos.

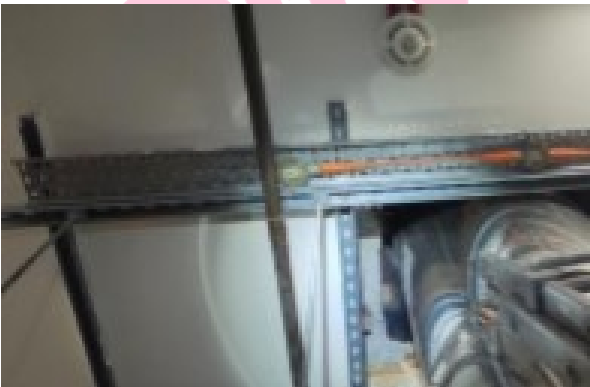
#### **Items 43 - Ref: 21-30788-1**

The ceiling in Area 1/Plant Room does not contain asbestos.

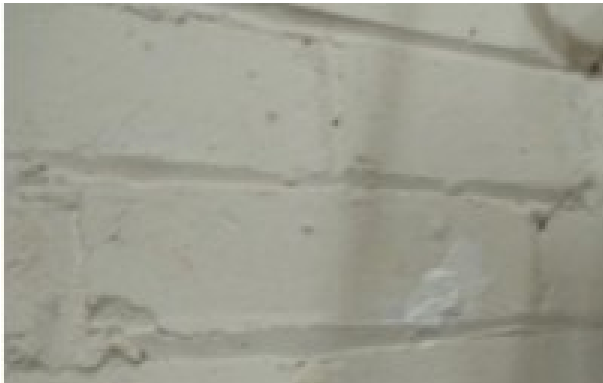
#### **Items 44 - Ref: 21-30788-2**

The residue to the walls in Area 1/Plant Room does not contain asbestos.

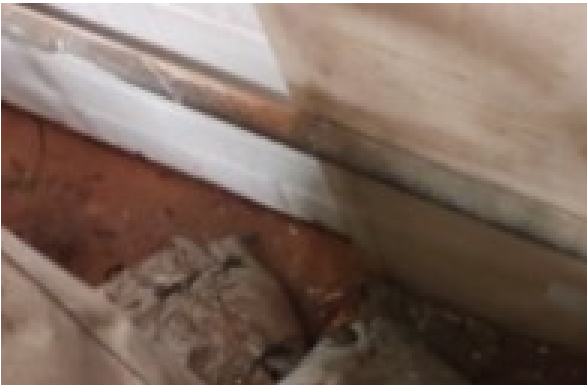
#### **Items 45 - Ref: 21-30788-3**

The debris to floor in Area 1/Plant Room does not contain asbestos.

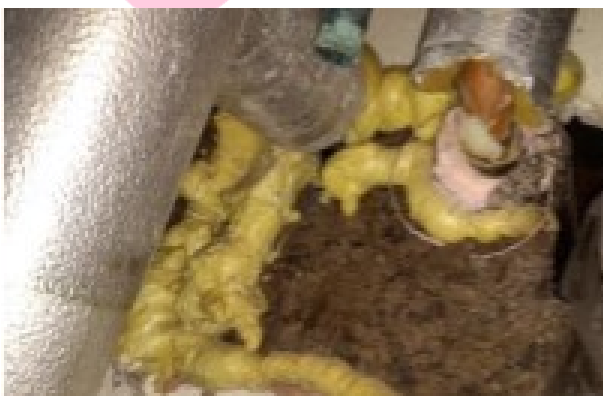
#### **Items 46 - Ref: 21-30788-4**

The pipes small bore penetration wall void in Area 1/Plant Room does not contain asbestos.

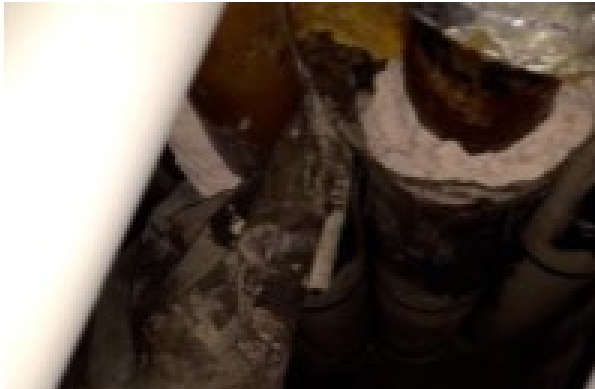
#### **Items 47 - Ref: 21-30788-5**

The pipes medium bore penetration wall in Area 1/Plant Room does not contain asbestos.

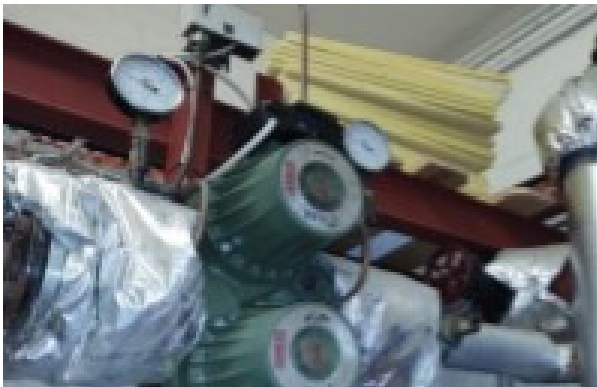
#### **Items 48 - Ref: Presumed**

*Presumed – Gaskets (Area 1/Plant Room) (Item 48) – Removed by Building Maintenance no paperwork supplied*

The gaskets in Area 1/Plant Room contain asbestos.

*Removed by Building Maintenance no paperwork supplied*

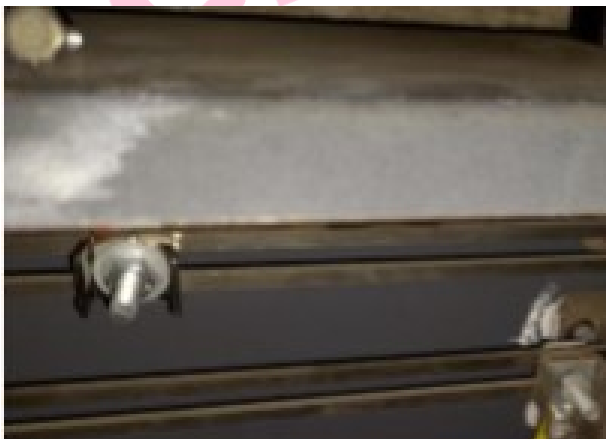
#### **Items 49 - Ref: 21-30854-1**

*21-30854-1 – Insulators to electrical box (Area 2/Electrical Switch Room) (Item 49) – Low Risk*

The insulators to electrical box in Area 2/Electrical Switch room does contain asbestos.

Any change in appearance should be reported to Property Services.

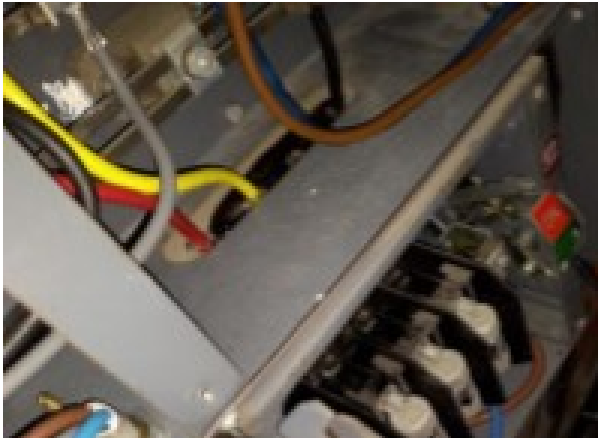
#### **Items 50 - Ref: Presumed**

*Presumed – Barrel fuses (Area 2/Electrical Switch Room) (Item 50) – Low Risk*

The barrel fuses in Area 2/Electrical Switch room does contain asbestos.

Any change in appearance should be reported to Property Services.
