*Control of Asbestos  
Regulations 2012*

**Asbestos Register for  
Bernard Gilpin Primary**

**UPRN: - 2904099**

**Date: 21 February 2023**

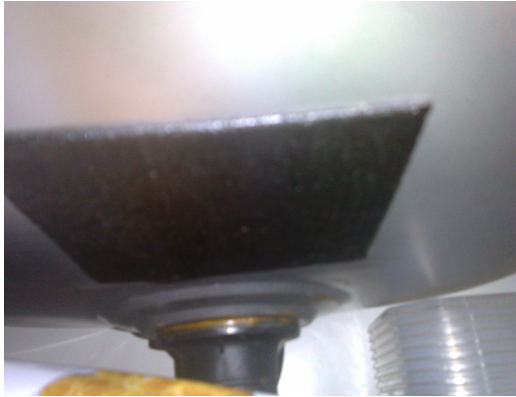
### **Item 1 Ref: DB09/3011**

The sink pad in Reception Kitchen 3 does not contain asbestos

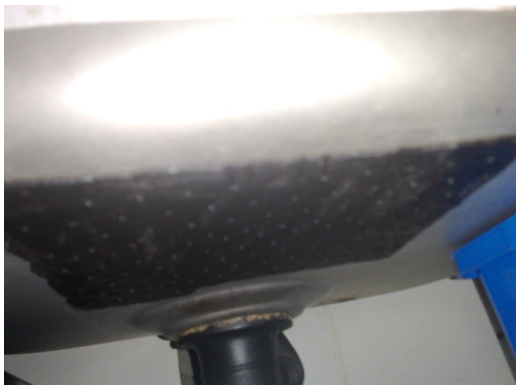
### **Item 2 - Ref: DB09/3012**

The sink pad in Classroom Lobby 5 does not contain asbestos.

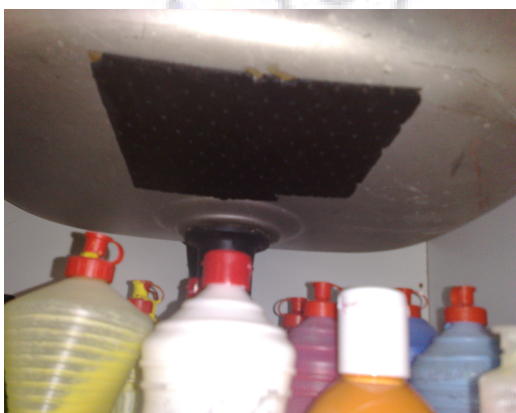
### **Item 3 - Ref: DB09/3013**

The sink pad in Classroom Lobby 15 does not contain asbestos.

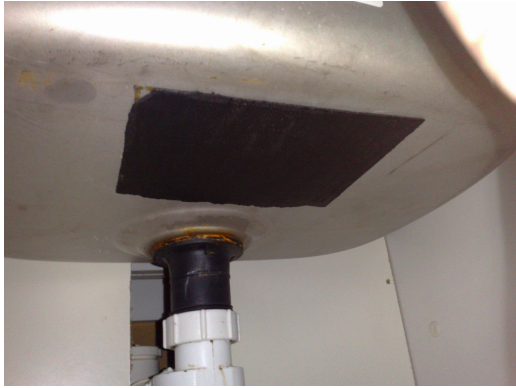
**Item 4 - Ref: DB09/3014**

The sink pad in Classroom Lobby 28 does not contain asbestos

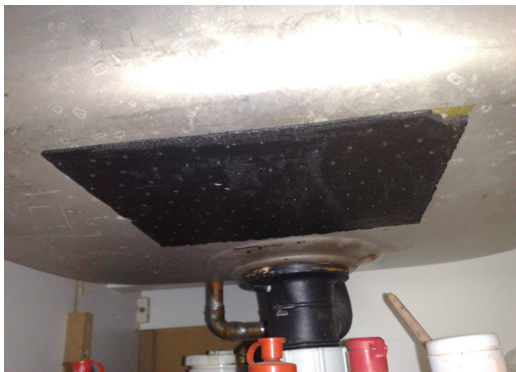
**Item 5 - Ref: DB09/3015**

The sink pad in Classroom Lobby 37 does not contain asbestos.

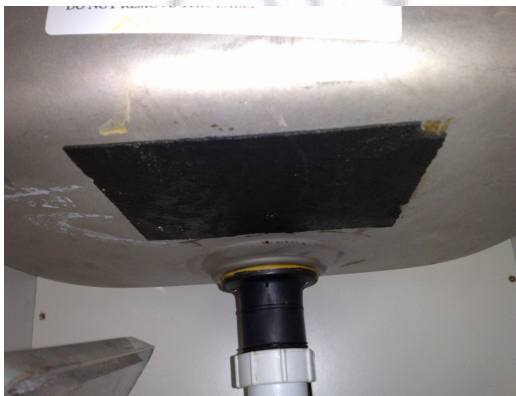
**Item 6 - Ref: BB09/3016**

The sink pad in Classroom Lobby 46 does not contain asbestos.

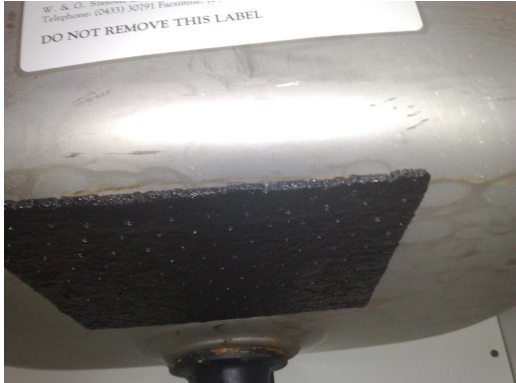
**Item 7 - Ref: DB09/3017**

The sink pad in Staffroom Kitchen 63 does not contain asbestos.

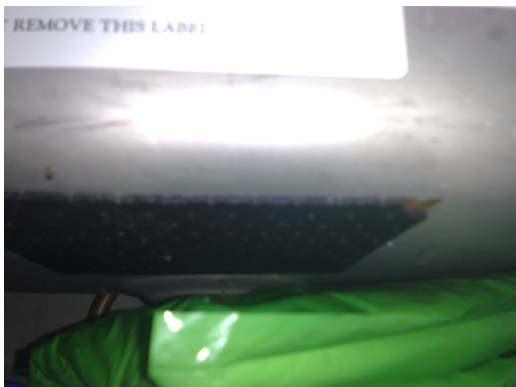
**Item 8 - Ref: Sample 08**

The sink Pad in Kitchen 66 does not contain asbestos.

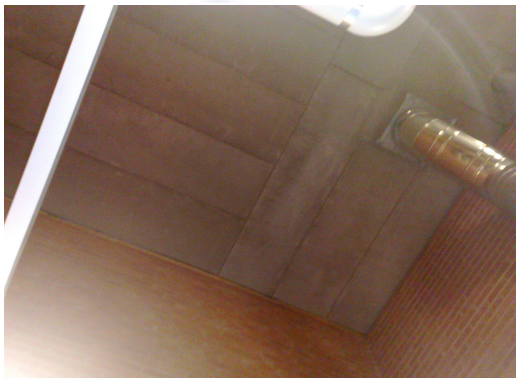
**Item 9 - Ref: DB09/3019**

The ceiling Panels in the Boiler House 76 do not contain asbestos.

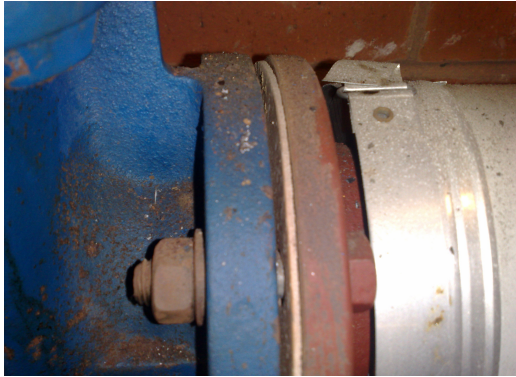
**Item 10 - Ref: DB09/3020**

The pipe gaskets in Boiler House (Room 76) contained asbestos.

*This was removed during boiler refurbishment in Summer 2014.*

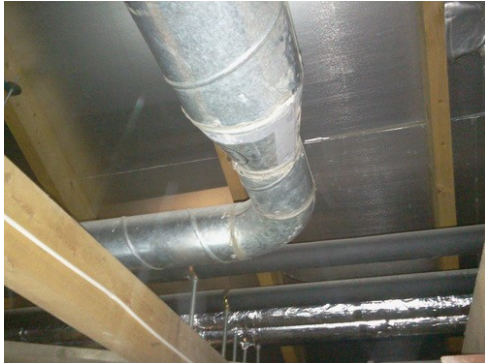
**Item 13 - Ref: 52897-1**

The Sealant to joints in metal duckwork in room 017/boys WC (void above suspended ceiling) does not contain asbestos.

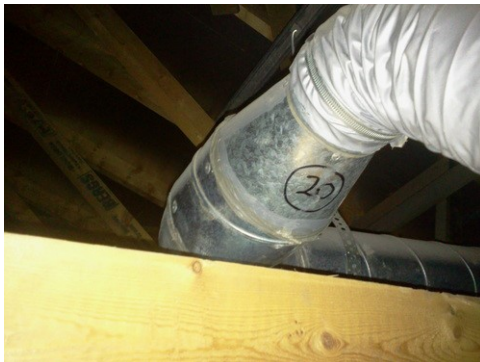
**Item 14 - Ref: As 52897-1**

The Sealant to joints in metal duckwork in room 023/girls WC (void above suspended ceiling) does not contain asbestos.

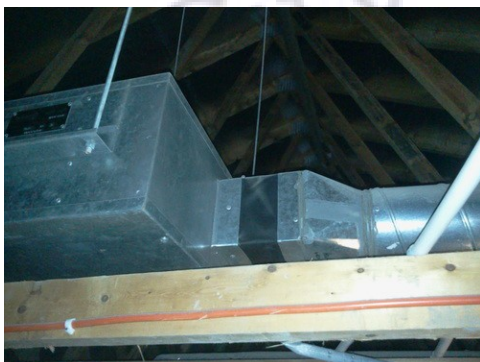
**Item 15 - Ref: As 52897-1**

The Sealant to joints in metal duckwork in room 024/corridor and lobby (void above suspended ceiling) does not contain asbestos.

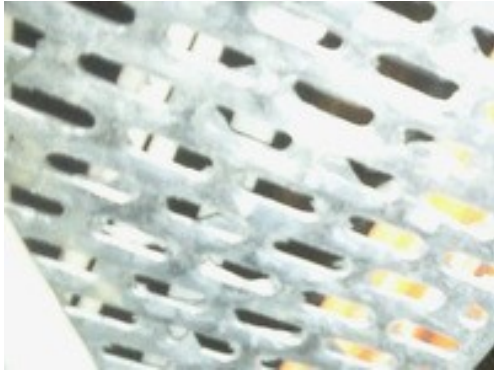
### **Item 16 - Ref: As 52897-1**

The Sealant to joints in metal duckwork in room 027/ practical classroom (void above suspended ceiling) does not contain asbestos.

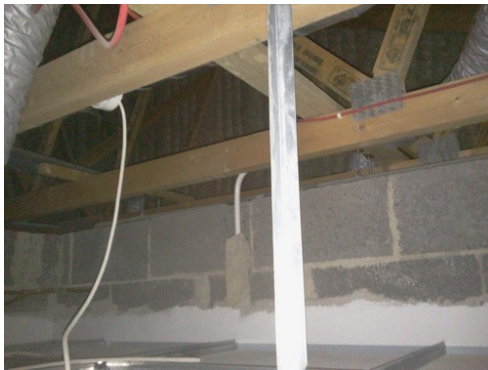
### **Item 17 - Ref: As 52897-1**

The Sealant to joints in metal duckwork in room 032/ caretakers store (void above suspended ceiling) does not contain asbestos.

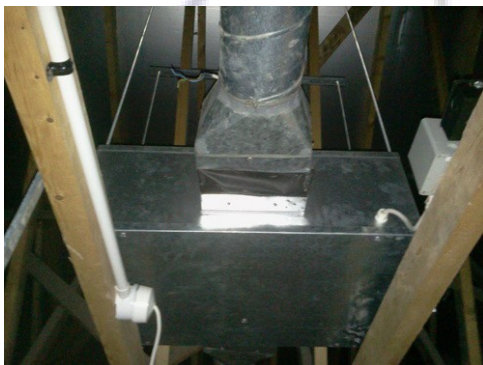
### **Item 18 - Ref: As 52897-1**

The Sealant to joints in metal duckwork in room 034/boys WC (void above suspended ceiling) does not contain asbestos.

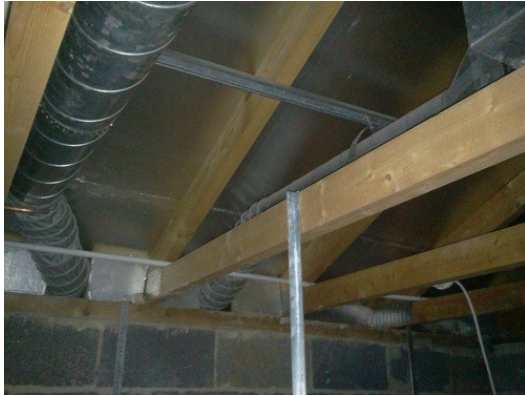
**Item 19 - Ref: As 52897-1**

The Sealant to joints in metal duckwork in room 035/girls WC (void above suspended ceiling) does not contain asbestos.

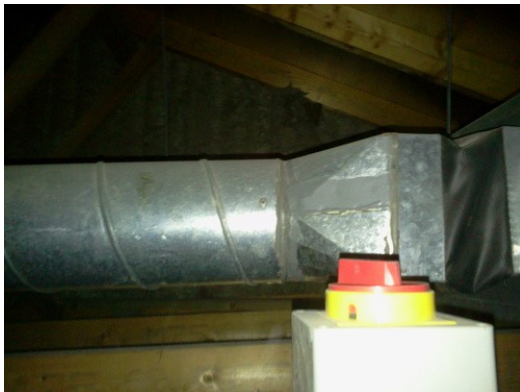
**Item 20 - Ref: As 52897-1**

The Sealant to joints in metal duckwork in room 047/girls WC (void above suspended ceiling) does not contain asbestos.

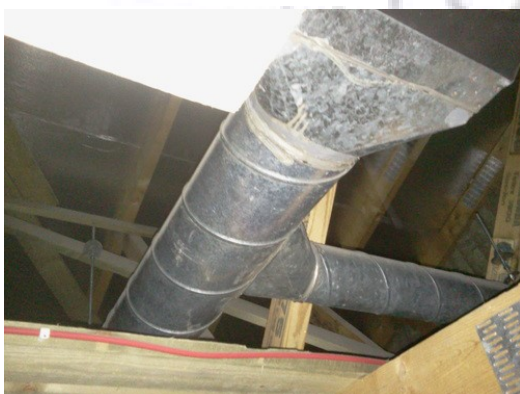
**Item 21 - Ref: As 52897-1**

The Sealant to joints in metal duckwork in room 048/boys WC (void above suspended ceiling) does not contain asbestos.

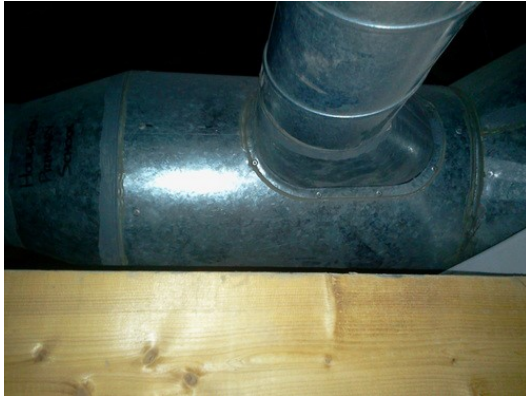
### **Item 22 - Ref: As 52897-1**

The Sealant to joints in metal duckwork in room 055/ classroom 1 (void above suspended ceiling) does not contain asbestos.

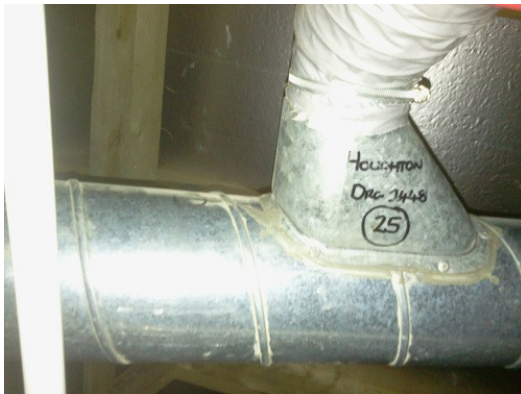
### **Item 23 - Ref: As 52897-1**

The Sealant to joints in metal duckwork in room 061/boys changing and lobby (void above suspended ceiling) does not contain asbestos.

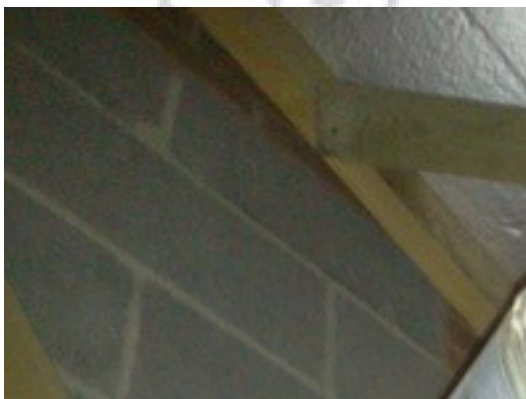
### **Item 24 - Ref: As 52897-1**

The Sealant to joints in metal duckwork in room 063/girls changing WC (void above suspended ceiling) does not contain asbestos.

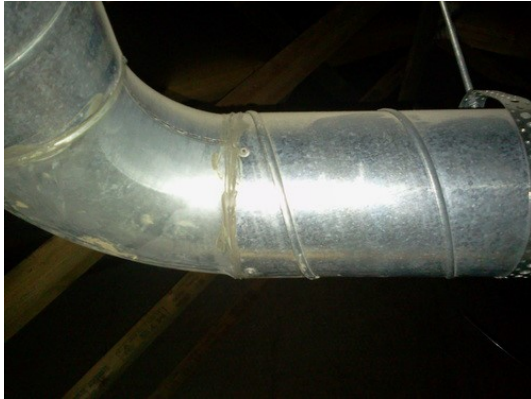
**Item 25 - Ref: As 52897-1**

The Sealant to joints in metal duckwork in room 064/girls changing and lobby (void above suspended ceiling) does not contain asbestos.

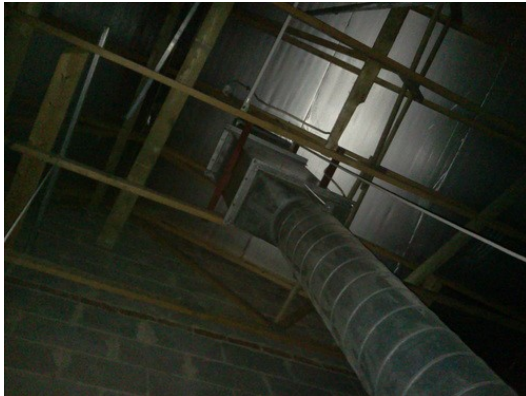
**Item 26 - Ref: As 52897-1**

The Sealant to joints in metal duckwork in room 068/servery (void above suspended ceiling) does not contain asbestos.

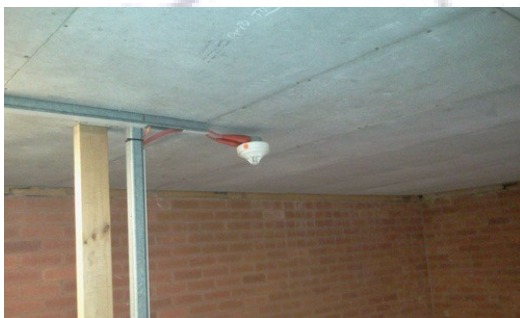
**Item 27 - Ref: 50830-1**

The ceiling in room 01/Boiler room including the mezzanine floor does not contain asbestos.

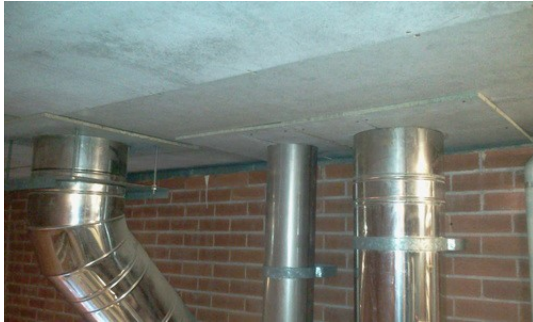
**Item 28 - Ref: As 50830-1**

The panels to boiler flue ceiling penetrations in room 01/Boiler room including the mezzanine floor does not contain asbestos.

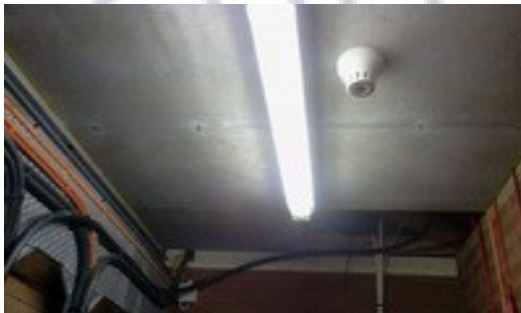
**Item 30 - Ref: As 50830-1**

The ceiling in room 02/ electrical intake room does not contain asbestos.

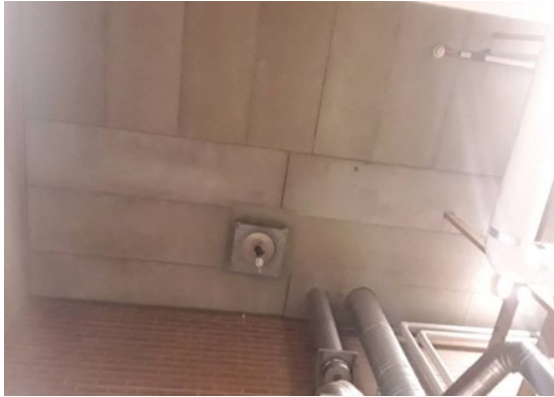
**Item 31 - Ref: NZ000134**

The ceiling in Room 01/Boiler room does not contain asbestos.

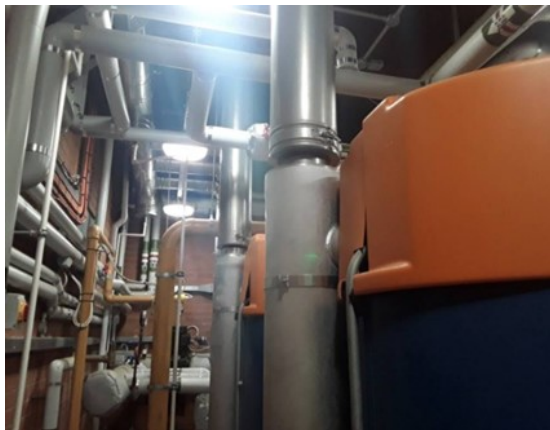
**Item 32 - Ref: NZ000135**

The flue pipe red mastic to joints in room 01/Boiler room does not contain asbestos.
