ASBESTOS SURVEY REPORT FOR CASTLETOWN PRIMARY SCHOOL

Asbestos Register for CASTLETOWN PRIMARY SCHOOL

Date: 12 December 2023

Castletown Primary - Last updated 12/12/2023 – Version 2

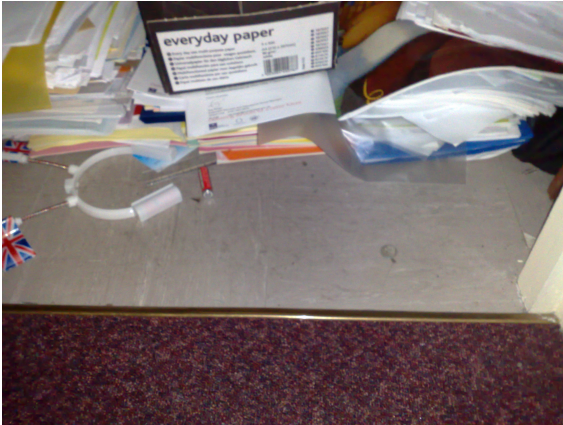
Various Ref: CS09/237

The vinyl flooring to the Heads room does not contain asbestos.

Similar vinyl flooring is located in:

Staff Rm, Repro Rm, Base 11/12, Base 13/14, CT Office, Base 7/8, Base 9/10, Base 3/4, Base 3/4 Stores, Base 5/6 Stores, Toy Store, Library Store, Cleaners Cupbd, Servery Staff Wc, Dep Ht Stores, Cleaners Store, Equipment Store, Reception Store, Base 2 Store, Secure Store 1 and Cleaners Equip Store.

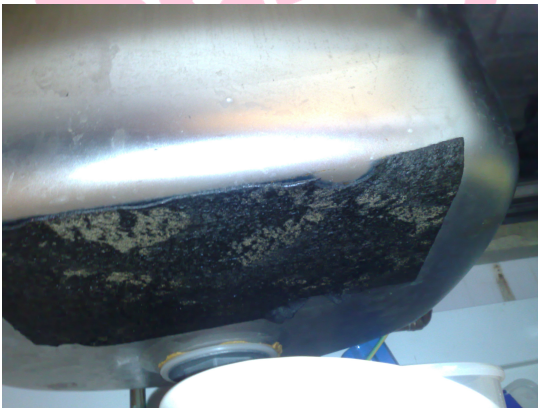
Various - Ref: CS09/238

The sink pad in the staff room does not contain asbestos.

Similar sink pads are located in;

Repro Rm, Base 11/12, Base 13/14, Base 7/8, Base 9/10, Base 5/6, Base 1/2 Prac, Nursery Playroom, Kitchen and Tea Room.

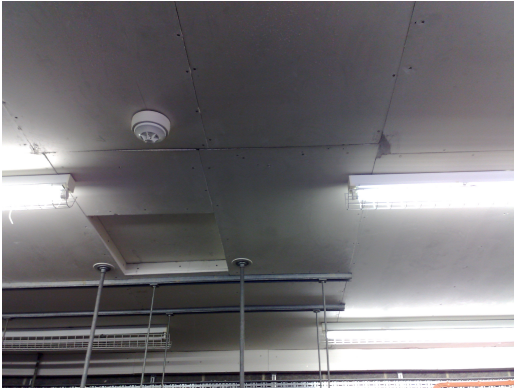
Various - Ref: CS09/239

The ceiling panels in the boiler room do not contain asbestos.

Similar ceilings are located in the electric room and Gas Room.

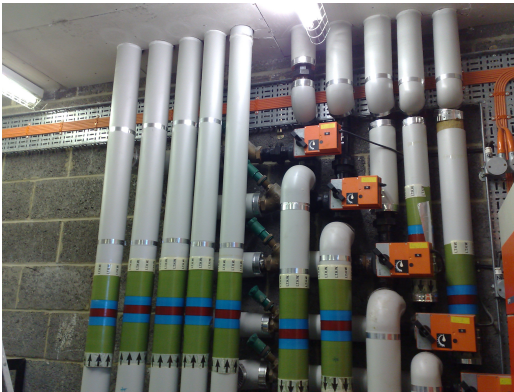
Item 29 - Ref: CS09/240

The pipe insulation to the boiler room does not contain asbestos.

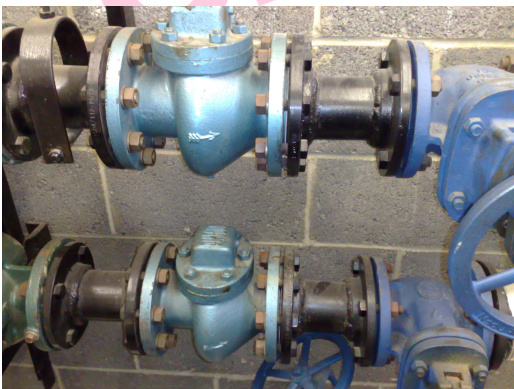
Item 30 - Ref: CS09/241

The gaskets throughout the Boiler Room contained asbestos.

These were removed in August 2015.

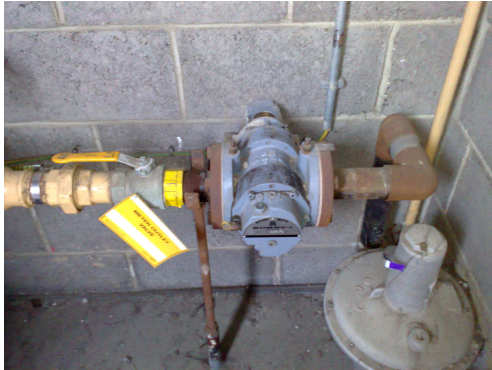
Item 33- Ref: CS09/242

The gaskets throughout the Gas Room contain asbestos.

Item 33	Gaskets to Gas Room	Very Low	12 monthly	03.02.24
<i>Item 34</i>	<i>No asbestos</i>	<i>Is present</i>		
<i>Item 35</i>	<i>No asbestos</i>	<i>Is present</i>

Any change in their appearance should be recorded and passed to Property Services.

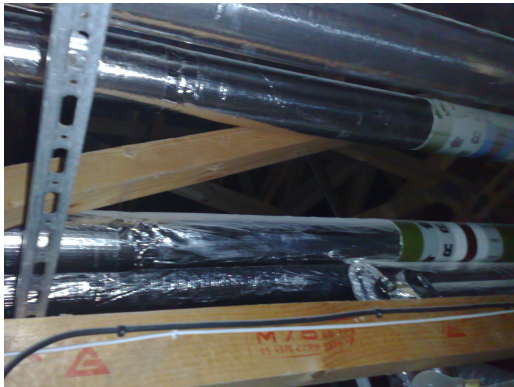
Item 36- Ref: CS09/243

The pipe insulation to the loft space does not contain asbestos.

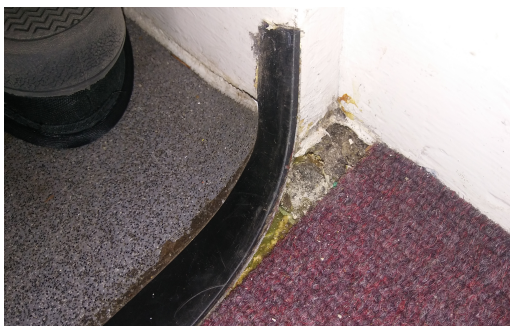
Item 41- Ref: As 343959-1

The scree to the floor in Year 5 Classroom does not contain asbestos.

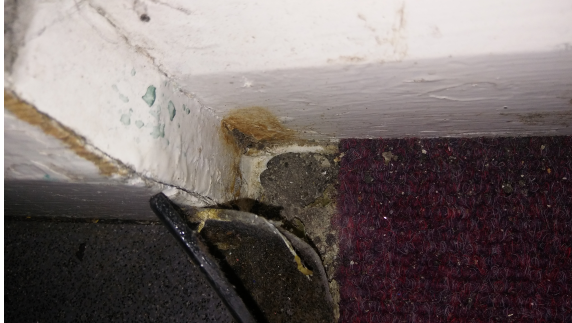
Item 42- Ref: 343959-1

The screed to the floor in Year 6 Classroom does not contain asbestos.

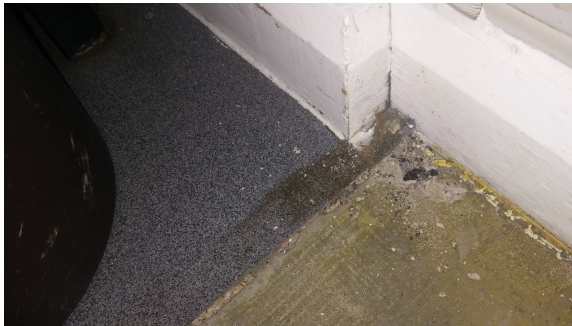
Item 43- Ref: 343959-1

The screed to the floor in Year 3 Classroom does not contain asbestos.

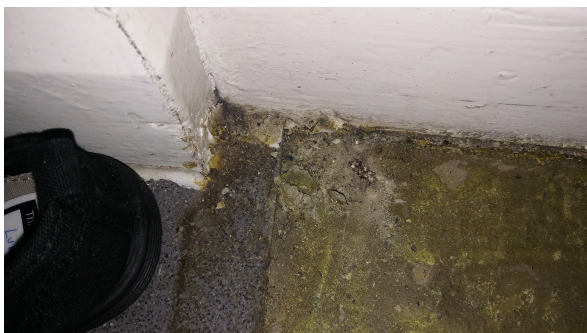
Item 44- Ref: 343959-1

The screed to the floor in Year 4 Classroom does not contain asbestos.

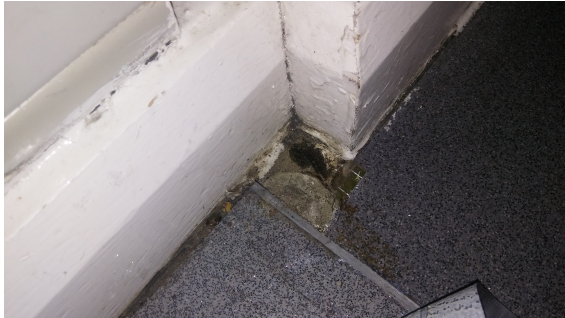
Item 45- Ref: 343959-1

The screed to the floor in Year 1 Classroom does not contain asbestos.

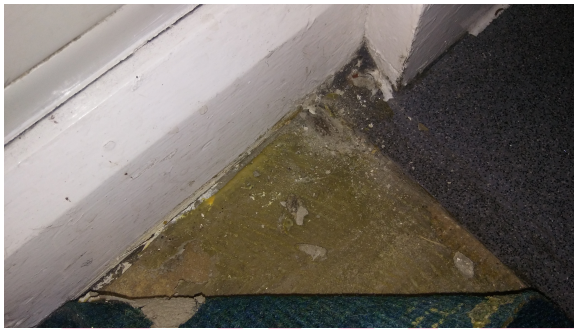
Item 46- Ref: 343959-1

The screed to the floor in Year 2 Classroom does not contain asbestos.

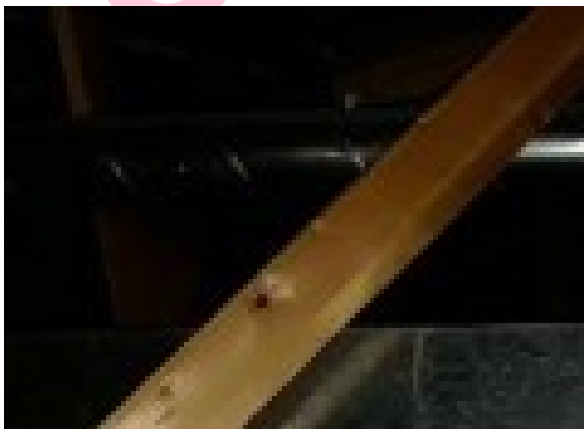
Item 47- Ref: 21-33433-1

The vessels – ducting inside ceiling void (Mastic) in the ceiling void above Boys Changing Rooms and Classroom does not contain asbestos.
