ASBESTOS SURVEY REPORT FOR EAST HERRINGTON ACADEMY, SUNDERLAND

EAST HERRINGTON ACADEMY, SUNDERLAND

Date: 09 September 2024

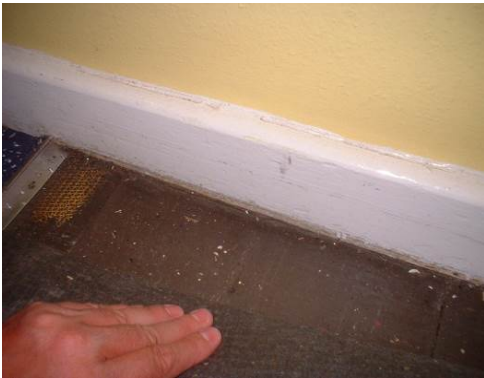
Item 2 - Ref: Sample 02

The vinyl flooring to the infant school corridor (Room 0/04) contains asbestos.

Any change in its appearance should be recorded and passed to Property Services.

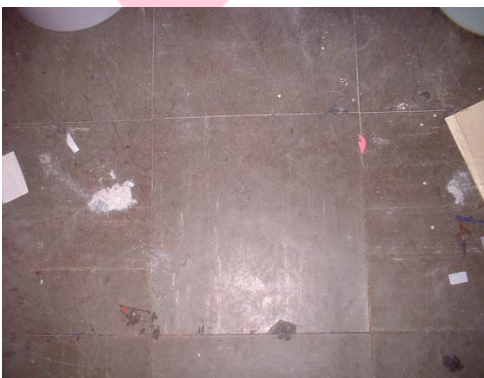
Item 3- As Sample 02

The floor covering to the infant school store room (Room 0/11) contains asbestos.

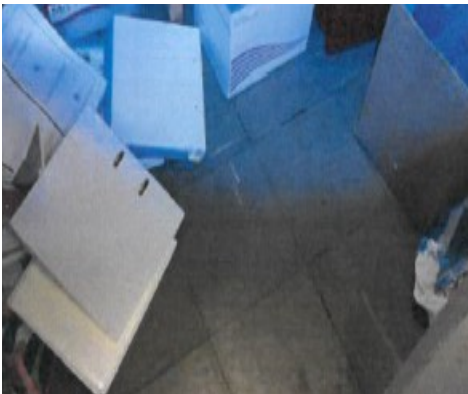
Item 7 – As Sample 08 & AQ000124

The floor covering (vinyl tiles & adhesive) (Room 0/11 Y2 classroom stationary cupboard) contains asbestos.

Any change in its appearance should be recorded and passed to Property Services.

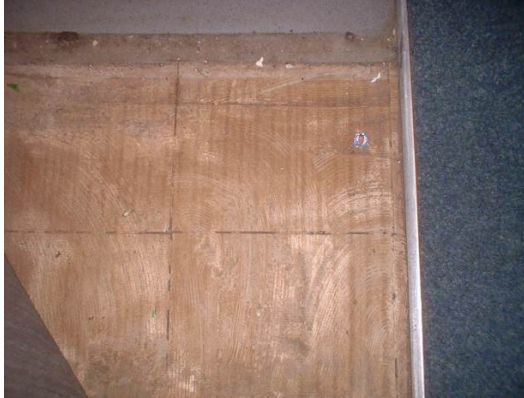
Item 9 - Ref: Sample 10

The vinyl flooring in the infant school cloak room/toilets classroom (Room 0/16) does not contain asbestos.

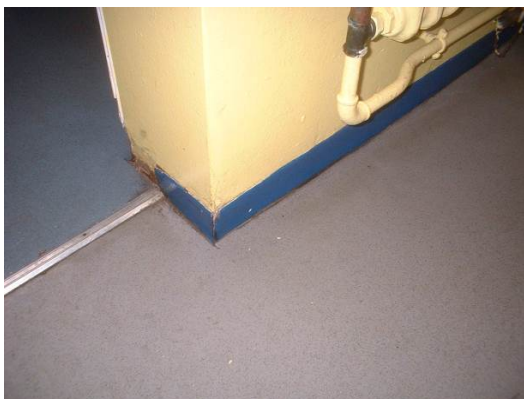
Item 11 - Ref: Sample 11

The skirting in the infant school cloakroom/toilets (Room 0/16) does not contain asbestos.

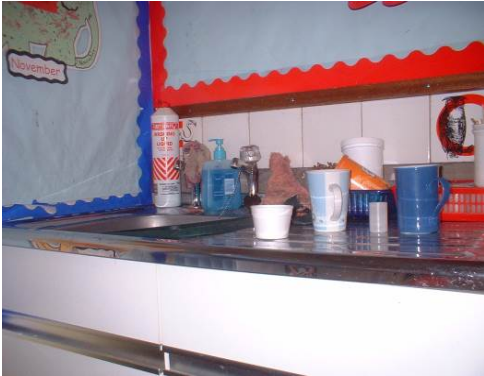
Item 12 - Ref: Sample 12

The sink pad in the infant school classroom (Room 0/17) does not contain asbestos.

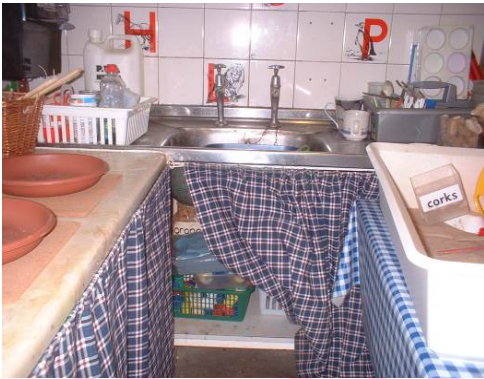
Item 13 – Ref: Sample 13

The sink pad in the infant school classroom (Room 0/19) contains asbestos.

Removed August 2018

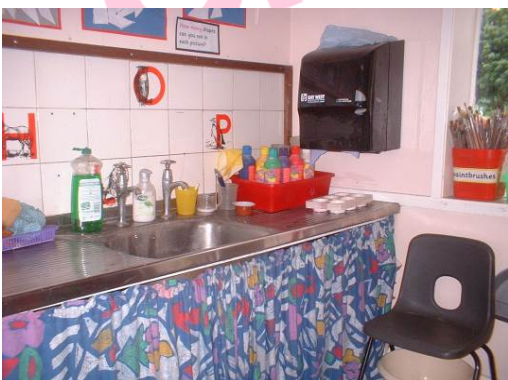
Item 14 - Ref: Sample 14

The sink pad in the infant school classroom (Room 0/21) contains asbestos.

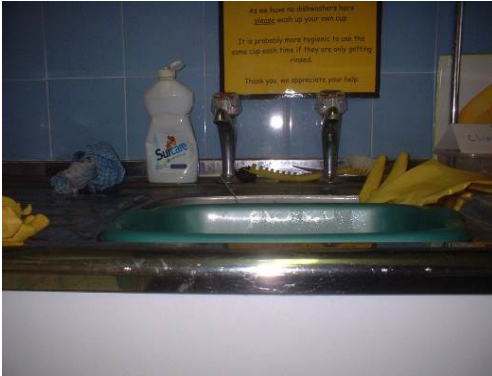
Item 15 - Ref: Sample 15

The sink pad in this infant school classroom (Room 0/23) does not contain asbestos.

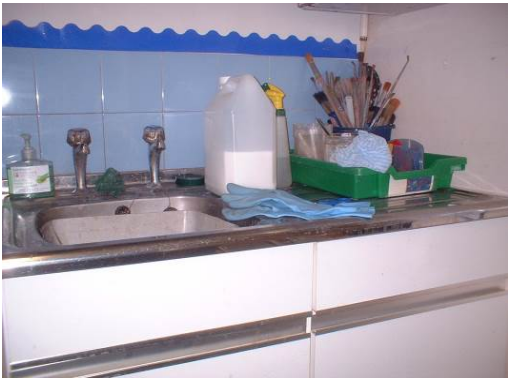
Item 16 – Ref: Sample 16

The sink pad in this infant school classroom (Room 0/23) does not contain asbestos.

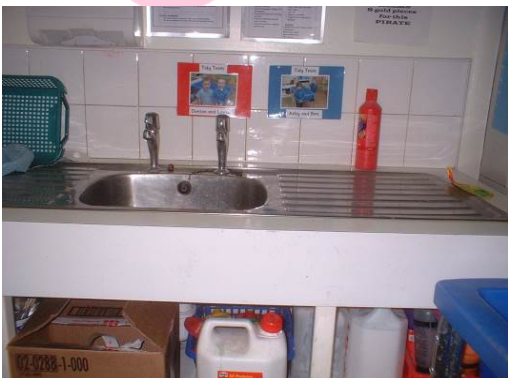
Item 17 - Ref: Sample 17

The sink pad in this infant school classroom (Room 0/26) does not contain asbestos.

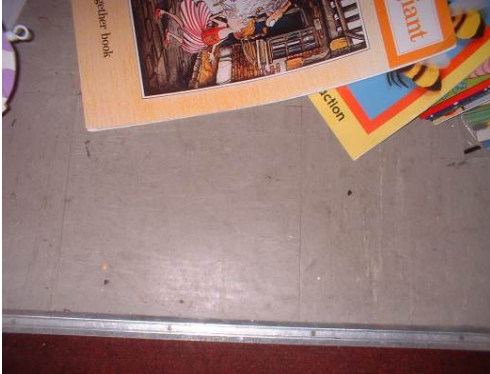
Item 18 - Ref: Sample 18

The vinyl flooring in the infant classroom store (Room 0/27) does not contain asbestos.

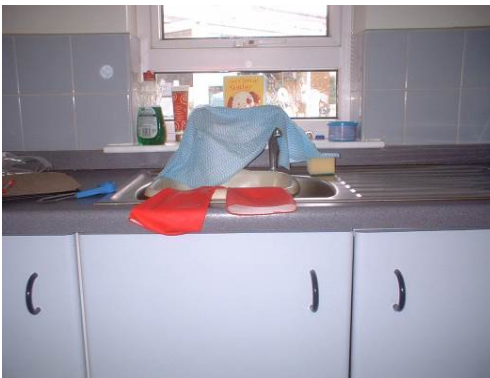
Item 19 – Ref: Sample 19

The sink pad in the infant school classroom kitchen (Room 0/28) does not contain asbestos.

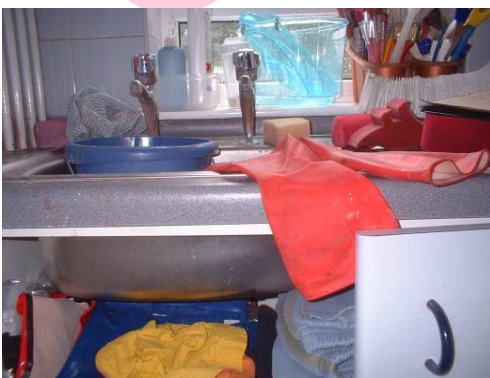
Item 20 - Ref: Sample 20

The sink pad in the infant school classroom washroom (Room 0/29) does not contain asbestos.

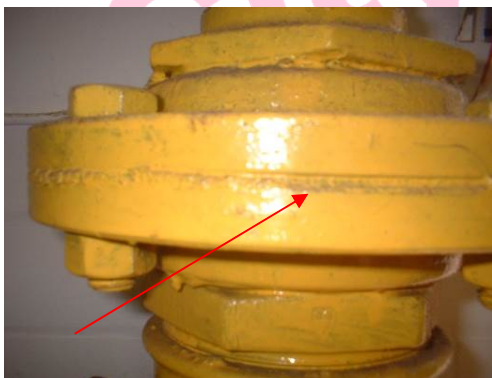
Item 23 - Ref: Sample 22

The pipework gasket in the infant school boiler room (Room 0/33) does not contain asbestos.

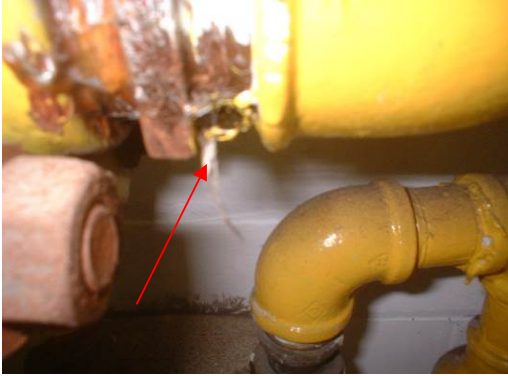
Item 24 - Ref: Sample 23

The redundant rope gasket in the primary school boiler room (Room 0/33) does not contain asbestos.

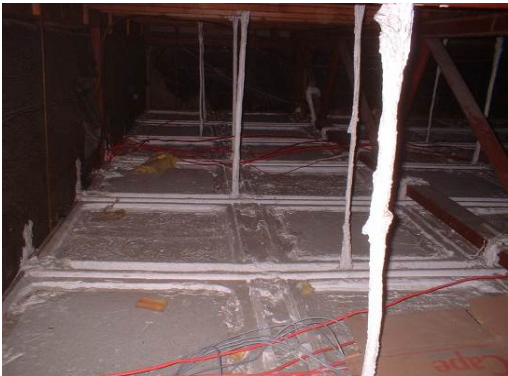
Item 25 - Ref: Sample 24

The main hall ceiling void floor area (Room 1/01) does not contain asbestos.

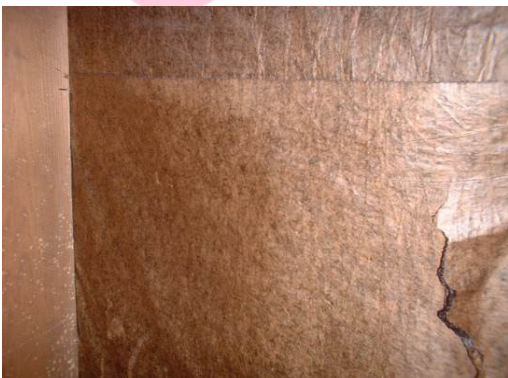
Item 26 - Ref: Sample 25

The infant school main hall roof felt (Room 1/01) does not contain asbestos.

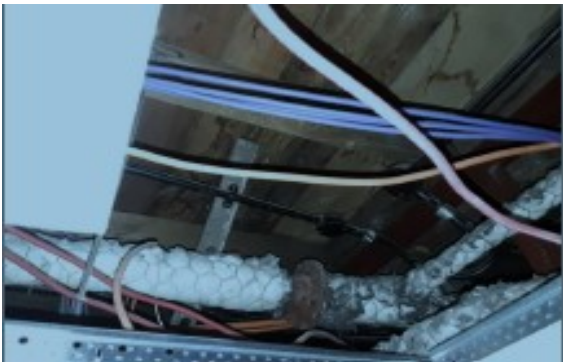
Item 40 - Ref: Presumed

The gasket within pipework flange in the ceiling void above office 1 & 2, Lobby and First Aid is presumed to contain asbestos.

Any change in its appearance should be recorded and passed to Property Services.

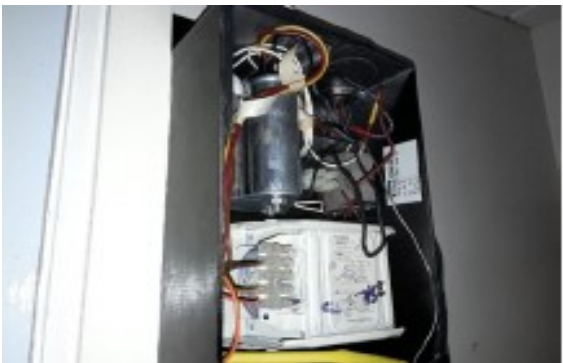
Item 41 - Ref: Presumed

The flashguard within control gear west in Classroom 1 is presumed to contain asbestos.

Removed 2019

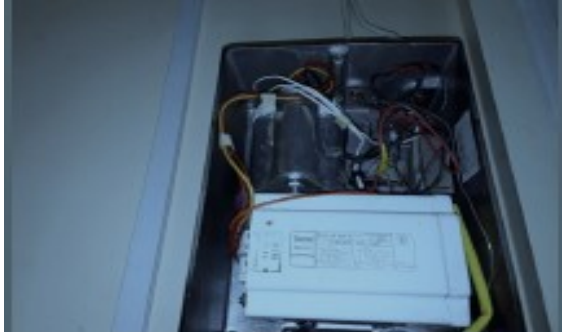
Item 42 - Ref: Presumed

The flashguard within control gear east in Classroom 2 is presumed to contain asbestos.

Removed 2019

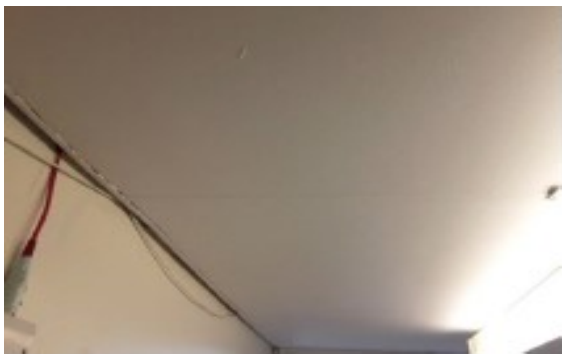
Item 43 - Ref: AL004376

The insulating board ceiling panels in the lobby do not contain asbestos.

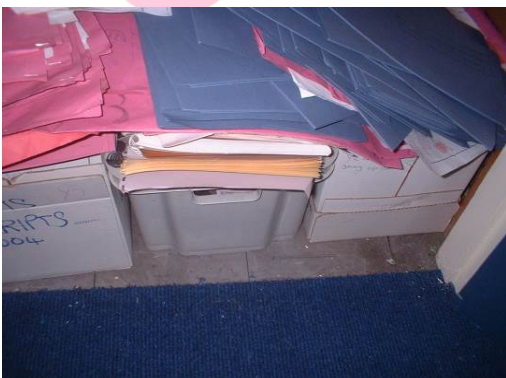
Item 3 - Ref: Sample 29

The vinyl floor tiles in the primary school classroom (Room 0/35) do not contain asbestos.

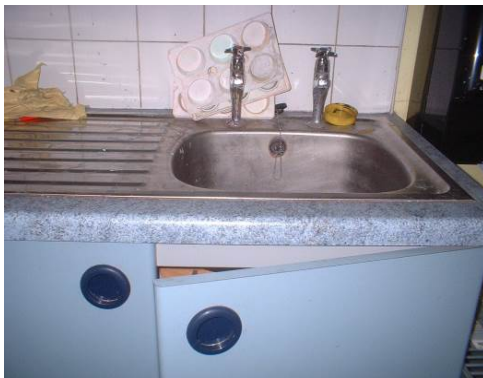
Item 8 - Ref: Sample 33

The sink pad in this primary school classroom (Room 0/38) does not contain asbestos.

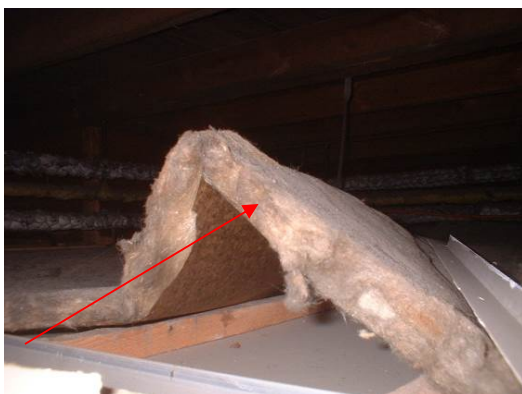
Item 9 - Ref: Sample 34

The ceiling void insulation to the hallway/corridor (Room 0/41) does not contain asbestos.

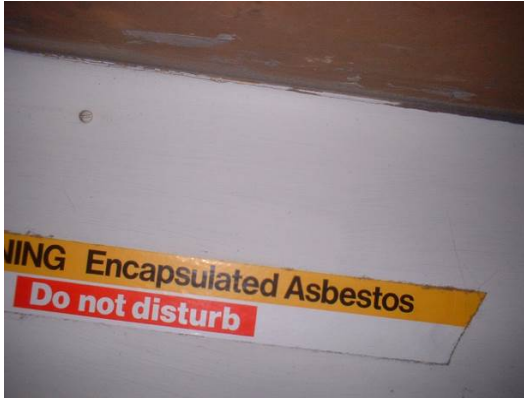
Ref: Sample 35

The insulating board inside the cupboard heaters within the Corridor/hallway (Room 0/41) contained asbestos.

All asbestos linings to the heaters in the school were removed in November 2013.

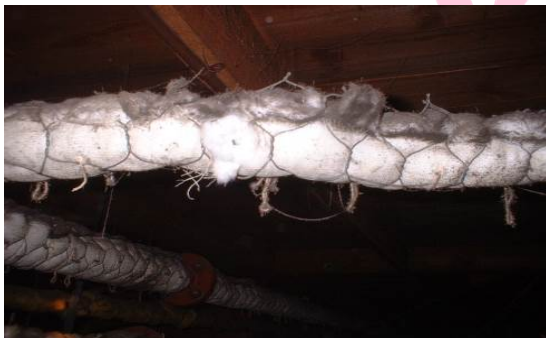
Item 10 - Ref: Sample 36

The lagging insulation to the pipework within the hallway corridor (Room 0/41) does not contain asbestos.

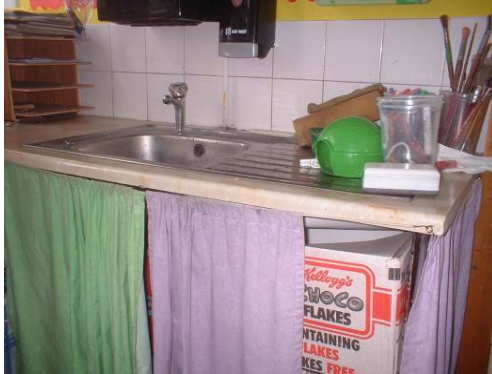
Item 11 - Ref: Sample 38

The sink pad within classroom 8 (Room 0/56) does not contain asbestos.

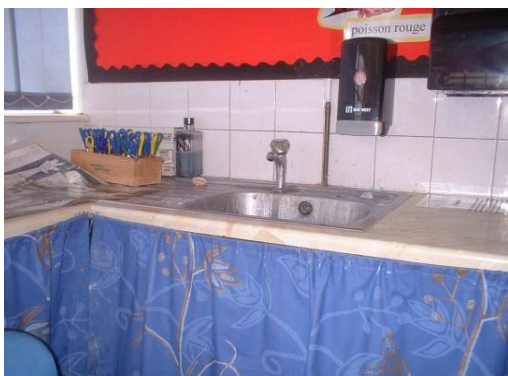
Item 13 - Ref: Sample 40

The sink pad in classroom 7 (Room 0/57) does not contain asbestos.

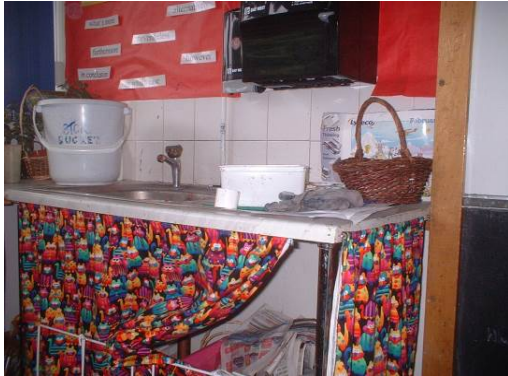
Item 14 - Ref: Sample 41

The sink pad in classroom 6 (Room 0/58) does not contain asbestos.

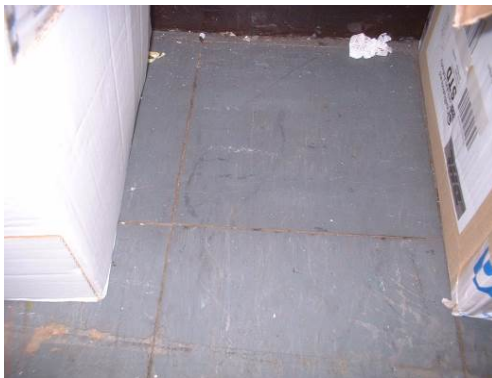
Item 15 - Ref: Sample 42

The vinyl flooring within classroom 6 (Room 0/58) does not contain asbestos.

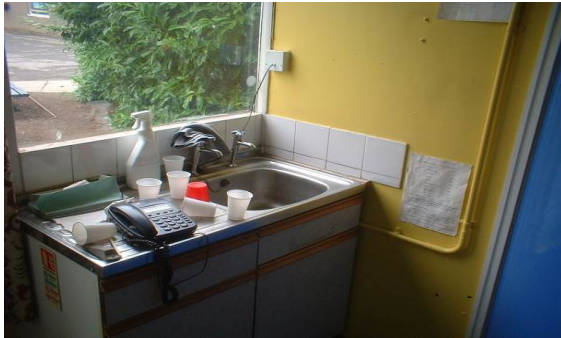
Item 22 – Ref: Sample 49

The sink pad in the library (Room 0/70) does not contain asbestos.

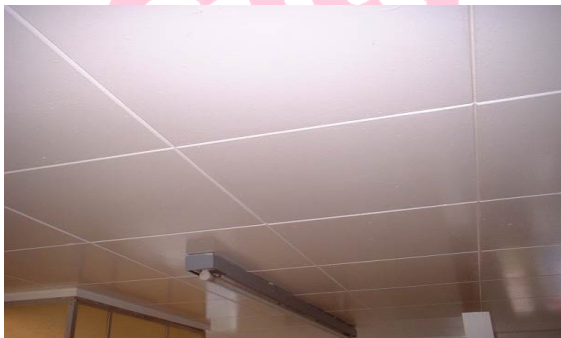
Item 23 - Ref: Sample 50

The ceiling tiles to the kitchen (Room 0/67) contain asbestos.

Any change in its appearance should be recorded and passed to Property Services.

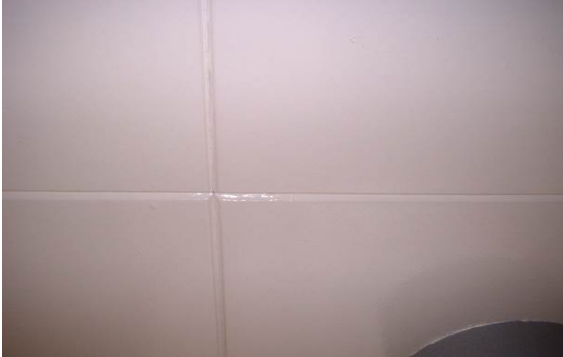
Item 24 – As Sample 50

The ceiling in the kitchen staff wc (Room 0/73) contains asbestos.

Any change in its appearance should be recorded and passed to Property Services.

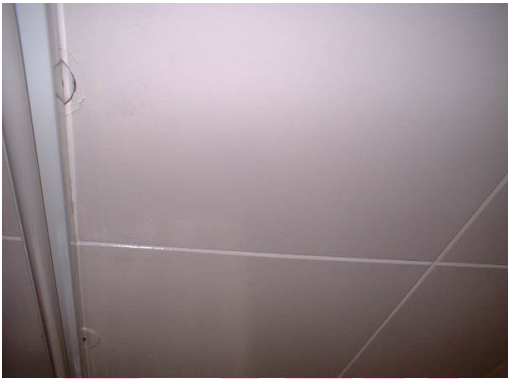
Item 25 – As Sample 50

The ceiling to the kitchen staff room (Room 0/72) contains asbestos.

Any change in its appearance should be recorded and passed to Property Services.

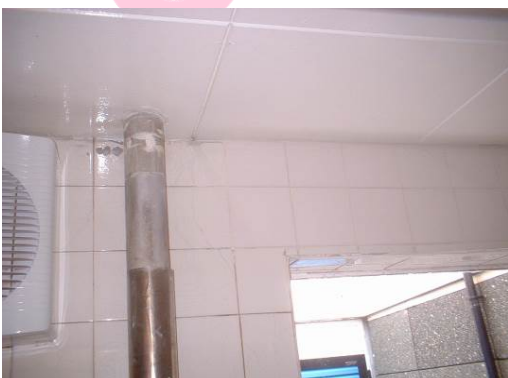
Item 26 - Ref: Sample 51

The flue to the kitchen (Room 0/67) contains asbestos.

Any change in its appearance should be recorded and passed to Property Services.

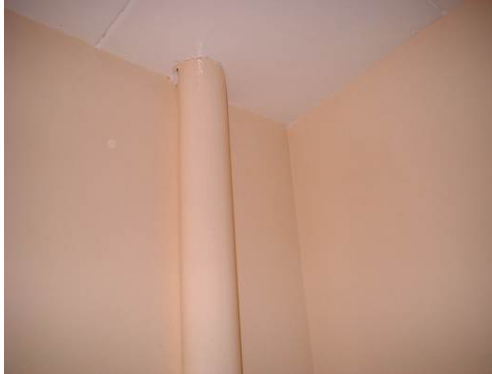
Item 27 – As Sample 51

The flue in the kitchen staff wc (Room 0/73) contains asbestos.

Any change in its appearance should be recorded and passed to Property Services.

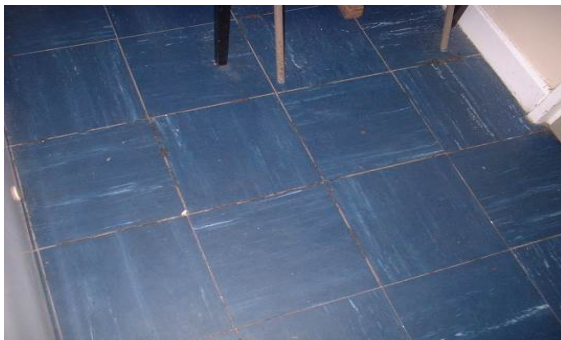
Item 28 –Ref: Sample 52

The vinyl flooring to the kitchen staff room (0/72) does not contain asbestos.

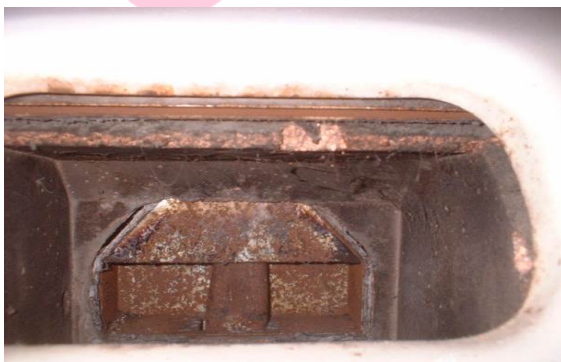
Item 29 - Ref: Sample 53

The panel within the sanitary unit in the kitchen staff wc (Room 0/73) does not contain asbestos.

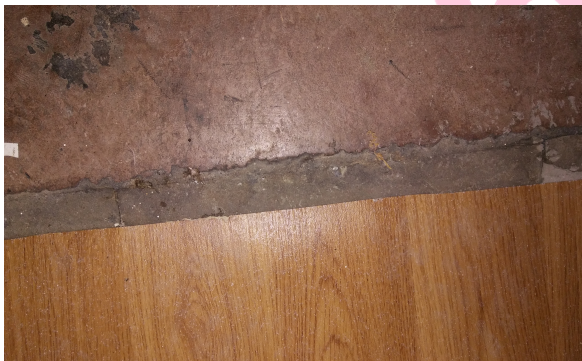
Item 34 - Ref: As 182913-10

The flooring in the corridor (Rm 0/22) contains asbestos.

Any change in its appearance should be recorded and passed to Property Services.

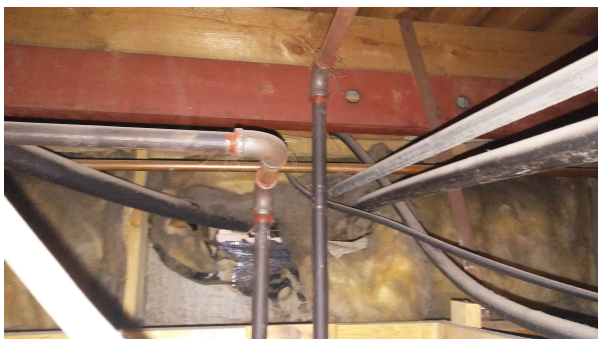
Item 35 - Ref: 182913-9

The felt to the old external wall in the void above rooms 0/21 – 0/24 does not contain asbestos.

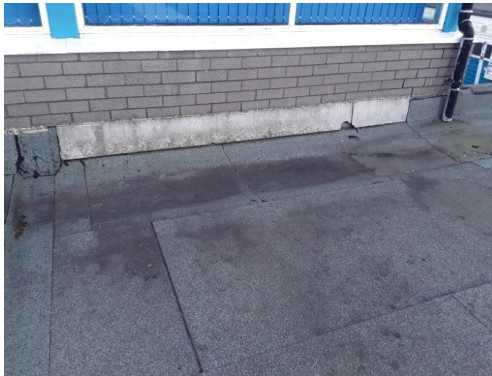
Item 99 Ref: PE001549

The upstanding felt to sports hall (External/Roof 7) contains asbestos.

Removed April 2022 – waiting WCN

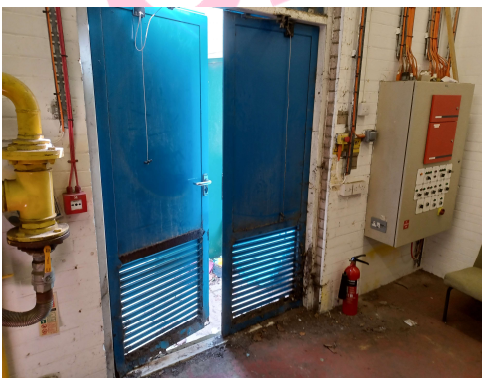
Item 113 Ref: 581161-7

The debris to entrance wall (Rm 0/26 KS1 Boiler Room) contains asbestos.

Removed January 2024.

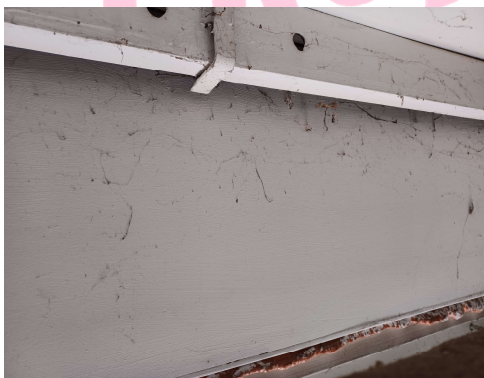
Item 116 Ref: As 581161-11

The panel above door (Rm 0/27 Boiler Room adj Kitchen) contains asbestos.

Removed October 2023.

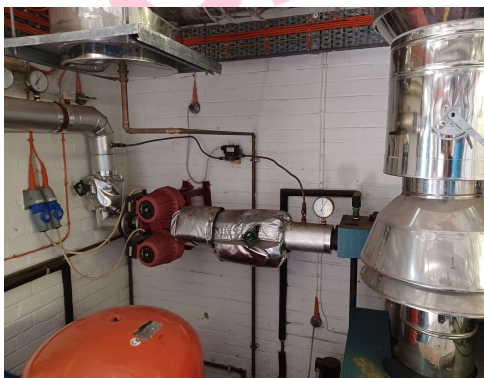
Item 119 Ref: As 581161-14

The debris to walls behind boilers (Rm 0/27 Boiler Room adj Kitchen) contains asbestos.

Removed October 2023.

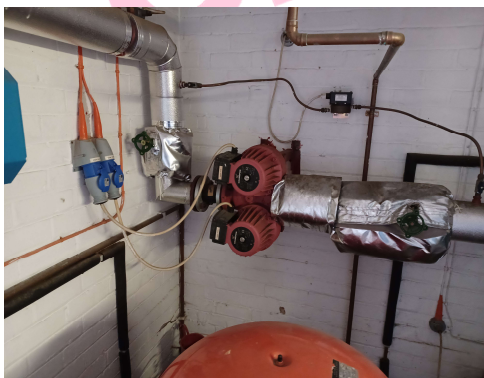
Item 122 Ref: 581161-17

The pipework flange gasket (Rm 0/27 Boiler Room adj Kitchen) does not contain asbestos.

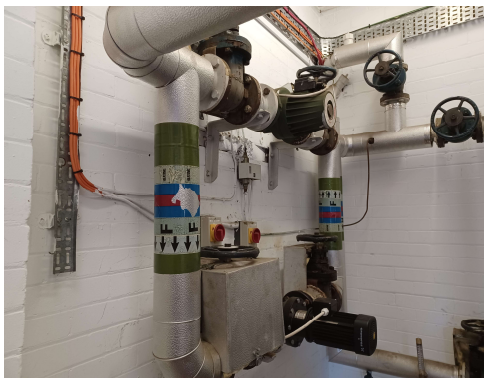
Item 124 Ref: 581161-5

The pipework flange gasket where accessible (Rm 0/28 Reception Classroom) does not contain asbestos.

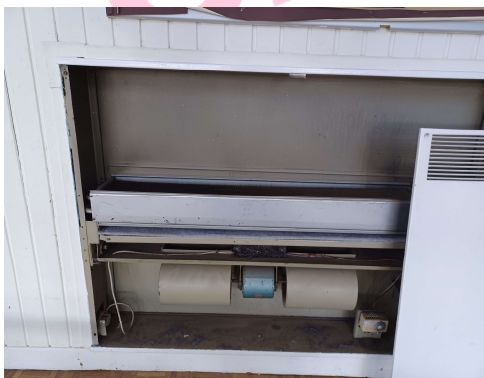
Item 125 Ref: Presumed

The panels behind heaters (Rm 0/29 Assembly Hall) contains asbestos.

Any change in its appearance should be recorded and passed to Property Services.

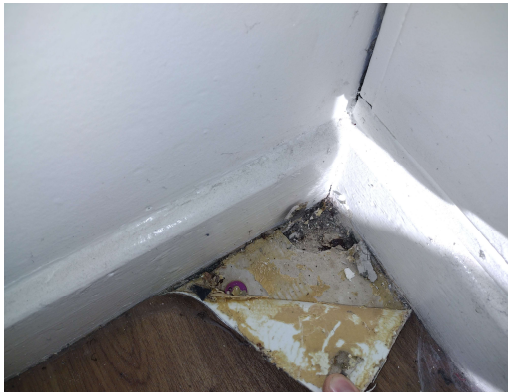
Item 130 Ref: 581161-18

The subfloor – floor tile without bitumen (Rm 0/34 Classroom) contains asbestos.

Any change in its appearance should be recorded and passed to Property Services.

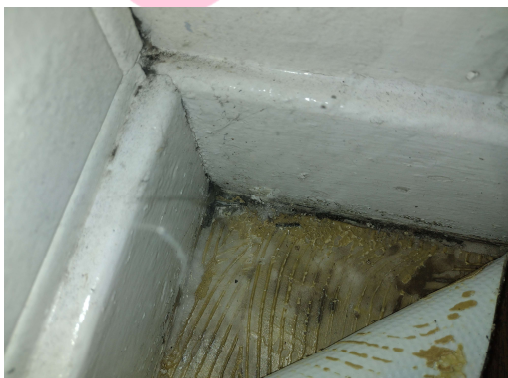
Item 131 Ref: As 581161-18

The subfloor – floor tile without bitumen (Rm 0/35 Classroom) contains asbestos.

Any change in its appearance should be recorded and passed to Property Services.

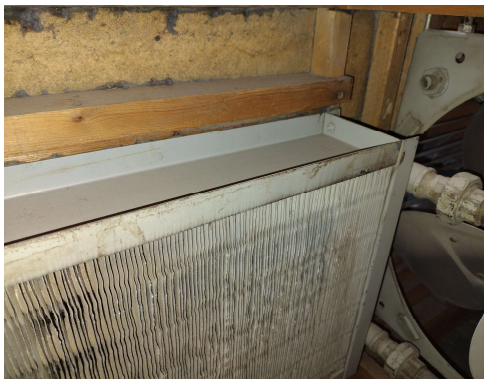
Item 133 Ref: 581161-20

The sealant surrounding convector (Rm 0/36 Classroom) contains asbestos.

Any change in its appearance should be recorded and passed to Property Services.

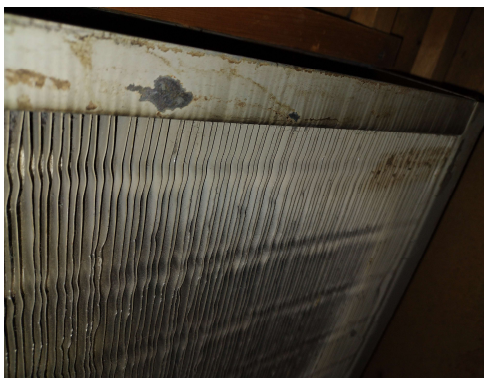
Item 137 Ref: As 581161-20

The sealant surrounding convector (Rm 0/38 Classroom) contains asbestos.

Any change in its appearance should be recorded and passed to Property Services.

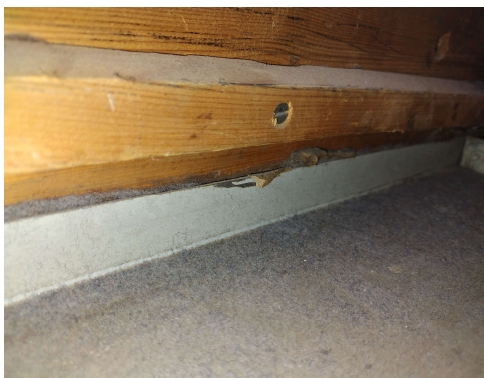
Item 140 Ref: As 581161-20

The sealant surrounding convector (Rm 0/40 Dining Hall) contains asbestos.

Any change in its appearance should be recorded and passed to Property Services.

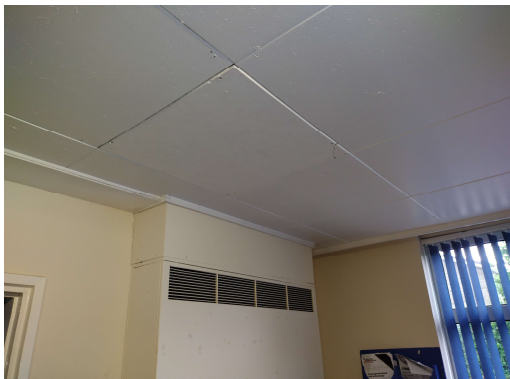
Item 142 Ref: 581161-22

The ceiling (Rm 0/41 Staff Room) does not contain asbestos.

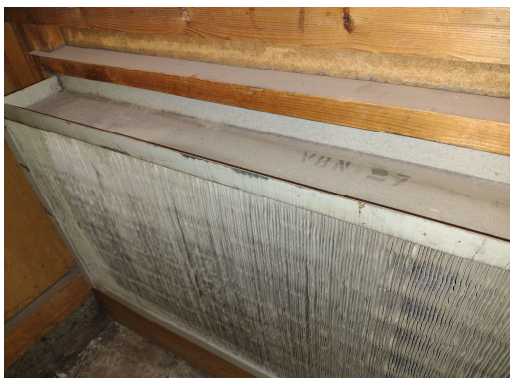
Item 143 Ref: As 581161-20

The sealant surrounding convector (Rm 0/42 Classroom) contains asbestos.

Any change in its appearance should be recorded and passed to Property Services.

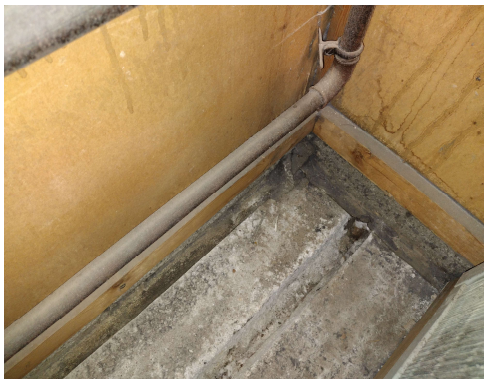
Item 145 Ref: As 581161-19

The damp proof course (Rm 0/42 Classroom) contains asbestos.

Any change in its appearance should be recorded and passed to Property Services.

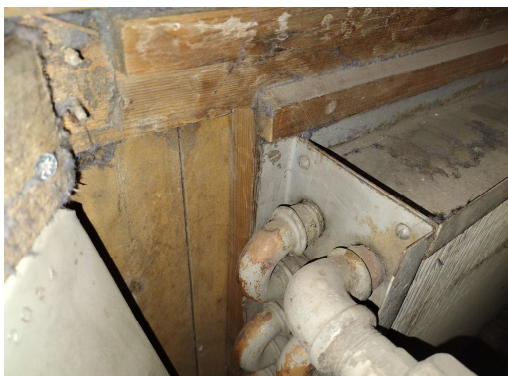
Item 146 Ref: As 581161-20

The sealant surrounding convector (Rm 0/43 Classroom) contains asbestos.

Any change in its appearance should be recorded and passed to Property Services.

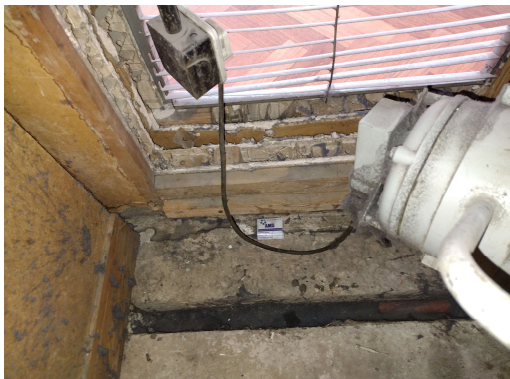
Item 148 Ref: As 581161-19

The damp proof course (Rm 0/43 Classroom) contains asbestos.

Any change in its appearance should be recorded and passed to Property Services.

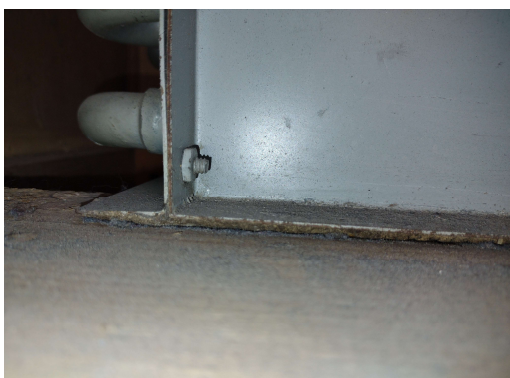
Item 149 Ref: As 581161-20

The sealant surrounding convector (Rm 0/44 Corridor) contains asbestos.

Any change in its appearance should be recorded and passed to Property Services.

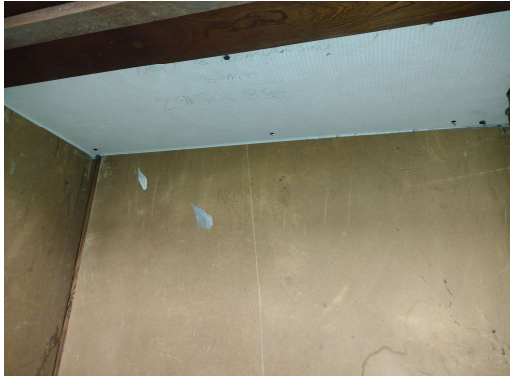
Item 150 Ref: As 581161-21

The ceiling (Rm 0/44 Corridor) does not contain asbestos.

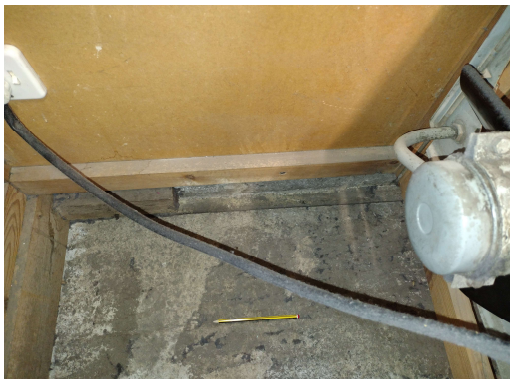
Item 151 Ref: As 581161-19

The damp proof course (Rm 0/45 Classroom) contains asbestos.

Any change in its appearance should be recorded and passed to Property Services.

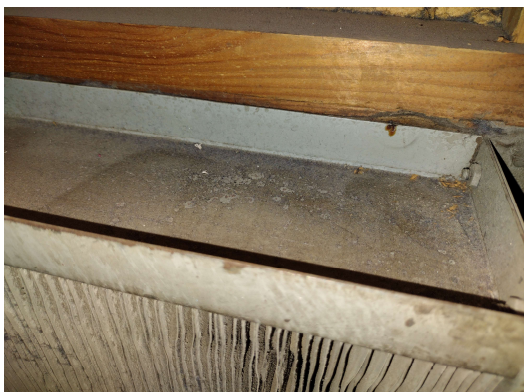
Item 152 Ref: As 581161-20

The sealant surrounding convector (Rm 0/45 Classroom) contains asbestos.

Any change in its appearance should be recorded and passed to Property Services.

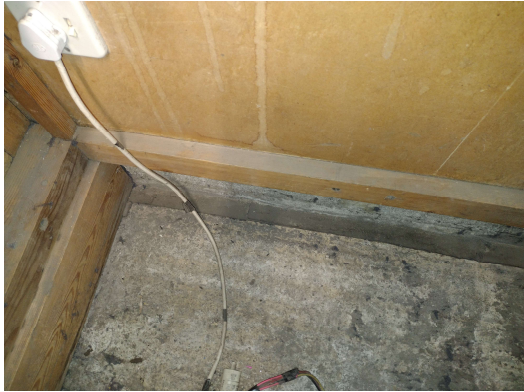
Item 153 Ref: As 581161-19

The damp proof course (Rm 0/46 Classroom) contains asbestos.

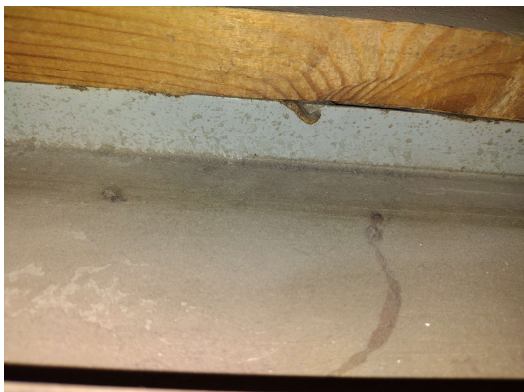
Item 154 Ref: As 581161-20

The sealant surrounding convector (Rm 0/46 Classroom) contains asbestos.

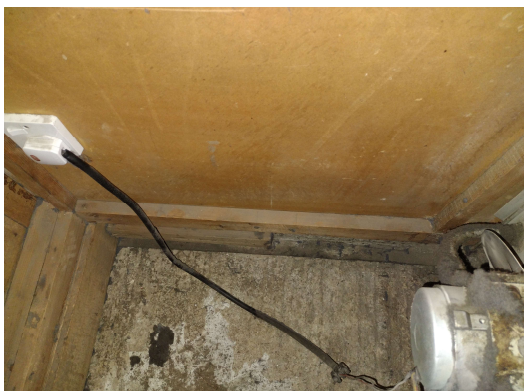
Item 155 Ref: As 581161-19

The damp proof course (Rm 0/47 Classroom) contains asbestos.

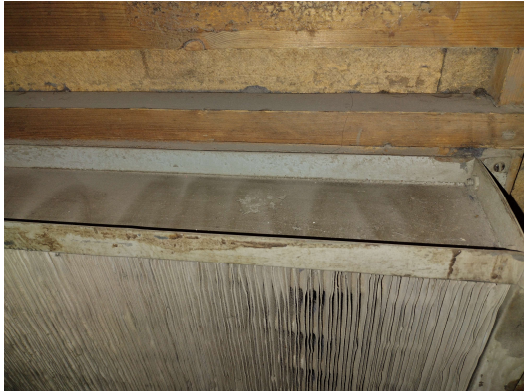
Item 156 Ref: As 581161-20

The sealant surrounding convector (Rm 0/47 Classroom) contains asbestos.

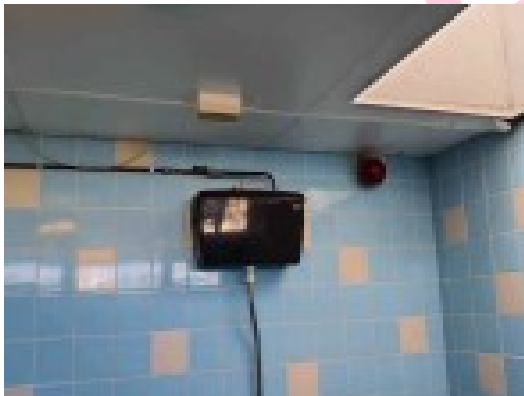
Item 157 Ref: FH0035350

The bakelite cistern in Year 5/6 boys toilet (G/004) does not contain asbestos.
