### ASBESTOS SURVEY REPORT FOR EPPLETON ACADEMY PRIMARY SCHOOL, HOUGHTON

## **Asbestos Register for EPPLETON ACADEMY PRIMARY SCHOOL**

**Date: 16<sup>th</sup> January 2025**

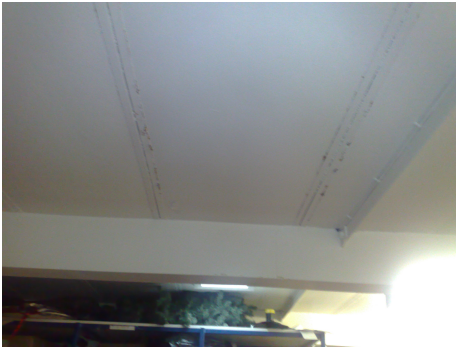
### **Various - Ref: NO09/201**

The ceiling tiles to the store room (Area 1a) contained asbestos. This has now been removed.

Similar ceiling tiles are located in Store Rooms 1B and 1C.

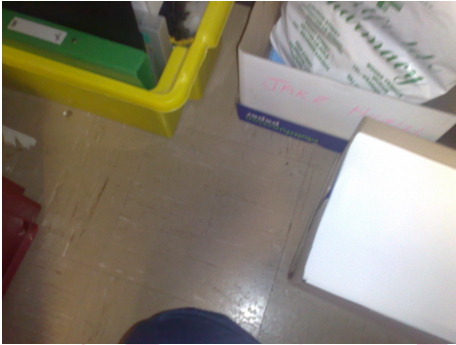
### **Various - Ref: NO09/202**

The floor tiles to the office store contain asbestos. Any change in its appearance should be recorded and passed to Property Services.

Similar flooring is located in the Resources Rm Store, HT Store (Removed 2017), Stock Store, Music Store, Teaching Area 4 Stores, Teaching Area 3 Store, (Library Stores 1 & 2 – Removed Feb 2017), Teaching Area 2 Store and Cleaners Store.

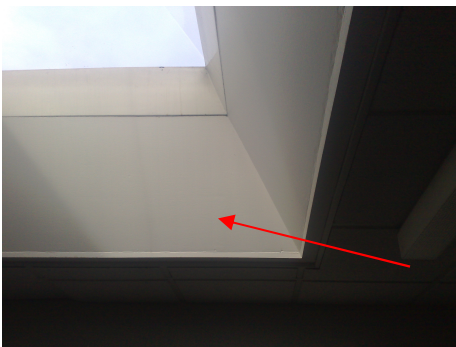
### **Item 7 - Ref: NO09/203**

The skylight upstands to cloakroom 1 adjacent to ICT do not contain asbestos.

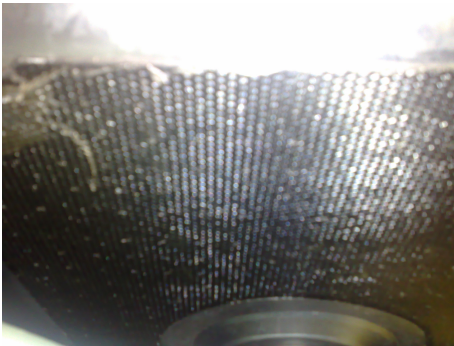
### **Item 09 - Ref: NO09/204**

The sink pad to Teaching Area 4 does not contain asbestos.

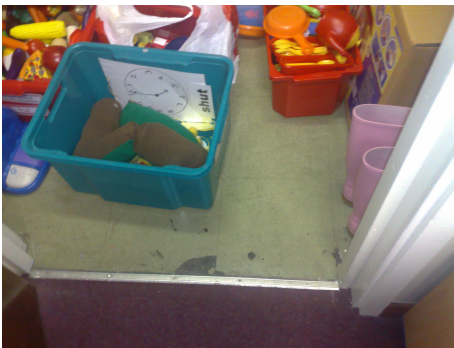
### **Item 16 - Ref: NO09/206**

The floor tiles to the Reception Class Stores 1 & 2 do not contain asbestos.

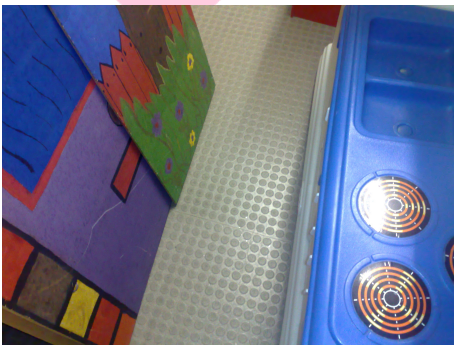
### **Various - Ref: Sample 08**

The flooring to the Changing Room does not contain asbestos.

Similar flooring is located in the Art Store.

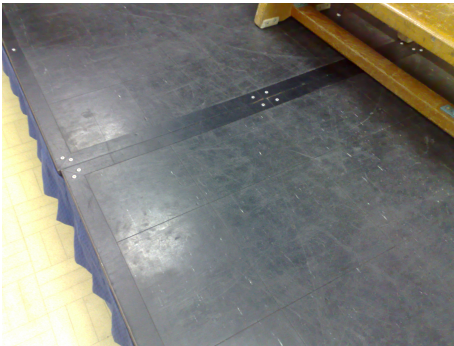
### **Item 23 - Ref: NO09/211**

The floor tiles to the Hall stairs do not contain asbestos.

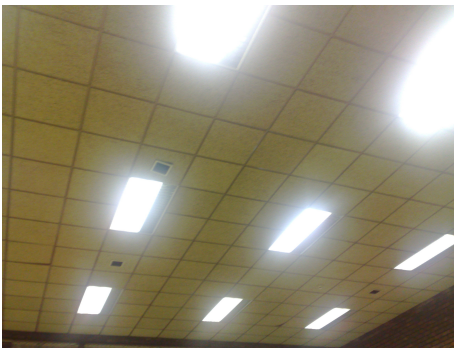
### **Item 24 - Ref: NO09/212**

The ceiling tiles to the hall do not contain asbestos.

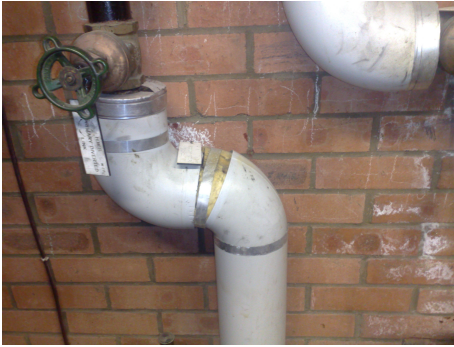
### **Item 26 - Ref: NO09/214**

The pipe insulation to the ground floor boiler house does not contain asbestos.

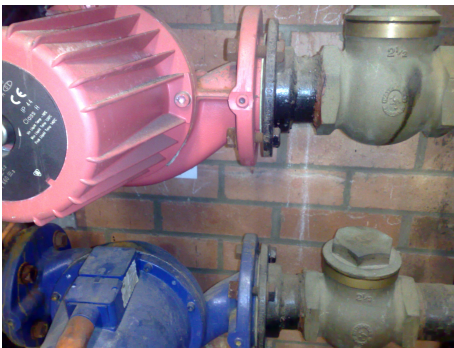
### **Item 27 - Ref: NO09/215**

The gasket material to the ground floor boiler room does not contain asbestos.

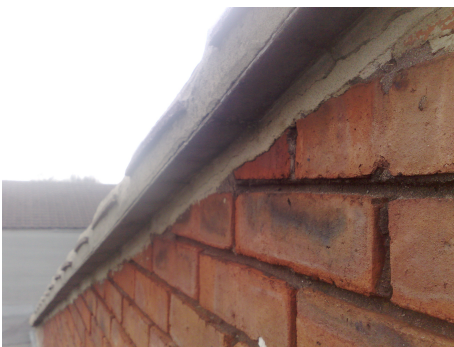
### **Item 28 - Ref: NO09/216**

The fillet boards to the gable of the building do not contain asbestos.

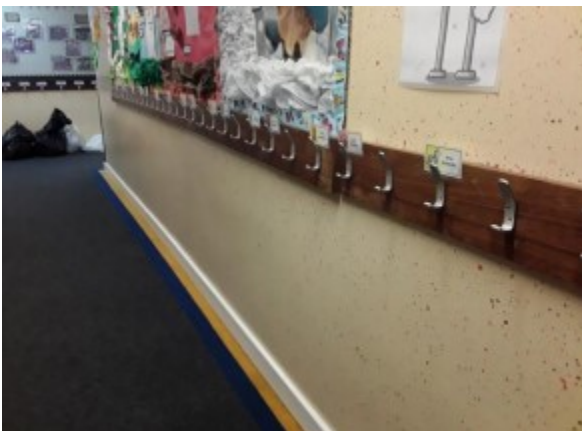
### **Item 31 - Ref: 21-35987-1**

The textured coating to the walls in Area 1 (Hall) does not contain asbestos.

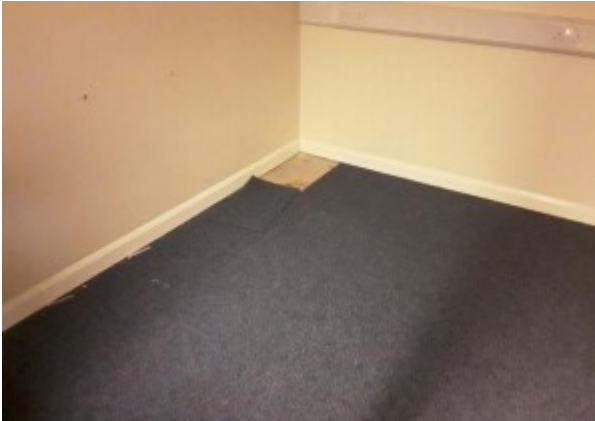
**Item 32 - Ref: 21-35987-2**

The asphalt floor in Area 2 (Cloakroom) does not contain asbestos.

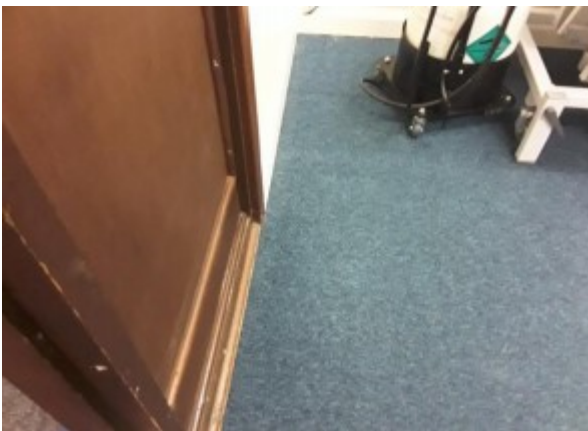
**Item 33 - Ref: 21-35987-2**

The asphalt floor in Area 3 (Medical Room) does not contain asbestos.

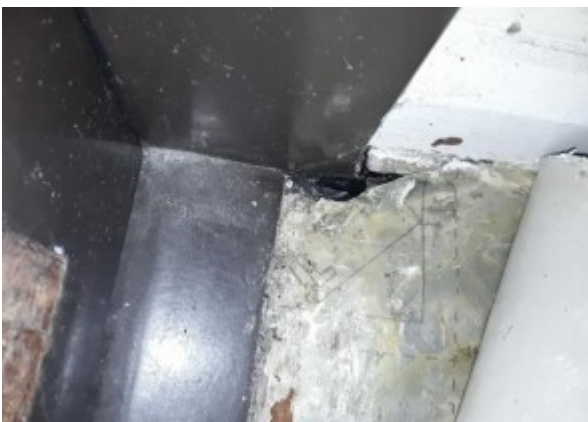
**Item 34 - Ref: 21-35987-2**

The asphalt floor in Area 4 (Teaching area 2) does not contain asbestos.

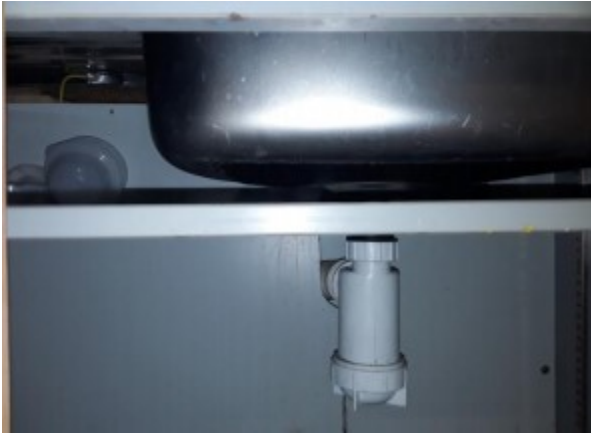
### **Item 35 - Ref: 21-35987-3**

The sink pad in Area 4 (Teaching area 2) does not contain asbestos.

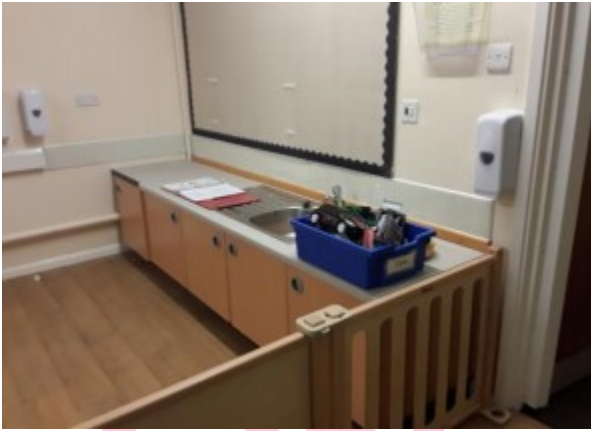
### **Item 36 - Ref: 21-35987-4**

The adhesive to ceramic tiles to wall on area 4 (Teaching area 2) does not contain asbestos.

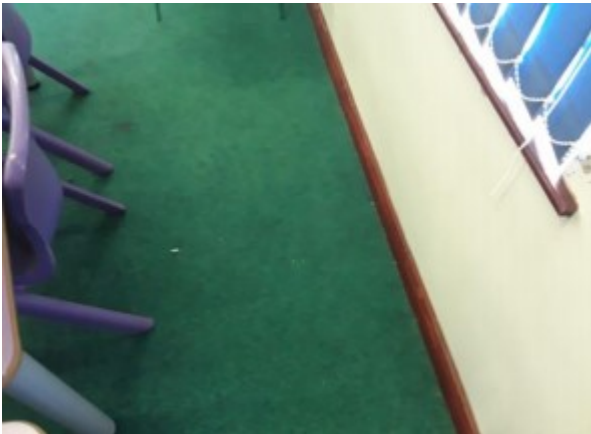
### **Item 37 - Ref: 21-35987-2**

The floor screed beneath the floor in Area 5 (Classroom) does not contain asbestos.

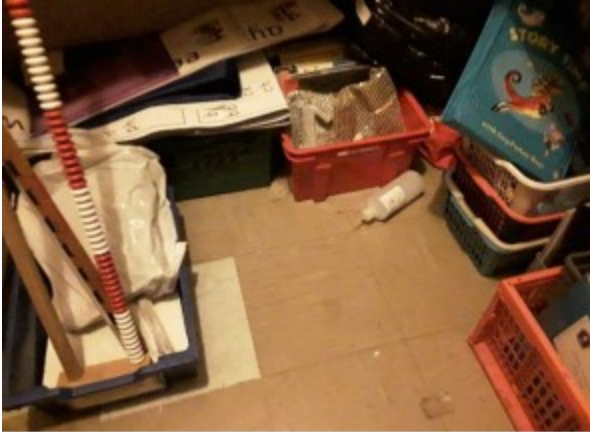
### **Item 38 - Ref: 21-35987-5**

The floor tiles and adhesive in Area 6 (Store Cupboard) contains asbestos.

Any change in appearance should be reported to Property Services.

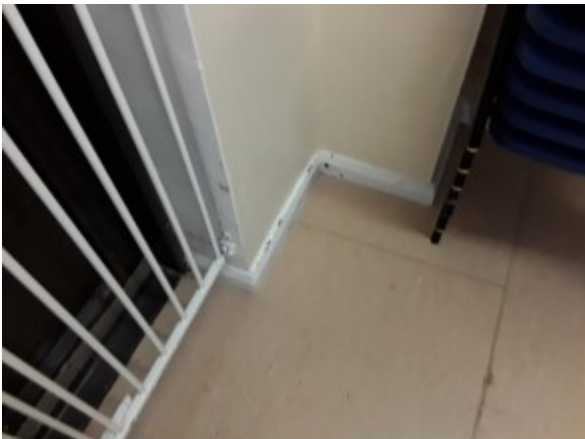
### **Item 39 - Ref: 21-35987-2**

The asphalt floor beneath floor screed in Area 7 (Classroom) does not contain asbestos.

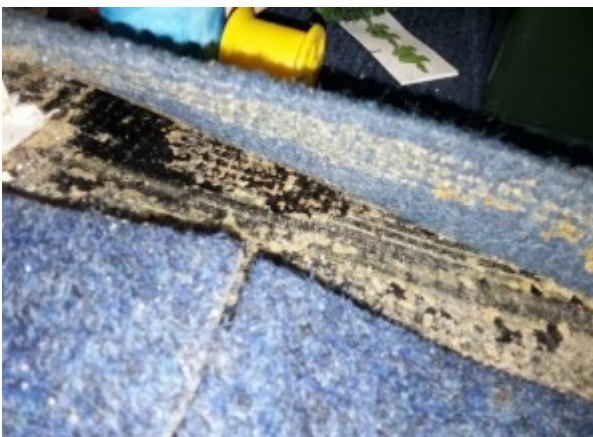
### **Item 40 - Ref: 21-35987-6**

The residual adhesive to the floor in Area 8 (Store Cupboard) contains asbestos.

Any change in appearance should be reported to Property Services.

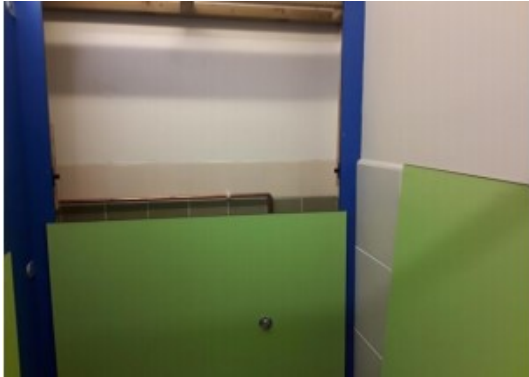
### **Item 41 - Ref: 21-35987-7**

The adhesive to ceramic wall tiles in Area 10 (Boys Toilets) does not contain asbestos.

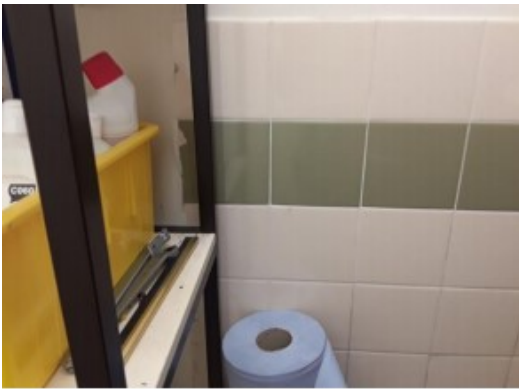
### **Item 42 - Ref: 21-35987-7**

The adhesive to ceramic wall tiles in Area 14 (Cleaners Cupboard) does not contain asbestos.

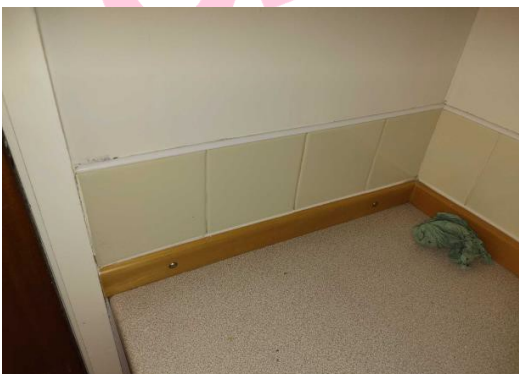
### **Item 43 Ref: 22-50674-1**

The adhesive behind ceramic tiles (Area 1/Upper KS2 Cloakroom) does not contain asbestos.

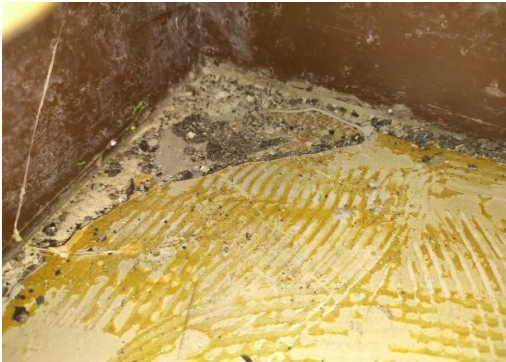
### **Item 44 Ref: 22-50674-2**

The black composite floor (Area 1/Upper KS2 Cloakroom) does not contain asbestos.

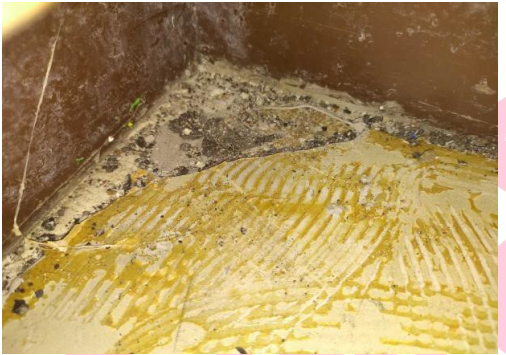
### **Item 45 Ref: 22-50674-7**

The brown adhesive residue below modern screed (Area 1/Upper KS2 Cloakroom) does not contain asbestos.

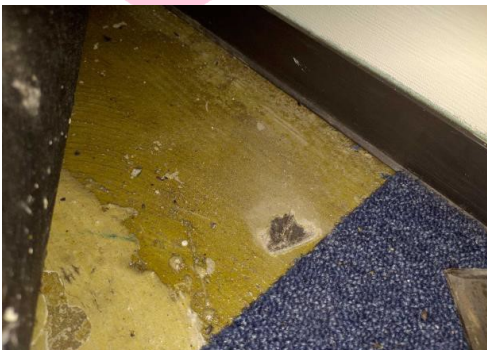
### **Item 46 Ref: 22-50674-2**

The black composite floor (Area 2/Year 6 Classroom) does not contain asbestos.

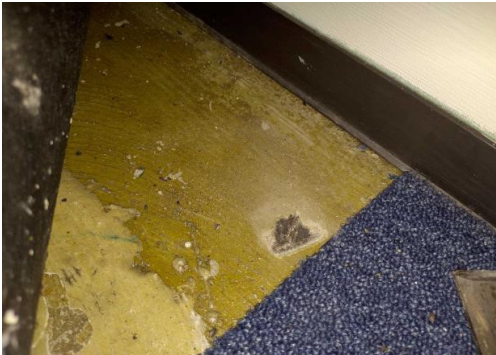
### **Item 47 Ref: 22-50674-7**

The brown adhesive residue below modern screed (Adhesive) (Area 2/Year 6 Classroom) does not contain asbestos.

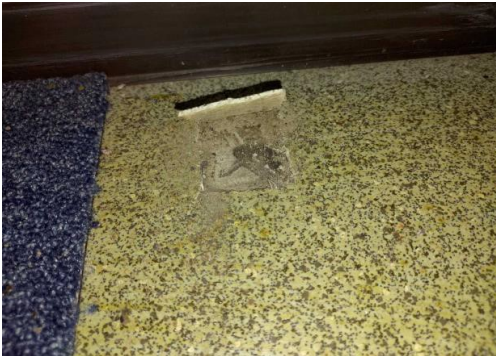
### **Item 48 Ref: 22-50674-2**

The black composite floor (Resin) (Area 3/Year 5 Classroom) does not contain asbestos.

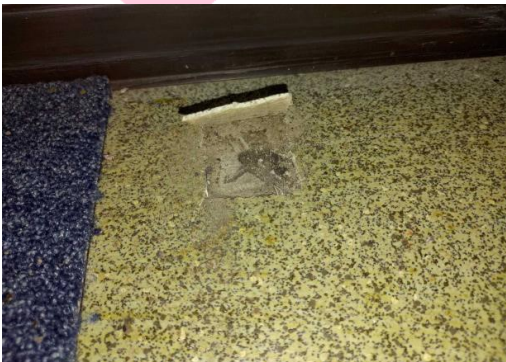
### **Item 49 Ref: 22-50674-7**

The brown adhesive residue below modern screed (Adhesive) (Area 3/Year 5 Classroom) does not contain asbestos.

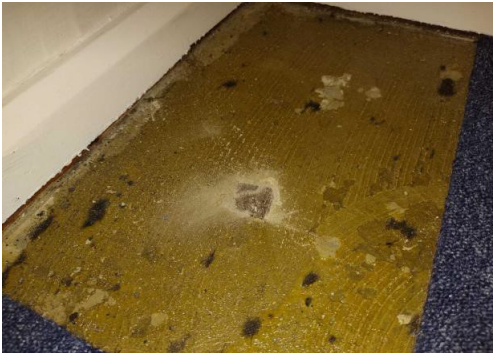
### **Item 50 Ref: 22-50674-2**

The black composite floor (Resin) (Area 4/Year 4 Classroom) does not contain asbestos.

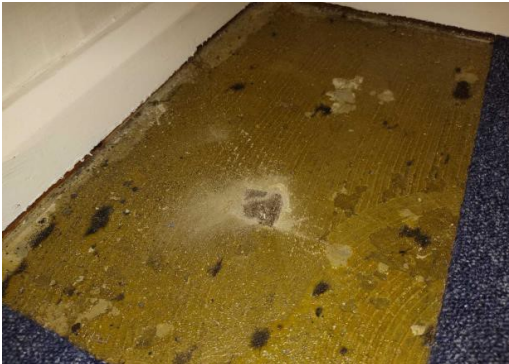
### **Item 51 Ref: 22-50674-2**

The brown adhesive residue below modern screed (Adhesive) (Area 4/Year 4 Classroom) does not contain asbestos.

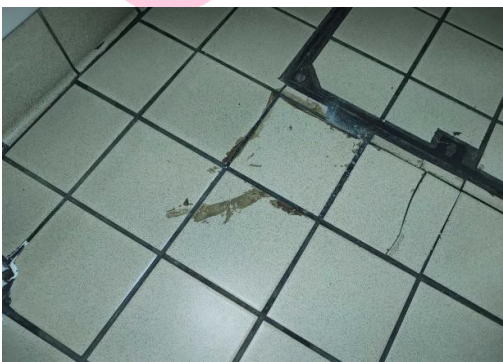
### **Item 52 Ref: 22-50674-4**

The adhesive below ceramic floor tiles (Area 5/Boys Toilet) does not contain asbestos.

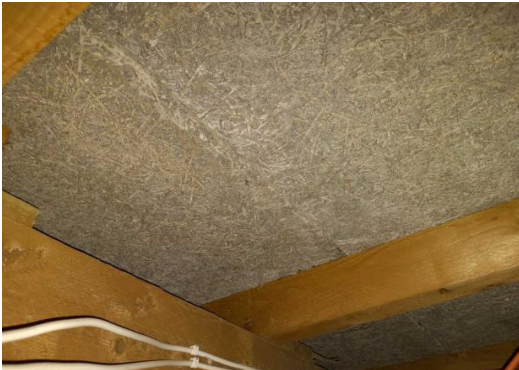
### **Item 53 Ref: 22-50674-5**

The flat roof underside above suspended ceiling (Area 5/Boys Toilet) does not contain asbestos.

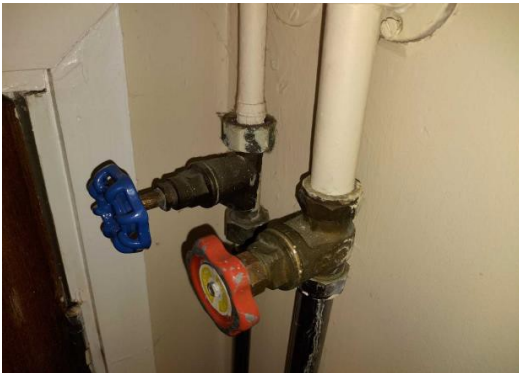
### **Item 54 Ref: 22-50674-6**

The pipes stop taps (Gaskets) (Area 5/Boys Toilet) contain asbestos.

Any change in appearance should be reported to Property Services.

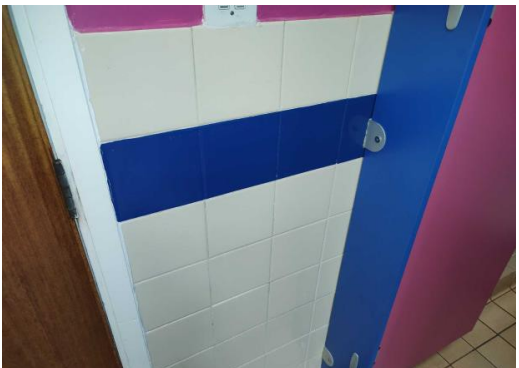
### **Item 55 Ref: 22-50674-3**

The adhesive behind ceramic tiles (Area 6/Girls Toilet) does not contain asbestos.

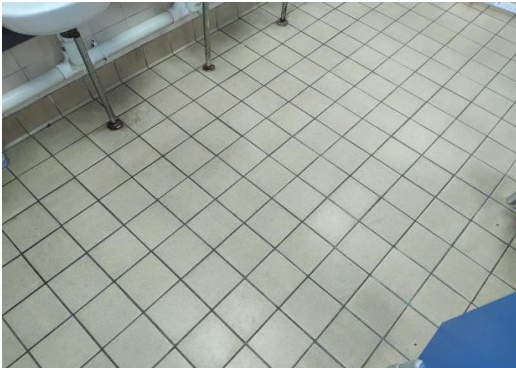
### **Item 56 Ref: 22-50674-4**

The adhesive below ceramic floor tiles (Area 6/Girls Toilet) does not contain asbestos.

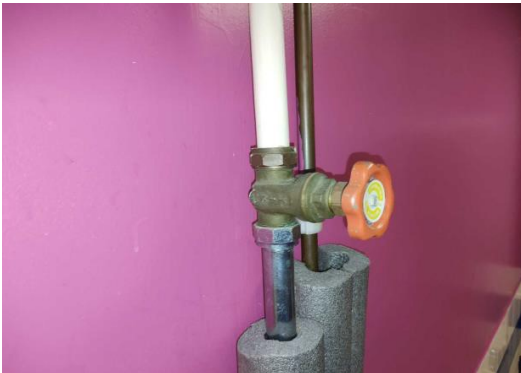
### **Item 57 Ref: 22-50674-6**

The pipes stop taps (Gaskets) (Area 6/Girls Toilet) contain asbestos.

Any change in appearance should be reported to Property Services.

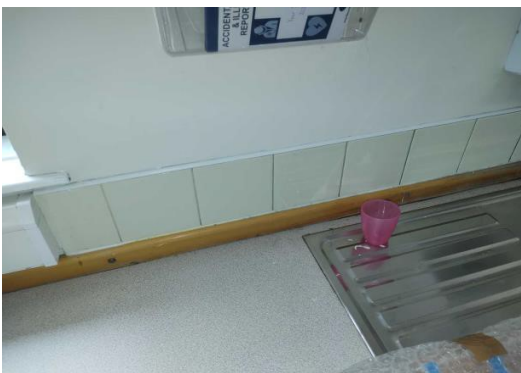
### **Item 58 Ref: 22-50674-1**

The adhesive behind ceramic tiles (Area 7/Lower KS2 Cloakroom) does not contain asbestos.

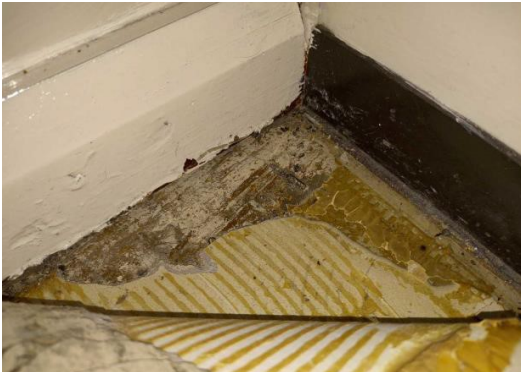
### **Item 59 Ref: 22-50674-2**

The black composite floor (Area 7/Lower KS2 Cloakroom) does not contain asbestos.

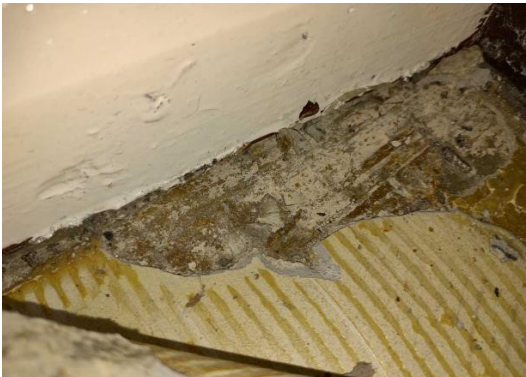
### **Item 60 Ref: 22-50674-7**

The brown adhesive residue below modern screed (Area 7/Lower KS2 Cloakroom) does not contain asbestos.

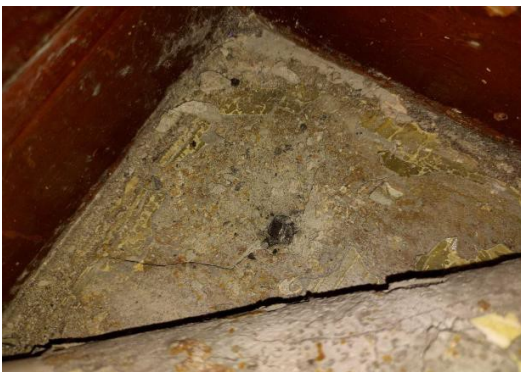
### **Item 61 Ref: 22-50674-2**

The black composite floor (Area 8/Lower KS2 Classroom 1) does not contain asbestos.

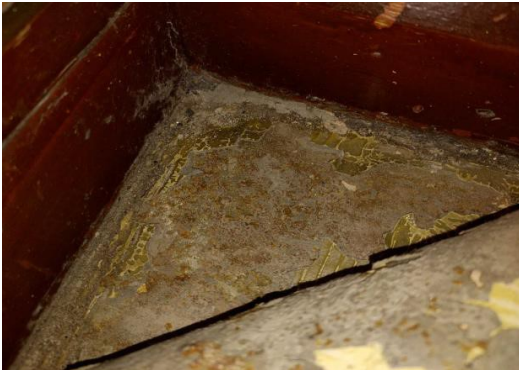
### **Item 62 Ref: 22-50674-7**

The brown adhesive residue below modern screed (Area 8/Lower KS2 Classroom 1) does not contain asbestos.

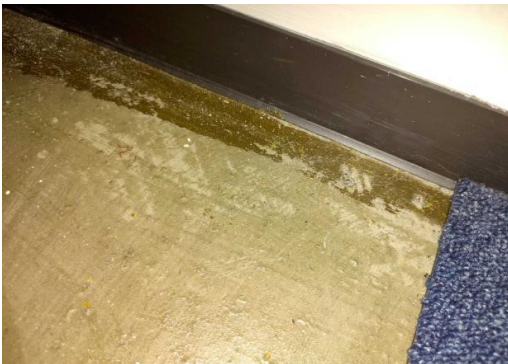
### **Item 63 Ref: 22-50674-2**

The black composite floor (Area 9/Lower KS2 Classroom 2) does not contain asbestos.

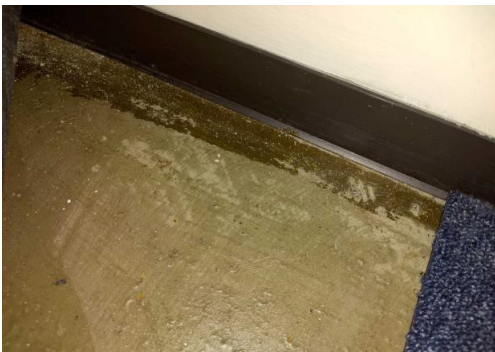
### **Item 64 Ref: 22-50674-7**

The brown adhesive residue below modern screed (Area 9/Lower KS2 Classroom 2) does not contain asbestos.

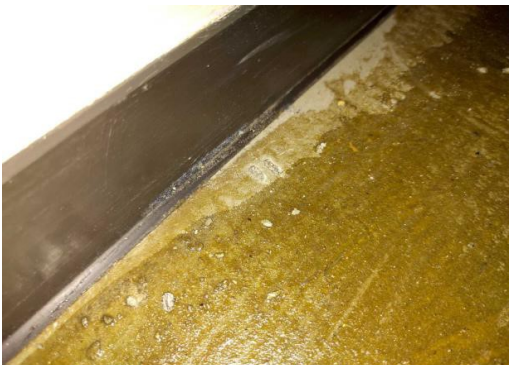
### **Item 65 Ref: 22-50674-2**

The black composite floor (Area 10/Lower KS2 Classroom 3) does not contain asbestos.

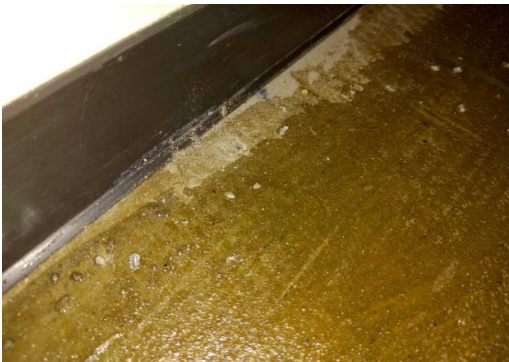
### **Item 66 Ref: 22-50674-7**

The brown adhesive residue below modern screed (Area 10/Lower KS2 Classroom 3) does not contain asbestos.

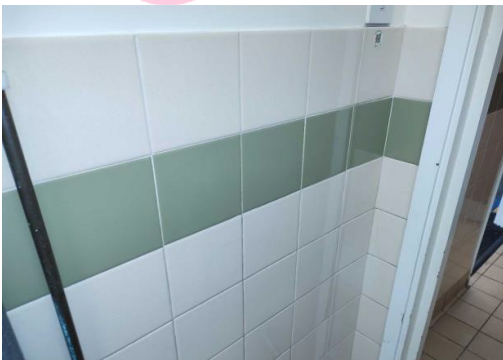
### **Item 67 Ref: 22-50674-3**

The adhesive behind ceramic tiles (Area 11/Shared Toilet) does not contain asbestos.

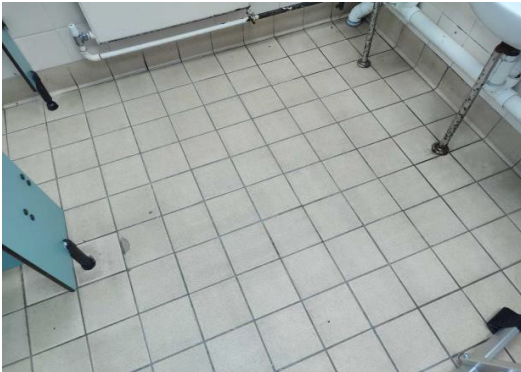
### **Item 68 Ref: 22-50674-4**

The adhesive below ceramic floor tiles (Area 11/Shared Toilet) does not contain asbestos.

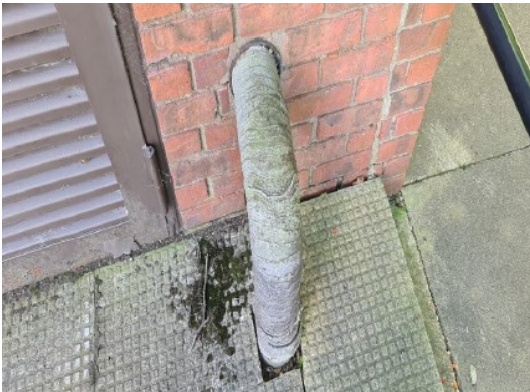
### **Item 69 Ref: 23/8/B/11/JGS7**

The Tape wrapping to gas inlet pipe (External) does not contain asbestos.

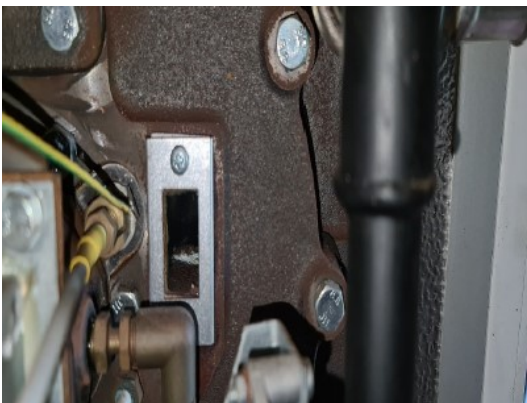
### **Item 70 Ref: 23/8/B/11/JGS1**

The Internal boiler pilot light sight glass gasket (Boiler Room) does not contain asbestos.

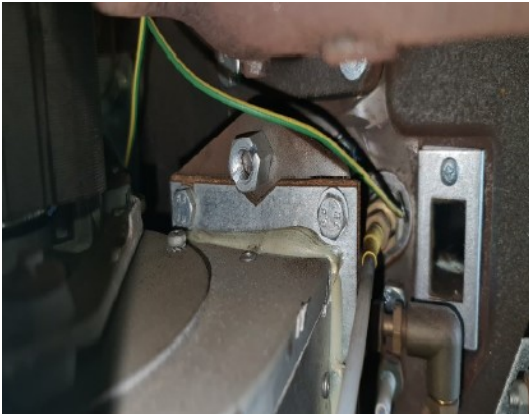
### **Item 71 Ref: 23/8/B/11/JGS2**

The Internal boiler pump gasket (Boiler Room) does not contain asbestos.

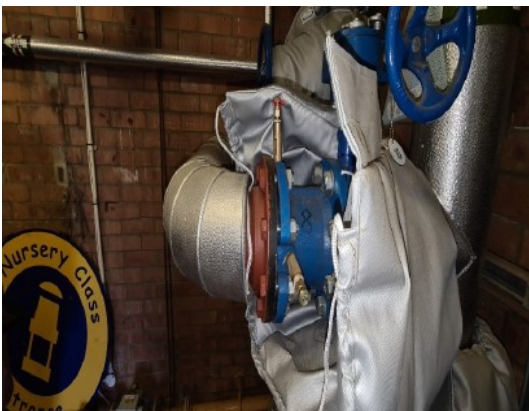
### **Item 72 Ref: 23/8/B/11/JGS3**

The Pipework flange gaskets (Boiler Room) does not contain asbestos.

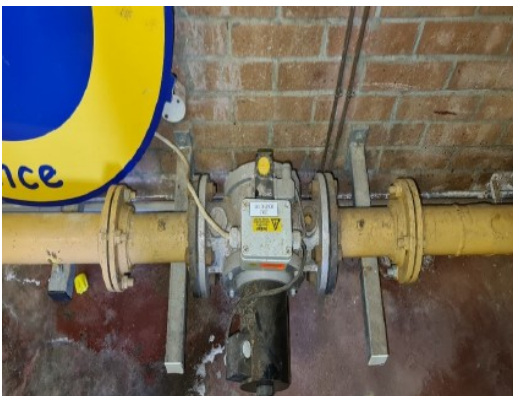
### **Item 73 Ref: 23/8/B/11/JGS4**

The Gas pipework flange joints gaskets (Boiler Room) does not contain asbestos.

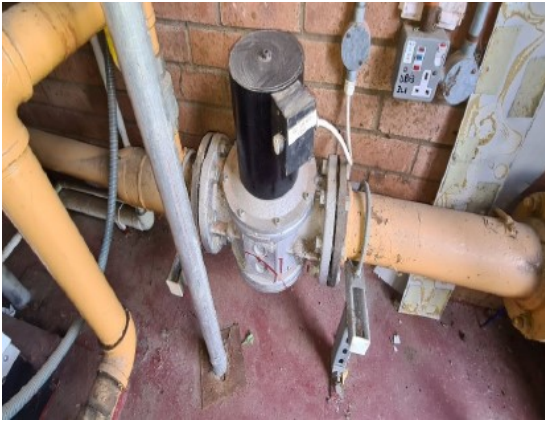
### **Item 74 Ref: 23/8/B/11/JGS5**

The Insulation valve joints putty (Boiler Room) does not contain asbestos.

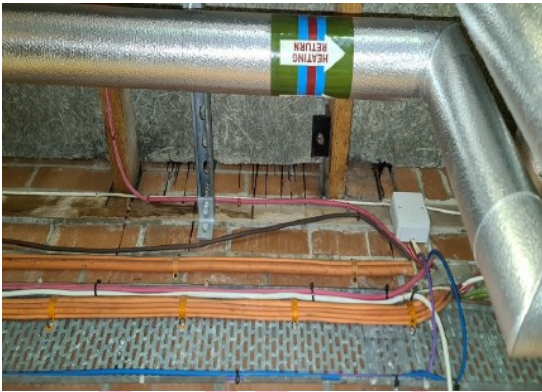
### **Item 75 Ref: 23/8/B/11/JGS6**

The High level walls/roof bitumen pitch residuals (Boiler Room) does not contain asbestos.

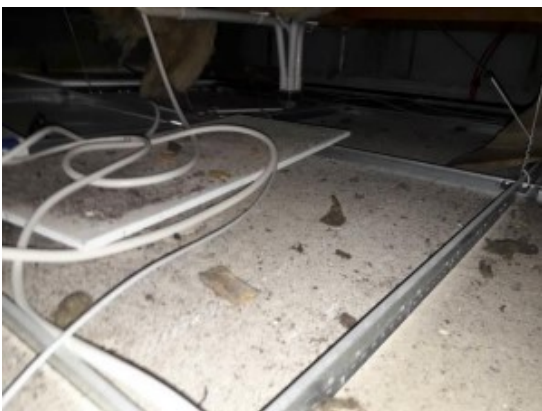
### **Item 76 Ref: BS422618**

The debris to suspended ceiling (Medical Room 1) does not contain asbestos.

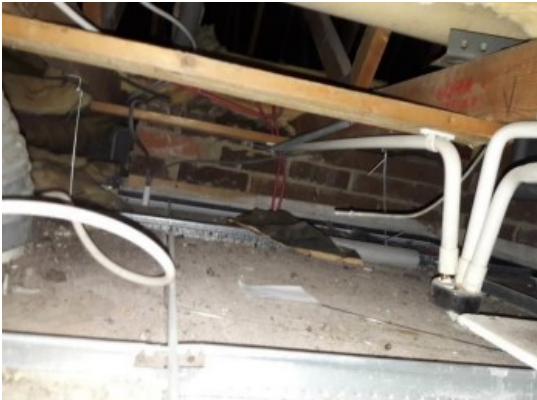
### **Item 77 Ref: BS422619**

The debris to suspended ceiling (Gents Toilets) does not contain asbestos.

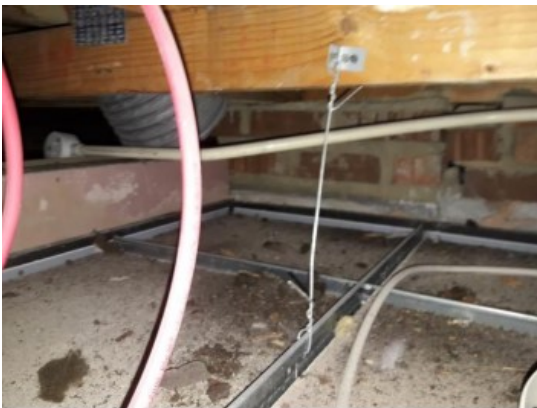
### **Item 78 Ref: BS422620**

The debris to suspended ceiling (Medical Room 2) does not contain asbestos.

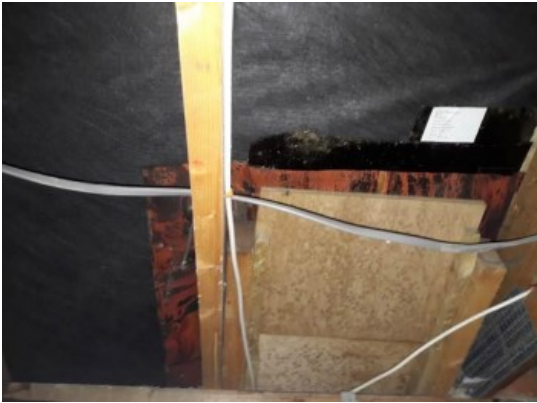
### Item 80 Ref: BS422622

The bitumen felt path to roof (Ladies Toilets) does not contain asbestos.

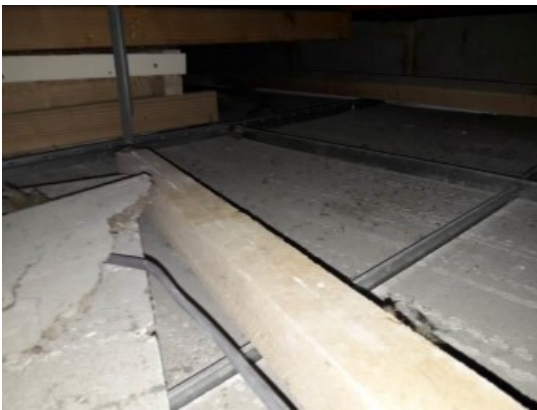
### Item 81 Ref: BS422623

The debris to suspended ceiling (Pupils Toilet) does not contain asbestos.

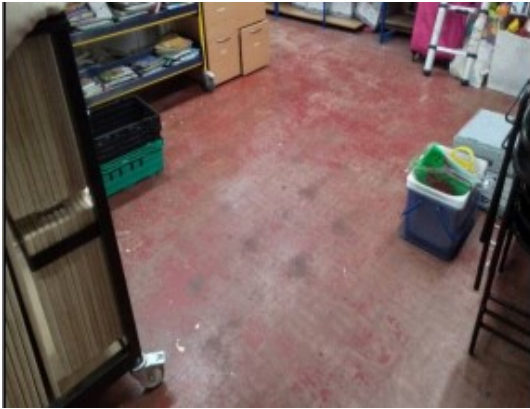
**Item 89 Ref: OQ000238**

The floor screed (Store Room G/001) does not contain asbestos.

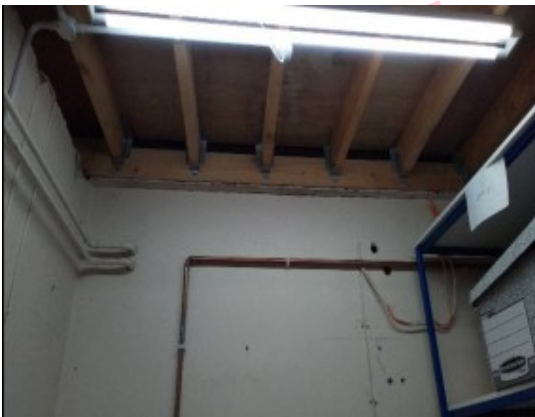
**Item 90 Ref: OQ000241**

The roof felt from external roof (Store Room G/001) does not contain asbestos.

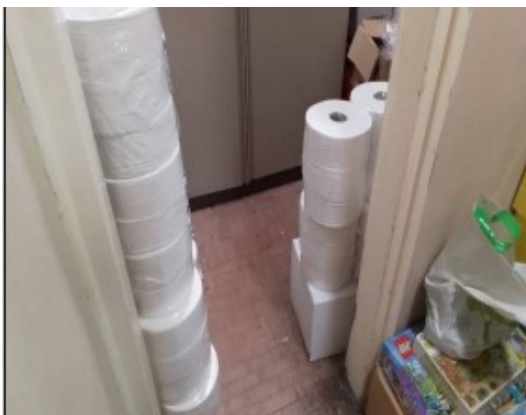
**Item 91 Ref: OQ000240**

The floor screed (Cupboard former shower G/002) does not contain asbestos.

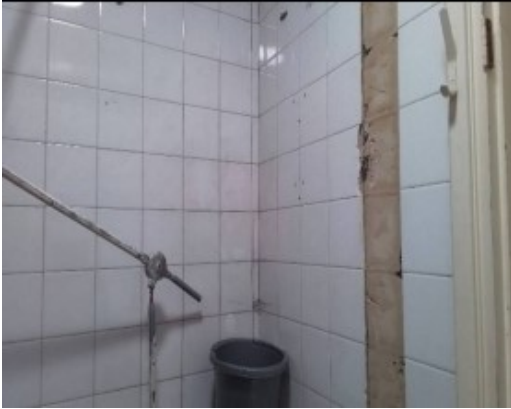
**Item 92 Ref: OQ000239**

The wall tile adhesive (Cupboard former shower G/002) does not contain asbestos.

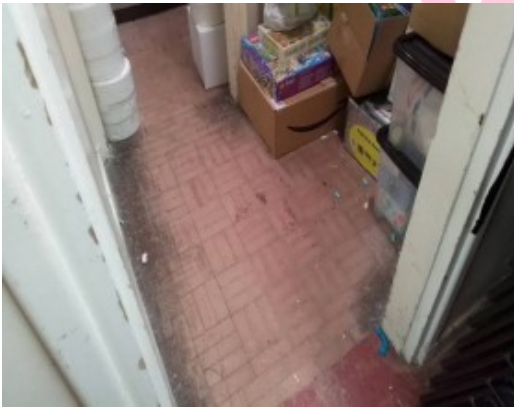
**Item 93 Ref: As OQ000240**

The floor screed (Cupboard G/003) does not contain asbestos.

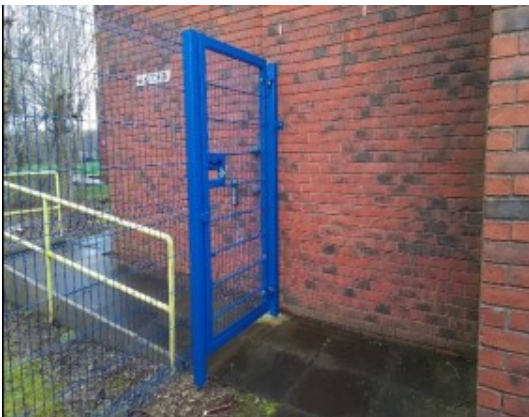
**Item 94 Ref: OQ000242**

The damp proof course (External E/001) does not contain asbestos.
