ASBESTOS SURVEY REPORT FOR EPPLETON ACADEMY PRIMARY SCHOOL, HOUGHTON

Asbestos Register for EPPLETON ACADEMY PRIMARY SCHOOL

EPPLETON PRIMARY SCHOOL

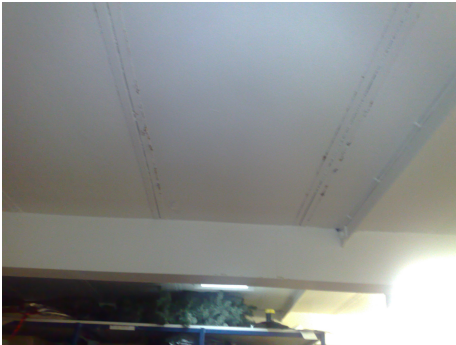
Various - Ref: NO09/201

The ceiling tiles to the store room (Area 1a) contained asbestos. This has now been removed.

Similar ceiling tiles are located in Store Rooms 1B and 1C.

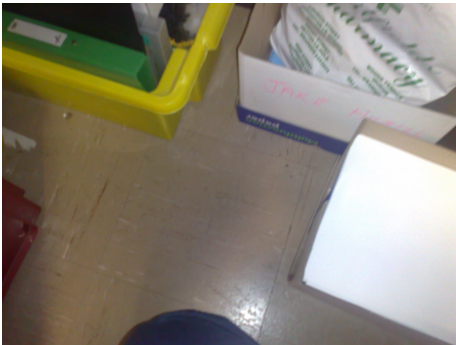
Various - Ref: NO09/202

The floor tiles to the office store contain asbestos. Any change in its appearance should be recorded and passed to Property Services.

Similar flooring is located in the Resources Rm Store, HT Store (Removed 2017), Stock Store, Music Store, Teaching Area 4 Stores, Teaching Area 3 Store, (Library Stores 1 & 2 – Removed Feb 2017), Teaching Area 2 Store and Cleaners Store.

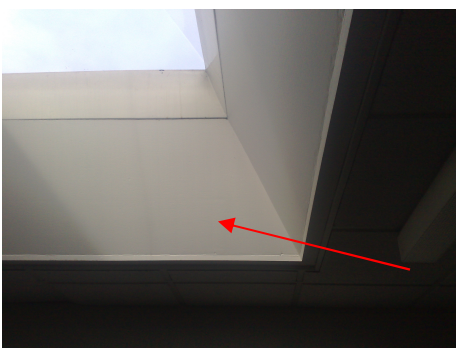
Item 7 - Ref: NO09/203

The skylight upstands to cloakroom 1 adjacent to ICT do not contain asbestos.

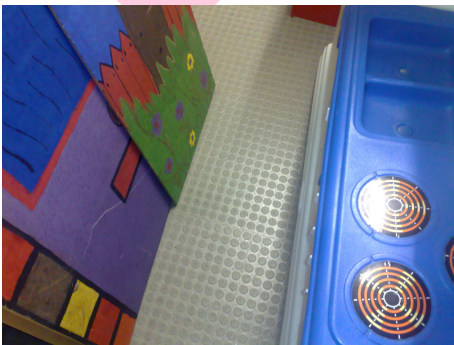
Various - Ref: Sample 08

The flooring to the Changing Room does not contain asbestos.

Similar flooring is located in the Art Store.

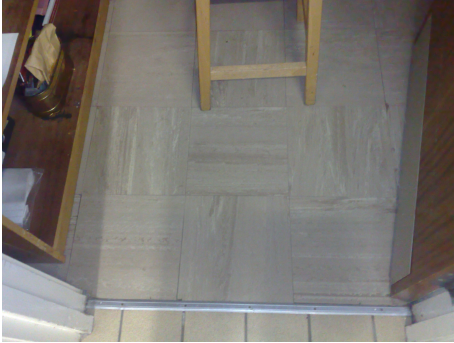
Item 19 - Ref: NO09/208

The floor tiles to the Kitchen Office do not contain asbestos.

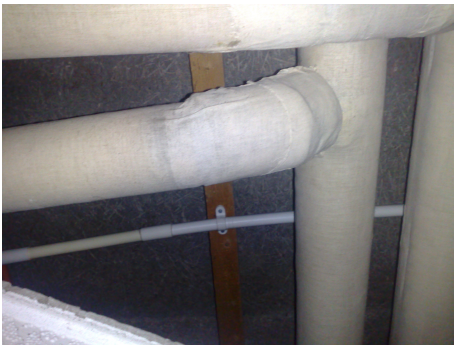
Item 20 - Ref: NO09/209

The pipe insulation to the ceiling void does not contain asbestos.

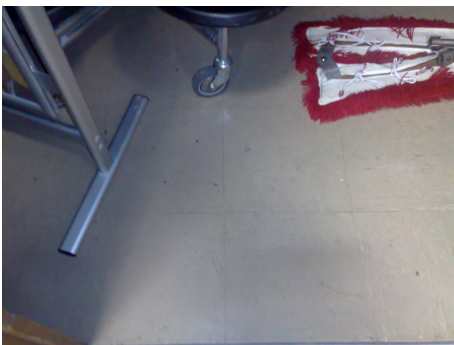
Various - Ref: NO09/210

The floor tiles to the Hall Table Store do not contain asbestos.
– These have now been removed.
Similar flooring is located in the Hall PE Store.

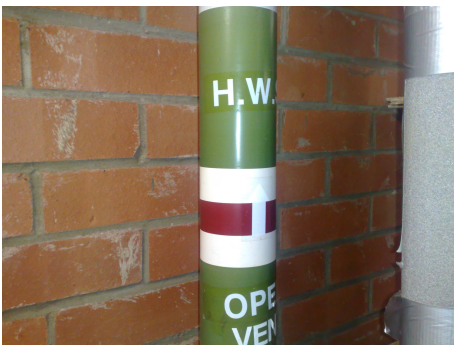
Item 25 - Ref: NO09/213

The pipe insulation to the first floor boiler house does not contain asbestos.

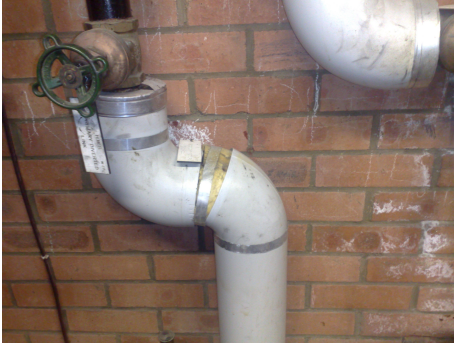
Item 26 - Ref: NO09/214

The pipe insulation to the ground floor boiler house does not contain asbestos.

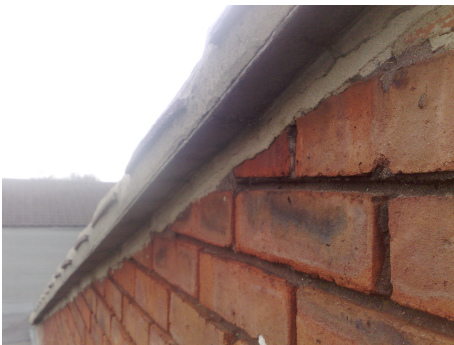
Item 28 - Ref: NO09/216

The fillet boards to the gable of the building do not contain asbestos.

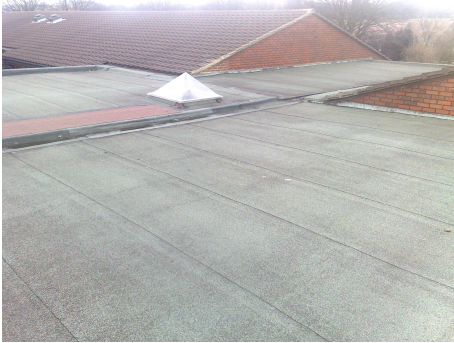
Item 29 - Ref: NO09/217

The roofing felt to the building does not contain asbestos.

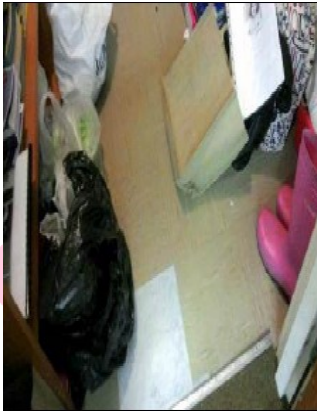
Item 30 - Ref: Presumed

The floor tiles to the Teaching Area 3 Store (Room 14) contain asbestos. Any change in its appearance should be recorded and passed to Property Services.

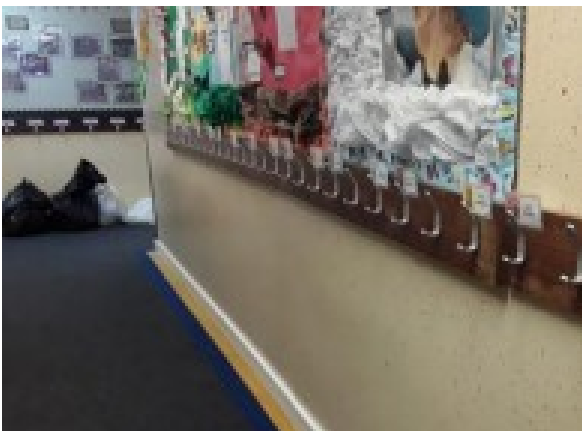
Item 31 - Ref: 21-35987-1

The textured coating to the walls in Area 1 (Hall) does not contain asbestos.

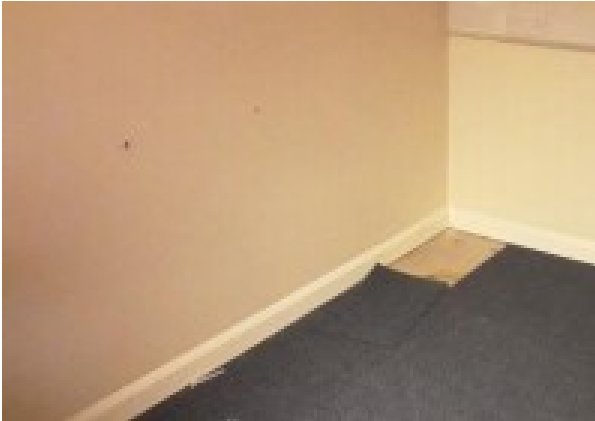
Item 32 - Ref: 21-35987-2

The asphalt floor in Area 2 (Cloakroom) does not contain asbestos.

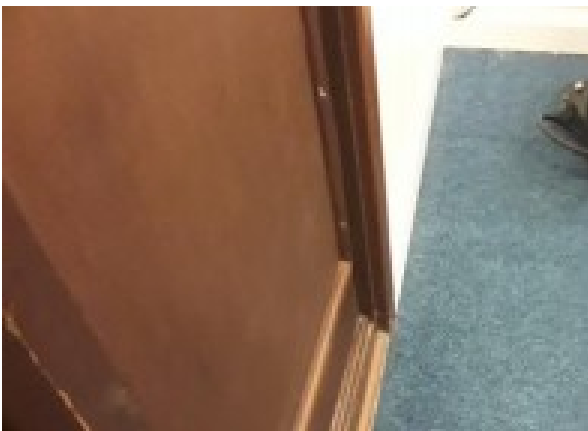
Item 33 - Ref: 21-35987-2

The asphalt floor in Area 3 (Medical Room) does not contain asbestos.

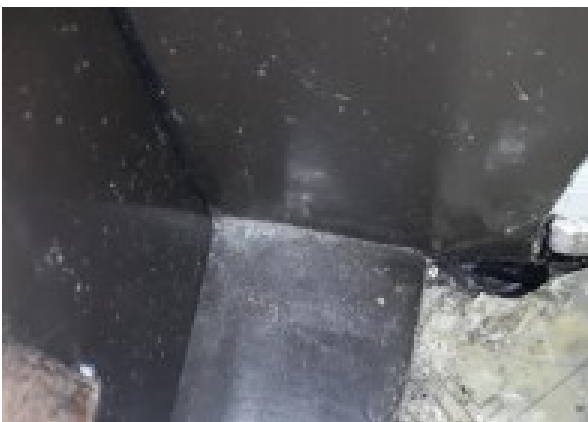
Item 34 - Ref: 21-35987-2

The asphalt floor in Area 4 (Teaching area 2) does not contain asbestos.

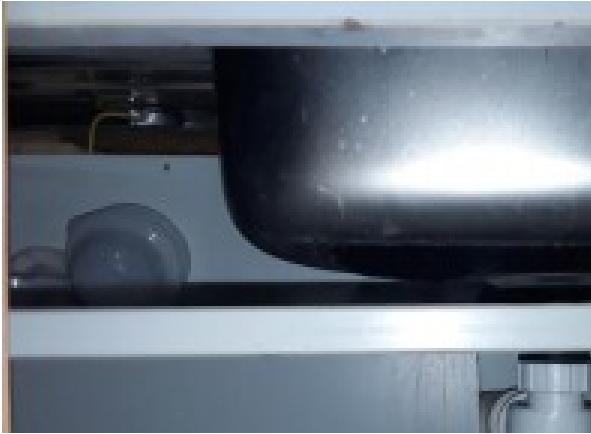
Item 35 - Ref: 21-35987-3

The sink pad in Area 4 (Teaching area 2) does not contain asbestos.

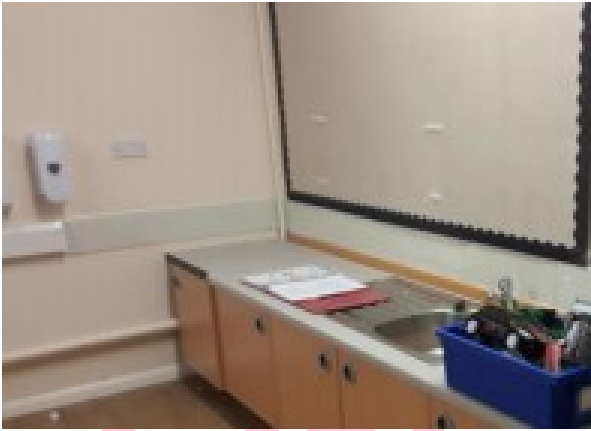
Item 36 - Ref: 21-35987-4

The adhesive to ceramic tiles to wall on area 4 (Teaching area 2) does not contain asbestos.

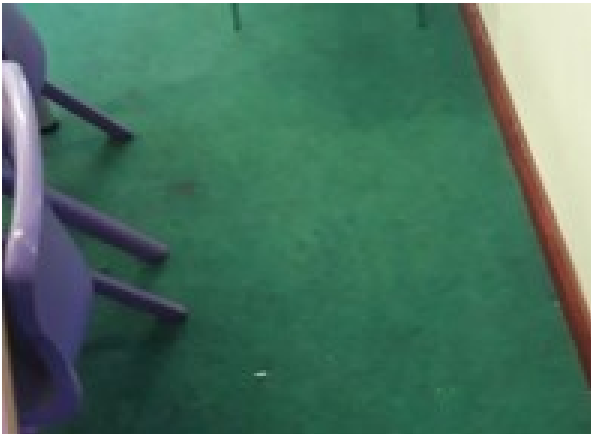
Item 37 - Ref: 21-35987-2

The floor screed beneath the floor in Area 5 (Classroom) does not contain asbestos.

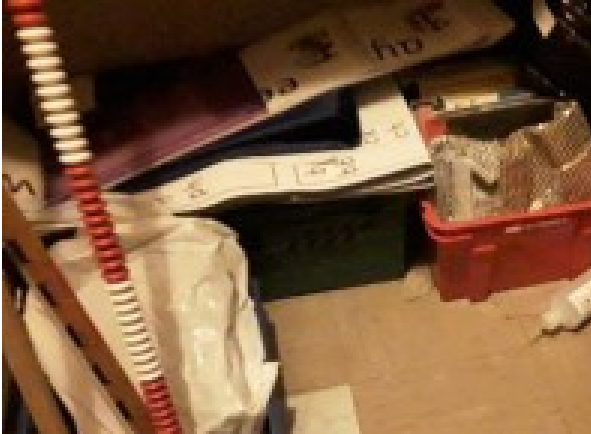
Item 38 - Ref: 21-35987-5

The floor tiles and adhesive in Area 6 (Store Cupboard) contains asbestos.

Any change in appearance should be reported to Property Services.

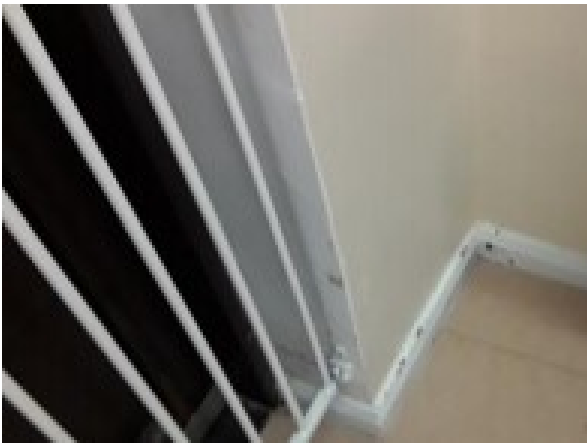
Item 39 - Ref: 21-35987-2

The asphalt floor beneath floor screed in Area 7 (Classroom) does not contain asbestos.

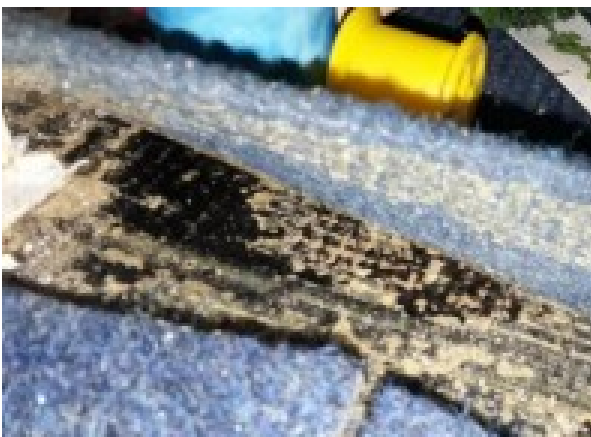
Item 40 - Ref: 21-35987-6

The residual adhesive to the floor in Area 8 (Store Cupboard) contains asbestos.

Any change in appearance should be reported to Property Services.

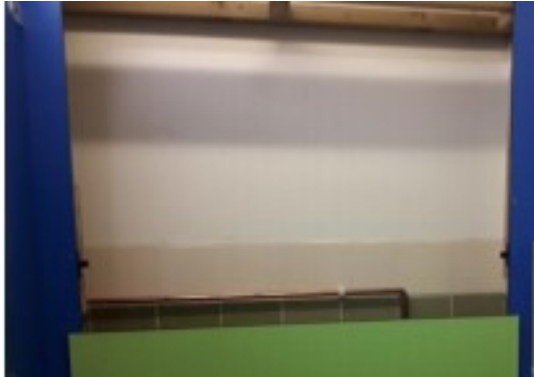
Item 41 - Ref: 21-35987-7

The adhesive to ceramic wall tiles in Area 10 (Boys Toilets) does not contain asbestos.

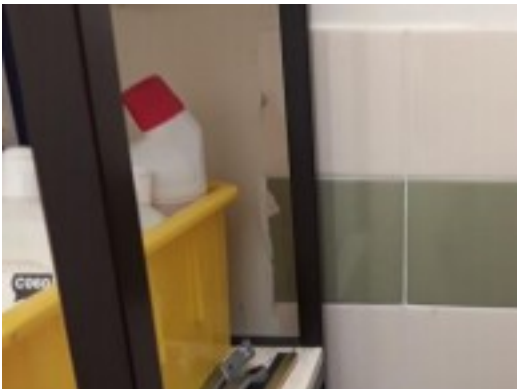
Item 42 - Ref: 21-35987-7

The adhesive to ceramic wall tiles in Area 14 (Cleaners Cupboard) does not contain asbestos.

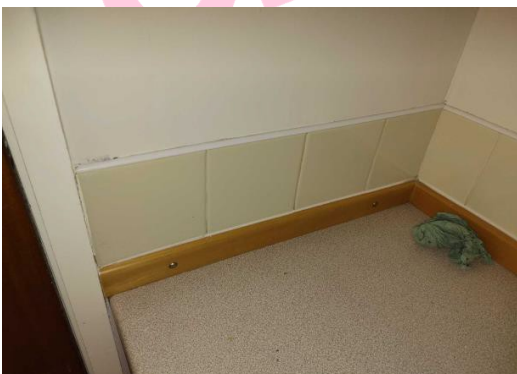
Item 43 Ref: 22-50674-1

The adhesive behind ceramic tiles (Area 1/Upper KS2 Cloakroom) does not contain asbestos.

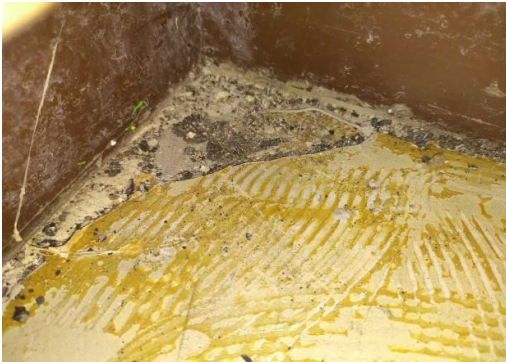
Item 44 Ref: 22-50674-2

The black composite floor (Area 1/Upper KS2 Cloakroom) does not contain asbestos.

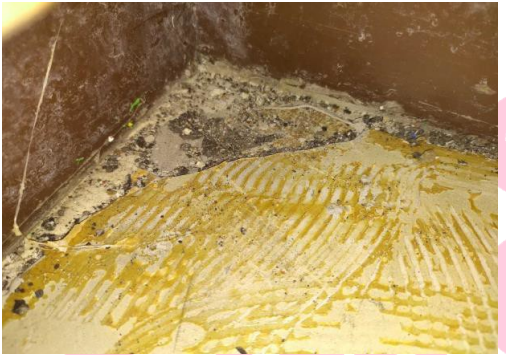
Item 45 Ref: 22-50674-7

The brown adhesive residue below modern screed (Area 1/Upper KS2 Cloakroom) does not contain asbestos.

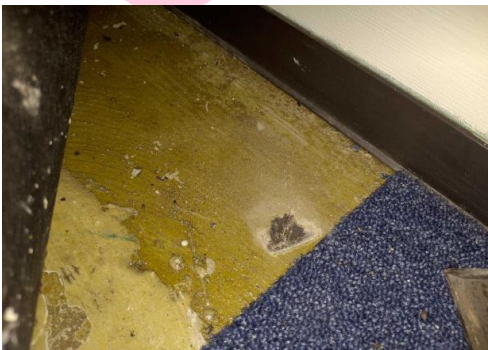
Item 46 Ref: 22-50674-2

The black composite floor (Area 2/Year 6 Classroom) does not contain asbestos.

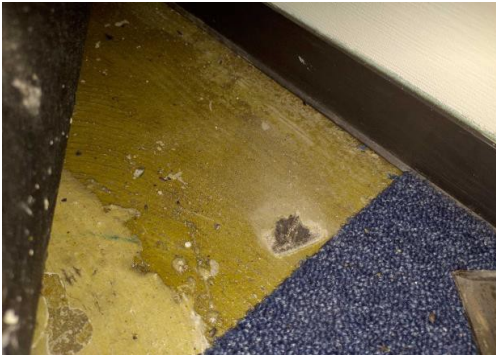
Item 47 Ref: 22-50674-7

The brown adhesive residue below modern screed (Adhesive) (Area 2/Year 6 Classroom) does not contain asbestos.

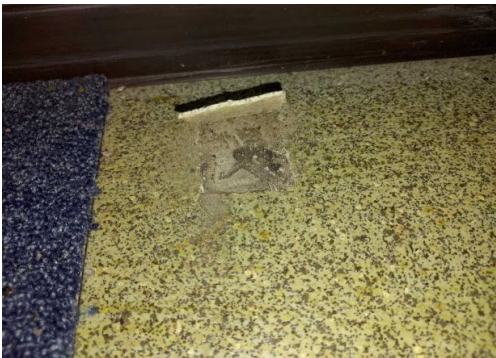
Item 48 Ref: 22-50674-2

The black composite floor (Resin) (Area 3/Year 5 Classroom) does not contain asbestos.

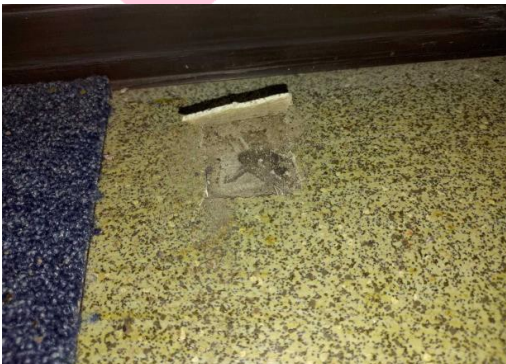
Item 49 Ref: 22-50674-7

The brown adhesive residue below modern screed (Adhesive) (Area 3/Year 5 Classroom) does not contain asbestos.

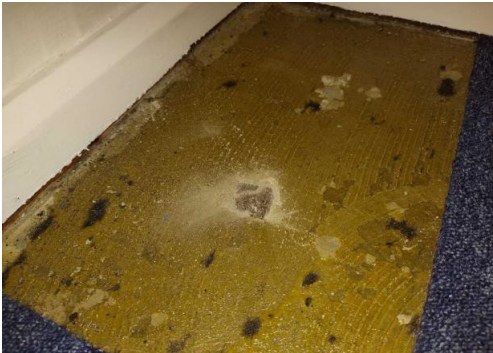
Item 50 Ref: 22-50674-2

The black composite floor (Resin) (Area 4/Year 4 Classroom) does not contain asbestos.

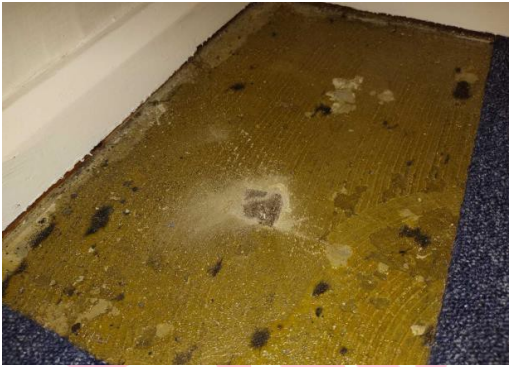
Item 51 Ref: 22-50674-2

The brown adhesive residue below modern screed (Adhesive) (Area 4/Year 4 Classroom) does not contain asbestos.

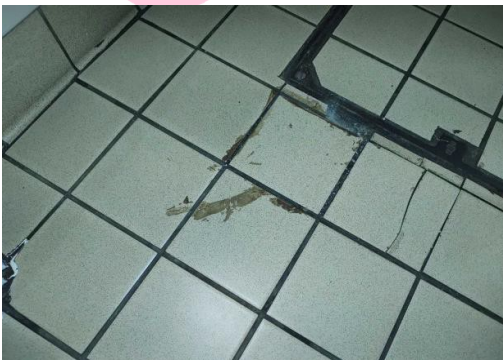
Item 52 Ref: 22-50674-4

The adhesive below ceramic floor tiles (Area 5/Boys Toilet) does not contain asbestos.

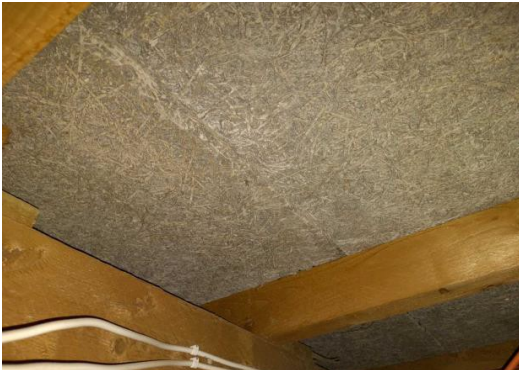
Item 53 Ref: 22-50674-5

The flat roof underside above suspended ceiling (Area 5/Boys Toilet) does not contain asbestos.

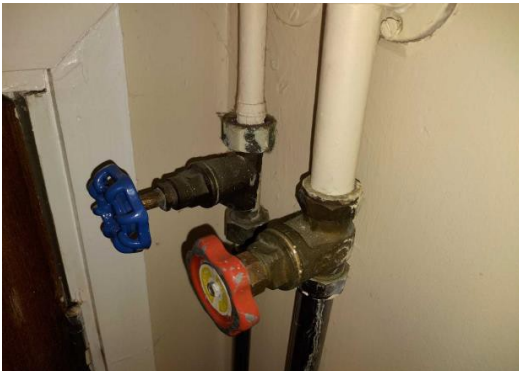
Item 54 Ref: 22-50674-6

The pipes stop taps (Gaskets) (Area 5/Boys Toilet) contain asbestos.

Any change in appearance should be reported to Property Services.

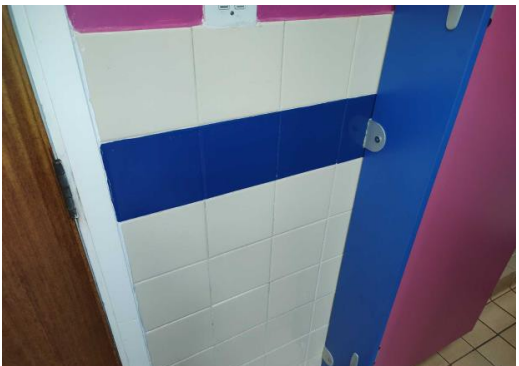
Item 55 Ref: 22-50674-3

The adhesive behind ceramic tiles (Area 6/Girls Toilet) does not contain asbestos.

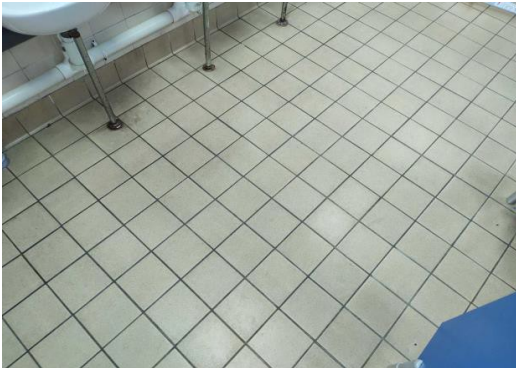
Item 56 Ref: 22-50674-4

The adhesive below ceramic floor tiles (Area 6/Girls Toilet) does not contain asbestos.

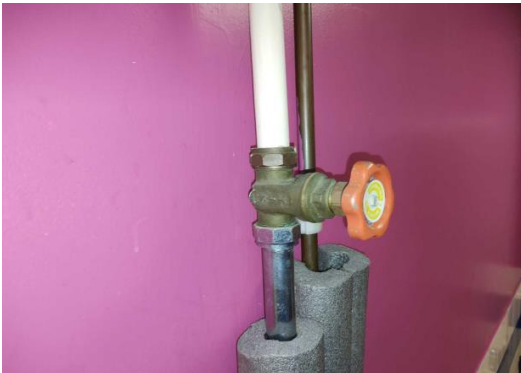
Item 57 Ref: 22-50674-6

The pipes stop taps (Gaskets) (Area 6/Girls Toilet) contain asbestos.

Any change in appearance should be reported to Property Services.

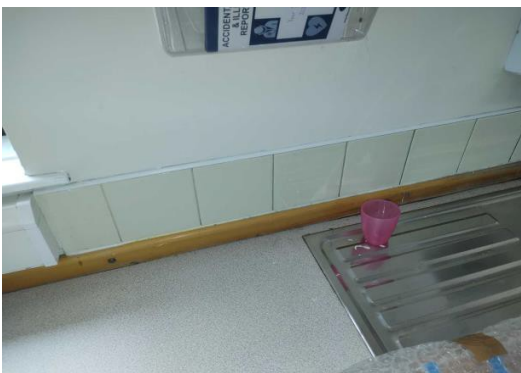
Item 58 Ref: 22-50674-1

The adhesive behind ceramic tiles (Area 7/Lower KS2 Cloakroom) does not contain asbestos.

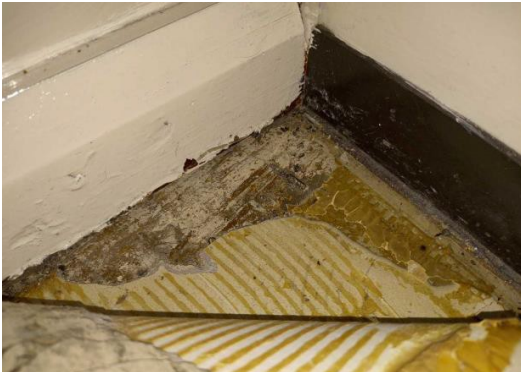
Item 59 Ref: 22-50674-2

The black composite floor (Area 7/Lower KS2 Cloakroom) does not contain asbestos.

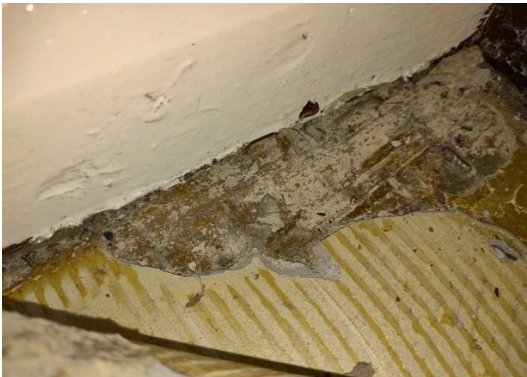
Item 60 Ref: 22-50674-7

The brown adhesive residue below modern screed (Area 7/Lower KS2 Cloakroom) does not contain asbestos.

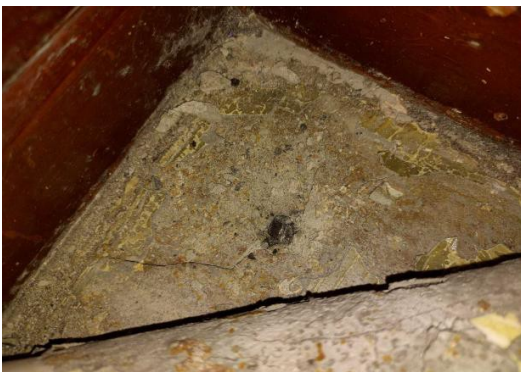
Item 61 Ref: 22-50674-2

The black composite floor (Area 8/Lower KS2 Classroom 1) does not contain asbestos.

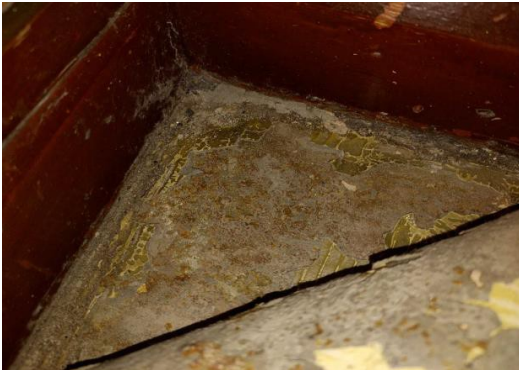
Item 62 Ref: 22-50674-7

The brown adhesive residue below modern screed (Area 8/Lower KS2 Classroom 1) does not contain asbestos.

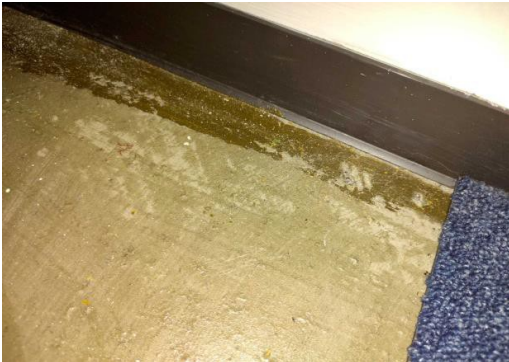
Item 63 Ref: 22-50674-2

The black composite floor (Area 9/Lower KS2 Classroom 2) does not contain asbestos.

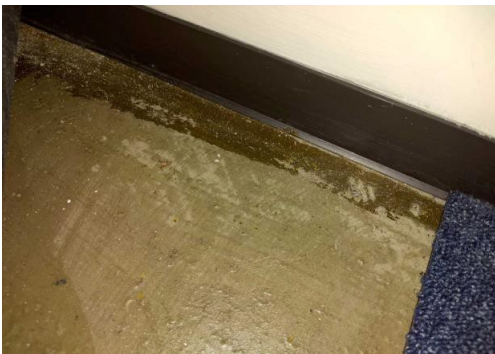
Item 64 Ref: 22-50674-7

The brown adhesive residue below modern screed (Area 9/Lower KS2 Classroom 2) does not contain asbestos.

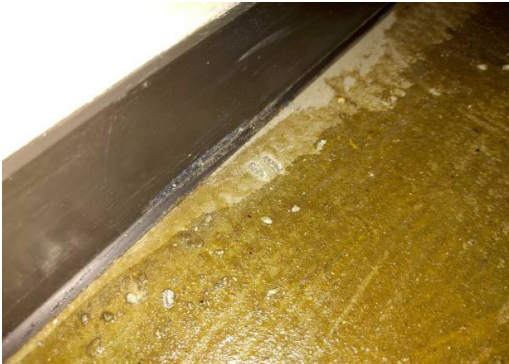
Item 65 Ref: 22-50674-2

The black composite floor (Area 10/Lower KS2 Classroom 3) does not contain asbestos.

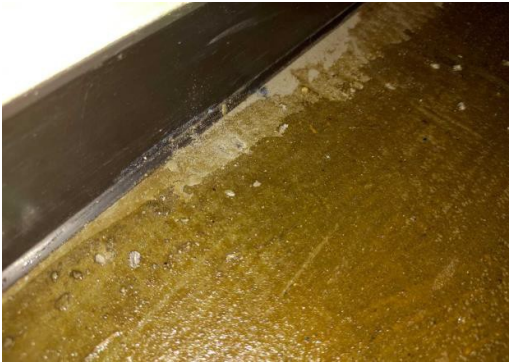
Item 66 Ref: 22-50674-7

The brown adhesive residue below modern screed (Area 10/Lower KS2 Classroom 3) does not contain asbestos.

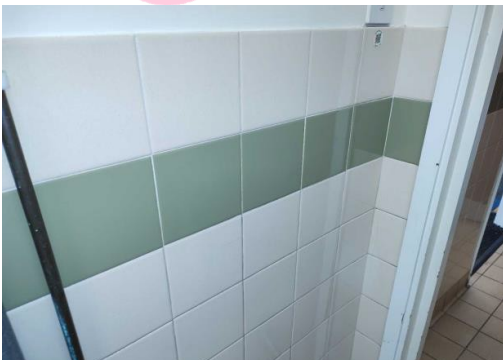
Item 67 Ref: 22-50674-3

The adhesive behind ceramic tiles (Area 11/Shared Toilet) does not contain asbestos.

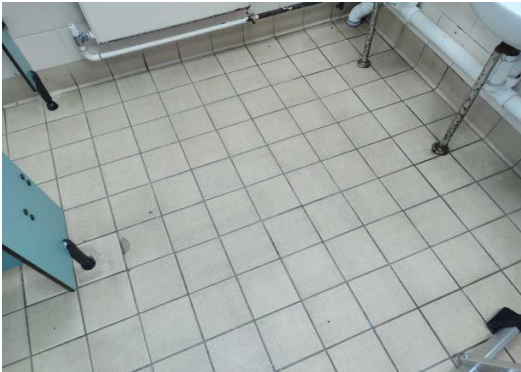
Item 68 Ref: 22-50674-4

The adhesive below ceramic floor tiles (Area 11/Shared Toilet) does not contain asbestos.

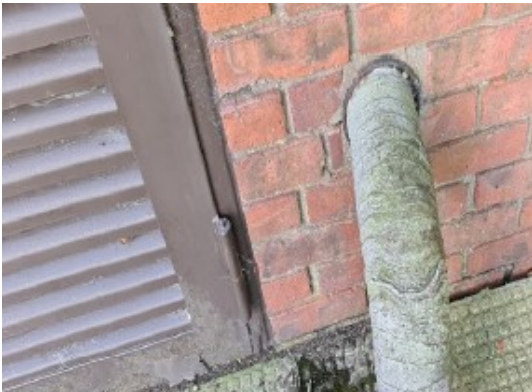
Item 69 Ref: 23/8/B/11/JGS7

The Tape wrapping to gas inlet pipe (External) does not contain asbestos.

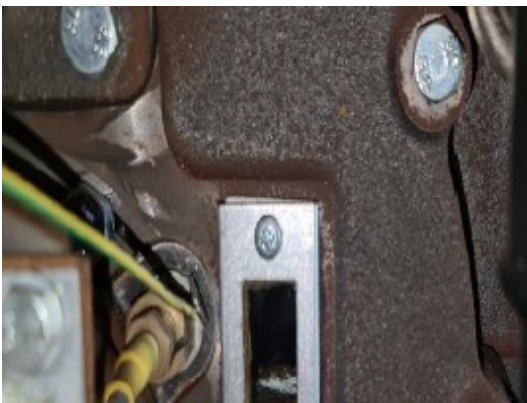
Item 70 Ref: 23/8/B/11/JGS1

The Internal boiler pilot light sight glass gasket (Boiler Room) does not contain asbestos.

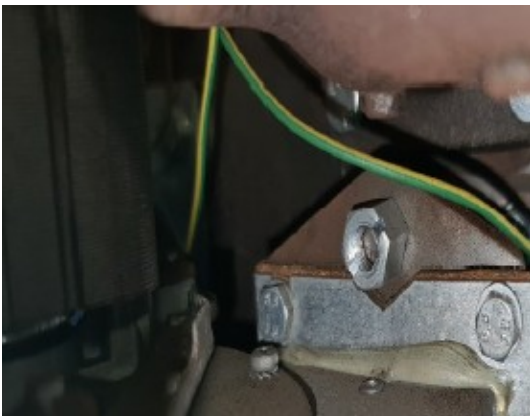
Item 71 Ref: 23/8/B/11/JGS2

The Internal boiler pump gasket (Boiler Room) does not contain asbestos.

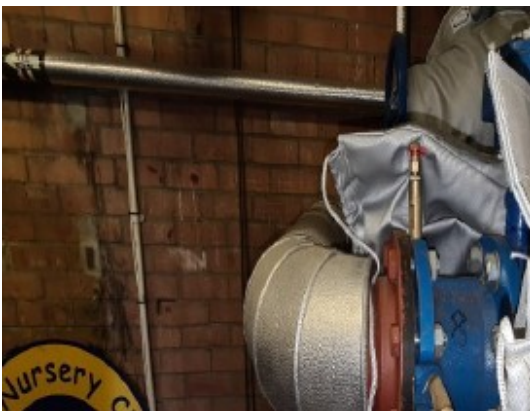
Item 72 Ref: 23/8/B/11/JGS3

The Pipework flange gaskets (Boiler Room) does not contain asbestos.

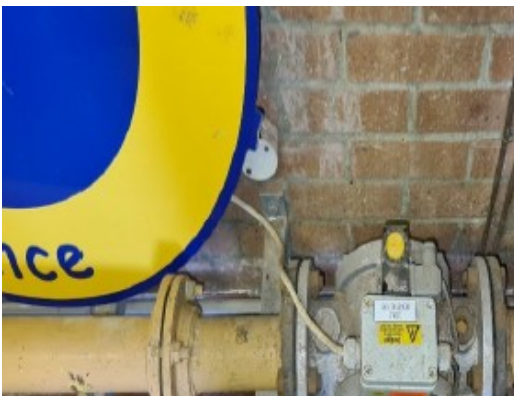
Item 73 Ref: 23/8/B/11/JGS4

The Gas pipework flange joints gaskets (Boiler Room) does not contain asbestos.

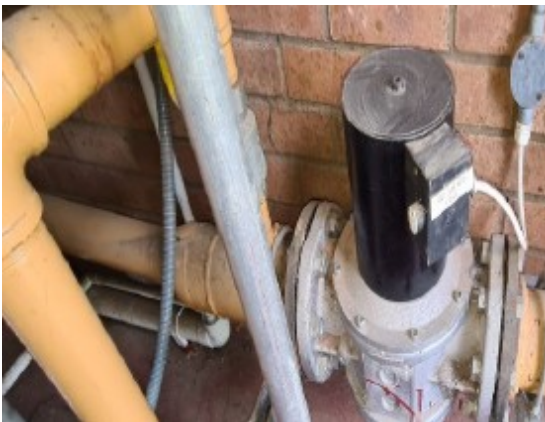
Item 74 Ref: 23/8/B/11/JGS5

The Insulation valve joints putty (Boiler Room) does not contain asbestos.

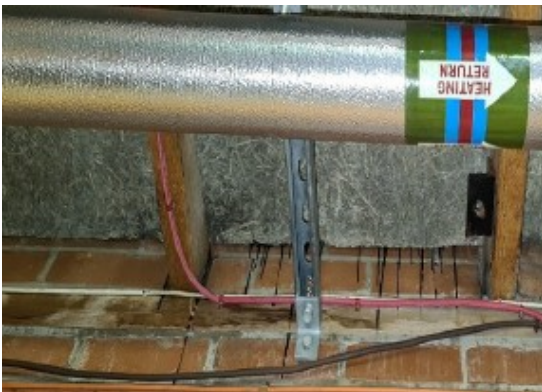
Item 75 Ref: 23/8/B/11/JGS6

The High level walls/roof bitumen pitch residuals (Boiler Room) does not contain asbestos.

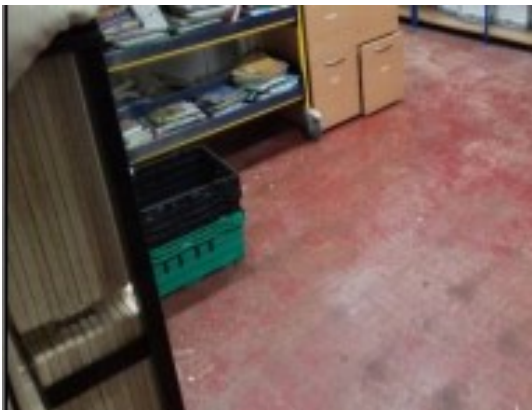
Item 89 Ref: OQ000238

The floor screed (Store Room G/001) does not contain asbestos.

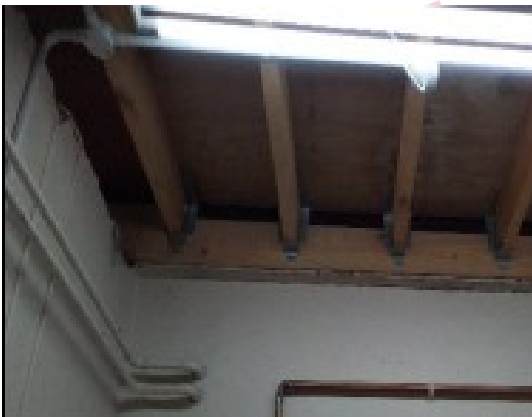
Item 90 Ref: OQ000241

The roof felt from external roof (Store Room G/001) does not contain asbestos.

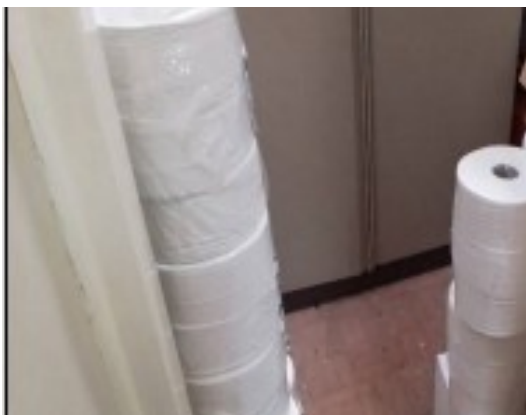
Item 91 Ref: OQ000240

The floor screed (Cupboard former shower G/002) does not contain asbestos.

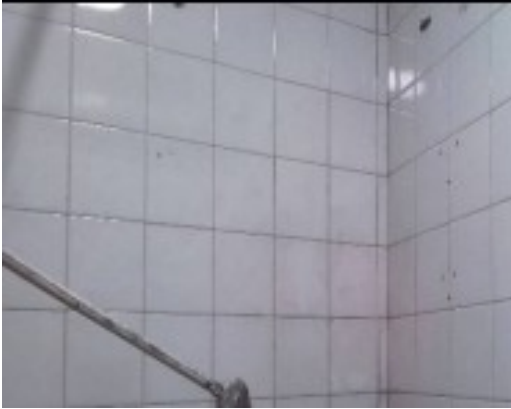
Item 92 Ref: OQ000239

The wall tile adhesive (Cupboard former shower G/002) does not contain asbestos.

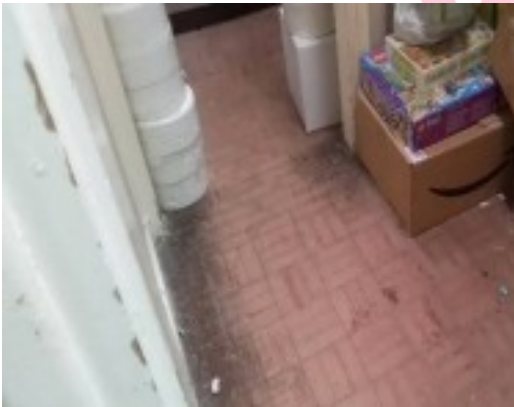
Item 93 Ref: As OQ000240

The floor screed (Cupboard G/003) does not contain asbestos.

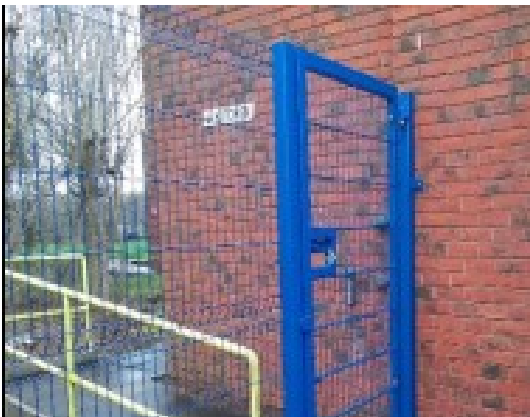
Item 94 Ref: OQ000242

The damp proof course (External E/001) does not contain asbestos.
