ASBESTOS SURVEY REPORT FOR EPPLETON ACADEMY PRIMARY SCHOOL, HOUGHTON

Asbestos Register for EPPLETON ACADEMY PRIMARY SCHOOL

Date: 19th May 2025

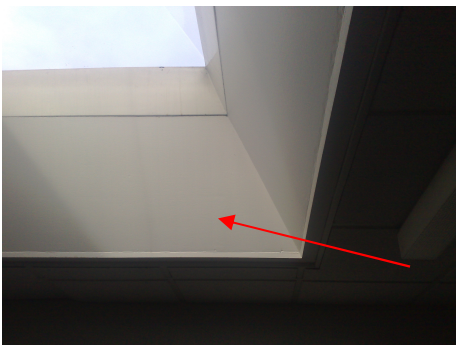
Item 7 - Ref: NO09/203

The skylight upstands to cloakroom 1 adjacent to ICT do not contain asbestos.

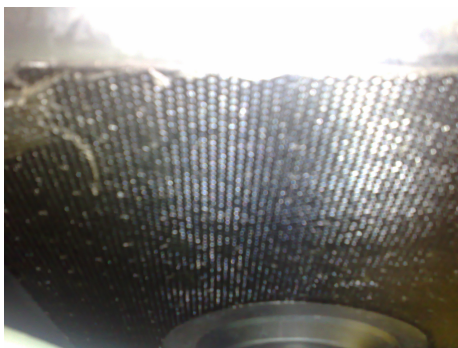
Item 09 - Ref: NO09/204

The sink pad to Teaching Area 4 does not contain asbestos.

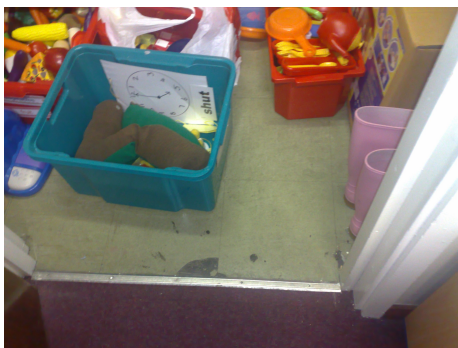
Item 16 - Ref: NO09/206

The floor tiles to the Reception Class Stores 1 & 2 do not contain asbestos.

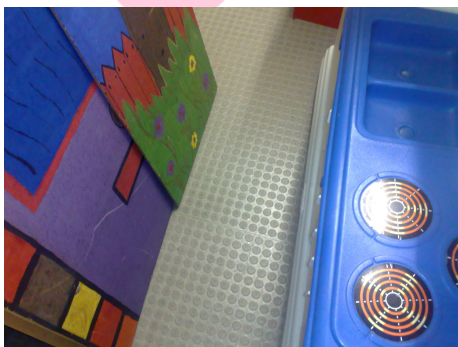
Various - Ref: Sample 08

The flooring to the Changing Room does not contain asbestos.

Similar flooring is located in the Art Store.

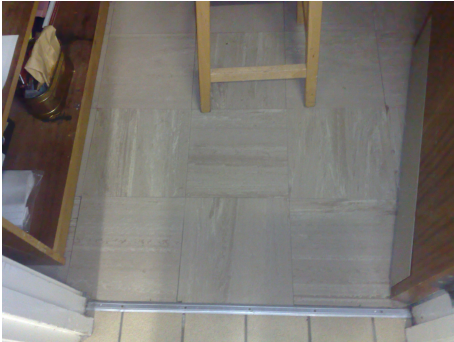
Item 19 - Ref: NO09/208

The floor tiles to the Kitchen Office do not contain asbestos.

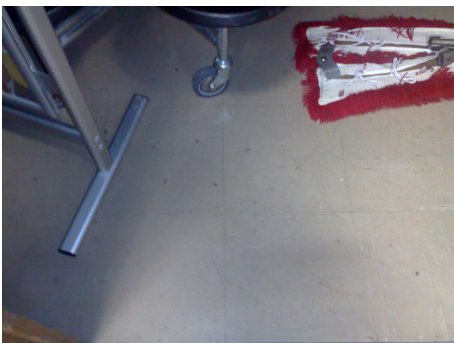
Various - Ref: NO09/210

The floor tiles to the Hall Table Store do not contain asbestos.
– These have now been removed.
Similar flooring is located in the Hall PE Store.

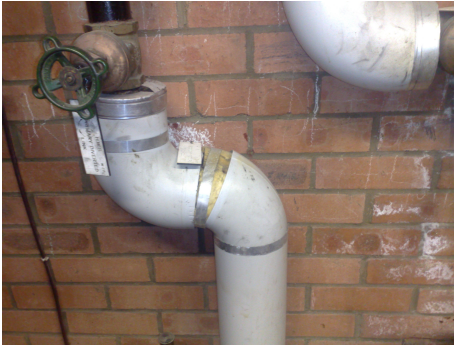
Item 26 - Ref: NO09/214

The pipe insulation to the ground floor boiler house does not contain asbestos.

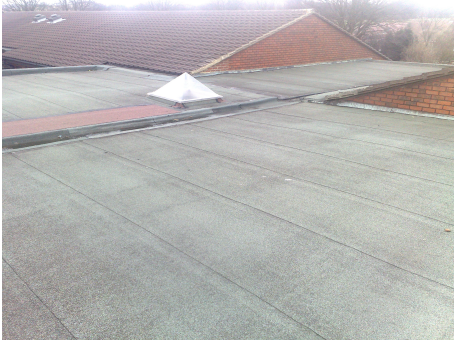
Item 29 - Ref: NO09/217

The roofing felt to the building does not contain asbestos.

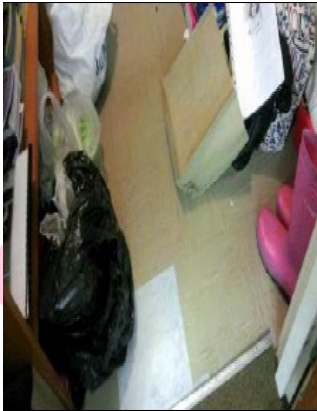
Item 30 - Ref: Presumed

The floor tiles to the Teaching Area 3 Store (Room 14) contain asbestos. Any change in its appearance should be recorded and passed to Property Services.

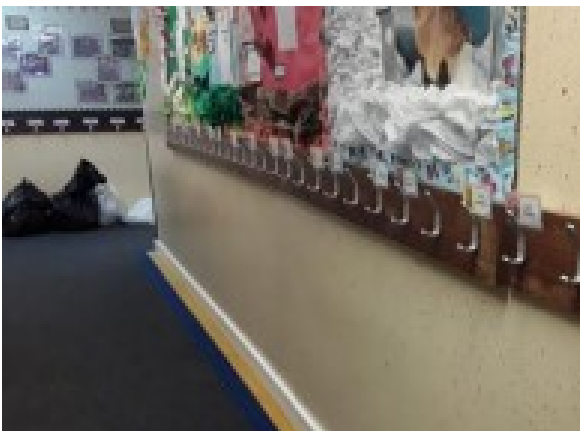
Item 31 - Ref: 21-35987-1

The textured coating to the walls in Area 1 (Hall) does not contain asbestos.

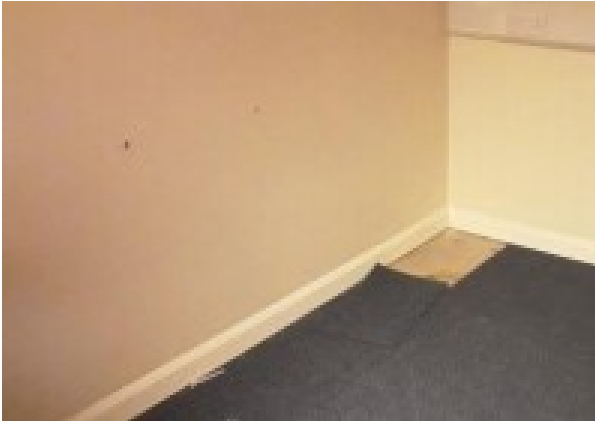
Item 32 - Ref: 21-35987-2

The asphalt floor in Area 2 (Cloakroom) does not contain asbestos.

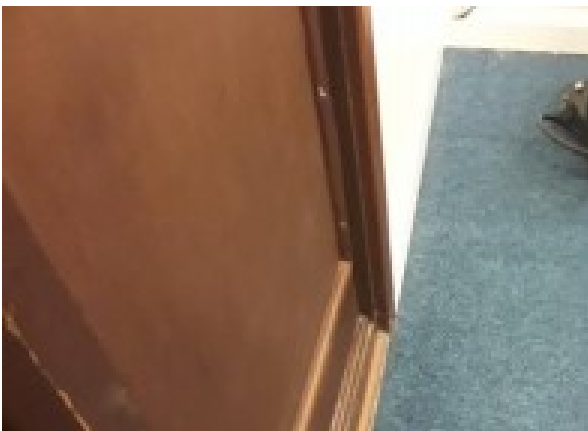
Item 33 - Ref: 21-35987-2

The asphalt floor in Area 3 (Medical Room) does not contain asbestos.

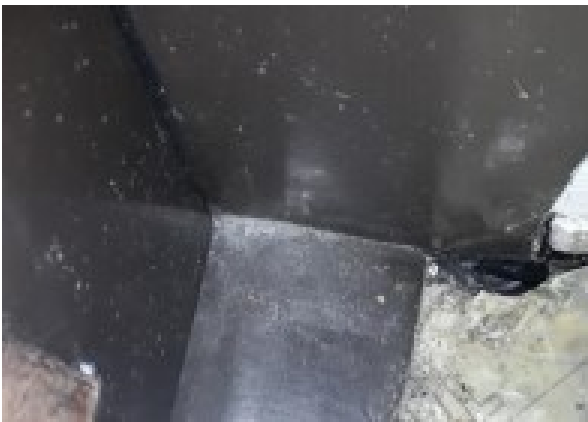
Item 34 - Ref: 21-35987-2

The asphalt floor in Area 4 (Teaching area 2) does not contain asbestos.

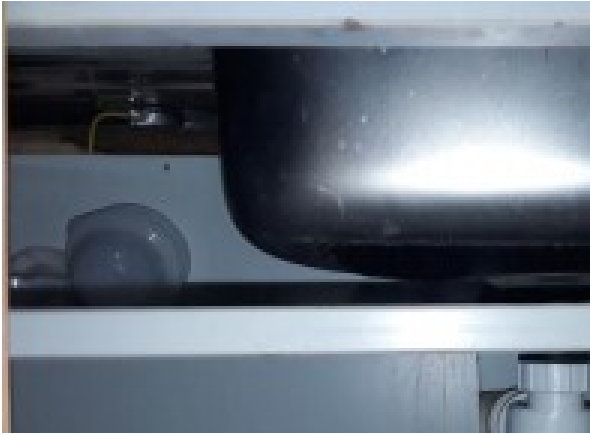
Item 35 - Ref: 21-35987-3

The sink pad in Area 4 (Teaching area 2) does not contain asbestos.

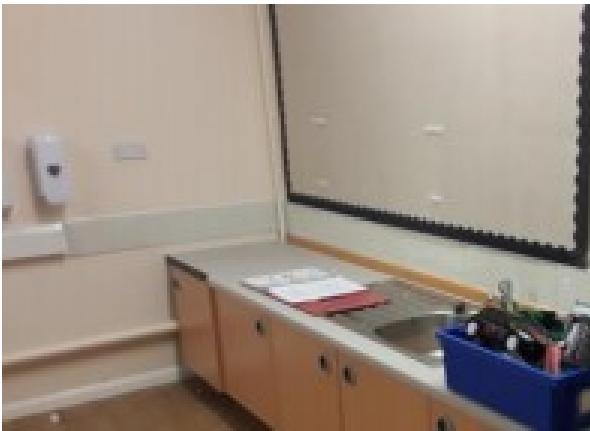
Item 36 - Ref: 21-35987-4

The adhesive to ceramic tiles to wall on area 4 (Teaching area 2) does not contain asbestos.

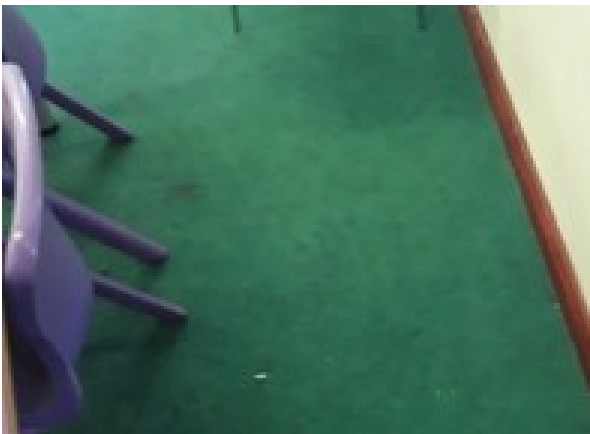
Item 37 - Ref: 21-35987-2

The floor screed beneath the floor in Area 5 (Classroom) does not contain asbestos.

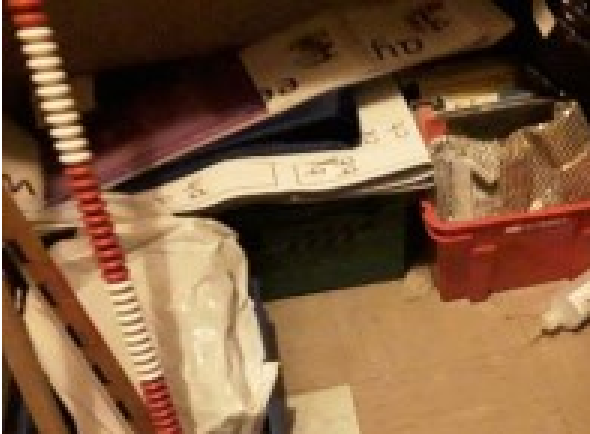
Item 38 - Ref: 21-35987-5

The floor tiles and adhesive in Area 6 (Store Cupboard) contains asbestos.

Any change in appearance should be reported to Property Services.

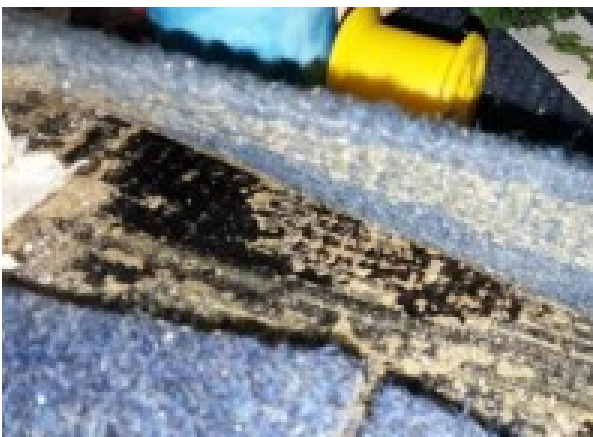
Item 40 - Ref: 21-35987-6

The residual adhesive to the floor in Area 8 (Store Cupboard) contains asbestos.

Any change in appearance should be reported to Property Services.

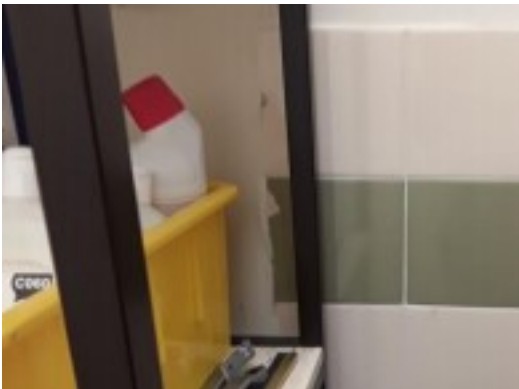
Item 42 - Ref: 21-35987-7

The adhesive to ceramic wall tiles in Area 14 (Cleaners Cupboard) does not contain asbestos.

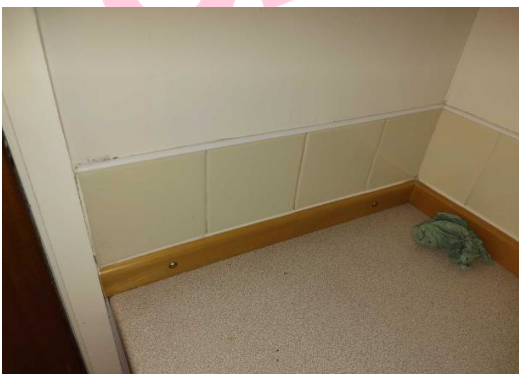
Item 43 Ref: 22-50674-1

The adhesive behind ceramic tiles (Area 1/Upper KS2 Cloakroom) does not contain asbestos.

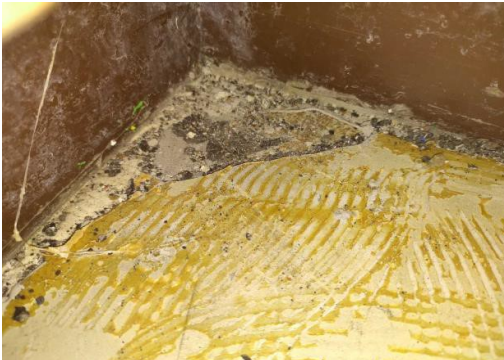
Item 44 Ref: 22-50674-2

The black composite floor (Area 1/Upper KS2 Cloakroom) does not contain asbestos.

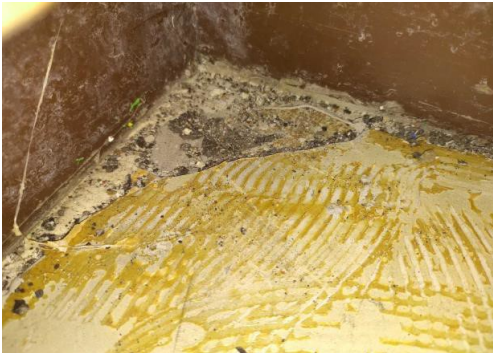
Item 45 Ref: 22-50674-7

The brown adhesive residue below modern screed (Area 1/Upper KS2 Cloakroom) does not contain asbestos.

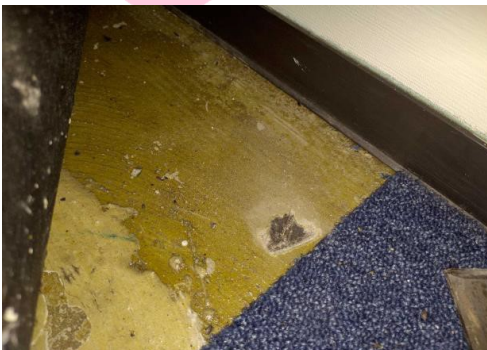
Item 46 Ref: 22-50674-2

The black composite floor (Area 2/Year 6 Classroom) does not contain asbestos.

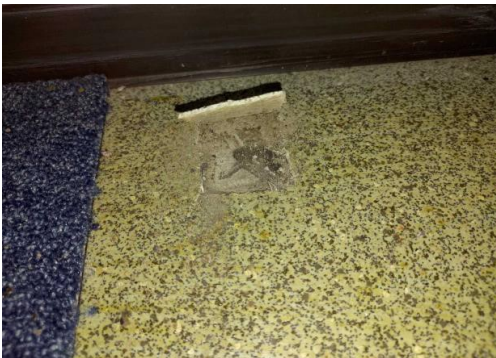
Item 48 Ref: 22-50674-2

The black composite floor (Resin) (Area 3/Year 5 Classroom) does not contain asbestos.

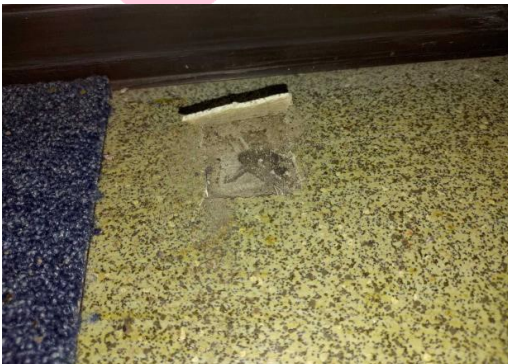
Item 49 Ref: 22-50674-7

The brown adhesive residue below modern screed (Adhesive) (Area 3/Year 5 Classroom) does not contain asbestos.

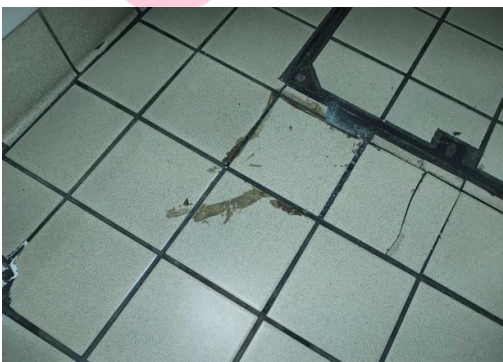
Item 52 Ref: 22-50674-4

The adhesive below ceramic floor tiles (Area 5/Boys Toilet) does not contain asbestos.

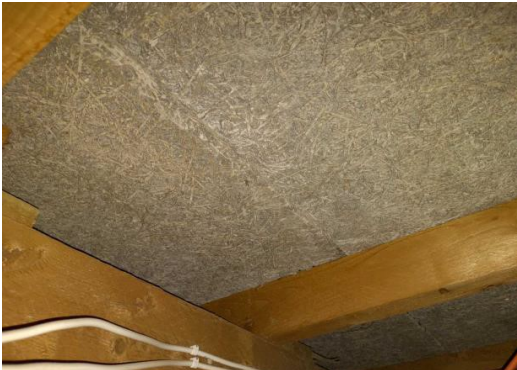
Item 53 Ref: 22-50674-5

The flat roof underside above suspended ceiling (Area 5/Boys Toilet) does not contain asbestos.

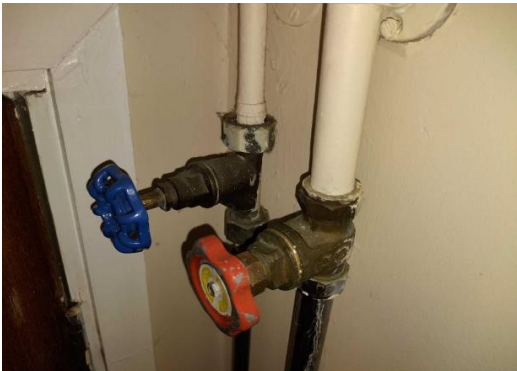
Item 54 Ref: 22-50674-6

The pipes stop taps (Gaskets) (Area 5/Boys Toilet) contain asbestos.

Any change in appearance should be reported to Property Services.

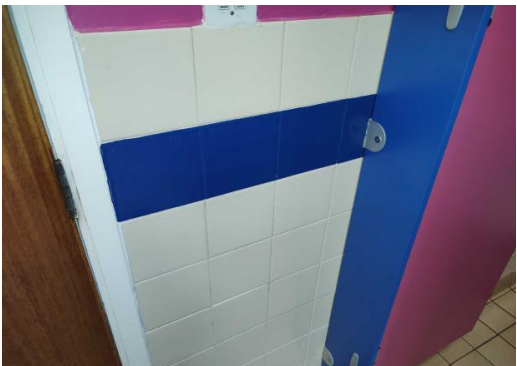
Item 55 Ref: 22-50674-3

The adhesive behind ceramic tiles (Area 6/Girls Toilet) does not contain asbestos.

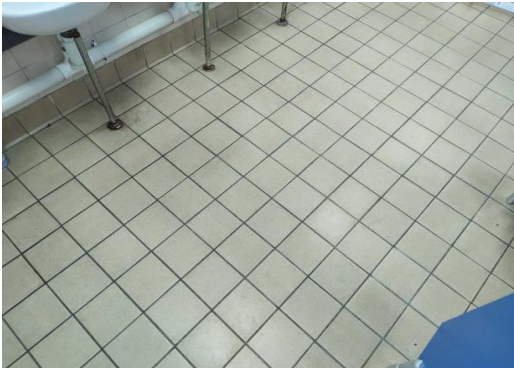
Item 56 Ref: 22-50674-4

The adhesive below ceramic floor tiles (Area 6/Girls Toilet) does not contain asbestos.

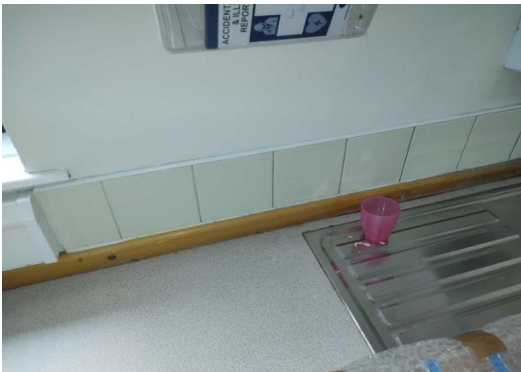
Item 58 Ref: 22-50674-1

The adhesive behind ceramic tiles (Area 7/Lower KS2 Cloakroom) does not contain asbestos.

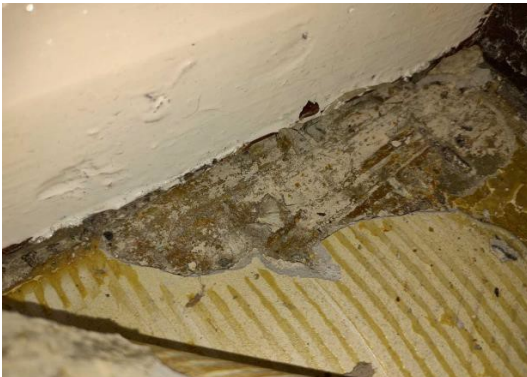
Item 60 Ref: 22-50674-7

The brown adhesive residue below modern screed (Area 7/Lower KS2 Cloakroom) does not contain asbestos.

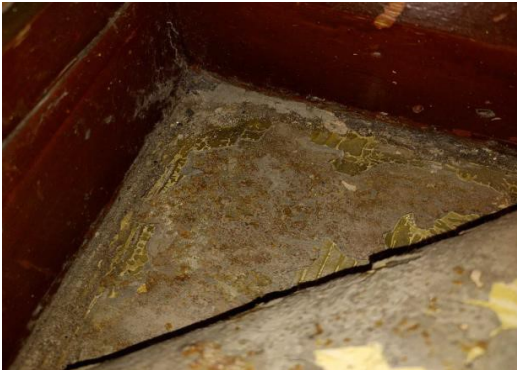
Item 62 Ref: 22-50674-7

The brown adhesive residue below modern screed (Area 8/Lower KS2 Classroom 1) does not contain asbestos.

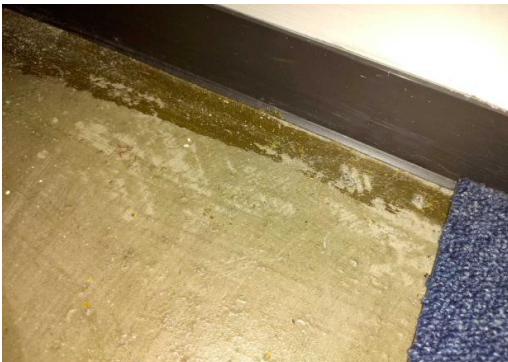
Item 63 Ref: 22-50674-2

The black composite floor (Area 9/Lower KS2 Classroom 2) does not contain asbestos.

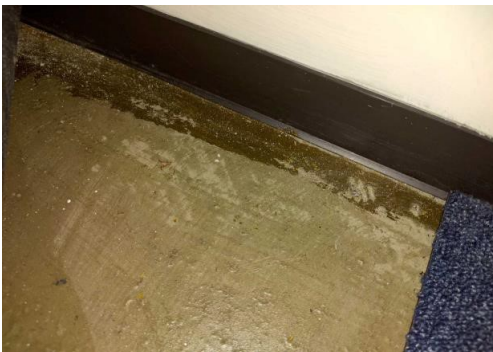
Item 64 Ref: 22-50674-7

The brown adhesive residue below modern screed (Area 9/Lower KS2 Classroom 2) does not contain asbestos.

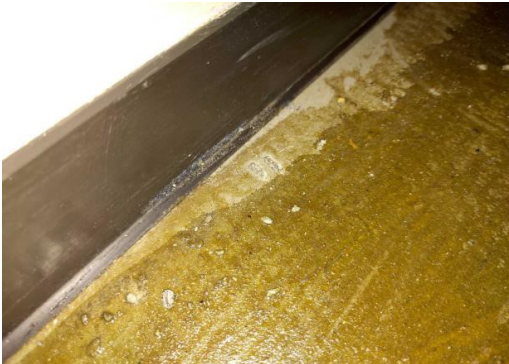
Item 65 Ref: 22-50674-2

The black composite floor (Area 10/Lower KS2 Classroom 3) does not contain asbestos.

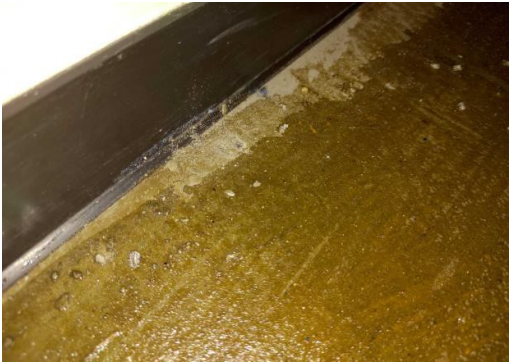
Item 66 Ref: 22-50674-7

The brown adhesive residue below modern screed (Area 10/Lower KS2 Classroom 3) does not contain asbestos.

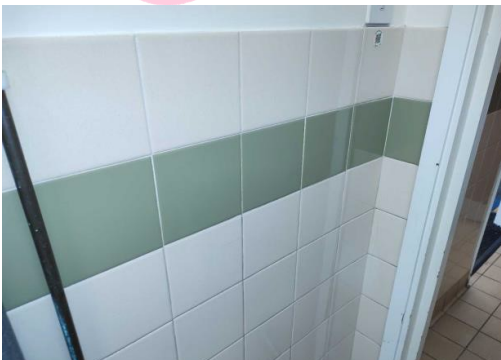
Item 67 Ref: 22-50674-3

The adhesive behind ceramic tiles (Area 11/Shared Toilet) does not contain asbestos.

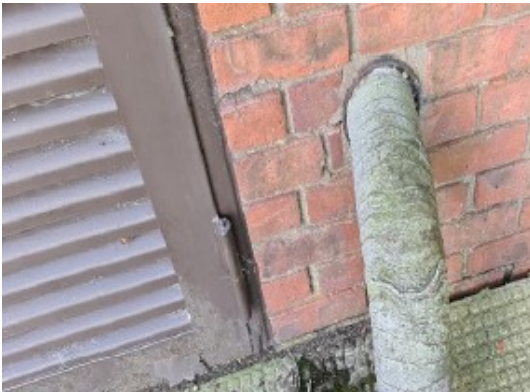
Item 69 Ref: 23/8/B/11/JGS7

The Tape wrapping to gas inlet pipe (External) does not contain asbestos.

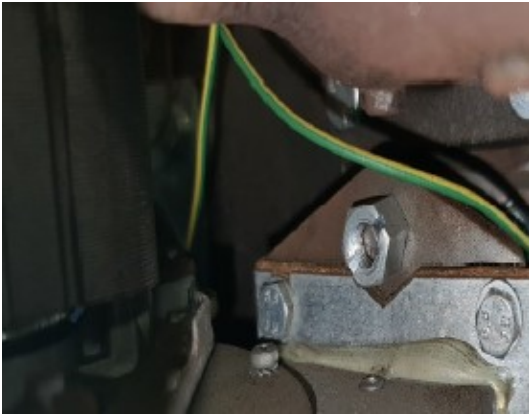
Item 71 Ref: 23/8/B/11/JGS2

The Internal boiler pump gasket (Boiler Room) does not contain asbestos.

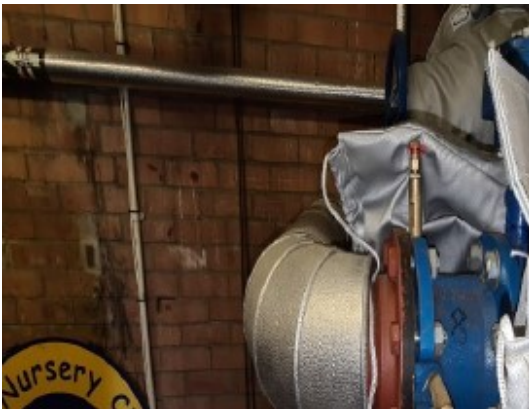
Item 72 Ref: 23/8/B/11/JGS3

The Pipework flange gaskets (Boiler Room) does not contain asbestos.

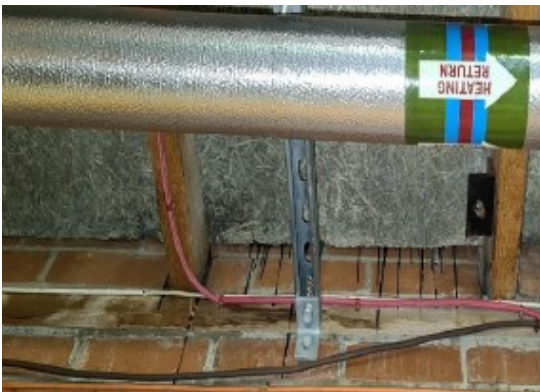
Item 75 Ref: 23/8/B/11/JGS6

The High level walls/roof bitumen pitch residuals (Boiler Room) does not contain asbestos.

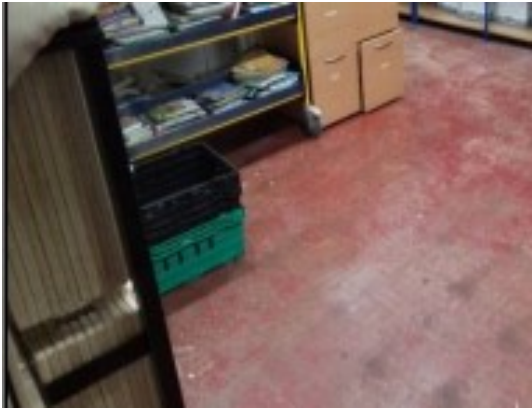
Item 89 Ref: OQ000238

The floor screed (Store Room G/001) does not contain asbestos.

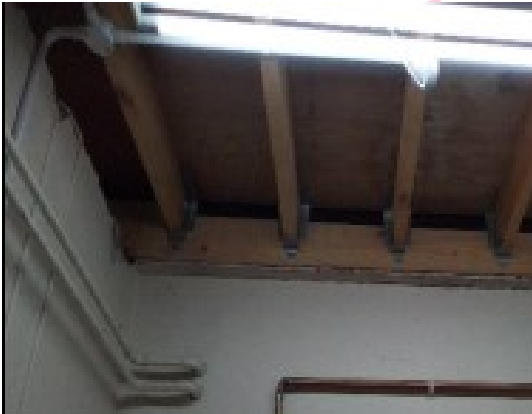
Item 90 Ref: OQ000241

The roof felt from external roof (Store Room G/001) does not contain asbestos.

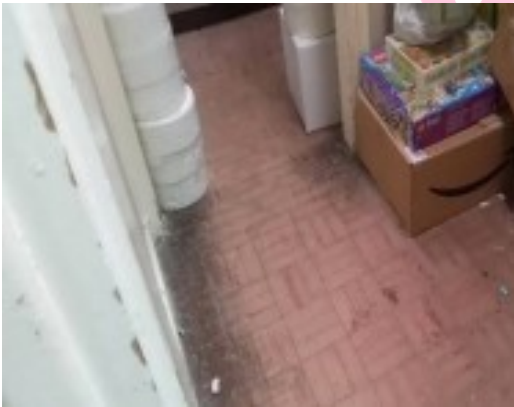
Item 93 Ref: As OQ000240

The floor screed (Cupboard G/003) does not contain asbestos.

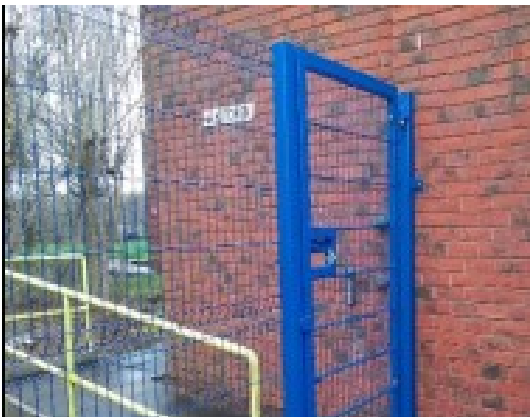
Item 94 Ref: OQ000242

The damp proof course (External E/001) does not contain asbestos.
