ASBESTOS SURVEY REPORT FOR EAST RAINTON PRIMARY SCHOOL,  
SCHOOL ROAD, EAST RAINTON, DH5 9RA.

**East Rainton Primary School, School Road, East  
Rainton, Houghton, DH5 9RA**

**Date: 20 March 2025**

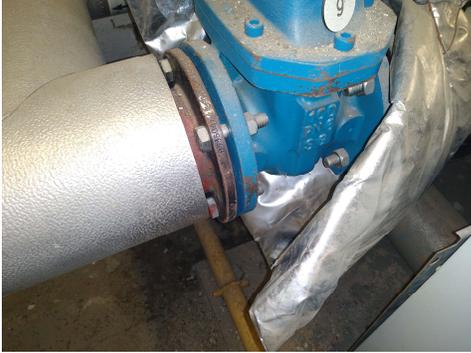
### **Item 1 Ref: 427459-15**

The gasket to pipework in -1/013 Plant Room does not contain asbestos.

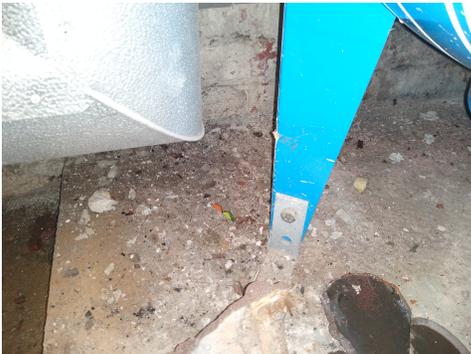
### **Item 2 Ref: 427459-16**

The general debris to floor in -1/013 Plant Room does not contain asbestos.

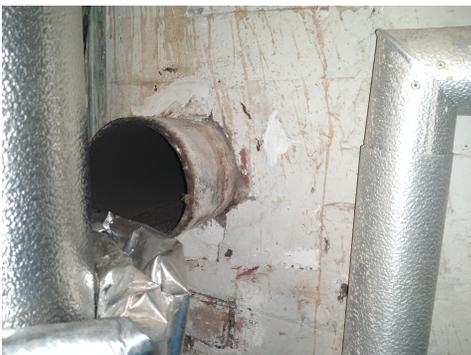
### **Item 3 Ref: 427459-17**

The debris to wall around pipe penetration in -1/013 Plant Room contains asbestos.

*Removed October 2020*

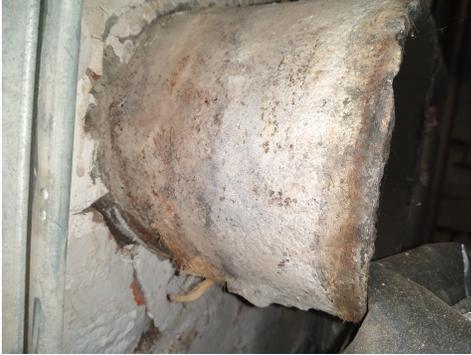
**Item 4 Ref: 427459-18**

The pipework residue in -1/013 Plant Room does not contain asbestos.

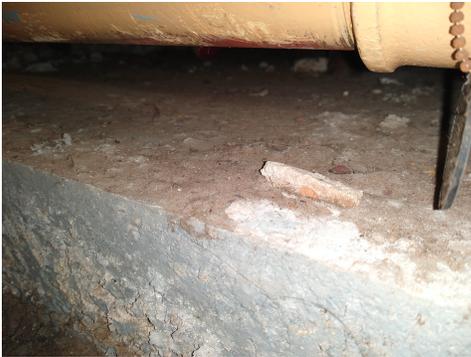
**Item 5 Ref: 427459-19**

The plinth in -1/013 Plant Room does not contain asbestos.

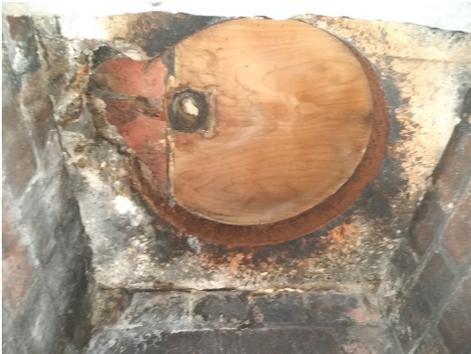
**Item 6 Ref: 427459-20**

The pipe lagging in -1/013 Plant Room does not contain asbestos.

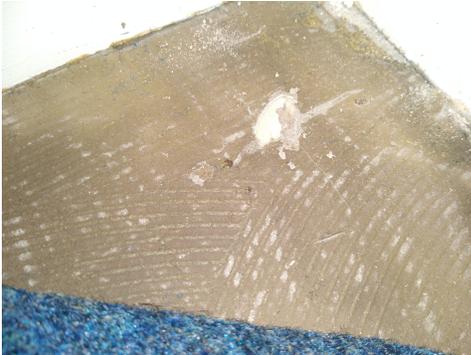
### **Item 7 Ref: 427459-1**

The floor covering in 0/005 Store does not contain asbestos.

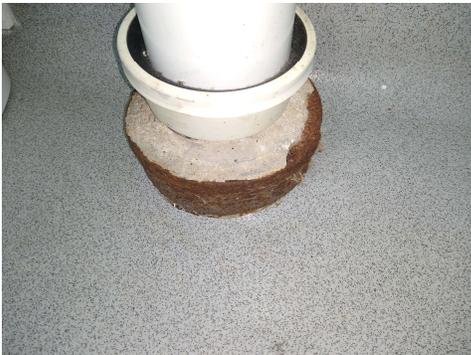
### **Item 8 Ref: Presumed**

The mastic in 0/008 Girls WC is presumed to contain asbestos.

Any change in its appearance should be recorded and passed to Property Services.

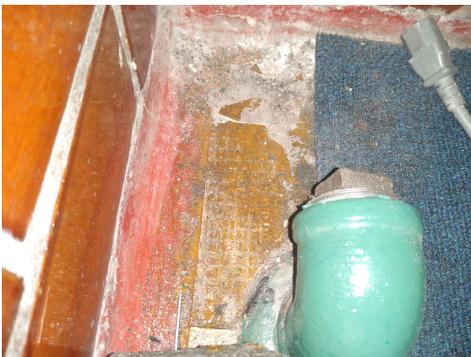
### **Item 9 Ref: 427459-2**

The floor covering in 0/009 Computer Room contains asbestos.

Any change in its appearance should be recorded and passed to Property Services.

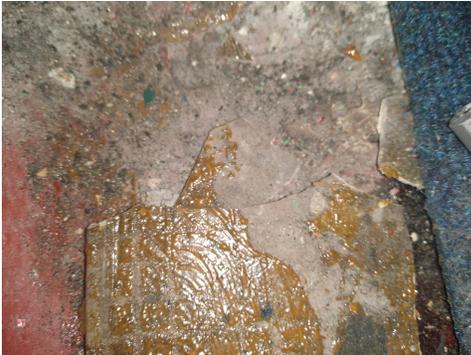
### **Item 10 Ref: 427459-5**

The floor in 0/009 Computer Room contains asbestos.

Any change in its appearance should be recorded and passed to Property Services.

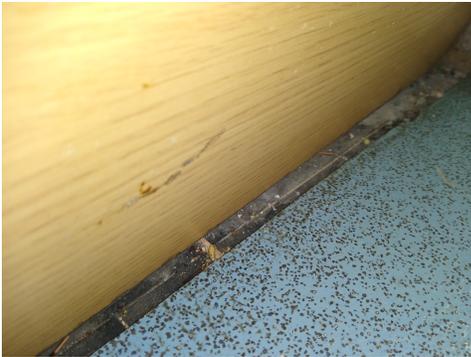
### **Item 11 Ref: 427459-3**

The floor in 0/010 Kitchenette contains asbestos.

Any change in its appearance should be recorded and passed to Property Services.

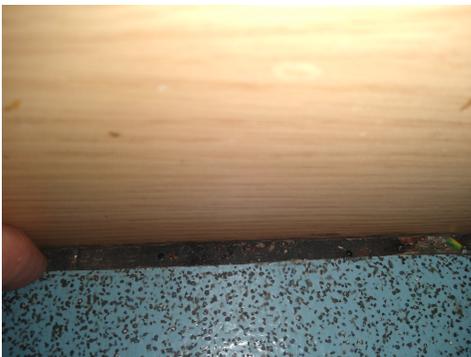
### **Item 12 Ref: 427459-4**

The floor in 0/010 Kitchenette contains asbestos.

Any change in its appearance should be recorded and passed to Property Services.

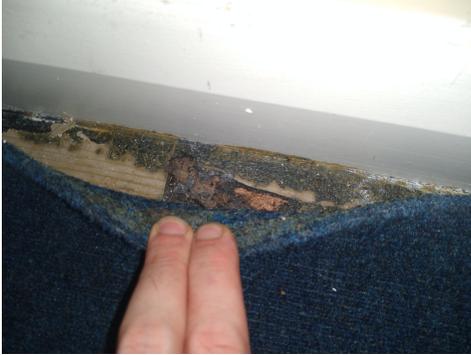
### **Item 13 Ref: As 427459-3**

The floor covering in 0/011 Staff Room contains asbestos.

Any change in its appearance should be recorded and passed to Property Services.

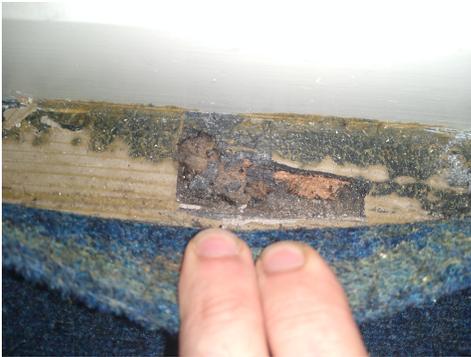
### **Item 14 Ref: As 427459-4**

The floor in 0/011 Staff Room contains asbestos.

Any change in its appearance should be recorded and passed to Property Services.

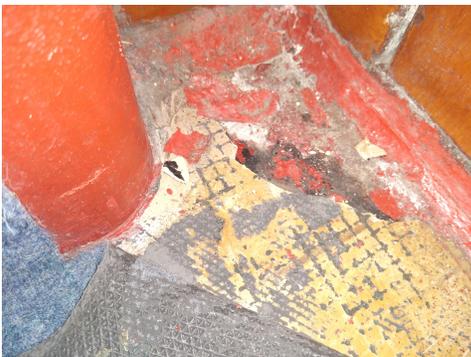
### **Item 15 Ref: As 427459-2**

The floor covering in 0/012 Corridor contains asbestos.

Any change in its appearance should be recorded and passed to Property Services.

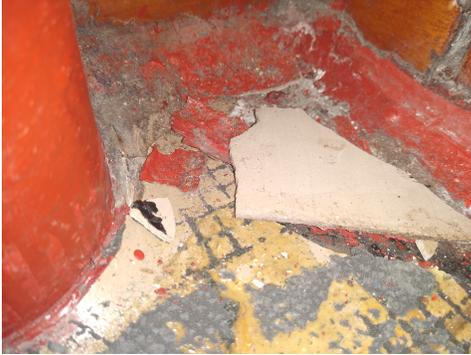
### **Item 16 Ref: As 427459-2**

The floor in 0/012 Corridor contains asbestos.

Any change in its appearance should be recorded and passed to Property Services.

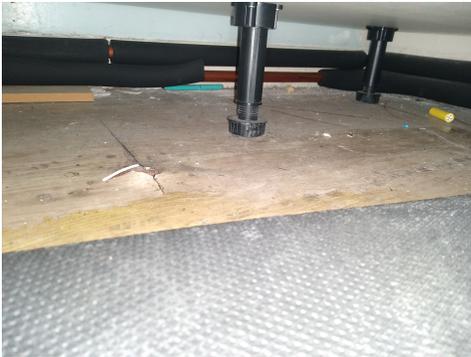
### **Item 17 Ref: 427459-6**

The floor covering in 0/014 Class 5 does not contain asbestos.

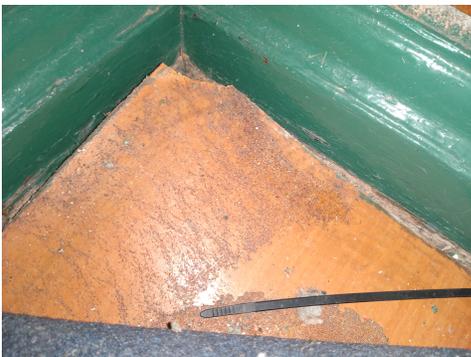
### **Item 18 Ref: 427459-7**

The floor covering in 0/015 Corridor does not contain asbestos.

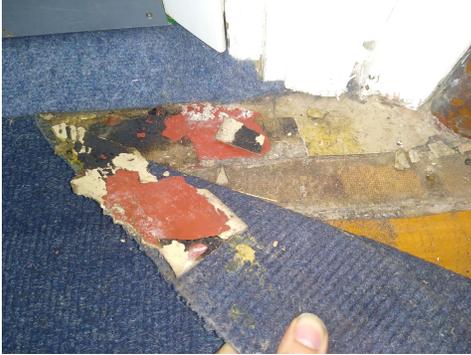
### **Item 19 Ref: As 427459-6**

The floor in 0/015 Corridor does not contain asbestos.

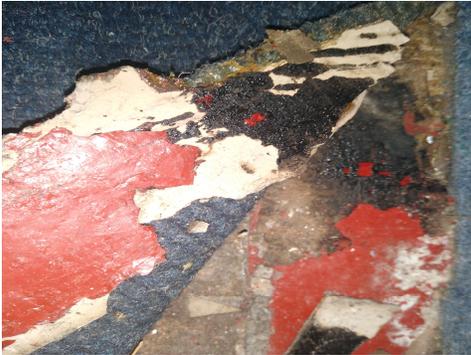
### **Item 20 Ref: As 427459-5**

The floor in 0/015 Corridor contains asbestos.

Any change in its appearance should be recorded and passed to Property Services.

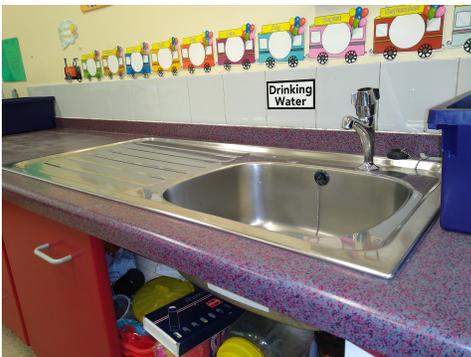
### **Item 21 Ref: 427459-8**

The sink pad in 0/021 Class 1 does not contain asbestos.

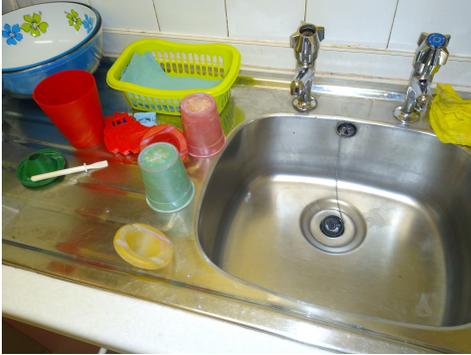
### **Item 22 Ref: 427459-9**

The sink pad in 0/022 Kitchen classroom 1 does not contain asbestos.

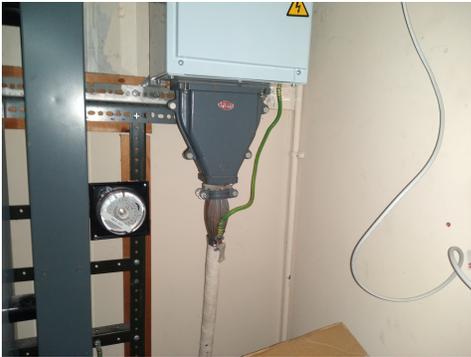
### **Item 23 Ref: Presumed**

The electrics in 0/023 Switch Room is presumed to contain asbestos.

Any change in its appearance should be recorded and passed to Property Services.

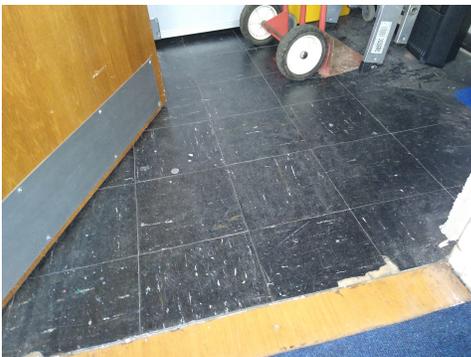
### **Item 24 Ref: 427459-10**

The floor covering in 0/023 Switch Room contains asbestos.

Any change in its appearance should be recorded and passed to Property Services.

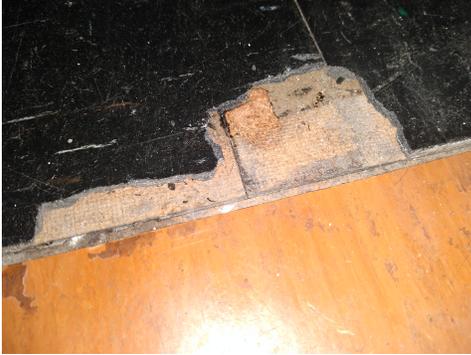
### **Item 25 Ref: 427459-11**

The floor in 0/023 Switch Room contains asbestos.

Any change in its appearance should be recorded and passed to Property Services.

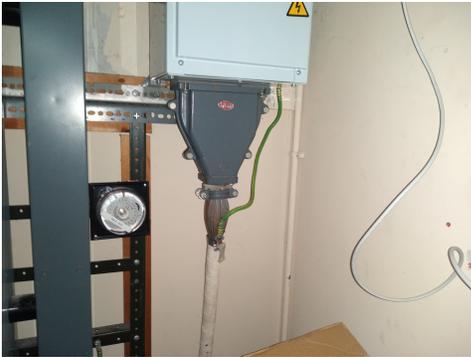
### **Item 26 Ref: Presumed**

The pipe lagging in 0/023 Switch Room is presumed to contain asbestos.

Any change in its appearance should be recorded and passed to Property Services.

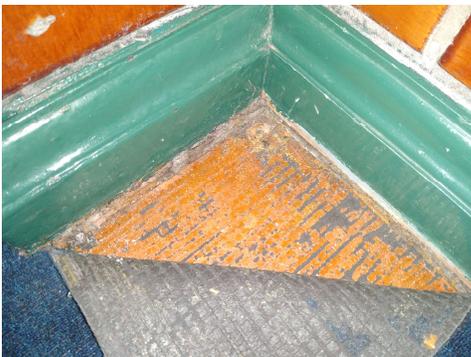
### **Item 27 Ref: As 427459-7**

The floor covering in 0/024 Corridor does not contain asbestos.

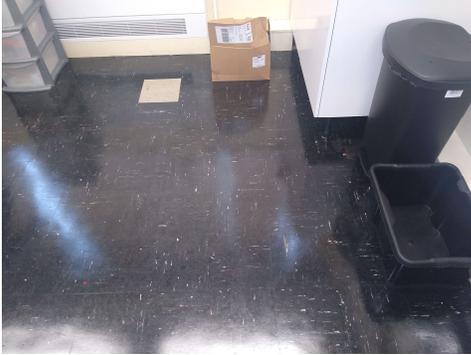
### **Item 28 Ref: As 427459-10**

The floor covering in 0/025 Class 2 contains asbestos.

Any change in its appearance should be recorded and passed to Property Services.

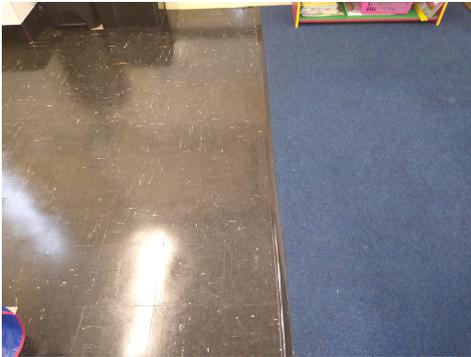
### **Item 29 Ref: As 427459-11**

The floor in 0/025 Class 2 contains asbestos.

Any change in its appearance should be recorded and passed to Property Services.

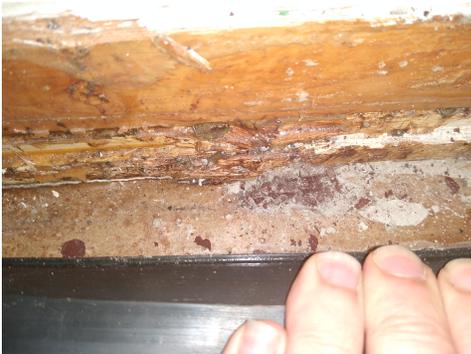
### **Item 30 Ref: 427459-12**

The floor covering in 0/026 Boys WC does not contain asbestos.

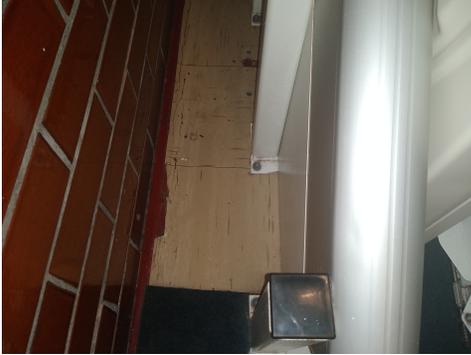
### **Item 31 Ref: 427459-13**

The floor covering in 0/030 Corridor contains asbestos.

Any change in its appearance should be recorded and passed to Property Services.

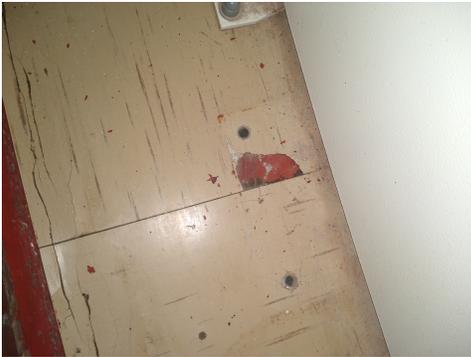
### **Item 32 Ref: 427459-14**

The floor in 0/030 Corridor contains asbestos.

Any change in its appearance should be recorded and passed to Property Services.

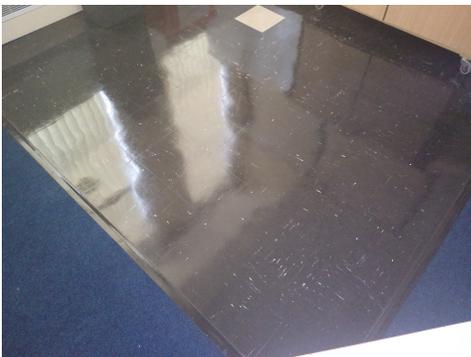
### **Item 33 Ref: As 427459-10**

The floor covering in 0/031 Class 3 contains asbestos.

Any change in its appearance should be recorded and passed to Property Services.

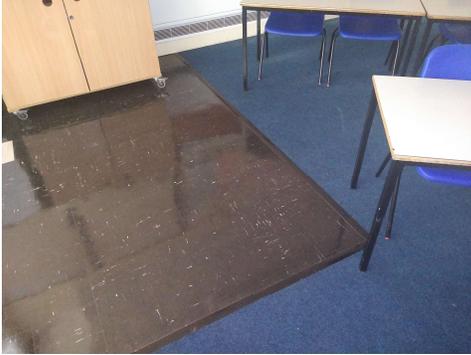
### **Item 34 Ref: As 427459-11**

The floor in 0/031 Class 3 contains asbestos.

Any change in its appearance should be recorded and passed to Property Services.

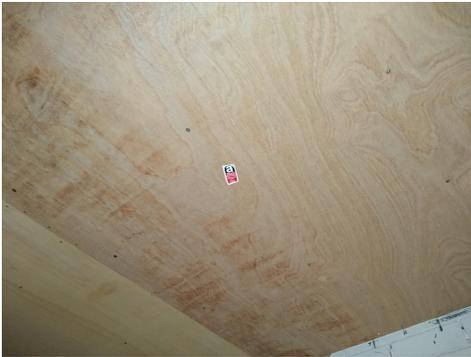
### **Item 35 Ref: Presumed**

The ceiling in 0/032 External Store is presumed to contain asbestos.

Any change in its appearance should be recorded and passed to Property Services.

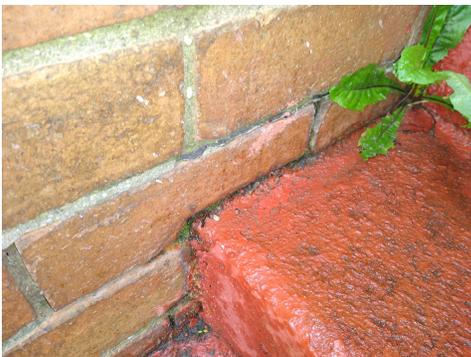
### **Item 36 Ref: 427459-21**

The damp proof course (External) does not contain asbestos.

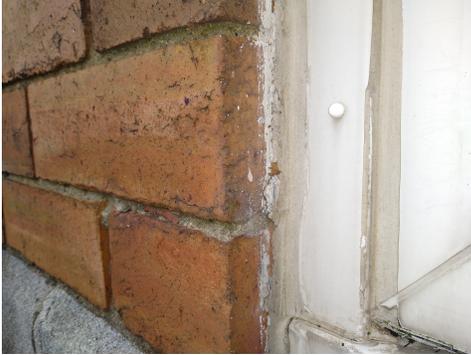
**Item 37 Ref: 427459-22**

The window frame (External) does not contain asbestos.

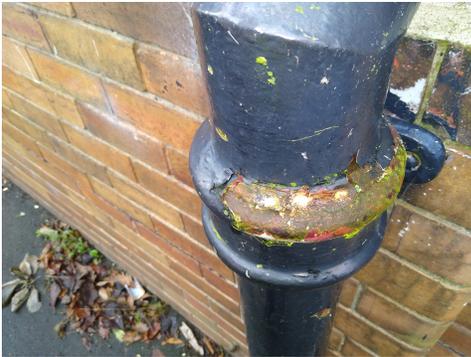
**Item 38 Ref: 427459-23**

The metal soil pipe frame (External) does not contain asbestos.

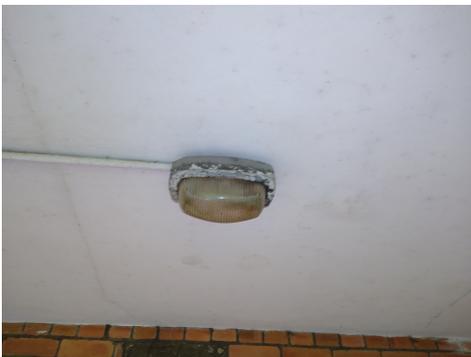
**Item 39 Ref: 427459-24**

The security lights (External) contain asbestos.

Any change in its appearance should be recorded and passed to Property Services.

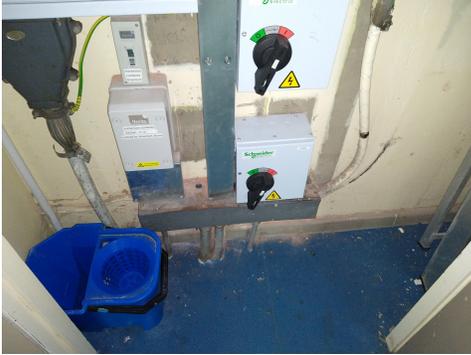
### **Item 40 Ref: Presumed**

The pipe lagging in 0/001 Kitchen electric cupboard - Canteen is presumed to contain asbestos.

Any change in its appearance should be recorded and passed to Property Services.

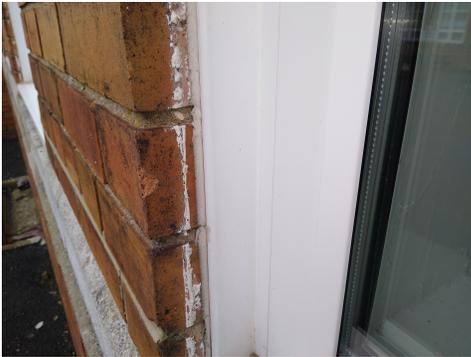
### **Item 41 Ref: 427459-25**

The window and door frame (External Canteen) do not contain asbestos.

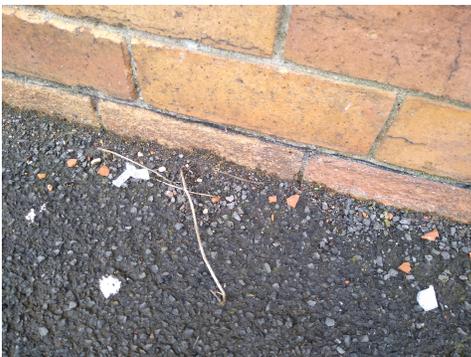
### **Item 42 Ref: 427459-26**

The damp proof course (External Canteen) does not contain asbestos.

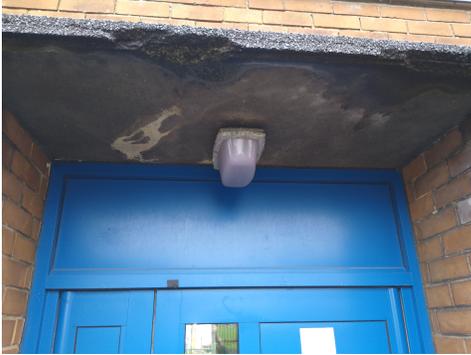
### **Item 43 Ref: 427459-27**

The security light (External Canteen) contains asbestos.

Any change in its appearance should be recorded and passed to Property Services.

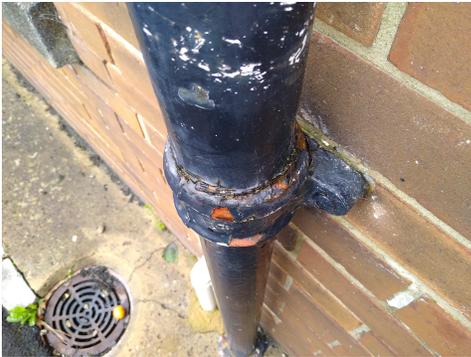
### **Item 44 Ref: 427459-28**

The metal soil pipe flange (External Canteen) does not contain asbestos.

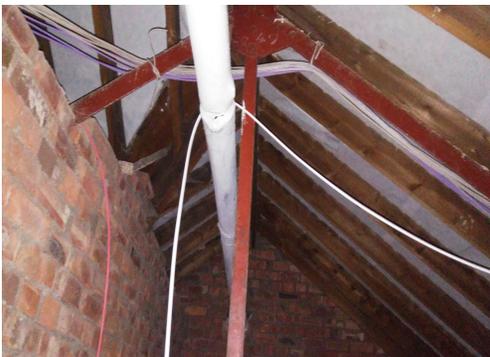
### **Item 45 Ref: 427459-6**

The pipe lagging in Loft Main Building contains asbestos.

Any change in its appearance should be recorded and passed to Property Services.

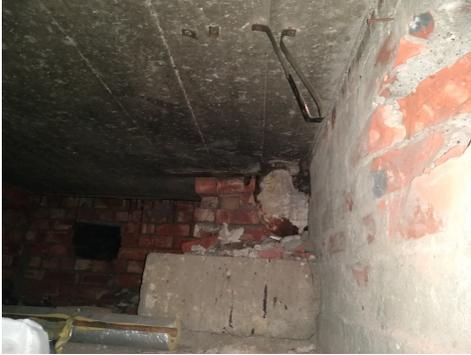
### **Item 46 Ref: Presumed**

The pipe lagging in Main service duct is presumed to contain asbestos.

Any change in its appearance should be recorded and passed to Property Services.

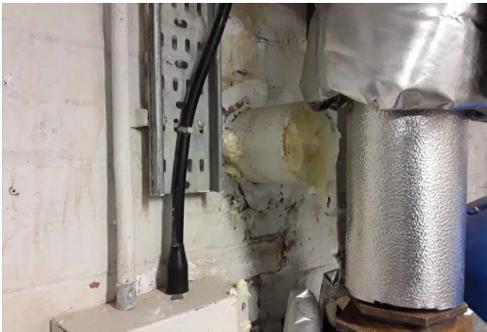
### **Item 47 Ref: Presumed**

The insulation inside pipe penetration to wall in Main Boiler Room is presumed to contain asbestos.

Any change in its appearance should be recorded and passed to Property Services.

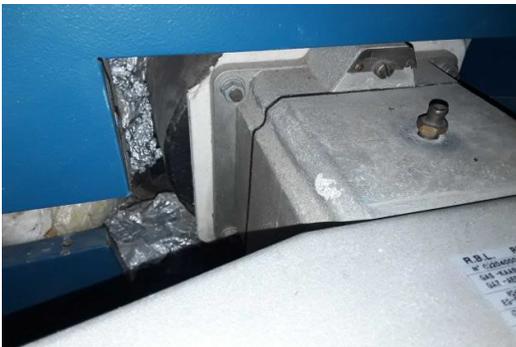
### **Item 48 Ref: 23-63275-3**

The insulation boards inside boilers in Main Boiler Room so not contain asbestos.

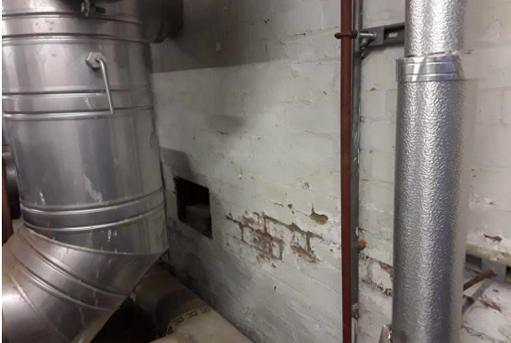
### **Item 49 Ref: 23-63275-4**

The residual insulation to walls in Main Boiler Room contains asbestos.

Any change in its appearance should be recorded and passed to Property Services.

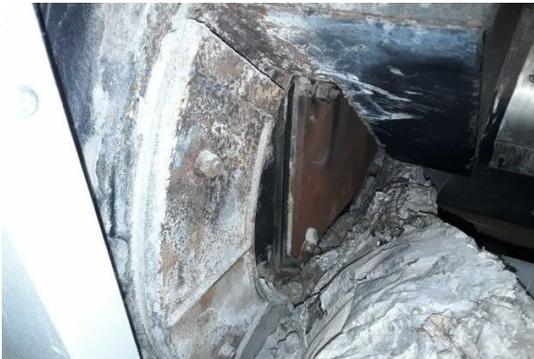
### **Item 50 Ref: 23-63275-5**

The gaskets inside boilers in Main Boiler Room does not contain asbestos.

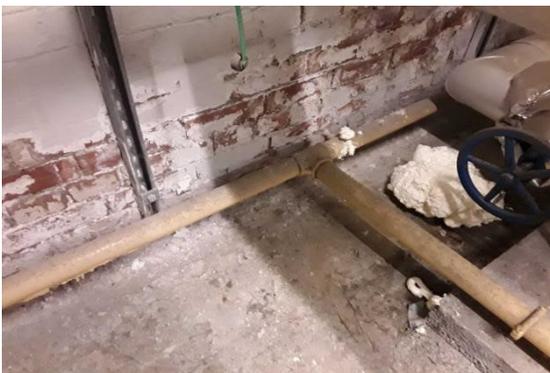
### **Item 51 Ref: 23-63275-6**

The debris to floor in Main Boiler Room contains asbestos.

*This was removed August 2023*

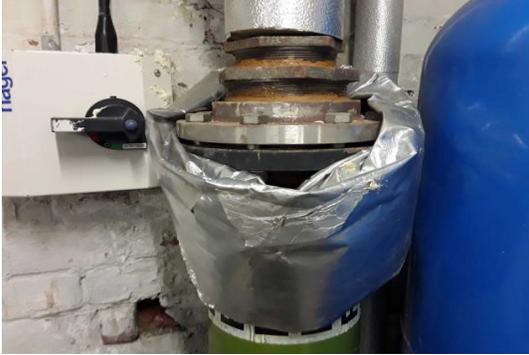
### **Item 52 Ref: 23-63275-7**

The pipe flange gaskets in Main Boiler Room does not contains asbestos.

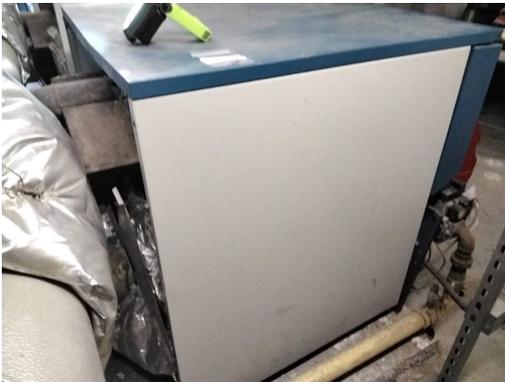
### **Item 53 Ref: KX001946/01**

The putty between boiler segments in Boiler Room does not contain asbestos.

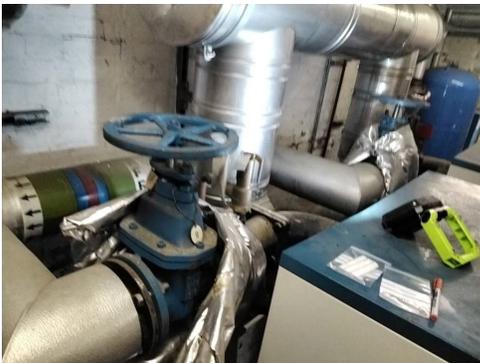
### **Item 54 Ref: KX001947/02**

The gaskets in Main Boiler Room does not contains asbestos.

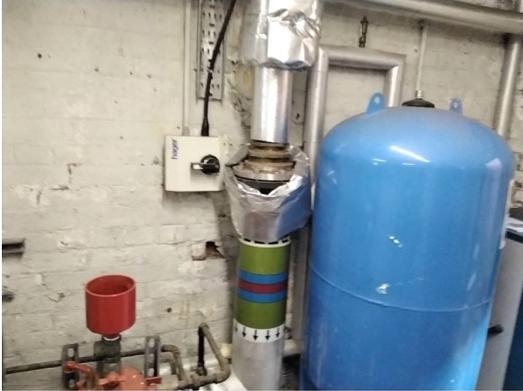
### **Item 55 Ref: KX001948/03**

The pipe flange gaskets in Main Boiler Room does not contains asbestos.

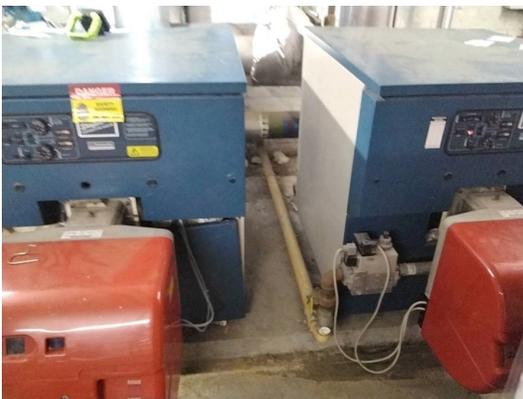
### **Item 56 Ref: KX001949/04**

The seal to pumps on front of boilers in Boiler Room does not contain asbestos.

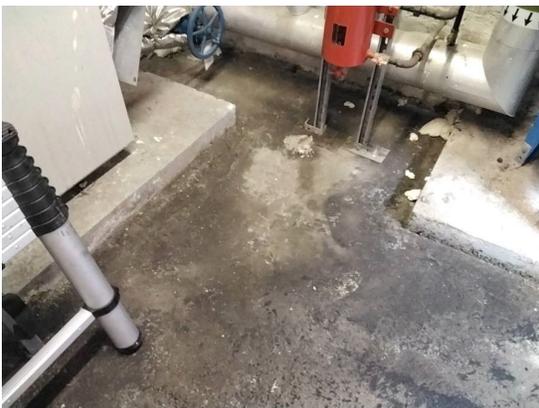
### **Item 57 Ref: KX001950/05**

The debris to floor between door and front boiler in Main Boiler Room does not contains asbestos.

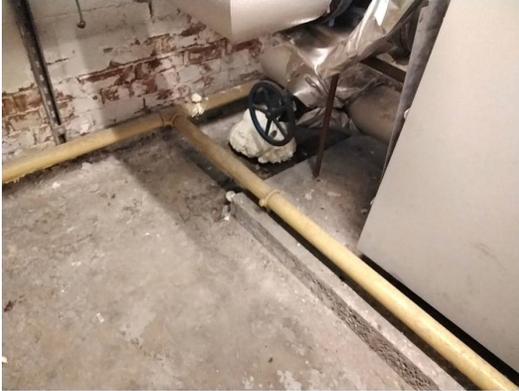
### **Item 58 Ref: KX001951/06**

The debris to floor behind rear boiler in Main Boiler Room contains asbestos.

*This was removed August 2023*

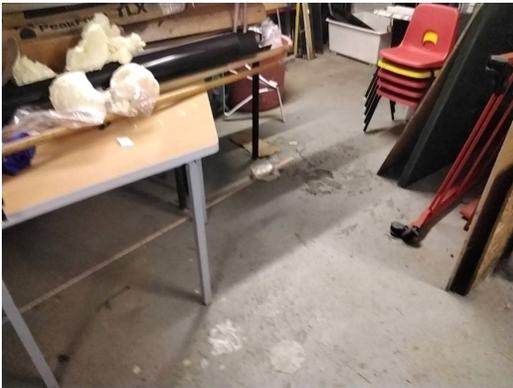
### **Item 59 Ref: KX001952/07**

The debris to floor in gas inlet room in Boiler Room does not contain asbestos.

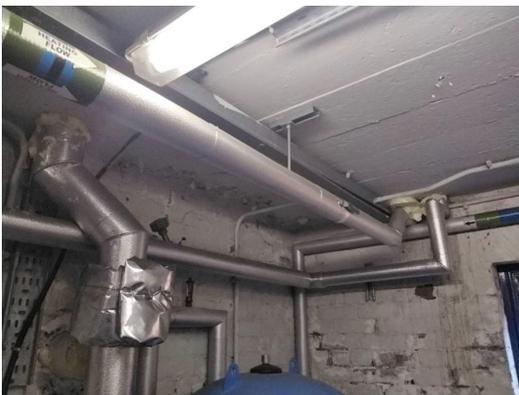
### **Item 60 Ref: KX001955/10**

The debris to ceiling penetrations in Main Boiler Room contains asbestos.

Any change in its appearance should be recorded and passed to Property Services.

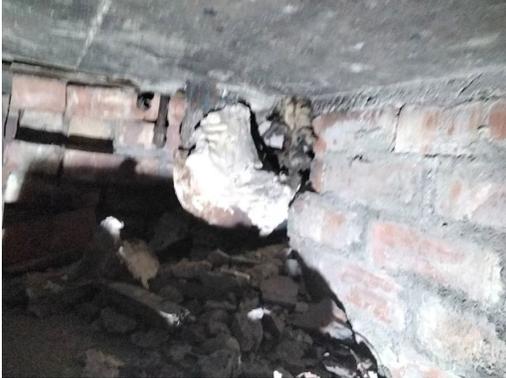
### **Item 61 Ref: KX001956/11**

The pipework insulation in Main Boiler Room contains asbestos.

Any change in its appearance should be recorded and passed to Property Services.

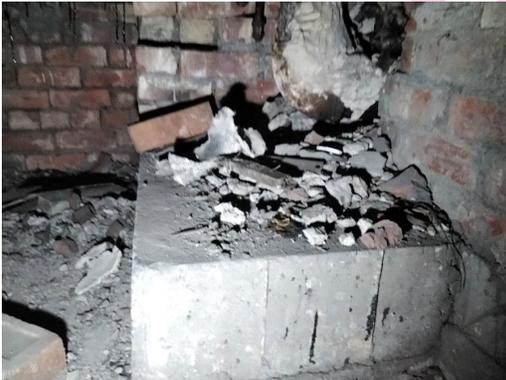
### **Item 62 Ref: KX001957/12**

The debris in Main Boiler Room contains asbestos.

Any change in its appearance should be recorded and passed to Property Services.

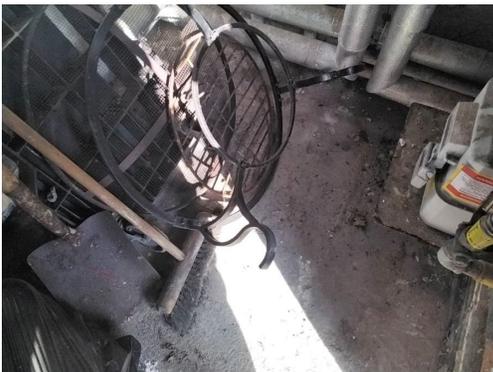
### **Item 63 Ref: KX001958/13**

The debris in Plant Room does not contain asbestos.

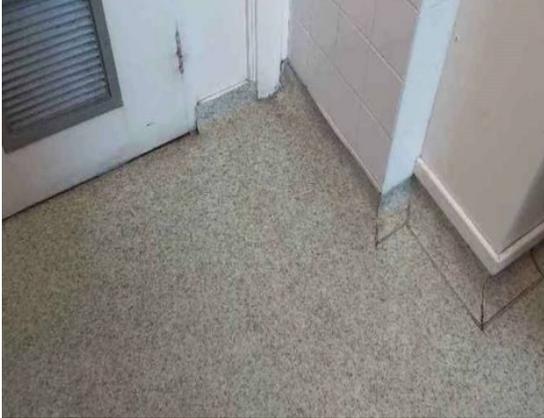
### **Item 64 Ref: OQ000499**

The floor tiles in the Male Toilet (G/001) does not contain asbestos.

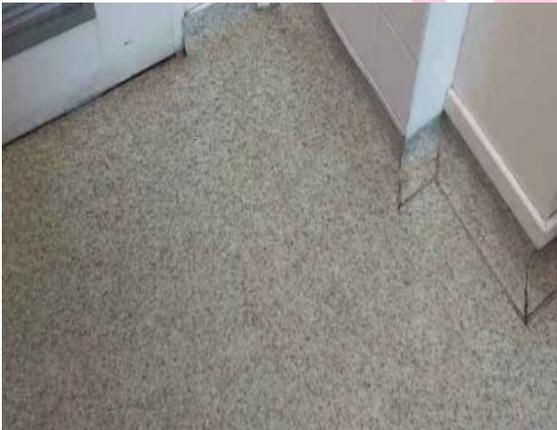
### **Item 65 Ref: As OQ000499**

The floor tiles in the Female toilet (G/002) does not contain asbestos.

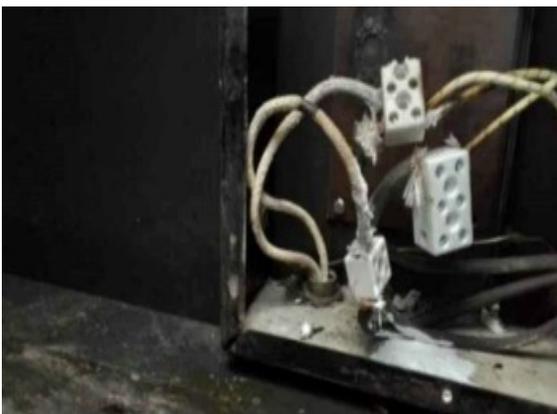
### **Item 66 Ref: OQ000506**

The electrical services cable/braiding insulation in the Kitchen (G/003) does contain asbestos.

*Removed September 2024*

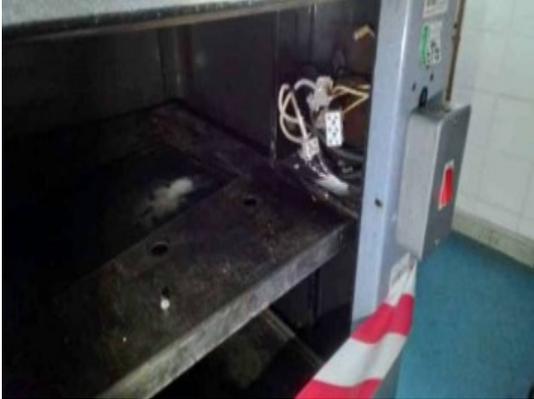
**Item 67 Ref: OQ000507**

The lining to the bottom of the electrical box in the Kitchen (G/003) does contain asbestos.

*Removed September 2024*
