ASBESTOS SURVEY REPORT FOR FULWEL JUNIOR SCHOOL, SEA ROAD, SUNDERLAND, SR6 9EE.

Asbestos Register for

Fulwell Junior School, Sea Road, Sunderland, SR6 9EE

Date: 30 May 2025

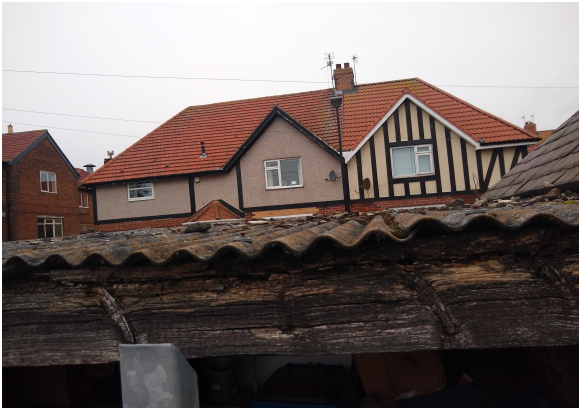
Item 1 Ref: As 392632-36

*The bin shed roof (External)
contains asbestos.*

Removed April 2024

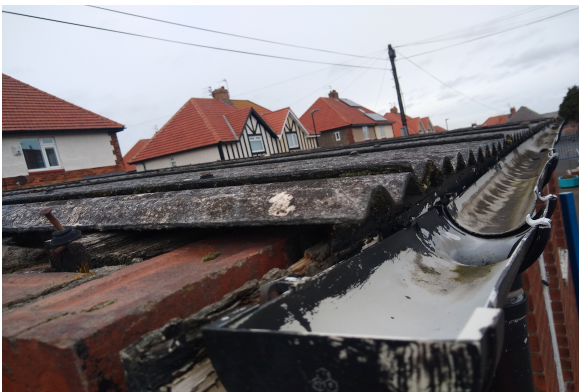
Item 2 Ref: As 392632-37

*The chair store roof (External)
contains asbestos.*

Removed April 2024

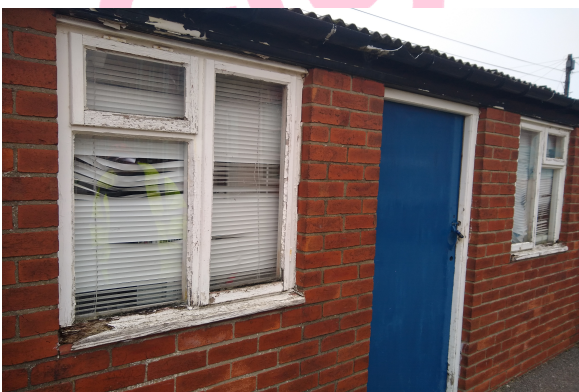
Item 3 Ref: As 392632-38

*The putty to window panes to
the bin/chair store (External)
does not contain asbestos.*

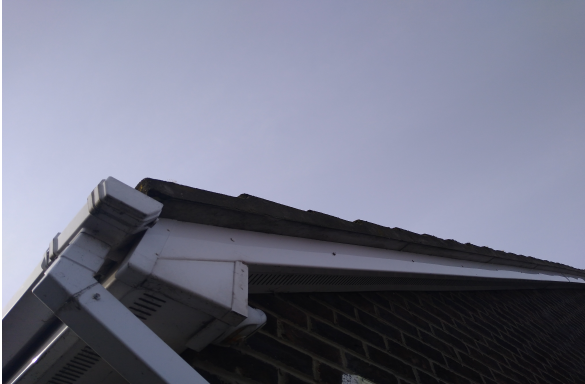
Item 4 Ref: 392632-33

The undercloaking to the caretaker's house (External) does not contain asbestos.

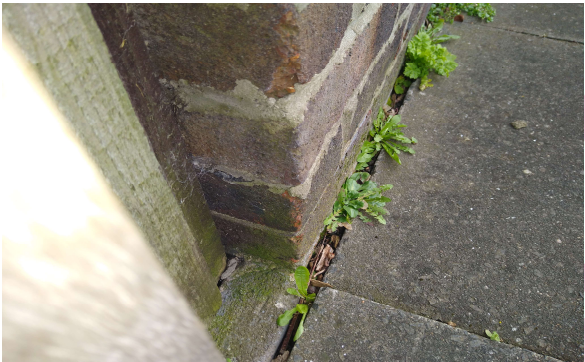
Item 5 Ref: 392632-31

The damp proof course to the caretaker's house (External) does not contain asbestos.

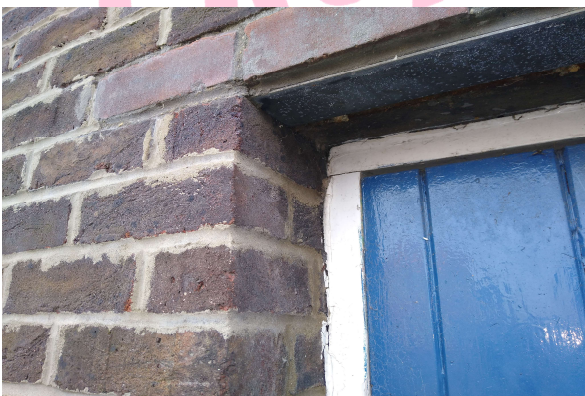
Item 6 Ref: 392632-32

The sealant to bin store door frame (External) contains asbestos.

Any change in its appearance should be recorded and passed to Property Services.

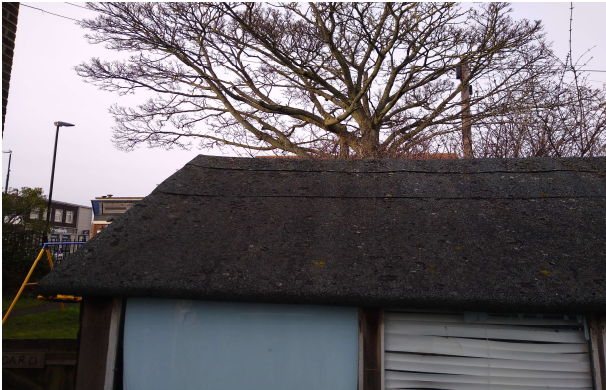
Item 7 Ref: 392632-34

The roof felt to the timber shed (External) does not contain asbestos.

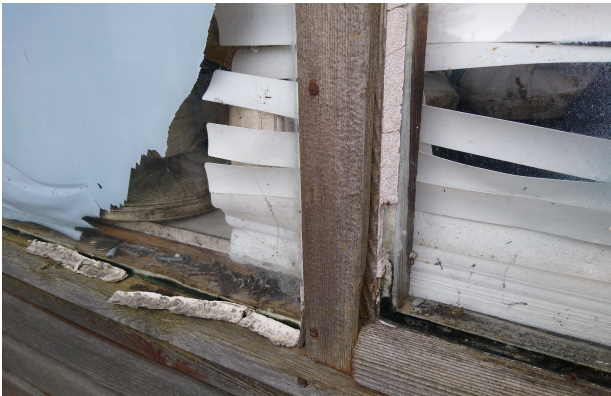
Item 8 Ref: 392632-35

The putty to glazing in the caretaker's house (External) does not contain asbestos.

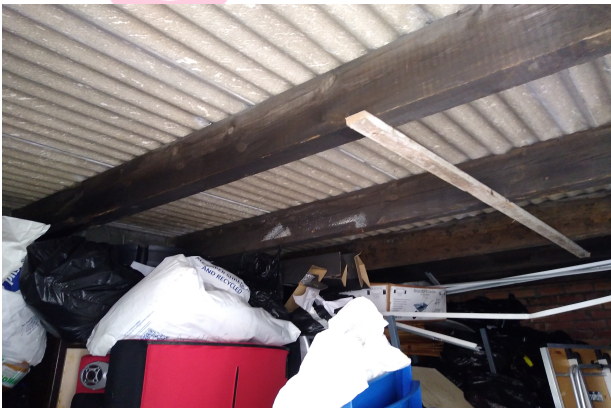
Item 9 Ref: 392632-37

The corrugated roof to the external store (Rm 0/01) contains asbestos.

Removed April 2024

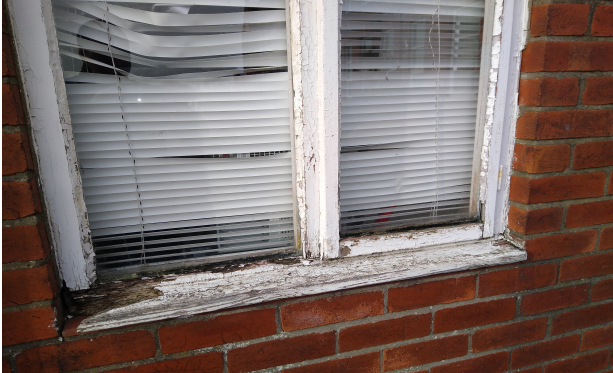
Item 10 Ref: 392632-38

The putty to glazing in the external store (Rm 0/01 - External) does not contain asbestos.

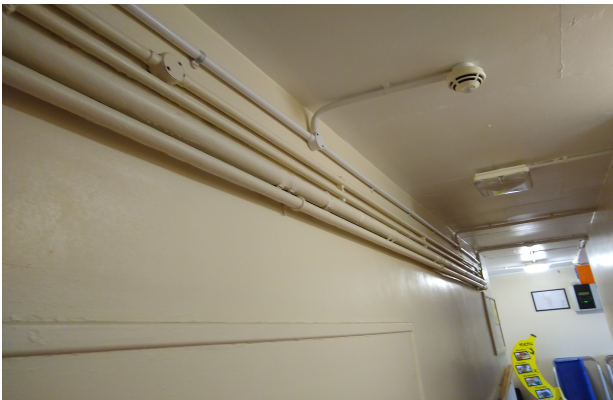
Item 11 Ref: Presumed

The lagging below pipework in the link corridor (Rm 0/02) is presumed to contain asbestos.

Any change in its appearance should be recorded and passed to Property Services.

(Pipework boxed - 2024)

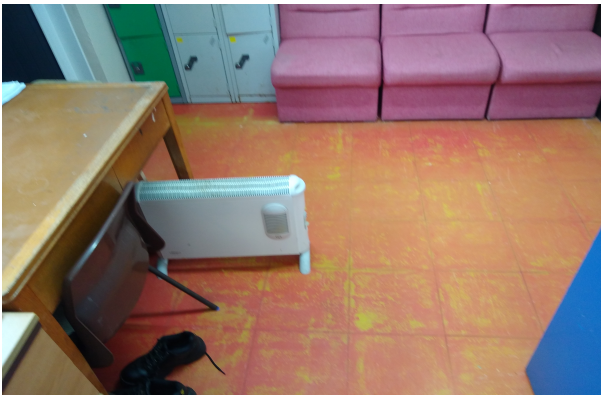
Item 15 Ref: 392632-26

The floor covering in the Dining hall building staff room (Rm 0/09) contains asbestos.

Any change in its appearance should be recorded and passed to Property Services.

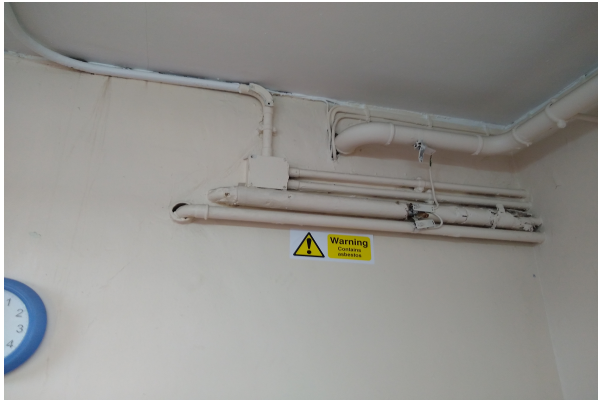
Item 16 Ref: 392632-27

The insulation to pipework elbow in the Dining hall building staff room (Rm 0/09) does not contain asbestos.

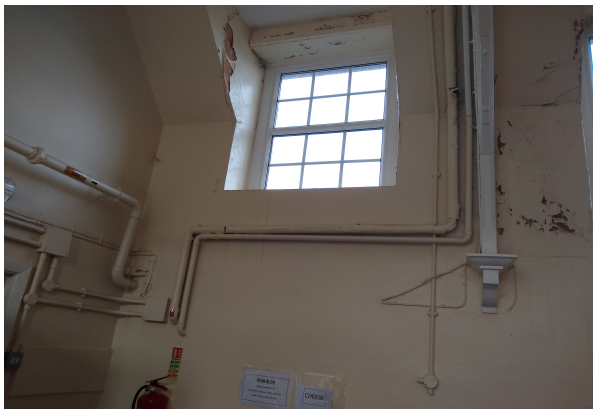
Item 17 Ref: 392632-28

The pipework lagging to elbows in the Dining hall building dining hall (Rm 0/10) does not contain asbestos.

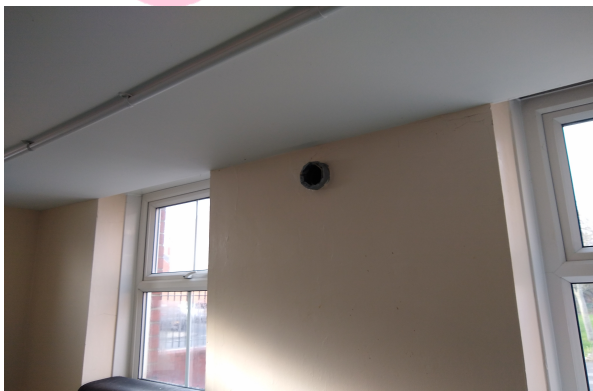
Item 18 Ref: 392632-29

The redundant flue in the Dining hall building food container store (Rm 0/11) contains asbestos.

Removed 2024 – waiting WCN's

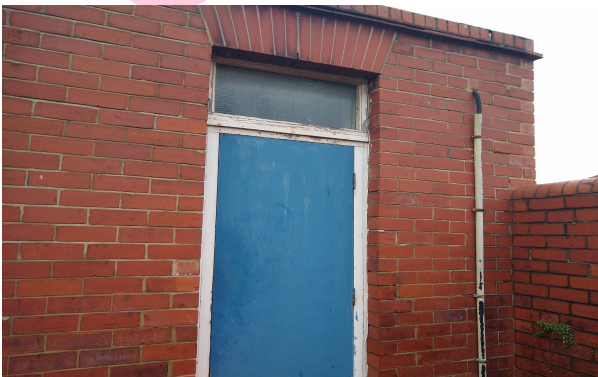
Item 21 Ref: 392632-39

The sealant to fire door of area 0/11 to the Dining hall building (External) does not contain asbestos.

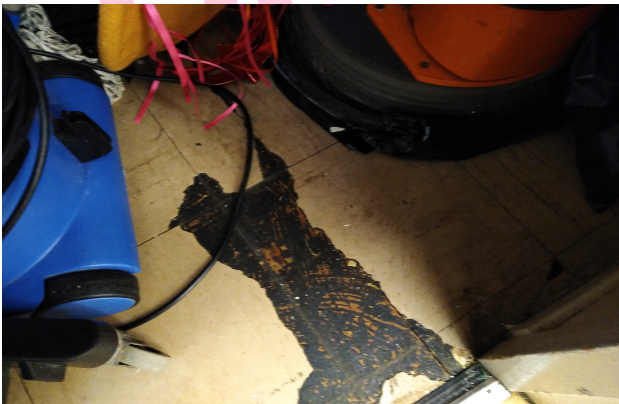
Item 30 Ref:As392632-11

The floor covering to the standalone portacabin electrical cupboard (Rm 0/04) does not contain asbestos.

Demolished in refurb 2024

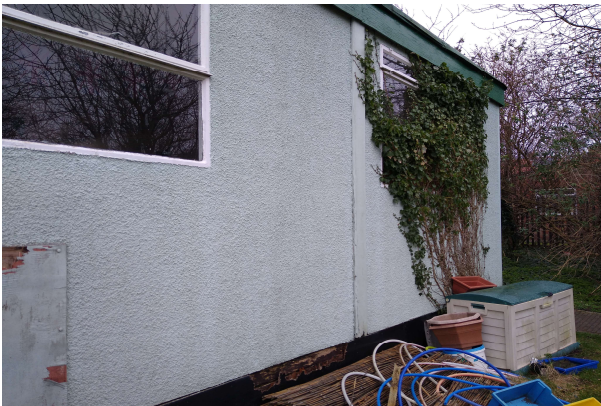
Item 32 Ref: 392632-13

The wall coating to the standalone portacabin (External) does not contain asbestos.

Demolished in refurb 2024

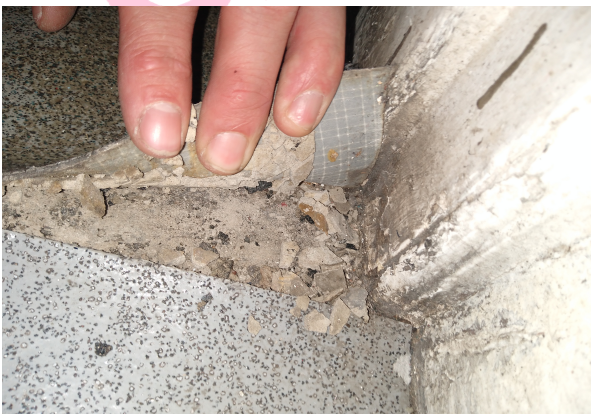
Item 39 Ref: 392632-21

The floor covering below modern screed in the lobby (Rm 0/05b) contains asbestos.

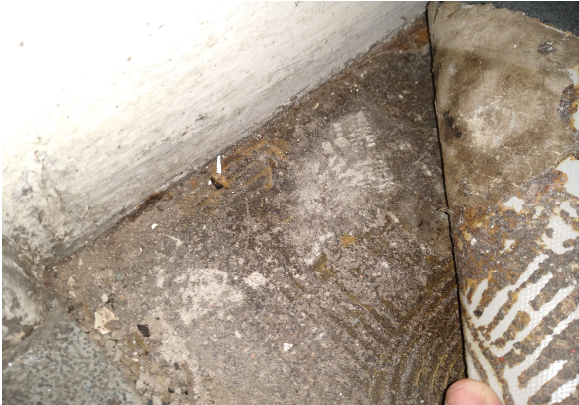
Item 40 Ref:As392632-21

The floor covering in the male staff wc (Rm 0/05d) contains asbestos.

Any change in its appearance should be recorded and passed to Property Services.

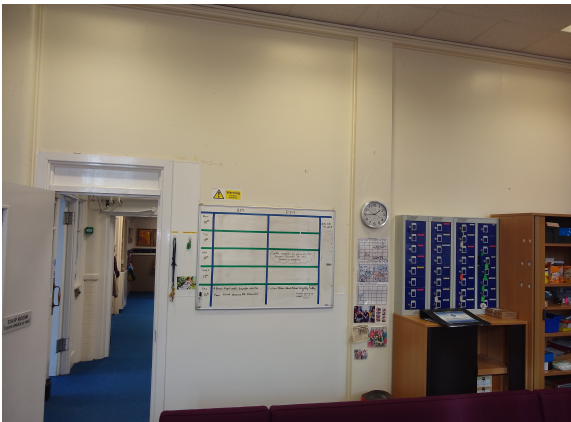
Item 41 Ref: 392632-18

The partition walls in the staff room (Rm 0/08) contains asbestos.

Removed March 2024

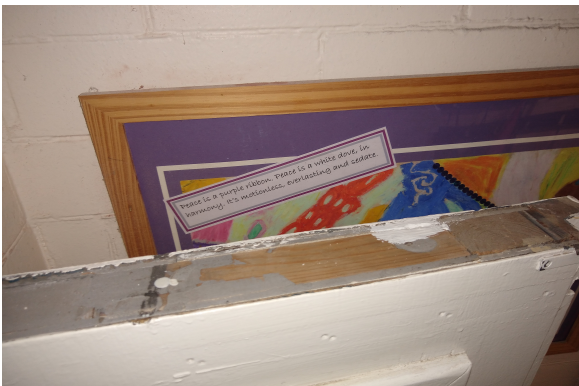
Item 42 Ref: 392632-19

The panels within the fire doors to 0/009 in the corridor (Rm 0/08a) does not contain asbestos.

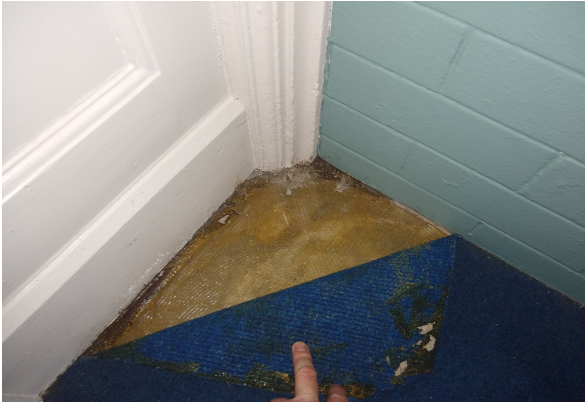
Item 43 Ref: 392632-5

The remnant adhesive to floor below modern screed in the reception lobby (Rm 0/11) contains asbestos.

Any change in its appearance should be recorded and passed to Property Services.

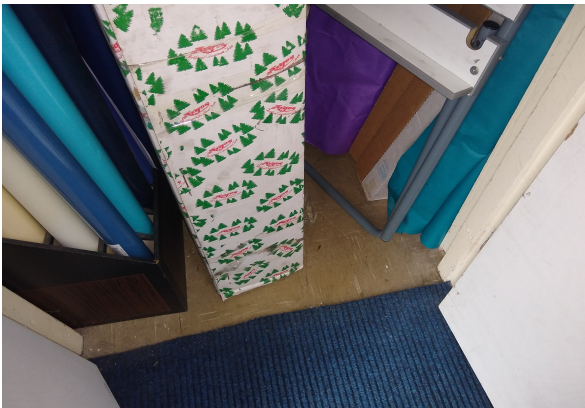
Item 44 Ref: 392632-15

The floor covering in the store (Rm 0/011a) does not contain asbestos.

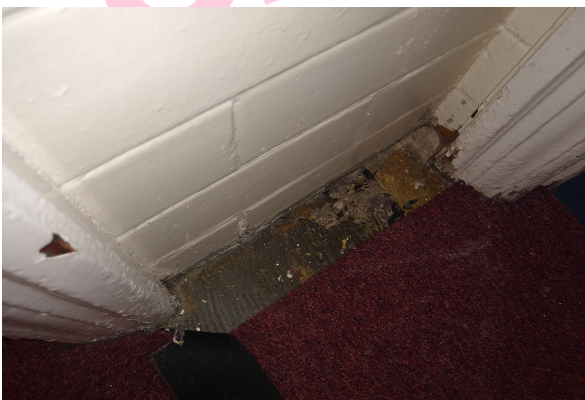
Item 45 Ref: 392632-16

The floor covering below carpet in the lobby (Rm 0/12) contains asbestos.

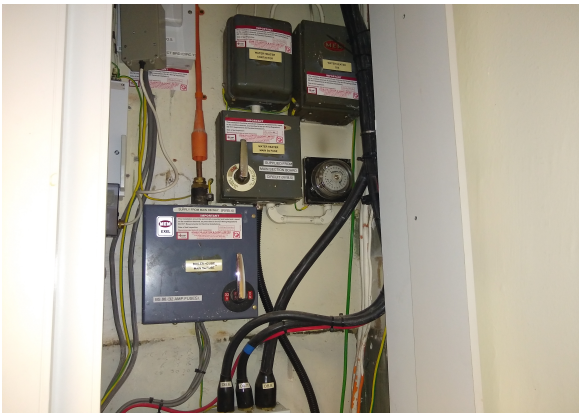
Item 47 Ref: Presumed

The electrics M.E.M in the office (Rm 0/15) contains asbestos.

Any change in its appearance should be recorded and passed to Property Services.

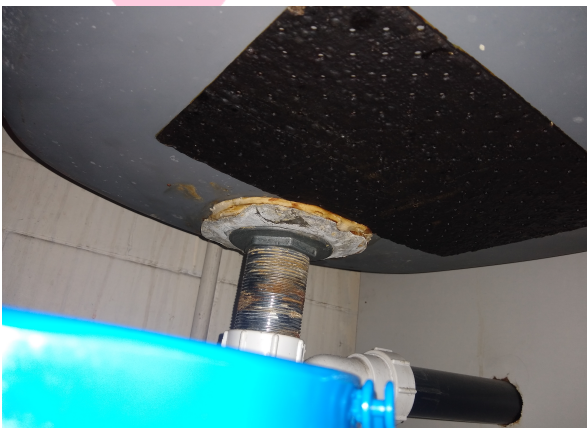
Item 48 Ref: 392632-3

The sink pad in the lobby (Rm 1/01) does not contain asbestos.

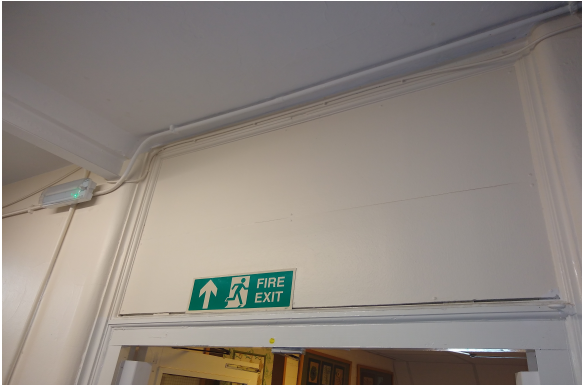
Item 52 Ref: 392632-4

The panel above door to stairwell in the corridor (Rm 1/19) contains asbestos.

Removed March 2023

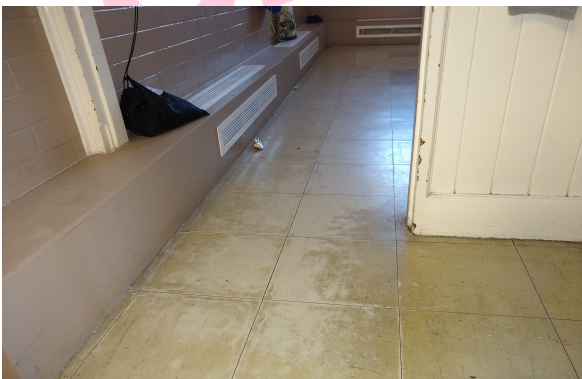
Item 54 Ref: As 392632-1

The floor covering in the cloakroom (Rm 1/M002) does not contain asbestos.

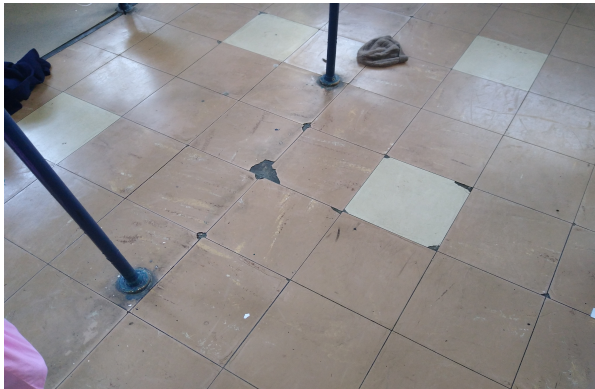
Item 55 Ref: 392632-8

The floor covering in the cloakroom (Rm 1/M003) does not contain asbestos.

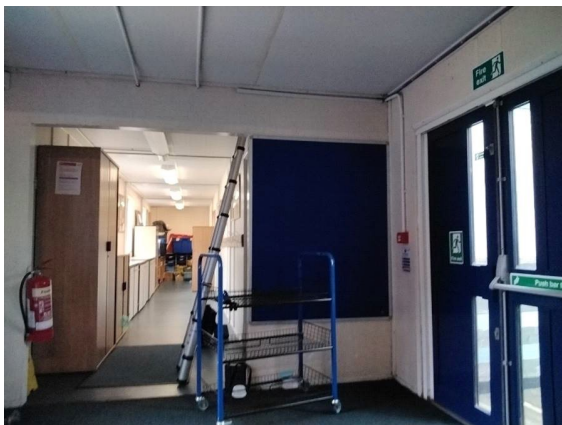
Item 56 Ref: CF006517

The wall coating (Entrance/Hall/Foyer/Lobby G/001) does not contain asbestos.

Demolished in refurb 2024

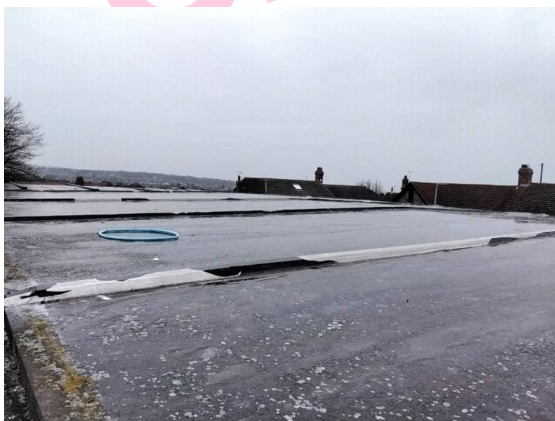
Item 57 Ref: CF006518

The roof jointing compound (External/E001) does not contain asbestos.

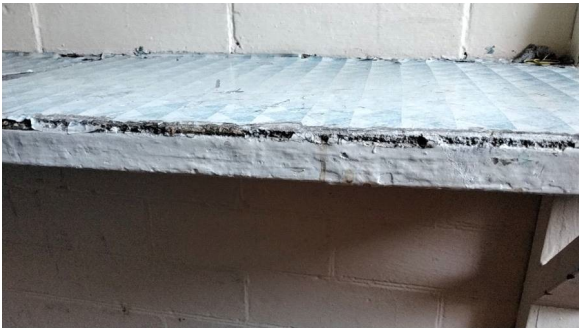
Item 92 Ref: NO000606

The Shelving heat pads to bottom and underside of shelf above (Cupboard Store G/034) contain asbestos.

Any change in its appearance should be recorded and passed to Property Services.

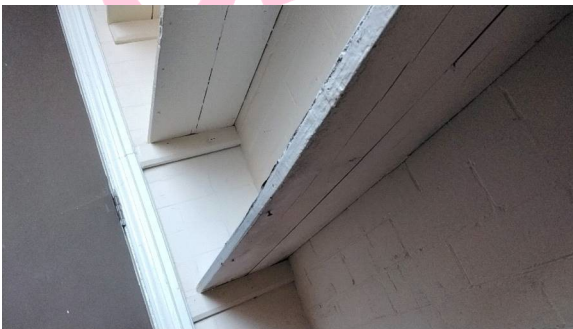
Item 93 Ref: NO000607

The Shelving remnants to shelving/nails etc (Cupboard Store G/034) contain asbestos.

Any change in its appearance should be recorded and passed to Property Services.

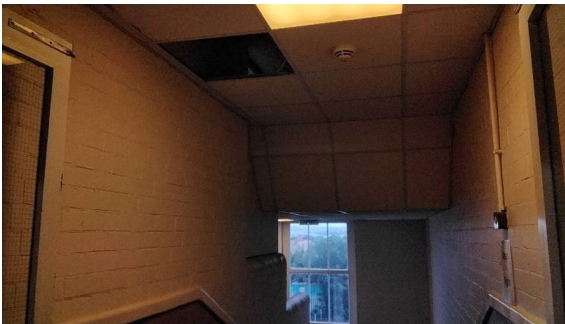
Item 95 Ref: NO000596

The Wall coating (Landing 1/001) does not contain asbestos.

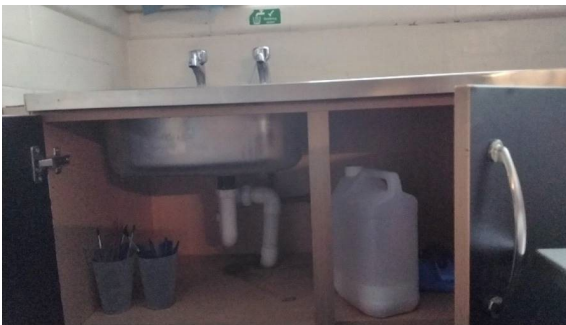
Item 104 Ref: As NO000598

The Under sink mat
(Classroom 1/017) does not
contain asbestos.

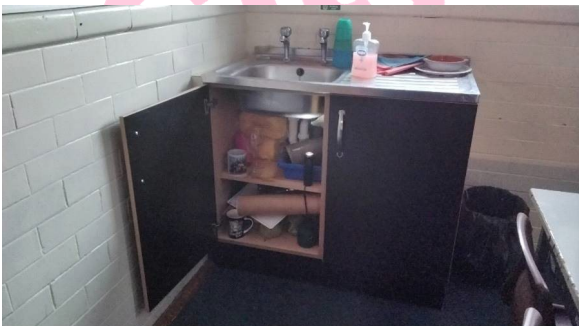
Item 105 Ref: As NO000598

The Under sink mat
(Classroom 1/018) does not
contain asbestos.

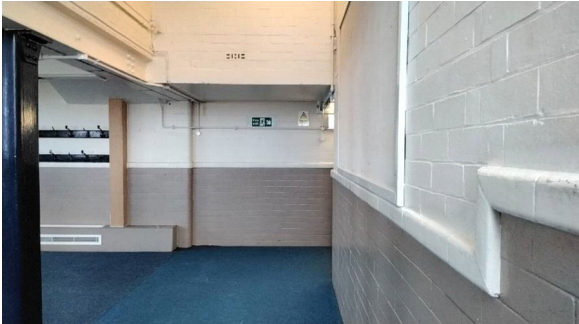
Item 112 Ref: As NO000600

The Wall coating fire flex paint (Landing MZ/003) does not contain asbestos.

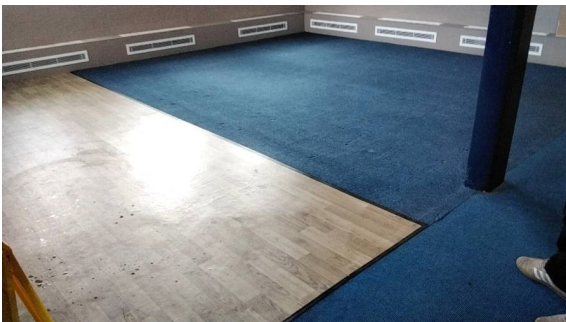
Item 113 Ref: As NO000608

The Floor adhesive (Landing MZ/003) contains asbestos.

Any change in its appearance should be recorded and passed to Property Services.

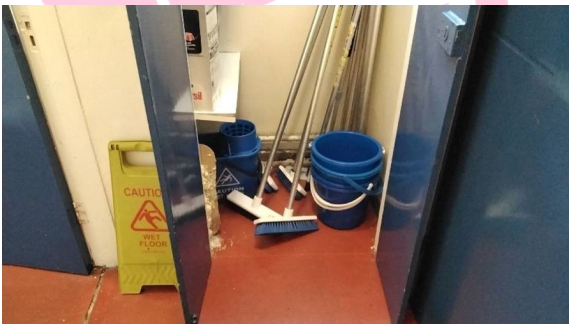
Item 120 Ref: NO000585

The Floor covering red (Cupboard G/003) contains asbestos.

Any change in its appearance should be recorded and passed to Property Services.
