ASBESTOS SURVEY REPORT FOR FULWEL JUNIOR SCHOOL, SEA ROAD, SUNDERLAND, SR6 9EE.

Asbestos Register for

Fulwell Junior School, Sea Road, Sunderland, SR6 9EE

Date: 31 July 2025

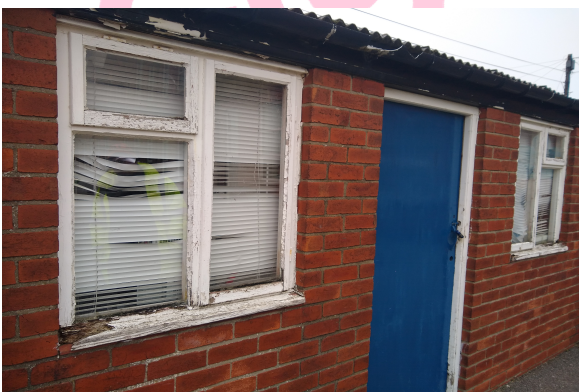
Item 3 Ref: As 392632-38

*The putty to window panes to
the bin/chair store (External)
does not contain asbestos.*

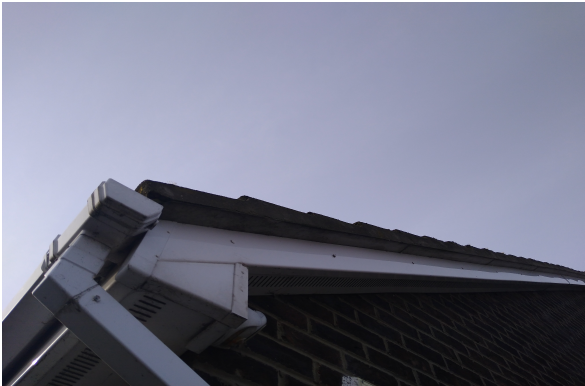
Item 4 Ref: 392632-33

The undercloaking to the caretaker's house (External) does not contain asbestos.

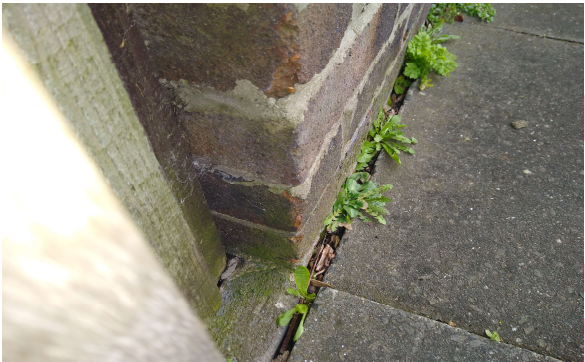
Item 5 Ref: 392632-31

The damp proof course to the caretaker's house (External) does not contain asbestos.

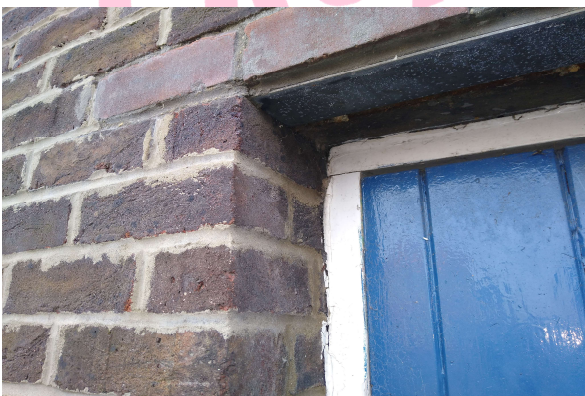
Item 6 Ref: 392632-32

The sealant to bin store door frame (External) contains asbestos.

Any change in its appearance should be recorded and passed to Property Services.

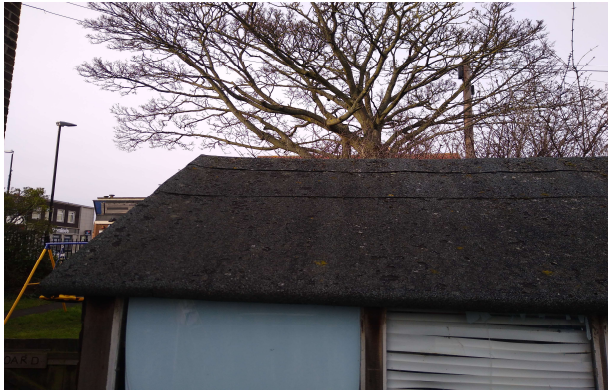
Item 7 Ref: 392632-34

The roof felt to the timber shed (External) does not contain asbestos.

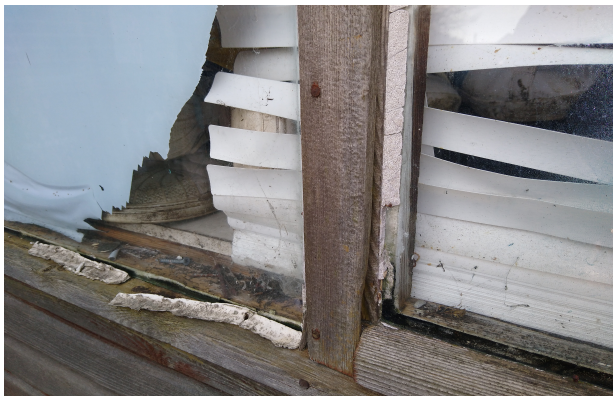
Item 8 Ref: 392632-35

The putty to glazing in the caretaker's house (External) does not contain asbestos.

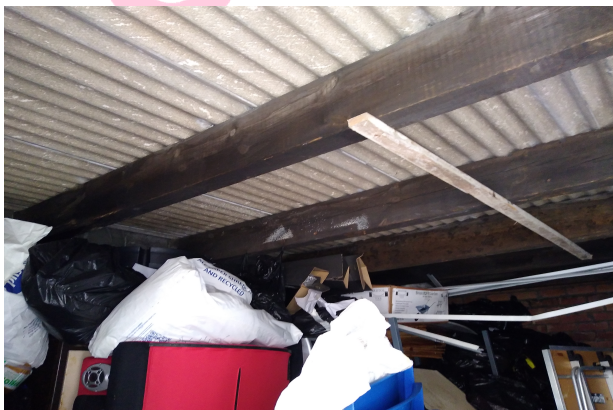
Item 9 Ref: 392632-37

The corrugated roof to the external store (Rm 0/01) contains asbestos.

Removed April 2024

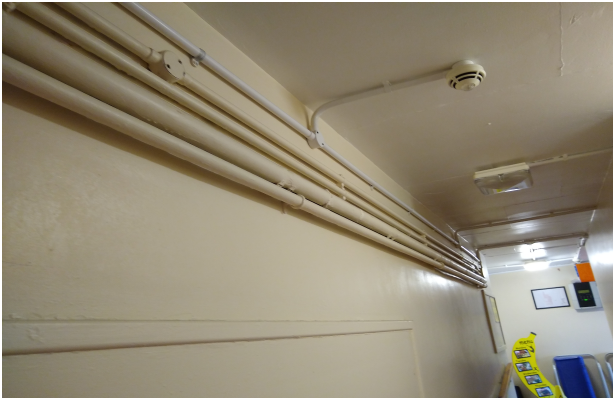
Item 11 Ref: Presumed

- (Item 11) Ref: Presumed – Below pipework lagging (boxed in - 2024) (Link corridor/Rm 002) – Low Risk
- (Item 12) Ref: 392632-24 – Sink paint (Kitchen/Rm 007) – No Risk

The lagging below pipework in the link corridor (Rm 0/02) is presumed to contain asbestos.

Any change in its appearance should be recorded and passed to Property Services.

(Pipework boxed - 2024)

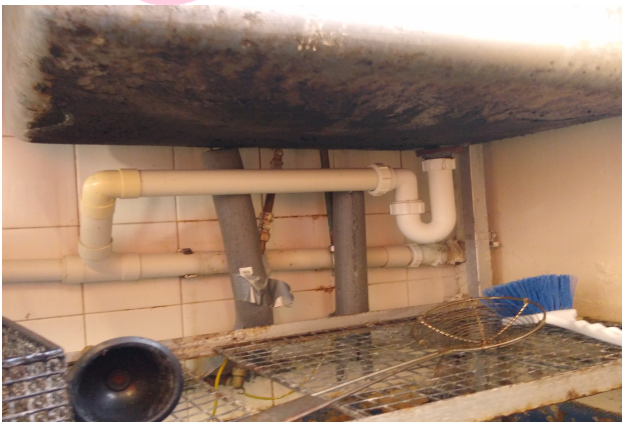
Item 12 Ref: 392632-24

The sink paint in the Dining hall building kitchen (Rm 0/07) does not contain asbestos.

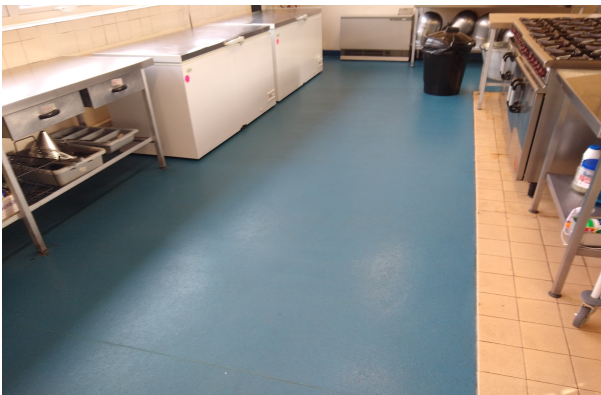
Item 14 Ref: Presumed

The adhesive below the lino and screed in the Dining hall building kitchen (Rm 0/07) is presumed to contain asbestos.

Any change in its appearance should be recorded and passed to Property Services.

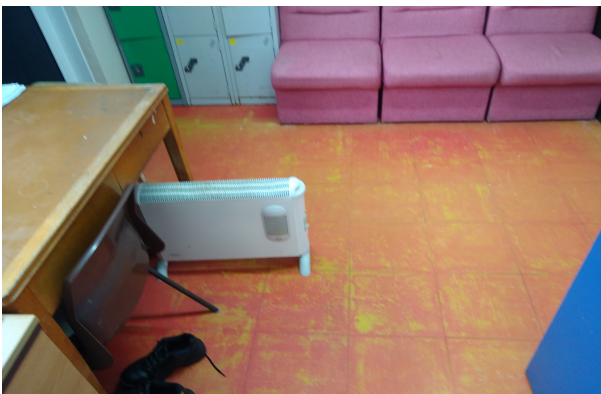
Item 15 Ref: 392632-26

The floor covering in the Dining hall building staff room (Rm 0/09) contains asbestos.

Any change in its appearance should be recorded and passed to Property Services.

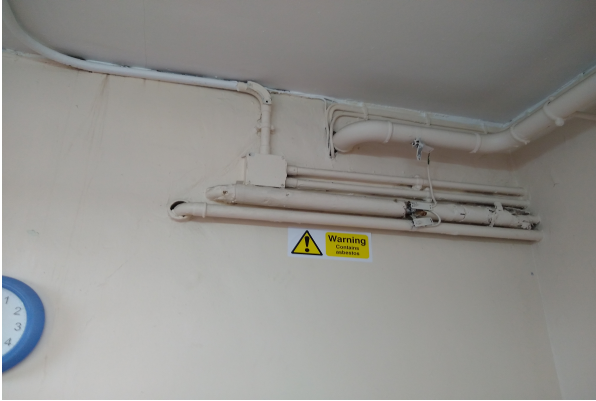
Item 16 Ref: 392632-27

The insulation to pipework elbow in the Dining hall building staff room (Rm 0/09) does not contain asbestos.

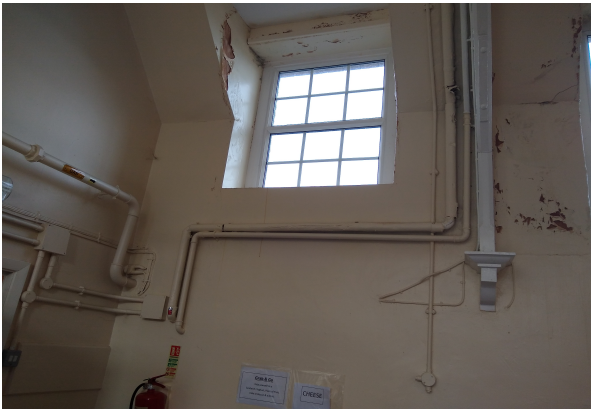
Item 17 Ref: 392632-28

The pipework lagging to elbows in the Dining hall building dining hall (Rm 0/10) does not contain asbestos.

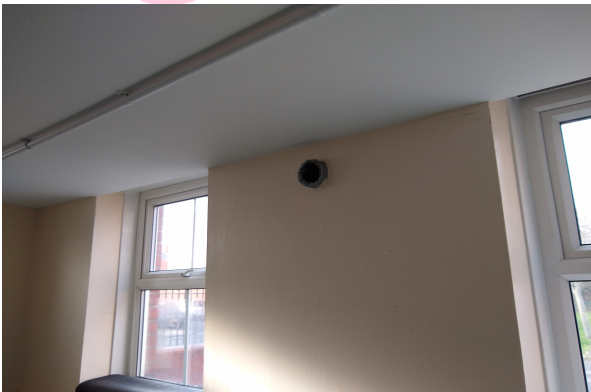
Item 18 Ref: 392632-29

The redundant flue in the Dining hall building food container store (Rm 0/11) contains asbestos.

Removed 2024 – waiting WCN's

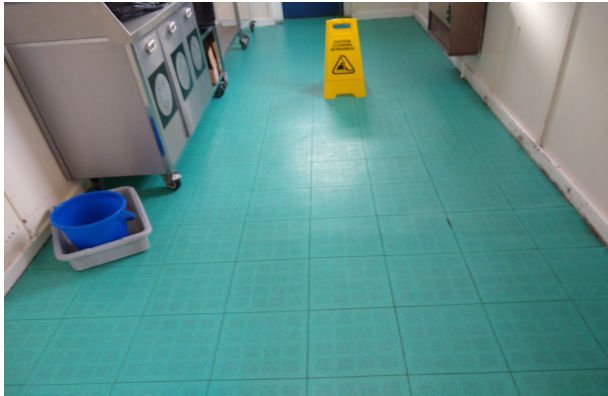
Item 19 Ref: 392632-30

The floor covering (red below top layer) in the Dining hall building food container store (Rm 0/11) contains asbestos.

Any change in its appearance should be recorded and passed to Property Services.

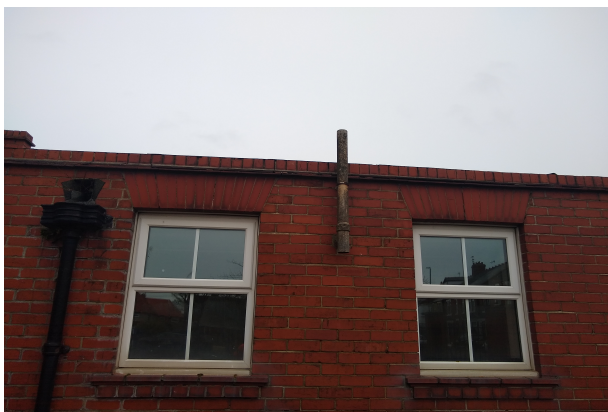
Item 20 Ref:As392632-29

The redundant flue to the Dining hall building (External) contains asbestos.

Removed 2024 – waiting WCN's

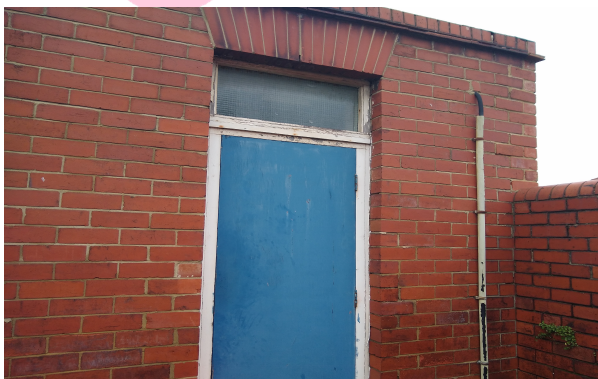
Item 21 Ref: 392632-39

The sealant to fire door of area 0/11 to the Dining hall building (External) does not contain asbestos.

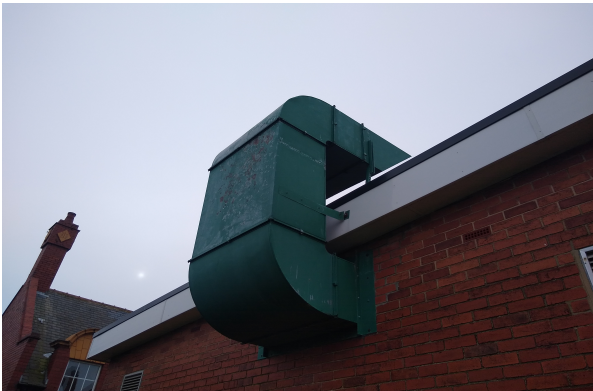
Item 23 Ref: 392632-41

The sealant to extractor ducting joints to the Dining hall building (External) does not contain asbestos.

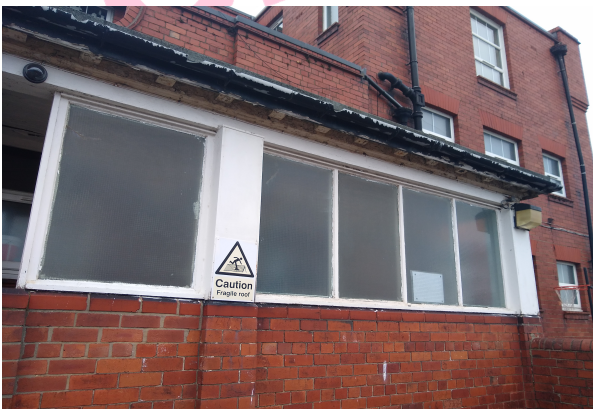
Item 24 Ref: 392632-42

The putty to window panes to the porch of the main building (External) does not contain asbestos.

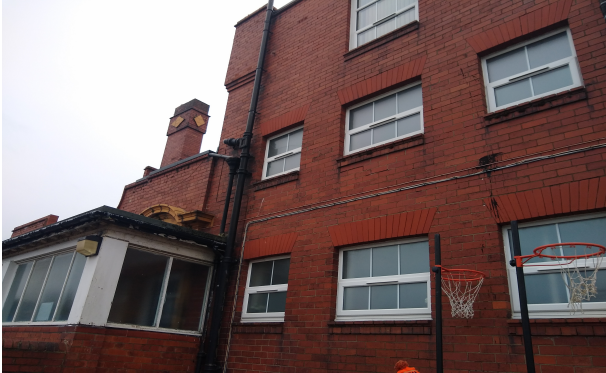
Item 25 Ref: 392632-43

The sealant to downpipe joints to the main building (External) does not contain asbestos.

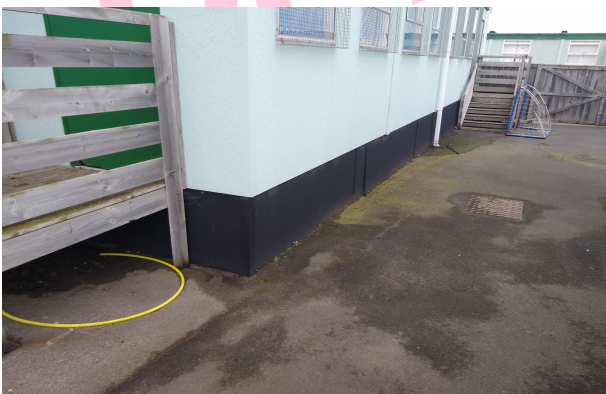
Item 27 Ref: 392632-45

The fascia board to floor void area to prefab building (External) does not contain asbestos.

Demolished in refurb 2024

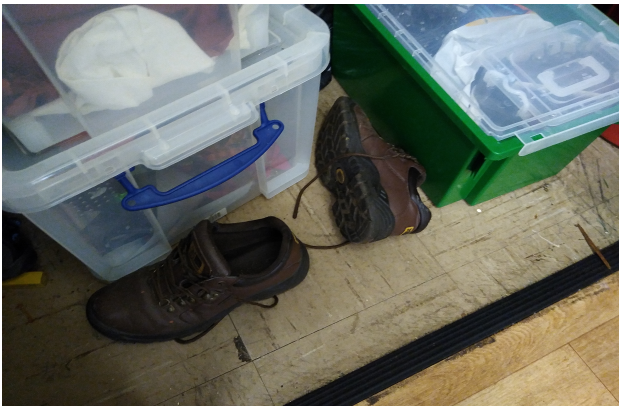
Item 29 Ref: 392632-11

The floor covering to the standalone portacabin store (Rm 0/02) does not contain asbestos.

Demolished in refurb 2024

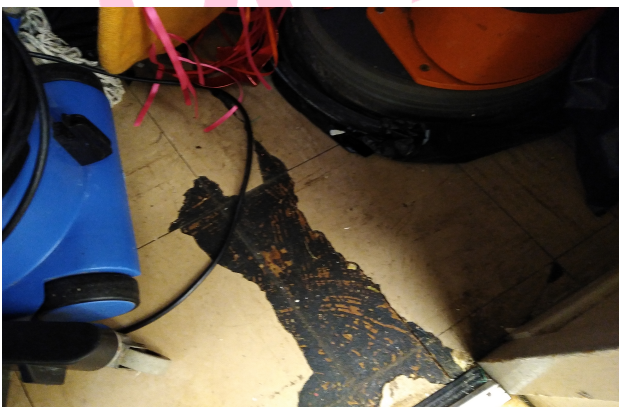
Item 30 Ref:As392632-11

The floor covering to the standalone portacabin electrical cupboard (Rm 0/04) does not contain asbestos.

Demolished in refurb 2024

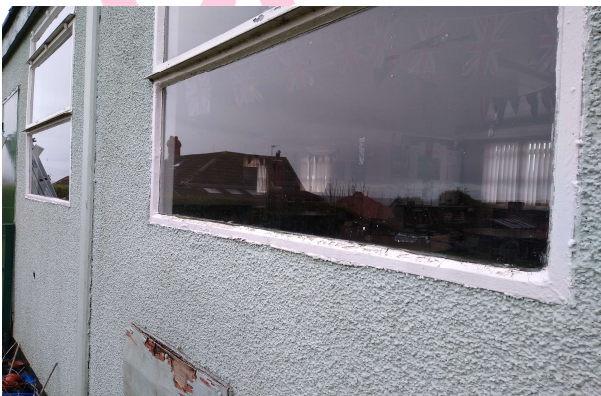
Item 33 Ref: 392632-14

The sealant to window frames to the standalone portacabin (External) does not contain asbestos.

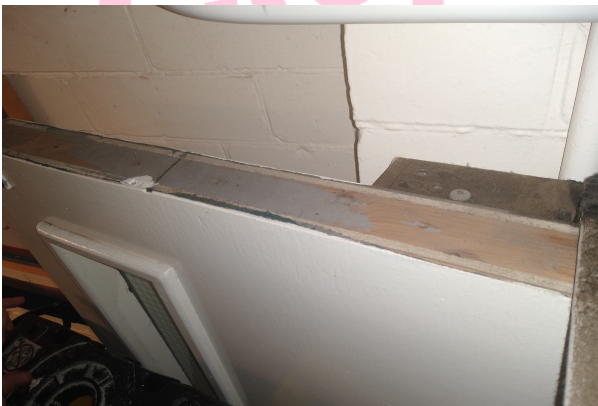
Item 36 Ref: 392632-23

The panels within the fire doors in the stairwell and corridor (Rm 0/04) does not contain asbestos.

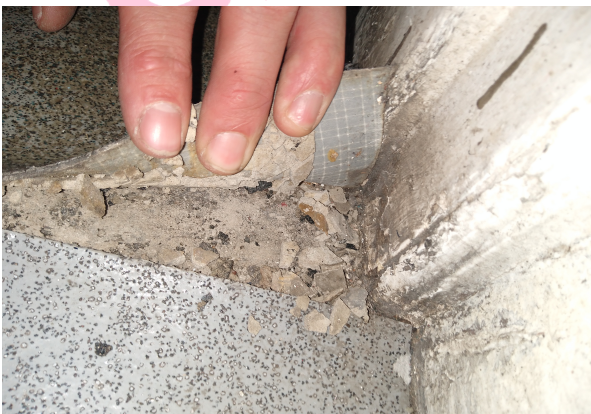
Item 39 Ref: 392632-21

The floor covering below modern screed in the lobby (Rm 0/05b) contains asbestos.

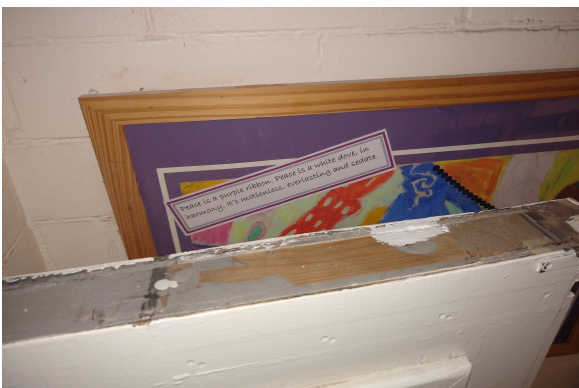
Item 42 Ref: 392632-19

The panels within the fire doors to 0/009 in the corridor (Rm 0/08a) does not contain asbestos.

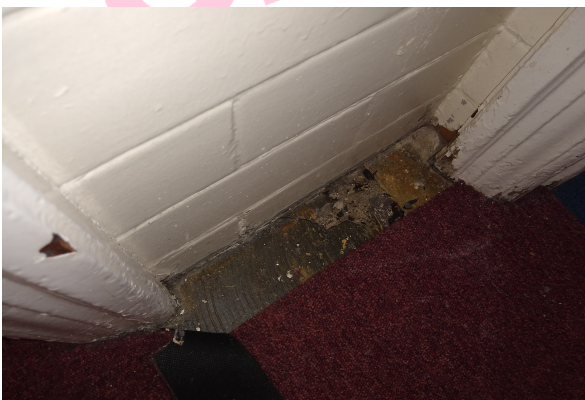
Item 45 Ref: 392632-16

The floor covering below carpet in the lobby (Rm 0/12) contains asbestos.

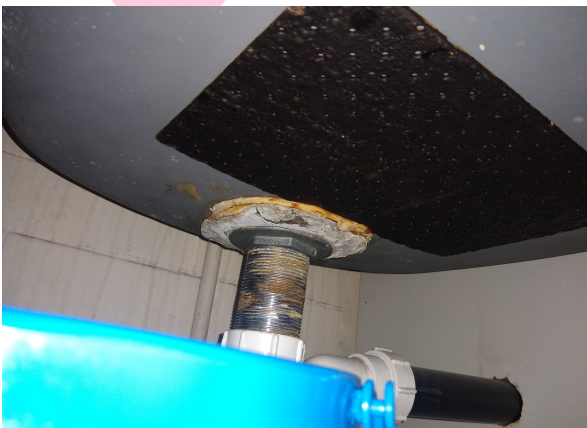
Item 48 Ref: 392632-3

The sink pad in the lobby (Rm 1/01) does not contain asbestos.

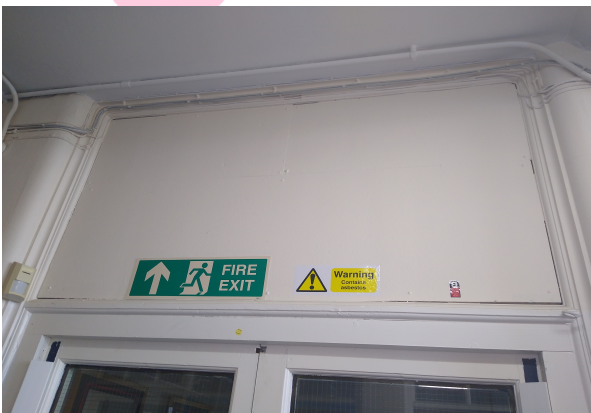
Item 51 Ref: 392632-6

The panel above door to stairwell in the corridor and lobby (Rm 1/12) contains asbestos.

Removed March 2023

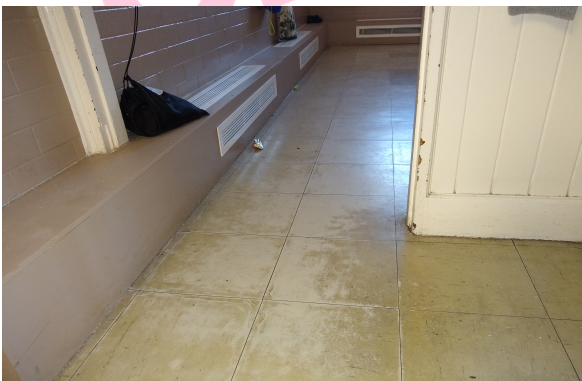
Item 54 Ref: As 392632-1

The floor covering in the cloakroom (Rm 1/M002) does not contain asbestos.

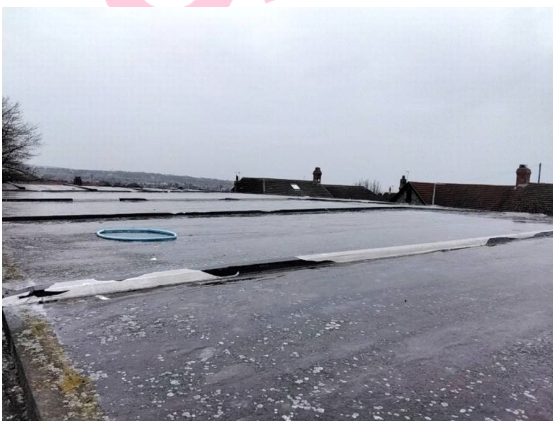
Item 57 Ref: CF006518

The roof jointing compound (External/E001) does not contain asbestos.

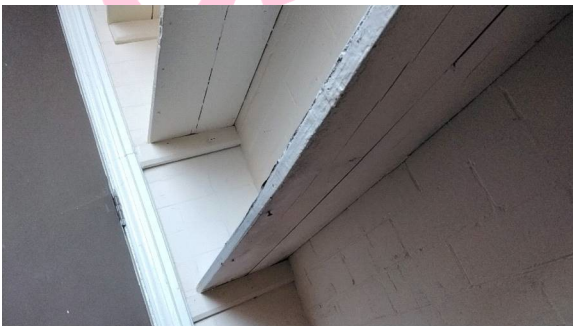
Item 93 Ref: NO000607

The Shelving remnants to shelving/nails etc (Cupboard Store G/034) contain asbestos.

Any change in its appearance should be recorded and passed to Property Services.

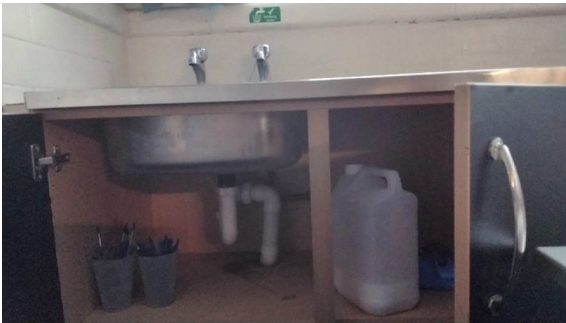
Item 104 Ref: As NO000598

The Under sink mat
(Classroom 1/017) does not
contain asbestos.

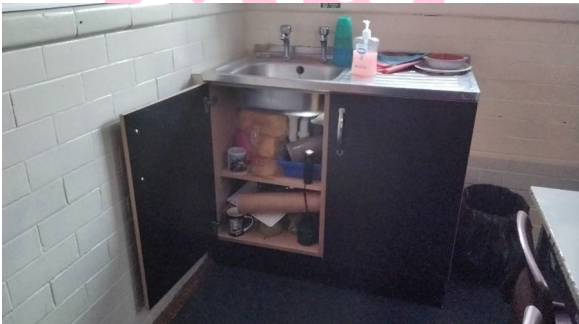
Item 105 Ref: As NO000598

The Under sink mat
(Classroom 1/018) does not
contain asbestos.

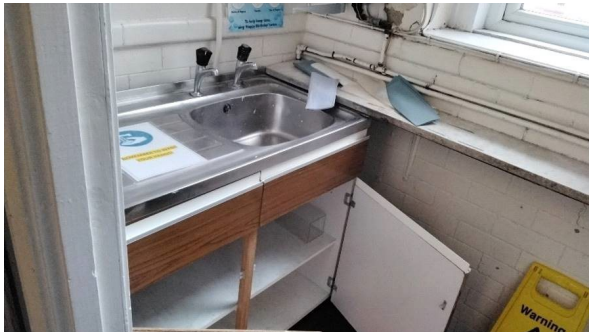
Item 106 Ref: NO000599

The Under sink mat (Corridor 1/019) does not contain asbestos.

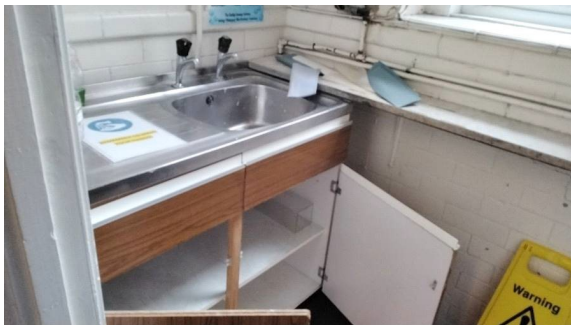
Item 107 Ref: As NO000597

The Pipework to sink water pipe (Corridor 1/019) does not contain asbestos.

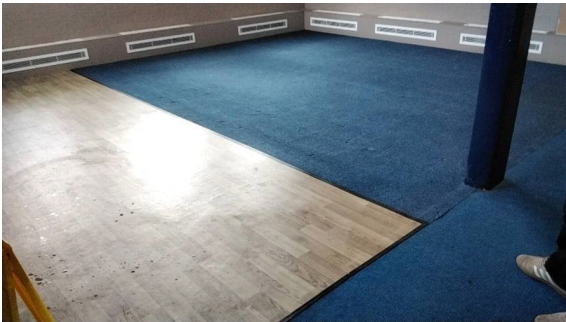
Item 113 Ref: As NO000608

The Floor adhesive (Landing MZ/003) contains asbestos.

Any change in its appearance should be recorded and passed to Property Services.

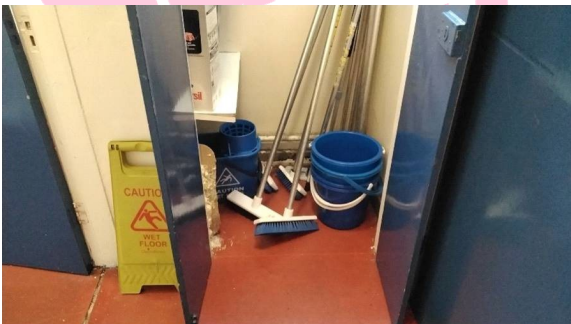
Item 120 Ref: NO000585

The Floor covering red (Cupboard G/003) contains asbestos.

Any change in its appearance should be recorded and passed to Property Services.

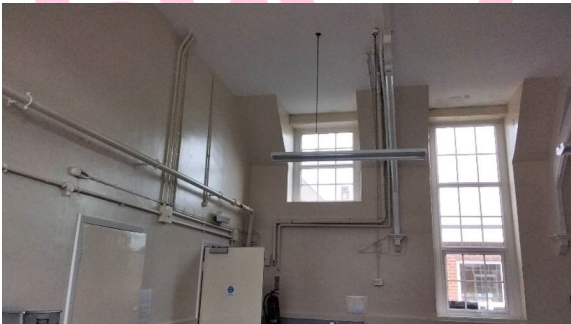
Item 129 Ref: Presumed

The Pipework insulation (Dining hall/area G/009) is presumed to contain asbestos.

Any change in its appearance should be recorded and passed to Property Services.
