ASBESTOS SURVEY REPORT FOR GRINDON INFANTS SCHOOL, SUNDERLAND

Asbestos Register for
GRINDON INFANTS SCHOOL

Grindon Infants School - Last updated 22/08/2022 – Version 2

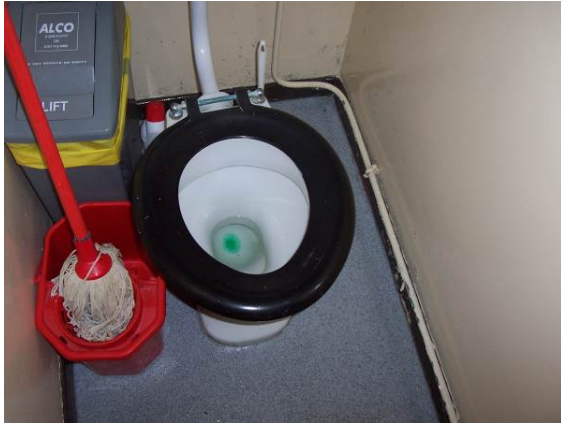
Various Ref: CS06/70

The toilet seat in the kitchen WC (Room1) does not contain asbestos.

Similar WC seats are located in Rooms 7 and 8.

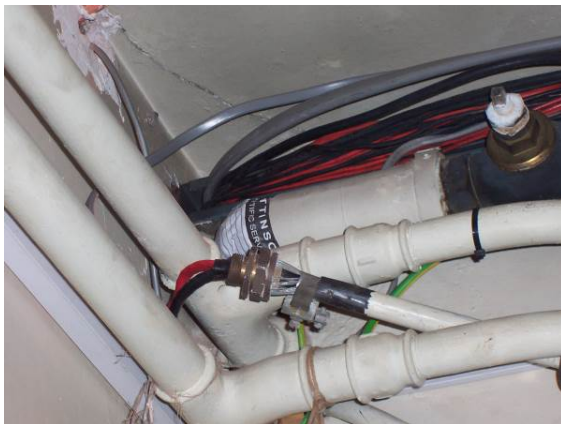
Various - Ref: CS06/71

The small bore pipework in the cleaner's cupboard (Room 35) contained asbestos.

This was removed in 2014.

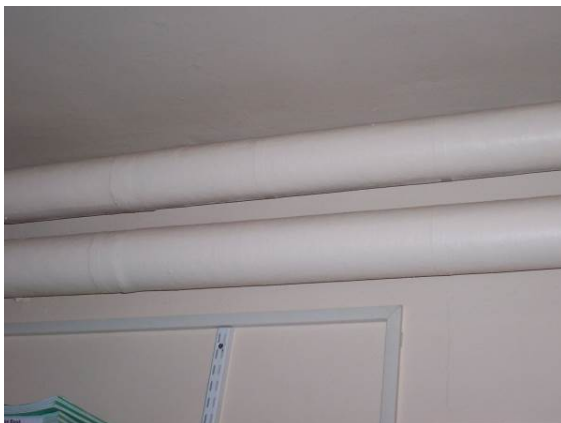
Various - Ref: CS06/73

The large bore pipework in store cupboard (room 12) does not contain asbestos.

Similar pipework is located in rooms 13, 16, 19, 20, 21 and 33.

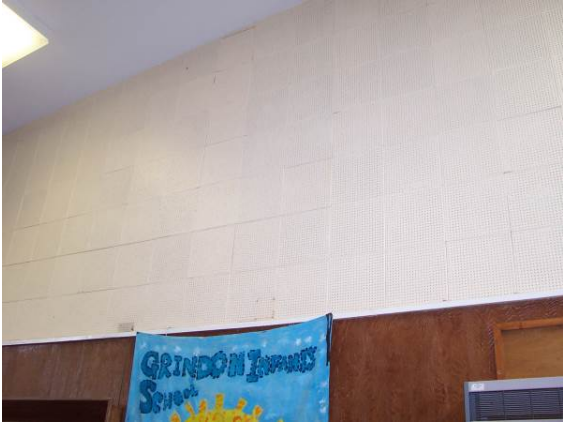
Item 10 - Ref: CS06/75

The acoustic panels in the main hall do not contain asbestos.

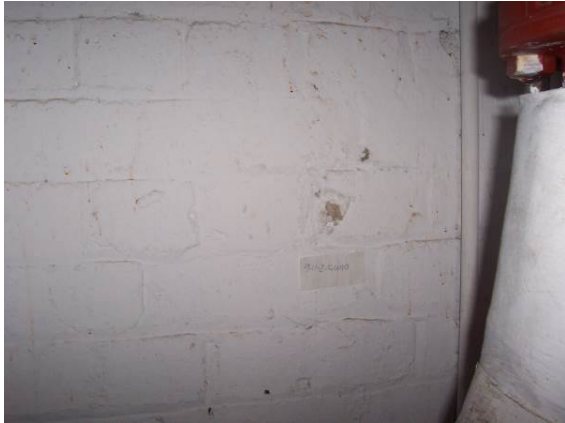
Item 24 - Ref: CS06/77

The debris to the walls in the plant room contained asbestos.

This was removed and environmental cleaned in summer 2012.

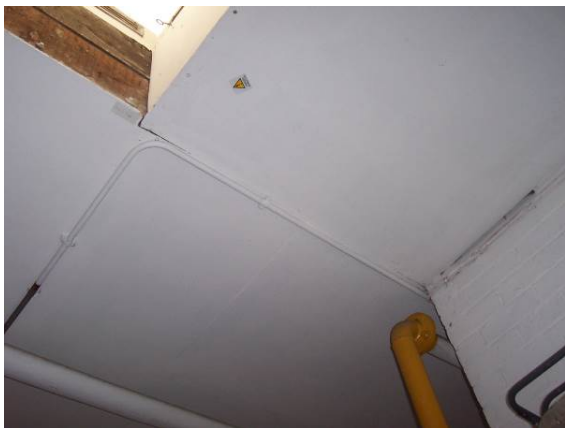
Various - Ref: CS06/78

The ceiling boards (skylight upstands) in the plant room contained asbestos.

Similar ceiling boards were located in the plant room corridor cupboard.

These were removed in summer 2012.

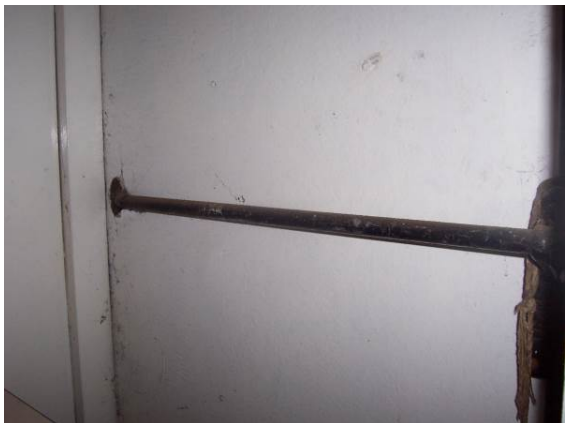
Item 26 - Ref: CS06/79

The panel to the door in the plant room contained asbestos.

This was removed in summer 2012.

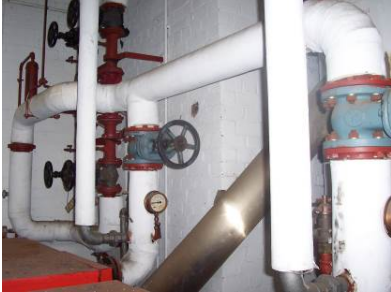
Item 27 - Ref: CS06/80

The pipework to the plant room does not contain asbestos.

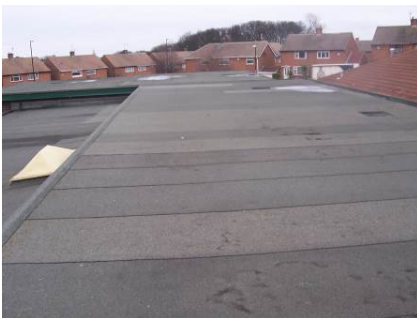
Item 29 – Ref: CS06/81

The external flat felt roof does not contain asbestos.

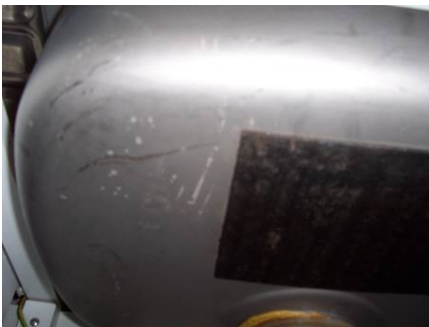
Item 31 – Ref: CS06/84

The sink pad in room R2 in the Nursery does not contain asbestos.

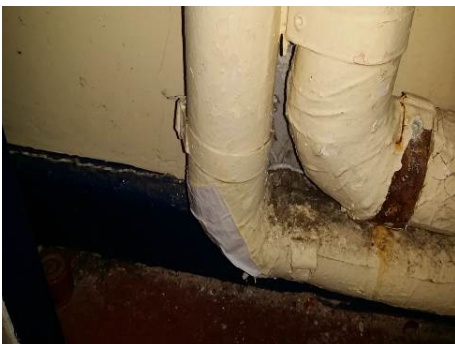
Item 32 – Ref: 79008-1

The pipe lagging to the small pipework on the pipe elbows to the Site Supervisors Cupboard (Rm 0/20) contained asbestos.

This was removed in August 2016.

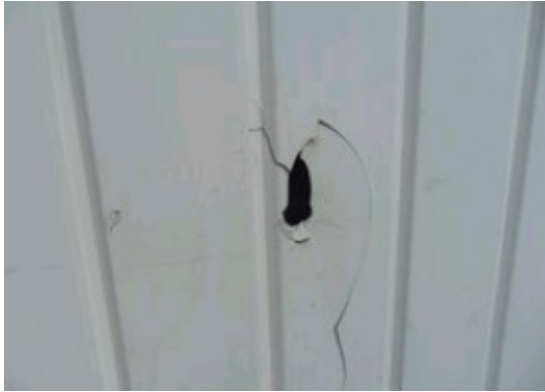
Item 36 – Ref: 79008-1

The tar paper behind PVC cladding (external) does not contain asbestos.

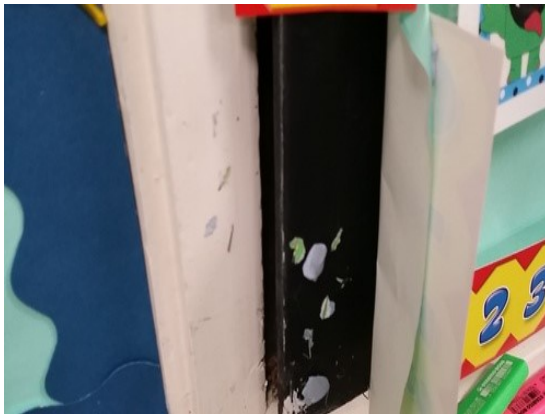
Item 37 – Ref: 97272-2

The coating to wood blackboard in 026/classroom does not contain asbestos.

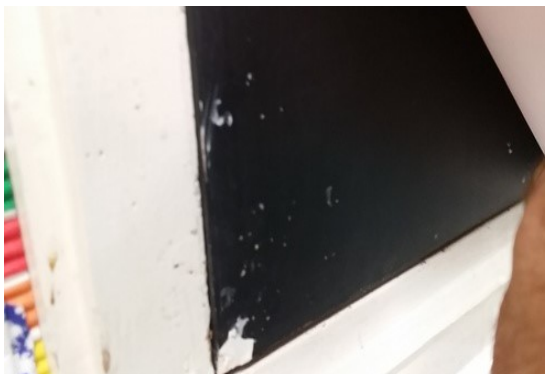
Item 38 – Ref: 97272-1

The coating to wood blackboard in 027/classroom does not contain asbestos.

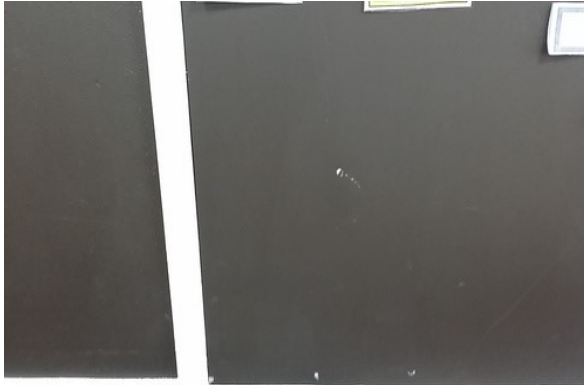
Item 39 – Ref: As 97272-1

The coating to wood blackboard in 028/ IT classroom does not contain asbestos.

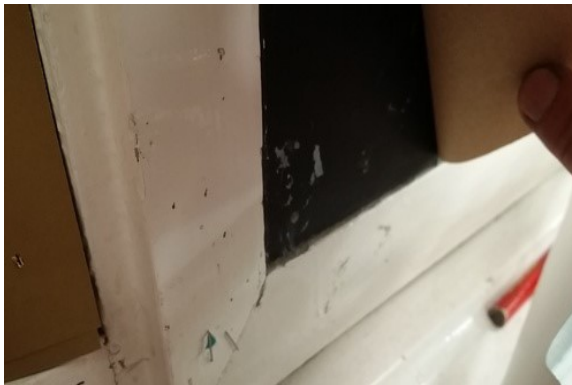
Item 40 – Ref: As 97272-1

The coating to wood blackboard in 029/classroom does not contain asbestos.

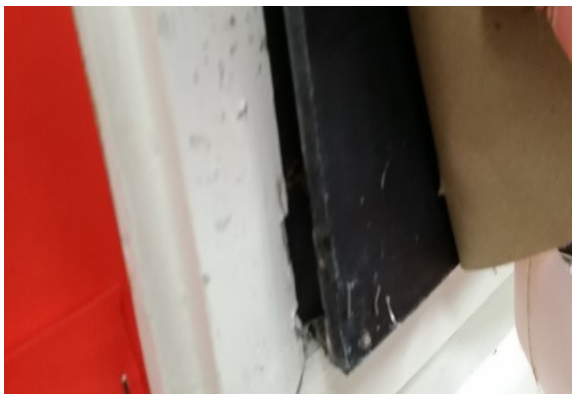
Item 41 – Ref: As 97272-1

The coating to wood blackboard in 030/classroom does not contain asbestos.

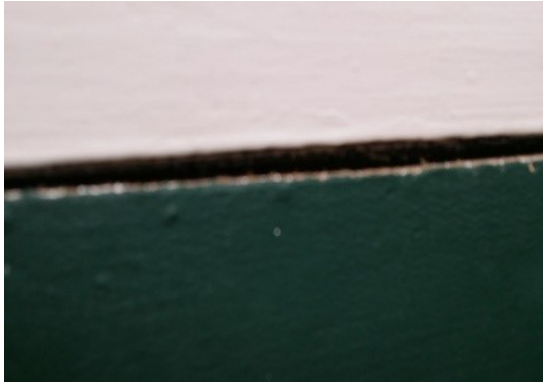
Item 42 – Ref: As 97272-1

The coating to wood blackboard behind fibreboard in 032/classroom does not contain asbestos.

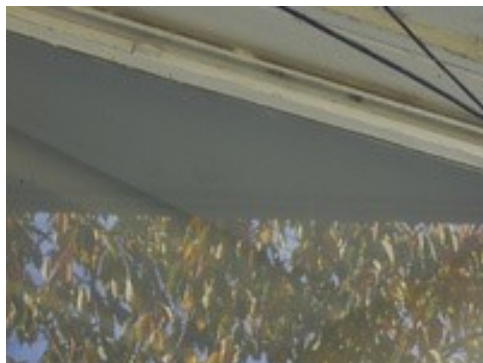
Item 47 – Ref: 62644-1

The sealant to frame (external - localised dining hall area)

Removed at time of kitchen refurb 2015
