ASBESTOS SURVEY REPORT FOR HILL VIEW INFANT SCHOOL, SUNDERLAND

HILL VIEW INFANT SCHOOL, SUNDERLAND

Date: 25 November 2024

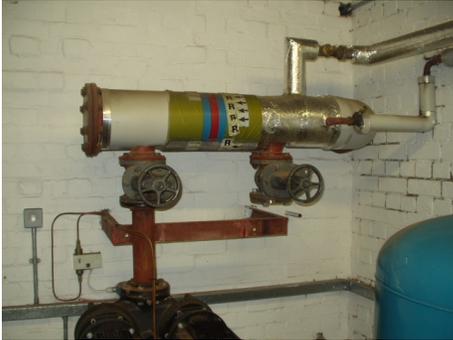
Item 1 Ref: Presumed

The pipework flange gaskets to the boiler room are strongly presumed to contain asbestos.

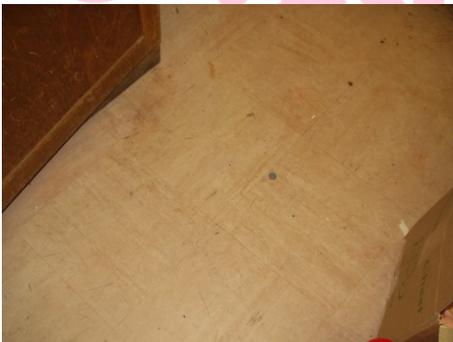
Item 3 - Ref: AW0834/08

The beige floor tiles to the store cupboard (Rm 0/16) do not contain asbestos.

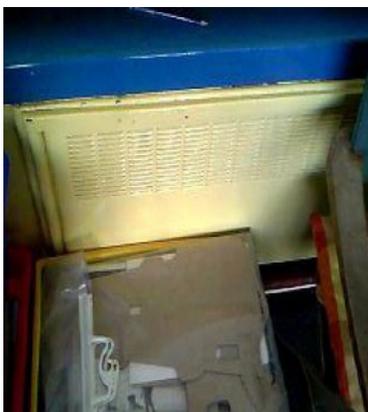
Item 15 – As BB000791

The insulation panel between the heater and the brickwork to the wall in room 0/49 does not contain asbestos.

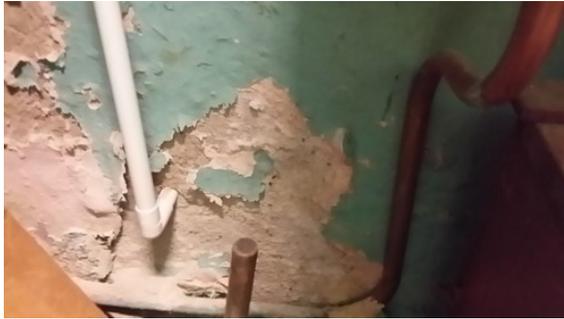
Item 25 - Ref: 102516-1

The plaster to wall (Rm 086/store) does not contain asbestos.

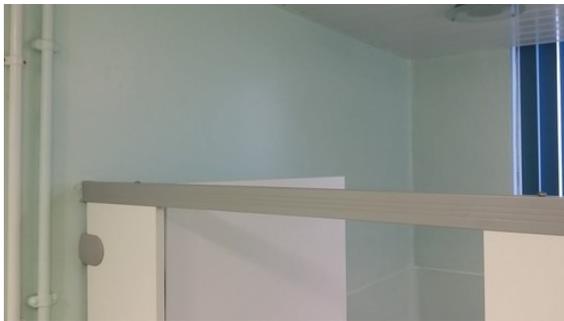
Item 26 - Ref: As 102516-

The plaster to wall (Rm 087/Female WC) does not contain asbestos.

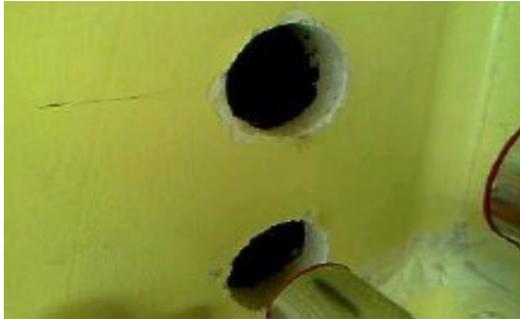
Item 28 - Ref: BB001184

The wall material (concrete & mesh) (Rm 01) does not contain asbestos.

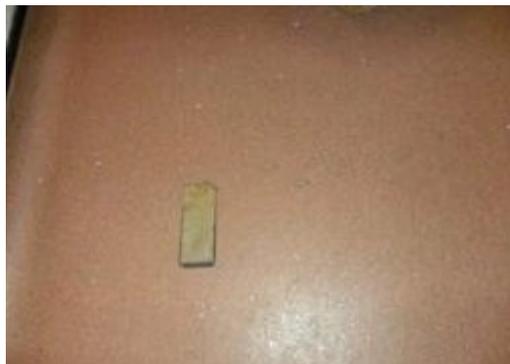
Item 29 - Ref: VP003141

The Pink vinyl floor covering (Rm 01/Female WC vestibule) does not contain asbestos.

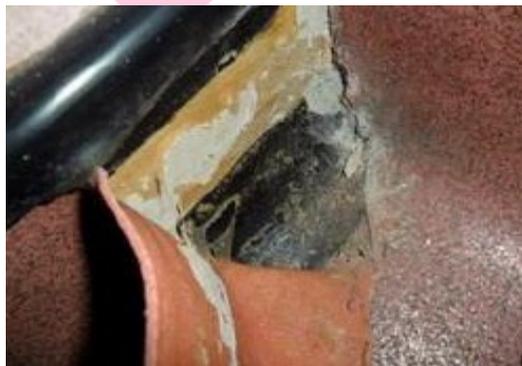
Item 30 - Ref: VP003142

The Skirting to base of wall (Rm 01/Female WC vestibule) does not contain asbestos.

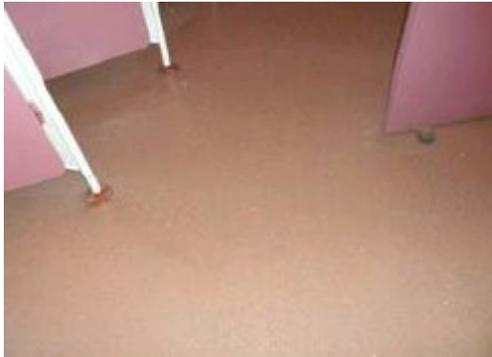
Item 31 - Ref: As

The Pink vinyl floor covering (Rm 02/Female WC) does not contain asbestos.

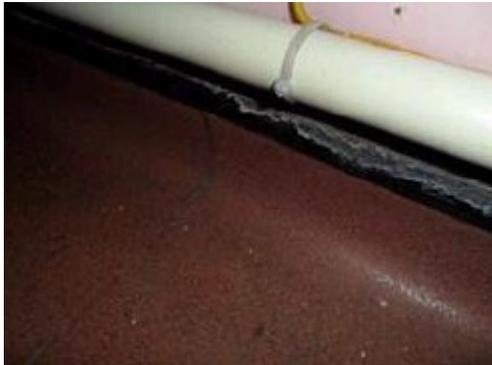
Item 32 - Ref: As

The Skirting to base of wall (Rm 02/Female WC) does not contain asbestos.

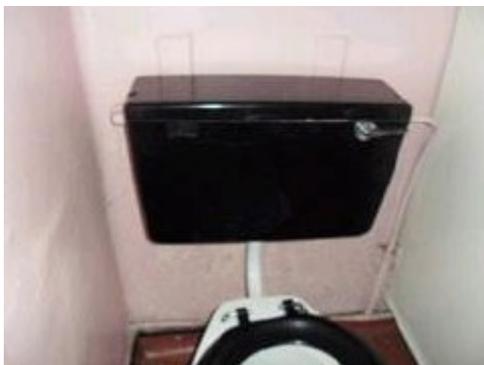
Item 33 - Ref: VP003143

The Toilet Cistern (Rm 02/Female WC) contains asbestos.

Removed

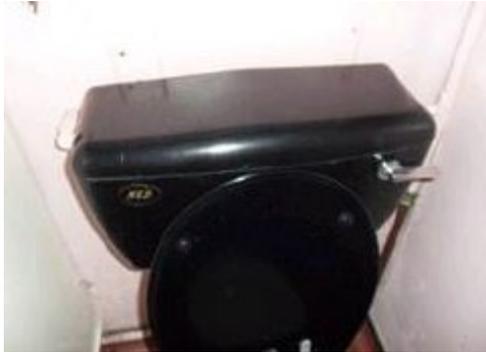
Item 34 - Ref: VP003144

The Toilet Cistern (Rm 02/Female WC) contains asbestos.

Removed

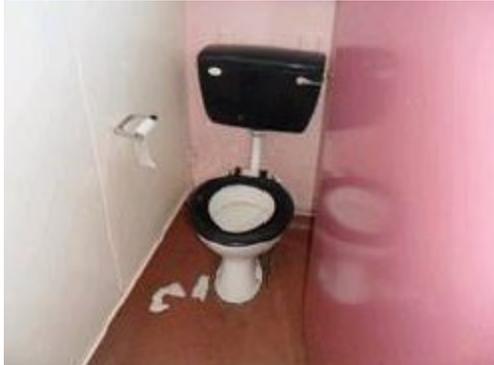
Item 35 - Ref: VP003145

The Toilet seats (Rm 02/Female WC) contains asbestos.

Removed

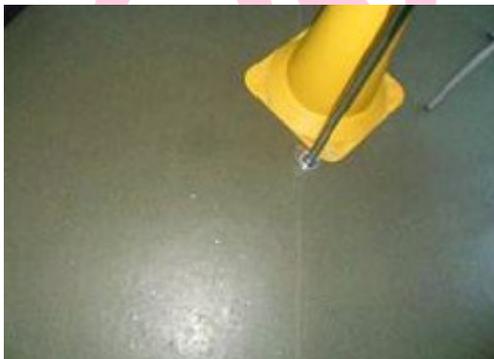
Item 36 - Ref: VP003146

The Green vinyl floor covering (Rm 03/Children's kitchen) does not contain asbestos.

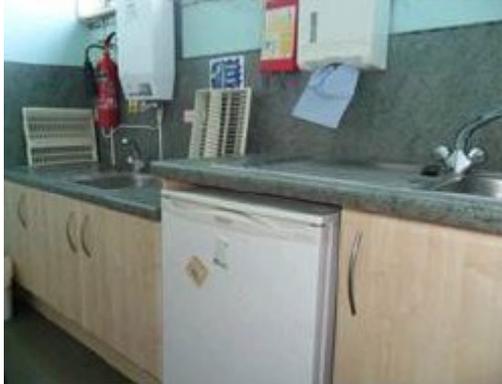
Item 37 - Ref: VP003146

The Bitumen pads to underside of sink and drainer (Rm 03/Children's kitchen) does not contain asbestos.

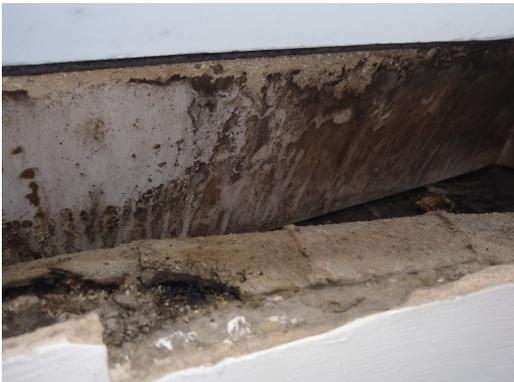
Item 38 Ref: 437902-1

The felt to top of skylights surrounding (0/030 Corridor) does not contain asbestos.

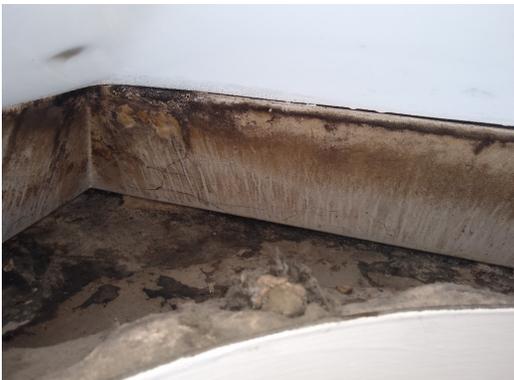
Item 39 Ref: 437902-2

437902-2 – Rope packers to skylight adjacent year 2 cloakroom (0/030 Corridor) (Item 39) – Low Risk

The rope packers to skylight adjacent year 2 cloakroom (0/030 Corridor) contain asbestos.

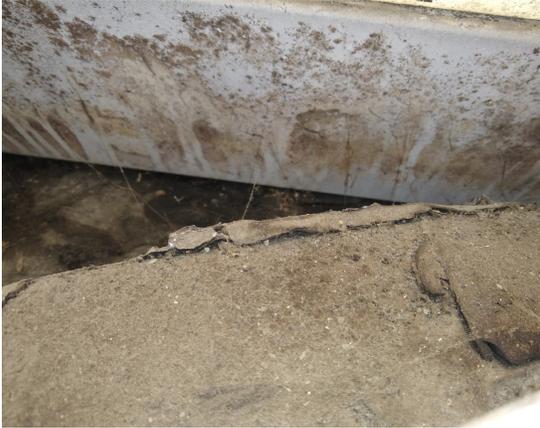
Item 40 Ref: 437902-4

The felt to top of skylights surrounding (0/050 Corridor) does not contain asbestos.

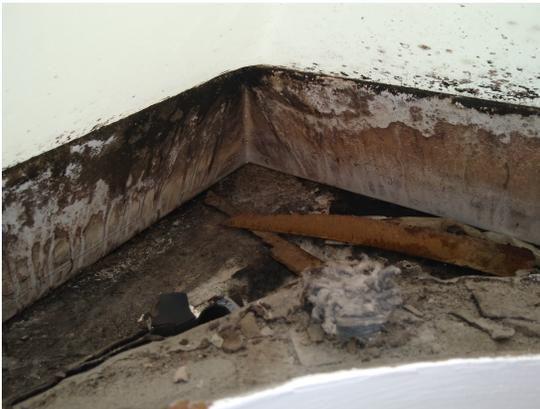
Item 41 Ref: 437902-3

437902-3 – Rope packers to skylight brackets (0/050 Corridor) (Item 41) – Low Risk

The rope packers to skylight brackets (0/050 Corridor) contain asbestos.

Any change in its appearance should be recorded, and passed to Property Services.

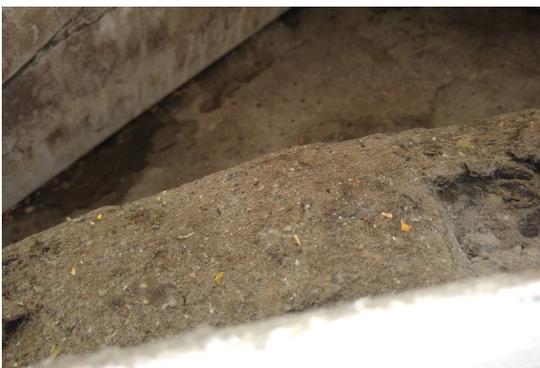
Item 42 Ref: As 437902-4

The felt to top of skylights surrounding (0/050a Lobby) does not contain asbestos.

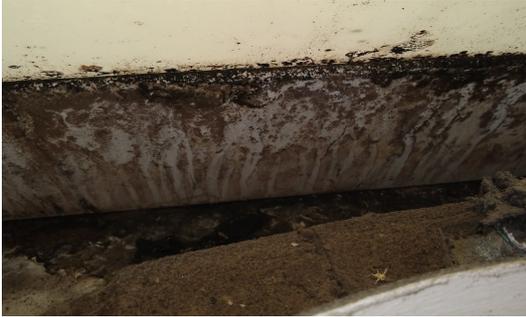
Item 43 Ref: As 437902-4

The felt to top of skylights surrounding (0/050b Lobby) does not contain asbestos.

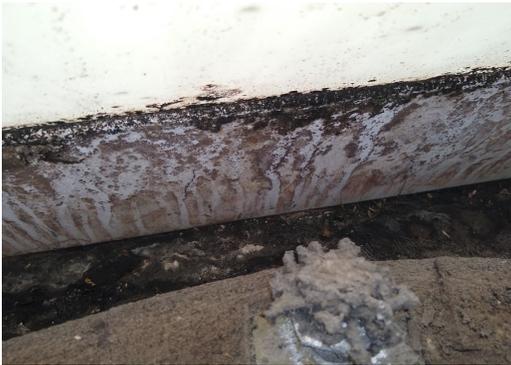
Item 44 Ref: As 437902-3

As 437902-3 – Rope packers to skylight brackets (0/050b Lobby) (Item 44) – Very Low Risk

The rope packers to skylight brackets (0/050b Lobby) contain asbestos.

Any change in its appearance should be recorded, and passed to Property Services.

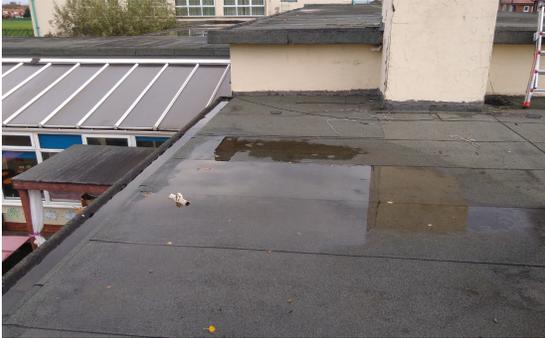
Item 46 Ref: 437902-6

The flat roof (External Roof 2) does not contain asbestos.

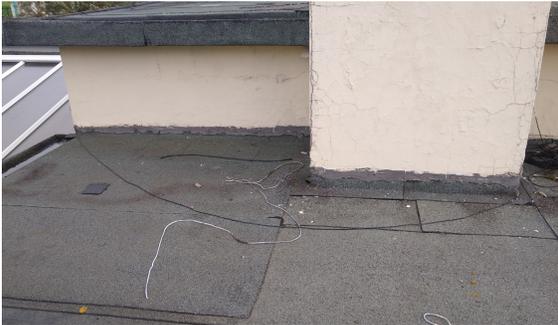
Item 47 Ref: 437902-7

The sealant to flashing (External Roof 2) does not contain asbestos.

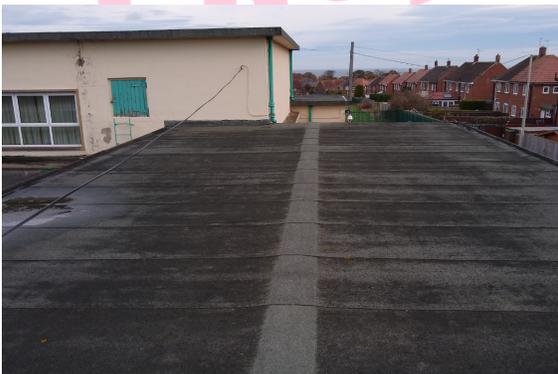
Item 48 Ref: 437902-8

The flat roof (External Roof 3) does not contain asbestos.

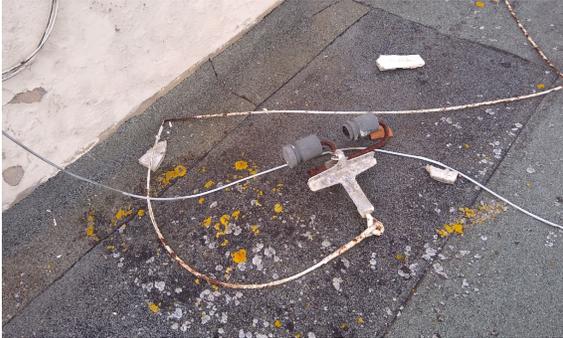
Item 49 Ref: 437902-9

The telephone insulation (External Roof 3) contains asbestos.

Removed March 2021

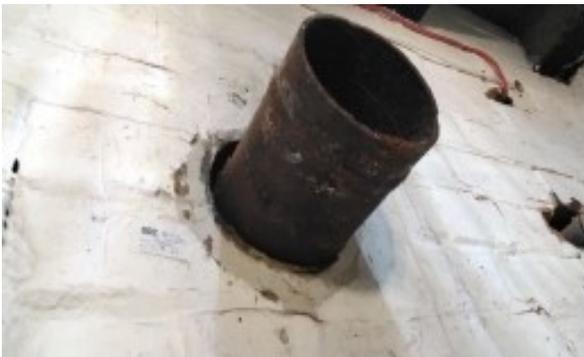
Item 77 Ref: NO000536

The debris/residue to wall redundant pipe area in the Boiler Room Z/001 does contain asbestos.

Environmental clean carried out August 2023. Any change in appearance notify Property Services.

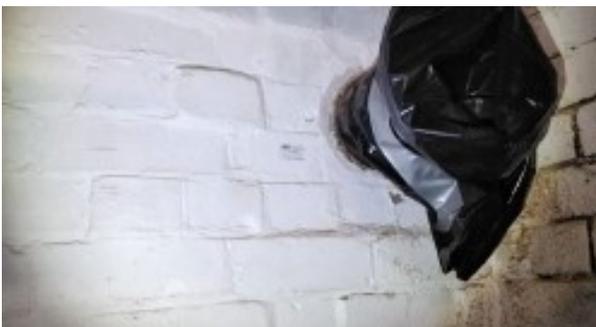
Item 78 Ref: NO000537

The debris/residue to wall adjacent to redundant pipe area in the Boiler Room Z/001 does contain asbestos.

Environmental clean carried out August 2023. Any change in appearance notify Property Services.

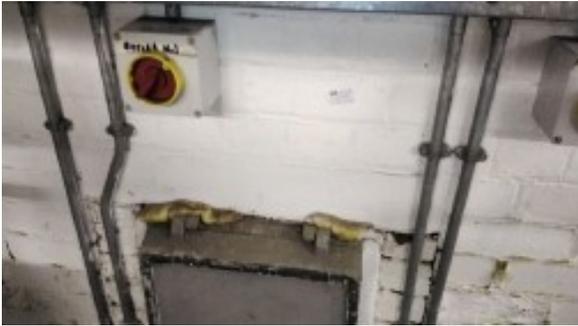
Item 79 Ref: NO000538

The debris/residue to flue chimney in the Boiler Room Z/001 does contain asbestos.

Environmental clean carried out August 2023. Any change in appearance notify Property Services.

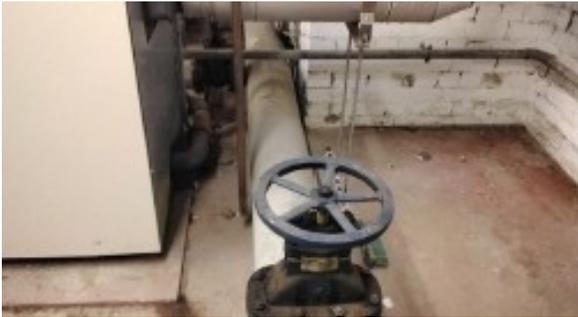
Item 80 Ref: NO000539

The debris/residue to floor behind boilers in the Boiler Room Z/001 does contain asbestos.

Environmental clean carried out August 2023. Any change in appearance notify Property Services.

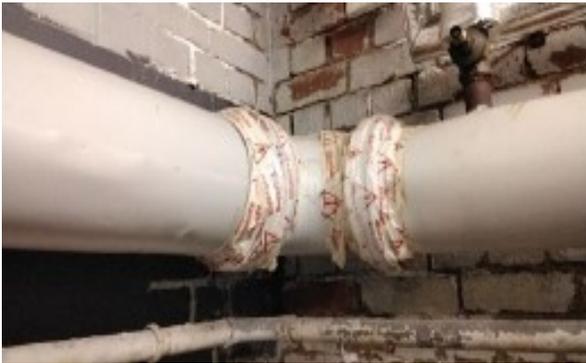
Item 86 Ref: Presumed

The pipework gaskets in the switch room Z/002 are presumed to contain asbestos.

Removed August 2023

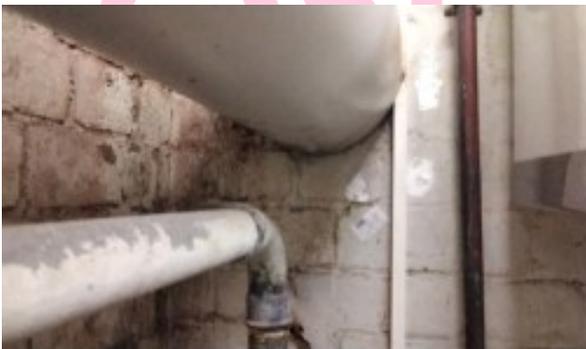
Item 87 Ref: NO00545

The debris/residue to walls behind redundant pipes in the switch room Z/002 does contain asbestos.

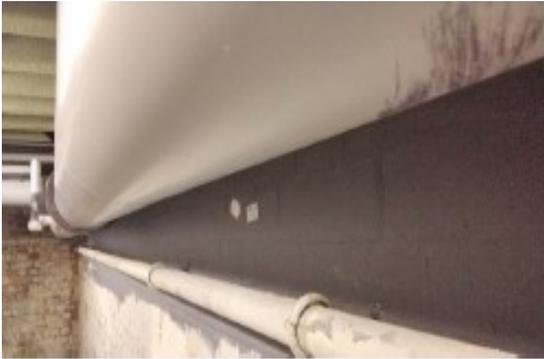
Item 88 Ref: NO000546

The debris/residue to walls behind redundant pipes partially sealed showing signs of deterioration in the switch room Z/002 does contain asbestos.

<i>Item 88</i>	<i>Debris/Residue to walls behind redundant pipes partially sealed showing signs of deterioration (Switch Room Z/002) (Encapsulated)</i>	<i>Low Risk</i>	<i>6 monthly</i>	<i>24/02/2025</i>
<i>Item 89</i>	<i>Debris/Residue to floor (Switch Room Z/002)(Encapsulated)</i>	<i>Medium</i>	<i>3 monthly</i>	<i>24/02/2025</i>
<i>Item 90</i>	<i>Electrical services cable braiding/insulation (Switch Room Z/002)</i>	<i>Very Low Risk</i>	<i>12 monthly</i>	<i>Removed August 2023</i>
<i>Item 91</i>	<i>Pipework gaskets valve over boiler (Room former coal bunker Z/004)</i>	<i>Very Low Risk</i>	<i>12 monthly</i>	<i>Removed August 2023</i>

Environmental clean carried out August 2023. Any change in appearance notify Property Services.

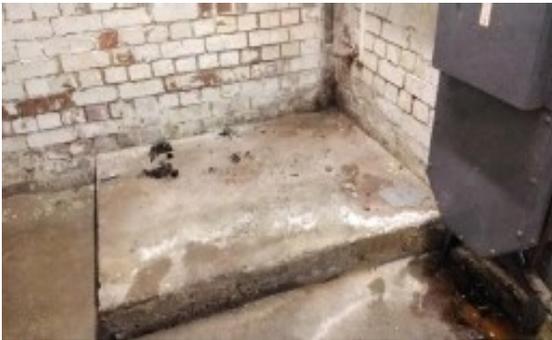
Item 89 Ref: NO000547

The debris/residue floor in the switch room Z/002 does contain asbestos.

Environmental clean carried out August 2023. Any change in appearance notify Property Services.

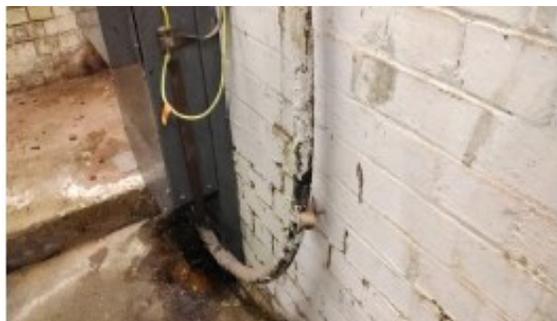
Item 90 Ref: Presumed

The electrical services cable braiding/insulation in the switch room Z/002 is presumed to contain asbestos.

Removed August 2023

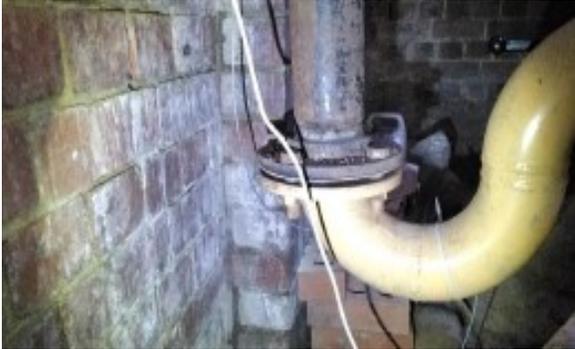
Item 91 Ref: NO000548

The pipework gaskets valve over boiler in the form coal bunker Z/004 does contain asbestos.

Removed August 2023
