ASBESTOS SURVEY REPORT FOR HILL VIEW INFANT SCHOOL, SUNDERLAND

Asbestos Register for

HILL VIEW INFANT SCHOOL, SUNDERLAND

Date: 04 July 2025

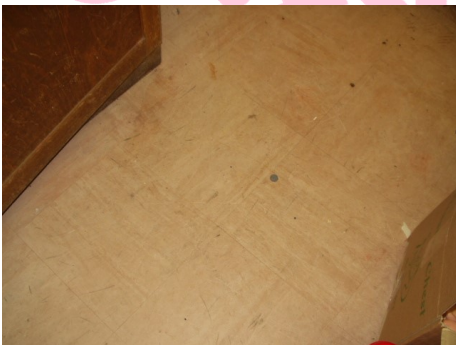
Item 3 - Ref: AW0834/08

The beige floor tiles to the store cupboard (Rm 0/16) do not contain asbestos.

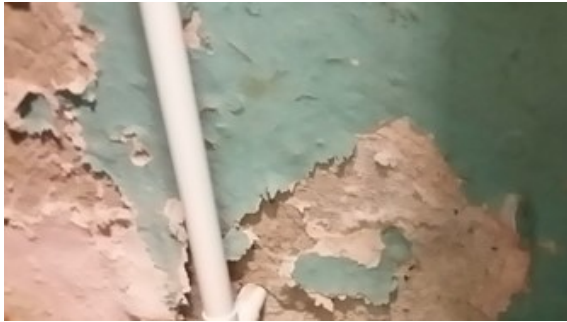
Item 25 - Ref: 102516-1

The plaster to wall (Rm 086/store) does not contain asbestos.

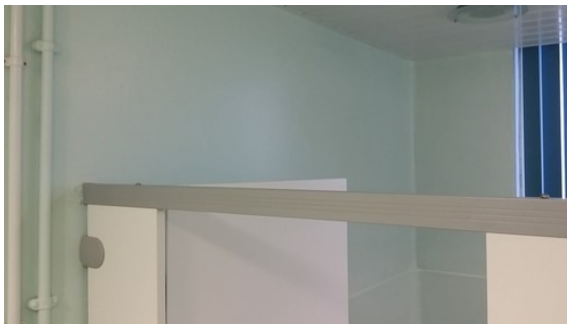
Item 26 - Ref: As 102516-

The plaster to wall (Rm 087/Female WC) does not contain asbestos.

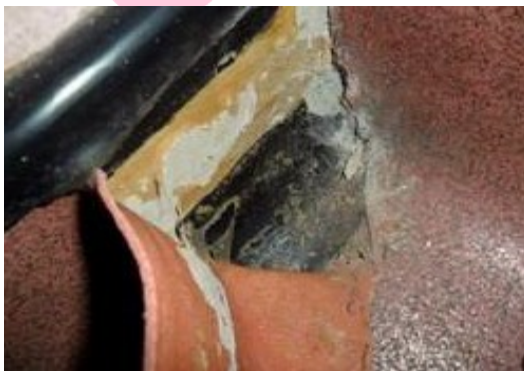
Item 30 - Ref: VP003142

The Skirting to base of wall (Rm 01/Female WC vestibule) does not contain asbestos.

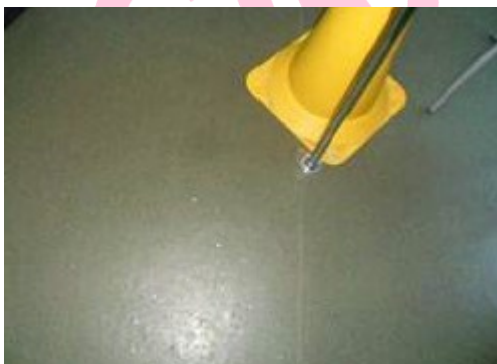
Item 36 - Ref: VP003146

The Green vinyl floor covering (Rm 03/Children's kitchen) does not contain asbestos.

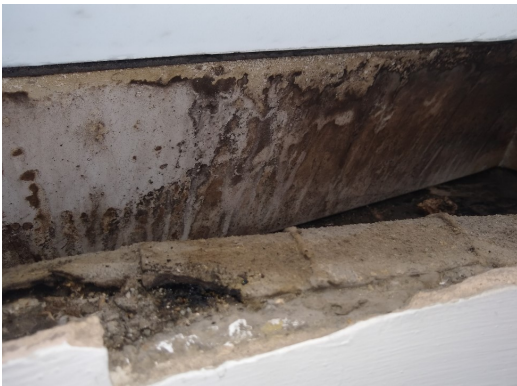
Item 38 Ref: 437902-1

The felt to top of skylights surrounding (0/030 Corridor) does not contain asbestos.

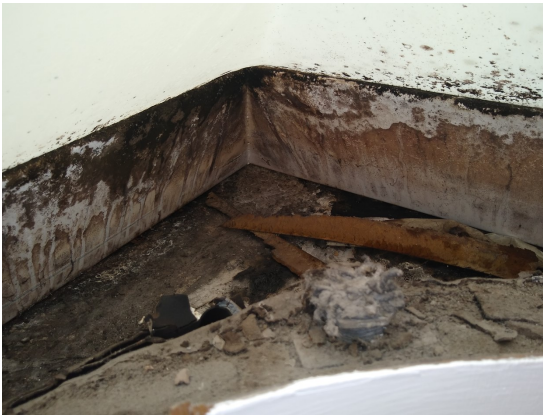
Item 41 Ref: 437902-3

437902-3 – Rope packers to skylight brackets (0/050 Corridor) (Item 41) – Low Risk

The rope packers to skylight brackets (0/050 Corridor) contain asbestos.

Any change in its appearance should be recorded, and passed to Property Services.

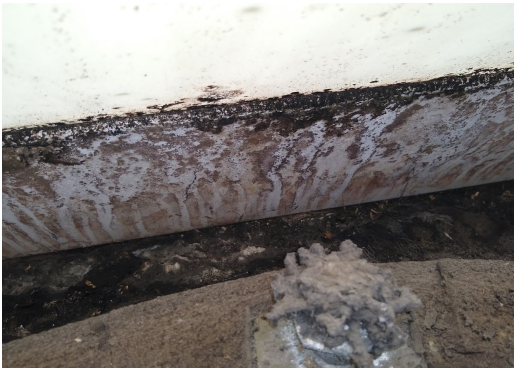
Item 44 Ref: As 437902-3

As 437902-3 – Rope packers to skylight brackets (0/050b Lobby) (Item 44) – Very Low Risk

The rope packers to skylight brackets (0/050b Lobby) contain asbestos.

Any change in its appearance should be recorded, and passed to Property Services.

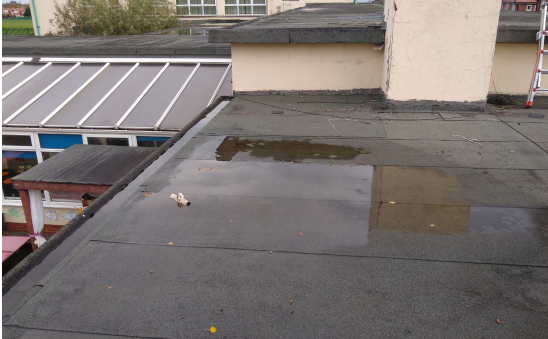
Item 46 Ref: 437902-6

The flat roof (External Roof 2) does not contain asbestos.

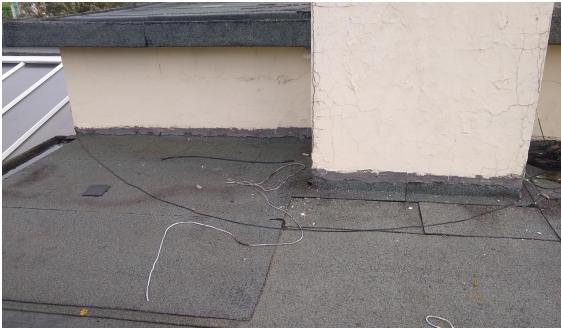
Item 47 Ref: 437902-7

The sealant to flashing (External Roof 2) does not contain asbestos.

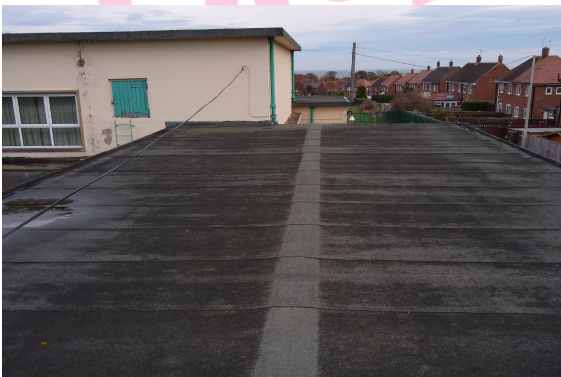
Item 48 Ref: 437902-8

The flat roof (External Roof 3) does not contain asbestos.

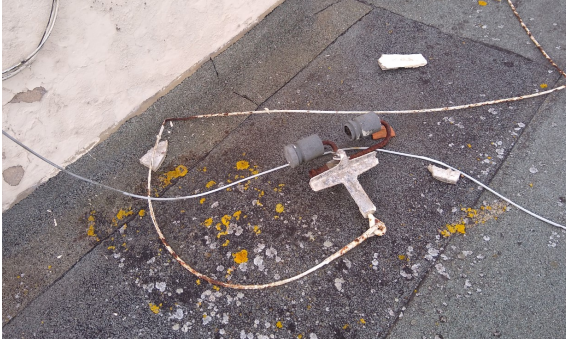
Item 49 Ref: 437902-9

The telephone insulation (External Roof 3) contains asbestos.

Removed March 2021

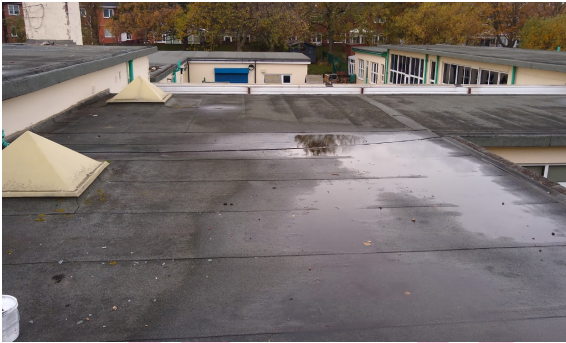
Item 50 Ref: 437902-10

The flat roof (External Roof 4) does not contain asbestos.

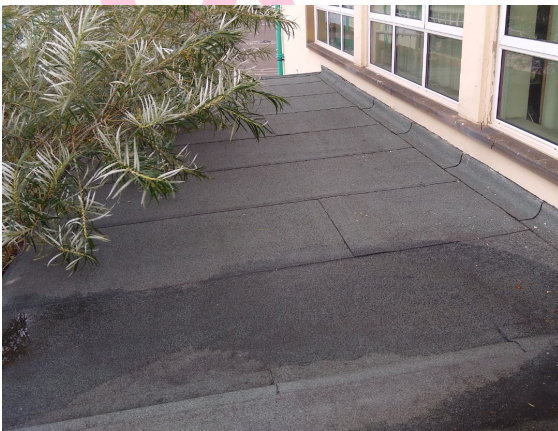
Item 51 Ref: 437902-11

The flat roof (External Roof 5) does not contain asbestos.

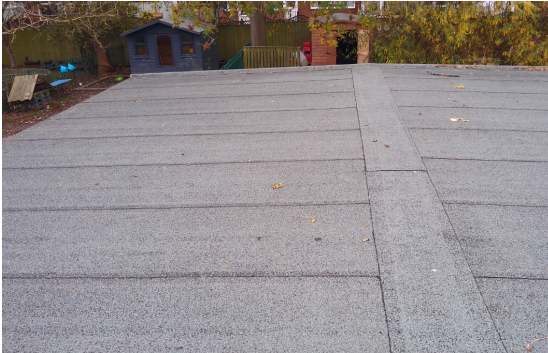
Item 52 Ref: 437902-12

The flat roof (External Roof 6) does not contain asbestos.

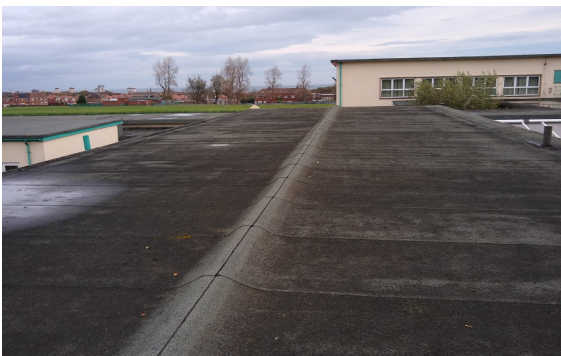
Item 53 Ref: 437902-13

The flat roof (External Roof 7) does not contain asbestos.

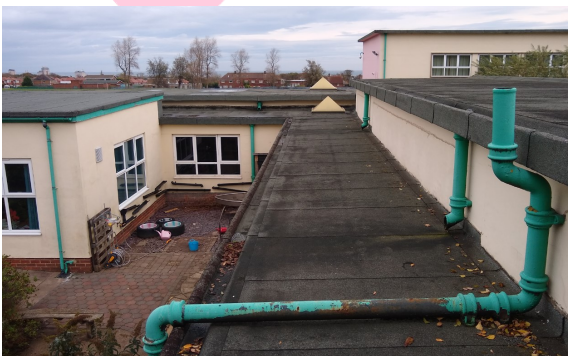
Item 54 Ref: 437902-14

The flat roof (External Roof 8) does not contain asbestos.

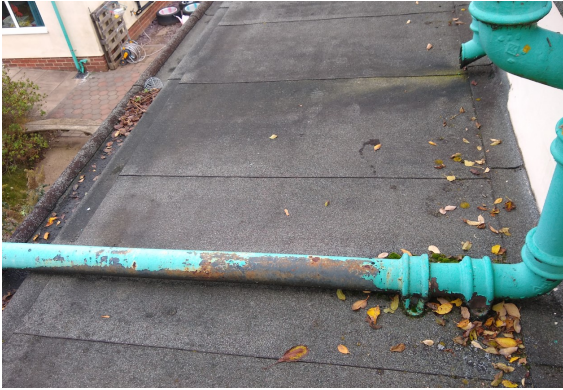
Item 55 Ref: 437902-15

The mastic to downpipe joints (External Roof 8) does not contain asbestos.

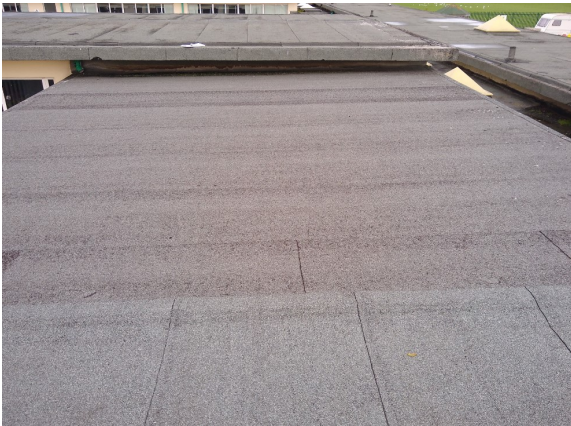
Item 56 Ref: 437902-16

The flat roof (External Roof 9) does not contain asbestos.

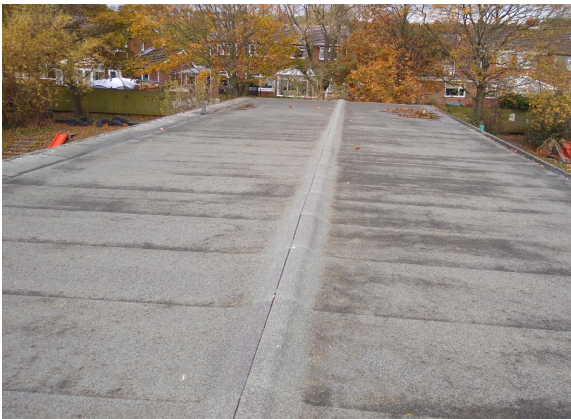
Item 57 Ref: 437902-17

The flat roof (External Roof 10) does not contain asbestos.

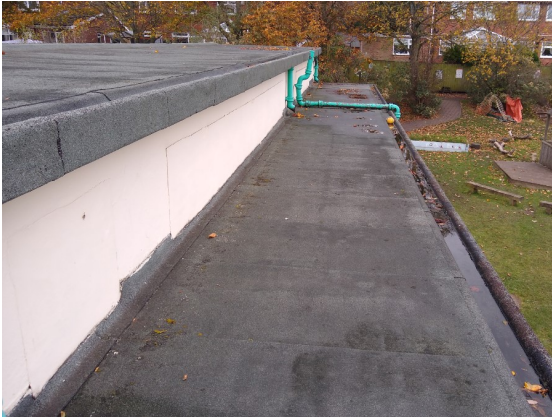
Item 58 Ref: 437902-18

The flat roof (External Roof 11) does not contain asbestos.

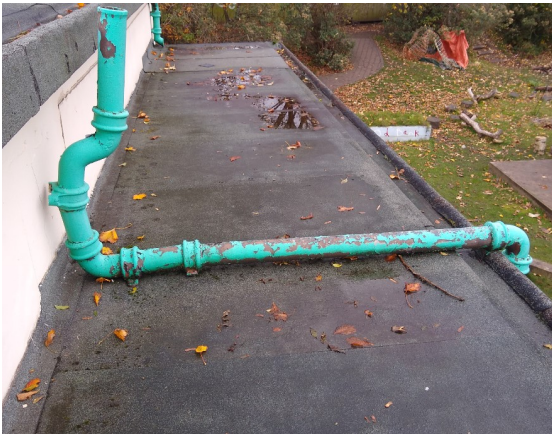
Item 59 Ref: As 437902-15

The mastic to downpipe joints (External Roof 11) does not contain asbestos.

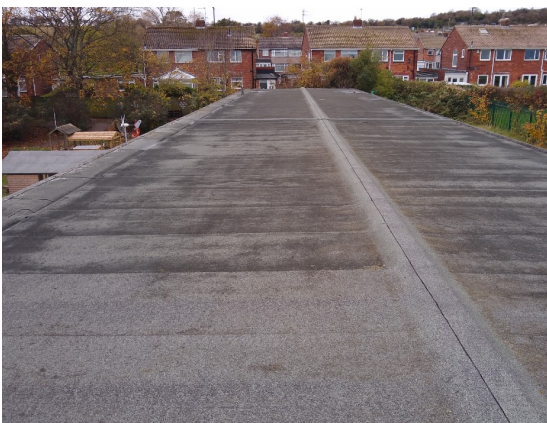
Item 60 Ref: 437902-19

The flat roof (External Roof 12) does not contain asbestos.

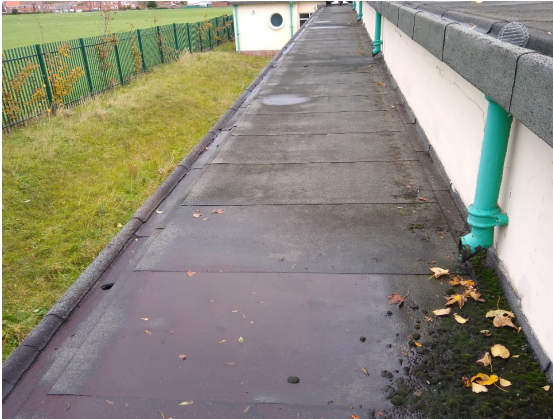
Item 61 Ref: 437902-20

The flat roof (External Roof 13) does not contain asbestos.

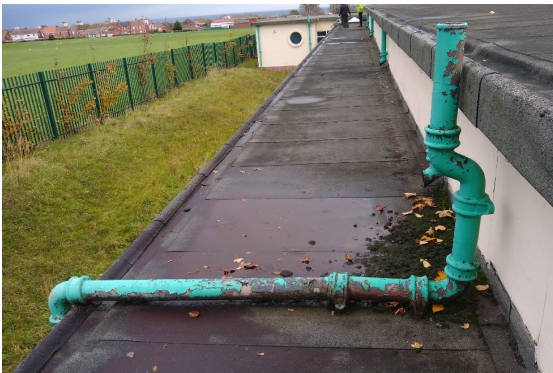
Item 62 Ref: As 437902-15

The mastic to downpipe joints (External Roof 13) does not contain asbestos.

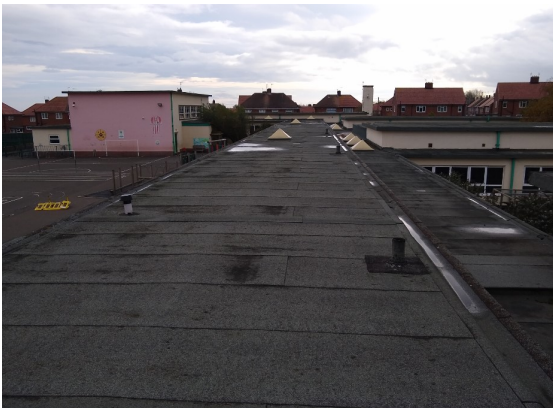
Item 63 Ref: 437902-21

The flat roof (External Roof 14) does not contain asbestos.

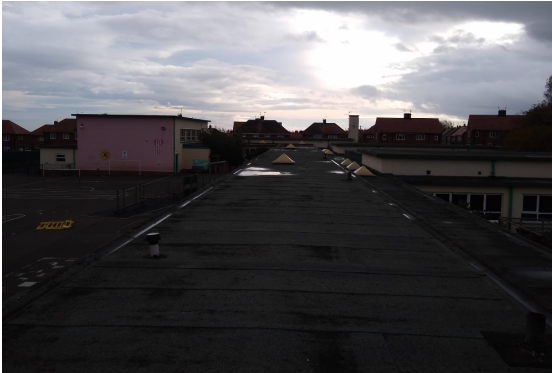
Item 64 Ref: 437902-22

The flat roof (External Roof 14) does not contain asbestos.

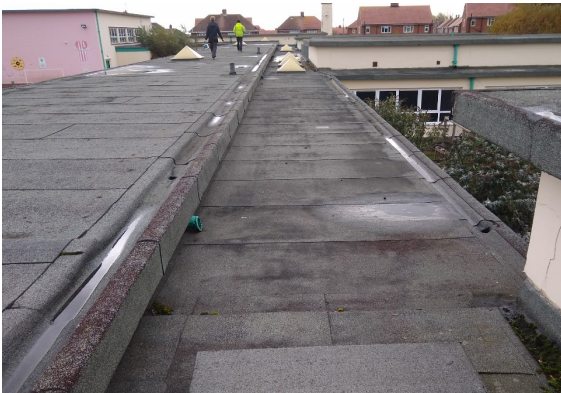
Item 65 Ref: 437902-23

The flat roof (External Roof 15) does not contain asbestos.

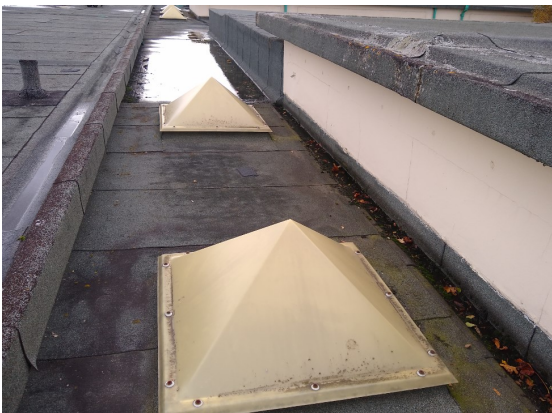
Item 66 Ref: 437902-24

The flat roof (External Roof 15) does not contain asbestos.

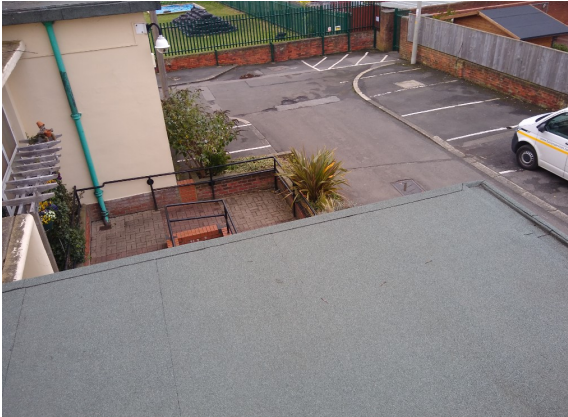
Item 67 Ref: 437902-25

The flat roof (External Roof 16) does not contain asbestos.

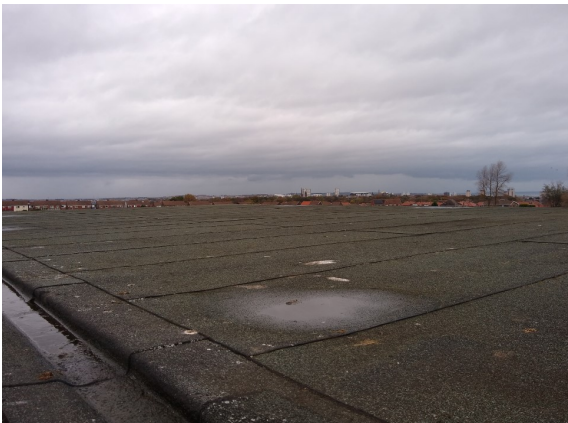
Item 68 Ref: 437902-26

The flat roof (External Roof 17) does not contain asbestos.

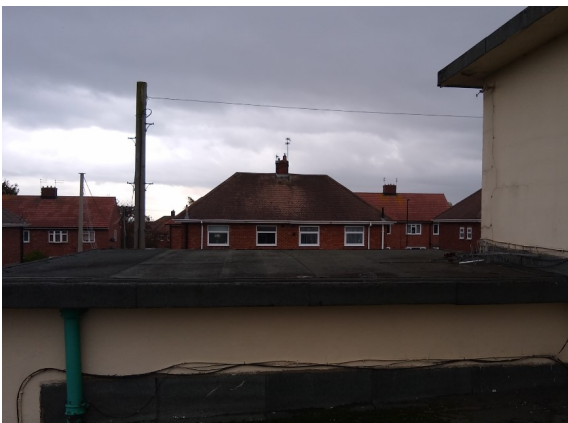
Item 69 Ref: 437902-27

The flat roof (External Roof 18) does not contain asbestos.

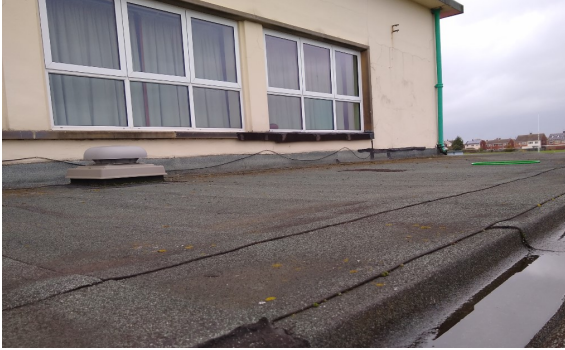
Item 70 Ref: 437902-28

The flat roof (External Roof 19) does not contain asbestos.

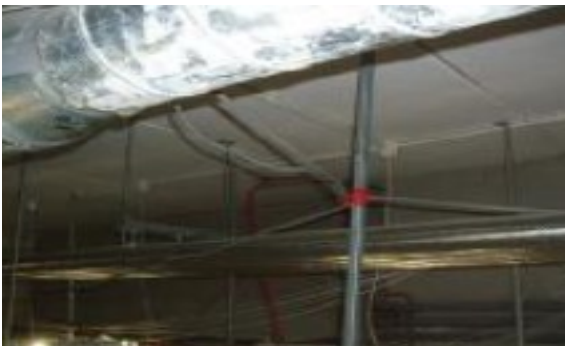
Item 71 Ref: SC17529

The ceiling board above ceiling tiles (Nursery WC ceiling void/Rm 013) does not contain asbestos.

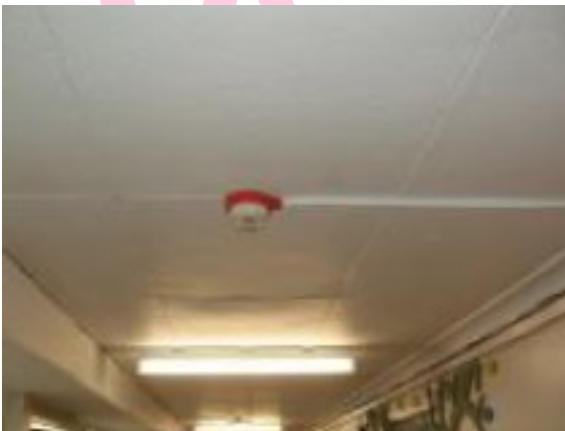
Item 72 Ref: SC17530

The ceiling board (Corridor 2/022) does not contain asbestos.

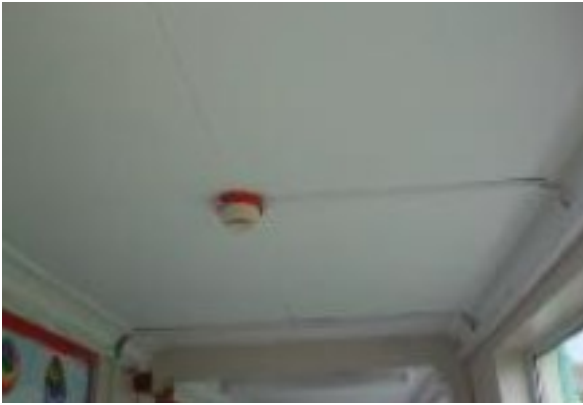
Item 73 Ref: SC17531

The ceiling board (Corridor 3/048) does not contain asbestos.

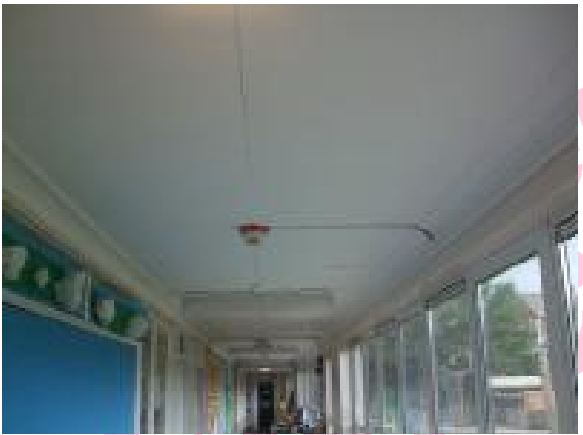
Item 74 Ref: SC17532

The ceiling board (Corridor 4/060) does not contain asbestos.

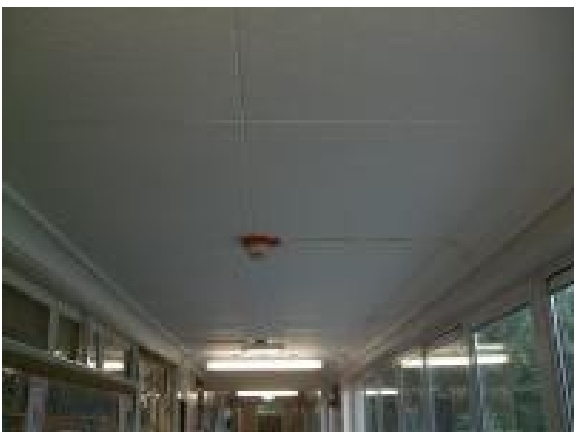
Item 75 Ref: SC17533

The ceiling board (Corridor 5/075) does not contain asbestos.

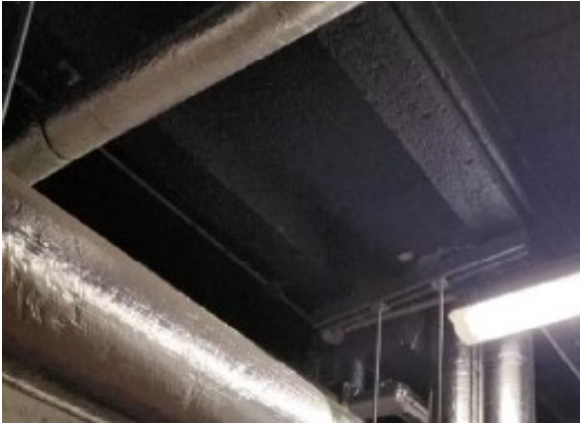
Item 76 Ref: NO000535

The debris/residue to the ceiling in the Boiler Room Z/001 does not contain asbestos.

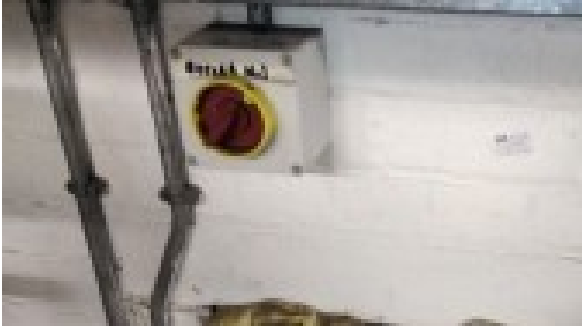
Item 79 Ref: NO000538

The debris/residue to flue chimney in the Boiler Room Z/001 does contain asbestos.

Environmental clean carried out August 2023. Any change in appearance notify Property Services.

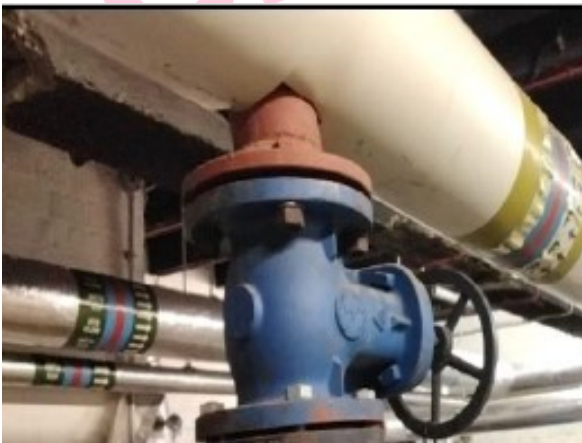
Item 81 Ref: NO000540

The pipework gaskets valve over boiler in the Boiler Room Z/001 does not contain asbestos.

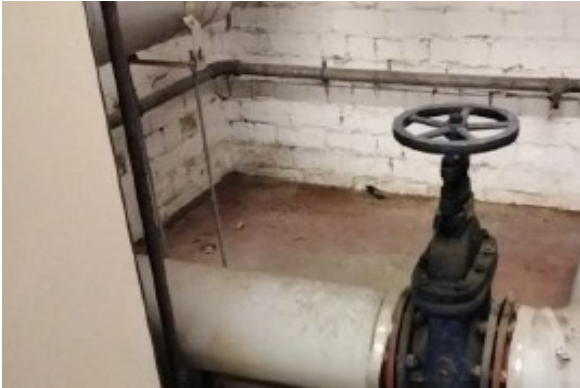
Item 82 Ref: NO00541

The pipework gaskets return flow valve and end stop in the Boiler Room Z/001 does not contain asbestos.

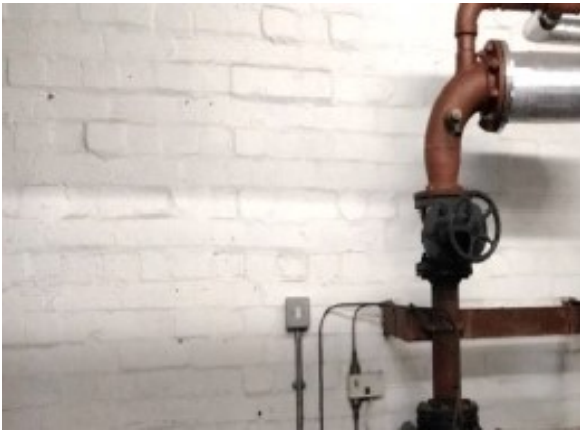
Item 83 Ref: NO00542

The pipework gaskets grunfos pumps in the Boiler Room Z/001 does not contain asbestos.

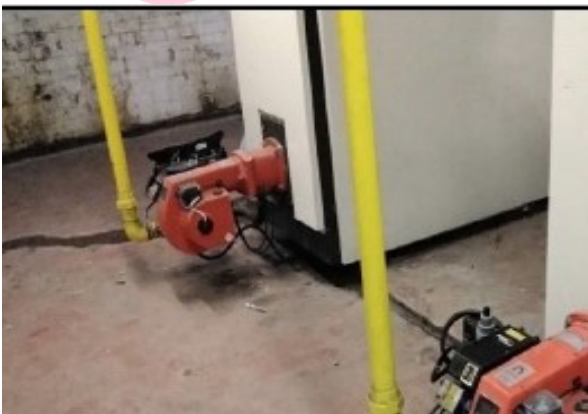
Item 84 Ref: NO000543

The pipework gasket on front of boiler in Boiler Room Z/001 does not contain asbestos.

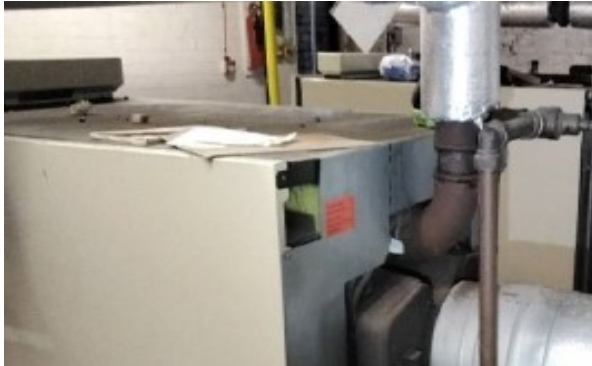
Item 85 Ref: NO000544

The boiler sealant at boiler HW outlet in the Boiler Room Z/001 does not contain asbestos.

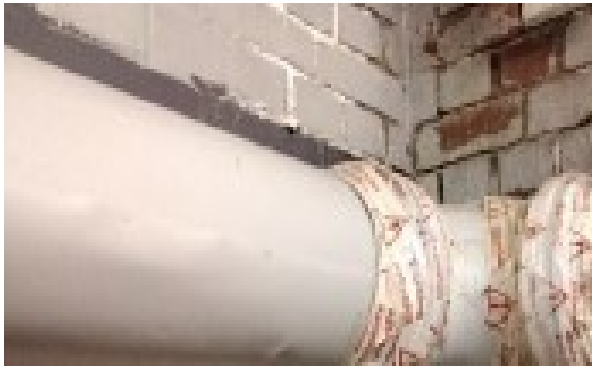
Item 86 Ref: Presumed

The pipework gaskets in the switch room Z/002 are presumed to contain asbestos.

Removed August 2023

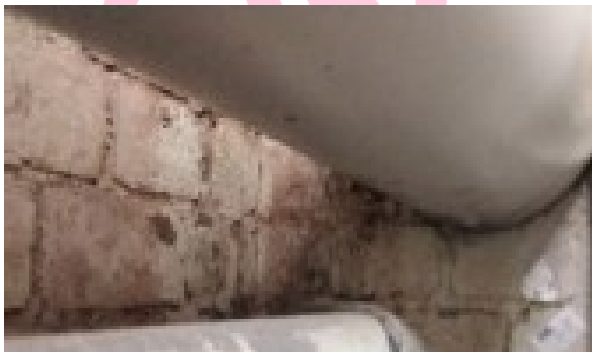
Item 87 Ref: NO00545

The debris/residue to walls behind redundant pipes in the switch room Z/002 does contain asbestos.

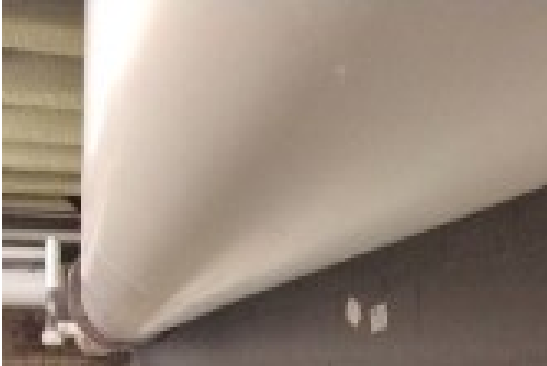
Item 88 Ref: NO000546

The debris/residue to walls behind redundant pipes partially sealed showing signs of deterioration in the switch room Z/002 does contain asbestos.

<i>Item 88</i>	<i>Debris/Residue to walls behind redundant pipes partially sealed showing signs of deterioration (Switch Room Z/002) (Encapsulated)</i>	<i>Low Risk</i>	<i>6 monthly</i>	<i>24/08/2025</i>
<i>Item 89</i>	<i>Debris/Residue to floor (Switch Room Z/002)(Encapsulated)</i>	<i>Medium</i>	<i>3 monthly</i>	<i>24/08/2025</i>
<i>Item 90</i>	<i>Electrical services cable braiding/insulation (Switch Room Z/002)</i>	<i>Very Low Risk</i>	<i>12 monthly</i>	<i>Removed August 2023</i>
<i>Item 91</i>	<i>Pipework gaskets valve over boiler (Room former coal bunker Z/004)</i>	<i>Very Low Risk</i>	<i>12 monthly</i>	<i>Removed August 2023</i>

Environmental clean carried out August 2023. Any change in appearance notify Property Services.

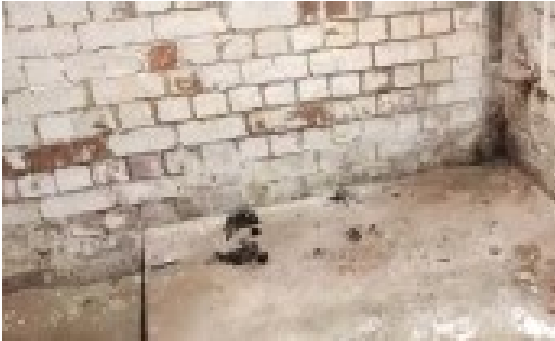
Item 89 Ref: NO000547

The debris/residue floor in the switch room Z/002 does contain asbestos.

Environmental clean carried out August 2023. Any change in appearance notify Property Services.

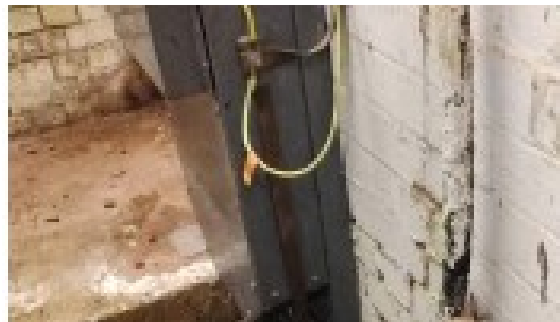
Item 90 Ref: Presumed

The electrical services cable braiding/insulation in the switch room Z/002 is presumed to contain asbestos.

Removed August 2023
