ASBESTOS SURVEY REPORT FOR HILL VIEW JUNIOR SCHOOL ACADEMY,  
QUEEN ALEXANDRA ROAD, SUNDERLAND, TYNE AND WEAR, SR2 9HE.

## *Control of Asbestos Regulations 2012*

**Hill View Junior School Academy, Queen Alexandra Road, Sunderland, SR2 9HE**

**Date: 06 August 2025**

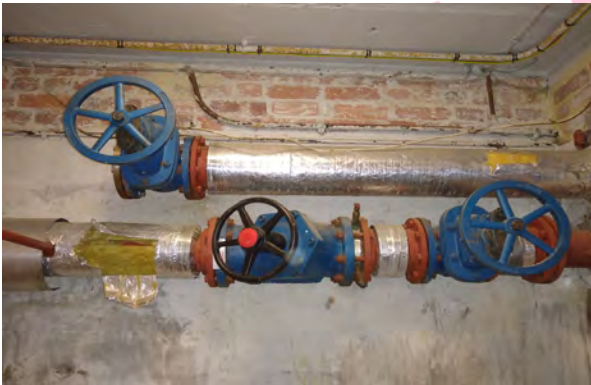
### **Item 14 Ref: 422644-11**

The pipework flange gaskets in the Switch Room (Rm -1/03) does not contain asbestos.

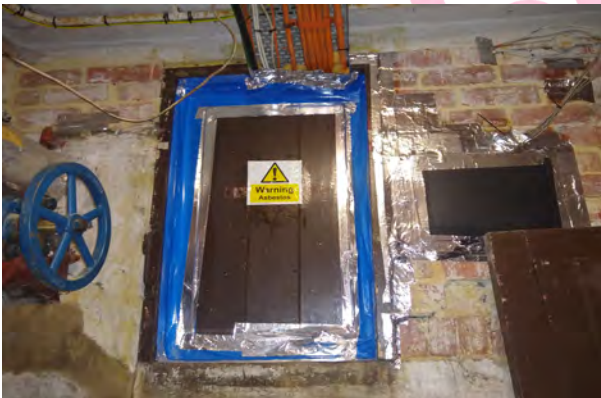
### **Item 17 Ref: 243272-1**

The lagging debris to floor in the Pipe Duct (Rm -1/04) does contain asbestos.

Any change in its appearance should be recorded and passed to Property Services.

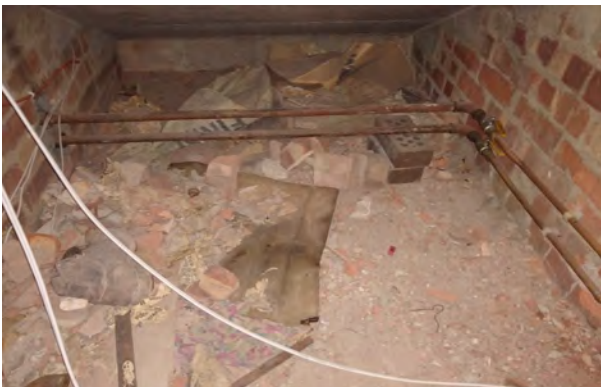
### **Item 18 Ref: 422644-15**

The loose lying felt to floor in the Main Entrance Lobby – void below stairs (Rm 0/01) does not contain asbestos.

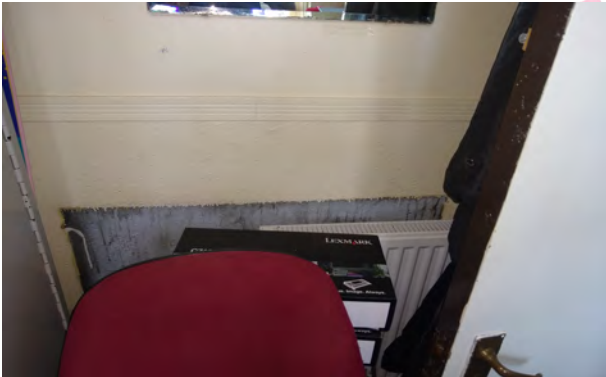
### **Item 23 Ref: As 422644-17**

The decorative finish to low level walls in the Office (Rm 0/06) does not contain asbestos.

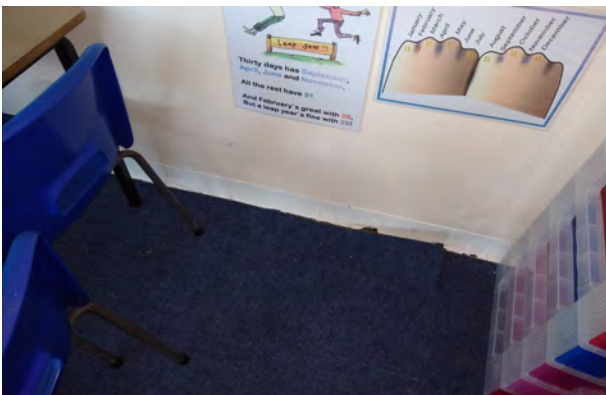
### **Item 24 Ref: 422644-19**

The skirting in the Classroom (Rm 0/08) does not contain asbestos.

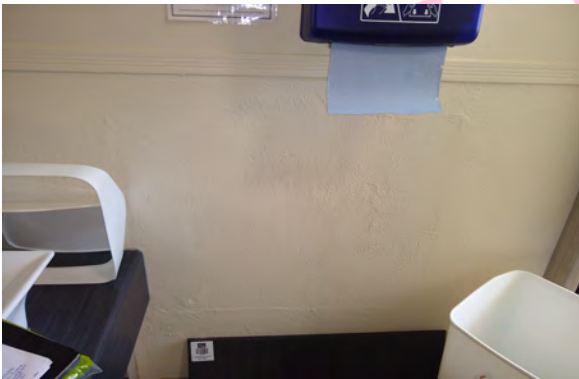
### **Item 38 Ref: 422644-27**

The patch repair to decorative finish to low level walls in the Male Staff WC & Lobby (Rm 0/20) does not contain asbestos.

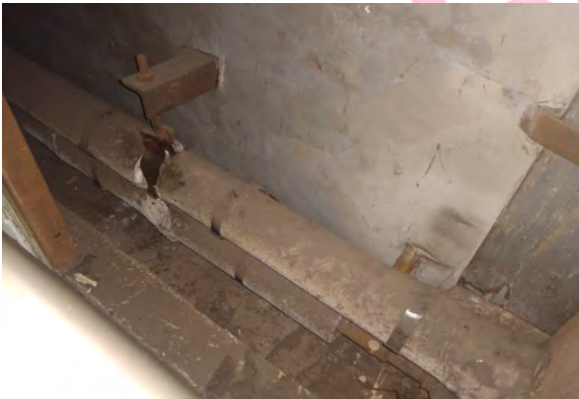
### **Item 68 Ref: 422644-41**

The pipe lagging in Classroom 4 – void within pipework boxing between redundant heaters (Rm 0/52) contains asbestos.

Any change in its appearance should be recorded and passed to Property Services.

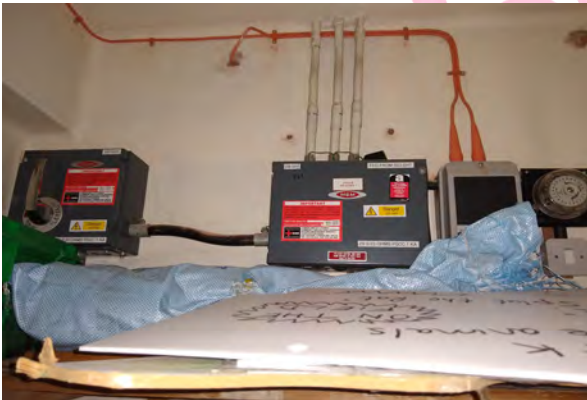
### **Item 119 Ref: Presumed**

The electrics in the Store (Rm 0/95) are presumed to contain asbestos.

Any change in its appearance should be recorded and passed to Property Services.

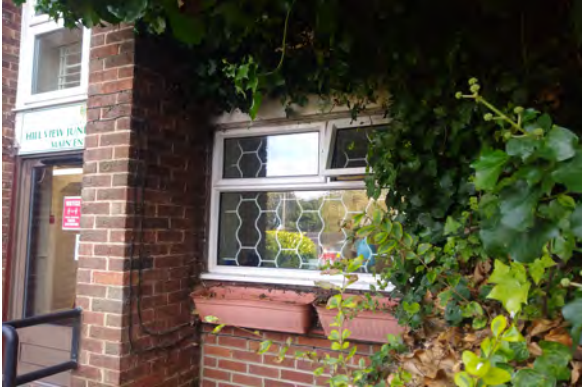
### **Item 151 Ref: 422644-65**

The remnant sealant to window frames either side of main entrance (External) contains asbestos.

Any change in its appearance should be recorded and passed to Property Services.

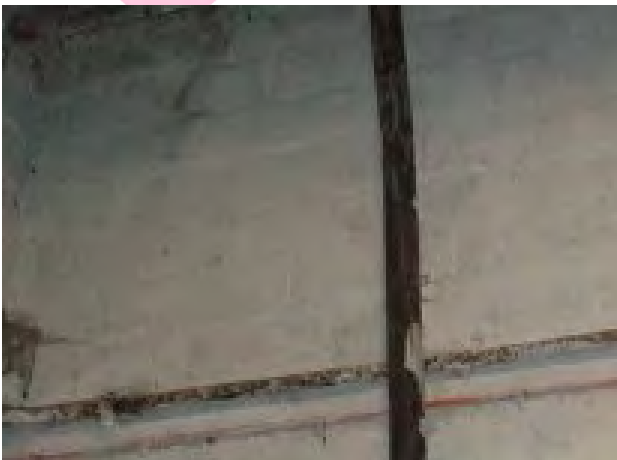
#### **Item 159 Ref: SC17527**

The insulation residue in the Plant Room (Basement) does not contain asbestos.
