ASBESTOS SURVEY REPORT FOR HOLLEY PARK ACADEMY, WASHINGTON

Asbestos Register for

**HOLLEY PARK ACADEMY SCHOOL,
WASHINGTON**

Date: 23rd June 2025

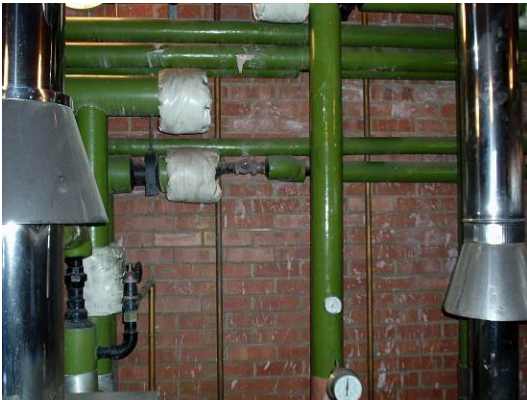
Item 2 - Ref: JP0542/07

The insulation to the pipework in the boiler room does not contain asbestos.

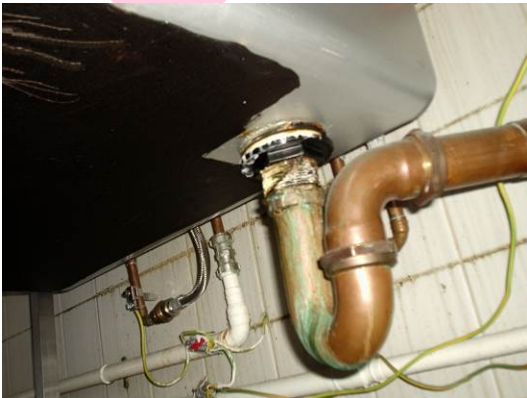
Item 3 - Ref: JP0545/07

The sink pad in the kitchen (Rm 0/8) does not contain asbestos.

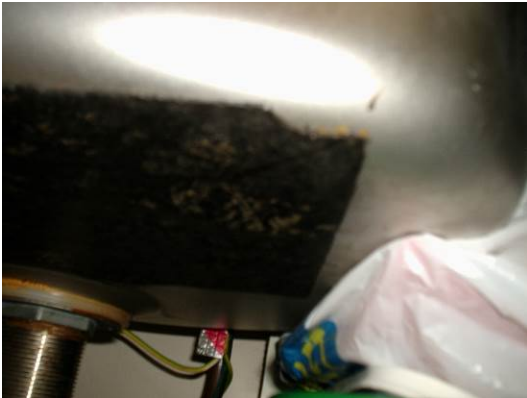
Item 5 - Ref: JP0547/07

The sink pad to classroom year 3 (Rm 0/12) does not contain asbestos.

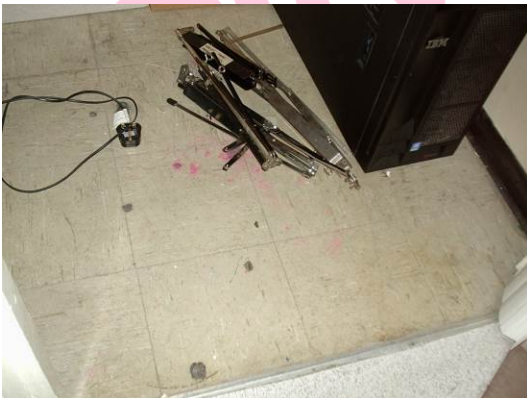
Item 6 – As JP0546/07

The vinyl floor tiles to the cleaners cupboard (Rm 0/16) contain asbestos.

Any change in its appearance should be recorded and passed to Property Services.

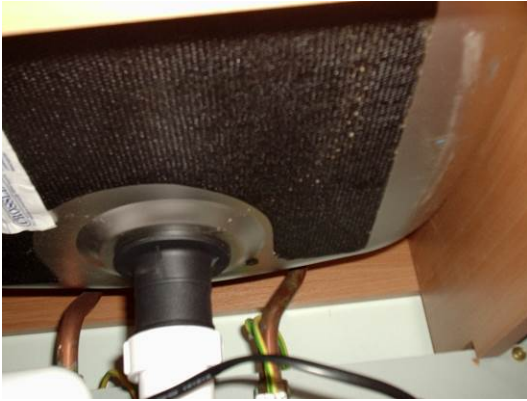
Item 7 - Ref: JP0548/07

The sink pad to classroom year 4 (Rm 0/20) does not contain asbestos.

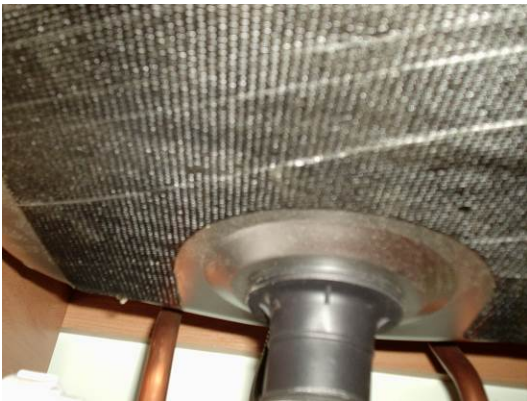
Item 8 - Ref: JP0549/07

The sink pad to classroom year 5 (Rm 0/21) does not contain asbestos.

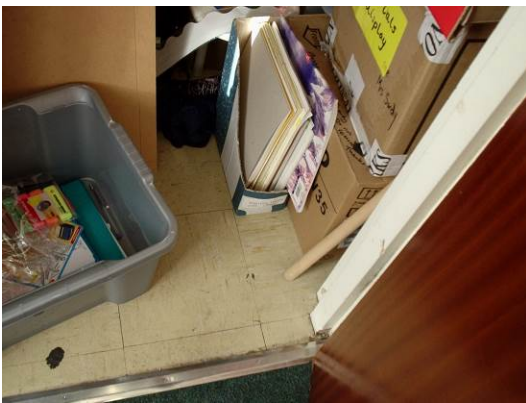
Item 11 – As JP0546/07

The cream floor tiles to the store cupboard (rm 0/27) contain asbestos.

Any change in its appearance should be recorded and passed to Property Services.

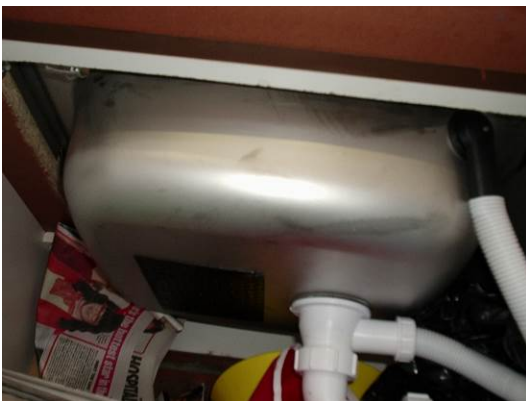
Item 12 – Ref: JP0552/07

The sink pad to classroom practical (Rm 0/29) does not contain asbestos.

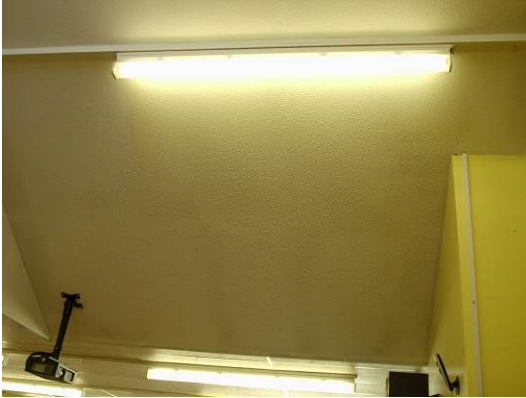
Item 13 - Ref: JP0553/07

The decorative coating to the ceiling in classroom reception 1 (Rm 0/31) does not contain asbestos.

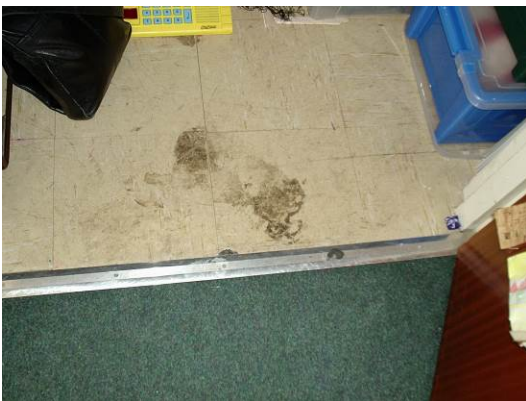
Item 15 – As JP0546/07

The cream floor tiles to the store (Rm 0/32) contain asbestos.

Any change in its appearance should be recorded, and passed to Property Services.

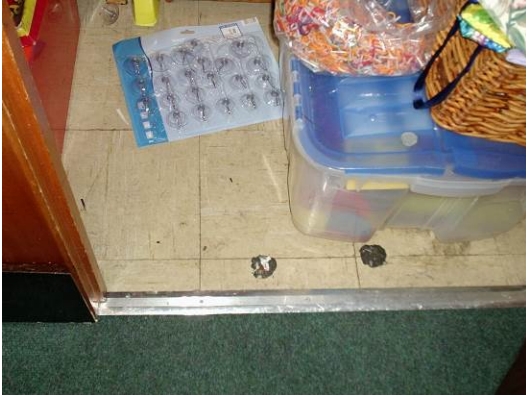
Item 16 – As JP0546/07

The cream floor tiles to the store (Rm 0/33) contain asbestos.

Any change in its appearance should be recorded and passed to Property Services.

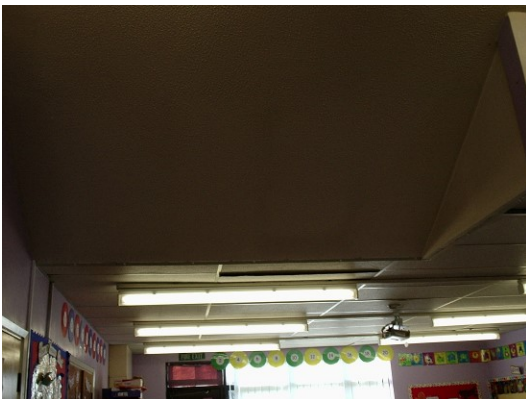
Item 18 – Ref: JP0554/07

The decorative coating to the ceiling in classroom reception 2 (Rm 0/35) does not contain asbestos.

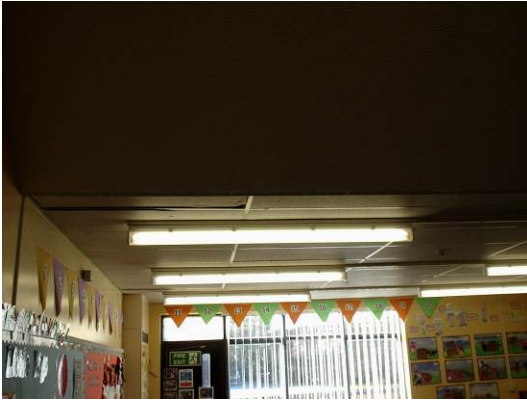
Item 19 Ref: JP0555/07

The decorative finish to the ceiling of Classroom Reception 3 (Rm 0/36) does not contain asbestos.

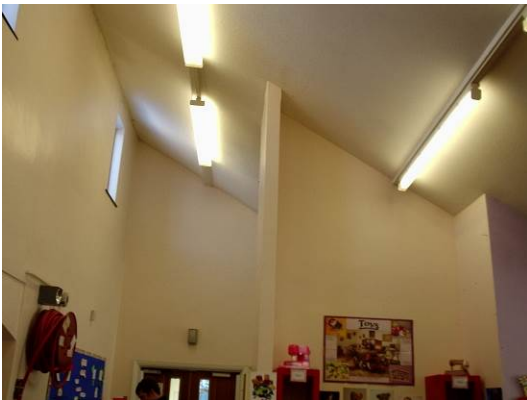
Item 20 - Ref: JP0556/07

The decorative finish to the ceiling of the corridor and practical area (Rm 0/37) does not contain asbestos.

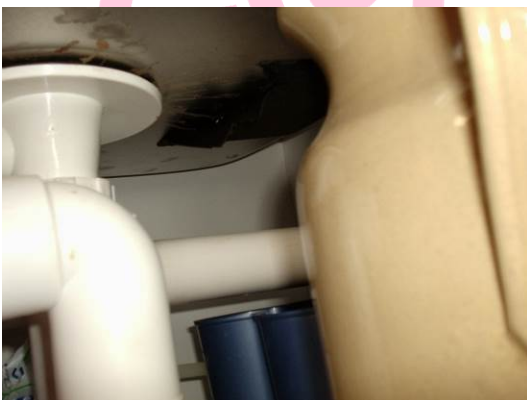
Item 21 - Ref: JP0558/07

The sink pad to the staff room (Rm 0/42) does not contain asbestos.

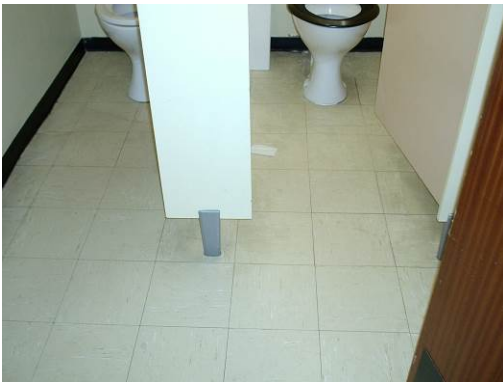
Item 23 – As JP0546/07

The cream floor tiles to the female toilets (Rm 0/44) contained asbestos.

These have now been removed.

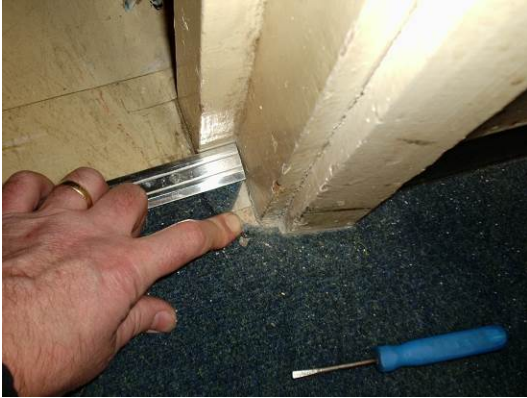
Item 25 - Ref: JP0559/07

The lino beneath the carpet in the corridor (Rm 0/50) does not contain asbestos.

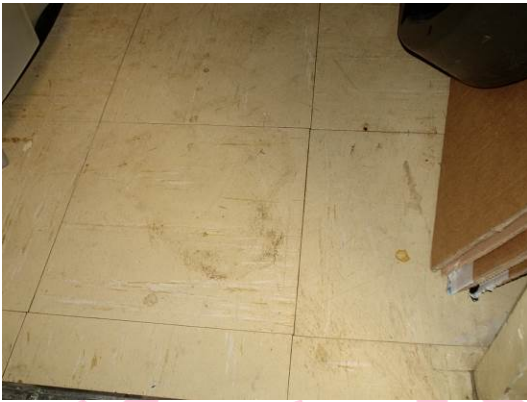
Item 26 – As JP0546/07

The cream floor tiles to the store room (Rm 0/51) contain asbestos.

Any change in its appearance should be recorded and passed to Property Services.

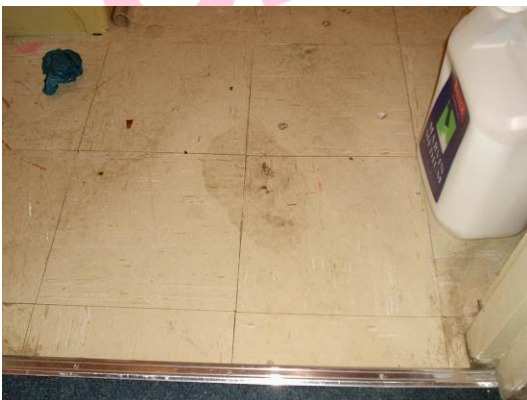
Item 27 – As JP0546/07

The cream floor tiles to the store room (Rm 0/52) contain asbestos.

Any change in its appearance should be recorded and passed to Property Services.

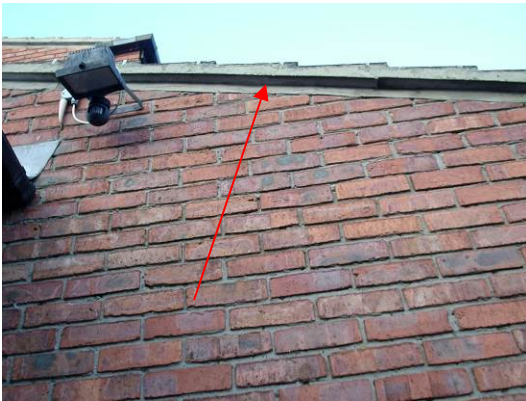
Item 28 - Ref: JP0544/07

The undercloaking to the external of the school contains asbestos.

Any change in its appearance should be recorded and passed to Property Services.

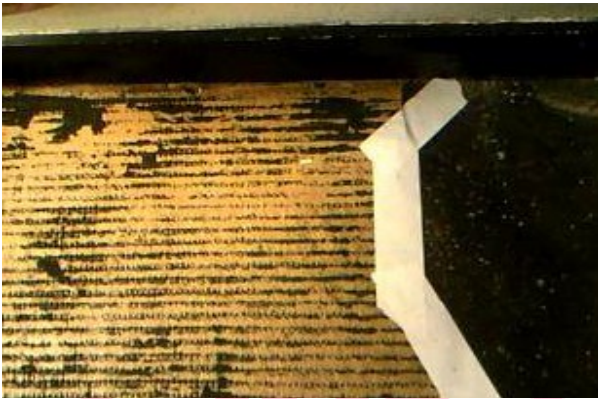
Item 32 - Ref: BB002525

The lino and screed below in the Key Stage 1 Cloaks does not contain asbestos.

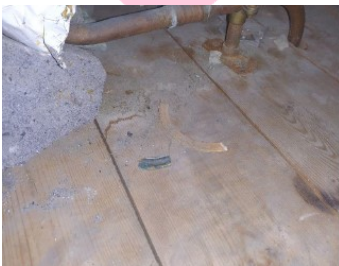
Item 33 Ref: RT000254

The loose gaskets - to plinth by water heater (1, Roof void 1, R/01) contain asbestos.

Any change in its appearance should be recorded and passed to Property Services.

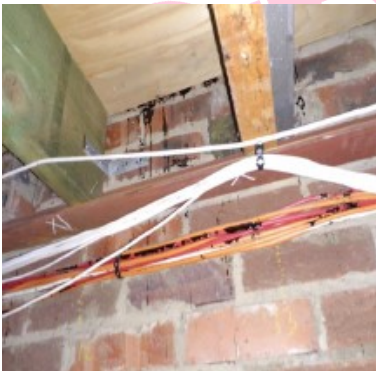
Item 36 Ref: As RT000255

The bitumen overspill - to walls/cabling in void (Nursery G/13) does not contain asbestos.

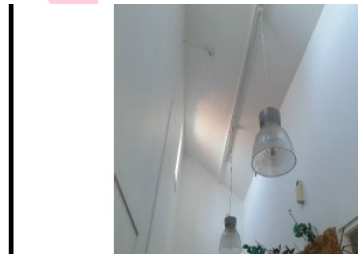
Item 39 Ref: As RT000257

The textured coating - to ceiling (Circulation G/17) does not contain asbestos.
